Remediation Summary & Deferral Request

Goodnight Midstream Permian, LLC Tanks CRP Burp

Eddy County, New Mexico
Unit Letter 25, Section 22, Township 31 South, Range 29 East
Latitude 32.35788 North, Longitude 103.73646 West
NMOCD Reference No. nAPP2420544315

Etech Environmental & Safety Solutions, Inc.
6309 Indiana Ave, Ste. D
Lubbock, Texas 79413

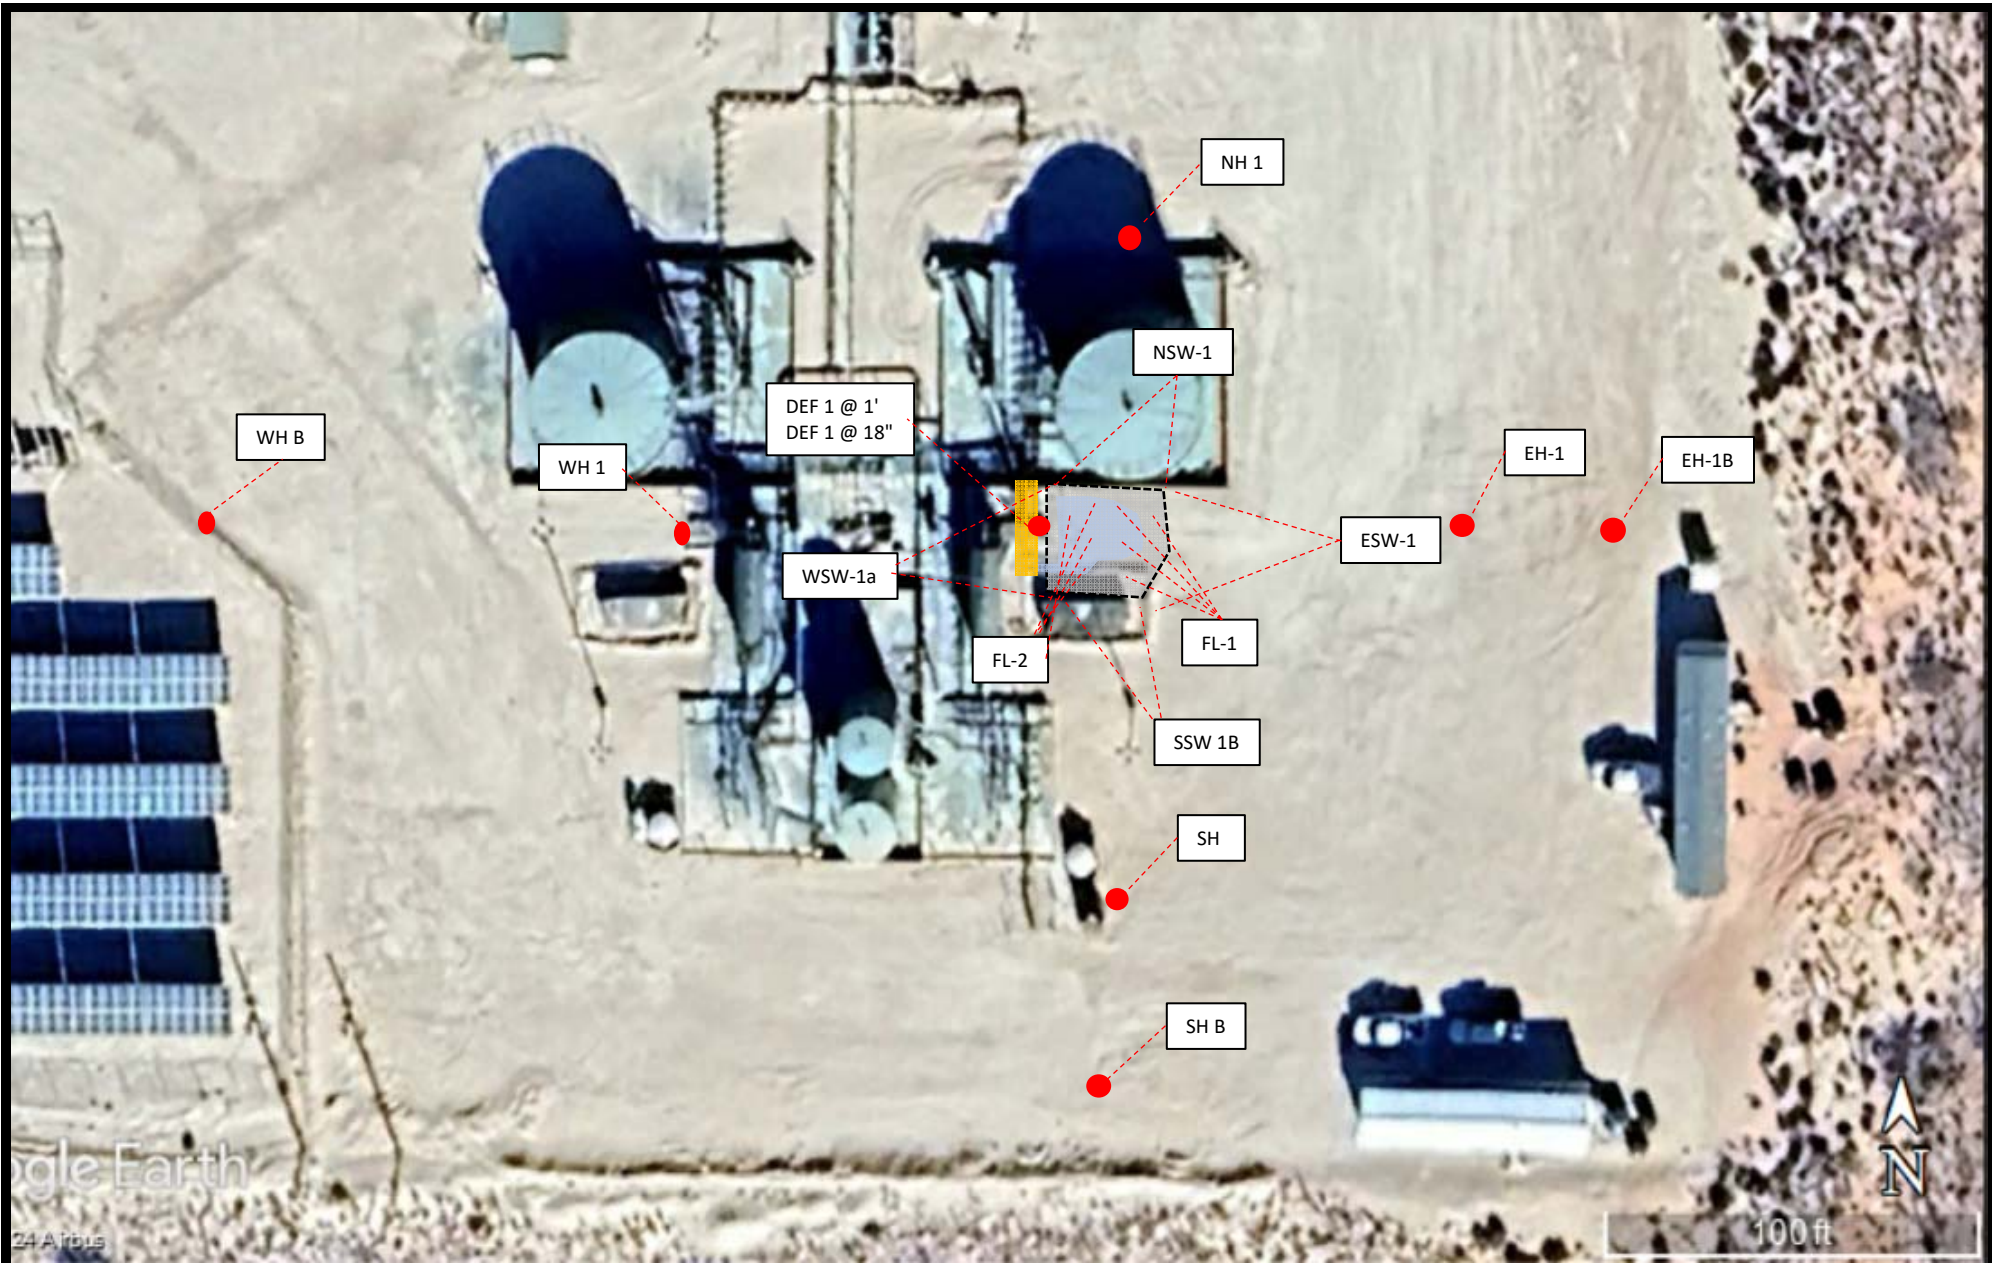
Figure 3

Site and Sample Location Map
