RUBY FEDERAL 28 WELL CHEMICAL TANK
nOY1724126728

PREPARED BY SAPEC-ECO, LLC.
PREPARED FOR MAVERICK PERMIAN, LLC.

Proposed Sampling and Remediation Work Plan

Re: Proposed Sampling and Remediation Work Plan
NMOCD Incident Number: **nOY1724126728**
Ruby Federal 28 Well Chemical Tank API No. 30-025-41018
Unit F, Section 17, Township 17S, Range 32E 1650 FNL 1500 FWL Lea County, NM
GPS Coordinates: Latitude 32.8373375 Longitude -103.7923813 NAD83

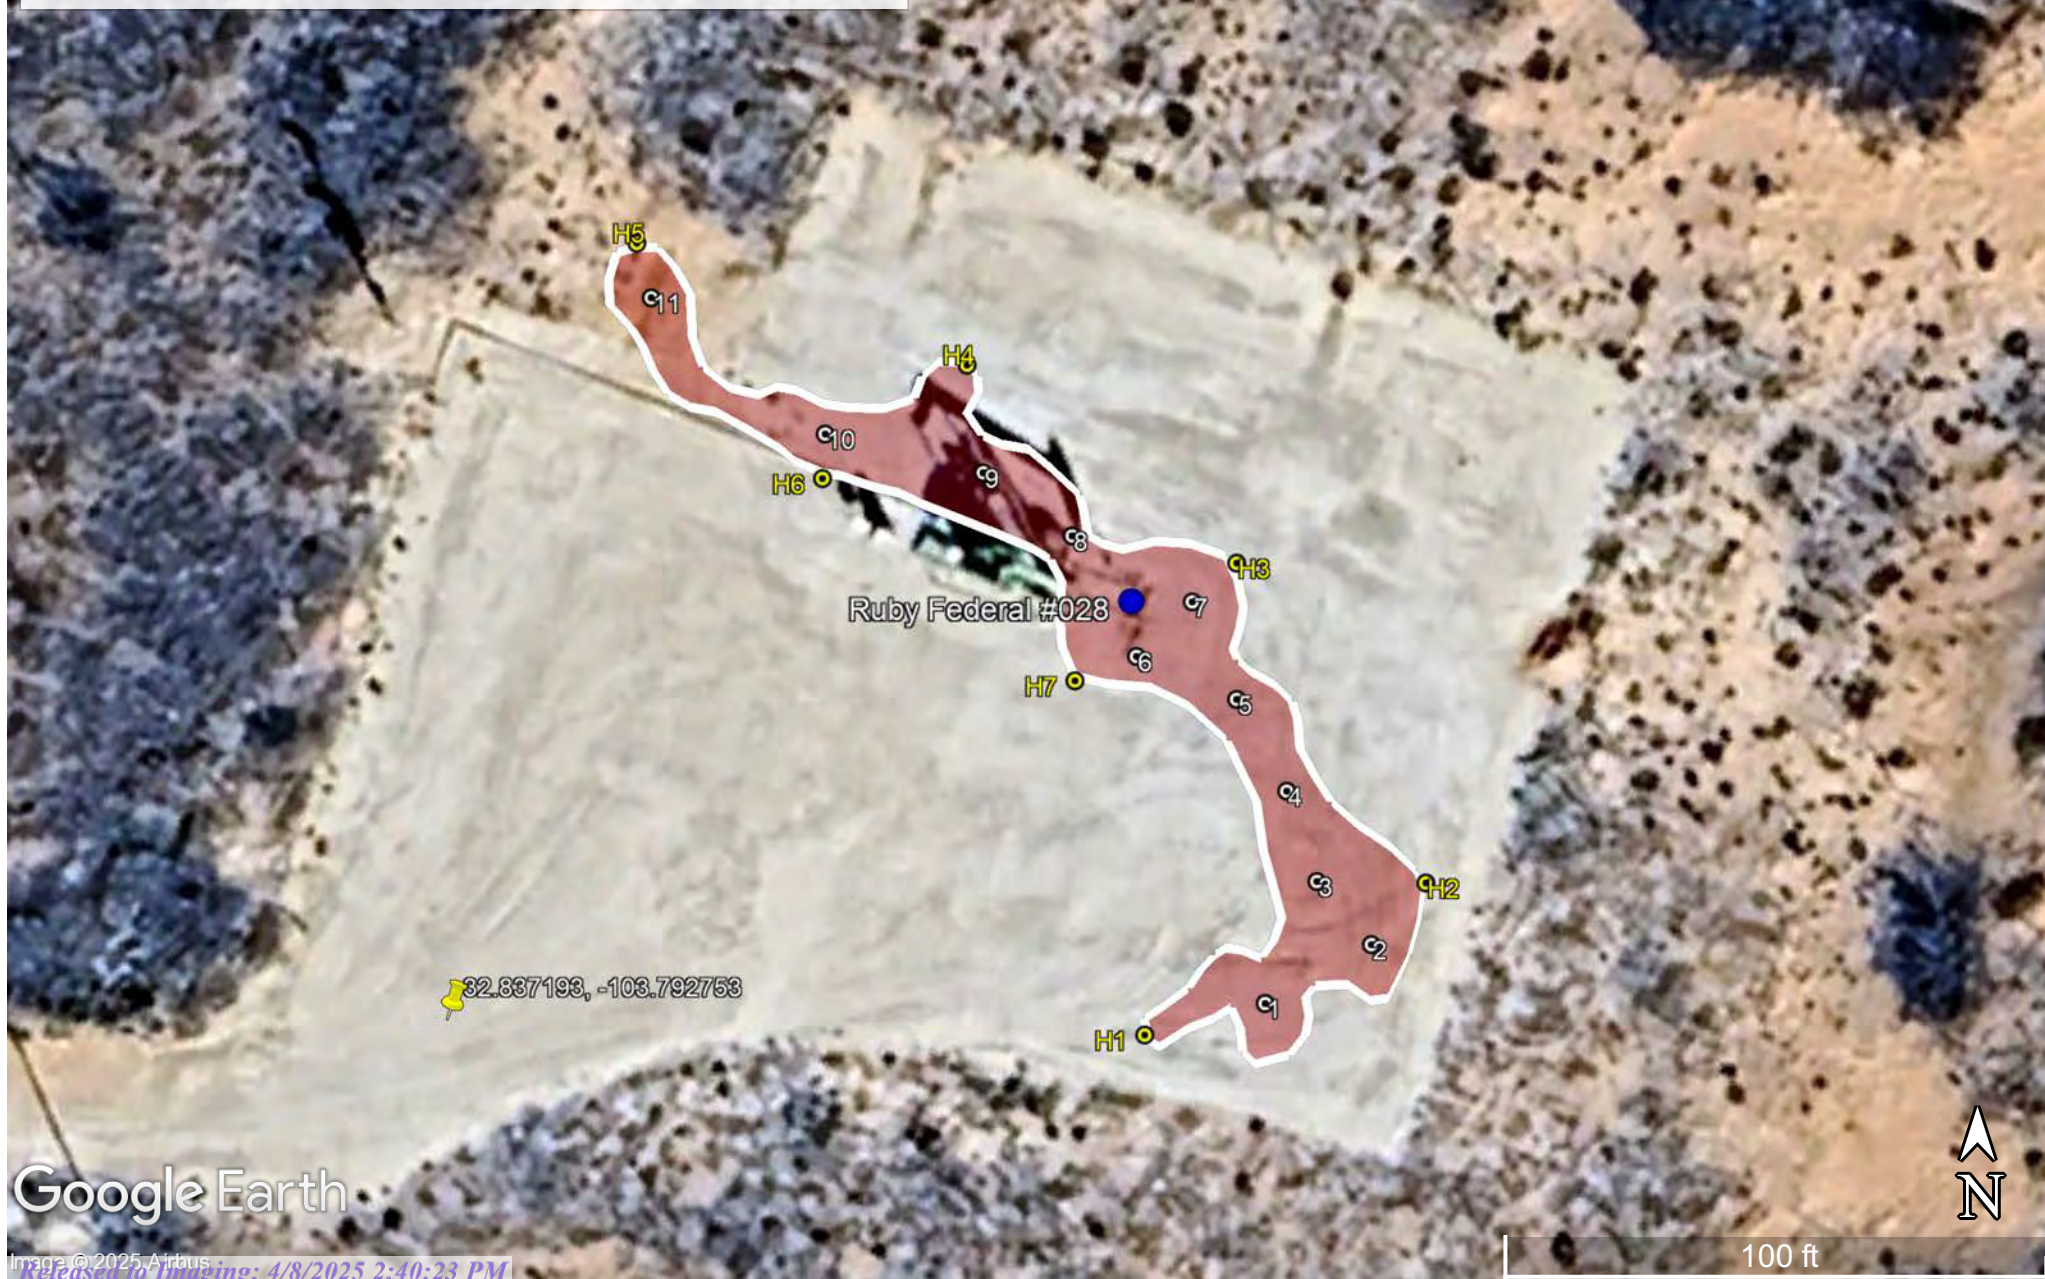
- Proposed horizontal samples
- Proposed vertical samples
- Release area - 3684 sqft

- A 48-hour sampling notification will be issued to the NMOCD for these sampling events. A variance request is included below for permission to use the delineation samples as confirmations samples depending on the sample results of the soil. A Proposed Sample Map can be found in Figure 1.

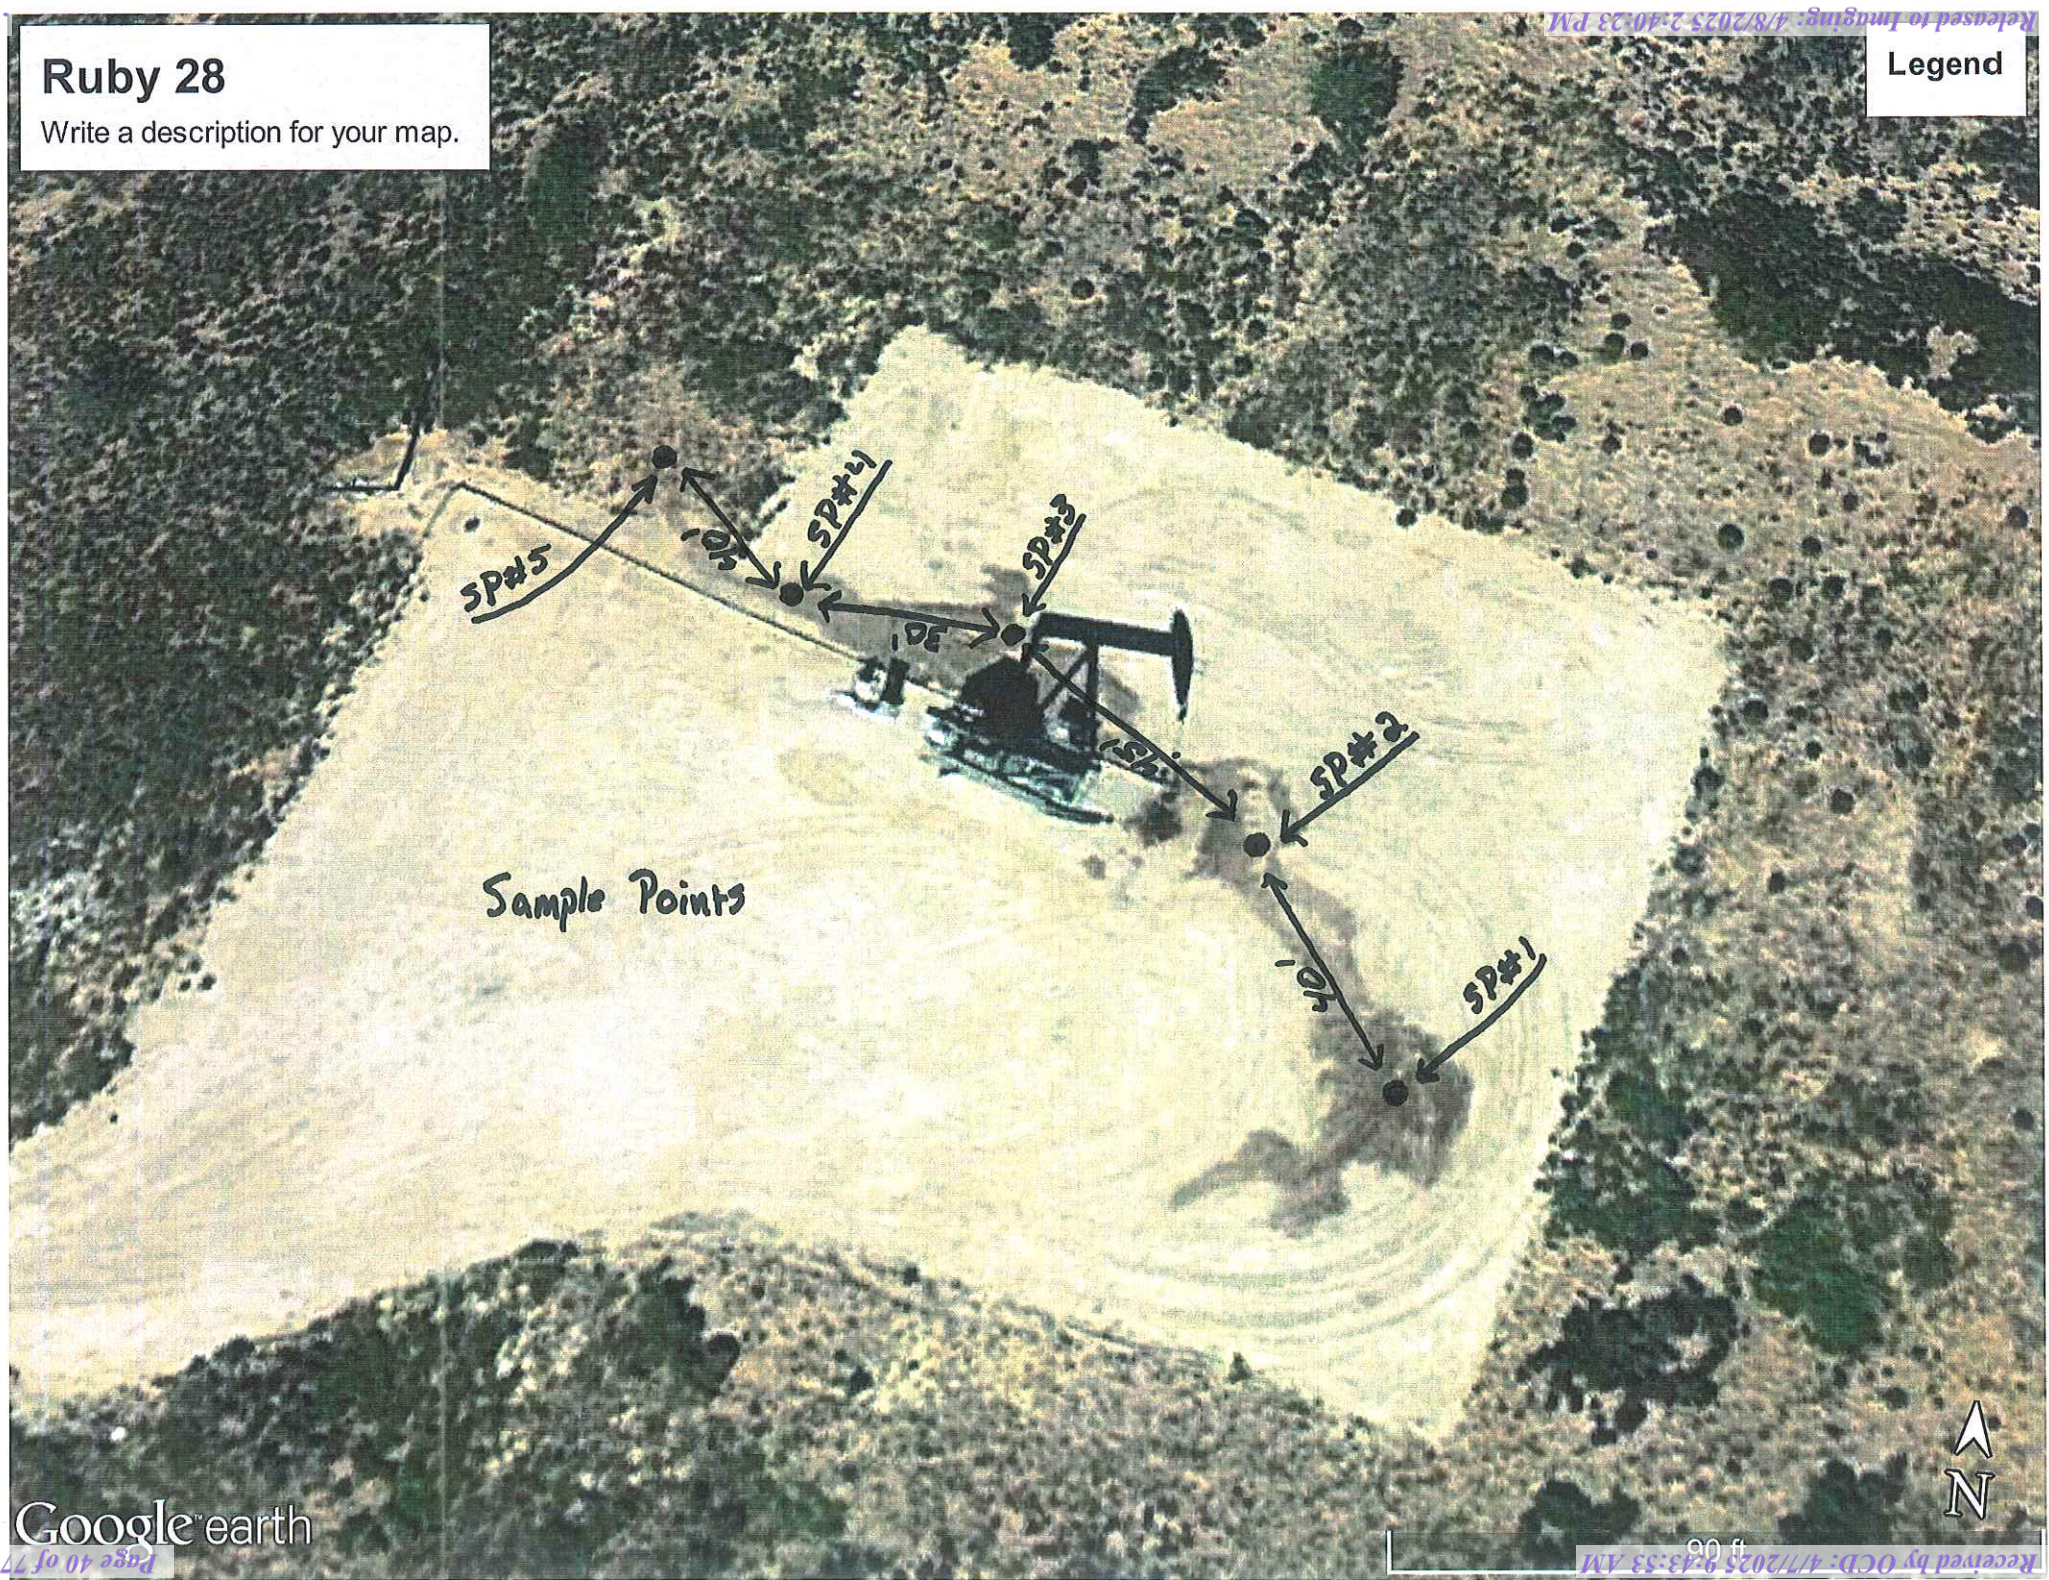
Sample Points

On August 25th 2017 a chemical tank leak happened on the Ruby 28 location resulting in the release of 16 bbls of fluid with 5 recovered. On August 8th 2018 COPC went to location and did samples in 5 different points to a depth of 8' (see attached map). All points had samples taken at surface, 1', 4' and 8' and had the samples from Surface, 1' and 4' tested for chlorides, BTEX and TPH, the 8' samples were tested for chlorides only. Sample points 1,3, 4 and 5 all showed chlorides of >250 at 4' with sample point 2 showing <250 at 8'. All samples showed clean of BTEX and TPH at the 4' depth. We propose digging the entire area to a depth of 2.5 feet and the area around sample point 2 to a depth of 5' and replacing with clean soil. We will also take confirmation wall samples once the dig is completed. We request immediate backfill since the dig around the wellhead is at the deepest depths and would interfere with any well work if it was needed. We will attach photos and maps of all work along with soil sample results.
