# Site Assessment Summary, Proposed Remediation Plan & Alternative Sampling Plan

## Permian Resources

### Whitten SWD ROW

NMOCD Reference No. nAPP2429762272 & nAPP2503175872

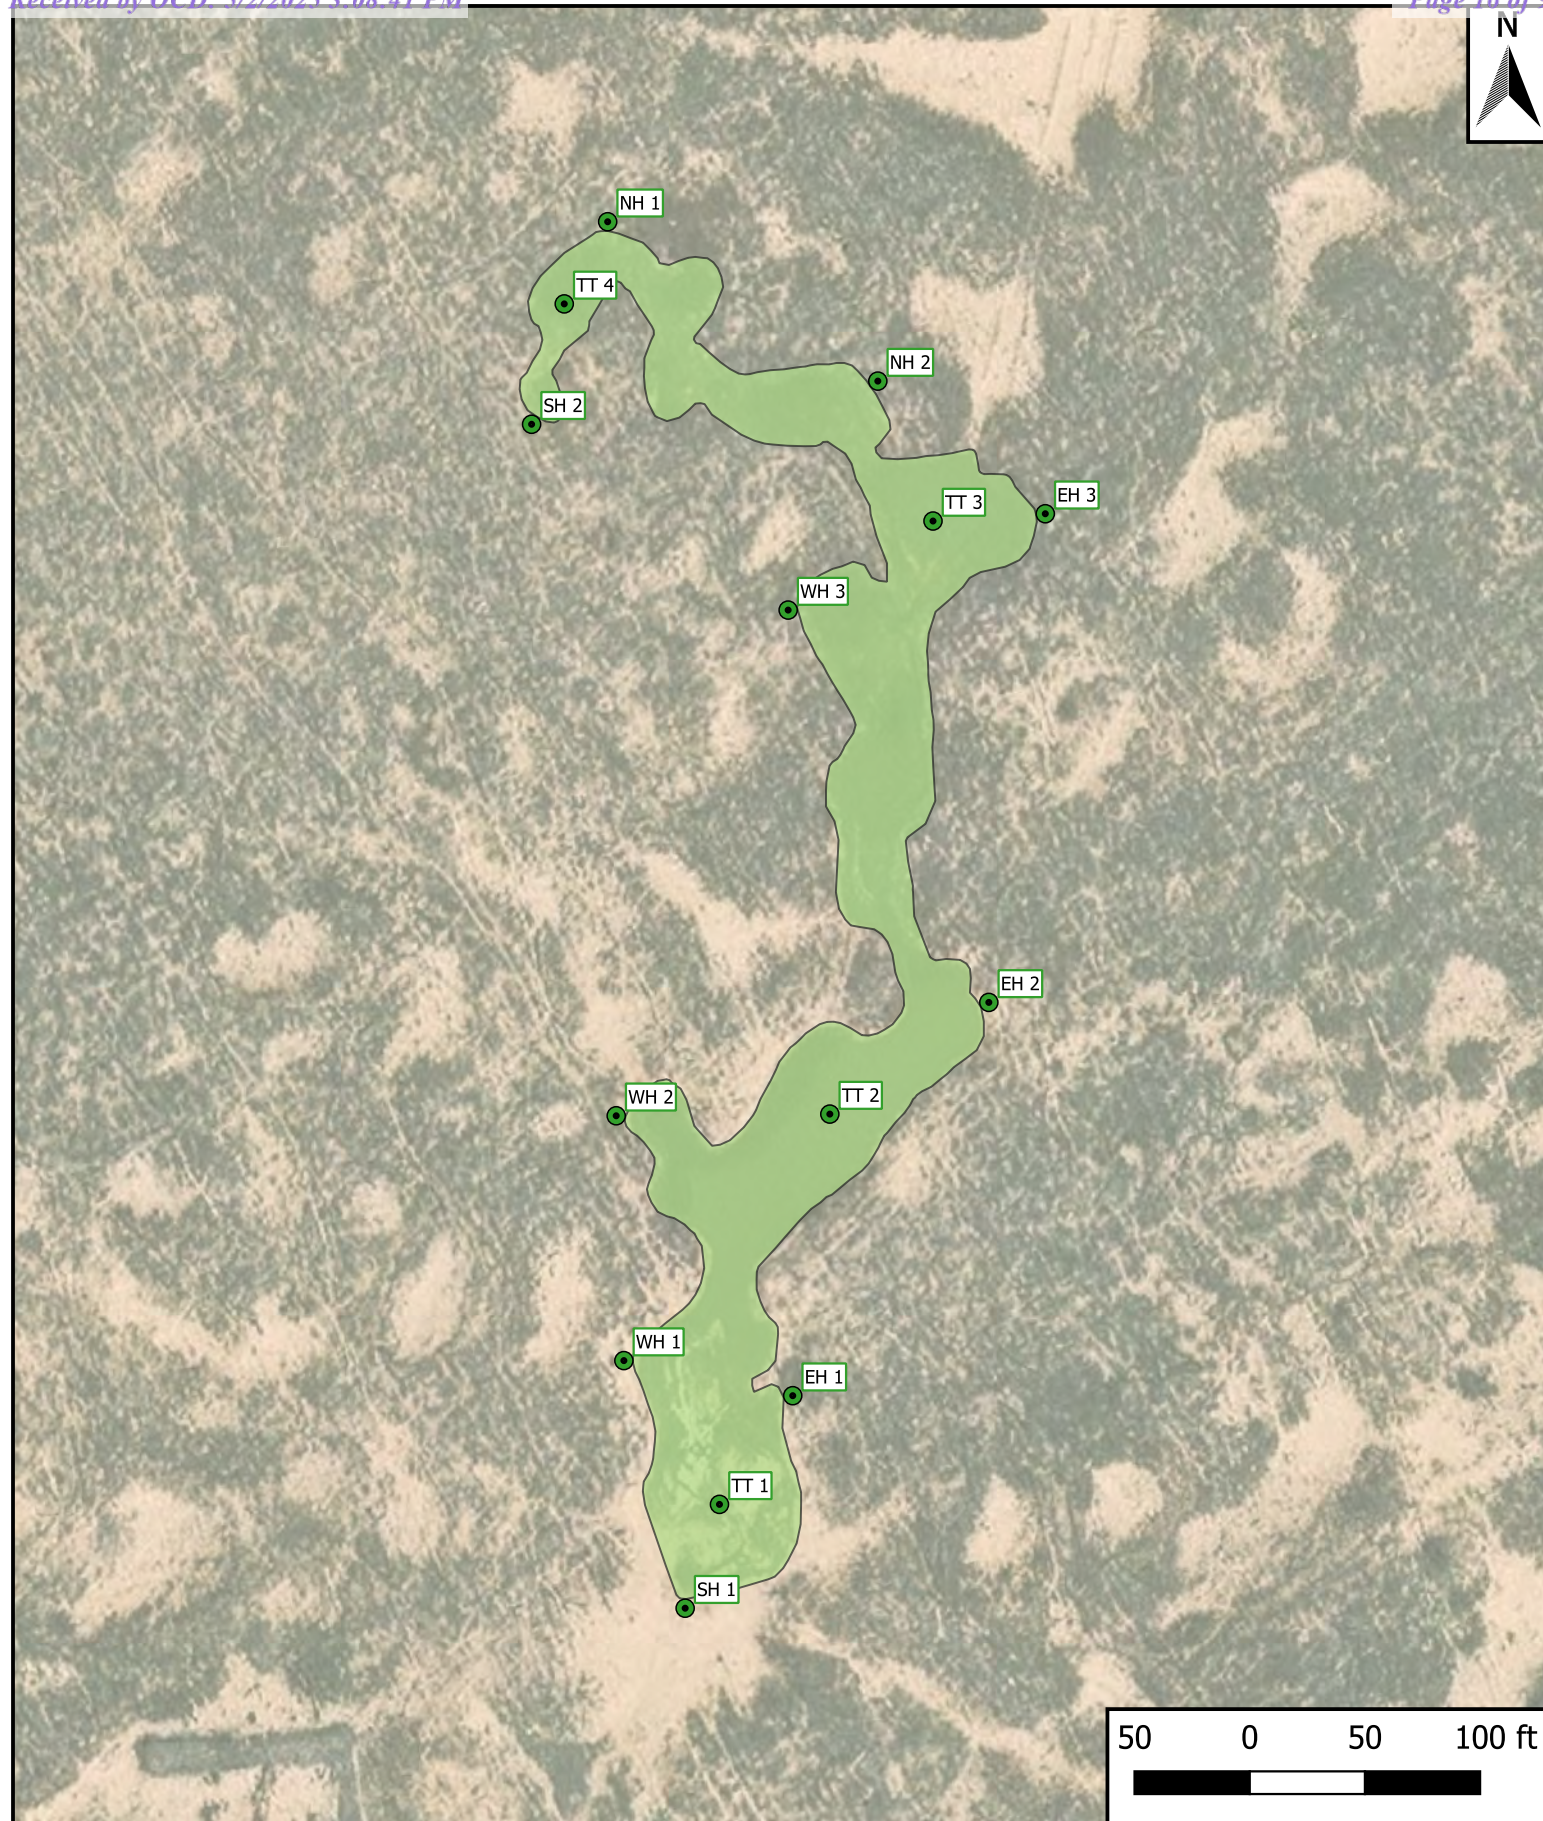
## **Figure 3**

### **Sample Location Map**

- Affected Area (~32,594 ft<sup>2</sup>)
- Delineation Sample Location

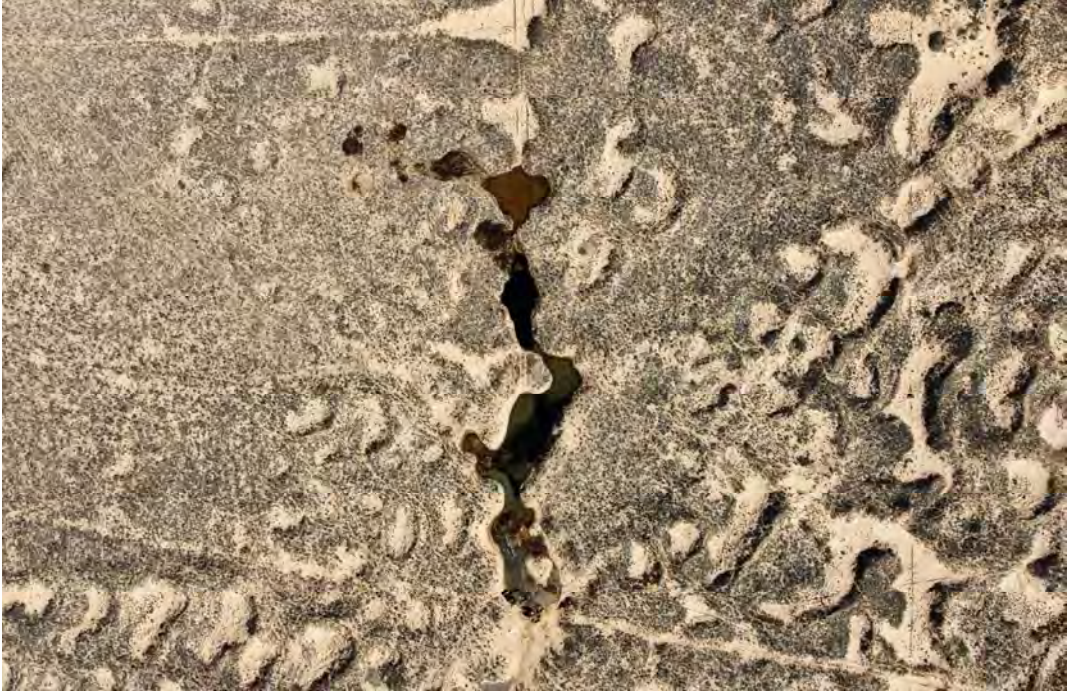
<b>Photo Number:</b> 1

<b>Photo Direction:</b> Overhead/Bird's Eye	
<b>Date:</b> 10/23/2024	
<b>Coordinates:</b> 32.575731,-103.536069	
<b>Photo Description:</b>  Aerial view of the affected area.

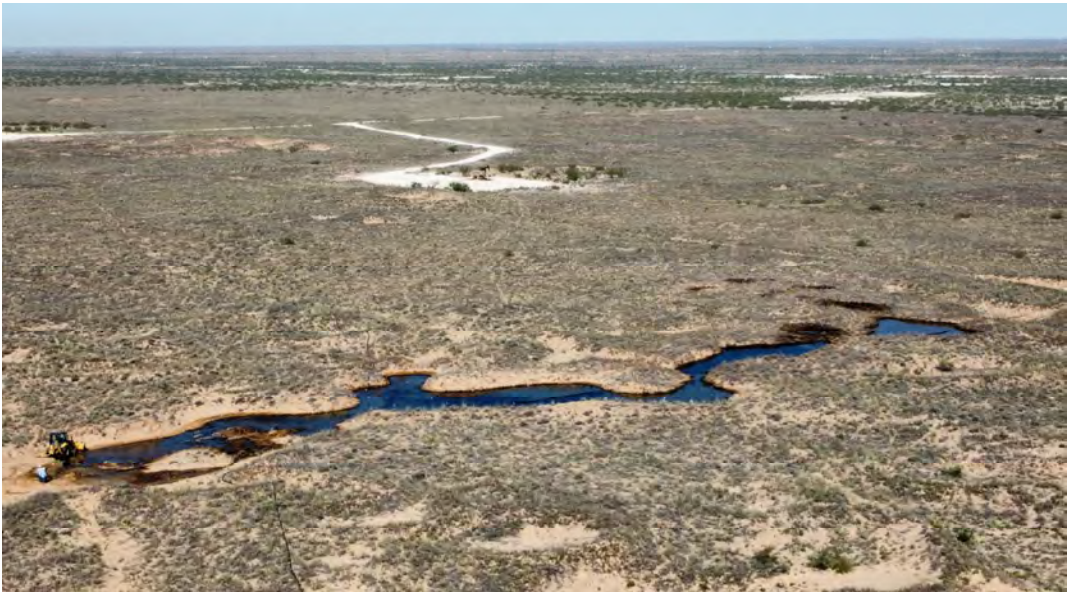
<b>Photo Number:</b> 2

<b>Photo Direction:</b> Northwest	
<b>Date:</b> 10/23/2024	
<b>Coordinates:</b> 32.575570,-103.535315	
<b>Photo Description:</b>  Aerial view of the affected area.

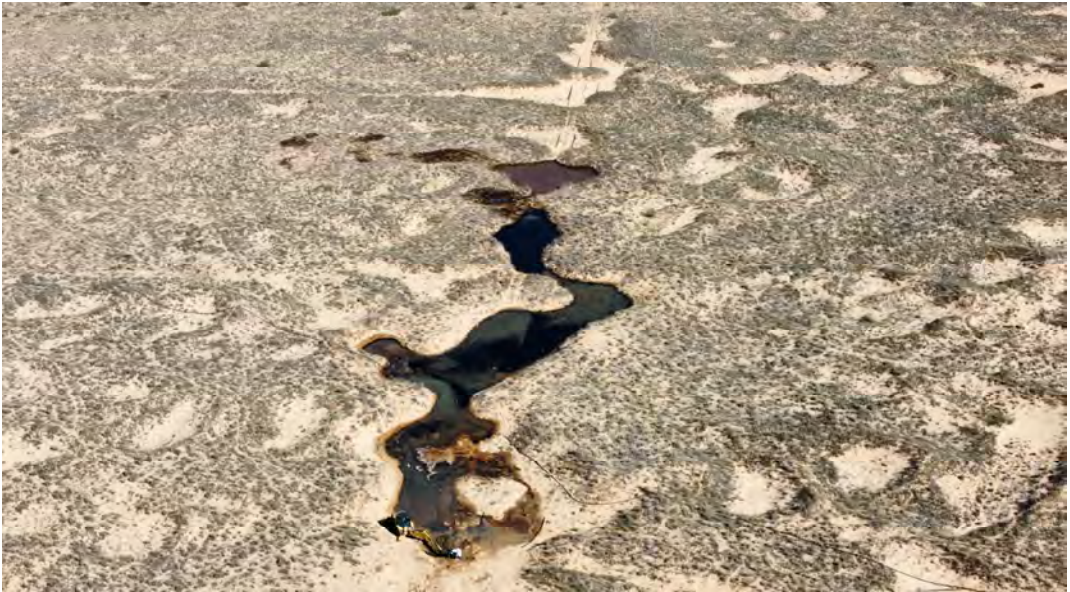
<b>Photo Number:</b> 3

<b>Photo Direction:</b> North-Northeast	
<b>Date:</b> 10/23/2024	
<b>Coordinates:</b> 32.574910,-103.536400	
<b>Photo Description:</b>  Aerial view of the affected area.

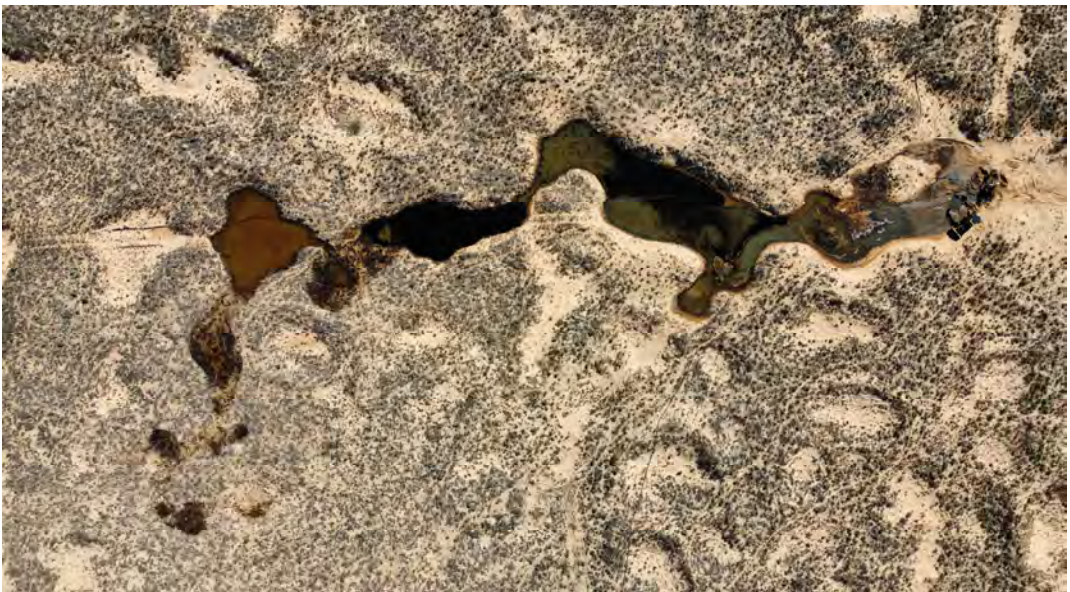
<b>Photo Number:</b> 4

<b>Photo Direction:</b> Overhead/Bird's Eye	
<b>Date:</b> 10/23/2024	
<b>Coordinates:</b> 32.576073,-103.536421	
<b>Photo Description:</b>  Aerial view of the affected area.

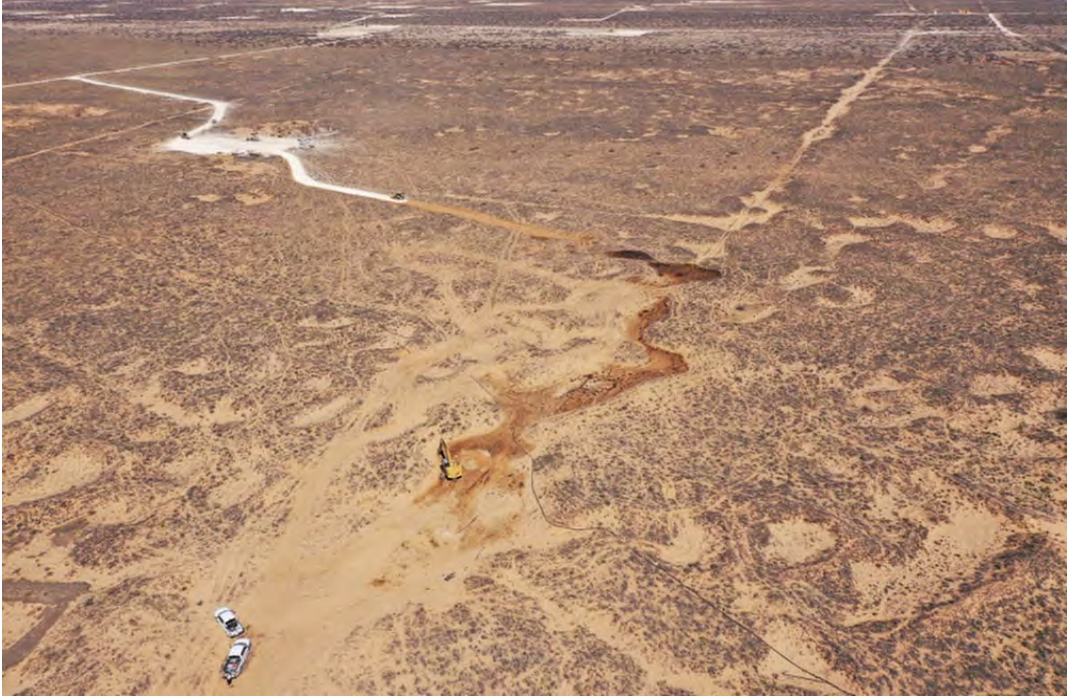
<b>Photo Number:</b> 5

<b>Photo Direction:</b> Northwest	
<b>Date:</b> 3/11/2025	
<b>Coordinates:</b> 32.574629,-103.535915	
<b>Photo Description:</b>  Aerial view of the affected area.

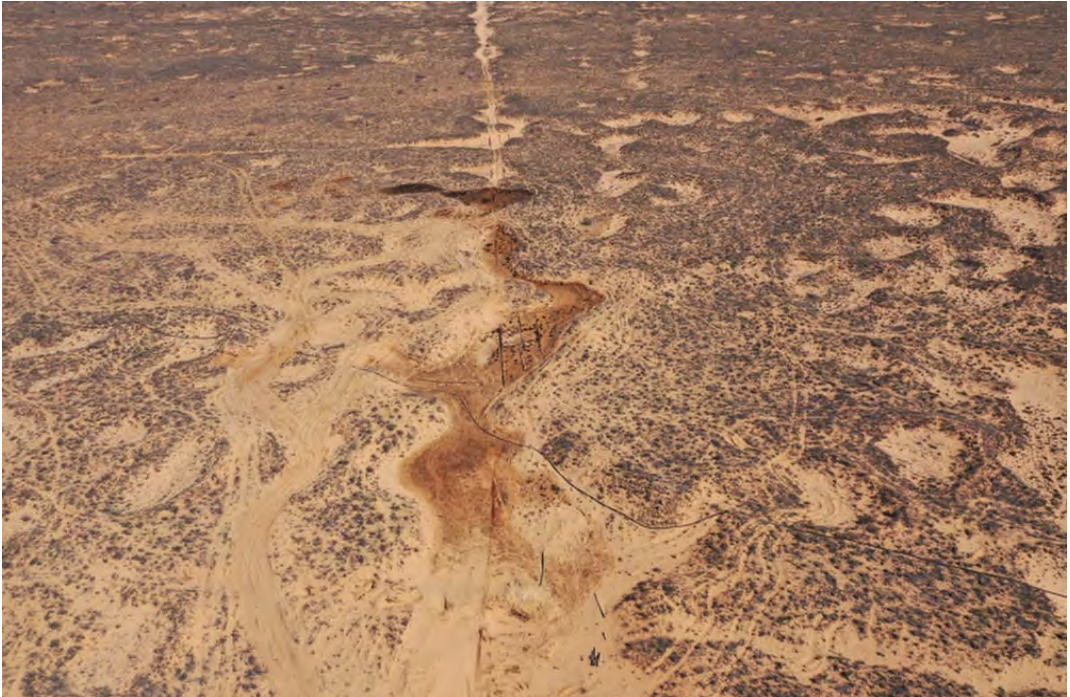
<b>Photo Number:</b> 6

<b>Photo Direction:</b> North-Northeast	
<b>Date:</b> 3/11/2025	
<b>Coordinates:</b> 32.574792,-103.536454	
<b>Photo Description:</b>  Aerial view of the affected area.

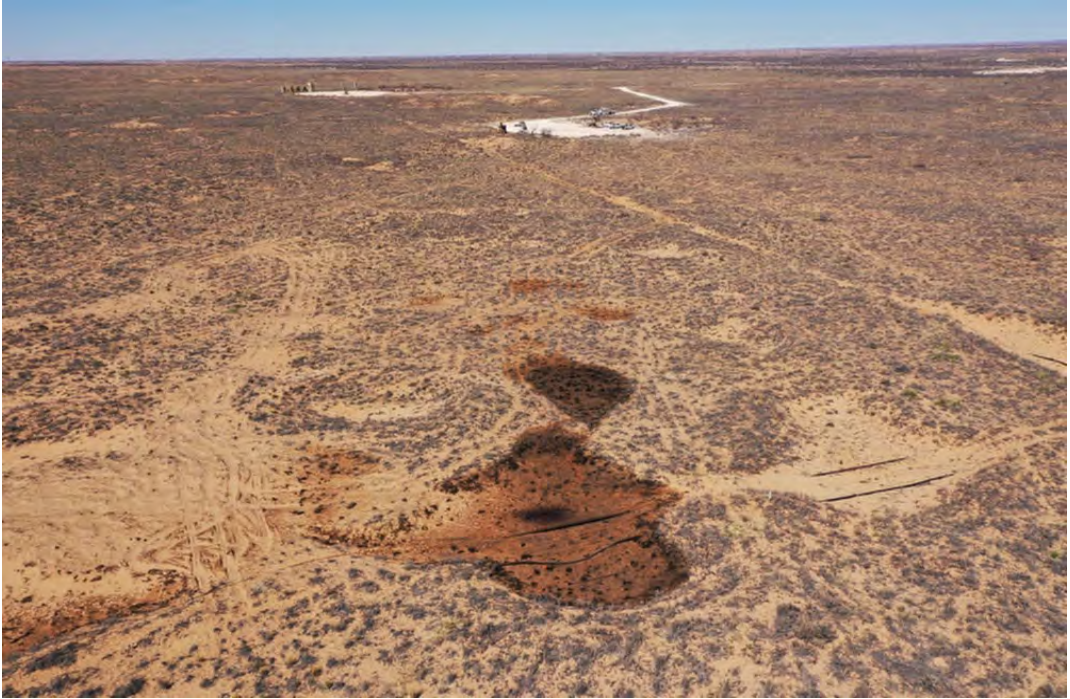
<b>Photo Number:</b> 7

<b>Photo Direction:</b> Northwest	
<b>Date:</b> 3/11/2025	
<b>Coordinates:</b> 32.576194,-103.535562	
<b>Photo Description:</b>  Aerial view of the affected area.

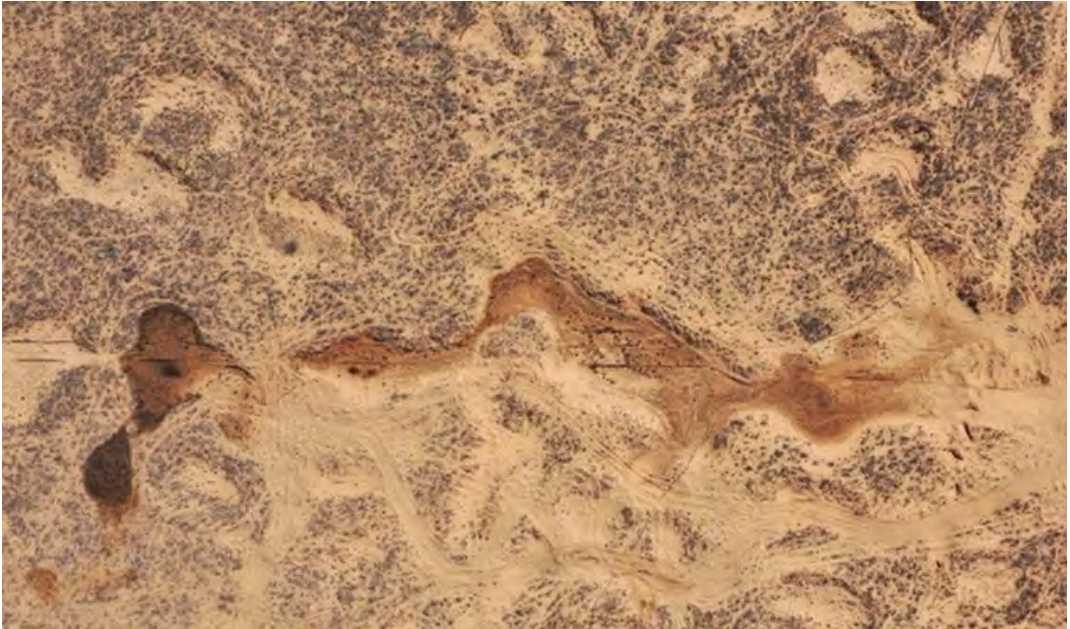
<b>Photo Number:</b> 8

<b>Photo Direction:</b> Overhead/Bird's Eye	
<b>Date:</b> 3/11/2025	
<b>Coordinates:</b> 32.575795,-103.536116	
<b>Photo Description:</b>  Aerial view of the affected area.
