Remediation Summary & Soil Closure Request

Mewbourne Oil Company Caper/Lox Battery

Lea County, New Mexico

NMOCD Reference No. nAPP2504558538

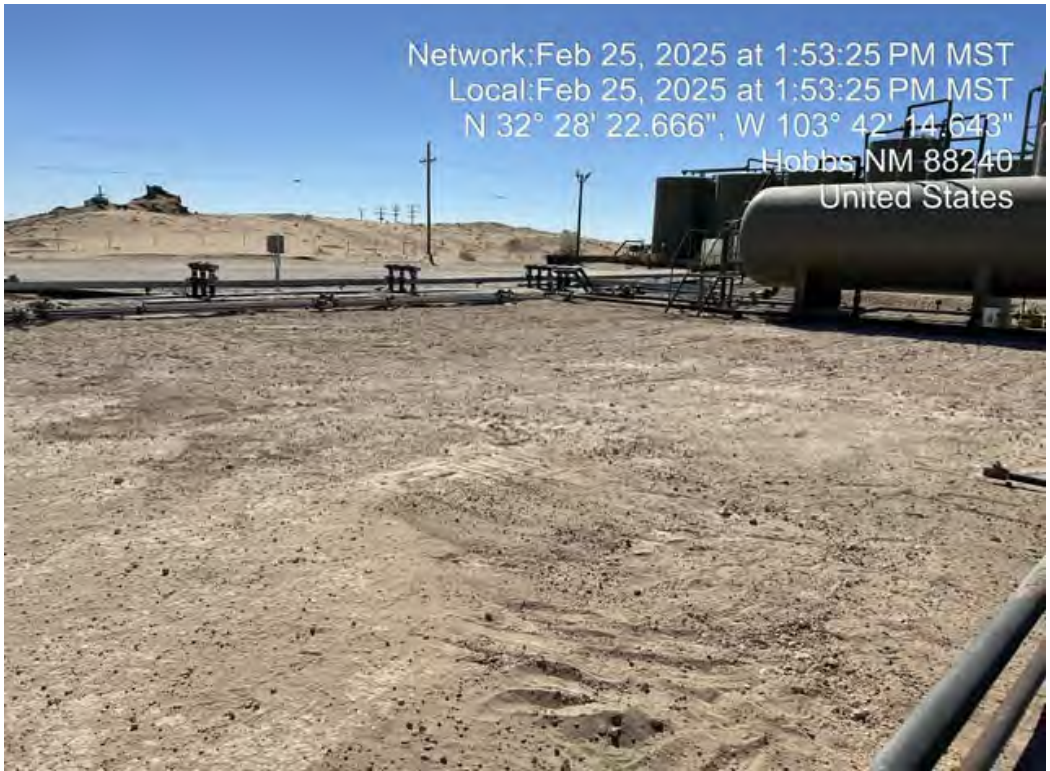
Photo Number: 7

<p>Network: Feb 25, 2025 at 1:53:25 PM MST Local: Feb 25, 2025 at 1:53:25 PM MST N 32° 28' 22.666", W 103° 42' 14.643" Hobbs, NM 88240 United States</p>
Photo Direction: Southeast	
Photo Description: View of the remediated area following backfilling and regrading.

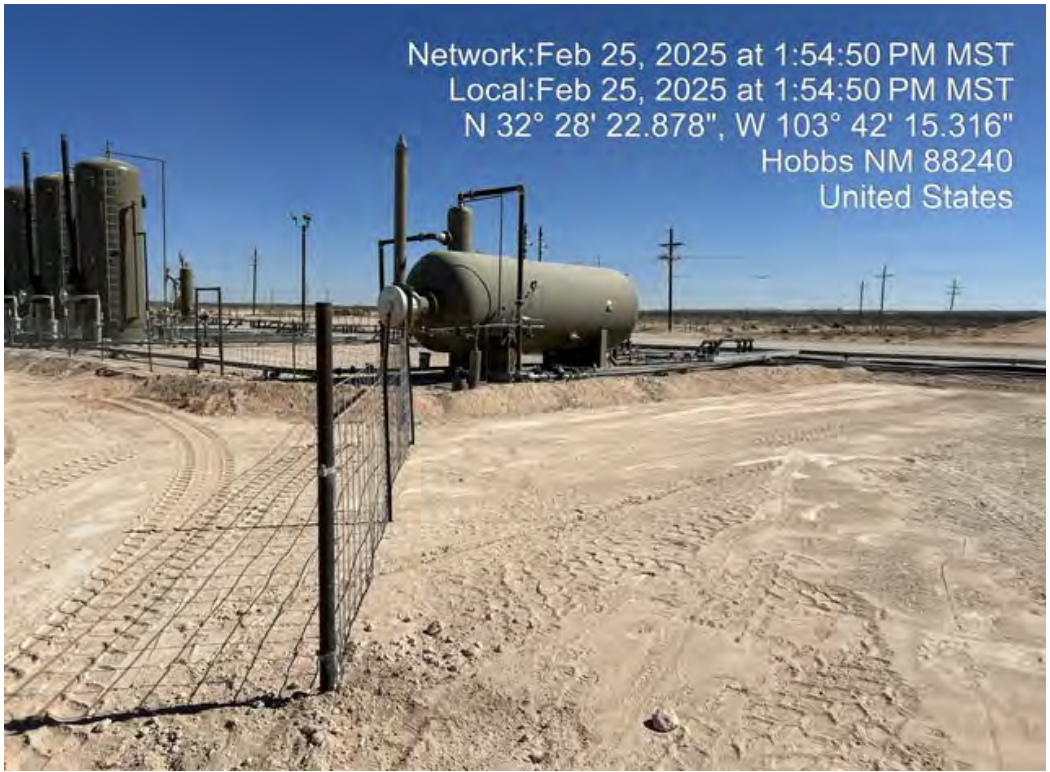
Photo Number: 8

<p>Network: Feb 25, 2025 at 1:54:50 PM MST Local: Feb 25, 2025 at 1:54:50 PM MST N 32° 28' 22.878", W 103° 42' 15.316" Hobbs, NM 88240 United States</p>
Photo Direction: Northeast	
Photo Description: View of the remediated area following backfilling and regrading.
