Remediation Summary & Soil Closure Request

3R Operating, LLC Shell State 4 Flowline

Lea County, New Mexico

NMOCD Reference No. nAPP2301367245, nPAC0715030512 & nPAC0600429640

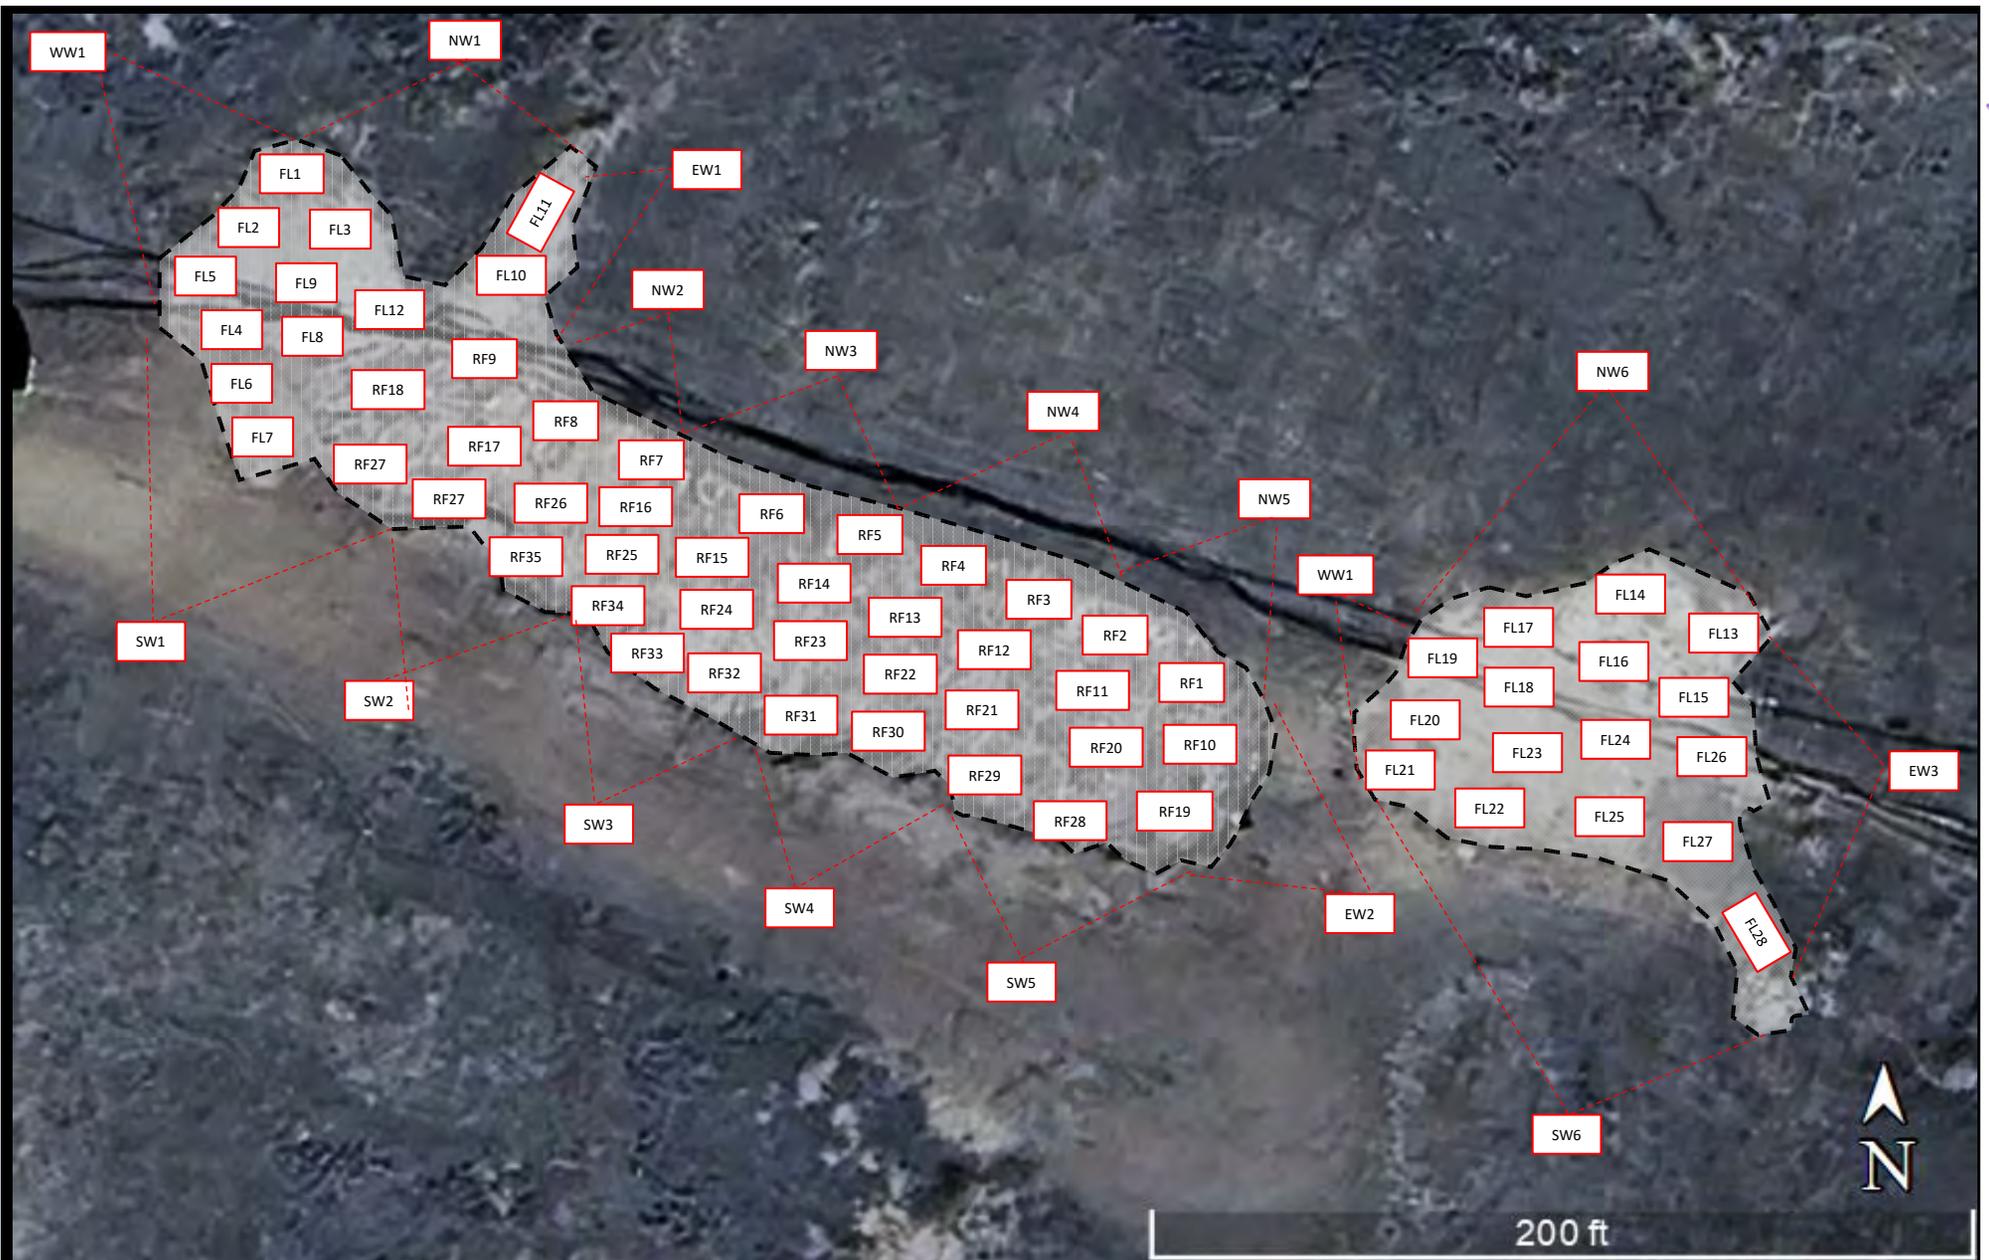
Figure 3 Sample Location Map

Dash (-): Sample not analyzed for that constituent.
Bold: NMOCD Closure Criteria exceedance.
Red: NMOCD Reclamation Standard exceedance.
 Red Border with Shading: Highest observed concentration.

In addition, Etech collected 35 replacement floor composite samples from the area previously remediated by an alternative environmental contractor. The collected soil samples were submitted to the laboratory for analysis of BTEX, TPH, and chloride concentrations. Laboratory analytical results indicated BTEX, TPH, and chloride concentrations were below the applicable NMOCD Closure Criteria and NMOCD Reclamation Standards in each of the submitted soil samples.

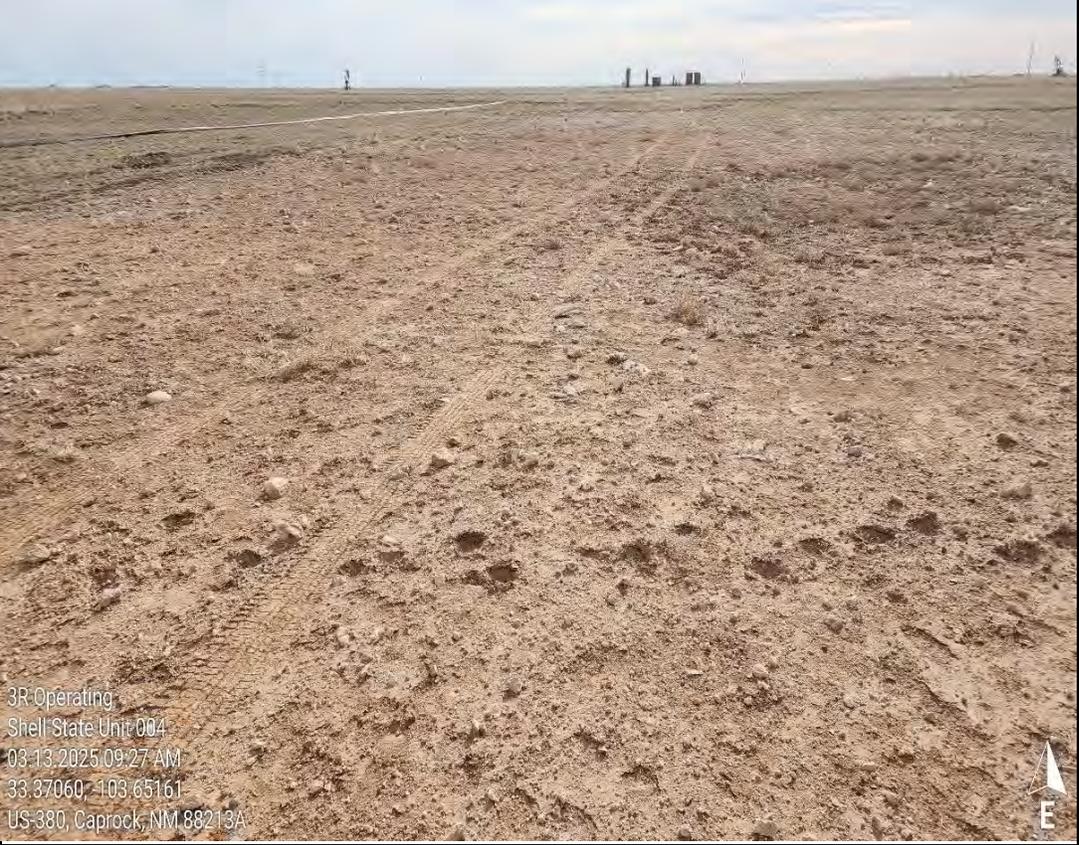
Photo Number: 1

Photo Direction: East	
Photo Description: View of the affected area prior to remediation activities.

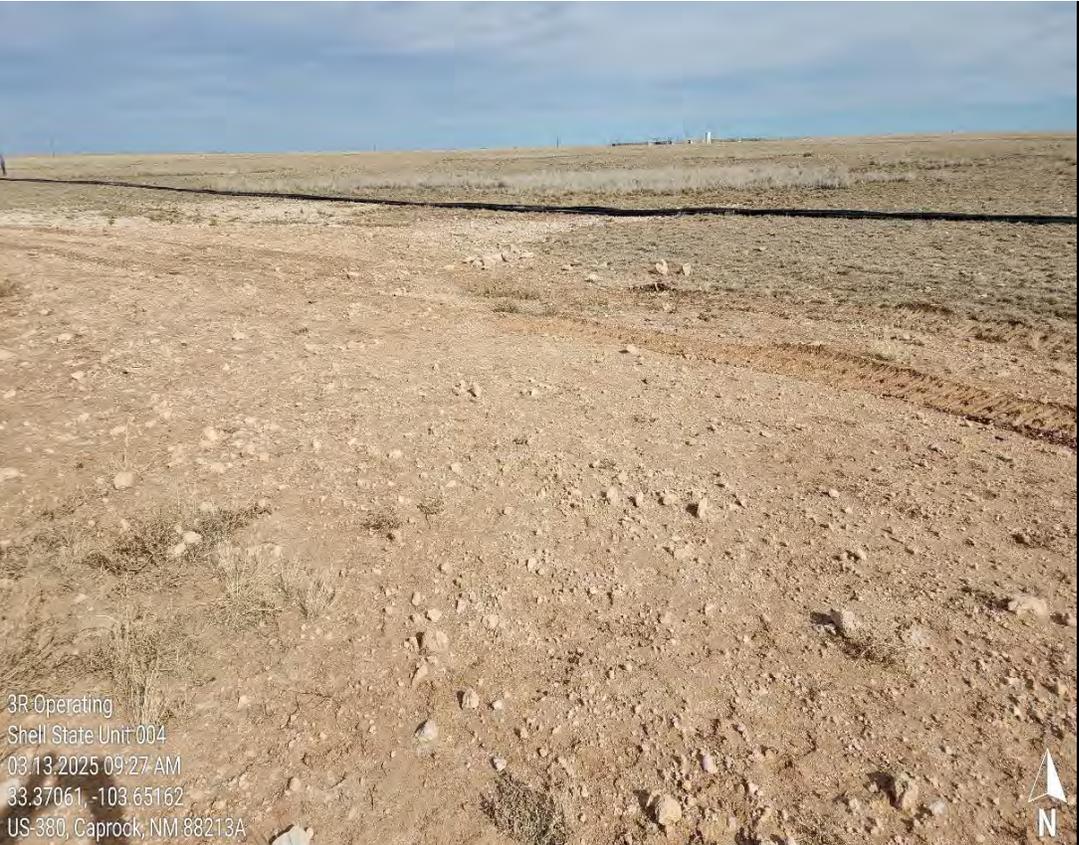
Photo Number: 2

Photo Direction: Northwest	
Photo Description: View of the affected area prior to remediation activities.

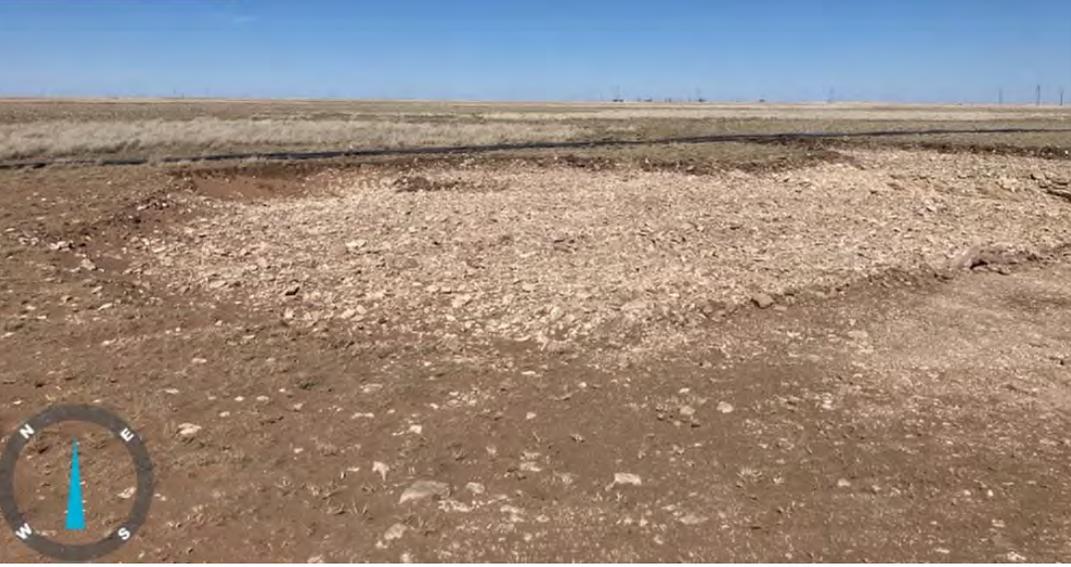
Mar 21, 2025 at 3:19:31 PM +33.370591,-103.651932 43° NE Altitude:1315.9meter Speed:0.0km/h
Photo Direction: South		
Photo Description: View of portion of the excavated area.

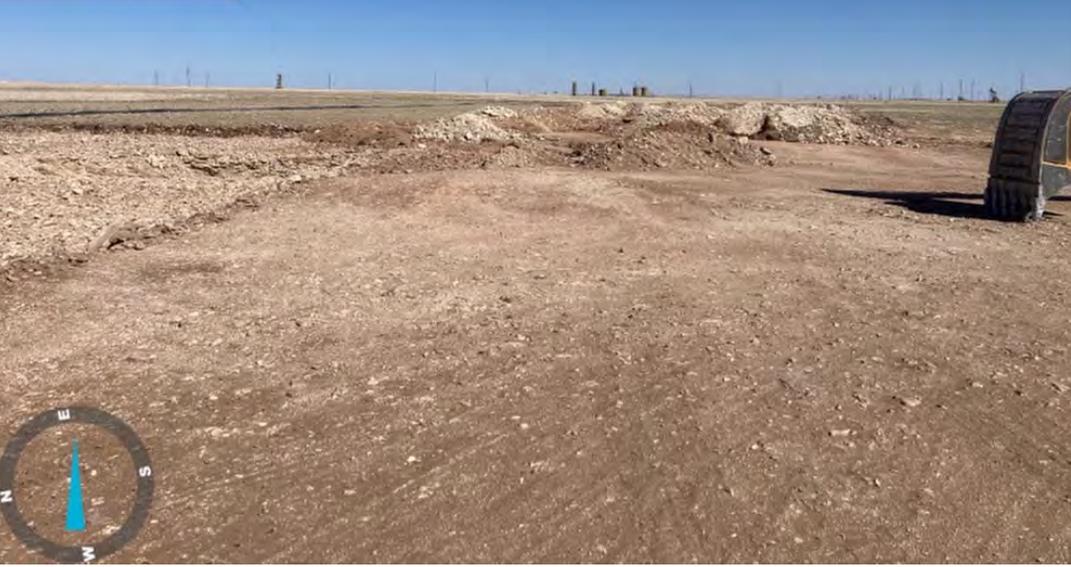
Photo Number: 4

Mar 21, 2025 at 3:19:37 PM +33.370667,-103.651995 100° E Altitude:1316.4meter Speed:0.0km/h
Photo Direction: East		
Photo Description: View of portion of the excavated area.

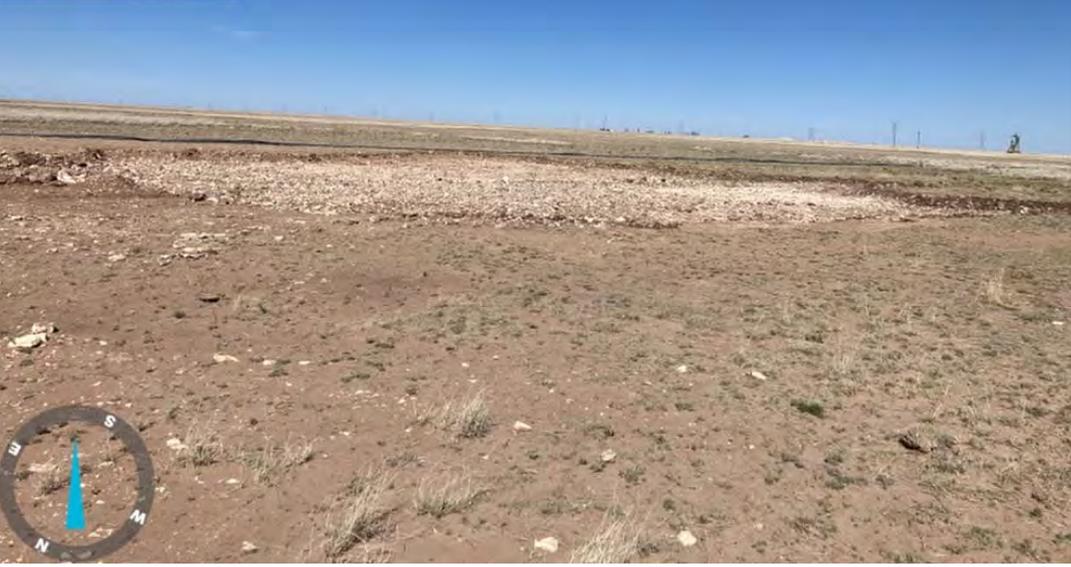
Photo Number: 5

<p>Mar 21, 2025 at 3:17:35 PM +33.370306,-103.651177 151° SE Altitude:1318.6meter Speed:1.9km/h</p>
Photo Direction: Southeast	
Photo Description: View of portion of the excavated area.

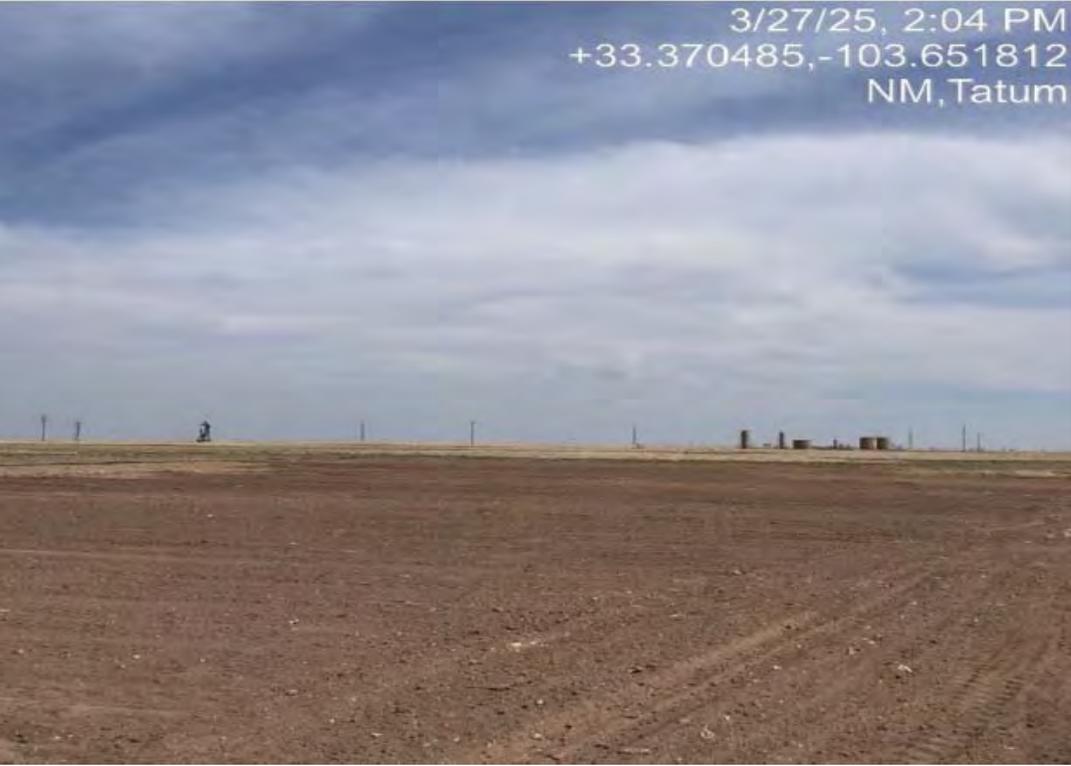
Photo Number: 6

<p>3/27/25, 2:04 PM +33.370485,-103.651812 NM,Tatum</p>
Photo Direction: East	
Photo Description: View of affected area after remediation activities.

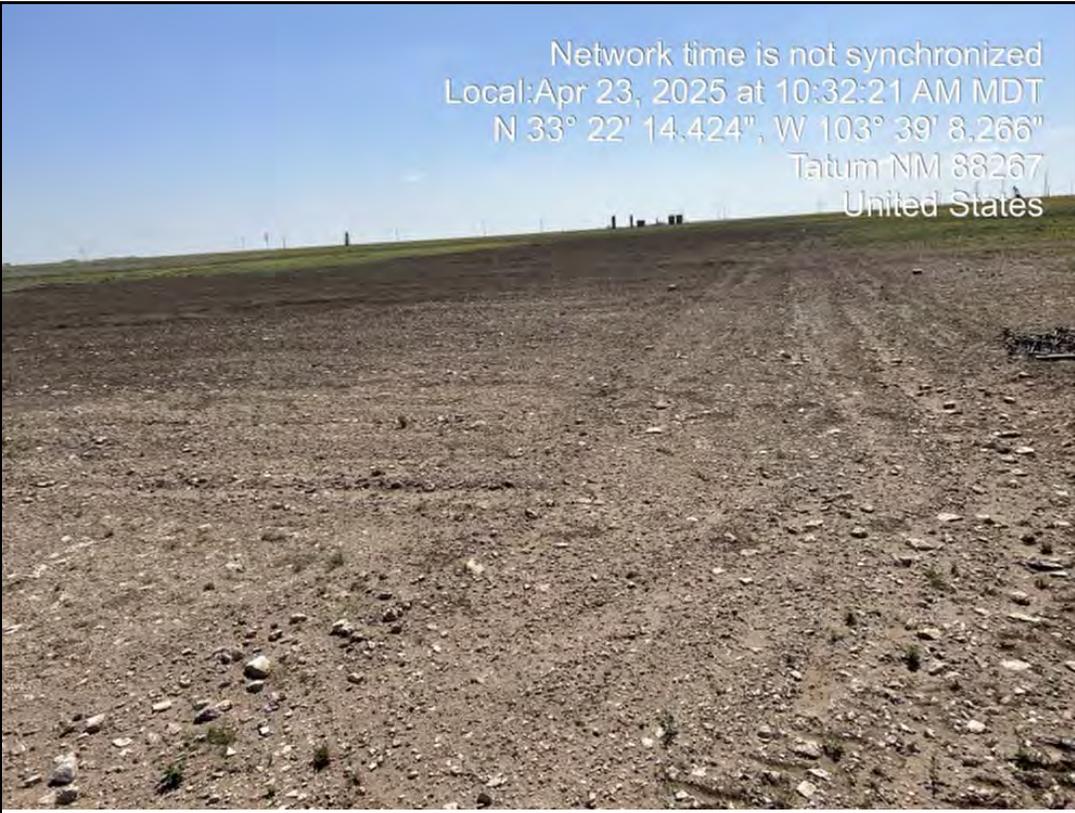
Photo Number: 7	<p>Network time is not synchronized Local: Apr 23, 2025 at 10:32:21 AM MDT N 33° 22' 14.424", W 103° 39' 8.266" Tatum NM 88267 United States</p>

Photo Direction: Southeast	
Photo Description: View of portion of the excavated area.

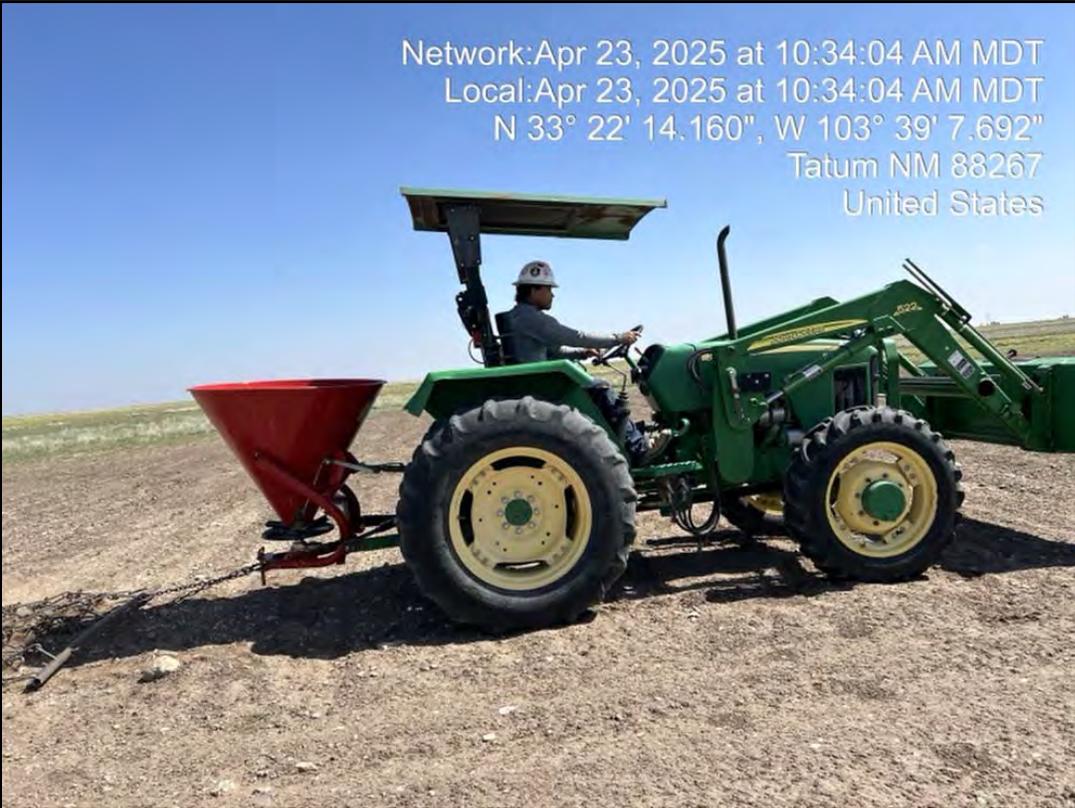
Photo Number: 8	<p>Network: Apr 23, 2025 at 10:34:04 AM MDT Local: Apr 23, 2025 at 10:34:04 AM MDT N 33° 22' 14.160", W 103° 39' 7.692" Tatum NM 88267 United States</p>

Photo Direction: East	
Photo Description: View of affected area after remediation activities.
