RECLAMATION REPORT

PREPARED FOR:
DEVON ENERGY PRODUCTION, LP.

LOCATION: Shetland 11 CTB 1

NMOCD REF. NO. NAPP2401523877

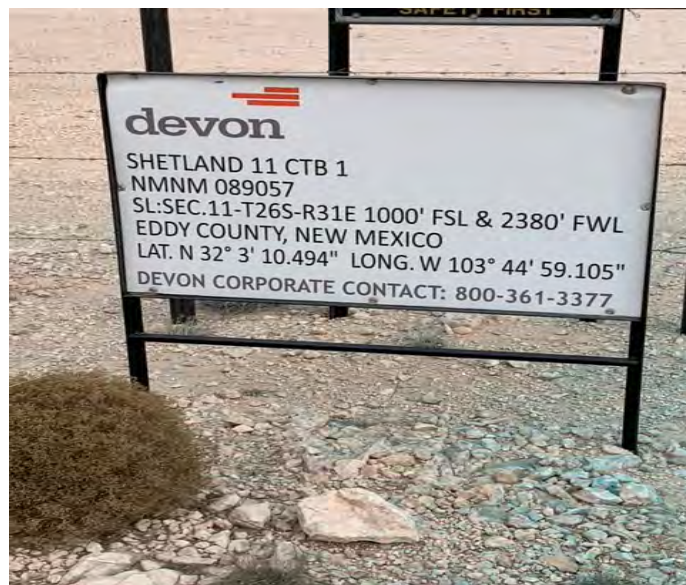
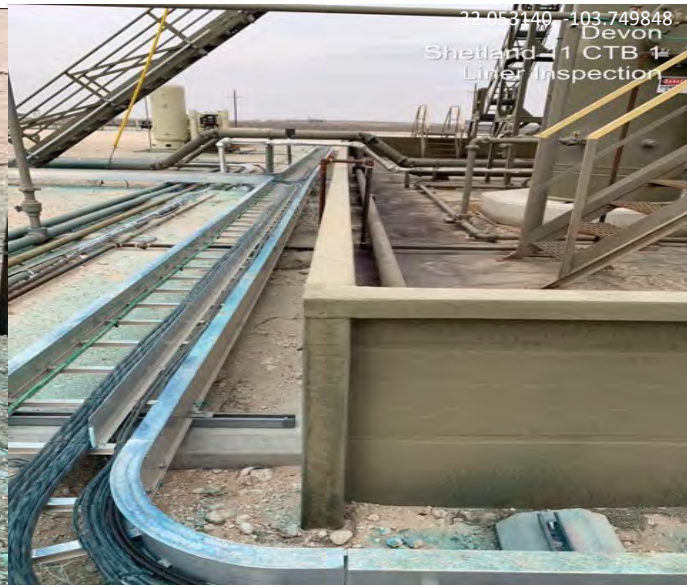
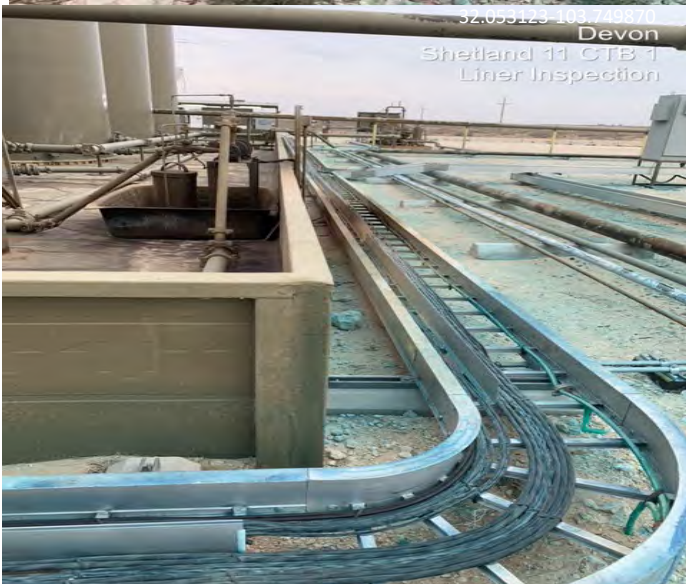
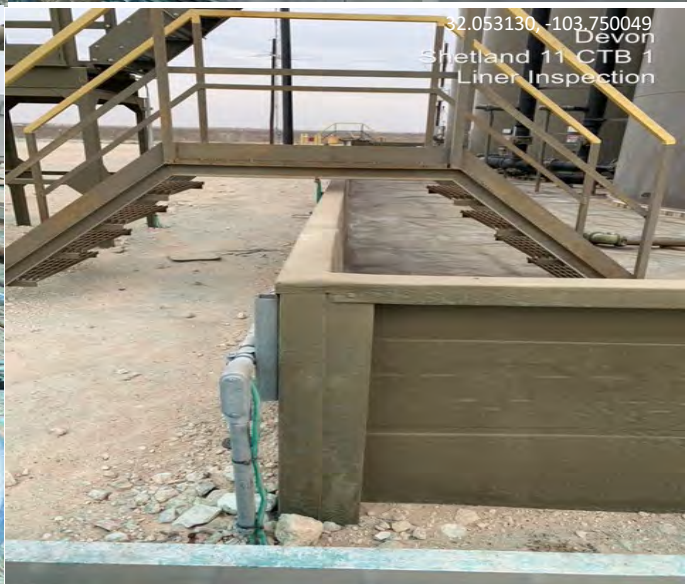
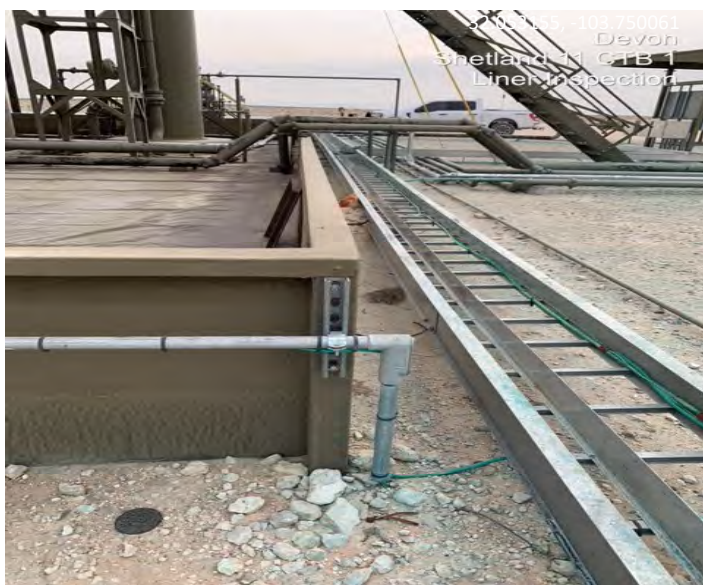
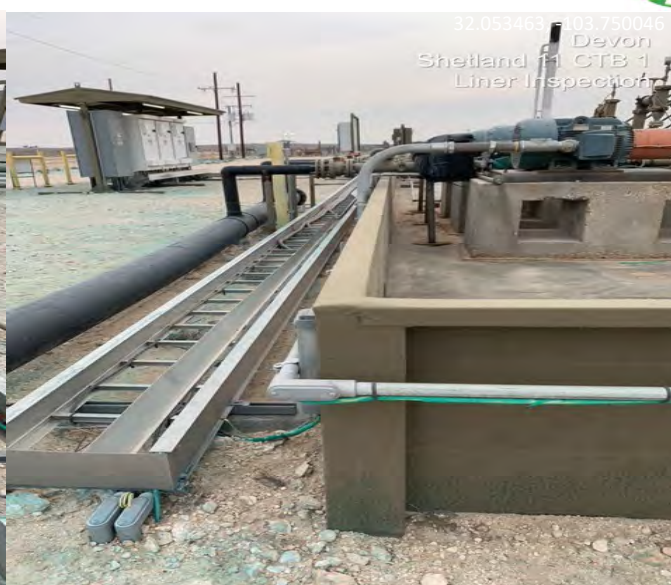
On February 29, 2024, after submitting a 48-hour notification application ID: 318173 to the NMOCD, Pima Environmental conducted a liner inspection at this location. We conducted that this liner and containment maintained its integrity and was able to retain the fluids. The Liner Inspection Form can be found in Appendix C. Photographic Documentation can be found in Appendix D.

Visualization	Yes	No	Comments
Is there a tear in the liner?		X	
Are there holes in the liner?		X	
Is the liner retaining any fluids?		X	
Does the liner have integrity to contain a leak?	X
