Re: Remediation Work Plan

State D A CTB
Hilcorp Energy Company
NMOCD Incident No: napp2505326850

Ensolum, LLC (Ensolum), on behalf of Hilcorp Energy Company (Hilcorp), presents this *Remediation Work Plan* (Work Plan) for a release at the State D A Central Tank Battery (CTB) (Site). The Site is located on New Mexico State Trust Land (STL), managed by the New Mexico State Land Office (NMSLO), in Unit L, Section 16, Township 21 South, Range 37 East, Lea County, New Mexico, (Figure 1). This Work Plan includes a summary of delineation activities performed at the Site and the proposed remediation of impacted soil originating from the release.

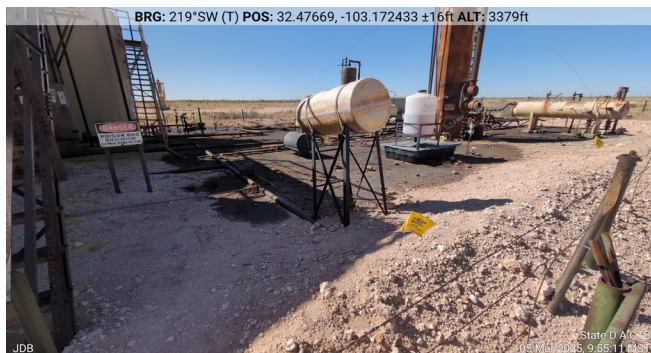
Photograph: 1 Date: 3/5/2025
Description: Soil staining from release
View: Southwest

Hilcorp proposes to excavate impacted soil at the Site to achieve NMOCD Closure Criteria. Soil will be excavated and transported off-Site for treatment/disposal at an NMOCD approved commercial landfarm. Once field screening indicates impacted soil has been removed, 5-point composite soil samples will be collected at least every 200 square feet from the floor and sidewalls of the excavation. The 5-point composite samples will be collected by placing five equivalent aliquots of soil into a 1-gallon, resealable plastic bag and homogenizing the samples by thoroughly mixing. Based on previous analytical results and no prior Closure Criteria exceedances of chloride, Hilcorp is requesting soil samples only be analyzed for TPH and BTEX during confirmation sampling. Once confirmed impacted soil has been removed, the excavation will be backfilled with clean imported soil and recontoured to match pre-existing conditions at the Site.

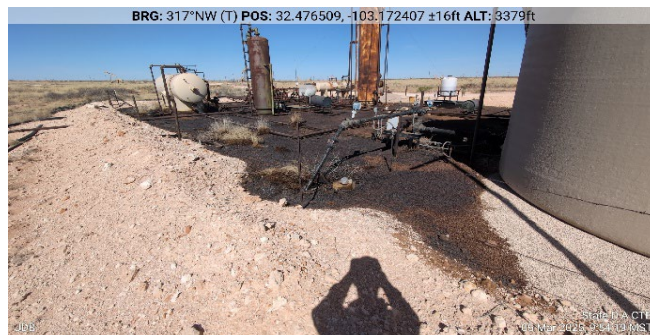
Photograph: 2 Date: 3/5/2025
Description: Soil staining from release
View: Northwest

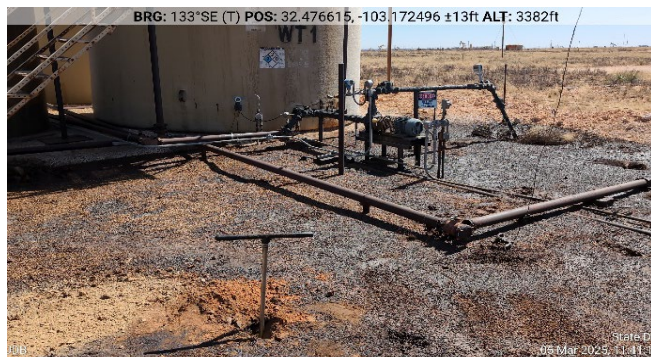
SS02 @ 0.5'
BTEX: 32.3
TPH: **8,150**
SS02A @ 9'
BTEX: 1.14
TPH: 459

Photograph: 3 Date: 3/5/2025
Description: Sample location SS02
View: Southeast
