Re: Reclamation Closure Report
Cotton Draw Unit 167 CTB
API No. N/A
GPS: Latitude 32.167493 Longitude -103.732874
UL - N, Sect 36, T24S, R31E
Eddy County, NM
NMOCD Ref. No. NAPP2103458288

Pima Environmental Services, LLC. (Pima) has been contracted by Devon Energy Production Company, LP (Devon) to submit this Reclamation Closure Report for a produced water release that occurred at the Cotton Draw Unit 167 CTB (Cotton). The initial C-141 was submitted on February 3, 2021 (Appendix C). This incident was assigned Incident ID NAPP2103458288 by the New Mexico Oil Conservation Division (NMOCD).

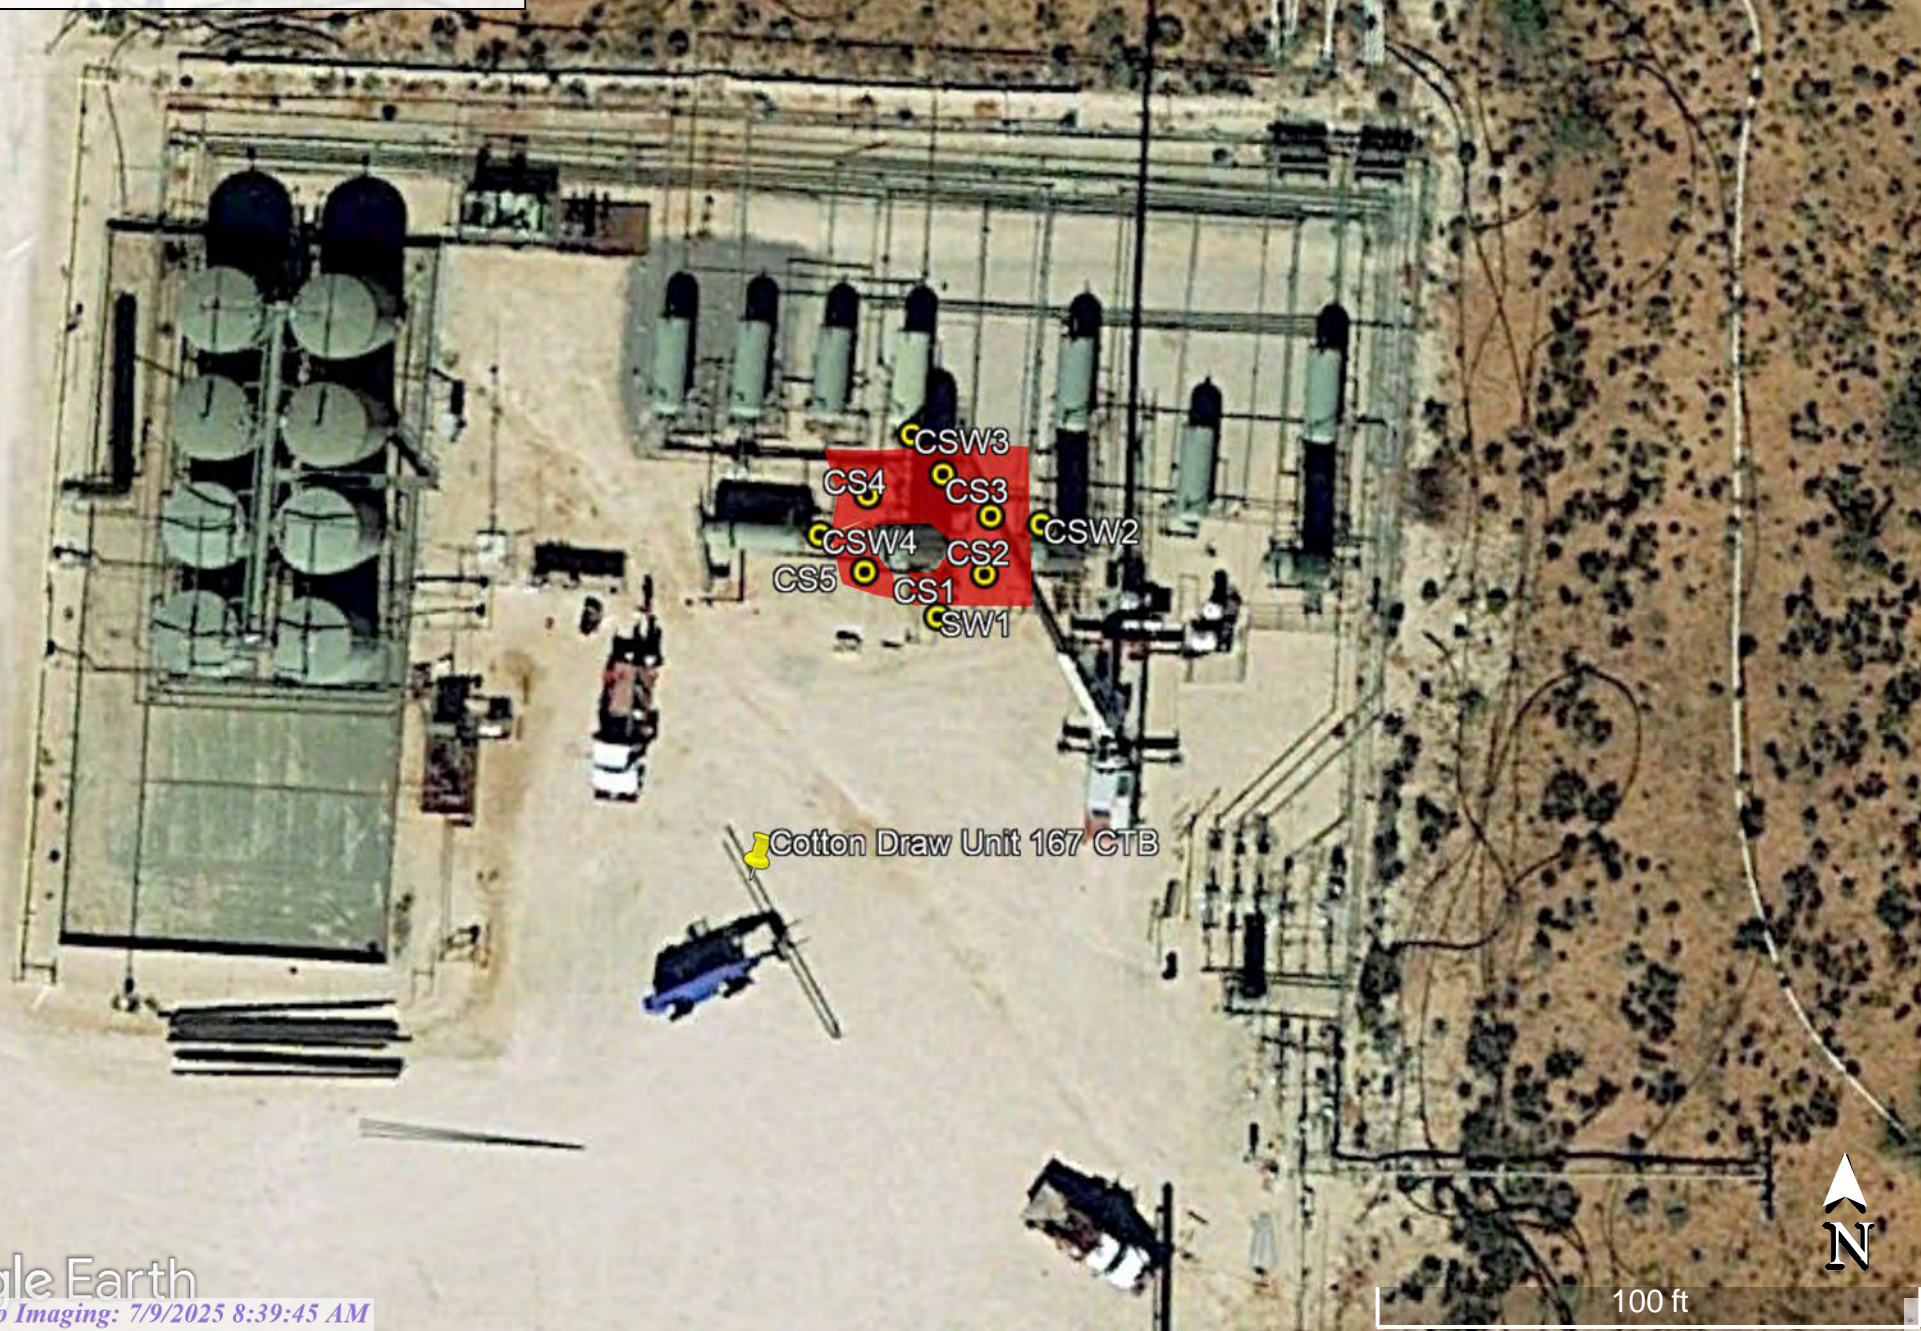
Confirmation Samples/Sidewalls

On July 24, 2023, after sending a 48-hour notification (Appendix C), Pima returned to the site to collect confirmation samples of the excavation. The results of this sampling event can be found in the following table. A Confirmation Sample Map can be found in Figure 5. Complete laboratory reports can be found in Appendix E.

Based on the sample results, the bottoms and sidewalls were below NMOCD Closure Criteria 19.15.29 NMAC. The contaminated material was sufficiently removed then transported to an NMOCD approved disposal site. The excavation was then backfilled with clean like material, machine compacted and returned to its previous state. See Appendix D for Photographic Documentation.

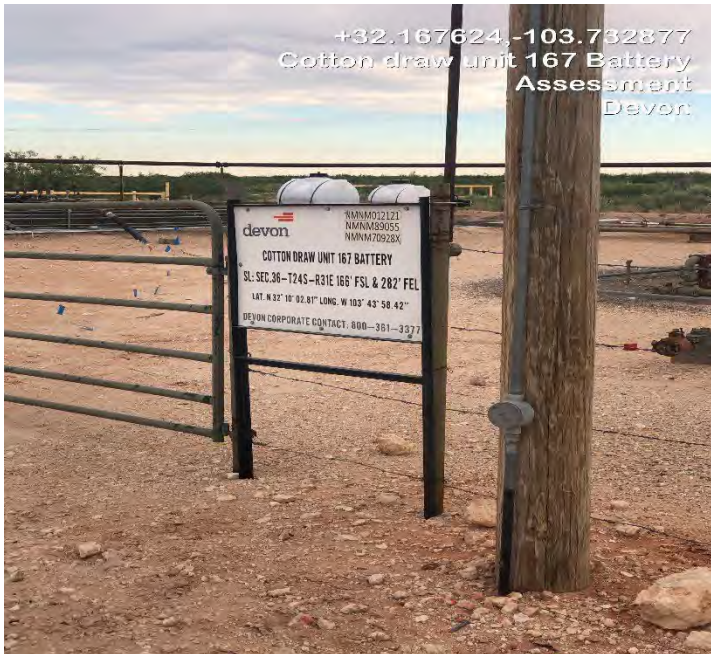
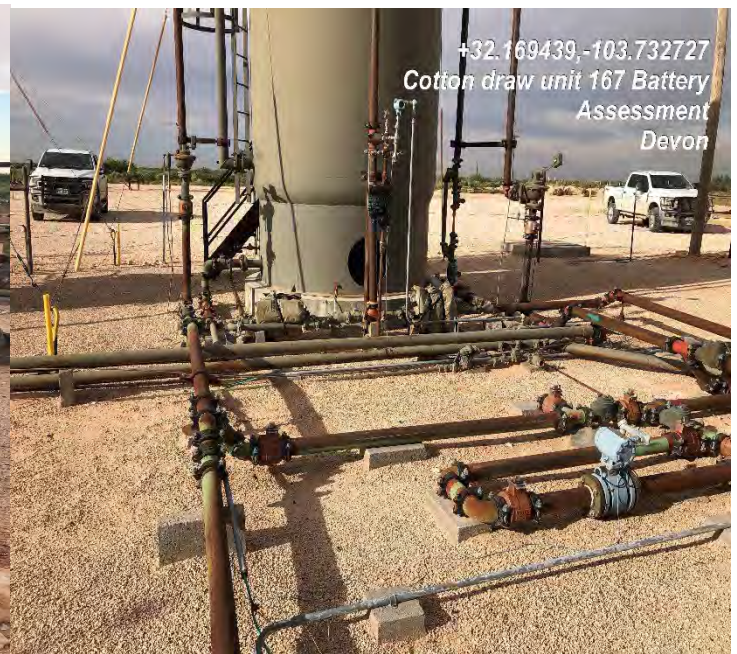
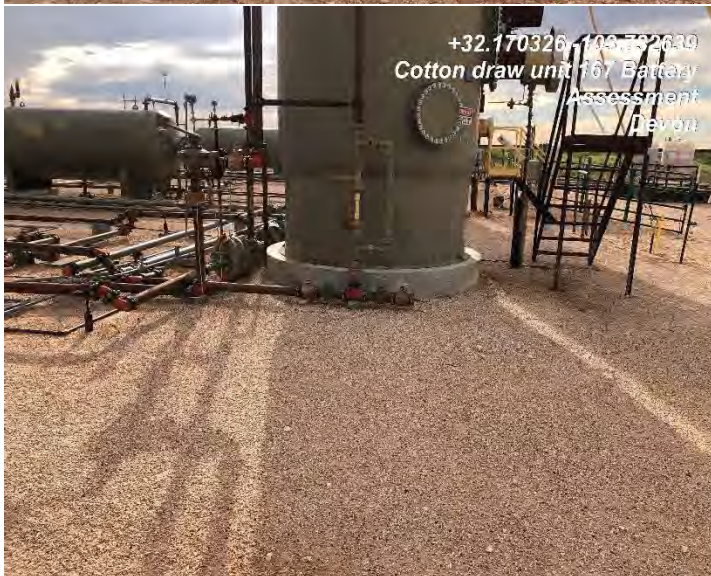
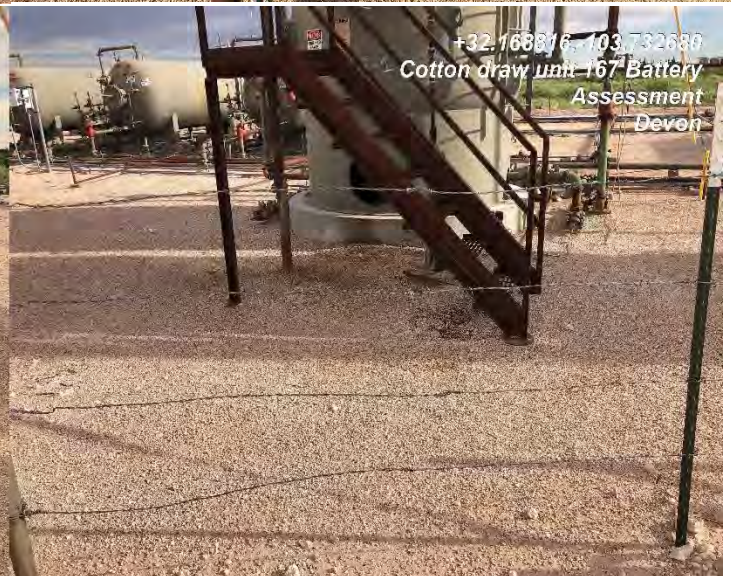
Site Assessment

June 15, 2023, Pima mobilized personnel to the site to begin collecting soil samples from spill area. The laboratory results of this sampling event can be found in the following data table. A Site Map can be found in Figure 4.

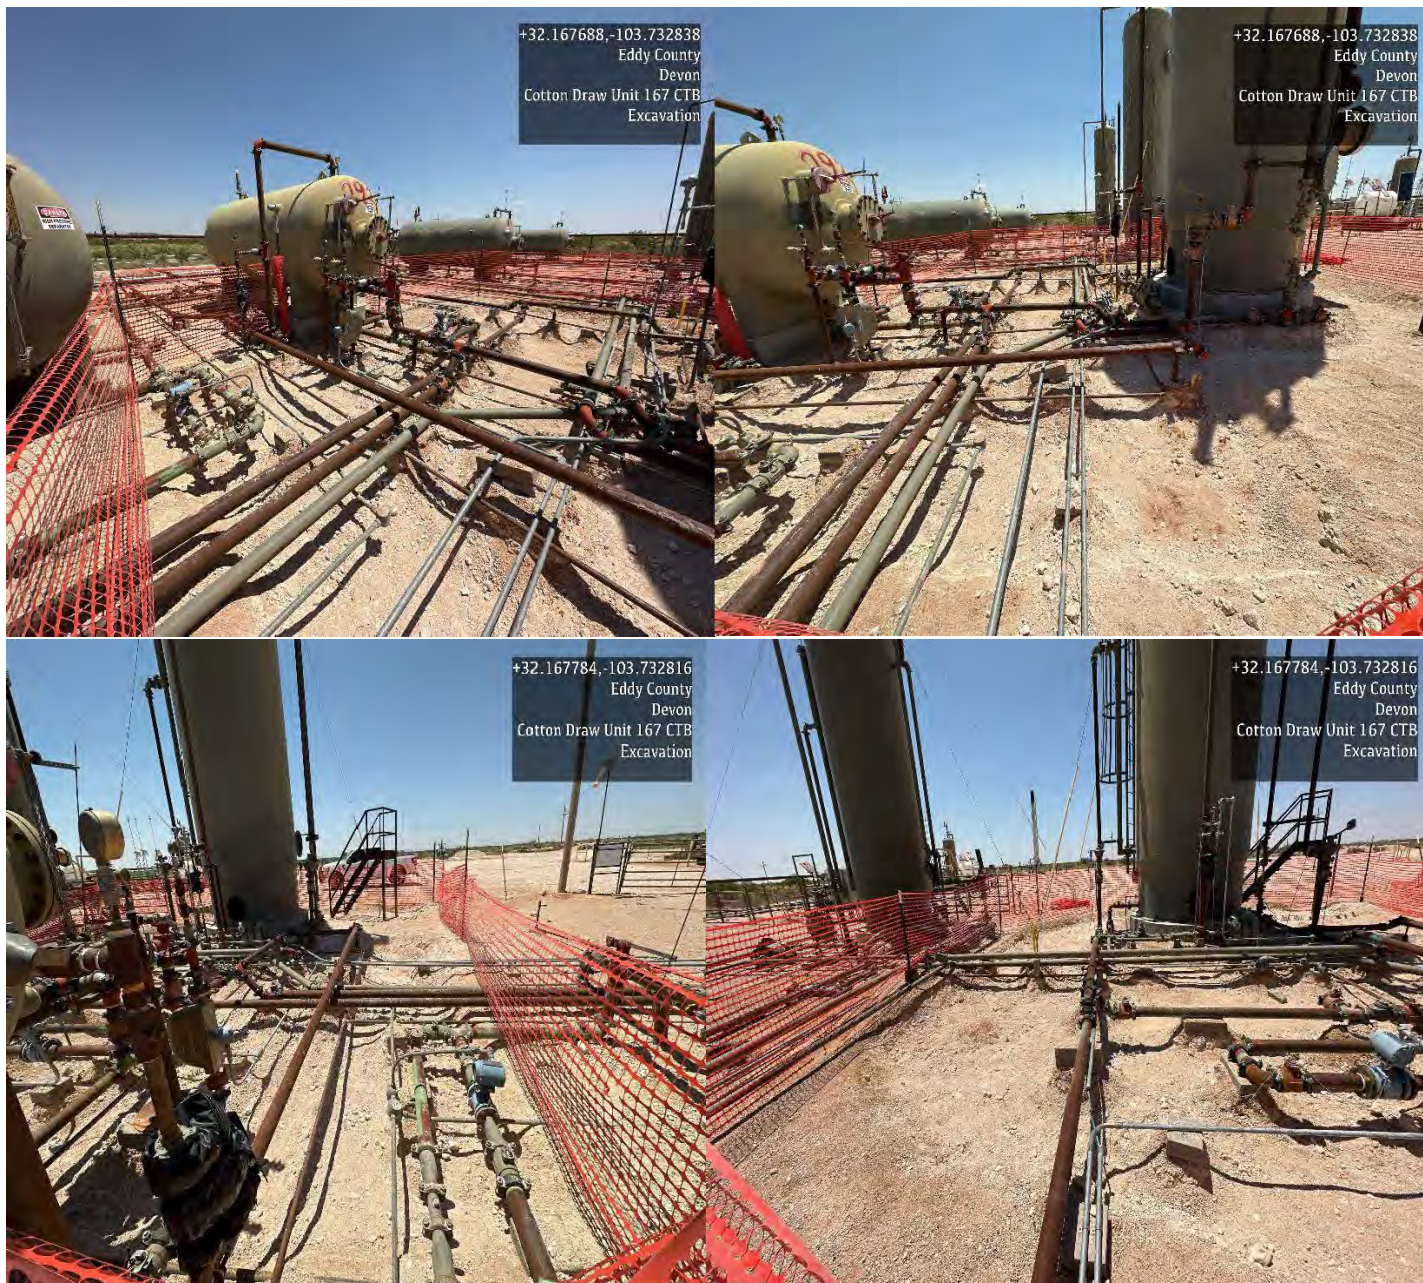
Excavation

On July 19, 2023, the Devon Construction Department mobilized personnel and equipment to begin immediate remediation activities. They began excavating the area to a depth of 2' BGS. The contaminated soil 28 cubic yards was hauled to an approved, lined disposal facility and clean backfill material was brought in.
