Incident Number: NAPP2513433622

## Closure Report

Maverick Compressor Station

Vertex File Number: 25A-02656

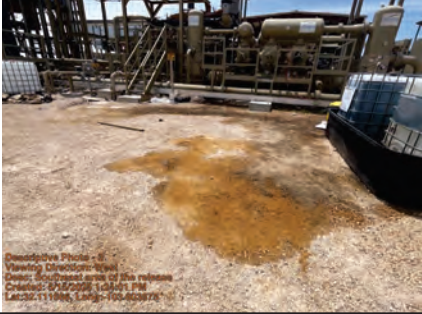
Equipment in the northeast area has minimal pooling underneath

Descriptive Photo - 3  
Viewing Direction: West  
Date: Southeast area of the release  
Created: 6/16/2025 1:52:19 PM  
Latitude: 11.666, Longitude: 103.60000

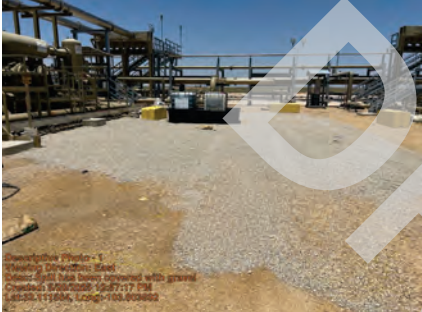
<p>Descriptive Photo - 1 Viewing Direction: East Owner: Spill has been covered with gravel Created: 5/28/2025 1:57:17 PM Lat:32.111604, Long:-103.804189</p>	<p>Viewing Direction: North</p>

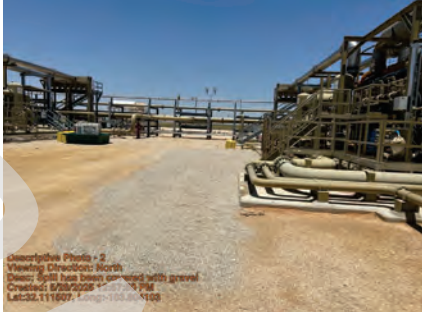
<p>Descriptive Photo - 2 Viewing Direction: North Owner: Spill has been covered with gravel Created: 5/28/2025 1:57:18 PM Lat:32.111607, Long:-103.804189</p>
<p>Viewing Direction: West</p>   <p>Descriptive Photo - 3 Viewing Direction: West Owner: BH25-07 @ 0' Created: 5/28/2025 1:58:40 PM Lat:32.111604, Long:-103.804189</p>	<p>Viewing Direction: East</p>

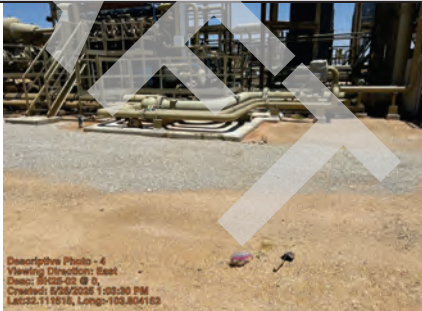
<p>Descriptive Photo - 4 Viewing Direction: East Owner: BH25-02 @ 0' Created: 5/28/2025 1:59:30 PM Lat:32.111616, Long:-103.804189</p>
<p>BH25-07 @ 0'</p>	<p>BH25-02 @ 0'</p>

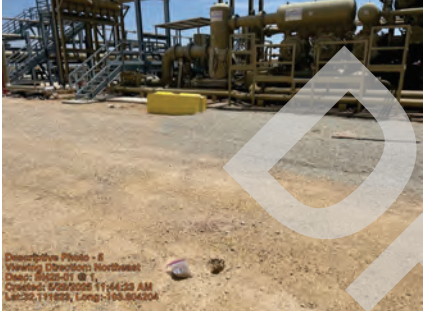
<p>Descriptive Photo - 6 Viewing Direction: Northeast Date: 6/29/2025 11:44:23 AM Created: 6/29/2025 11:44:23 AM Lat: 33.117294, Long: -108.869604</p>	<p>Viewing Direction: West</p>

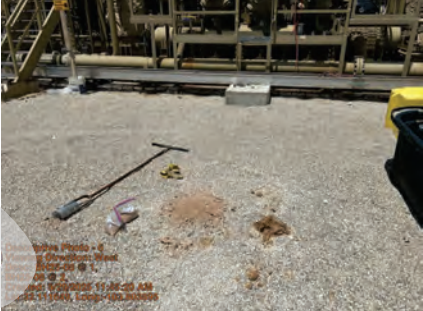
<p>Descriptive Photo - 8 Viewing Direction: West Date: 6/29/2025 11:44:23 AM Created: 6/29/2025 11:44:23 AM Lat: 33.117294, Long: -108.869604</p>
<p>BH25-01 @ 1'</p>	<p>BH25-08 @ 1' BH25-08 @ 2'</p>
<p>Viewing Direction: South</p>

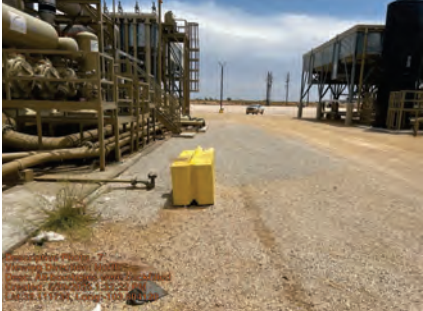
<p>Descriptive Photo - 7 Viewing Direction: South Date: 6/29/2025 11:44:23 AM Created: 6/29/2025 11:44:23 AM Lat: 33.117294, Long: -108.869604</p>	<p>Viewing Direction: North</p>

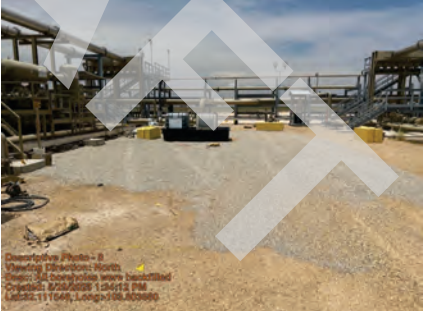
<p>Descriptive Photo - 8 Viewing Direction: North Date: 6/29/2025 11:44:23 AM Created: 6/29/2025 11:44:23 AM Lat: 33.117294, Long: -108.869604</p>
<p>All boreholes were backfilled</p>	<p>All boreholes were backfilled</p>

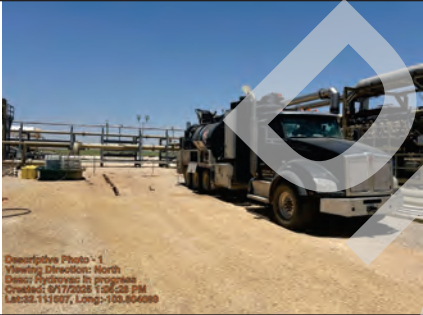
<p>Descriptive Photo - 1 Viewing Direction: North Event: Hydrovac in progress Created: 6/17/2025 1:56:28 PM Lat:32.113697, Long:-103.864088</p>	<p>Viewing Direction: North</p>

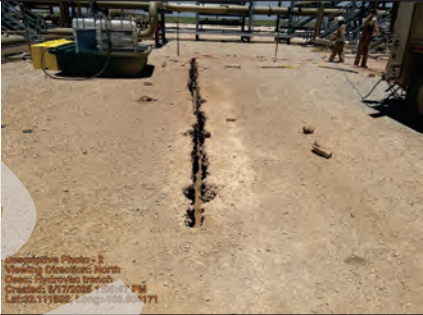
<p>Descriptive Photo - 2 Viewing Direction: North Event: Hydrovac trench Created: 6/17/2025 1:56:47 PM Lat:32.113697, Long:-103.864071</p>
<p>Viewing Direction: East</p>

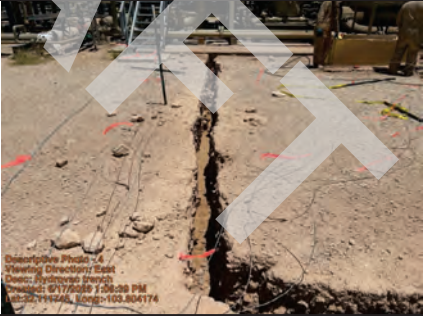
<p>Descriptive Photo - 4 Viewing Direction: East Event: Hydrovac trench Created: 6/17/2025 1:56:58 PM Lat:32.113697, Long:-103.864174</p>

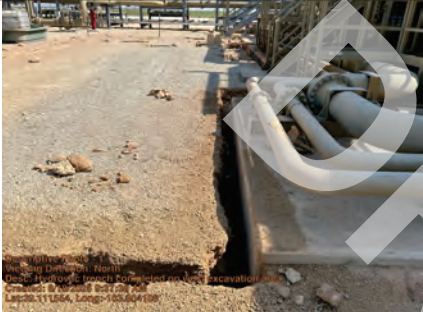
<p>Hydrovac trench completed on west excavation area</p>	<p>Viewing Direction: West</p>

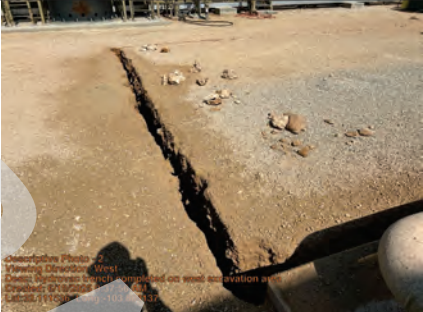
<p>Hydrovac trench completed on west excavation area</p>
<p>Viewing Direction: North</p>

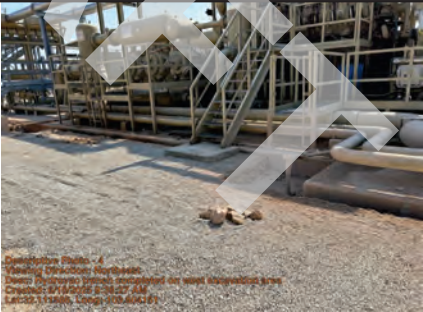
<p>Hydrovac trench completed on west excavation area</p>

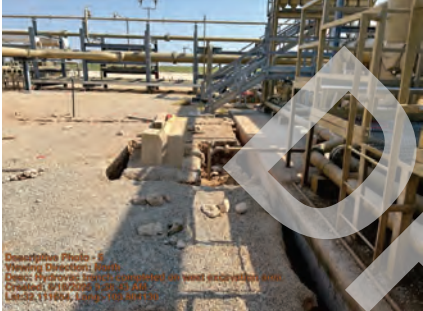
<p>Hydrovac trench completed on west excavation area</p>	<p>Viewing Direction: East</p>

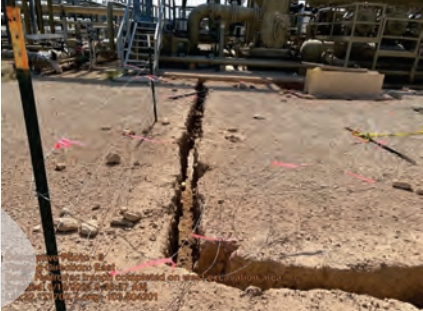
<p>Hydrovac trench completed on west excavation area</p>
<p>Viewing Direction: East</p>

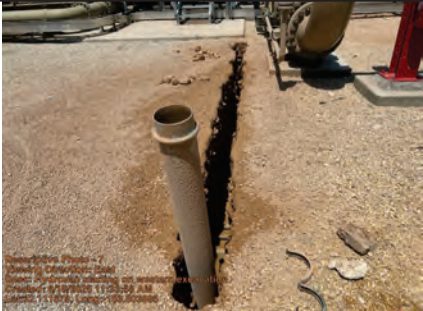
<p>Hydrovac starting on western excavation</p>	<p>Viewing Direction: South</p>

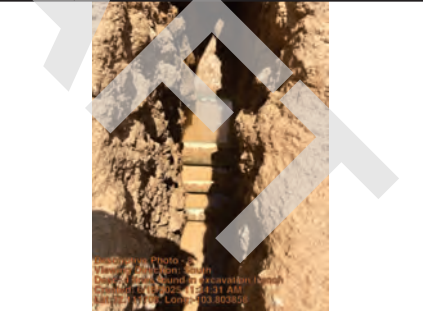
<p>4 lines found in excavation trench</p>

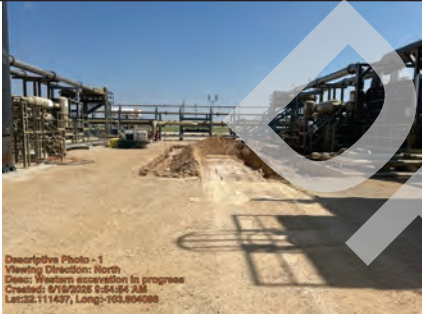
<p>Descriptive Photo - 1 Viewing Direction: North Date: Western excavation in progress Created: 6/18/2025 9:54:54 AM Lat:32.111497, Long:-103.804088</p>	<p>Viewing Direction: East</p>

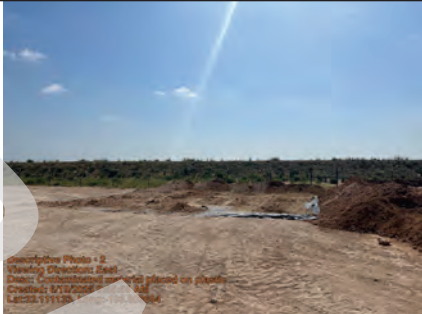
<p>Descriptive Photo - 2 Viewing Direction: East Date: Contaminated material placed on plastic Created: 6/18/2025 9:54:54 AM Lat:32.111497, Long:-103.804088</p>
<p>Viewing Direction: Northeast</p>

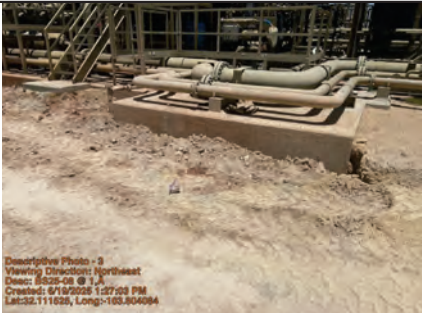
<p>Descriptive Photo - 3 Viewing Direction: Northeast Date: BS25-08 @ 1' Created: 6/18/2025 1:57:03 PM Lat:32.111626, Long:-103.804084</p>	<p>Viewing Direction: Northwest</p>

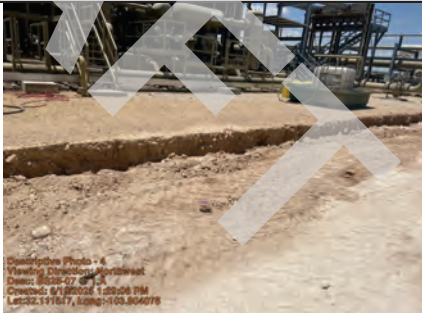
<p>Descriptive Photo - 4 Viewing Direction: Northwest Date: BS25-07 @ 1' Created: 6/18/2025 1:59:08 PM Lat:32.111617, Long:-103.804078</p>
<p>BS25-08 @ 1'</p>	<p>BS25-07 @ 1'</p>

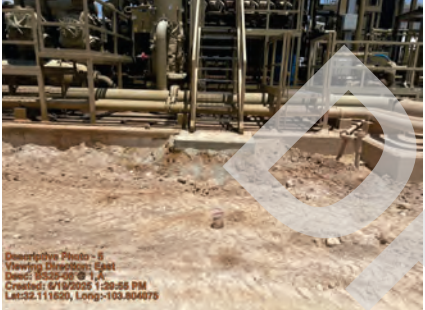
<p>Descriptive Photo - 6 Viewing Direction: East Date: 6/18/2025 @ 1:11 Created: 6/18/2025 1:20:55 PM Lat:32.111625, Long:-103.854978</p>	<p>Viewing Direction: West</p>

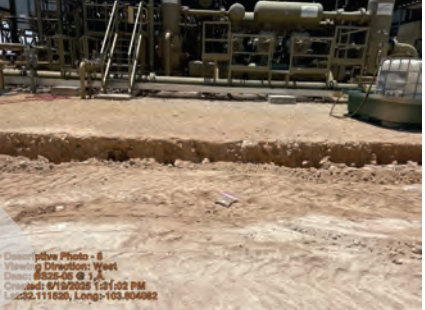
<p>Descriptive Photo - 5 Viewing Direction: West Date: 6/18/2025 @ 1:11 Created: 6/18/2025 1:21:02 PM Lat:32.111625, Long:-103.854982</p>
<p>BS25-06 @ 1'</p>	<p>BS25-05 @ 1'</p>
<p>Viewing Direction: Northeast</p>

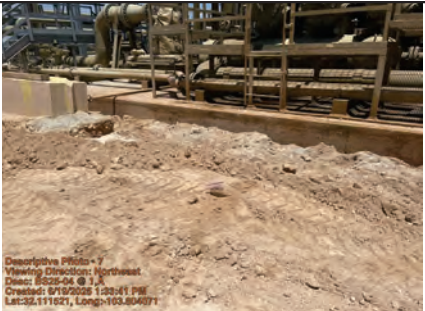
<p>Descriptive Photo - 7 Viewing Direction: Northeast Date: 6/18/2025 @ 1:11 Created: 6/18/2025 1:20:41 PM Lat:32.111625, Long:-103.854978</p>	<p>Viewing Direction: West</p>

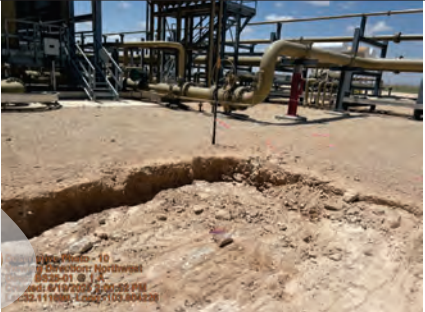
<p>Descriptive Photo - 10 Viewing Direction: Northwest Date: 6/19/2023 @ 1:15 Created: 6/19/2023 2:20:55 PM Lat:32.117104, Long:-103.894976</p>
<p>BS25-02 @ 1'</p>	<p>BS25-01 @ 1'</p>
<p>Viewing Direction: East</p>   <p>Descriptive Photo - 11 Viewing Direction: East Date: BACKFILL Created: 6/19/2023 2:59:53 PM Lat:32.117104, Long:-103.894976</p>	<p>Viewing Direction: North</p>   <p>Descriptive Photo - 12 Viewing Direction: North Date: Western excavation completed and fenced Created: 6/19/2023 3:14:36 PM Lat:32.117104, Long:-103.894976</p>
<p>BACKFILL</p>	<p>Western excavation completed and fenced</p>

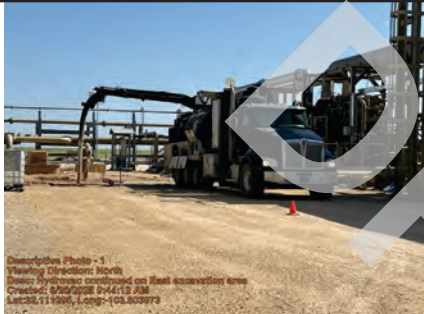
Hydrovac continued on East excavation area

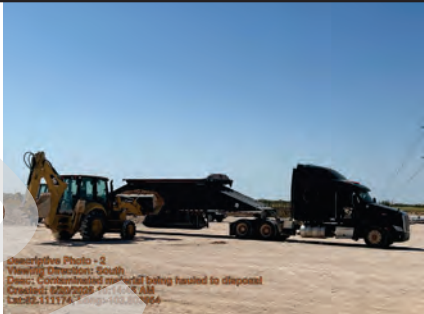
Contaminated material being hauled to disposal

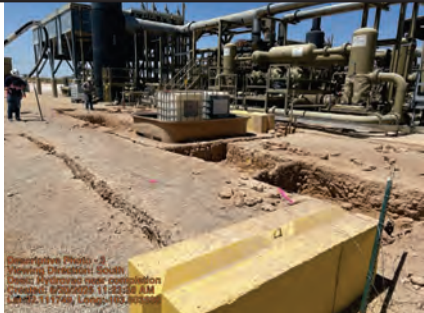
Hydrovac near completion

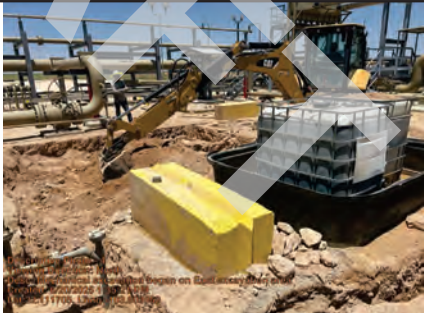
Mechanical excavation began on East excavation area

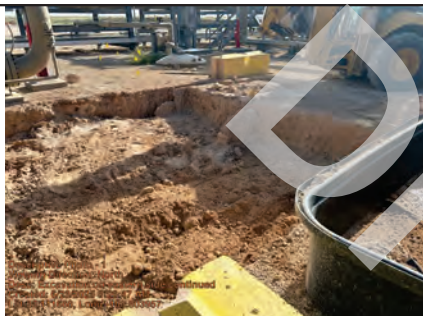
Excavation on eastern side continued

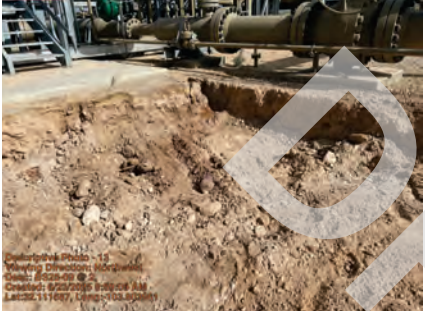
<p>Geographic Photo - 13 Viewing Direction: Northwest Date: 6/24/2025 8:06 AM Created: 6/23/2025 8:06 AM Lat: 32.111697, Long: -103.402024</p>	<p>Viewing Direction: North</p>

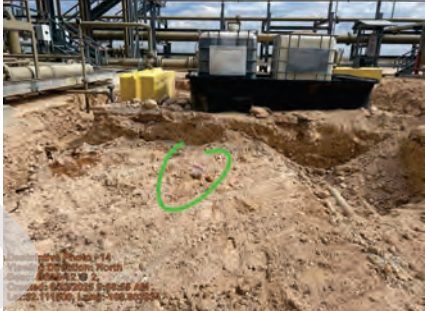
<p>Geographic Photo - 14 Viewing Direction: North Date: 6/24/2025 8:06 AM Created: 6/23/2025 8:06 AM Lat: 32.111697, Long: -103.402024</p>
<p>BS25-10 @ 2'</p>	<p>BS25-12 @ 2'</p>
<p>Viewing Direction: South</p>

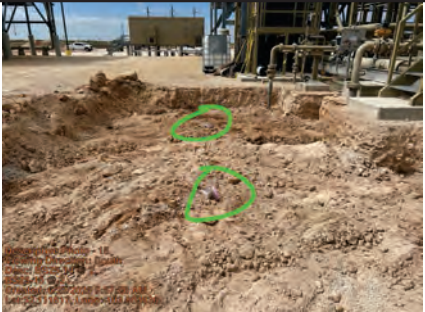
<p>Geographic Photo - 15 Viewing Direction: South Date: 6/24/2025 8:06 AM Created: 6/23/2025 8:06 AM Lat: 32.111697, Long: -103.402024</p>	<p>Viewing Direction: Northeast</p>

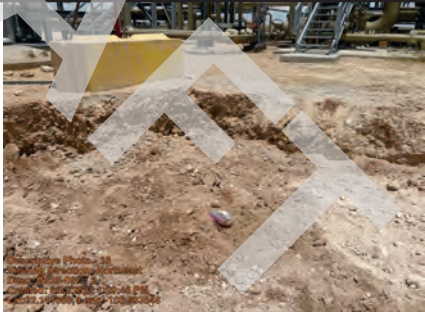
<p>Geographic Photo - 16 Viewing Direction: Northeast Date: 6/24/2025 8:06 AM Created: 6/23/2025 8:06 AM Lat: 32.111697, Long: -103.402024</p>
<p>BS25-14 @ 2'</p> <p>BS25-15 @ 2'</p>	<p>BS25-09 @ 2'</p>

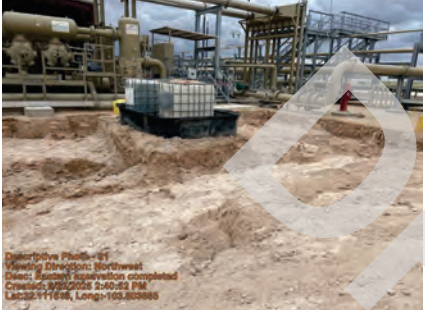
<div>Descriptive Photo - 31 Viewing Direction: Northwest Desc: Eastern excavation completed Created: 6/23/2025 2:40:23 PM Lat:32.111696, Long:-103.833876</div></div> <div>Eastern excavation completed</div>	<div>Viewing Direction: Southwest</div> <div>

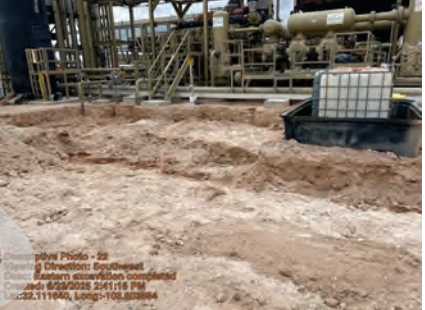
<div>Descriptive Photo - 32 Viewing Direction: Southwest Desc: Eastern excavation completed Created: 6/23/2025 2:41:16 PM Lat:32.111696, Long:-103.833876</div></div> <div>Eastern excavation completed</div>
<div>Viewing Direction: West</div> <div>

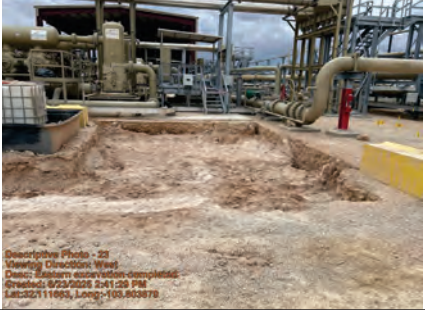
<div>Descriptive Photo - 33 Viewing Direction: West Desc: Eastern excavation completed Created: 6/23/2025 2:41:25 PM Lat:32.111696, Long:-103.833876</div></div> <div>Eastern excavation completed</div>
