## RECLAMATION CLOSURE REPORT

PREPARED FOR:  
DEVON ENERGY PRODUCTION, LP.

PREPARED BY:  
PIMA ENVIRONMENTAL SERVICES, LLC.

**LOCATION:** Ragin Cajun 12 CTB 3

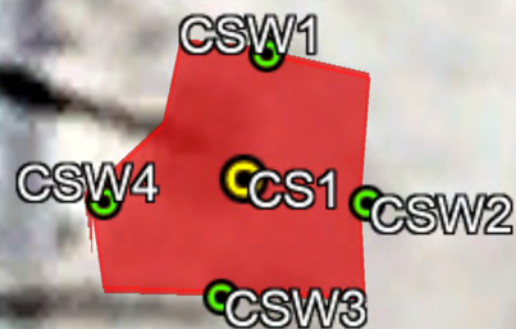
Devon Energy  
Incident ID: NAPP2423962613  
Lea County, NM  
Confirmation Sample Map

- Confirmation Sidewall Samples
- Confirmation Sample
- Ragin Cajun 12 CTB 3

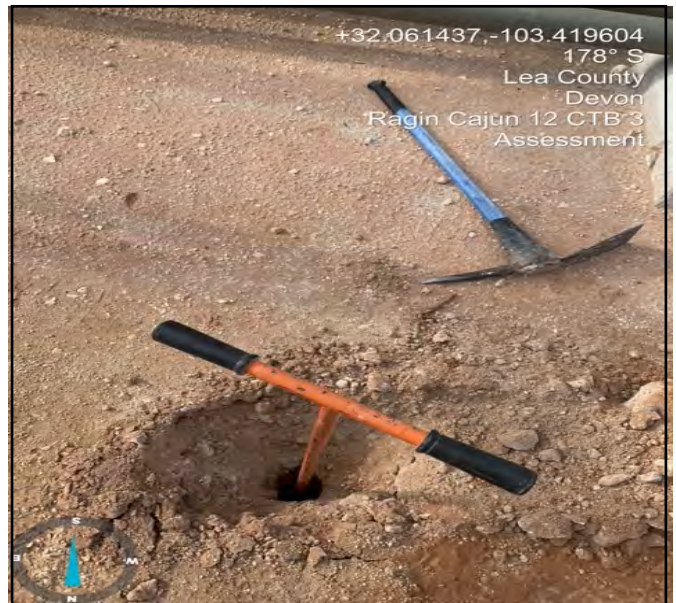
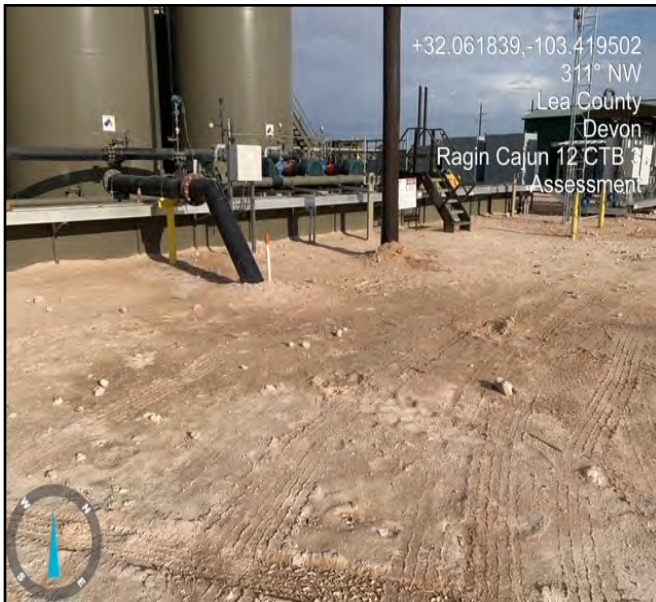
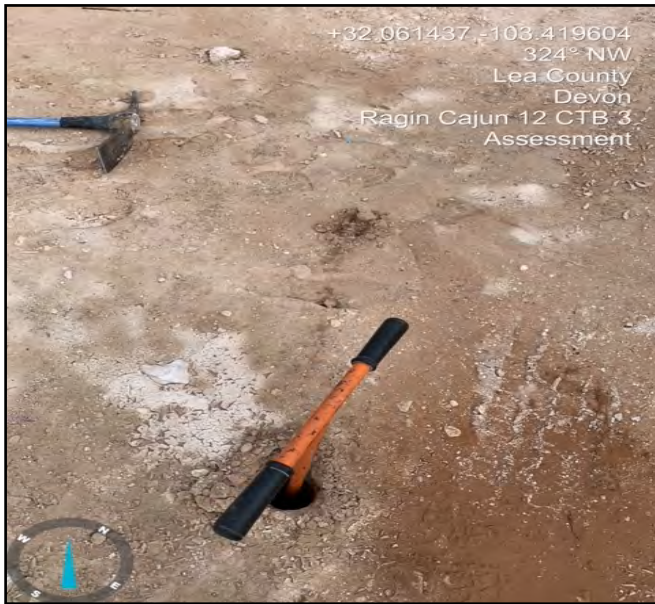
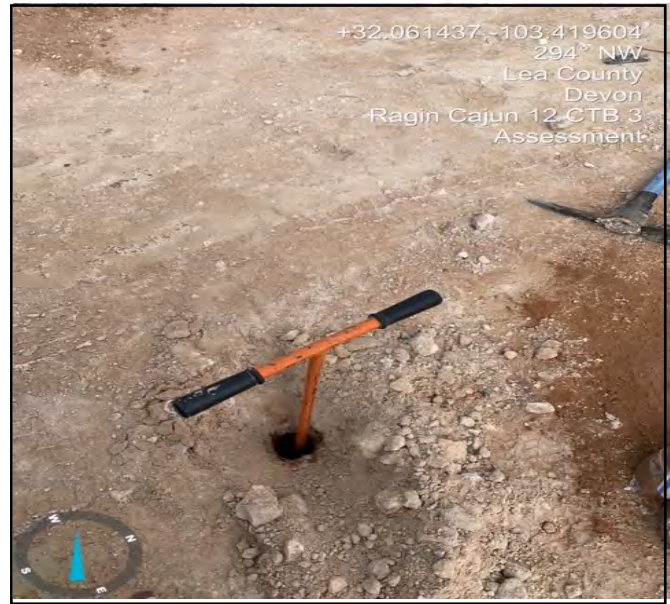
### Assessment:

Photo taken during assessment, taken facing South.

Photo taken during assessment, taken facing Northwest.

Photo taken during assessment, taken facing Southwest.

On August 29, 2024, Pima Environmental conducted a site assessment and obtained soil samples. The laboratory results of this sampling event can be found in Figure 4. Analytical Laboratory Reports can be found in Appendix D. Photographic Documentation can be found in Appendix C.

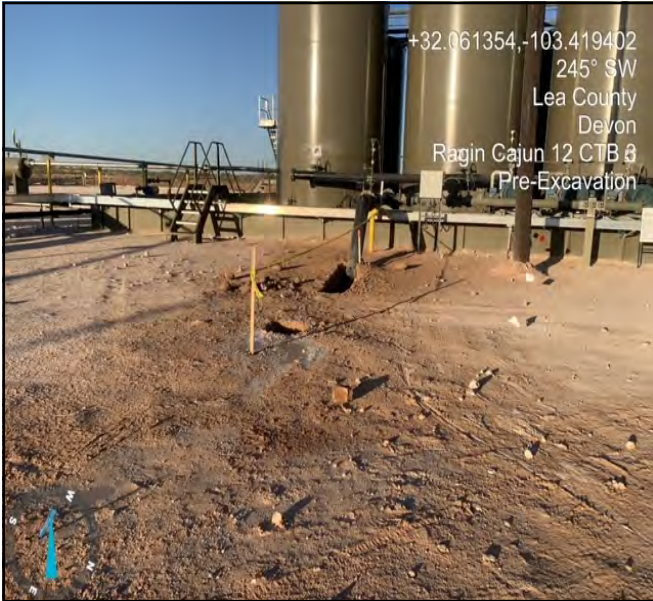
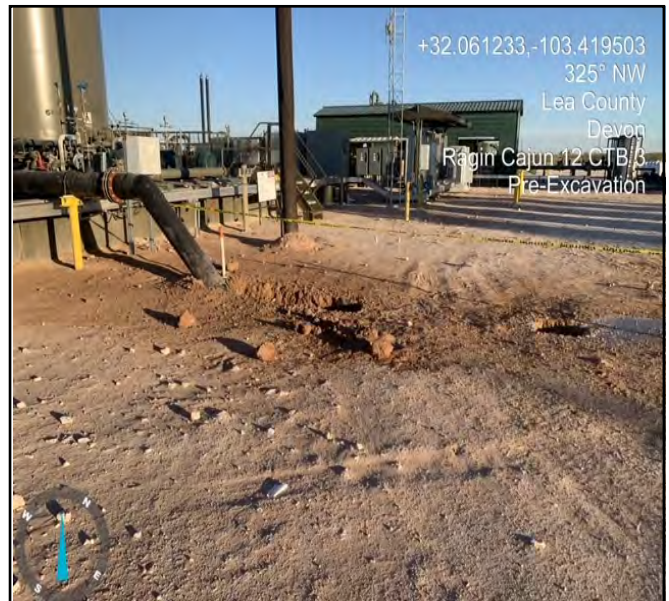
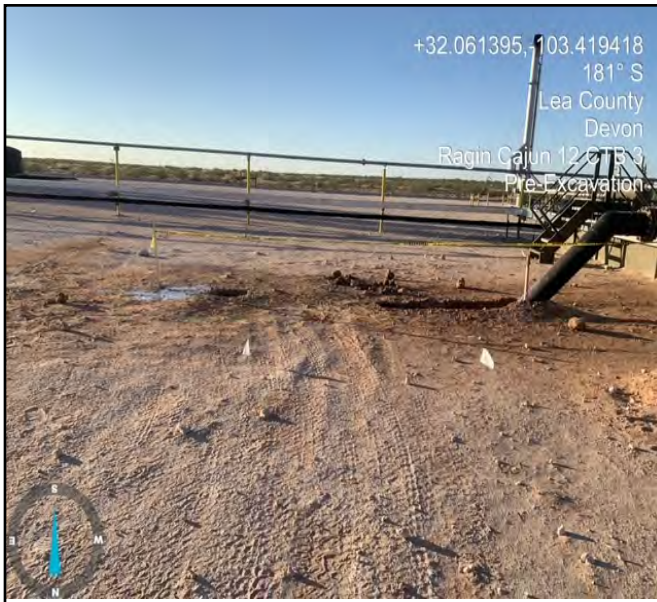
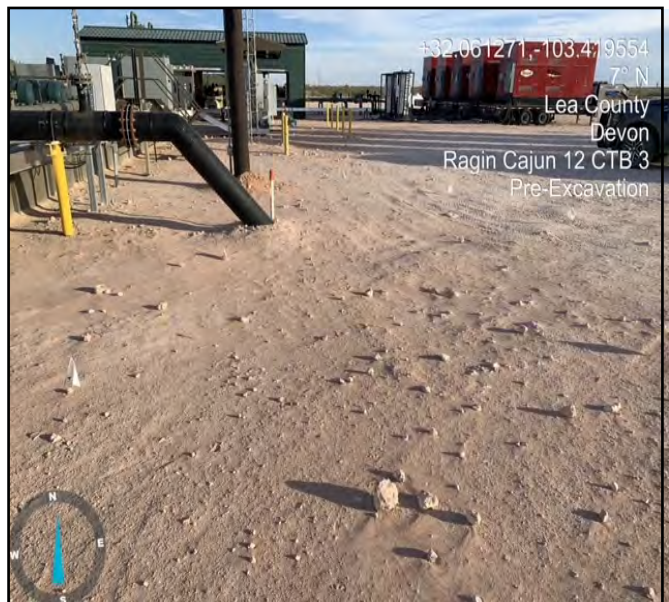
### Pre-Excavation:

Photo taken prior to excavation, taken facing Southwest.

Photo taken prior to excavation, taken facing Northwest.

Photo taken prior to excavation, taken facing South

Photo taken prior to excavation, taken facing North.

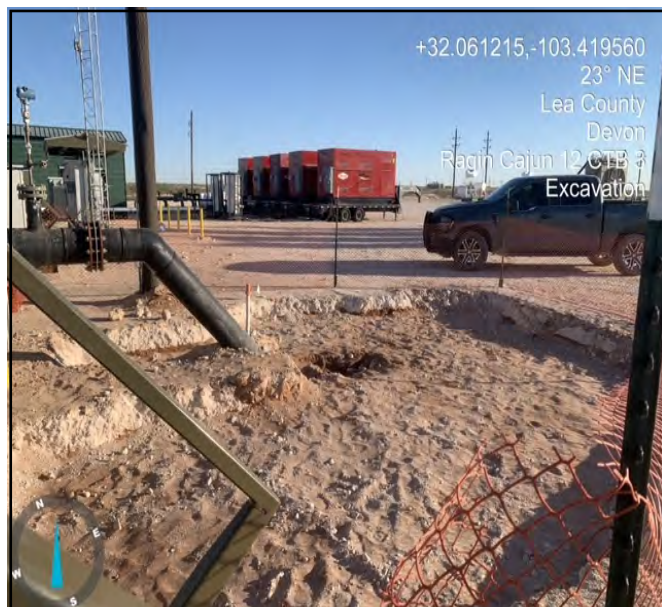
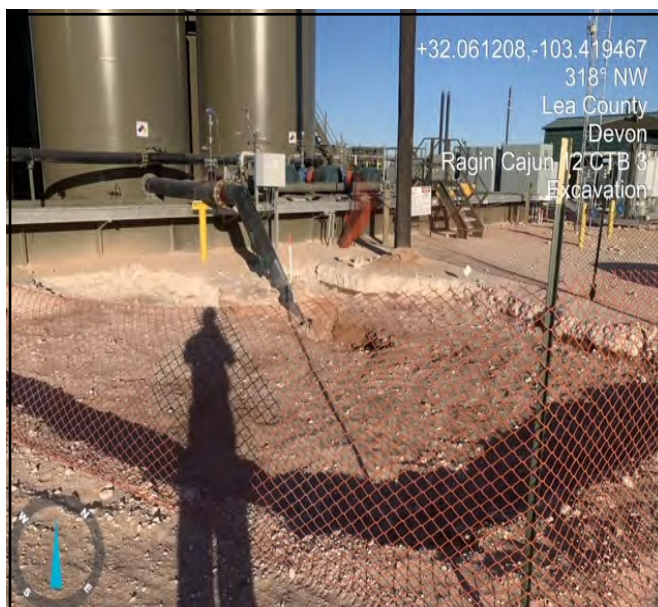
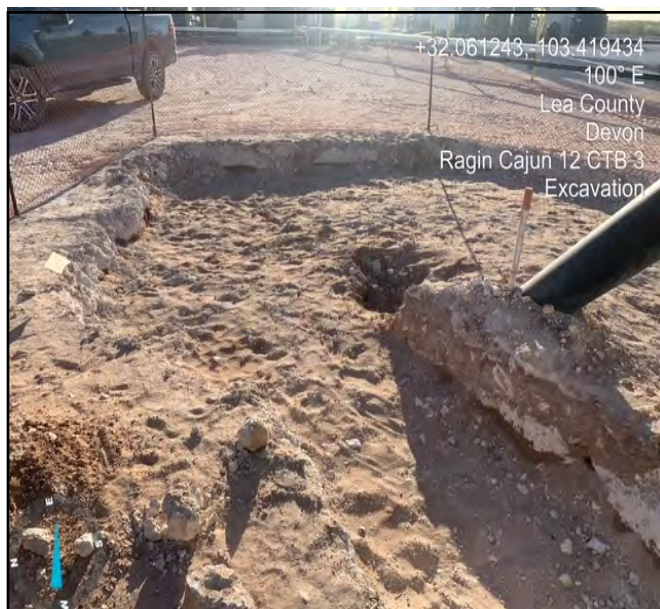
### Excavation:

Pictures taken during excavation, Facing Northeast.

Pictures taken during excavation, Facing Northwest.

Pictures taken during excavation, Facing East.

Pictures taken during excavation, Facing Southwest.

On October 28, 2024, the Devon Construction Department mobilized personnel and equipment to begin immediate remediation activities. They began by excavating the area to a depth of 1' BGS. The contaminated soil (7 cubic yards) was hauled to an approved, lined disposal facility (R360 Antelope Draw) and clean backfill material was brought in.

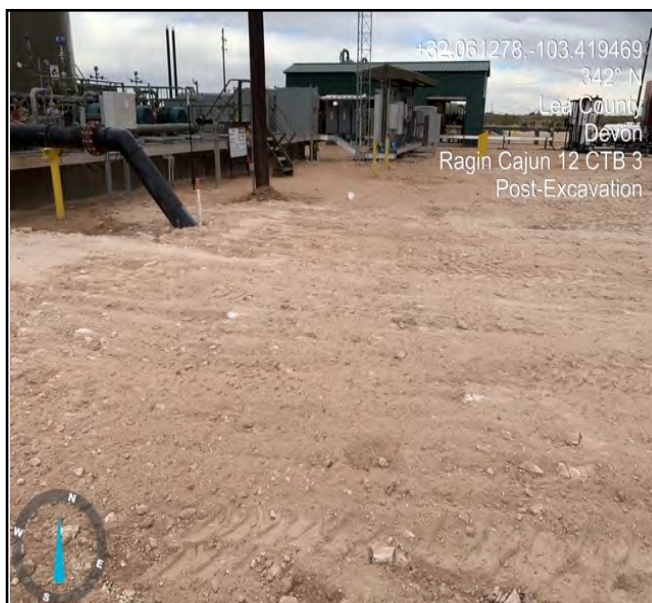
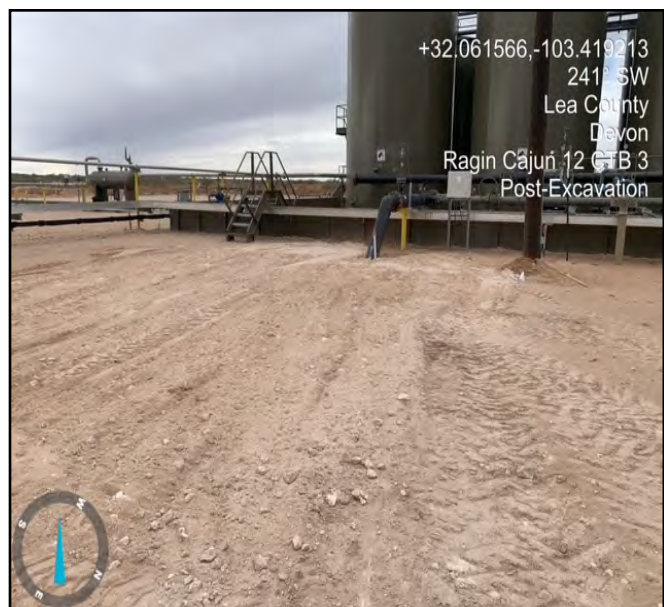
### Post- Excavation:

Photo taken pursuant to excavation, taken facing West.

Photo taken pursuant to excavation, taken facing North

Photo taken pursuant to excavation, taken facing Southwest.

On October 31, 2024, after sending a 48-hour notification, application ID: 396945, Pima returned to the site to collect confirmation samples of the excavation. The results of this sampling event can be found in Figure 4. Analytical Laboratory Reports can be found in Appendix D. Photographic Documentation can be found in Appendix C.

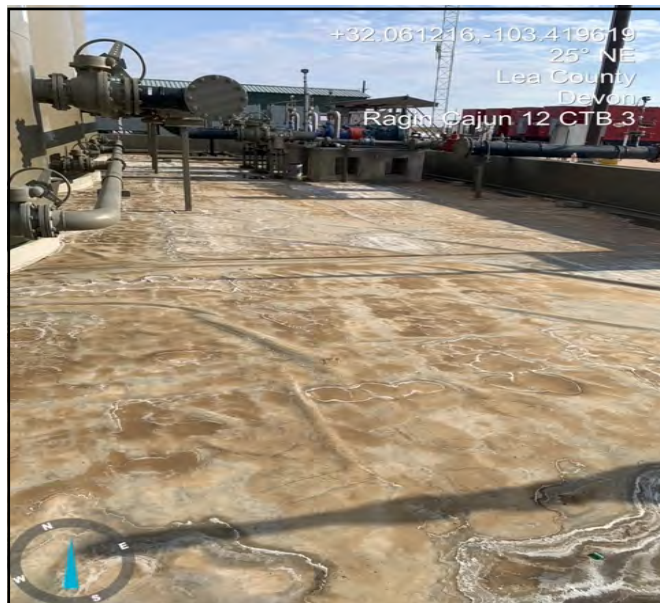
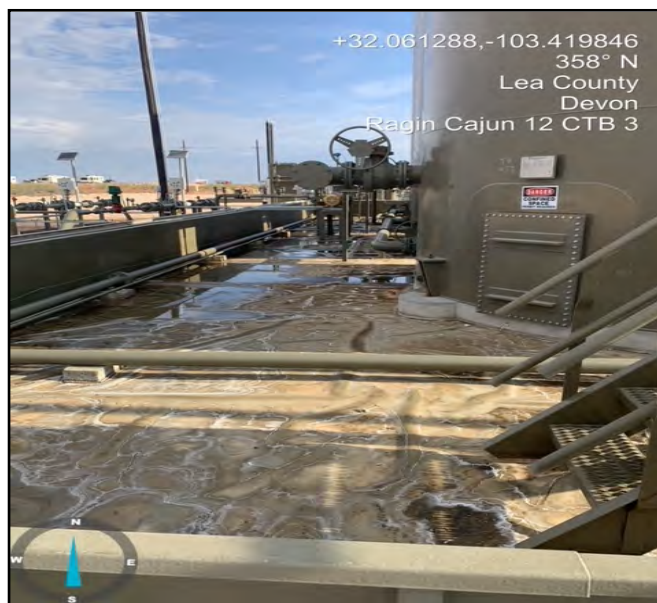
### Intial Liner Inspection:

Photo of liner taken prior to power washing.  
Facing Northeast.

Photo of liner taken prior to power washing.  
Facing North.

On September 6, 2024, Pima personnel mobilized equipment to the site to perform power washing of the liner and containment. A vacuum truck accompanied the crew to recover the power washing fluids.

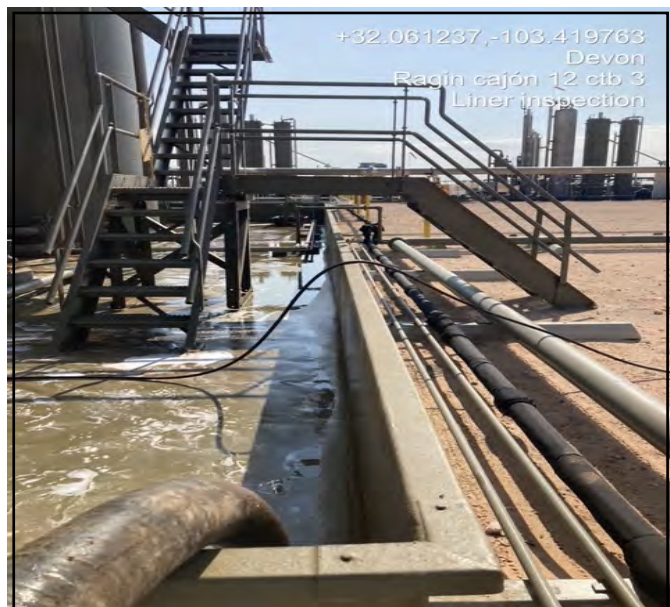
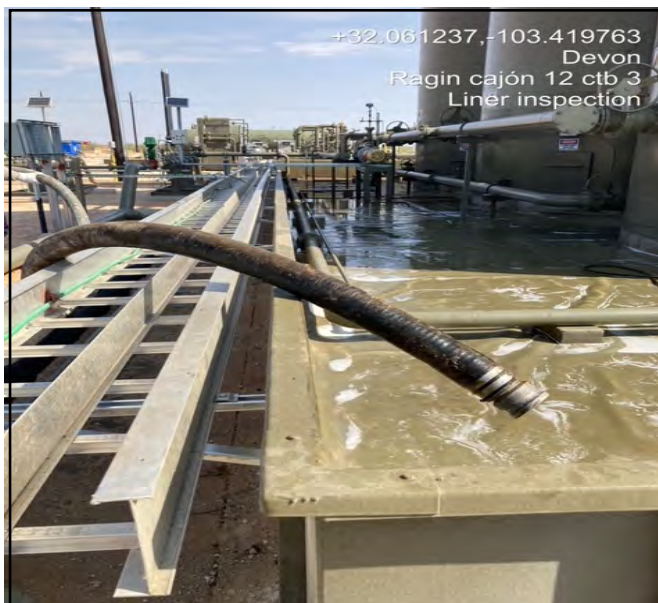
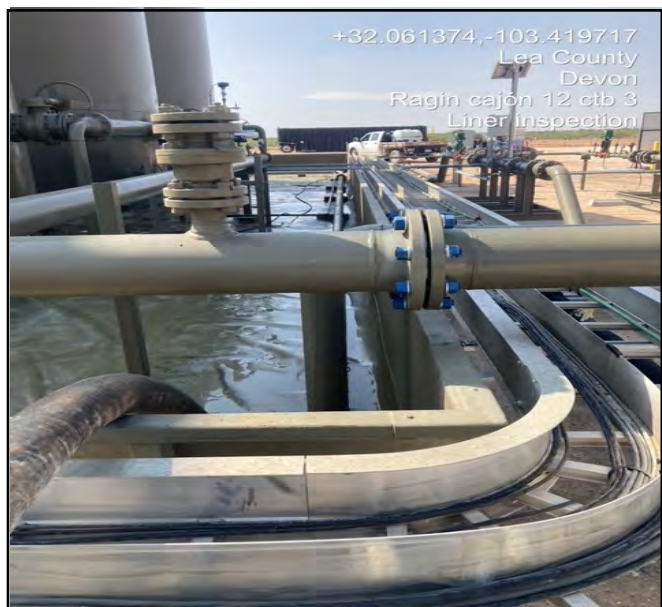
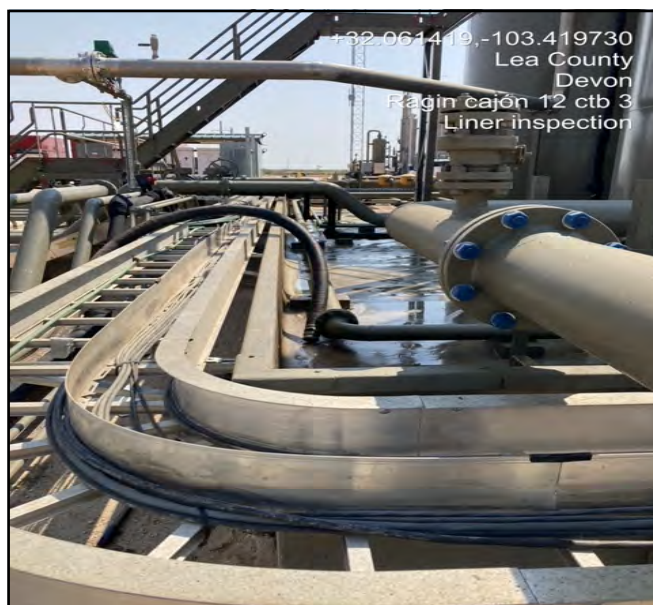
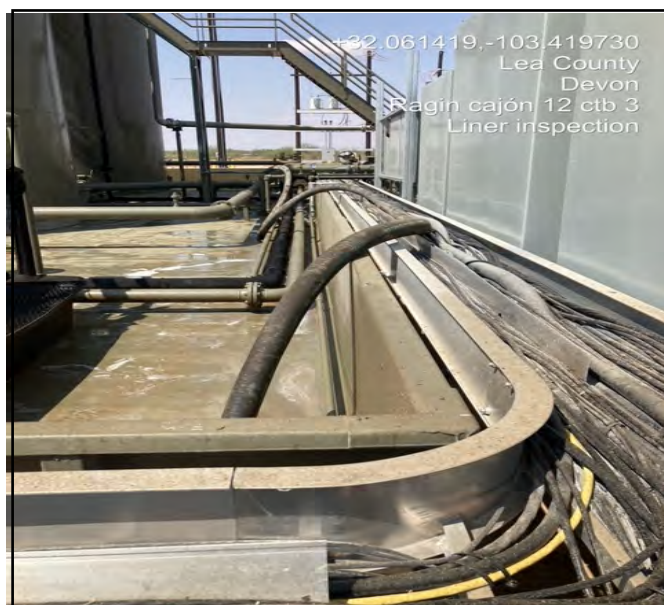
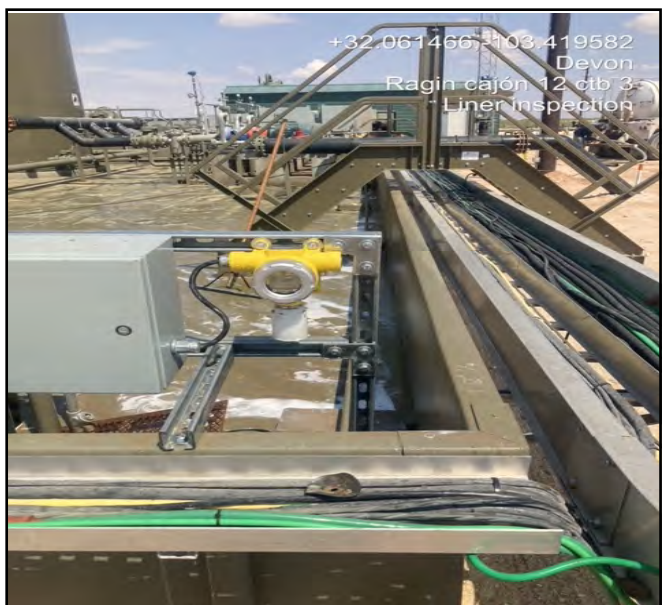
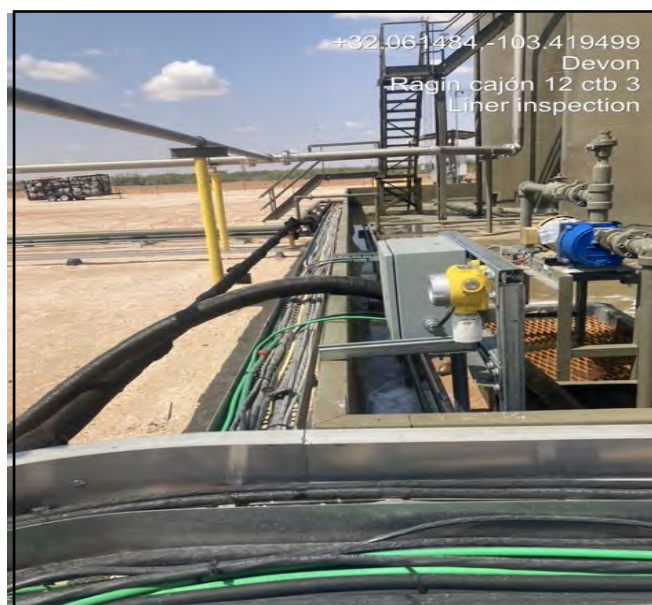
### Liner Inspection:

Photo taken pursuant to power washing.

On September 11, 2024, after submitting a 48-hour notification application ID: 381653 to the OCD, Pima Environmental conducted a liner inspection at this location. Pima concluded that this liner and containment maintained its integrity and was able to retain fluids. The liner inspection form and photographic documentation can be found in Appendix D.

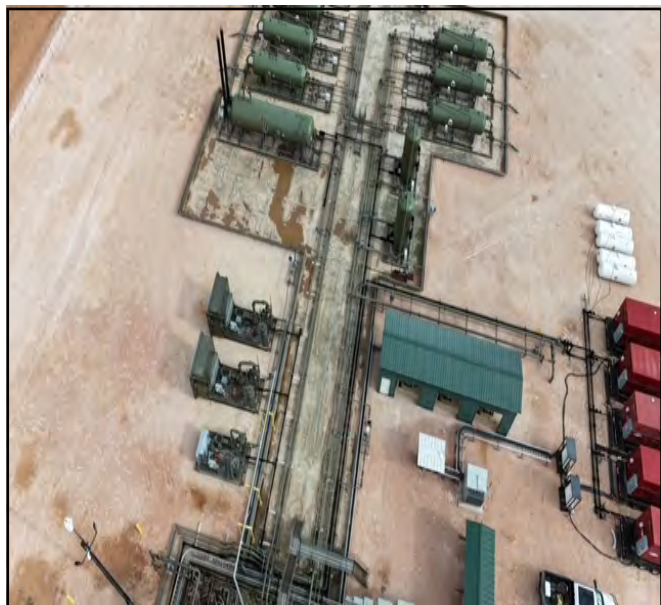
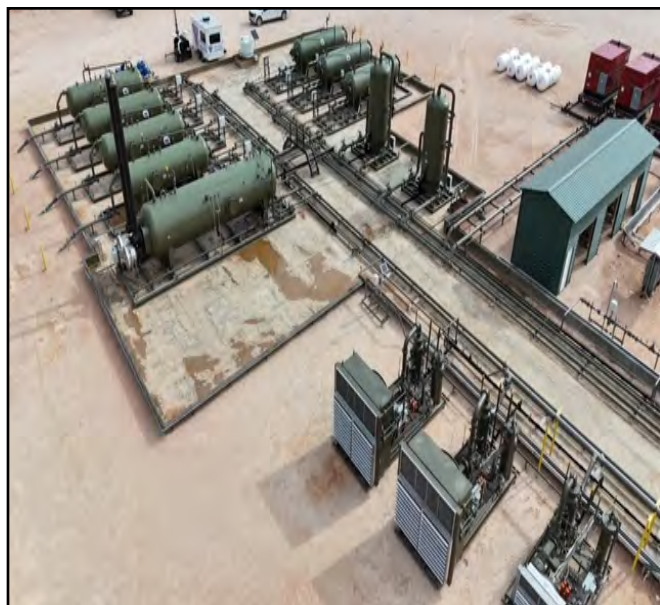
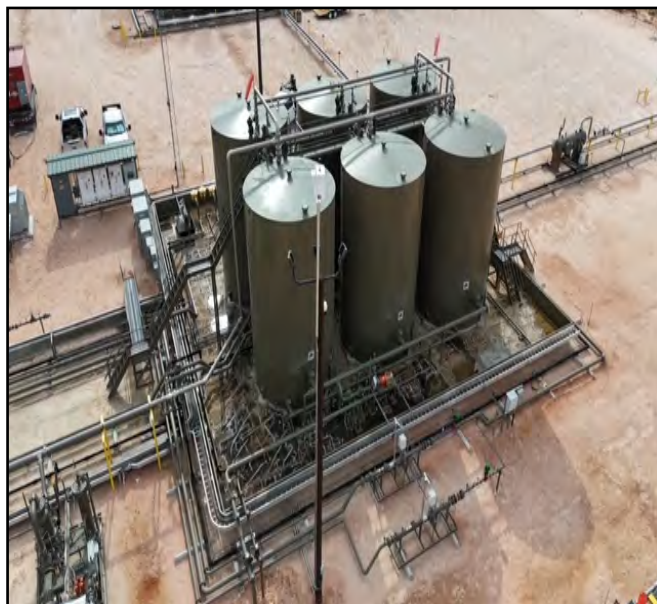
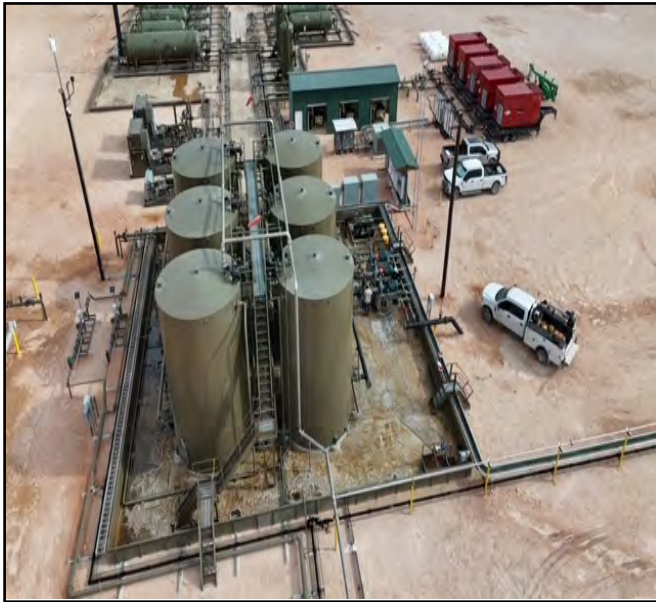
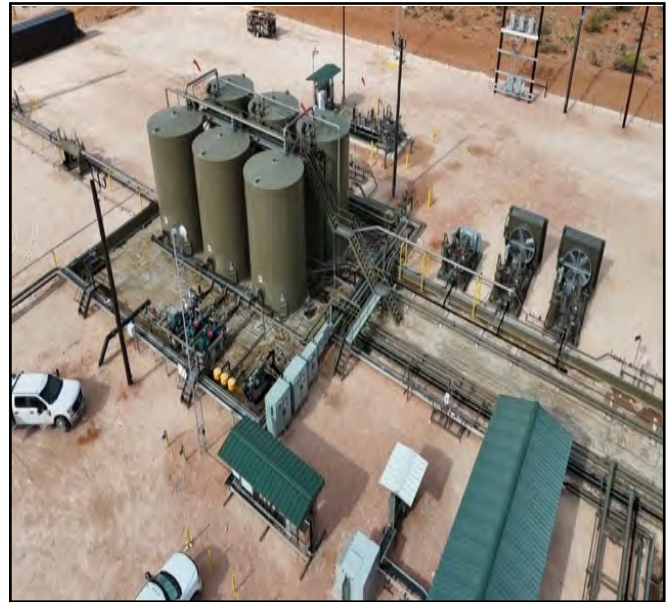
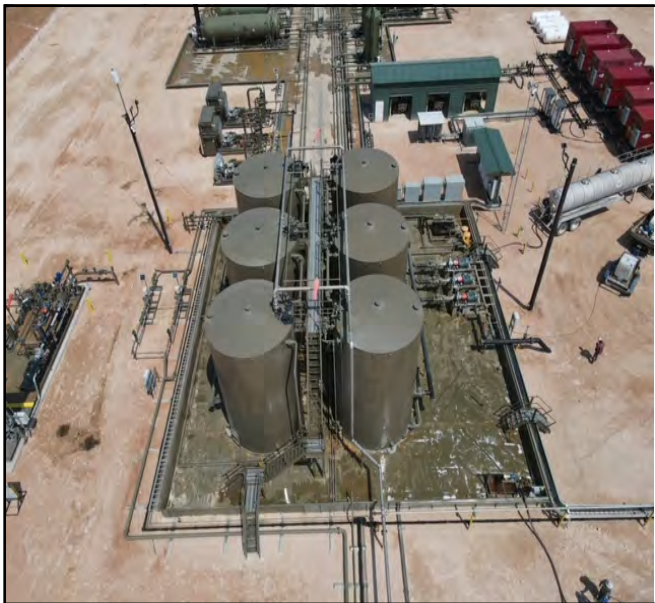
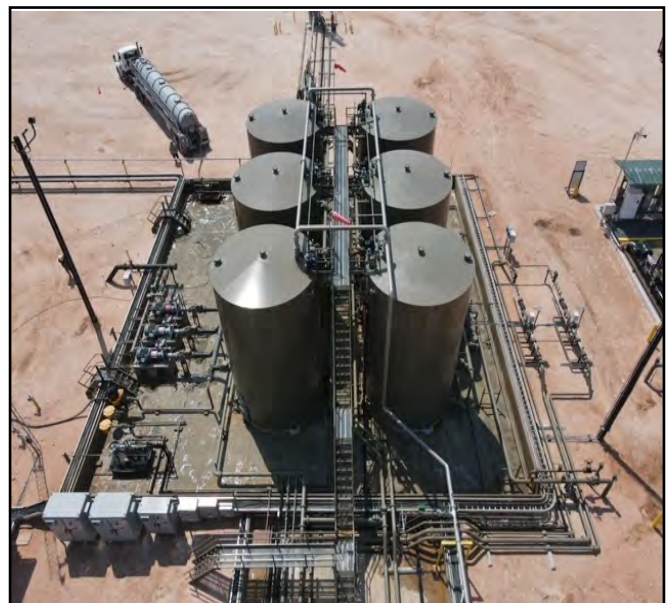
### Aerial Photos:

Aerial photo of liner.
