## Remediation Closure and Reclamation Report

Rumble State #4H

API: 30-015-45749

May 2025

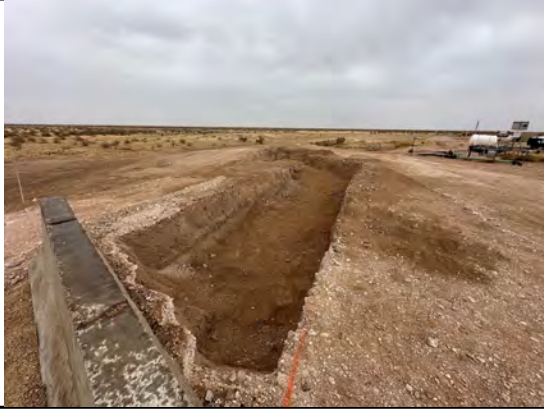
**Viewing Direction: Northeast**

4ft Excavation Areas

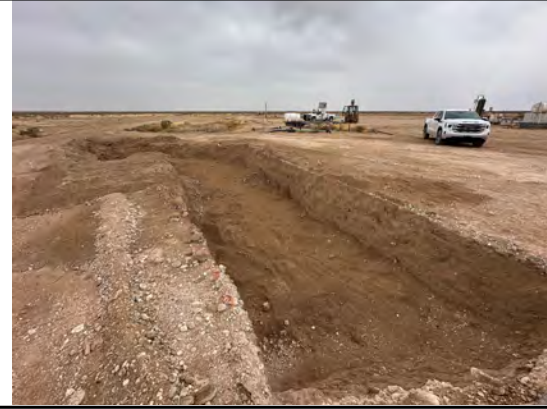
**Viewing Direction: South**

4ft Excavation Areas

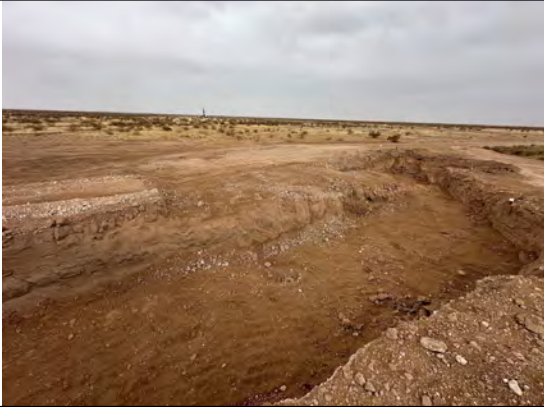
**Viewing Direction: East**

4ft Excavation Areas

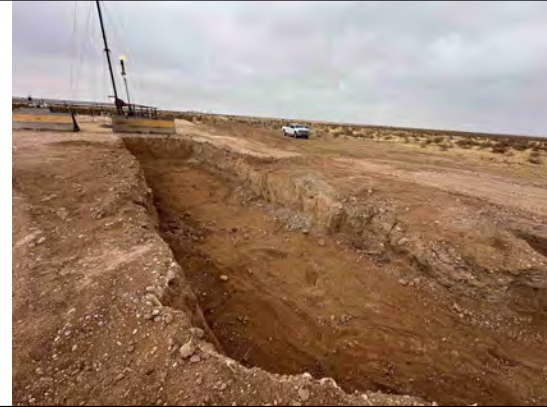
**Viewing Direction: North**

4ft Excavation Areas

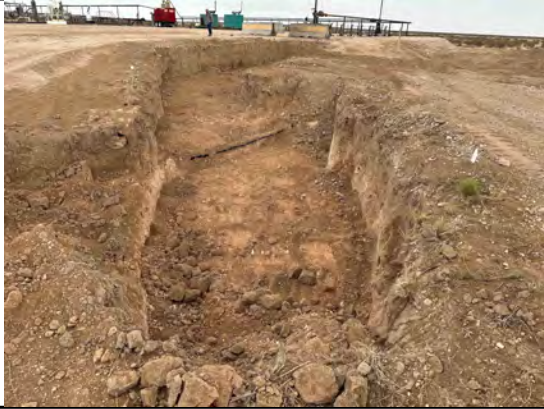
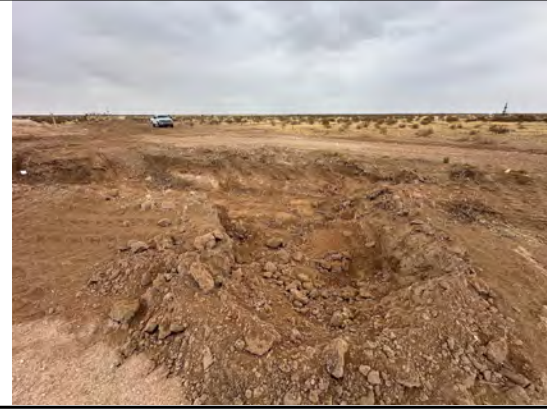
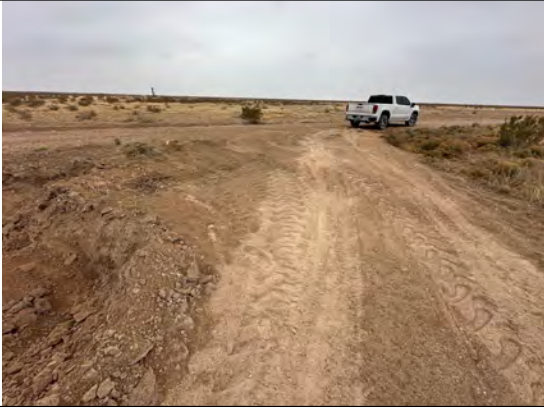
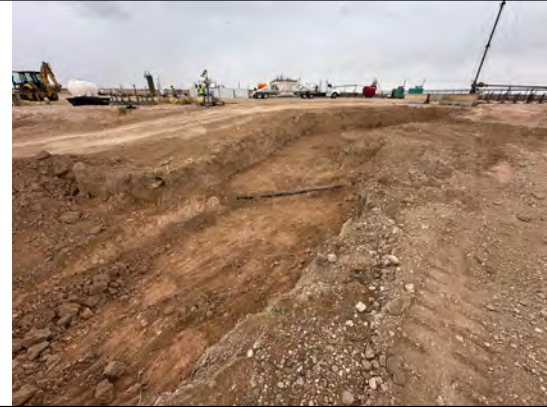
Overview of excavation/scrape areas

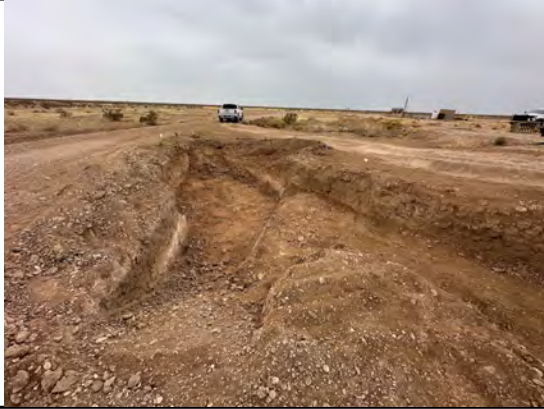
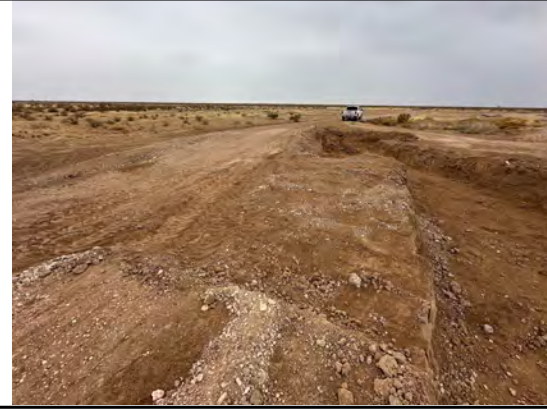
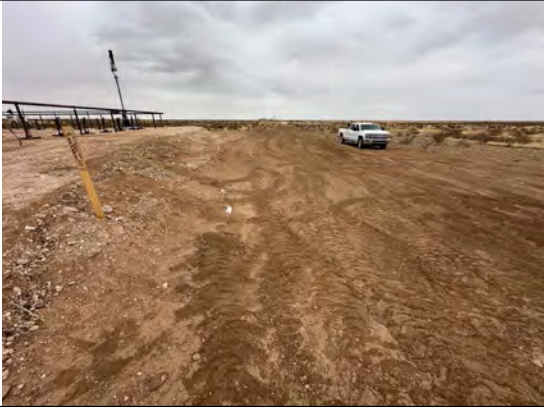
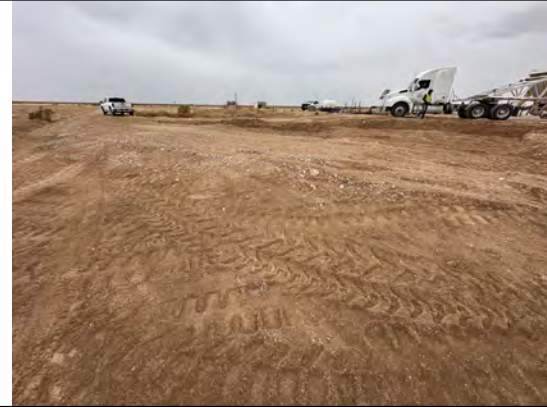
Overview of excavation/scrape areas

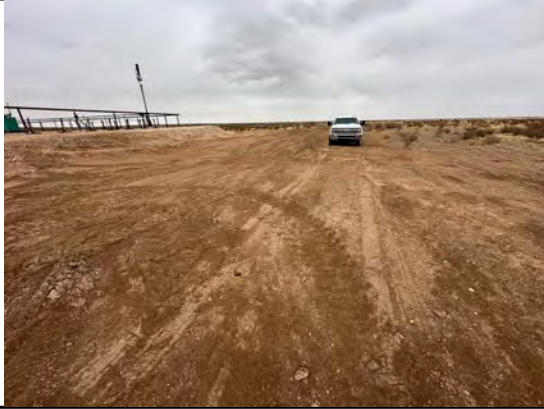
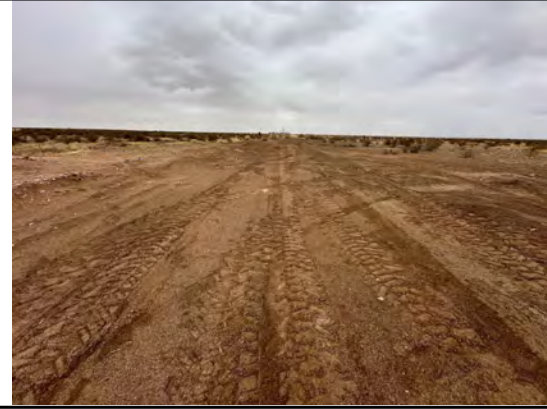
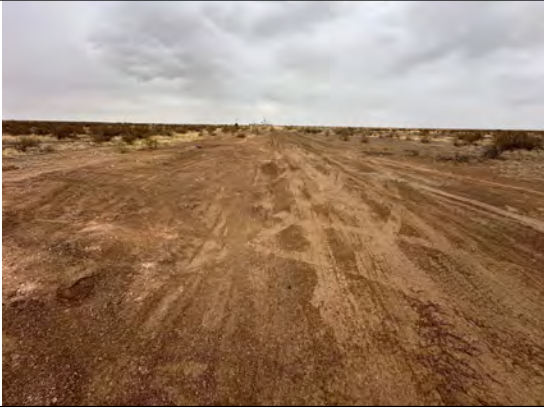
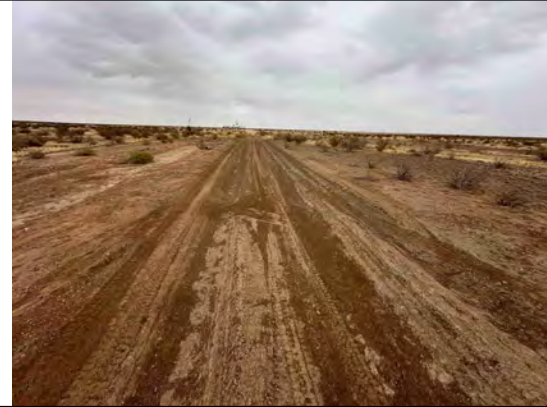
Overview of excavation/scrape areas

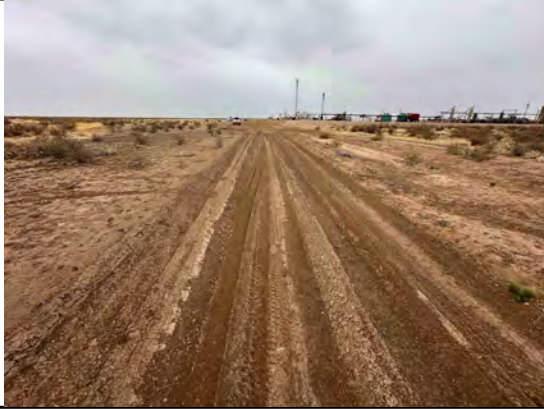
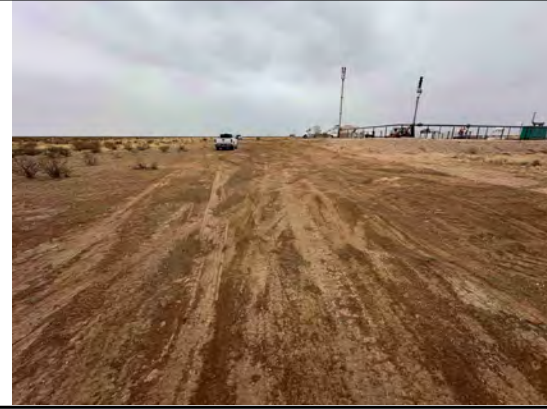
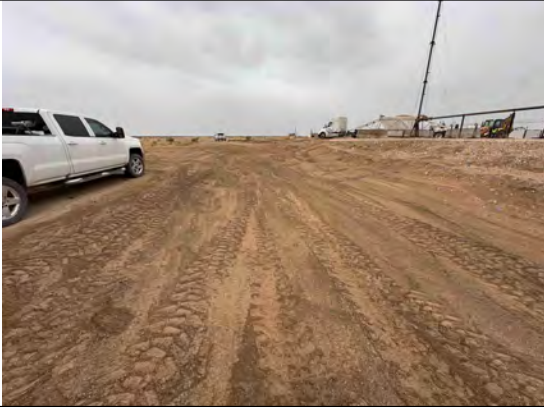
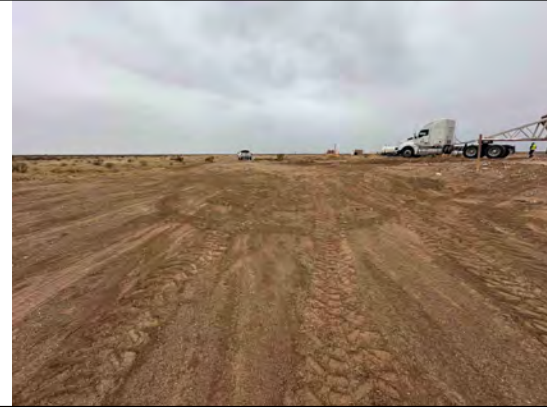
Overview of excavation/scrape areas

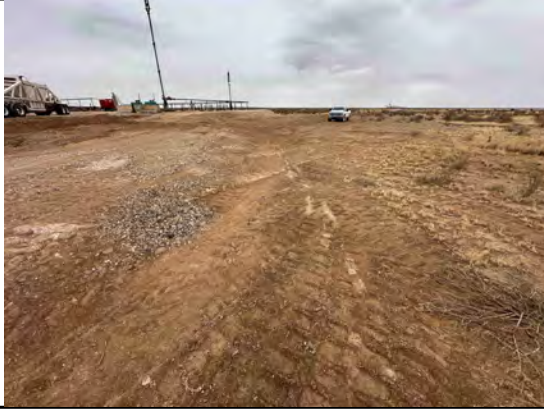
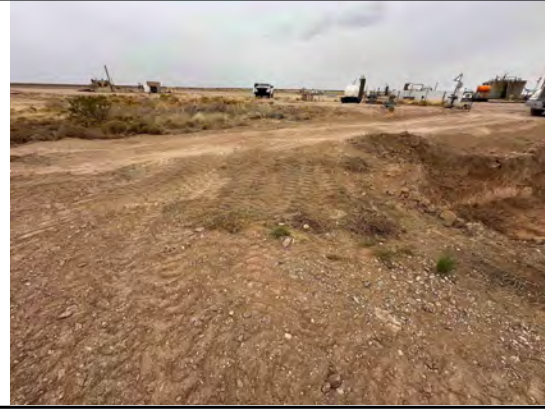
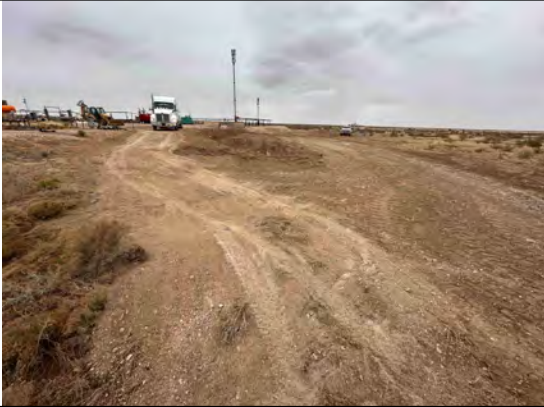
Overview of excavation/scrape areas

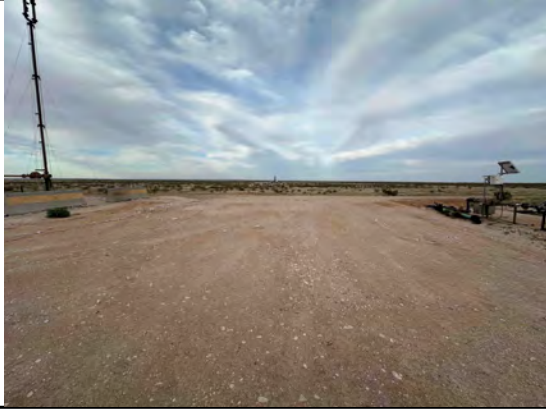
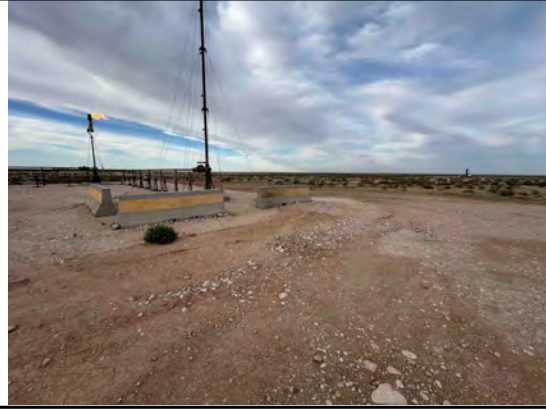
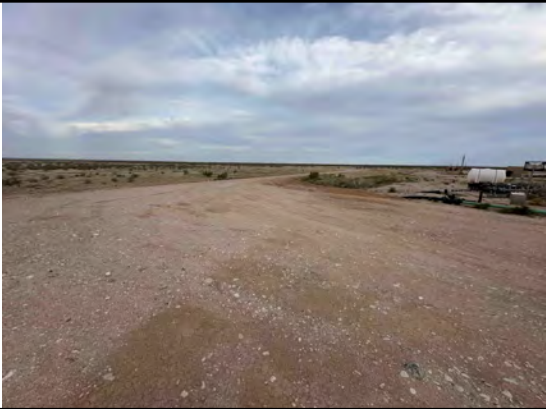
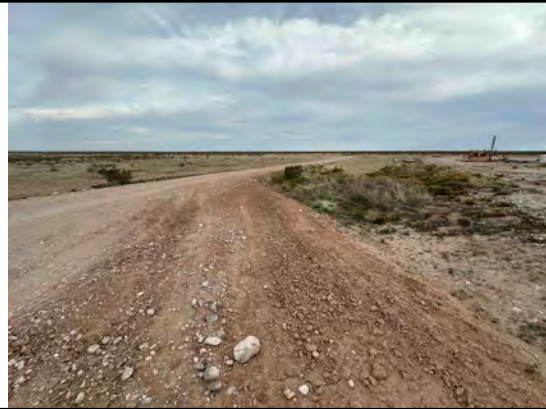
Overview of backfilled/reclaimed areas

The site was contoured to match surrounding topography as near as practicable to restore natural drainage, which is generally in a southwest-to-northeast direction. Compaction on the reclaimed areas was addressed by decompaction via cross ripping to a maximum depth of 18 inches (or as site conditions allow) with a furrow spacing of 2 feet. Decompaction activities were conducted post-backfill and pre-seeding to maximize seed to soil contact and promote vegetation establishment.

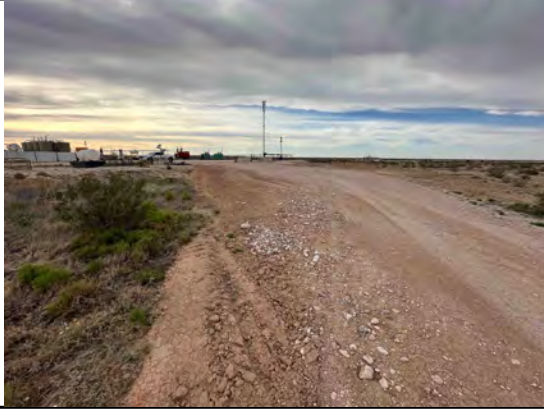
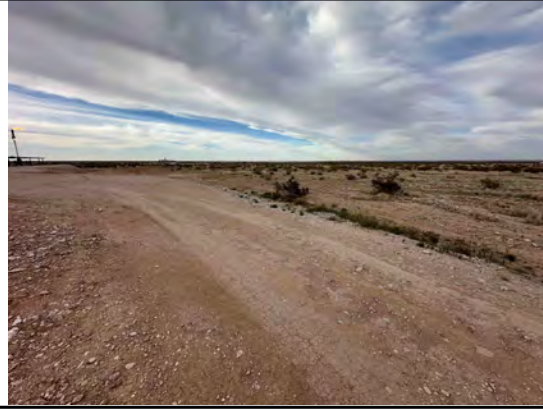
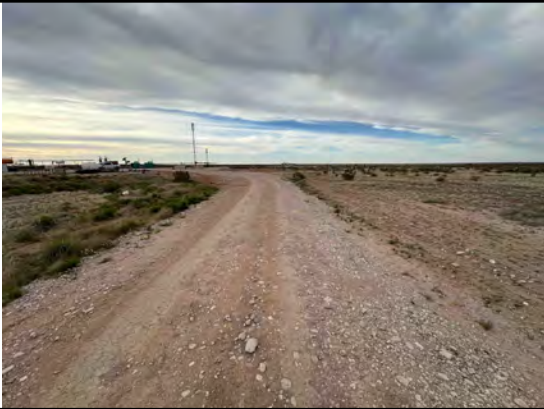
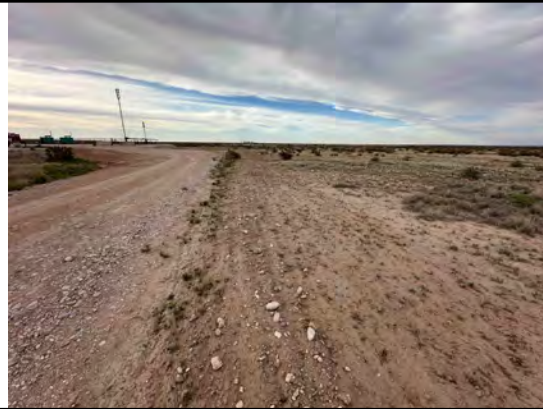
Overview of backfilled/reclaimed areas

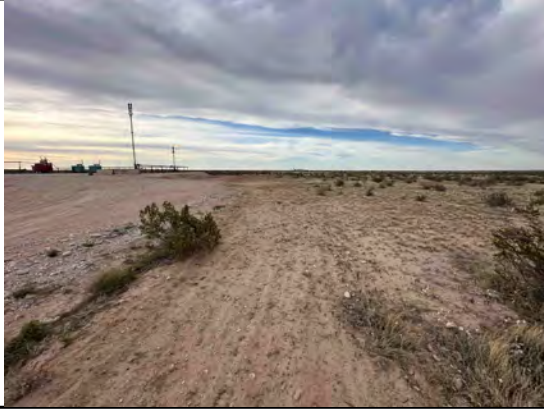
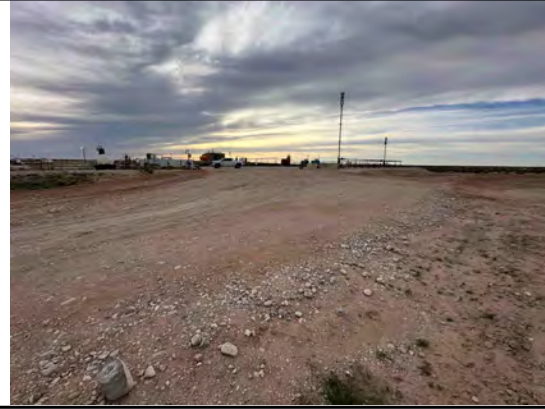
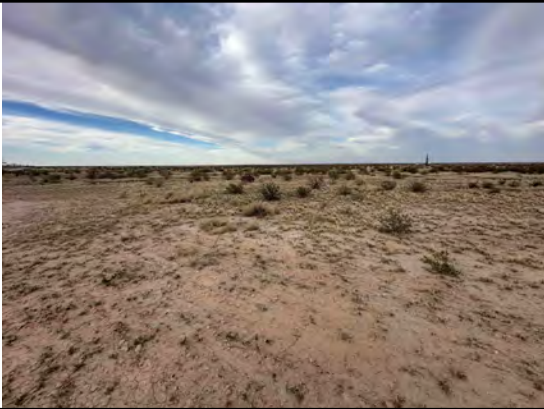
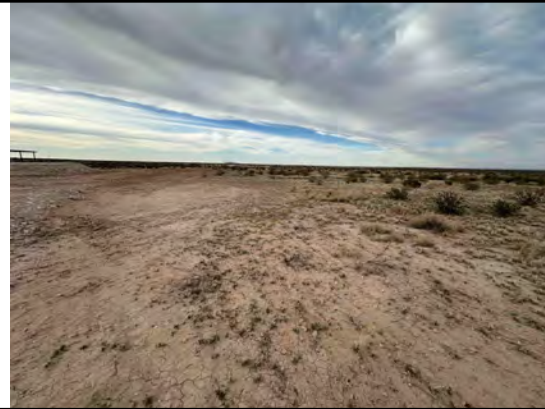
Overview of backfilled/reclaimed areas

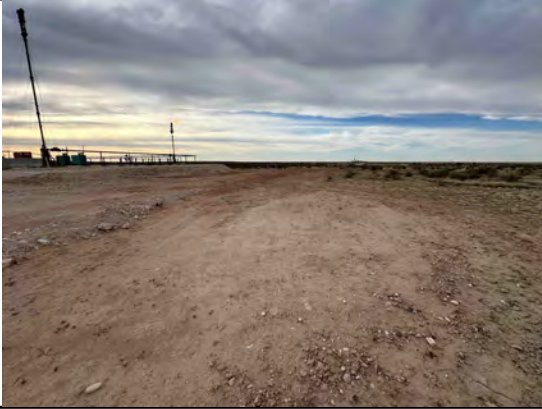
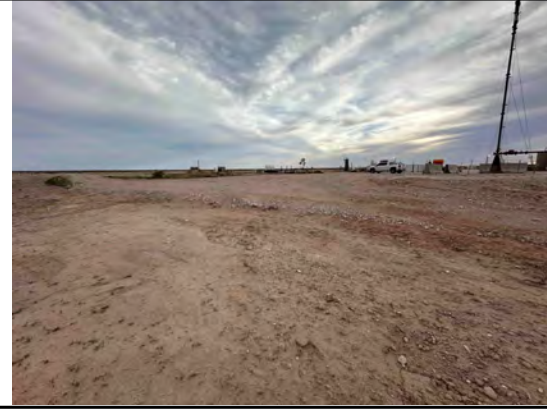
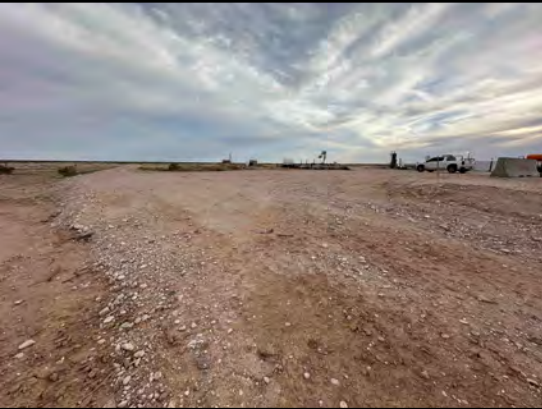
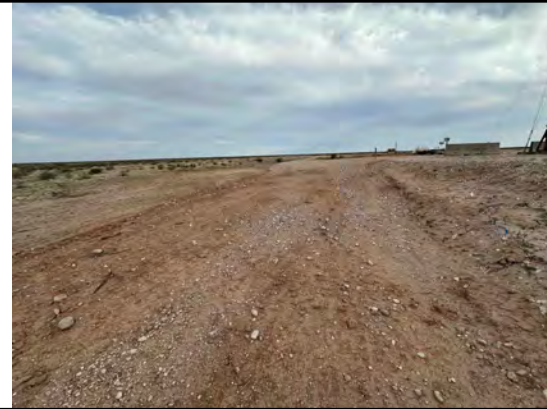
Overview of backfilled/reclaimed areas

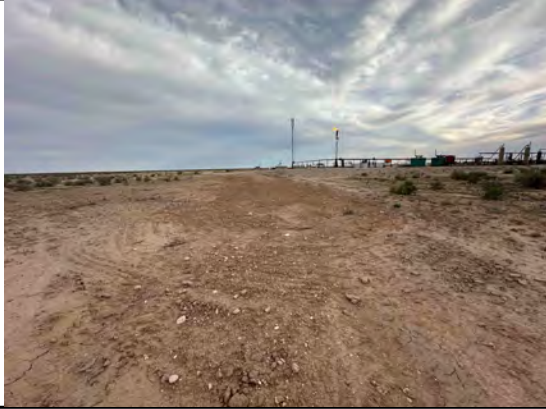
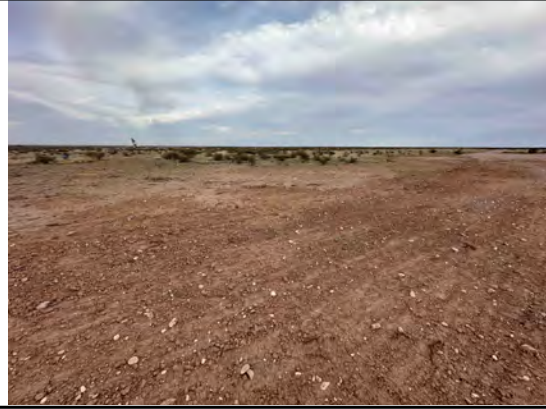
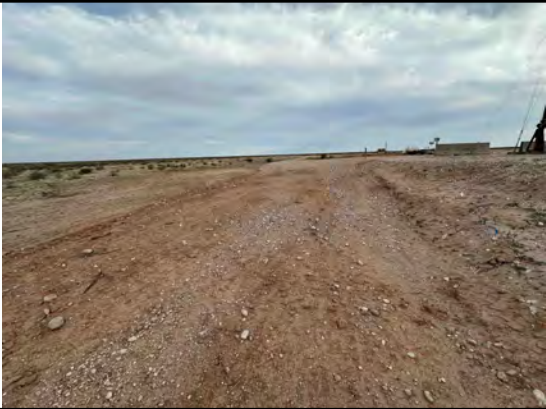
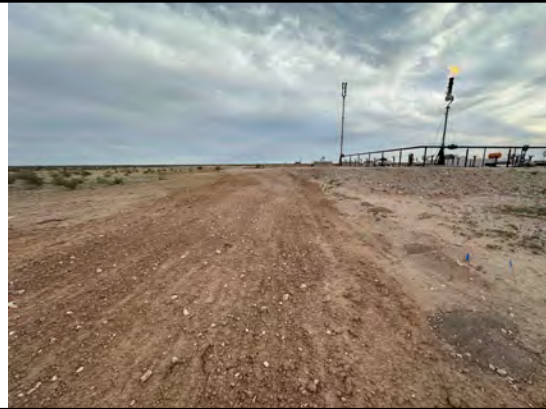
Overview of backfilled/reclaimed areas
