**Re: Closure Request  
PLU 30 Big Sinks Battery  
Incident Numbers nAPP2508749187 & nAPP2510447031  
Eddy County, New Mexico**

Ensolum, LLC (Ensolum), on behalf of XTO Energy, Inc (XTO), has prepared this *Closure Request* to document the findings of a liner integrity inspection conducted at the PLU 30 Big Sinks Battery (Site) following two releases of produced water within a lined containment. Based on the liner integrity inspection activities, XTO is submitting this *Closure Request*, describing the inspection results and requesting closure for Incident Numbers nAPP2508749187 & nAPP2510447031.

XTO Energy, Inc  
Closure Request  
PLU 30 Big Sinks Battery

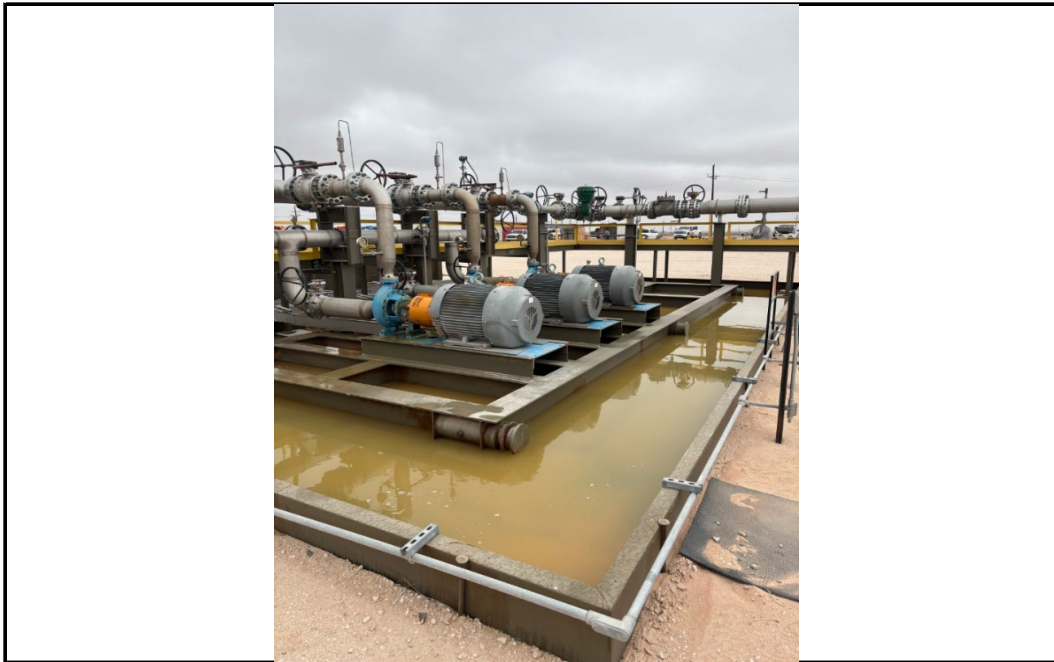
Photograph 1

On March 27, 2025, failure of a seal on a saltwater disposal (SWD) produced water pump resulted in the release of approximately 60 barrels (bbls) of produced water into a lined containment. A vacuum truck was dispatched to the Site to recover free-standing fluids and all fluids were recovered. The lined containment was power washed to remove any residual fluids. XTO reported the release to the New Mexico Oil Conservation Division (NMOCD) via a Notification of Release (NOR) and submitted an Initial C-141 Application (C-141) on March 28, 2025. The release was assigned Incident Number nAPP2508749187.

Description: Initial release in lined containment - nAPP2508749187

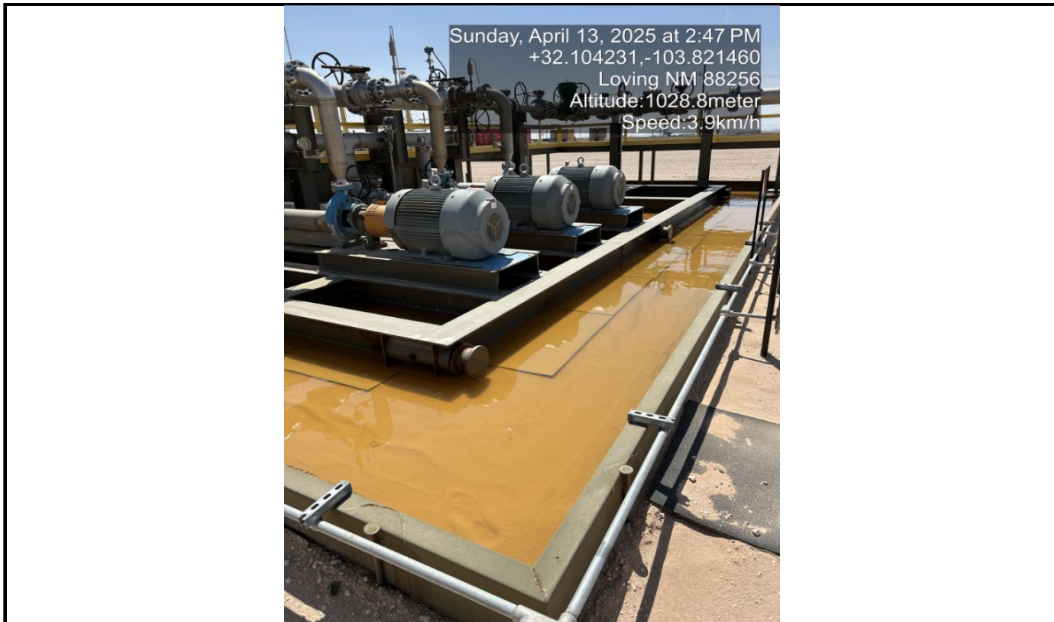
Photograph 2

On April 13, 2025, a seal on a SWD produced water pump failed, resulting in the release of approximately 20 bbls of produced water into the same lined containment as the March 27, 2025 produced water release. A vacuum truck was dispatched to the Site to recover free-standing fluids and all fluids were recovered. The lined containment was power washed to remove any residual fluids. XTO reported the release to the NMOCD via a NOR and submitted a C-141 on April 14, 2025. The release was assigned Incident Number nAPP2510447031.

Description: Initial release in lined containment - nAPP2510447031

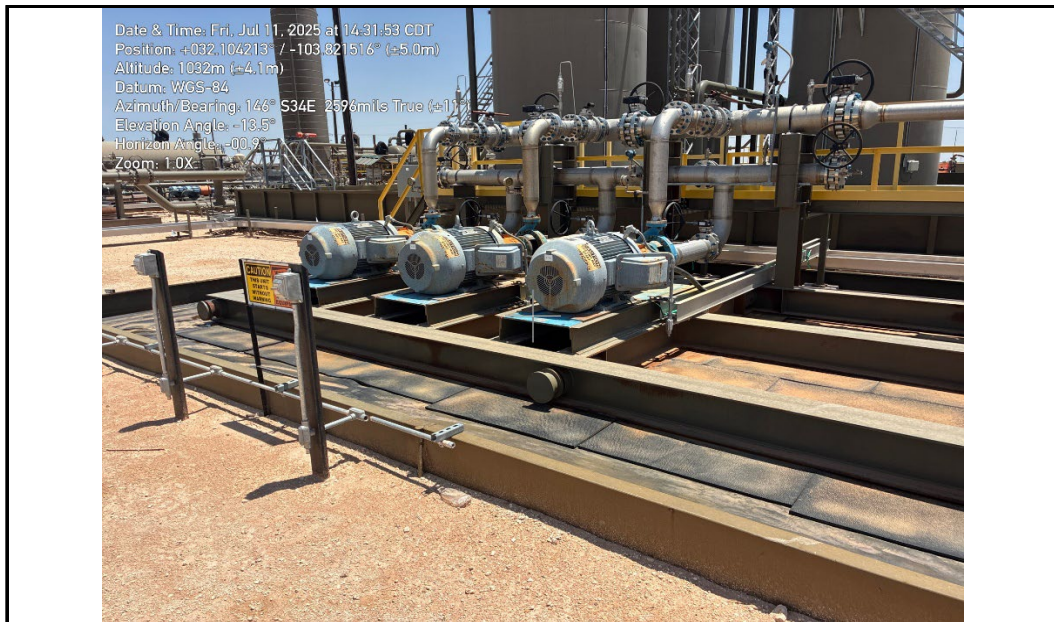
Photograph 4

A 48-hour advanced notice of the liner inspection was submitted to the NMOCD for both releases on July 9, 2025. The lined containment was cleaned of all debris and power washed and a liner integrity inspection was conducted by Ensolum personnel on July 11, 2025. The lined containment was inspected, and it was determined that the liner was operating as designed. Upon inspection, no rips, tears, holes, or damage was observed. The lined containment has rubber mats protecting the floor from the pump skid. These rubber mats are stained but were properly cleaned prior to inspection. The liner was determined to be operating sufficiently, and all released fluids were recovered. Photographic documentation of the inspection is included in Appendix B.

Description: Liner inspection activities. Stained rubber mats protecting the lined containment floor from the pump skid. Facing southeast.

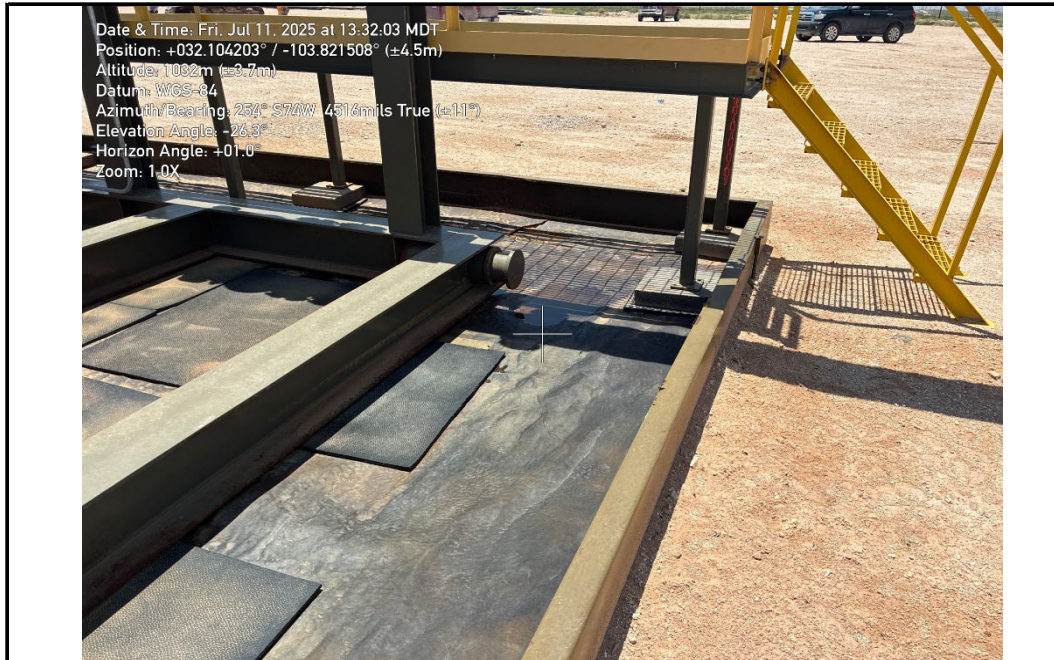
Photograph 5

Description: Liner inspection activities facing southwest

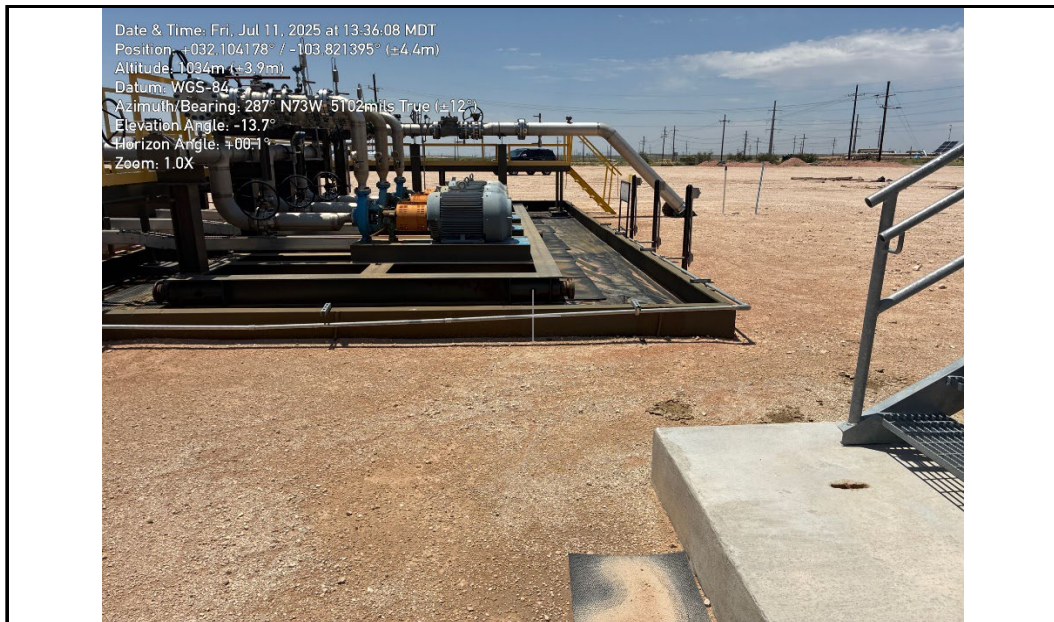
Photograph 6

Description: Liner inspection activities facing west

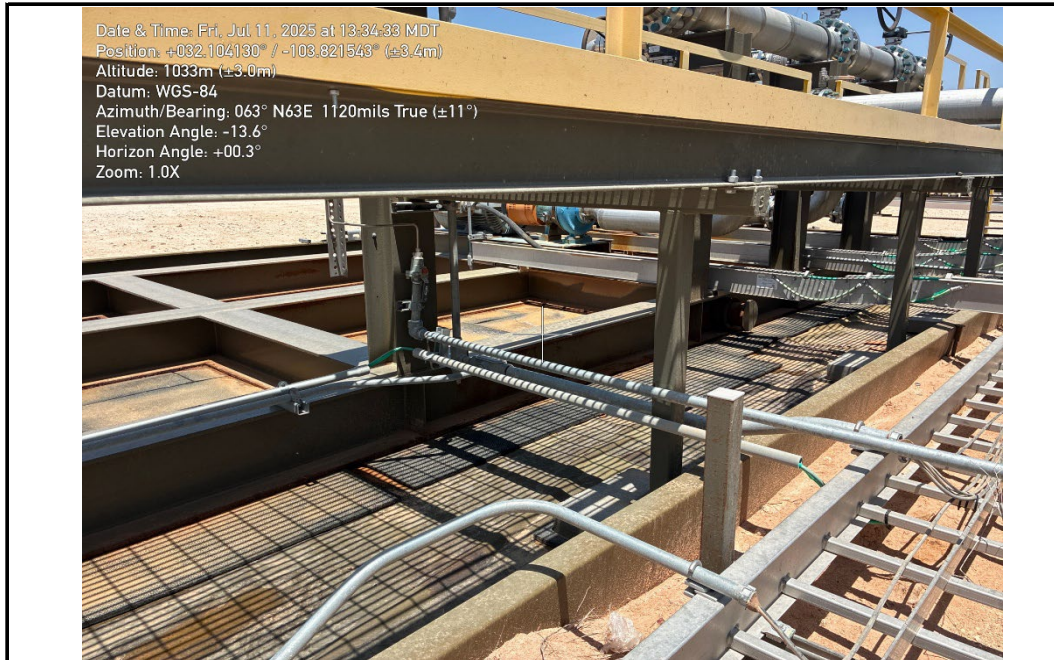
Photograph 7

Description: Liner inspection activities facing northeast

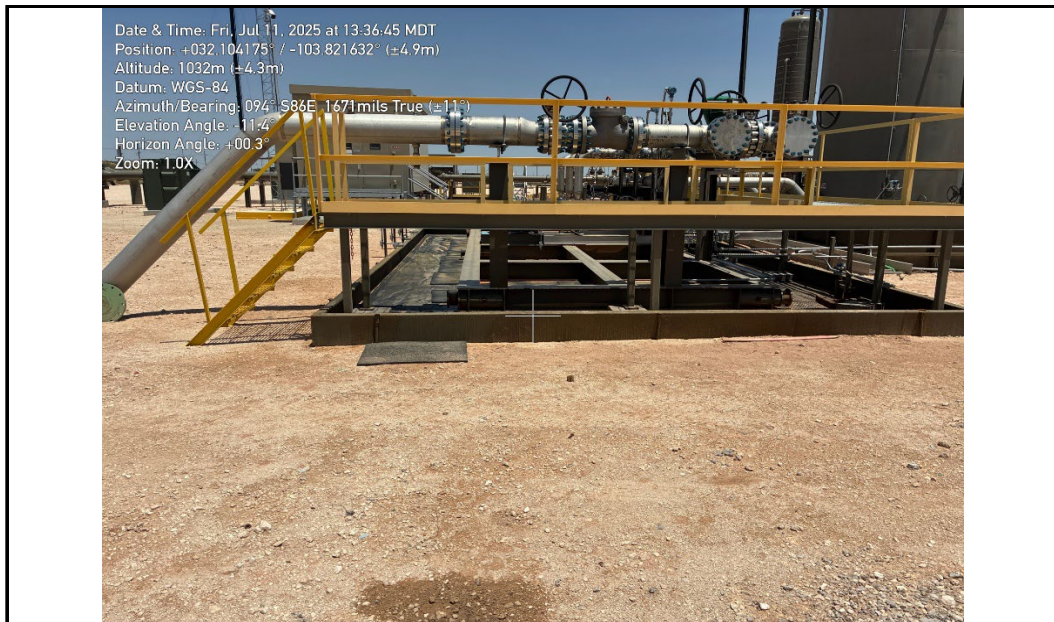
Photograph 8

Description: Liner inspection activities facing east
