CLOSURE REQUEST REPORT

Rustler Bluff 33

Eddy County, New Mexico
Incident Number nAPP2303929522

Prepared for: Chevron USA, Inc. 6301 Deauville Blvd Midland, TX, 79706

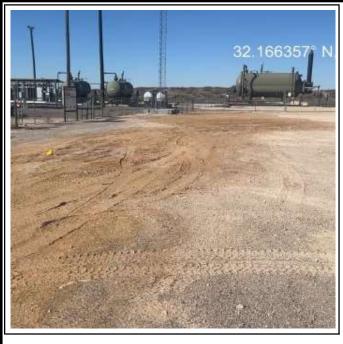
Photograph 1 Date: 02/10/2023 Description: Western view of area of concern.

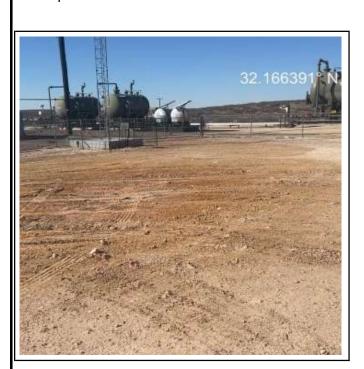
Photograph 3 Date: 02/10/2023 Description: Southwestern view of the area of concern.

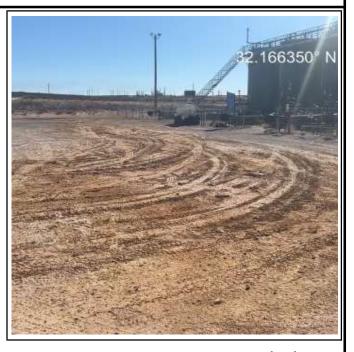
Photograph 2 Date: 02/10/2023 Description: Southeastern view of the area of concern.

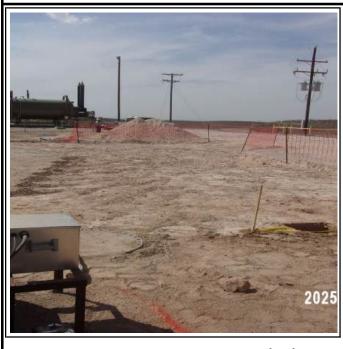
Photograph 5 Date: 03/26/2025 Description: Western view following excavation activities.

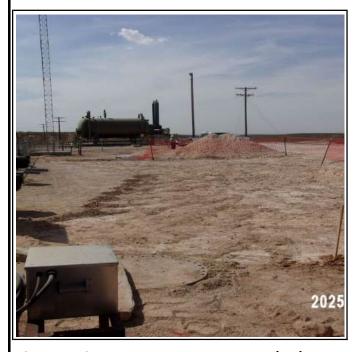
Photograph 7 Date: 03/26/2025 Description: Western view following excavation activities.

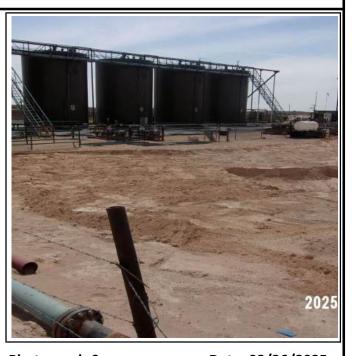
Photograph 6 Date: 03/26/2025
Description: Southwestern view following excavation activities.

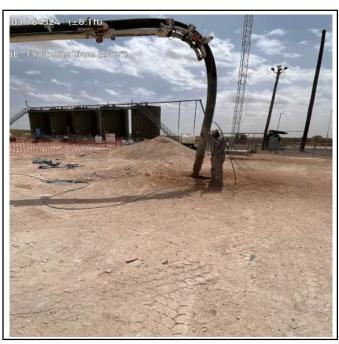
Photograph 8 Date: 04/03/2025
Description: Southern view following excavation activities.

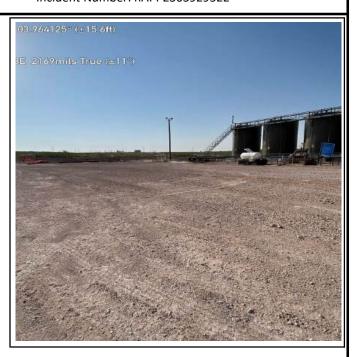
Photograph 10 Date: 05/23/2025 Description: Southeastern view after corrective actions.
