# O-1 LINE LEAK

## Remediation Summary & Closure Report

**NMOCD Incident No. nAPP2230128101**  
**UL "I", Sec. 36, T17S, R31E**  
**32.78793°, -103.81779°**  
**Eddy County, New Mexico**

July 10, 2025

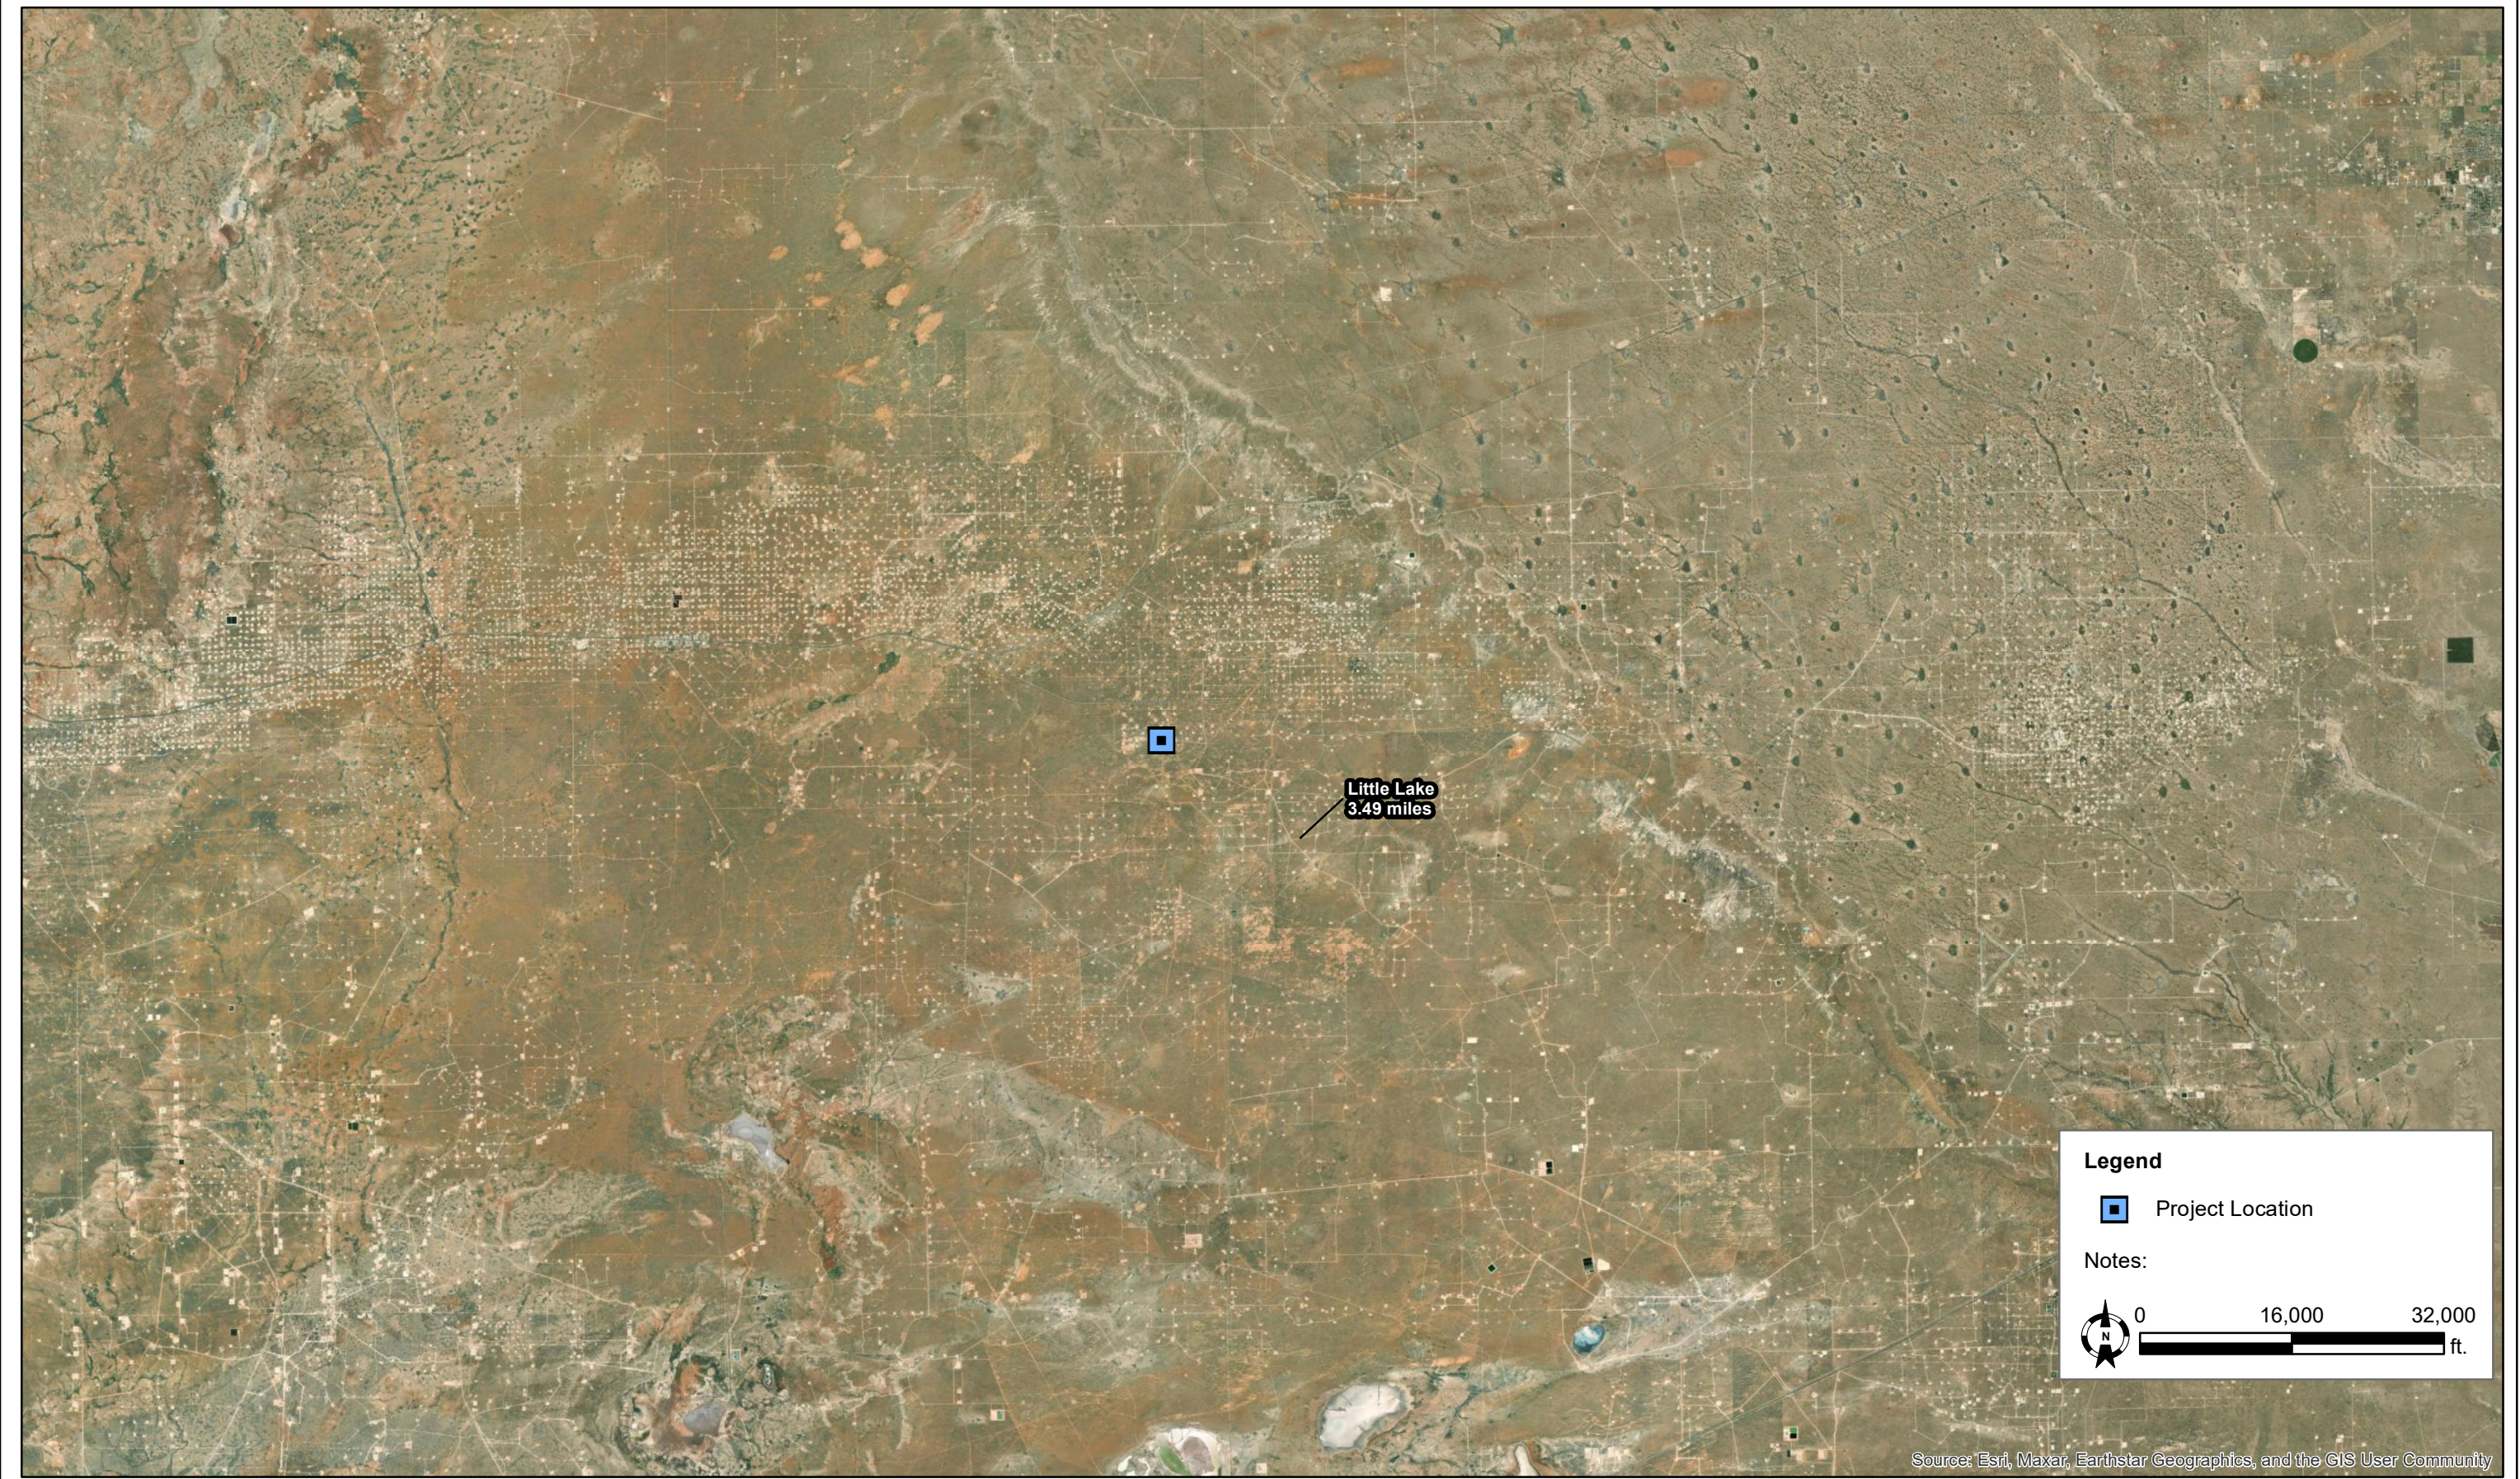
<b>Tasman, Inc.</b> 2620 W. Marland Blvd Hobbs, NM 88240	<b>DCP Operating Company, LP</b> <b>O-1 Line Leak - nAPP2230128101</b> UL "I", Sec. 36. T17S, R31E Eddy County, New Mexico	Surface Water Map	Figure 3
DESIGNED BY: L. Flores				
DRAWN BY: L. Flores

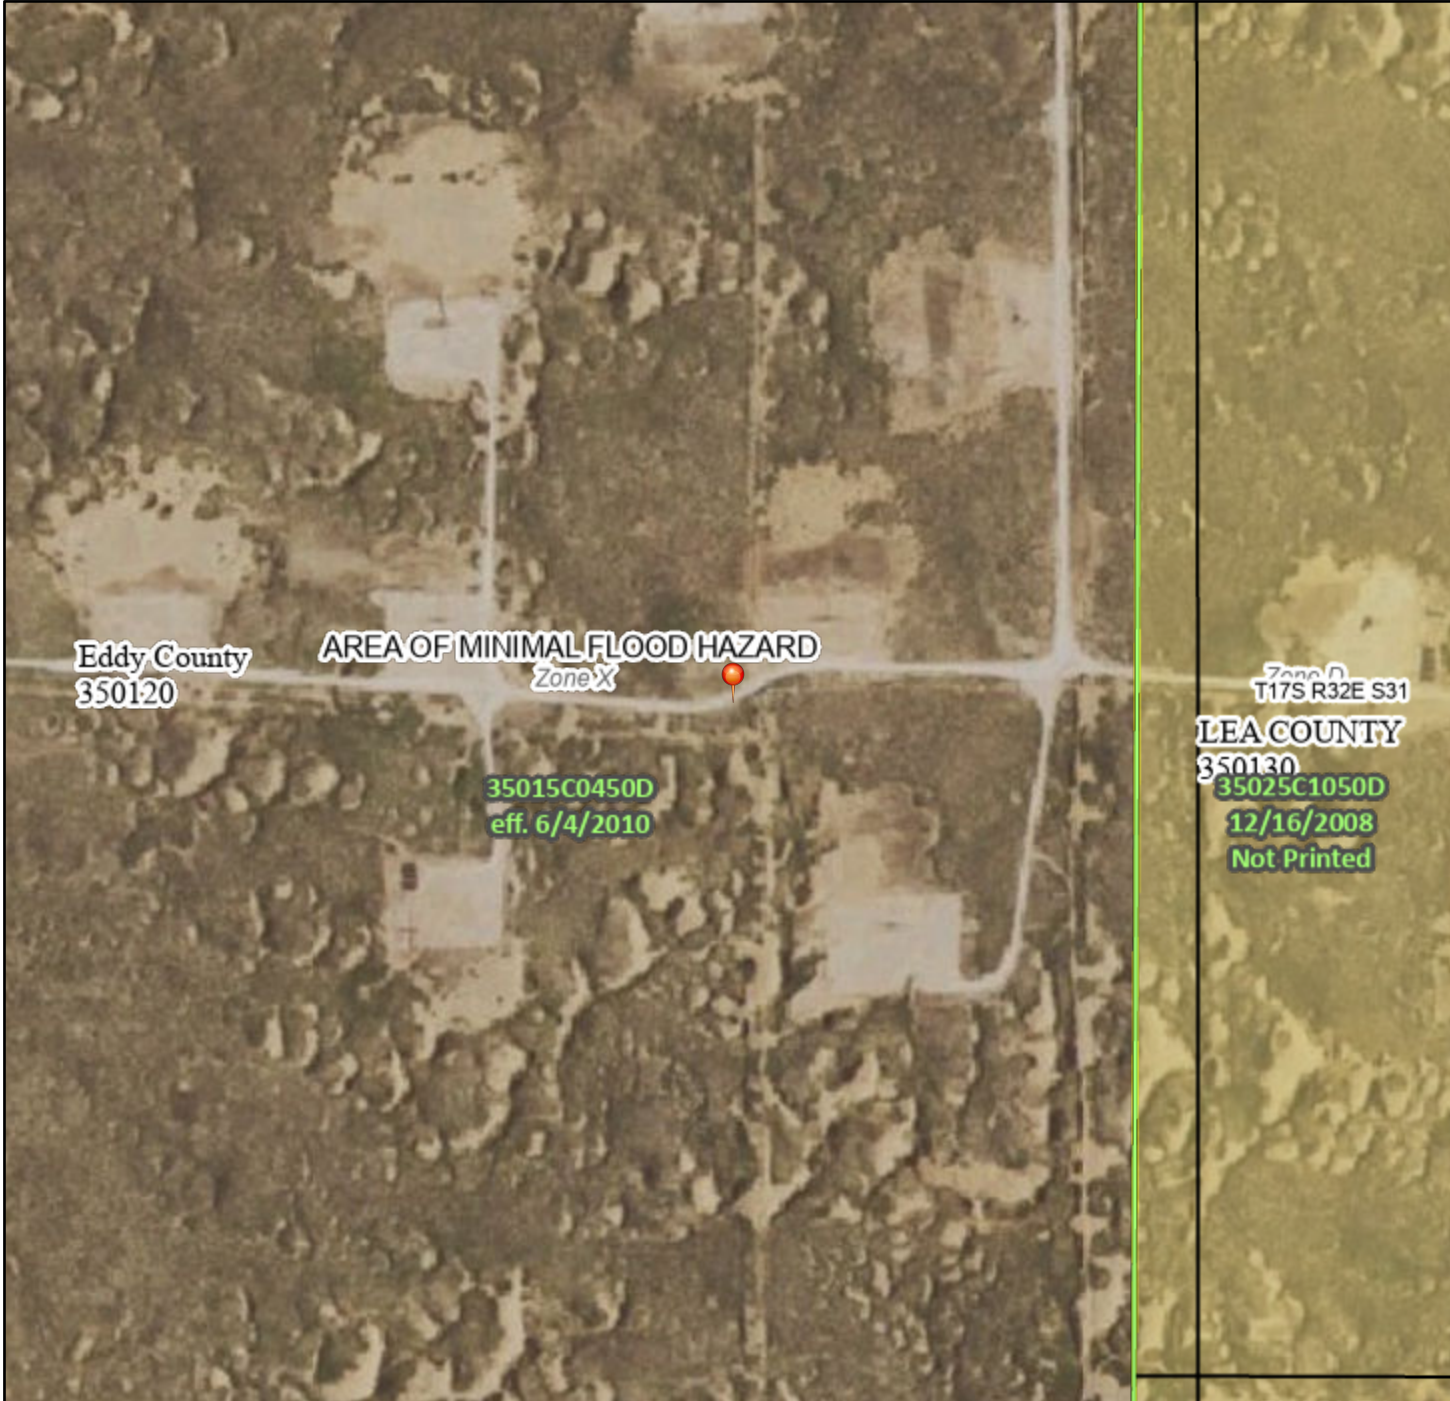
# National Flood Hazard Layer FIRMette

Review of flood map data published by the Federal Emergency Management Agency (FEMA) indicates the site is not located within a 100-year floodplain. A copy of the FEMA FIRMete Map can be found attached as Figure 4.
