VACUUM ABO UNIT #006

nGRL0917640334

PREPARED BY SAPEC-ECO, LLC.
PREPARED FOR MAVERICK PERMIAN, LLC.

Proposed Sampling and Remediation Work Plan

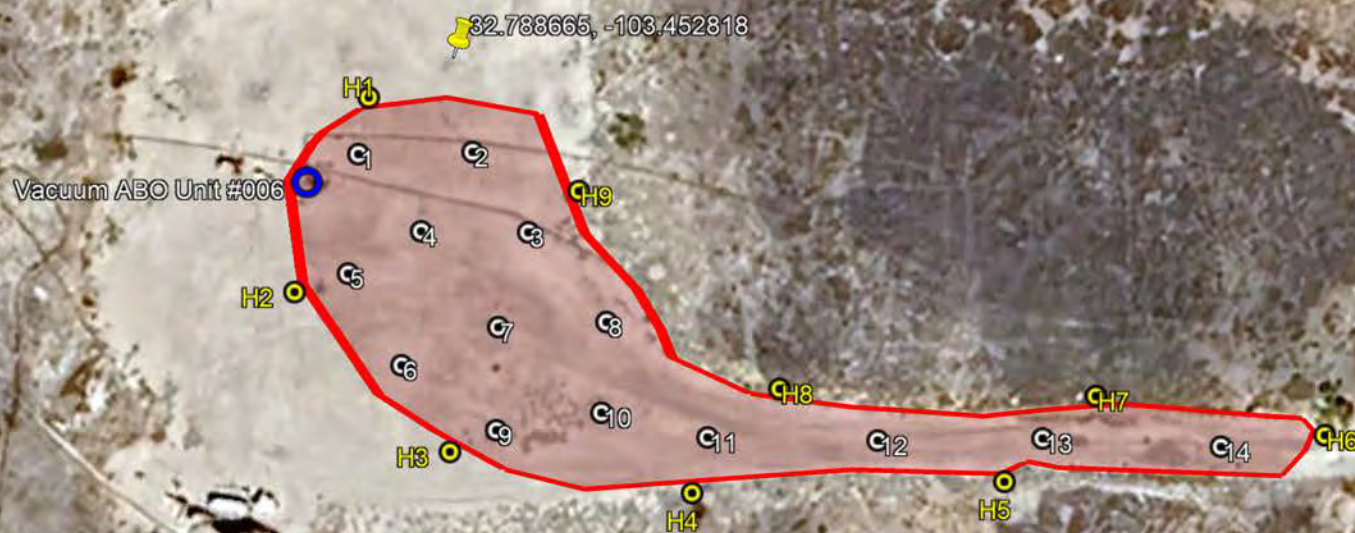
Maverick Permian
API #30-025-03012
Lea County, NM
nGRL0917640334
Proposed Sample Map

- The area of concern measures approximately 12,804 square feet and is solely on the pad surface and lease road.
- Collect discrete samples from within and around the edges of the release area to evaluate the presence of contaminants. Seventy (70) samples will be collected from 14 different sample points within the release area from depths of surface, 1', 2', 3', and 4' bgs. Forty-five (45) samples will be collected from 9 different sample points around the edges of the release area from depths of surface, 1', 2', 3', and 4' bgs.

- Proposed horizontal samples
- Proposed vertical samples
- Release area - 12,804 sqft
- Vacuum ABO Unit #006

- A 48-hour sampling notification will be issued to the NMOCD for these sampling events. A variance request is included below for permission to use the delineation samples as confirmations samples depending on the sample results of the soil. A Proposed Sample Map can be found in Figure 1.

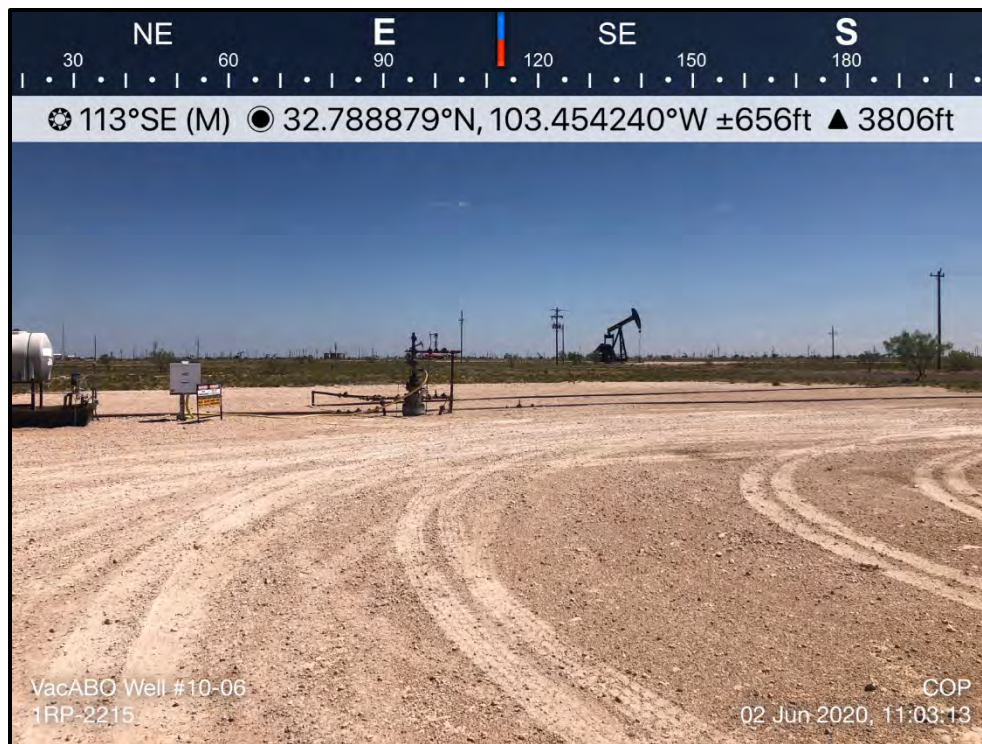
TETRA TECH, INC. PROJECT NO. 212C-MD-02152	DESCRIPTION	View facing east of well head and control box on well pad.	1
	SITE NAME	VAC ABO Well # 10-06 Flowline Release	6/2/2020

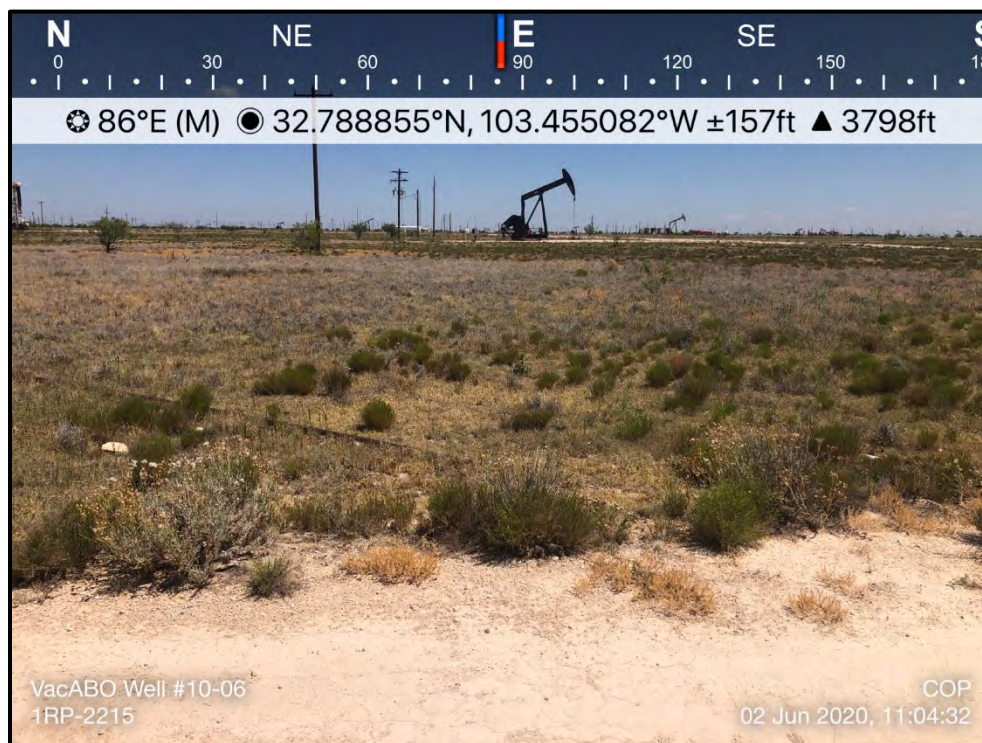
TETRA TECH, INC. PROJECT NO. 212C-MD-02152	DESCRIPTION	View facing east on the eastern edge of the well pad.	2
	SITE NAME	VAC ABO Well # 10-06 Flowline Release	6/2/2020

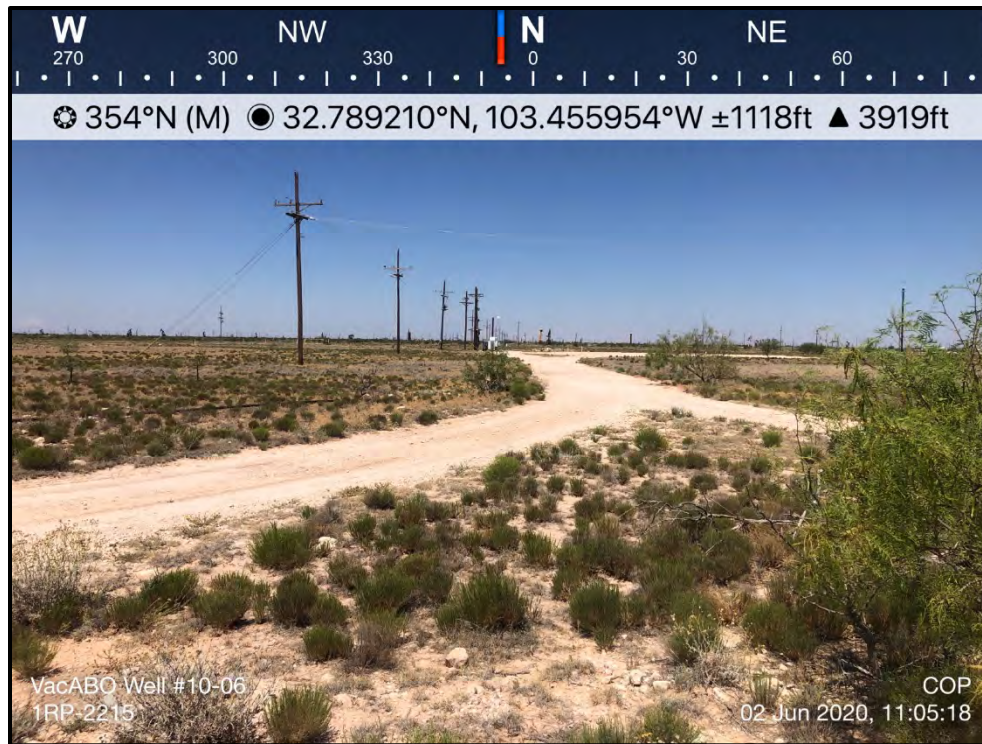
TETRA TECH, INC. PROJECT NO. 212C-MD-02152	DESCRIPTION	View facing north of lease road adjacent to well pad.	3
	SITE NAME	VAC ABO Well # 10-06 Flowline Release	6/2/2020
