TEXLAND PETROLEUM-HOBBS, LLC

Re-vegetation Report

STATE A 29 #7

nAPP2429542850

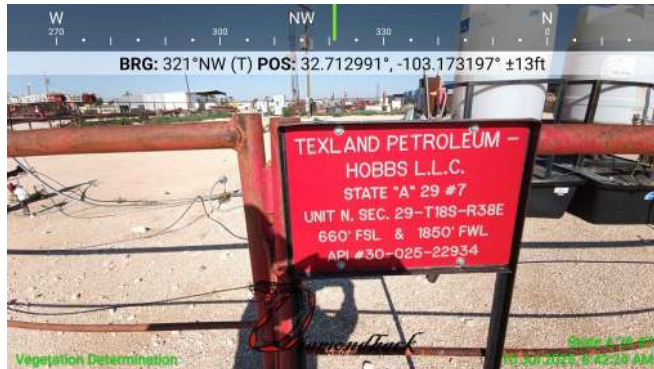
Figure 1

- Figure 1: State A 29 #7 well marker
- Figures 11 and 13: Face north and south, capturing the tree line separating the subject area from the road
- Figures 2–10 and 12: Taken from the perimeter facing inward, representative of site vegetation
