**Re: Closure Report
BTA Oil Producers, LLC
Mesa Bronco (Giant) CTB Release
Unit Letter C, Section 01, Township 26 South, Range 32 East
Lea County, New Mexico
Incident ID nAPP2506049156**

Closure Report
June 23, 2025

BTA Oil Producers, LLC

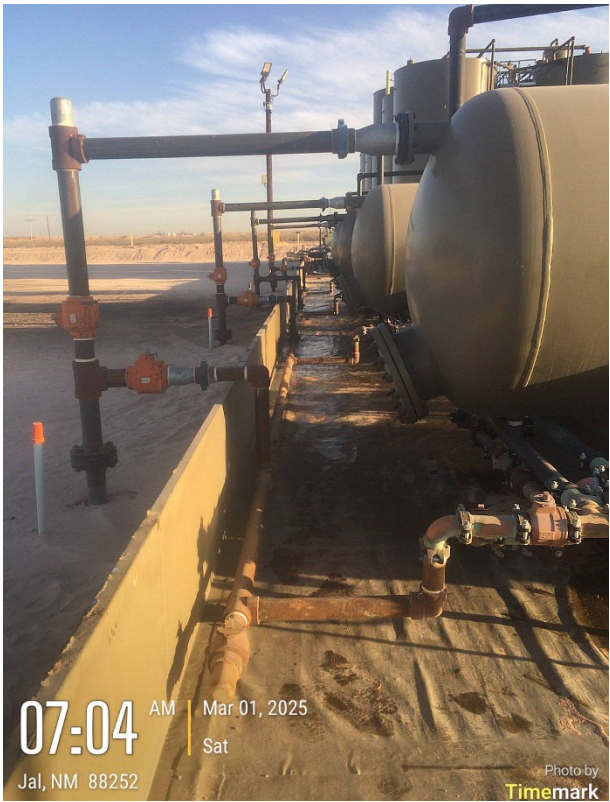
TETRA TECH, INC. PROJECT NO. 212C-MD-03810	DESCRIPTION	View of approximate release extent inside tank battery containment.	1
	SITE NAME	Mesa Giant CTB Release	3/1/2025

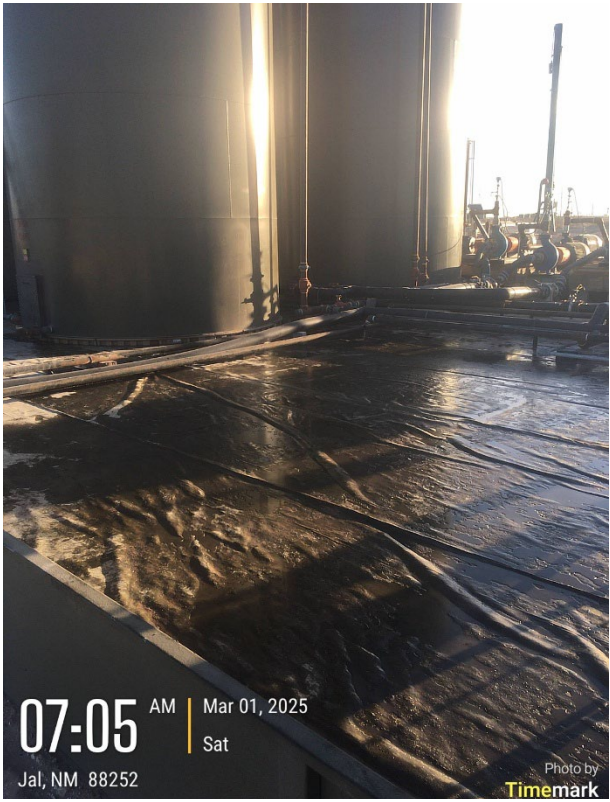
TETRA TECH, INC. PROJECT NO. 212C-MD-03810	DESCRIPTION	View of approximate release extent inside tank battery containment.	2
	SITE NAME	Mesa Giant CTB Release	3/1/2025

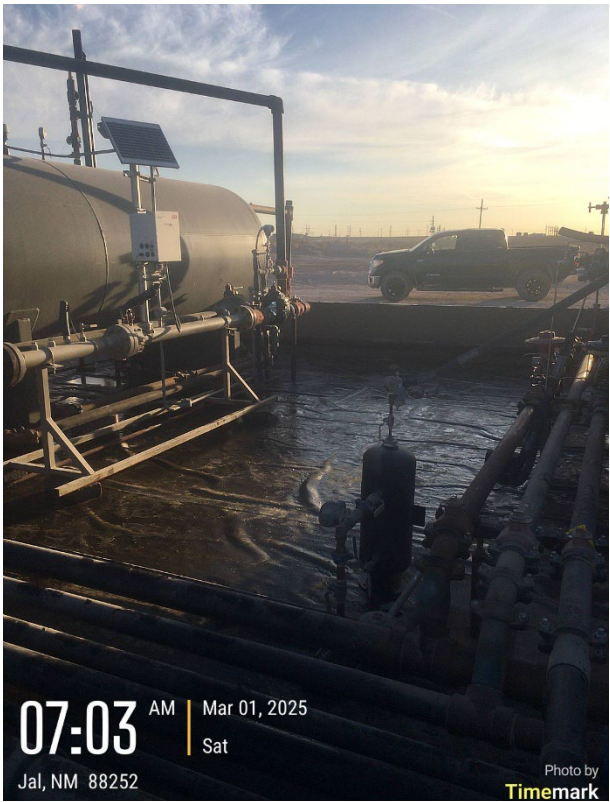
TETRA TECH, INC. PROJECT NO. 212C-MD-03810	DESCRIPTION	View of approximate release extent inside tank battery containment.	3
	SITE NAME	Mesa Giant CTB Release	3/1/2025

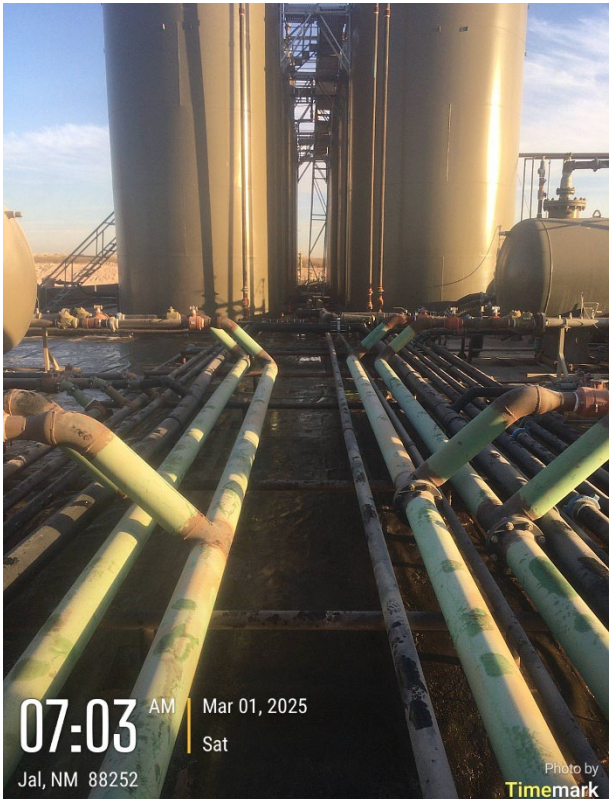
TETRA TECH, INC. PROJECT NO. 212C-MD-03810	DESCRIPTION	View of approximate release extent inside tank battery containment.	4
	SITE NAME	Mesa Giant CTB Release	3/1/2025

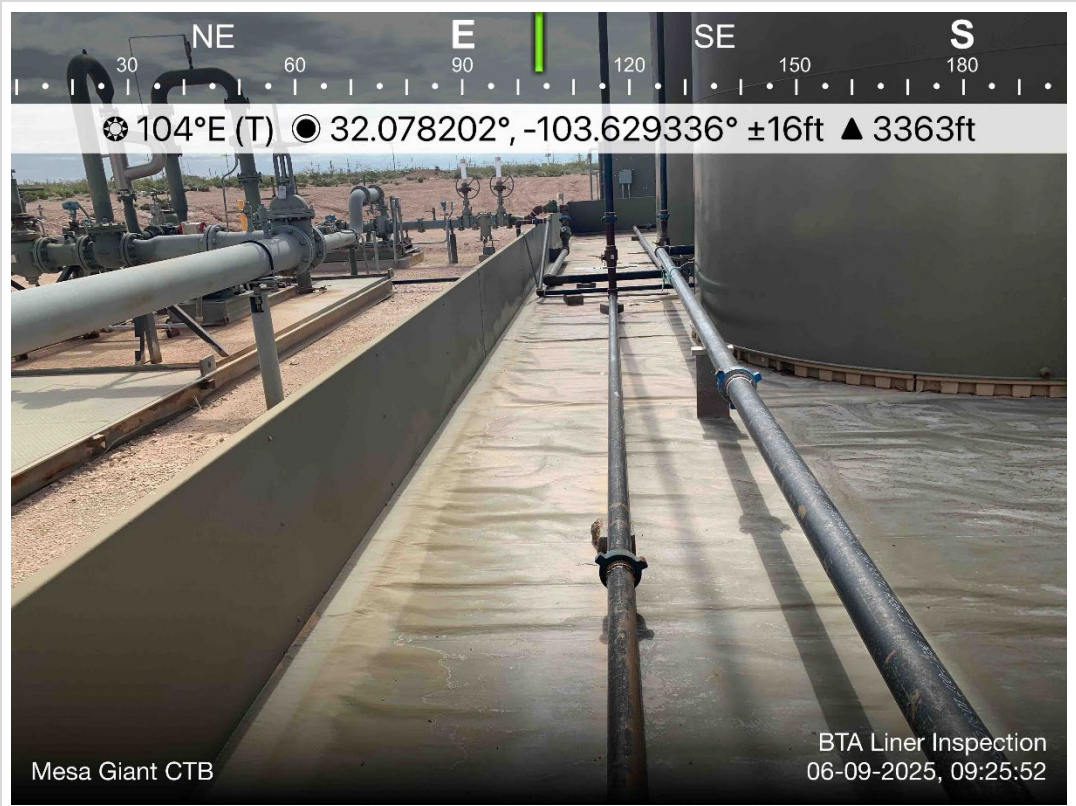
TETRA TECH, INC. PROJECT NO. 212C-MD-03810	DESCRIPTION	View east. Inside tank battery containment. Current lined containment conditions: no rips, holes, or tears observed.	5
	SITE NAME	Mesa Giant CTB Release	6/9/2025

On June 9, 2025, Tetra Tech personnel were on site to perform an inspection of the liner within the containment area of the Mesa Giant CTB. This work was completed to verify the integrity of the liner. The liner was observed to underlie the entirety of the tank battery containment area. The liner was intact with no visible rips or tears and encompassed by an approximately 2-foot-tall muscle wall. The liner was anchored on the interior. At the time of the inspection, the liner was intact and had the ability to contain the documented release. Photographic documentation of the liner inspection is included in Appendix D.

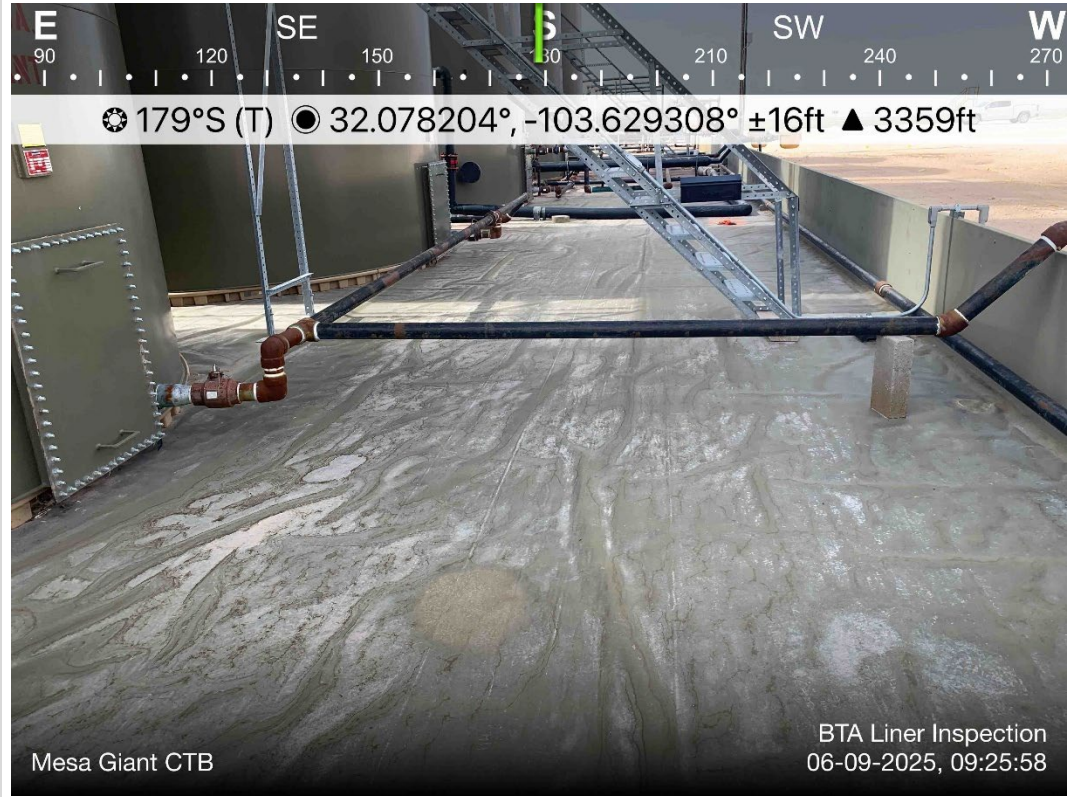
TETRA TECH, INC. PROJECT NO. 212C-MD-03810	DESCRIPTION	View south. Inside tank battery containment. Current lined containment conditions: no rips, holes, or tears observed.	6
	SITE NAME	Mesa Giant CTB Release	6/9/2025

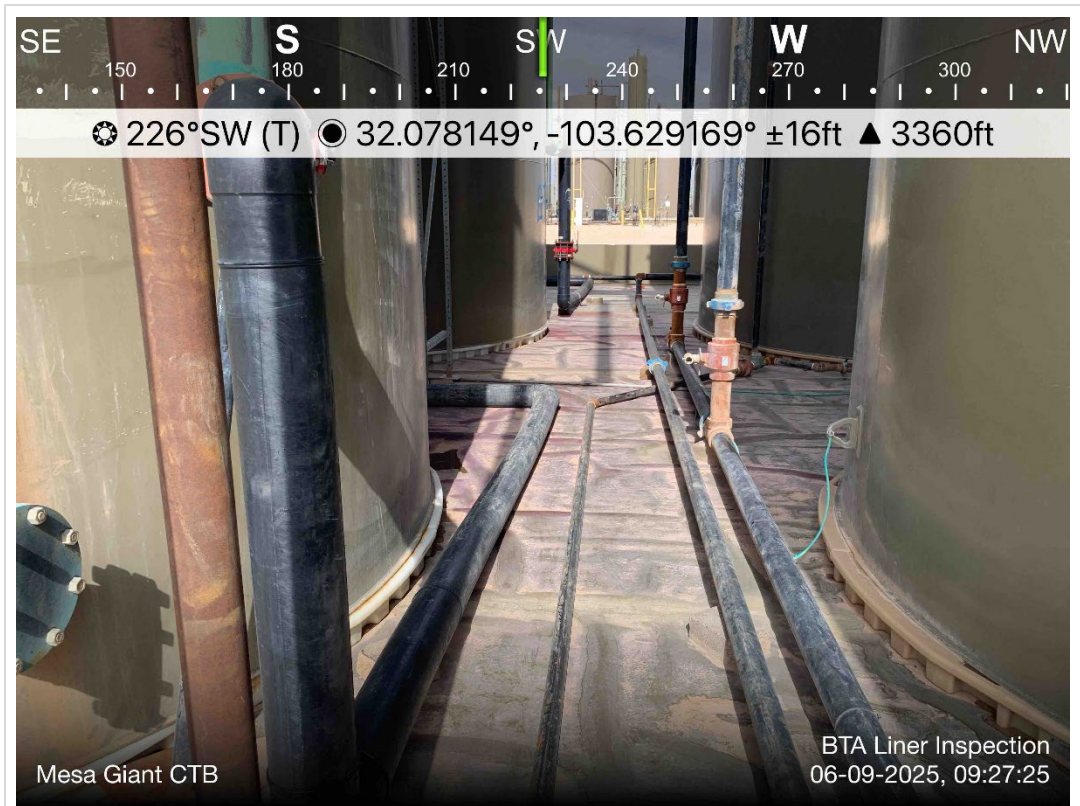
TETRA TECH, INC. PROJECT NO. 212C-MD-03810	DESCRIPTION	View southwest. Inside tank battery containment. Current lined containment conditions: no rips, holes, or tears observed.	7
	SITE NAME	Mesa Giant CTB Release	6/9/2025

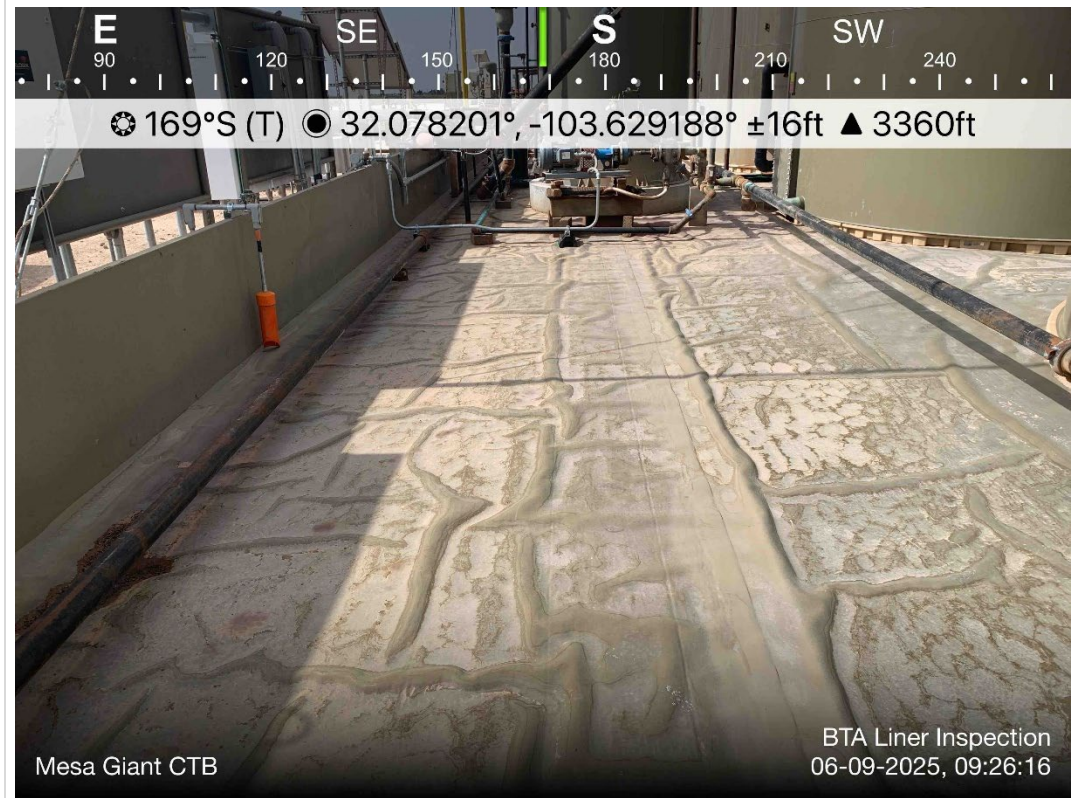
TETRA TECH, INC. PROJECT NO. 212C-MD-03810	DESCRIPTION	View south. Inside tank battery containment. Current lined containment conditions: no rips, holes, or tears observed.	8
	SITE NAME	Mesa Giant CTB Release	6/9/2025

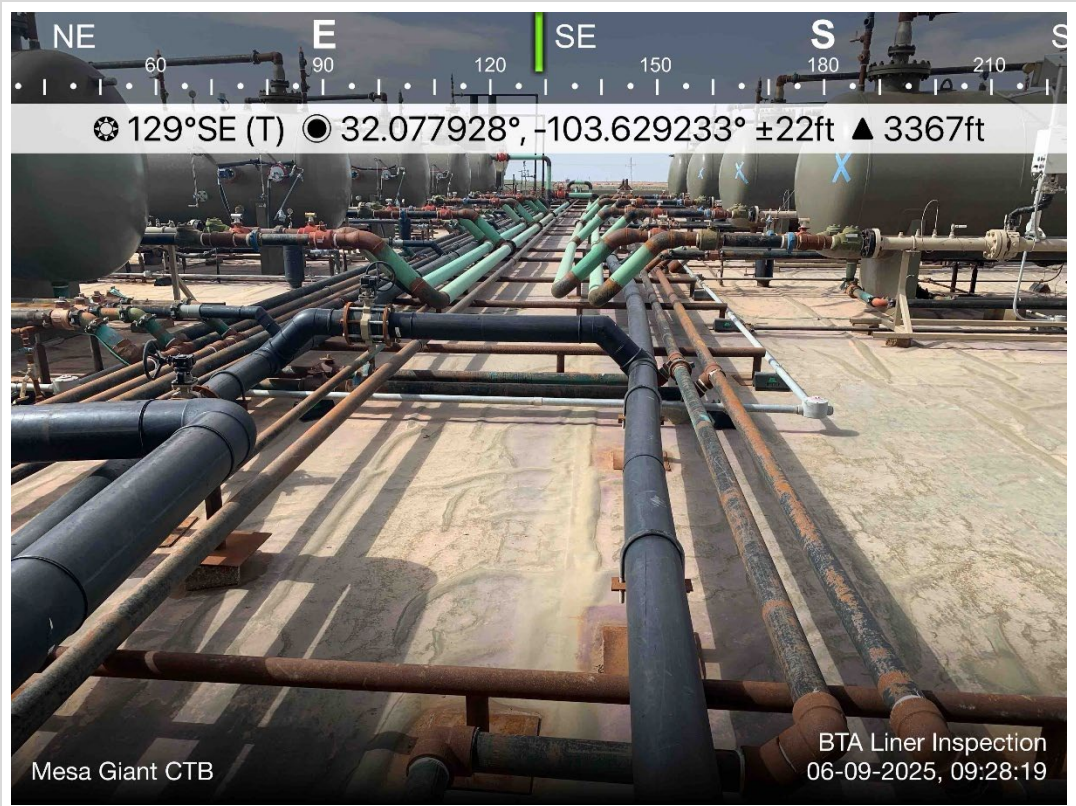
TETRA TECH, INC. PROJECT NO. 212C-MD-03810	DESCRIPTION	View southeast. Inside tank battery containment. Current lined containment conditions: no rips, holes, or tears observed.	9
	SITE NAME	Mesa Giant CTB Release	6/9/2025

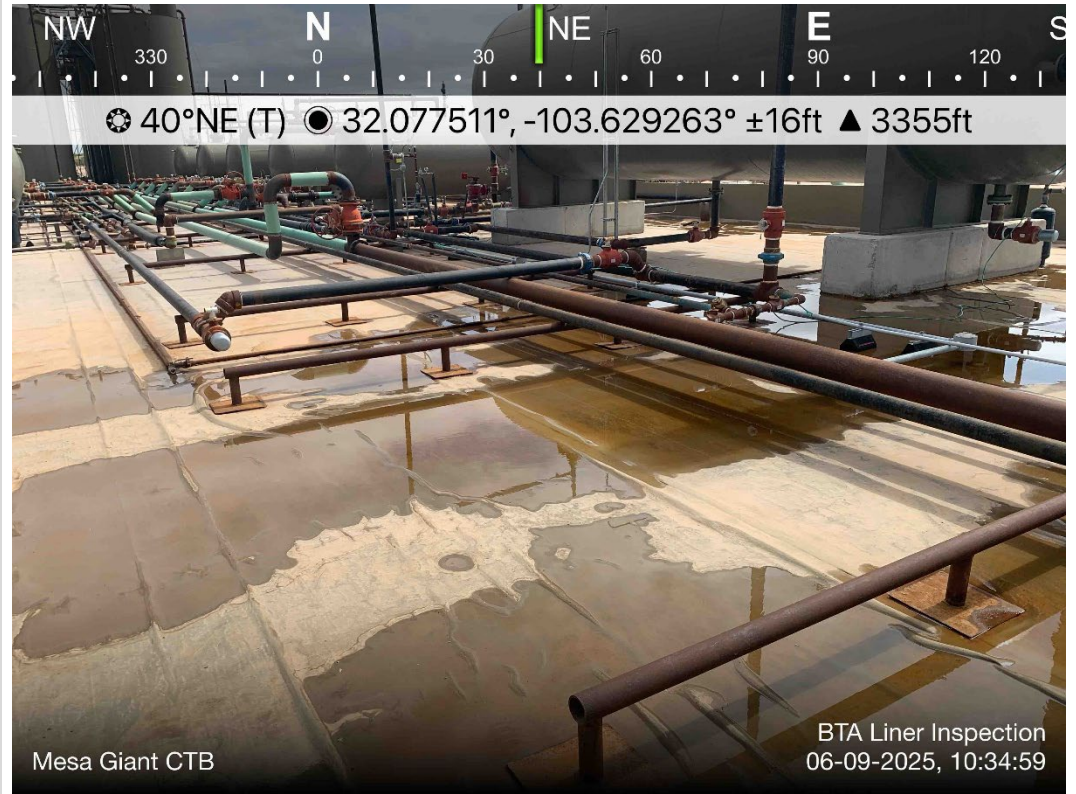
TETRA TECH, INC. PROJECT NO. 212C-MD-03810	DESCRIPTION	View northeast. Inside tank battery containment post rain event. Current lined containment conditions: no rips, holes, or tears observed.	10
	SITE NAME	Mesa Giant CTB Release	6/9/2025

pressure washing activities indicate no fluids on the liners as these activities occurred prior to the rain events. Nonetheless, the standing fluid observed in the official liner inspection photographs lend further evidence to the integrity of the liner as a competent fluid barrier.

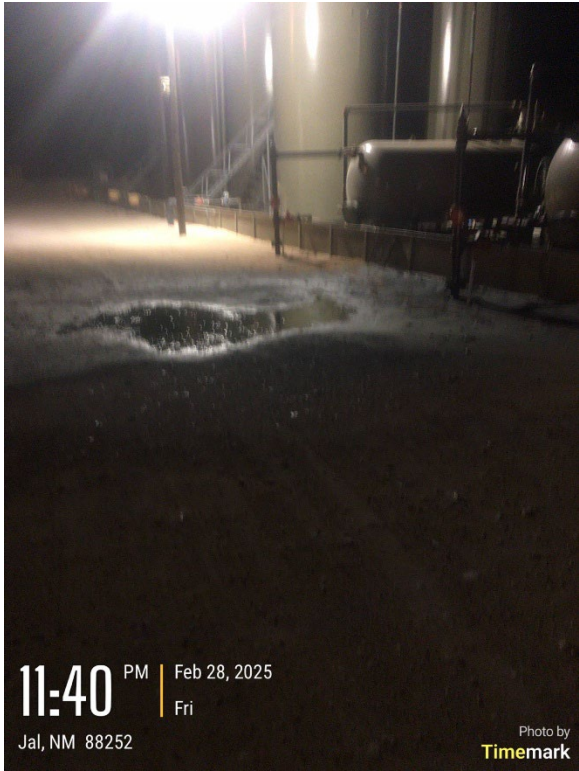
TETRA TECH, INC. PROJECT NO. 212C-MD-03810	DESCRIPTION	View of approximate release extent on west side of tank battery.	1
	SITE NAME	Mesa (Giant) Bronco CTB Release	2/28/2025

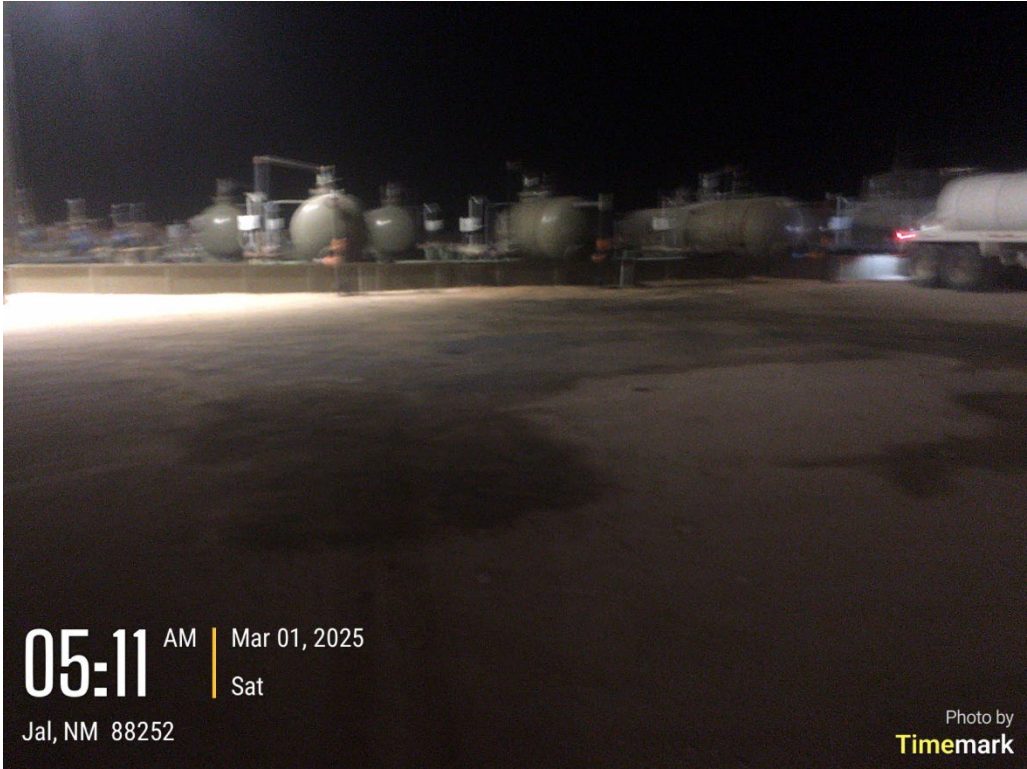
TETRA TECH, INC. PROJECT NO. 212C-MD-03810	DESCRIPTION	View of approximate release extent on west side of the tank battery.	2
	SITE NAME	Mesa (Giant) Bronco CTB Release	3/1/2025

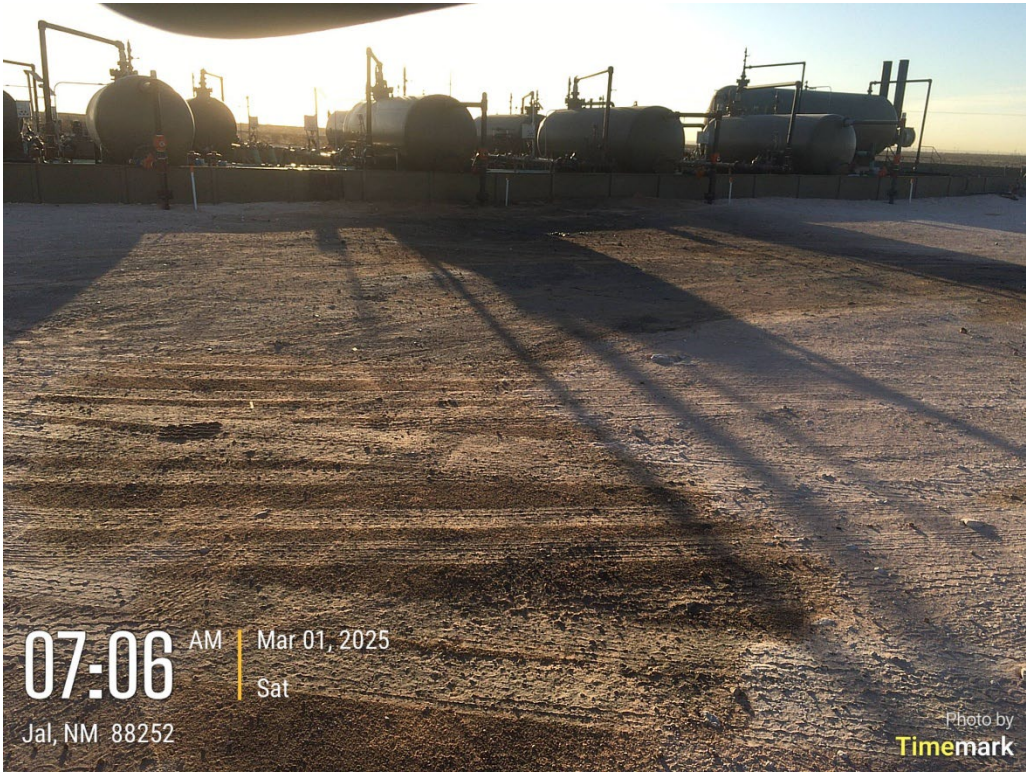
TETRA TECH, INC. PROJECT NO. 212C-MD-03810	DESCRIPTION	View of approximate release extent. Staining observed on the soil surface.	3
	SITE NAME	Mesa (Giant) Bronco CTB Release	3/1/2025

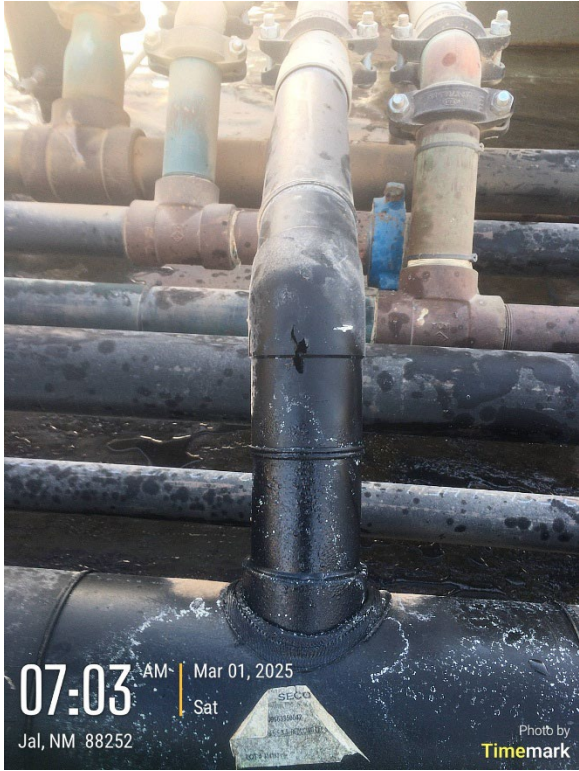
TETRA TECH, INC. PROJECT NO. 212C-MD-03810	DESCRIPTION	View of approximate release point. Equipment failure in the 3-inch polyline.	4
	SITE NAME	Mesa (Giant) Bronco CTB Release	3/1/2025

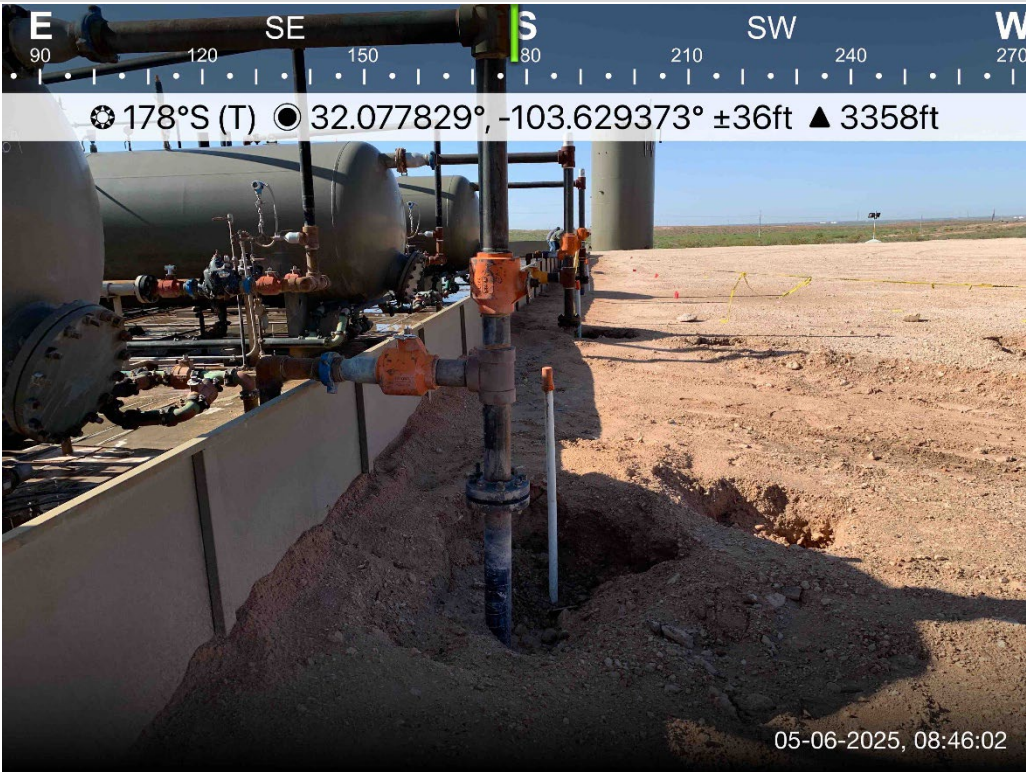
TETRA TECH, INC. PROJECT NO. 212C-MD-03810	DESCRIPTION	View south of line hydrovac activities prior to excavation.	5
	SITE NAME	Mesa (Giant) Bronco CTB Release	5/6/2025

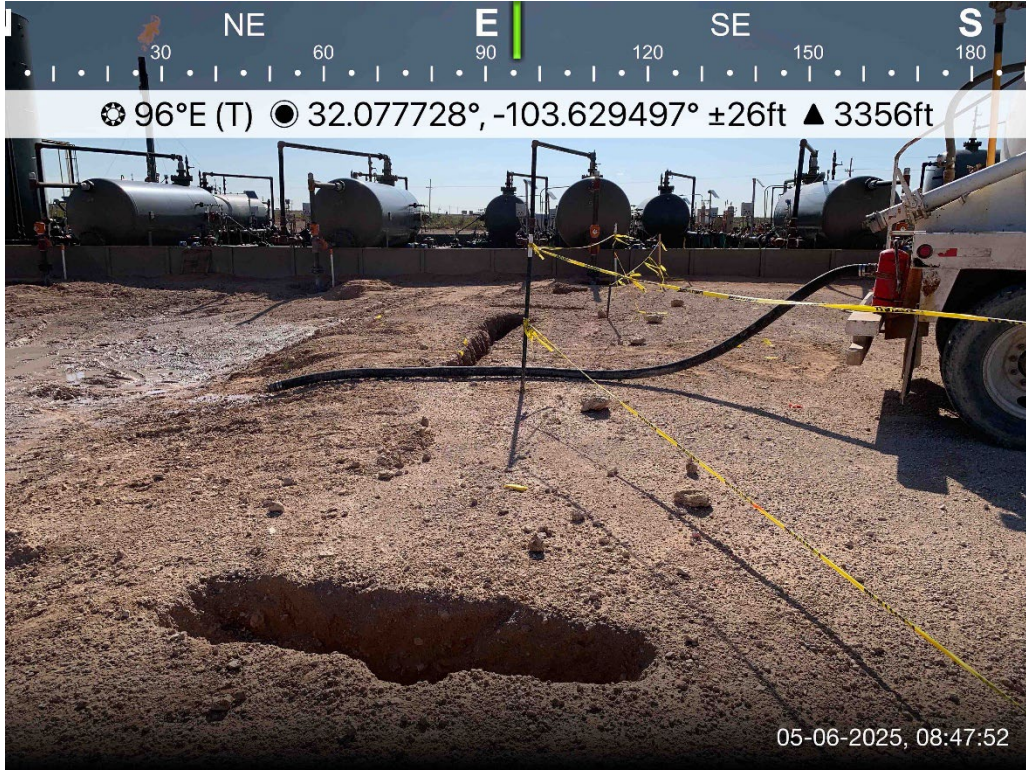
TETRA TECH, INC. PROJECT NO. 212C-MD-03810	DESCRIPTION	View east of line hydrovac activities prior to excavation.	6
	SITE NAME	Mesa (Giant) Bronco CTB Release	5/6/2025

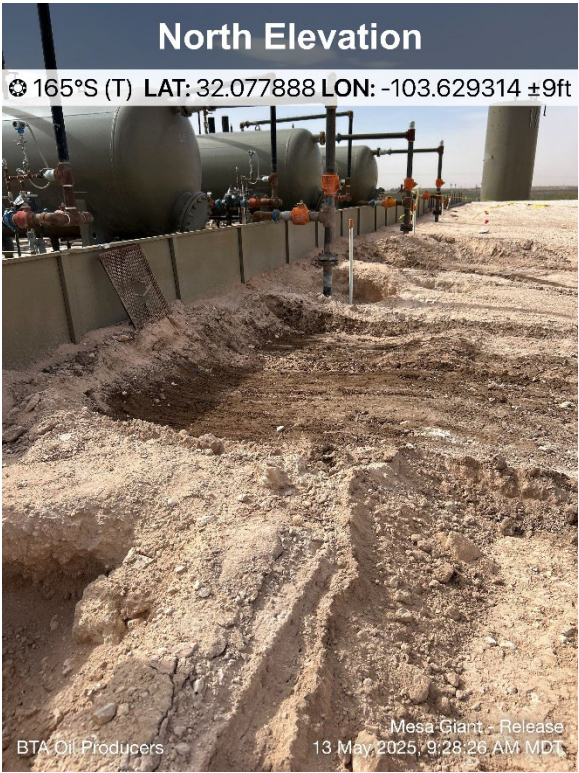
TETRA TECH, INC. PROJECT NO. 212C-MD-03810	DESCRIPTION	View south of the excavated areas on the western side of the combined tank battery.	7
	SITE NAME	Mesa (Giant) Bronco CTB Release	5/13/2025

Soils in the delineated release extent were excavated as indicated in Figure 4. The areas within the release footprint were excavated to a maximum depth of 1.5 ft bgs based on field screening values and confirmation sampling results. Due to safety concerns associated with working around pressurized lines, prior to remediation, hydro-excavation was used to daylight lines in the vicinity of the release. All pressurized lines located in the area of the release were found to be at least 4 ft bgs. Photographs from the excavated areas prior to backfill are provided in Appendix F. All excavated material was transported off-site for proper disposal. Approximately 148 cubic yards of material were transported to the Northern Delaware Basin Landfill in Jal, New Mexico. Copies of the waste manifests are included in Appendix G.

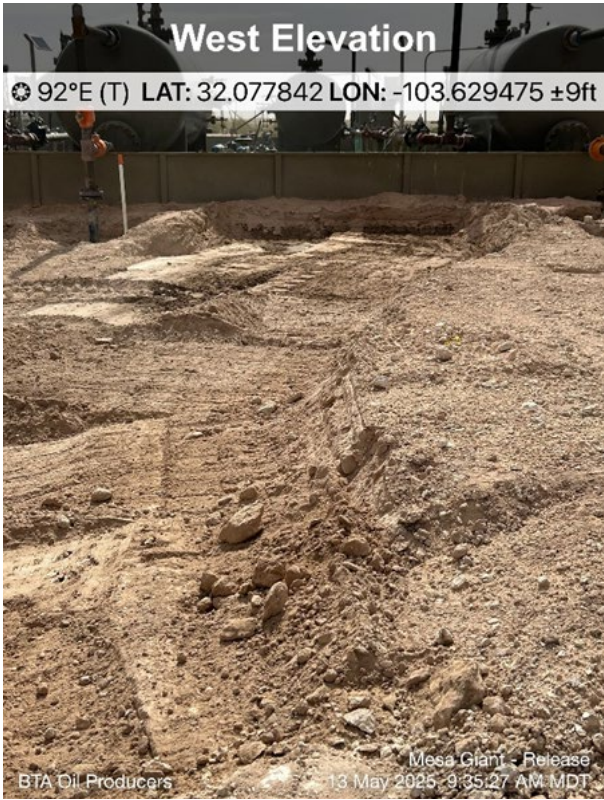
TETRA TECH, INC. PROJECT NO. 212C-MD-03810	DESCRIPTION	View east of the excavation progress.	8
	SITE NAME	Mesa (Giant) Bronco CTB Release	5/13/2025

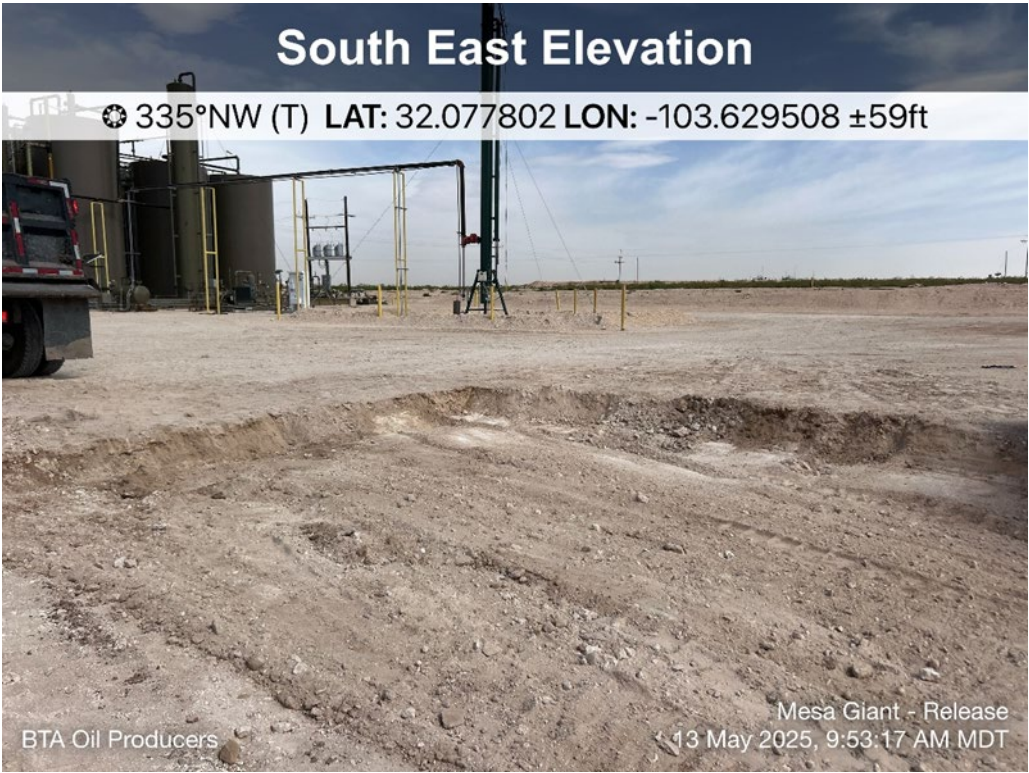
TETRA TECH, INC. PROJECT NO. 212C-MD-03810	DESCRIPTION	View northwest of the excavation progress.	9
	SITE NAME	Mesa (Giant) Bronco CTB Release	5/13/2025

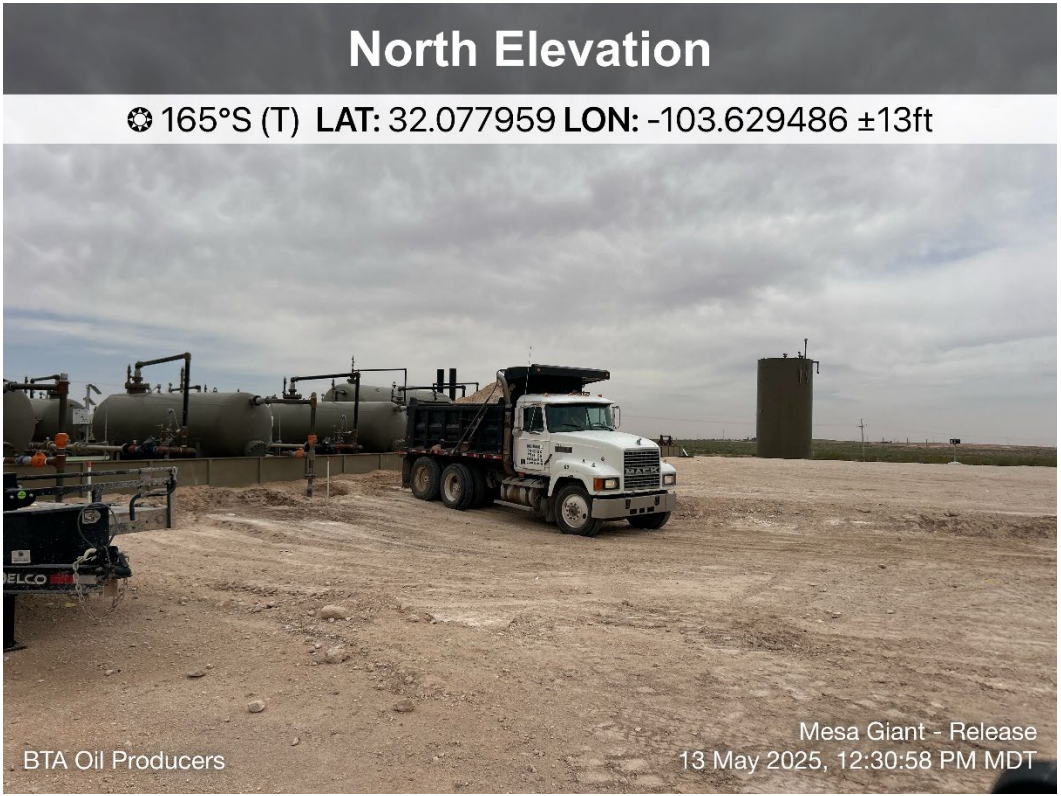
TETRA TECH, INC. PROJECT NO. 212C-MD-03810	DESCRIPTION	View south of excavation backfilling activities.	10
	SITE NAME	Mesa (Giant) Bronco CTB Release	5/13/2025

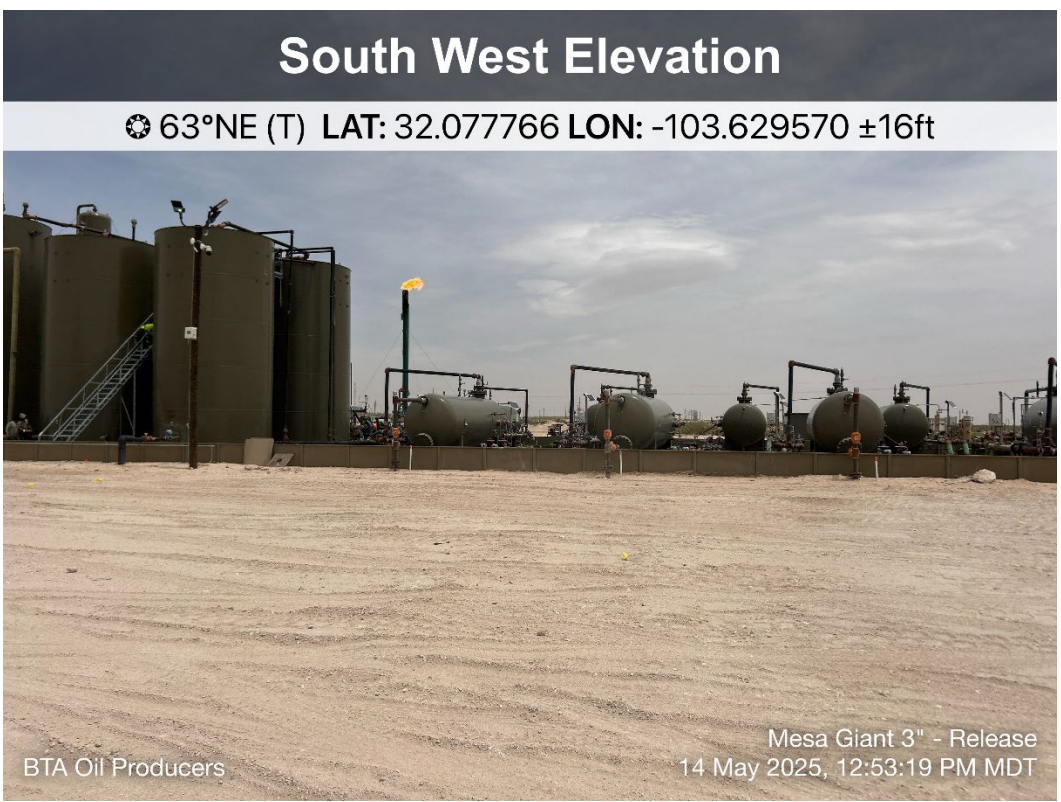
TETRA TECH, INC. PROJECT NO. 212C-MD-03810	DESCRIPTION	View northeast of backfilled excavation.	11
	SITE NAME	Mesa (Giant) Bronco CTB Release	5/14/2025

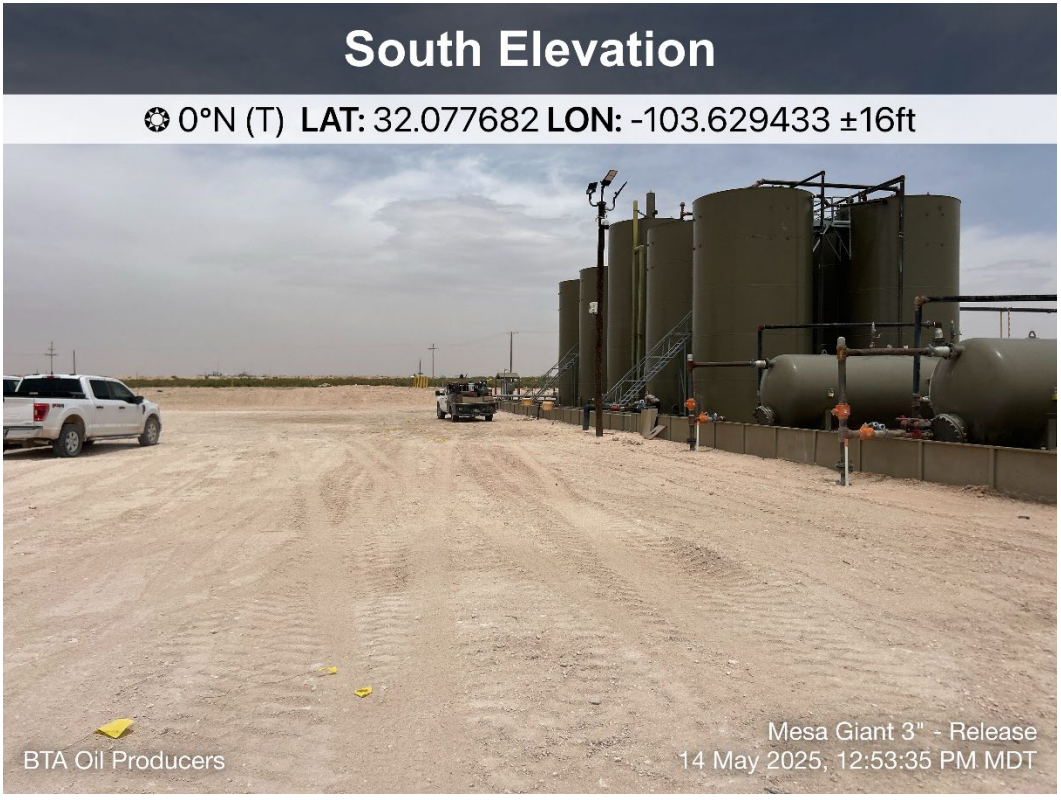
TETRA TECH, INC. PROJECT NO. 212C-MD-03810	DESCRIPTION	View north of backfilled excavation.	12
	SITE NAME	Mesa (Giant) Bronco CTB Release	5/14/2025
