RE: **Nailed It A CTB - Deferral Request Report**

Incident Number: nAPP2518171474

Project No. VP-660

Nailed It A CTB - Deferral Request Report
Incident Number: nAPP2518171474
32.003155°, -103.828381°

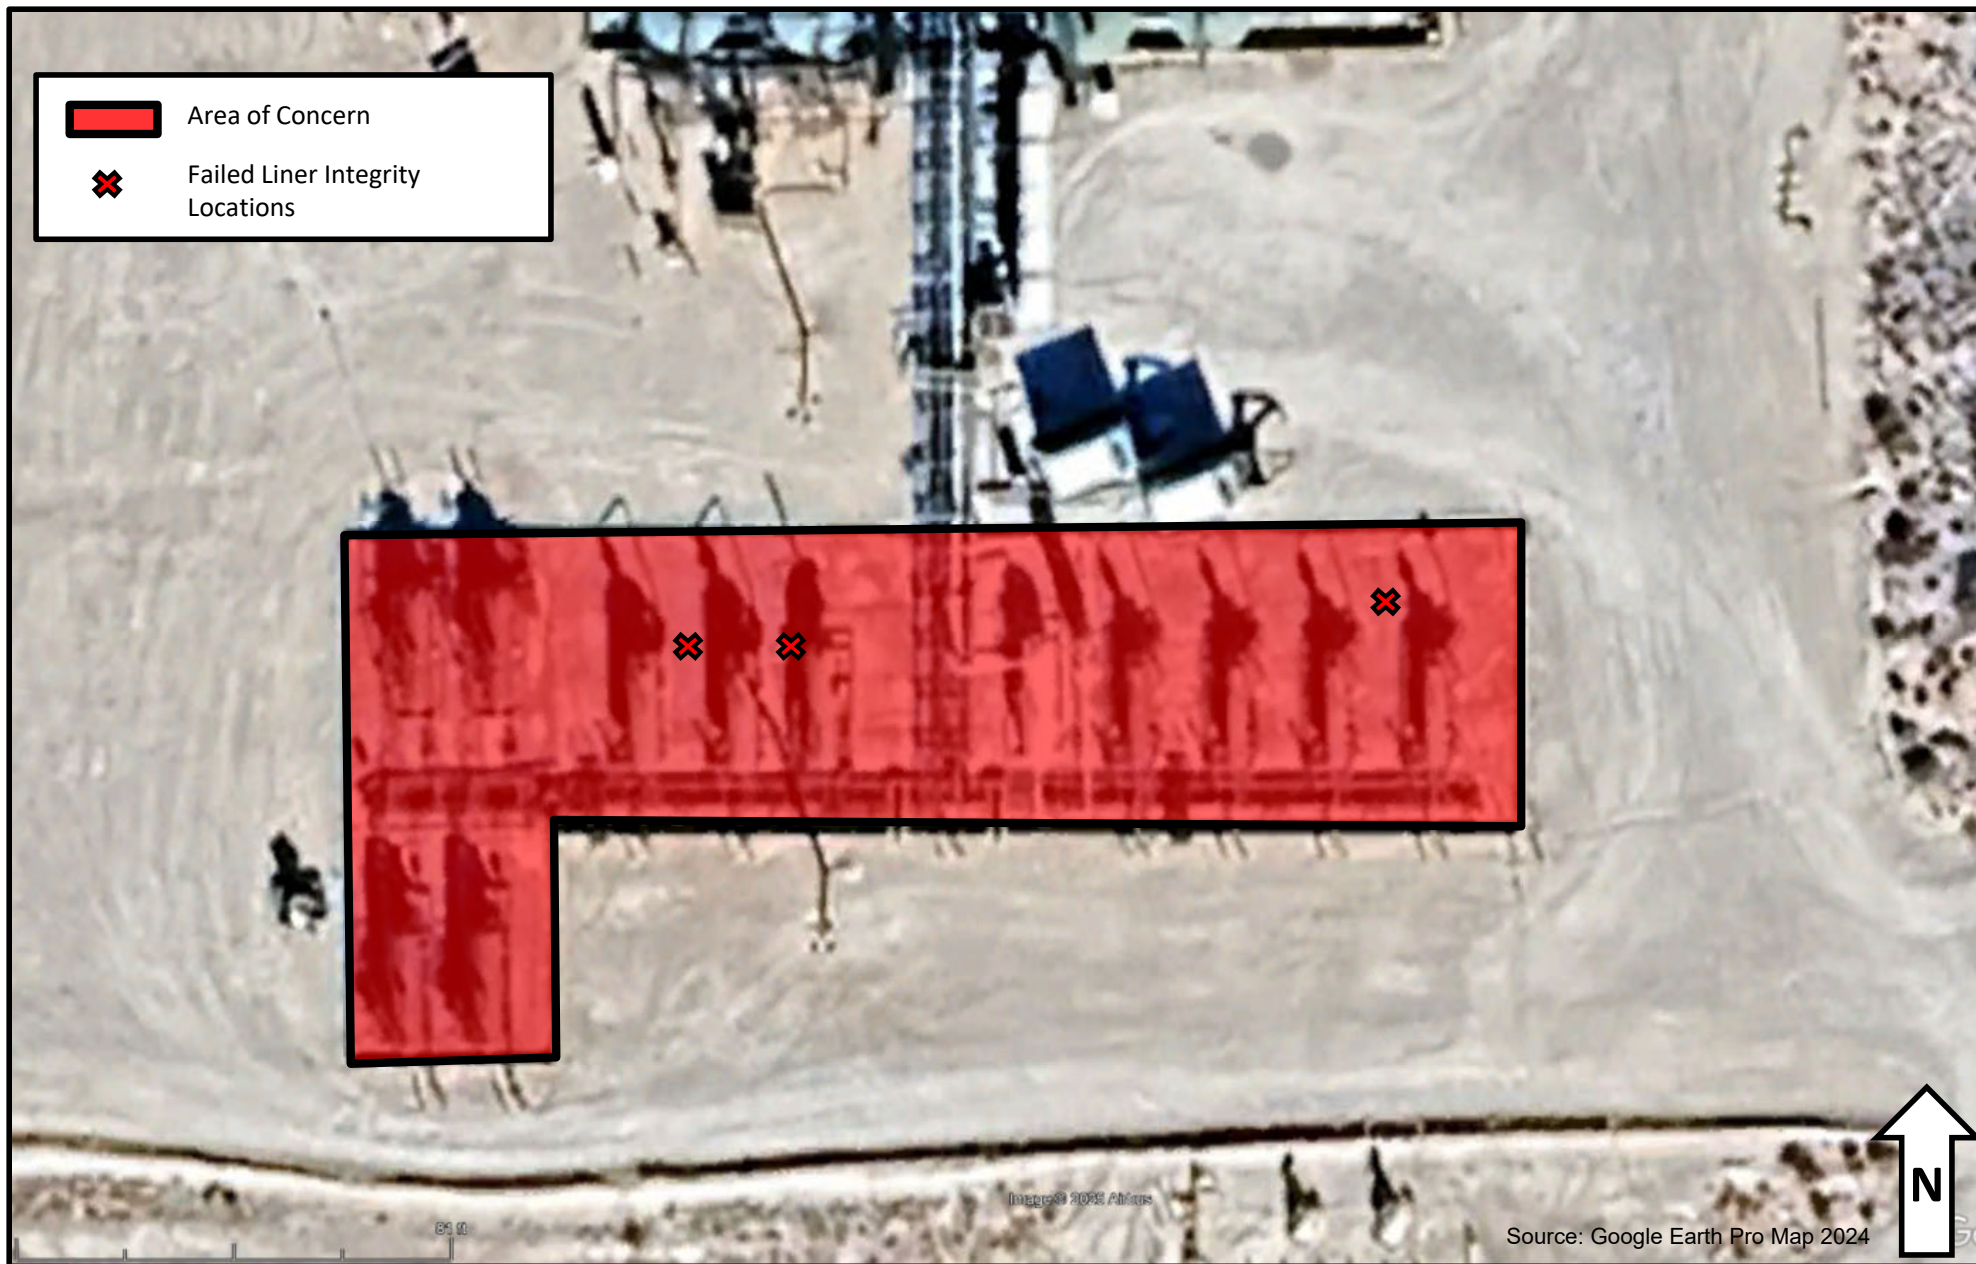
Figure 2 – Release Extent

On June 30, 2025, a release of approximately 150 barrels (bbls) of produced water and 5 bbls of crude oil occurred within a LSC (**Figure 2**). It was reported by Civitas that a vacuum truck was immediately dispatched to the Site recovering the 155 bbls of fluids.

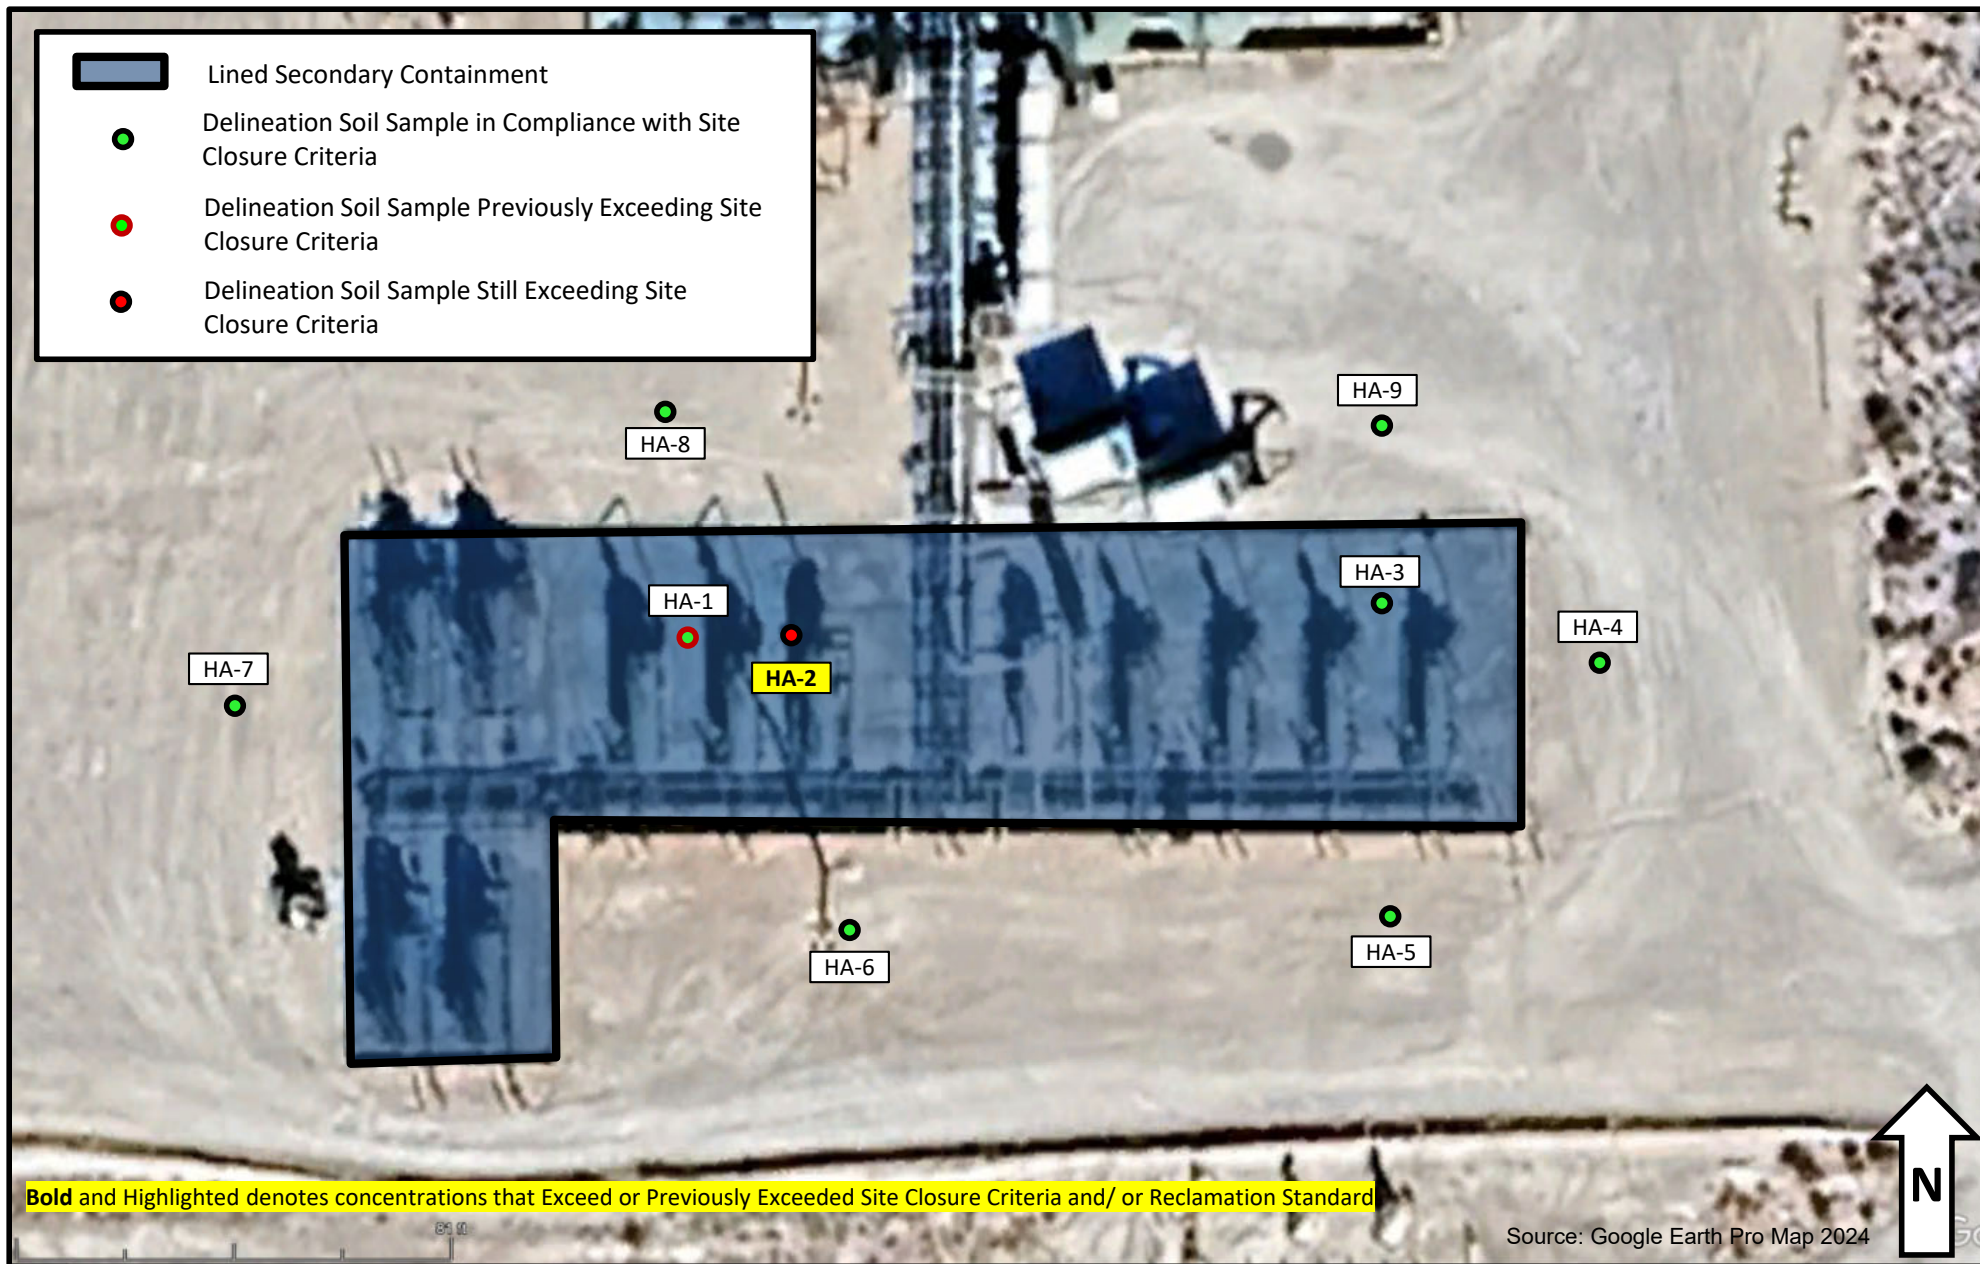
Figure 5 – Delineation Soil Sample Locations

Laboratory analytical results for delineation soil samples collected within the AOC and directly beneath the LSC (HA-1 and HA-2) indicated TPH-GRO+TPH-DRO+TPH-ORO and /or Chloride were above the Site Closure Criteria and/or the reclamation standard. Elevated TPH concentrations, specifically TPH-DRO, were characterized by concentrations ranging from 125 mg/kg to 291 mg/kg. Elevated Chloride concentrations were characterized by concentrations ranging from 766 mg/kg to 1,090 mg/kg. Laboratory results are summarized in **Table 1**, included in the attachments. The locations of all delineation soil samples are shown in **Figure 5**.

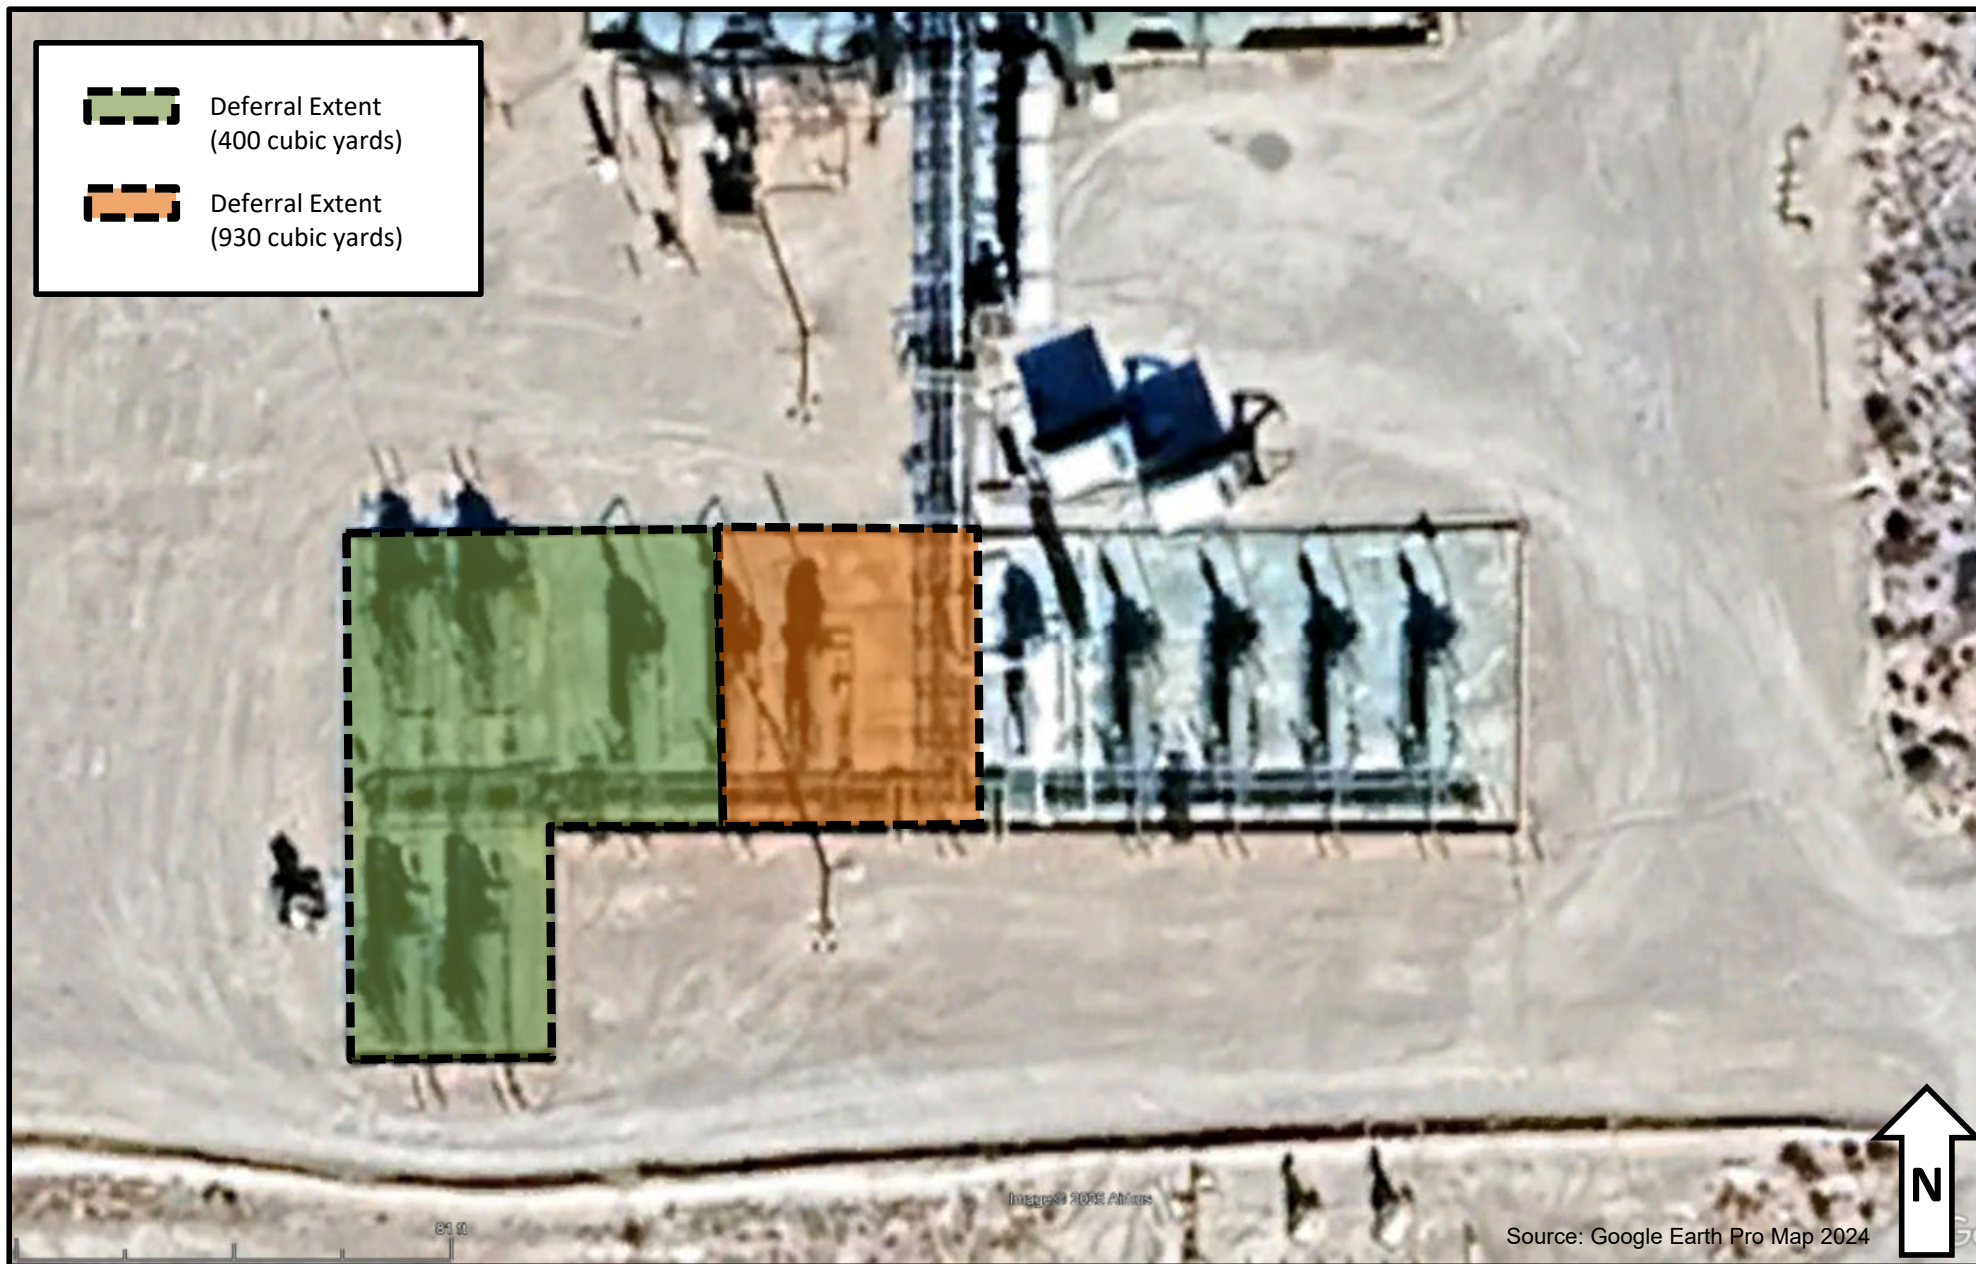
Figure 6 – Deferral Extent

Based on laboratory analytical results, residual soil impacts associated with the AOC appear to reside below the LSC up to 2 feet bgs directly in the vicinity of HA-1. During delineation soil sampling activities of HA-2, refusal was met via hand auger at 4 feet bgs before achieving vertical delineation. For this DRR, Civitas estimates residual chloride impacts to reside below the LSC up to 10 feet bgs directly in the vicinity of HA-2 until additional delineation can be achieved via mechanical equipment when the Site undergoes major facility deconstruction or P&A, whichever comes first. As a result, Civitas respectfully requests deferral of up to approximately 1,338 CY of residual soil impacted beneath the LSC and up to 10 feet bgs until the Site undergoes major facility deconstruction or P&A, whichever comes first.

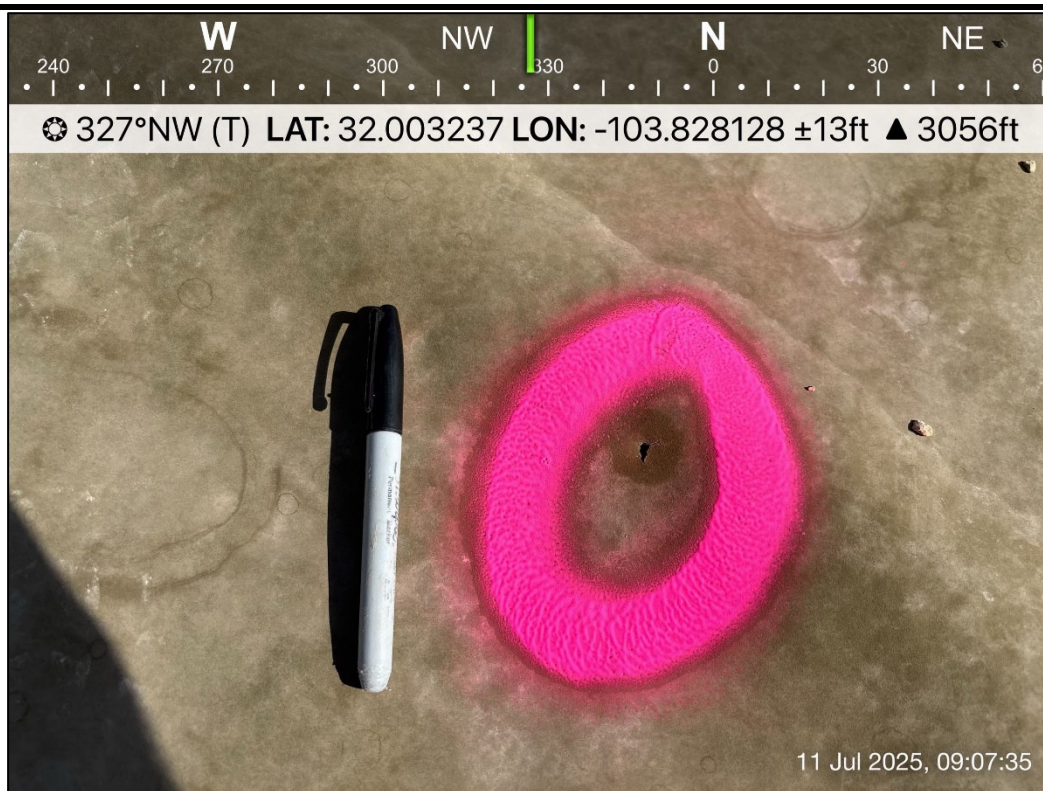
On July 11, 2025, ESRR conducted a thorough visual inspection of the LSC for tears, cracks, cuts, breaks, and other signs of damage, confirming the presence or absence of any evidence for a potential breach to the LSC. The LSC failed inspection and was considered to not be performing as designed due to cuts and tears observed (**Figure 2**). No fluids were observed to have escaped laterally to the pad surface or adjacent native soils. **Photographic Documentation** of liner inspection activities is attached.

PHOTO 19: Northwestern view of failed liner integrity. 7/11/2025

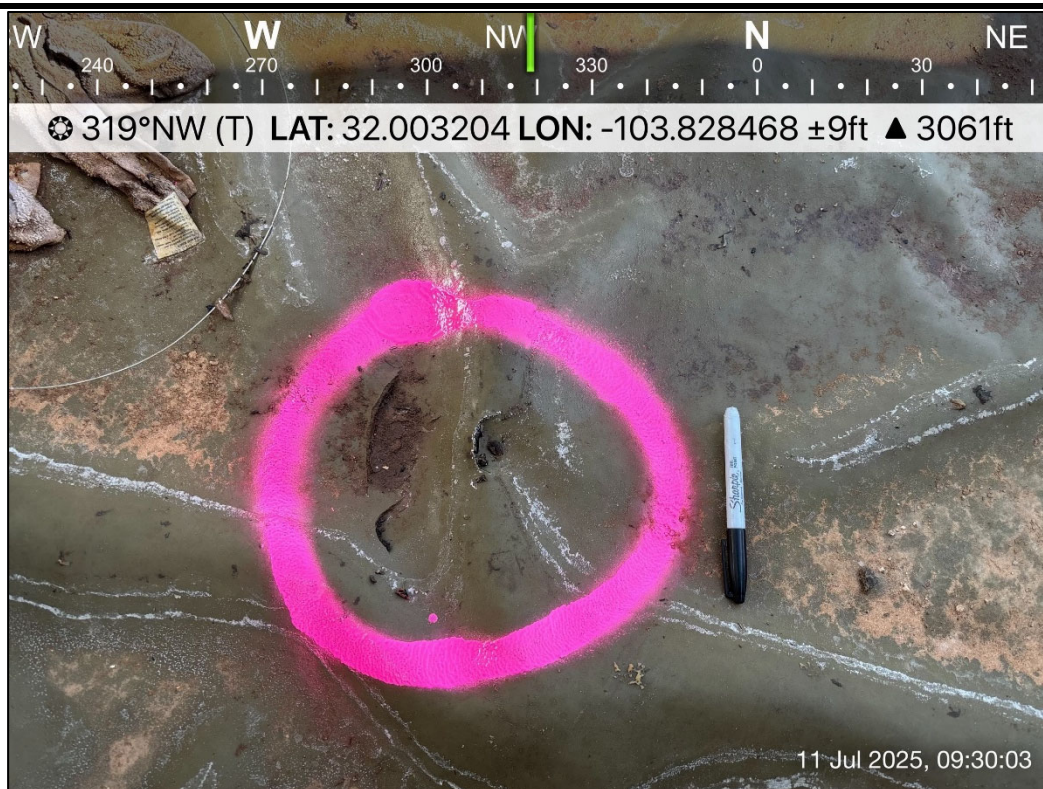
PHOTO 20: Northwestern view of failed liner integrity. 7/11/2025

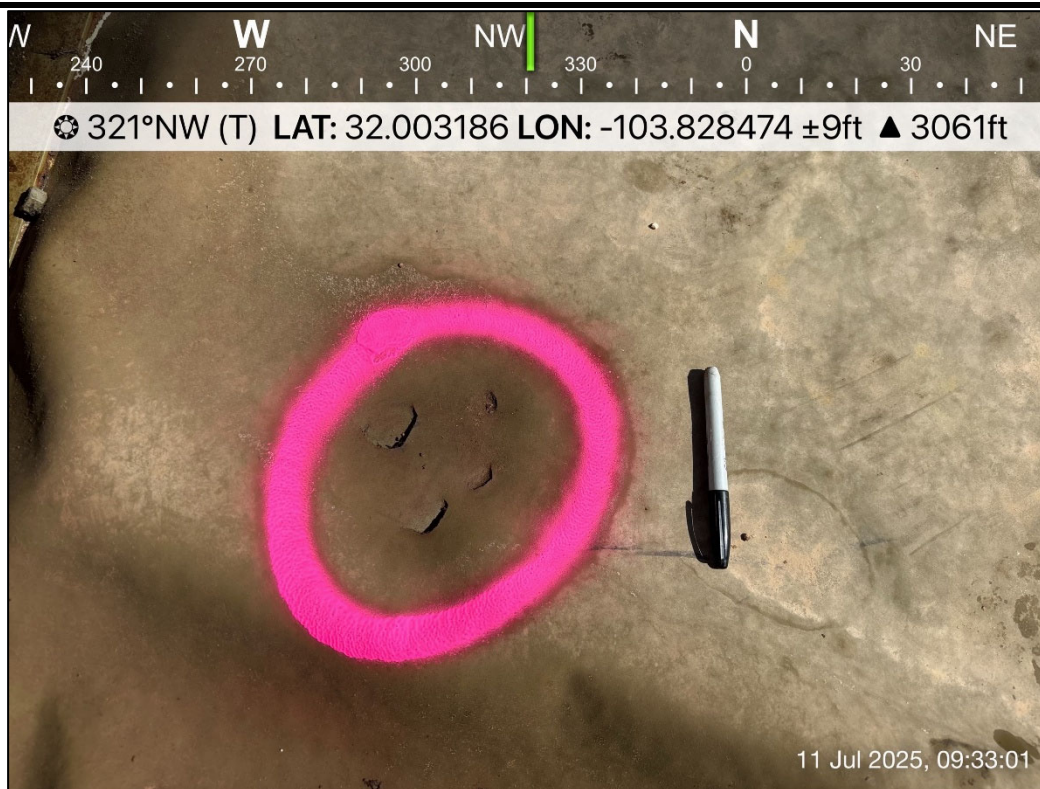
PHOTO 21: Northwestern view of failed liner integrity. 7/11/2025
