Cause of Release 2" Flowline corroded and released produced water and crude oil into pasture.

Characterization and Remediation Workplan
South Justis Unit D24 Flowline Failure
Produced Water and Crude Oil Release
Lea County, New Mexico
nAPP2308648014

SITE CHARACTERIZATION, REMEDIATION, AND CLOSURE REPORT

**SOUTH JUSTIS UNIT #24 FLOWLINE
32.103843, -103.122835
UNIT E, SECTION 25, T25S-R37E
LEA COUNTY, NEW MEXICO
NMOCD INCIDENT ID # nAPP2308648014**

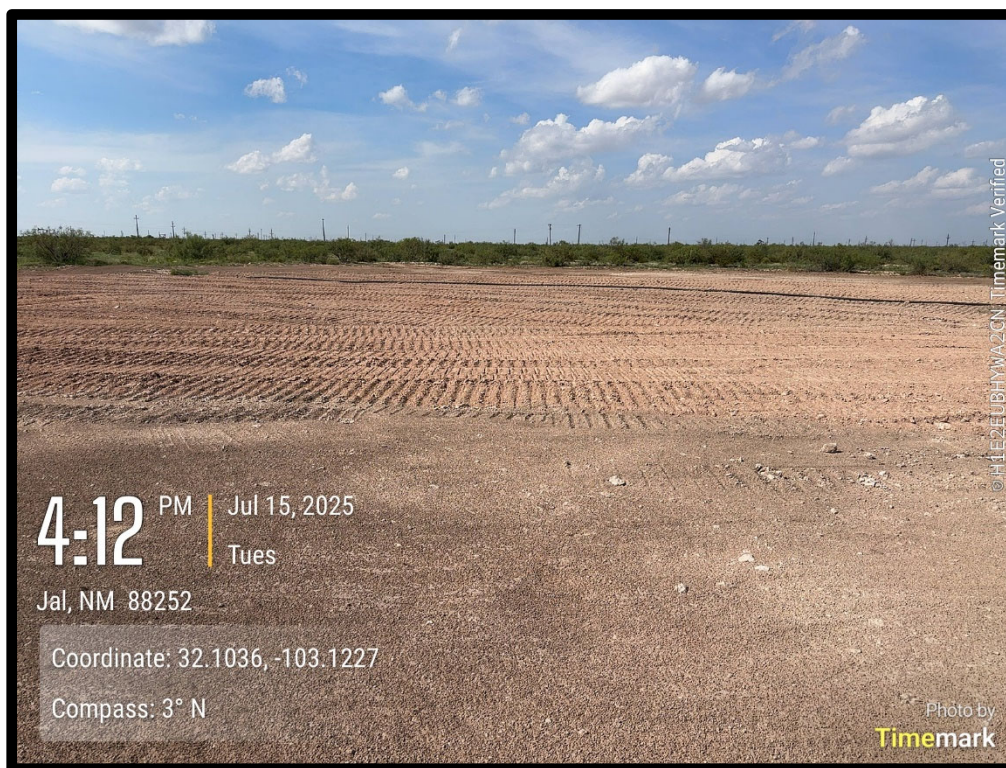
PHOTOGRAPH NO. 3 – A view of the excavation area upon completion of backfill operations. The view is towards the southwest.

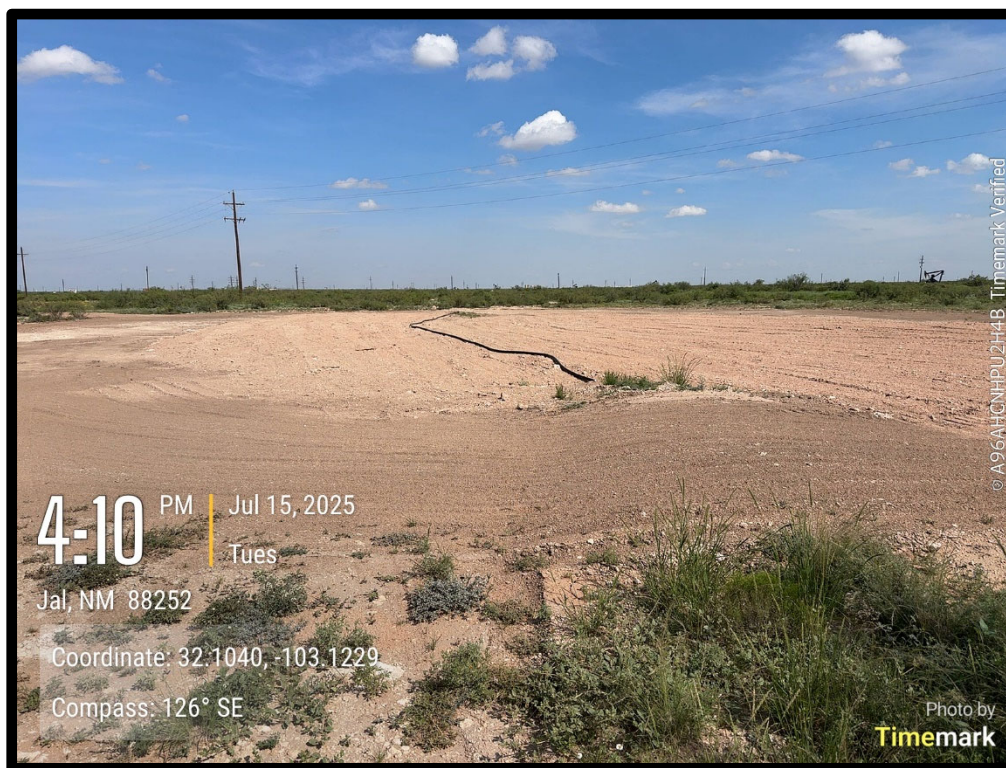
PHOTOGRAPH NO. 4 – An additional view of the excavation upon completion of backfill operations. The view is towards the southeast.
