**Re: Remediation Report and Closure Request
Maverick Permian, LLC
Oxy State F1 Battery Release
Unit Letter Unit Letter M, Section 01, Township 21 South, Range 36 East
Lea County, New Mexico
Incident ID# nAPP2317958480**

Reclamation Report and Closure Request
Oxy State F1 Battery Release
Incident ID# nAPP2317958480

Maverick Permian, LLC
August 13, 2025

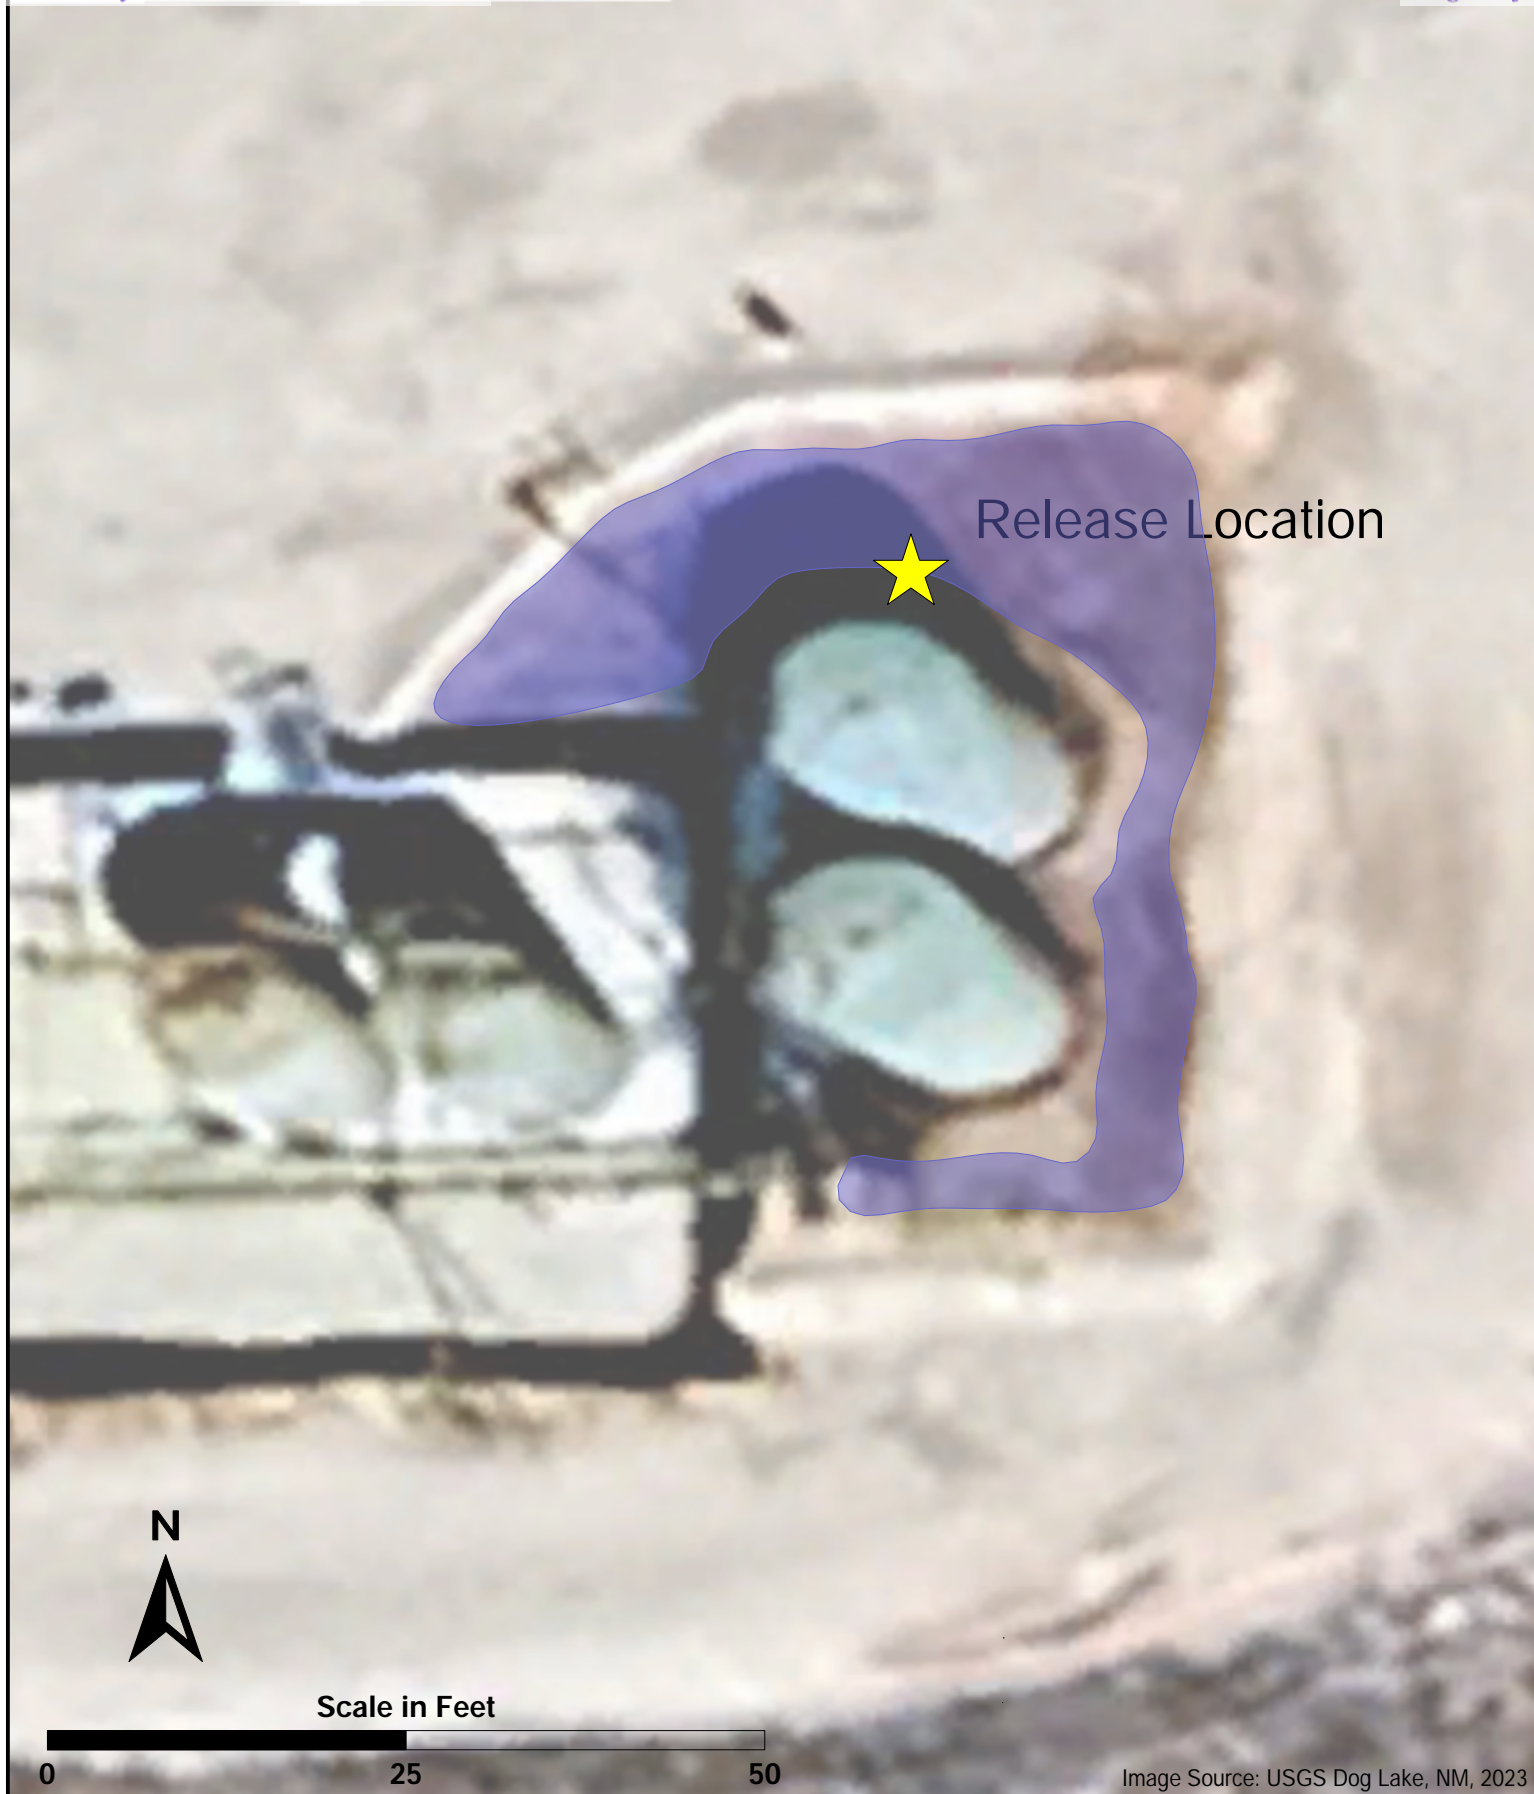
Figure
2

The release occurred due to an overfilling of a produced water tank within the tank battery into an approximately 1,375-square-foot area, as shown in **Figure 2**. According to Site records, initial response actions were taken by Maverick at the release site on June 27, 2023. On August 2, 2023, Tetra Tech performed a site visit and preliminary inspection and found that the release occurred into a section of unlined tank battery secondary containment.

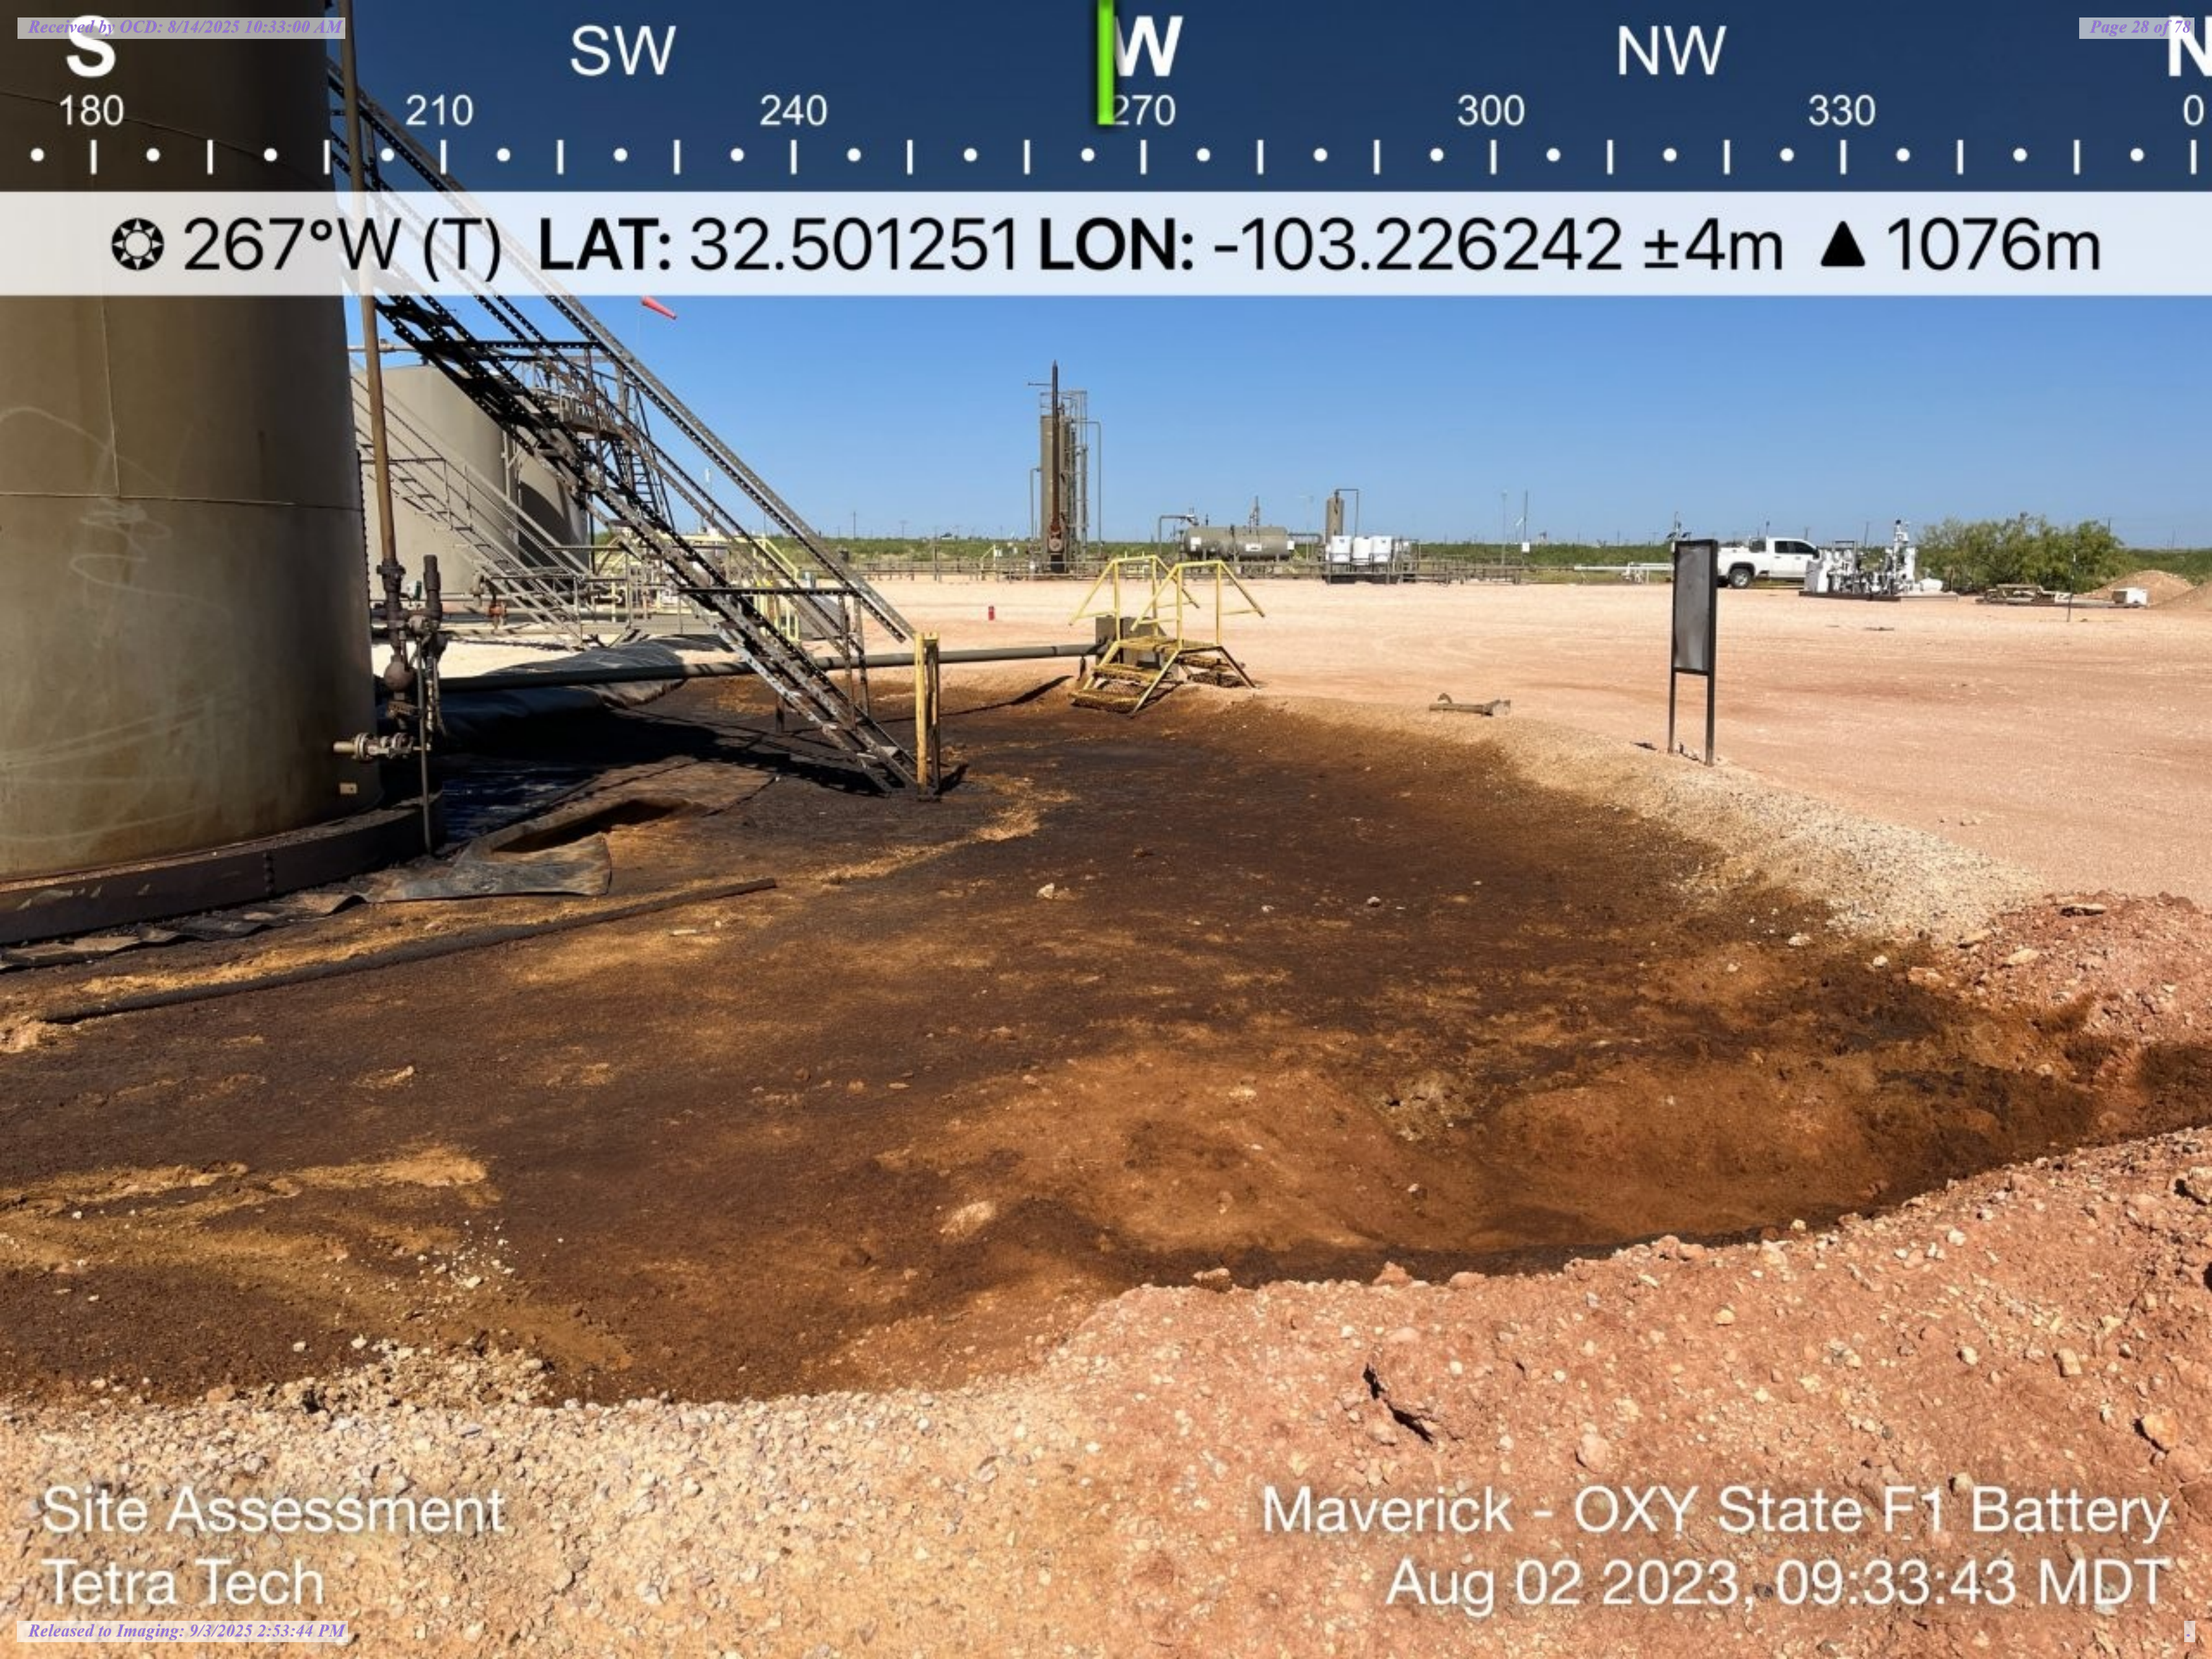
Site Assessment
Tetra Tech

Maverick - OXY State F1 Battery
Aug 02 2023, 09:33:43 MDT
