**Re: Remediation Report and Closure Request
Maverick Permian, LLC
Oxy State F1 Battery Release
Unit Letter Unit Letter M, Section 01, Township 21 South, Range 36 East
Lea County, New Mexico
Incident ID# nAPP2317958480**

Reclamation Report and Closure Request
Oxy State F1 Battery Release
Incident ID# nAPP2317958480

Maverick Permian, LLC
August 13, 2025

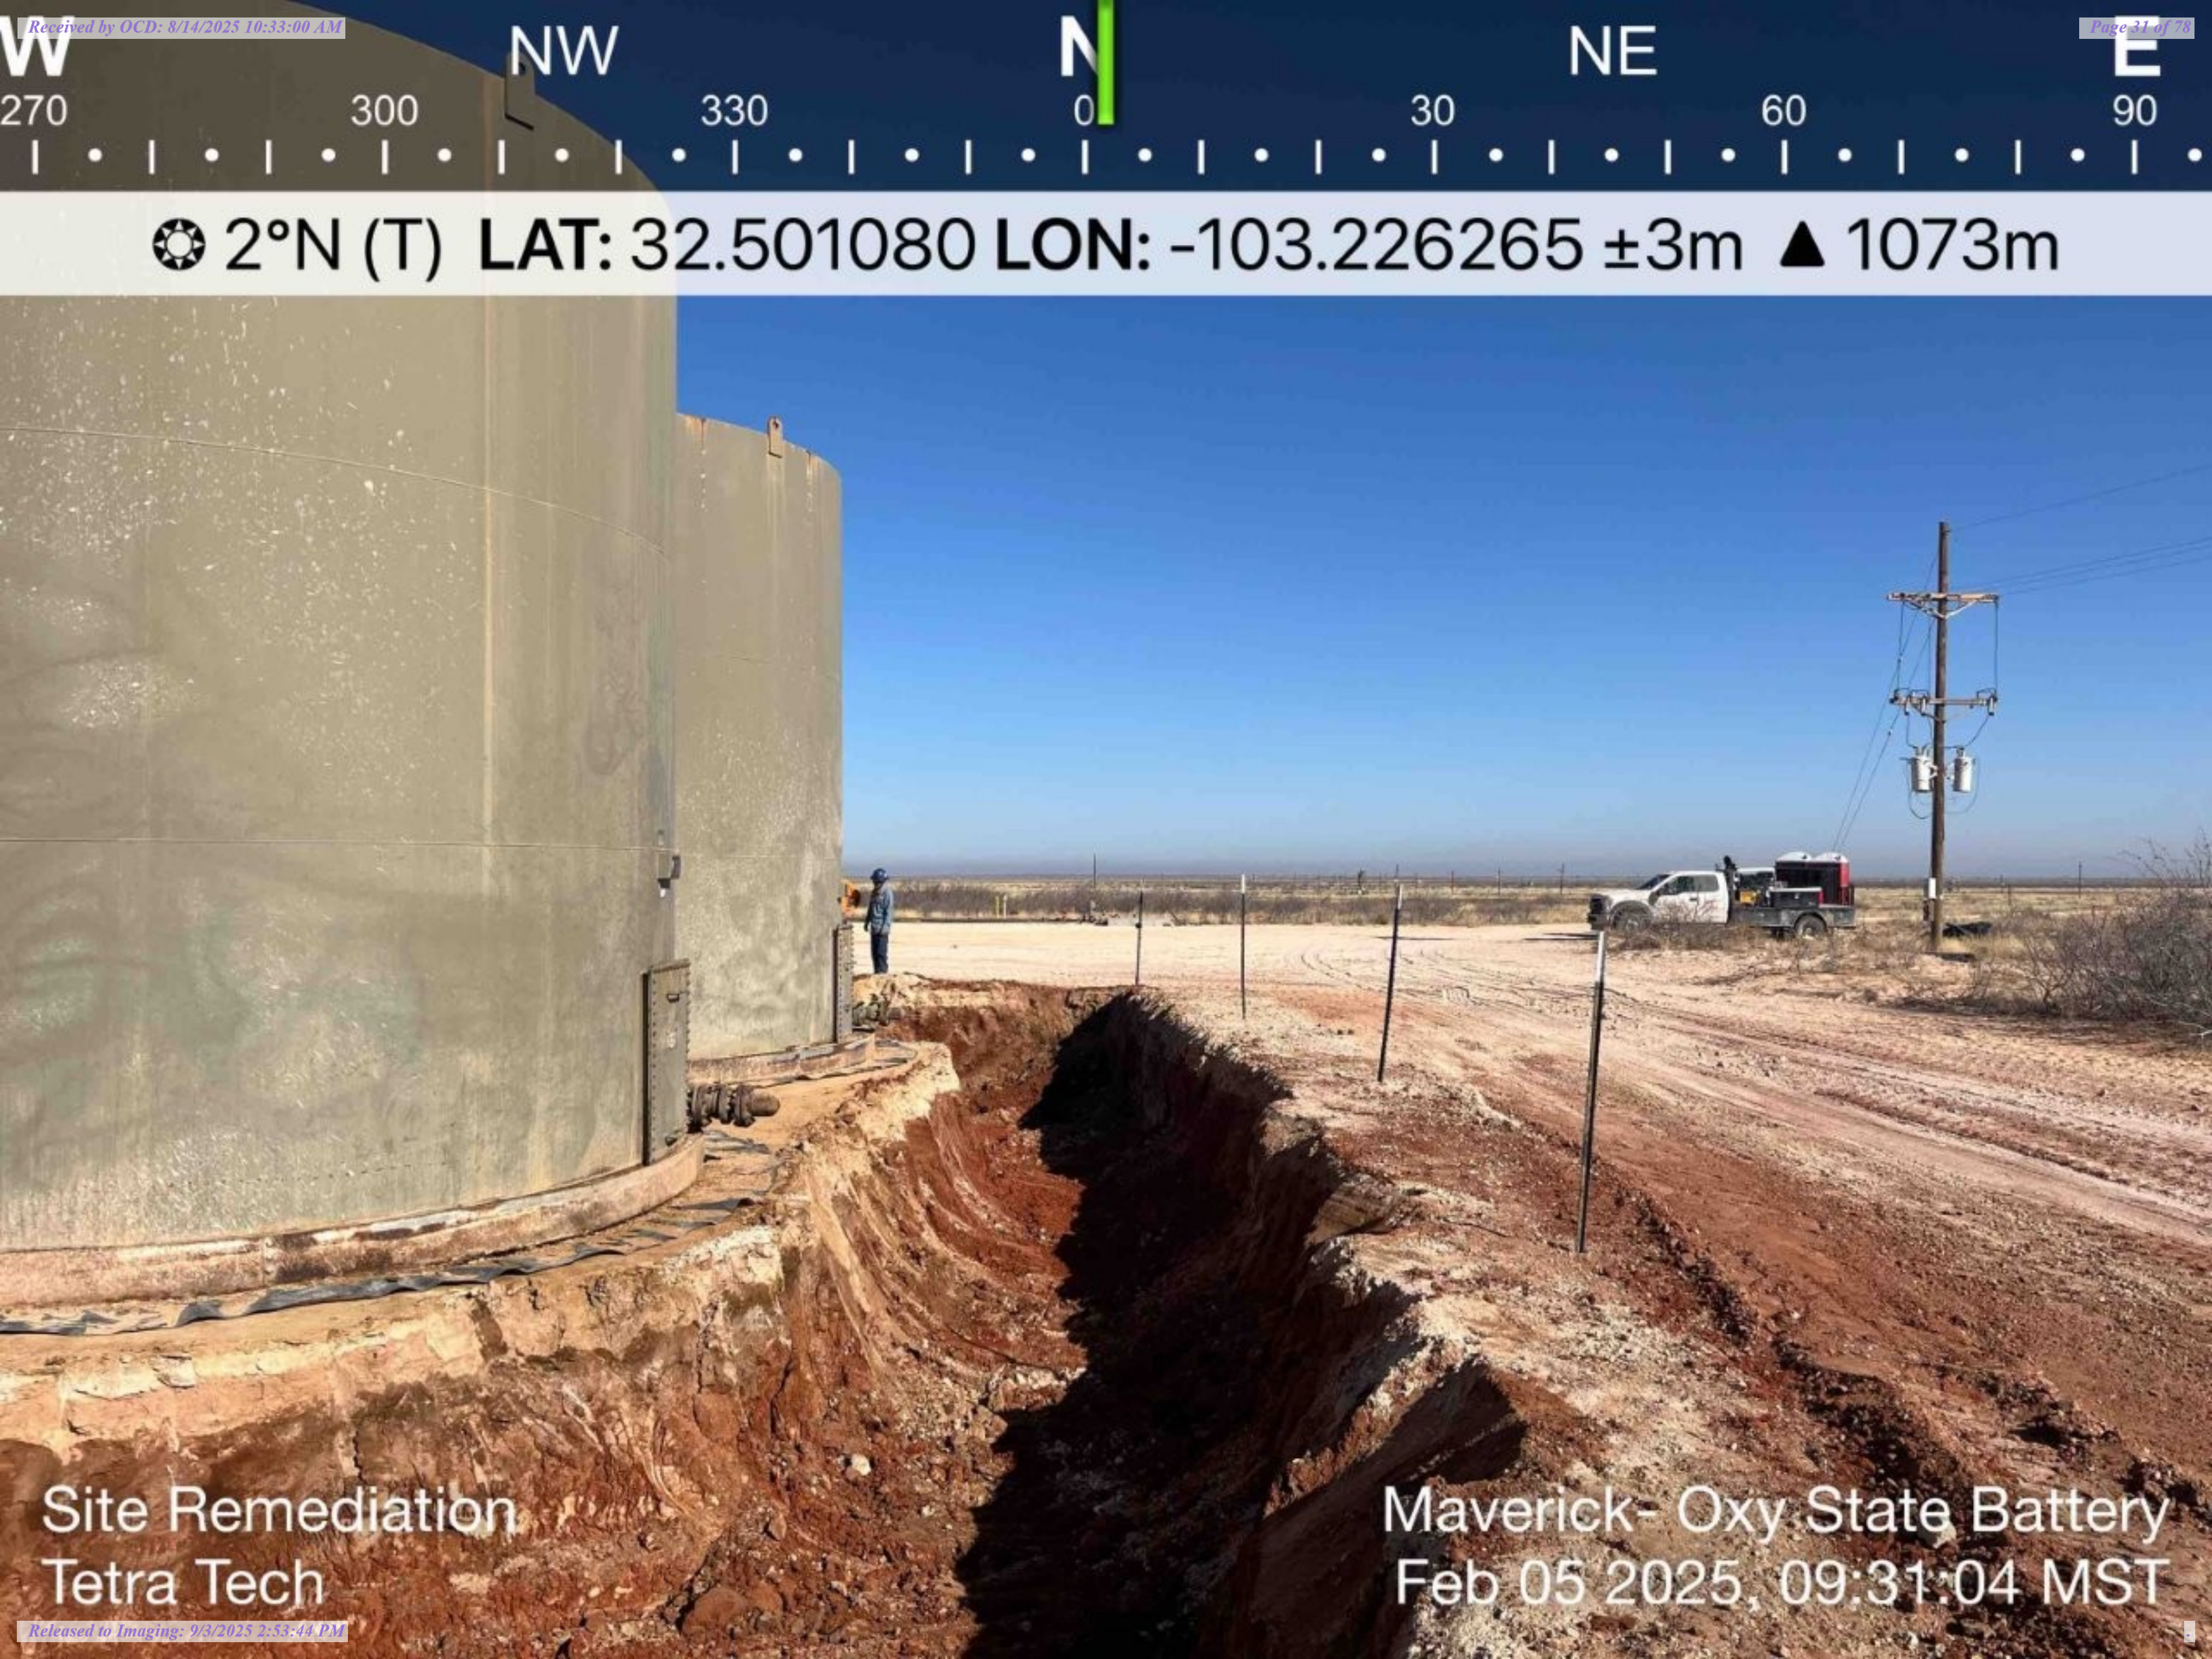
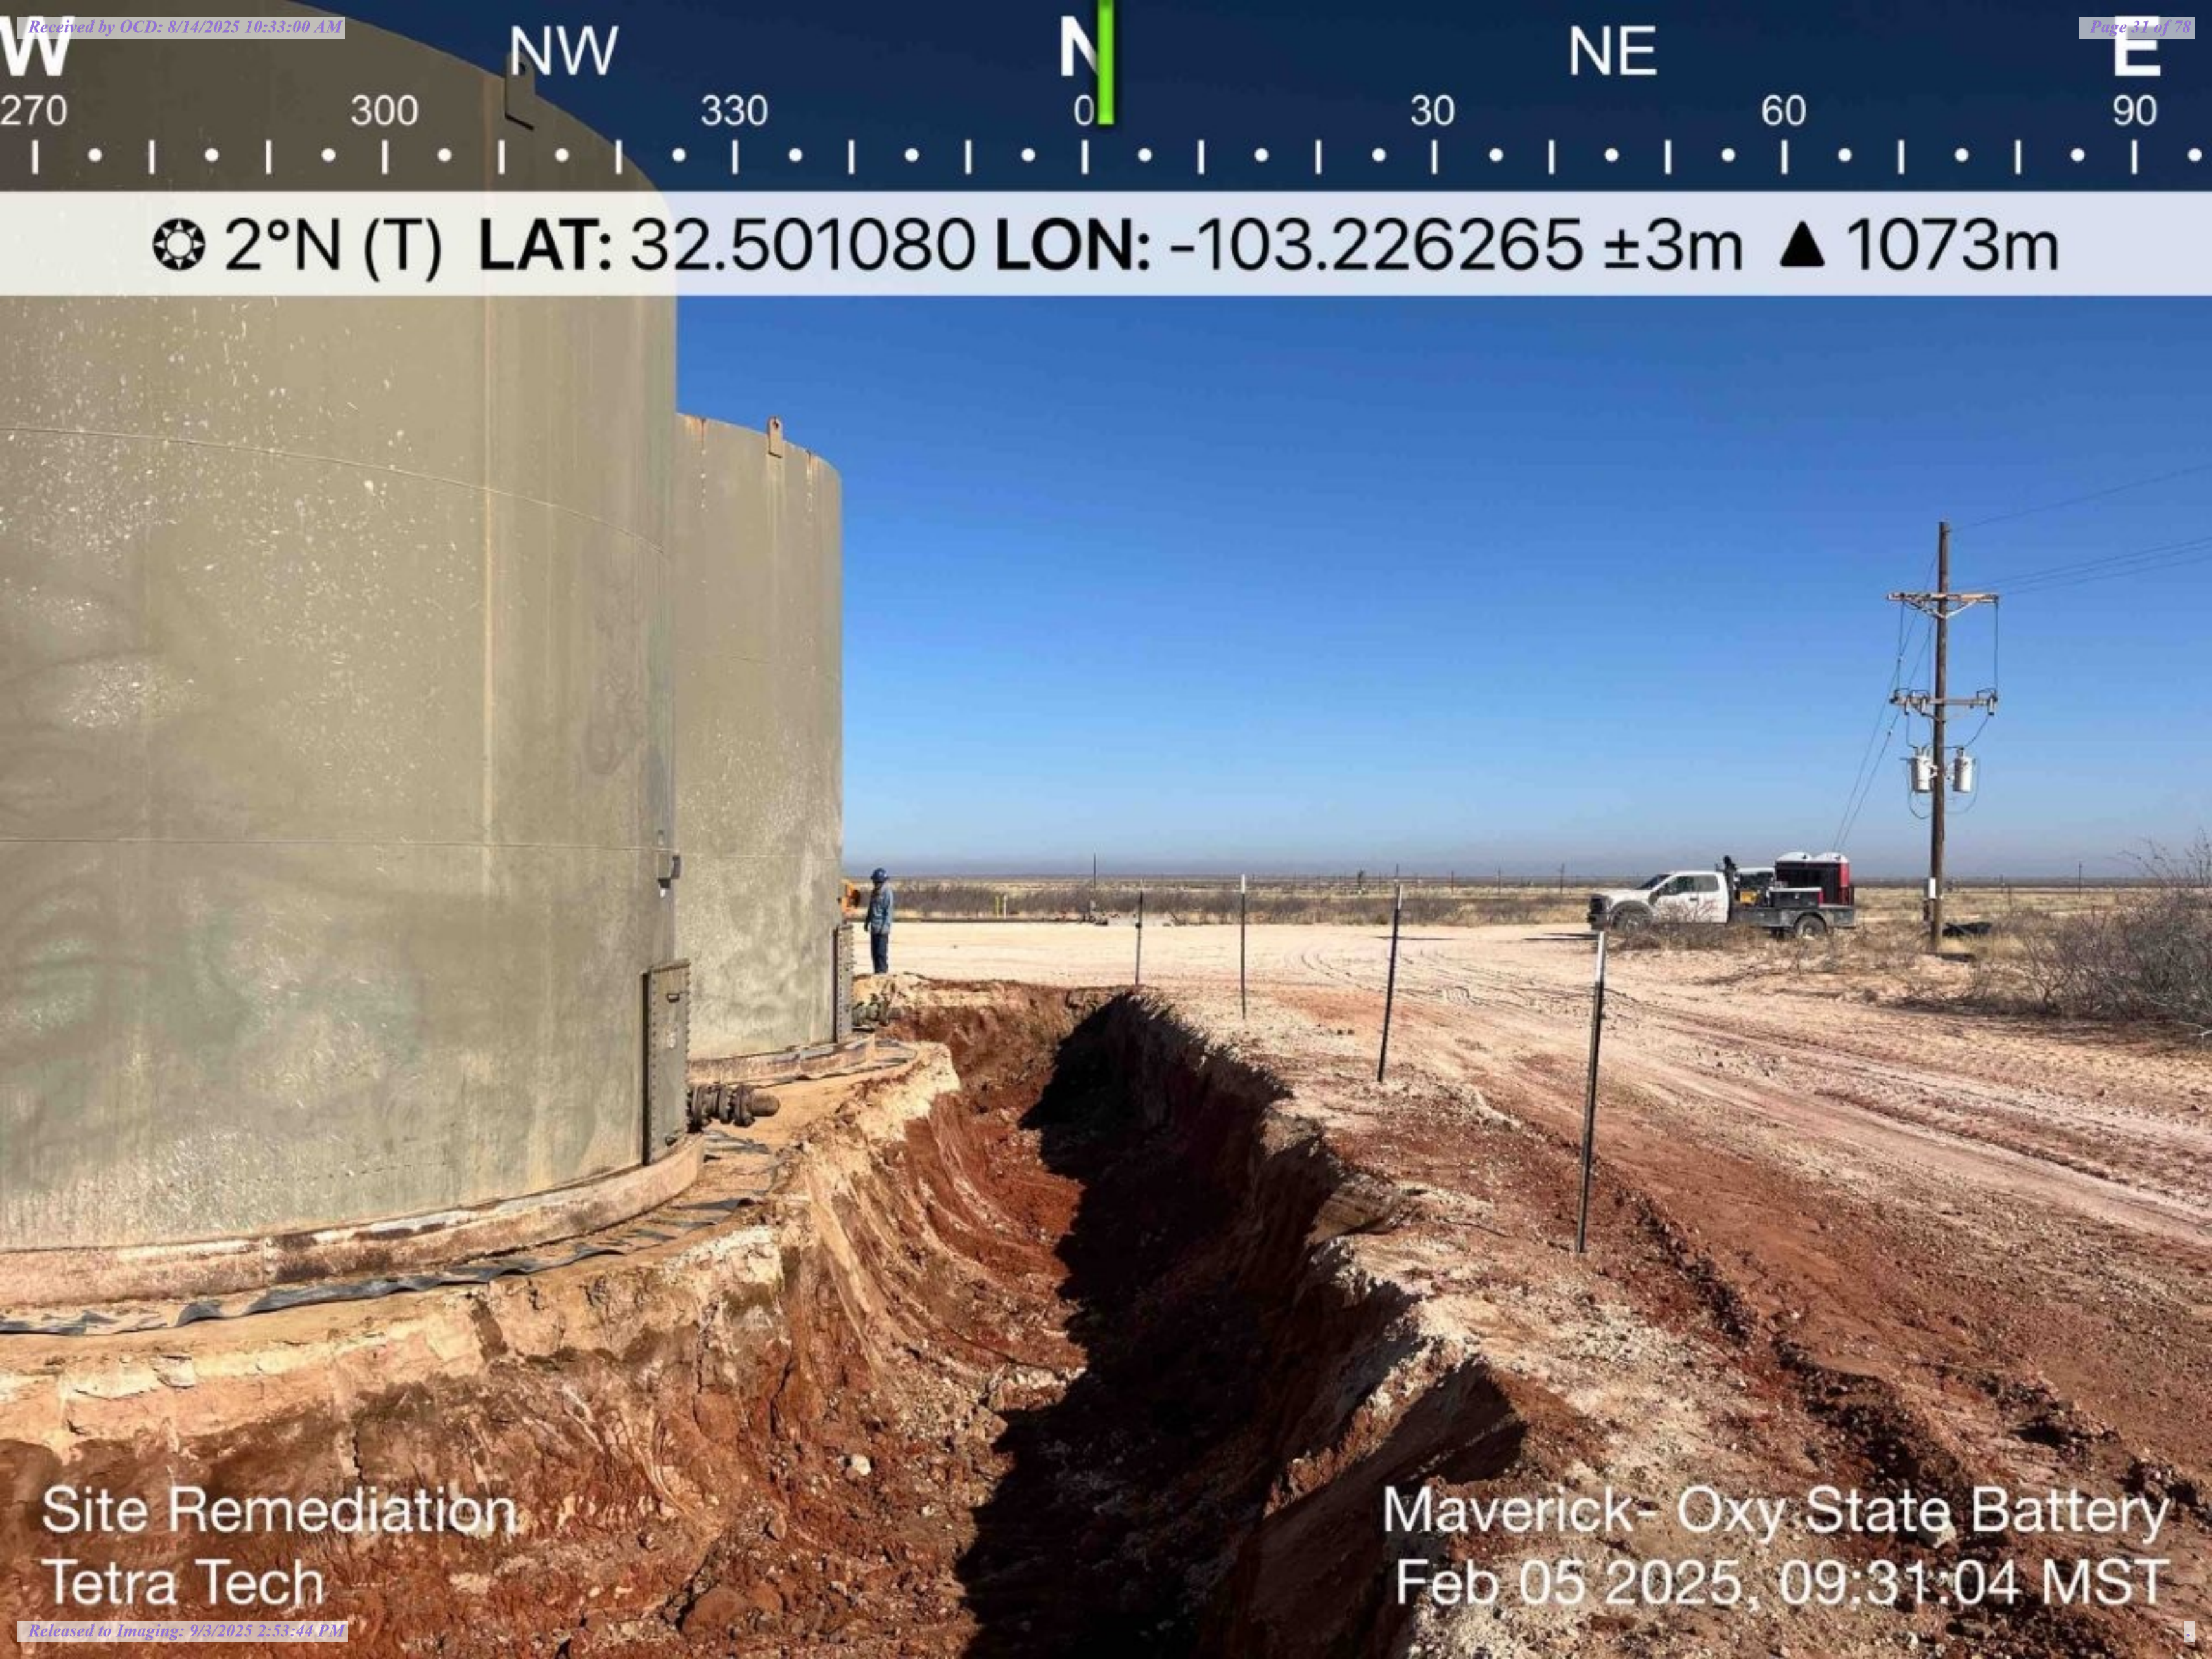
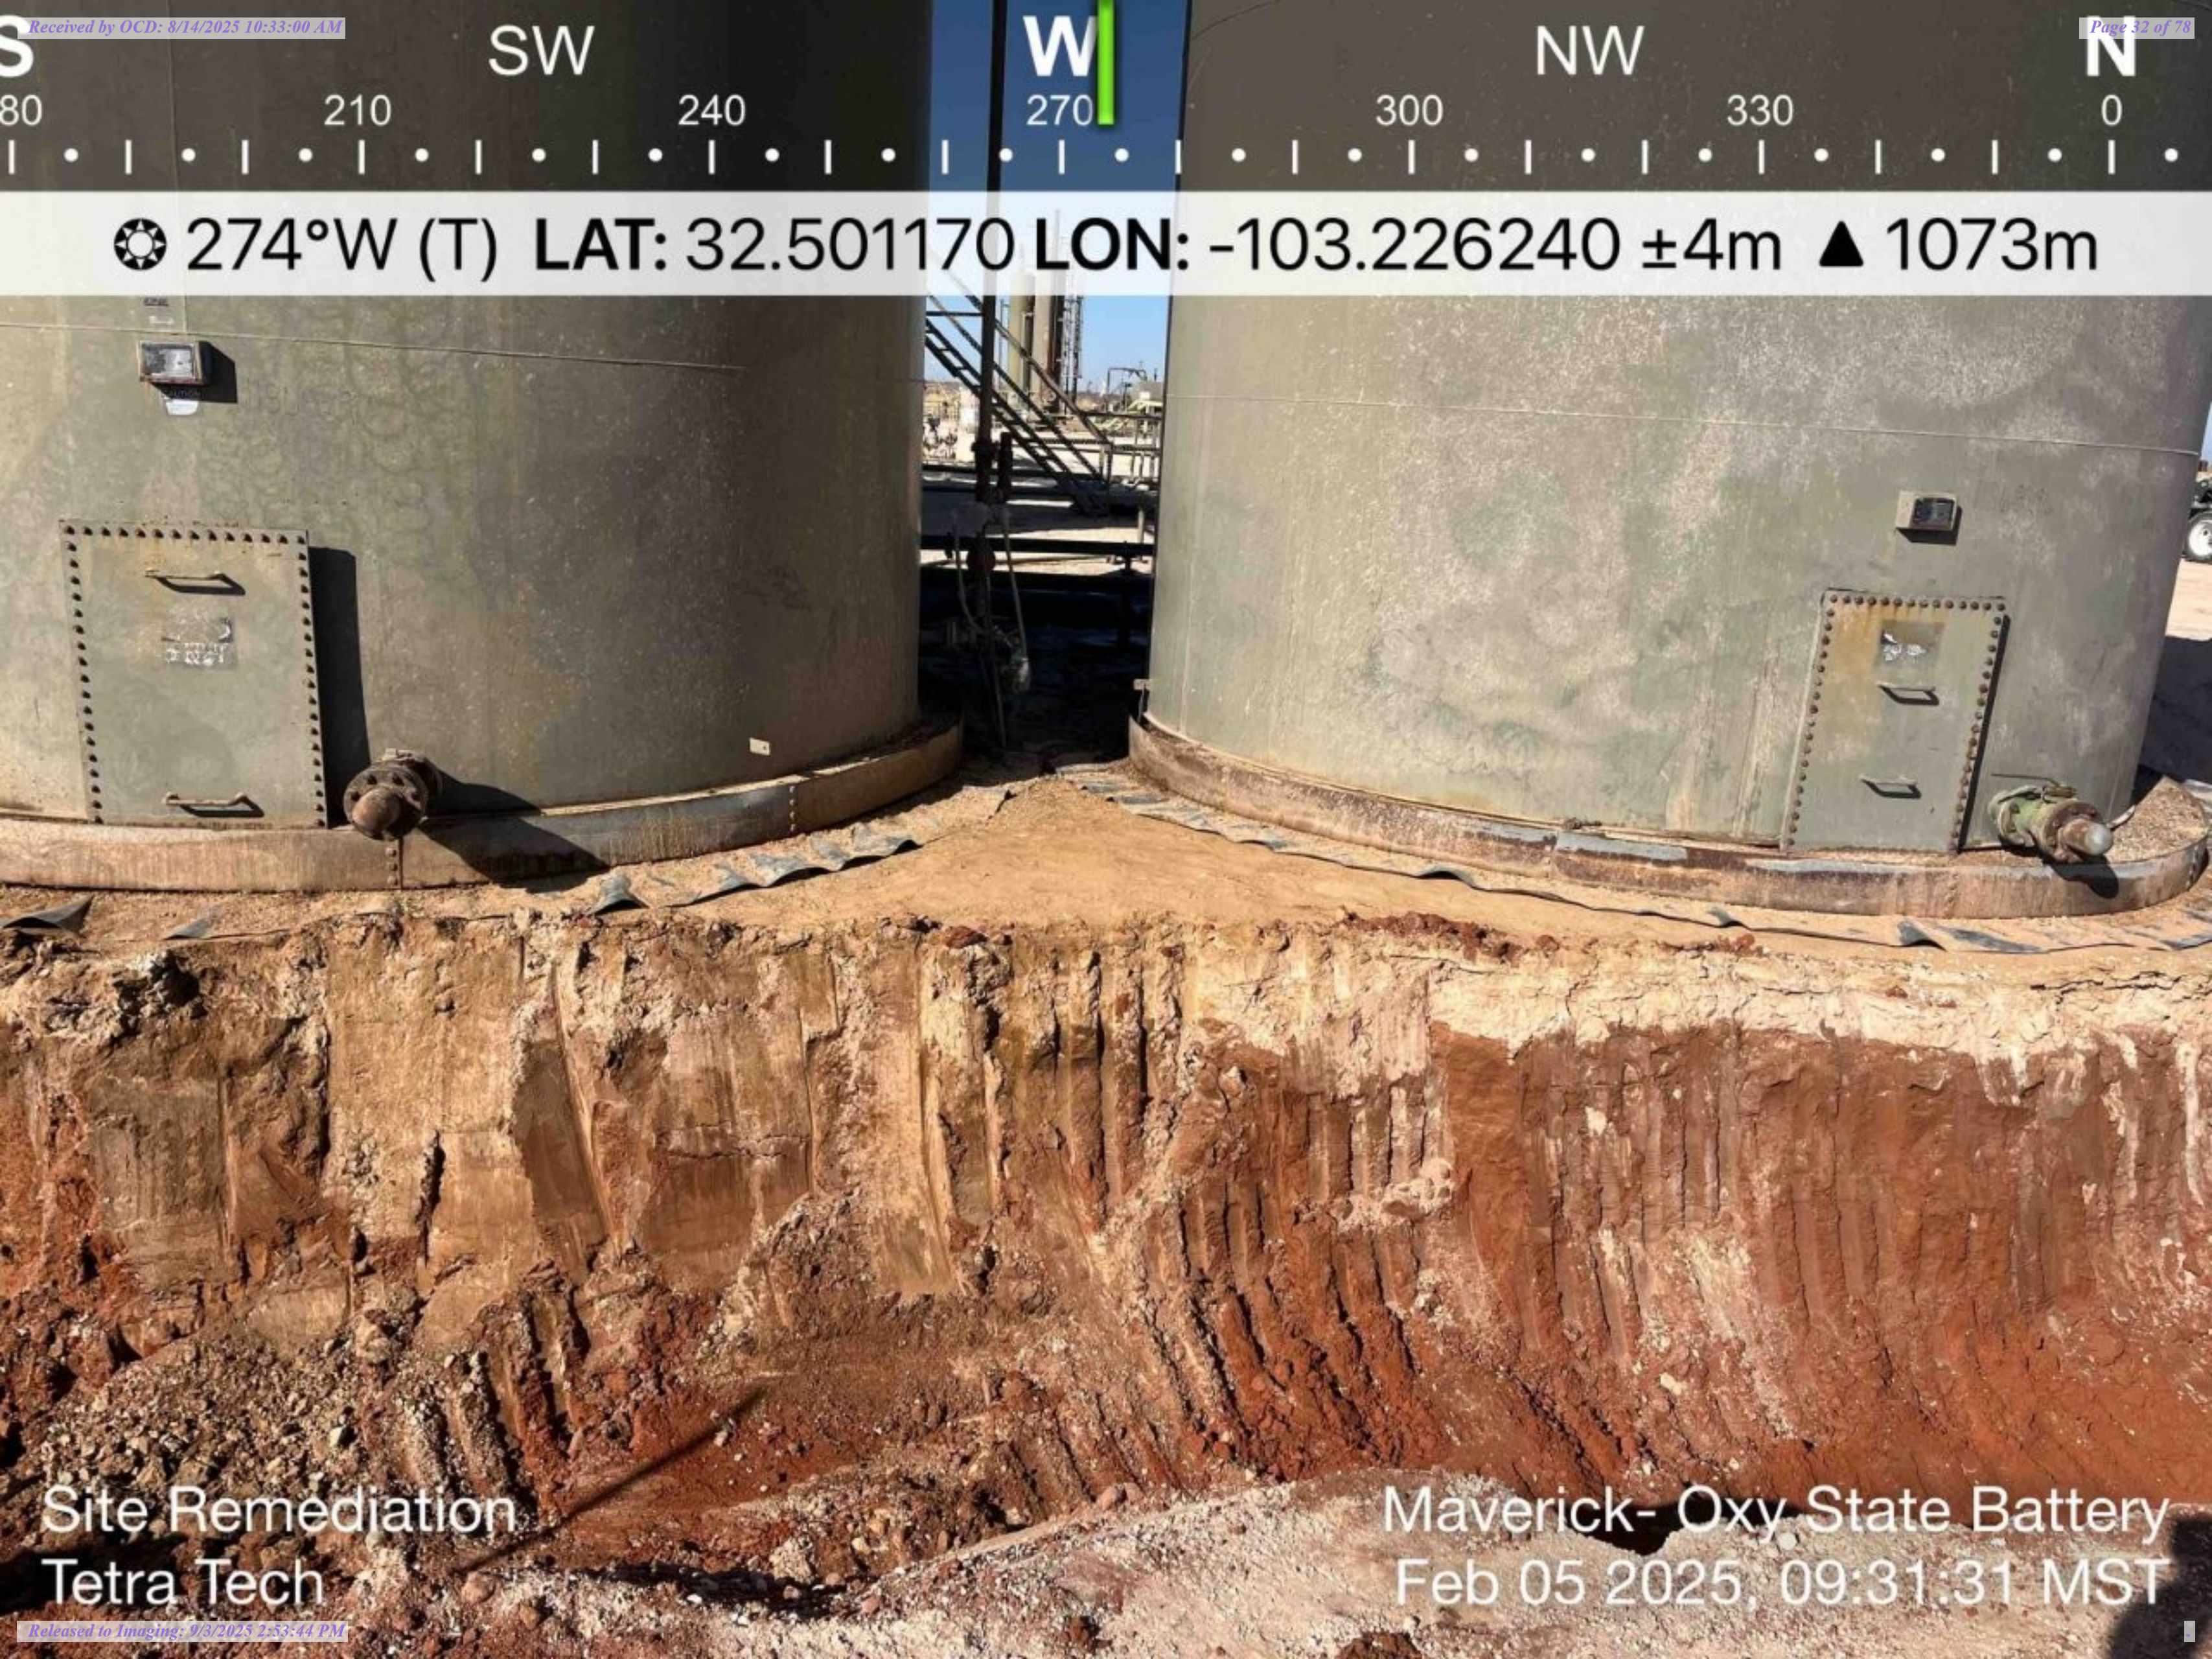
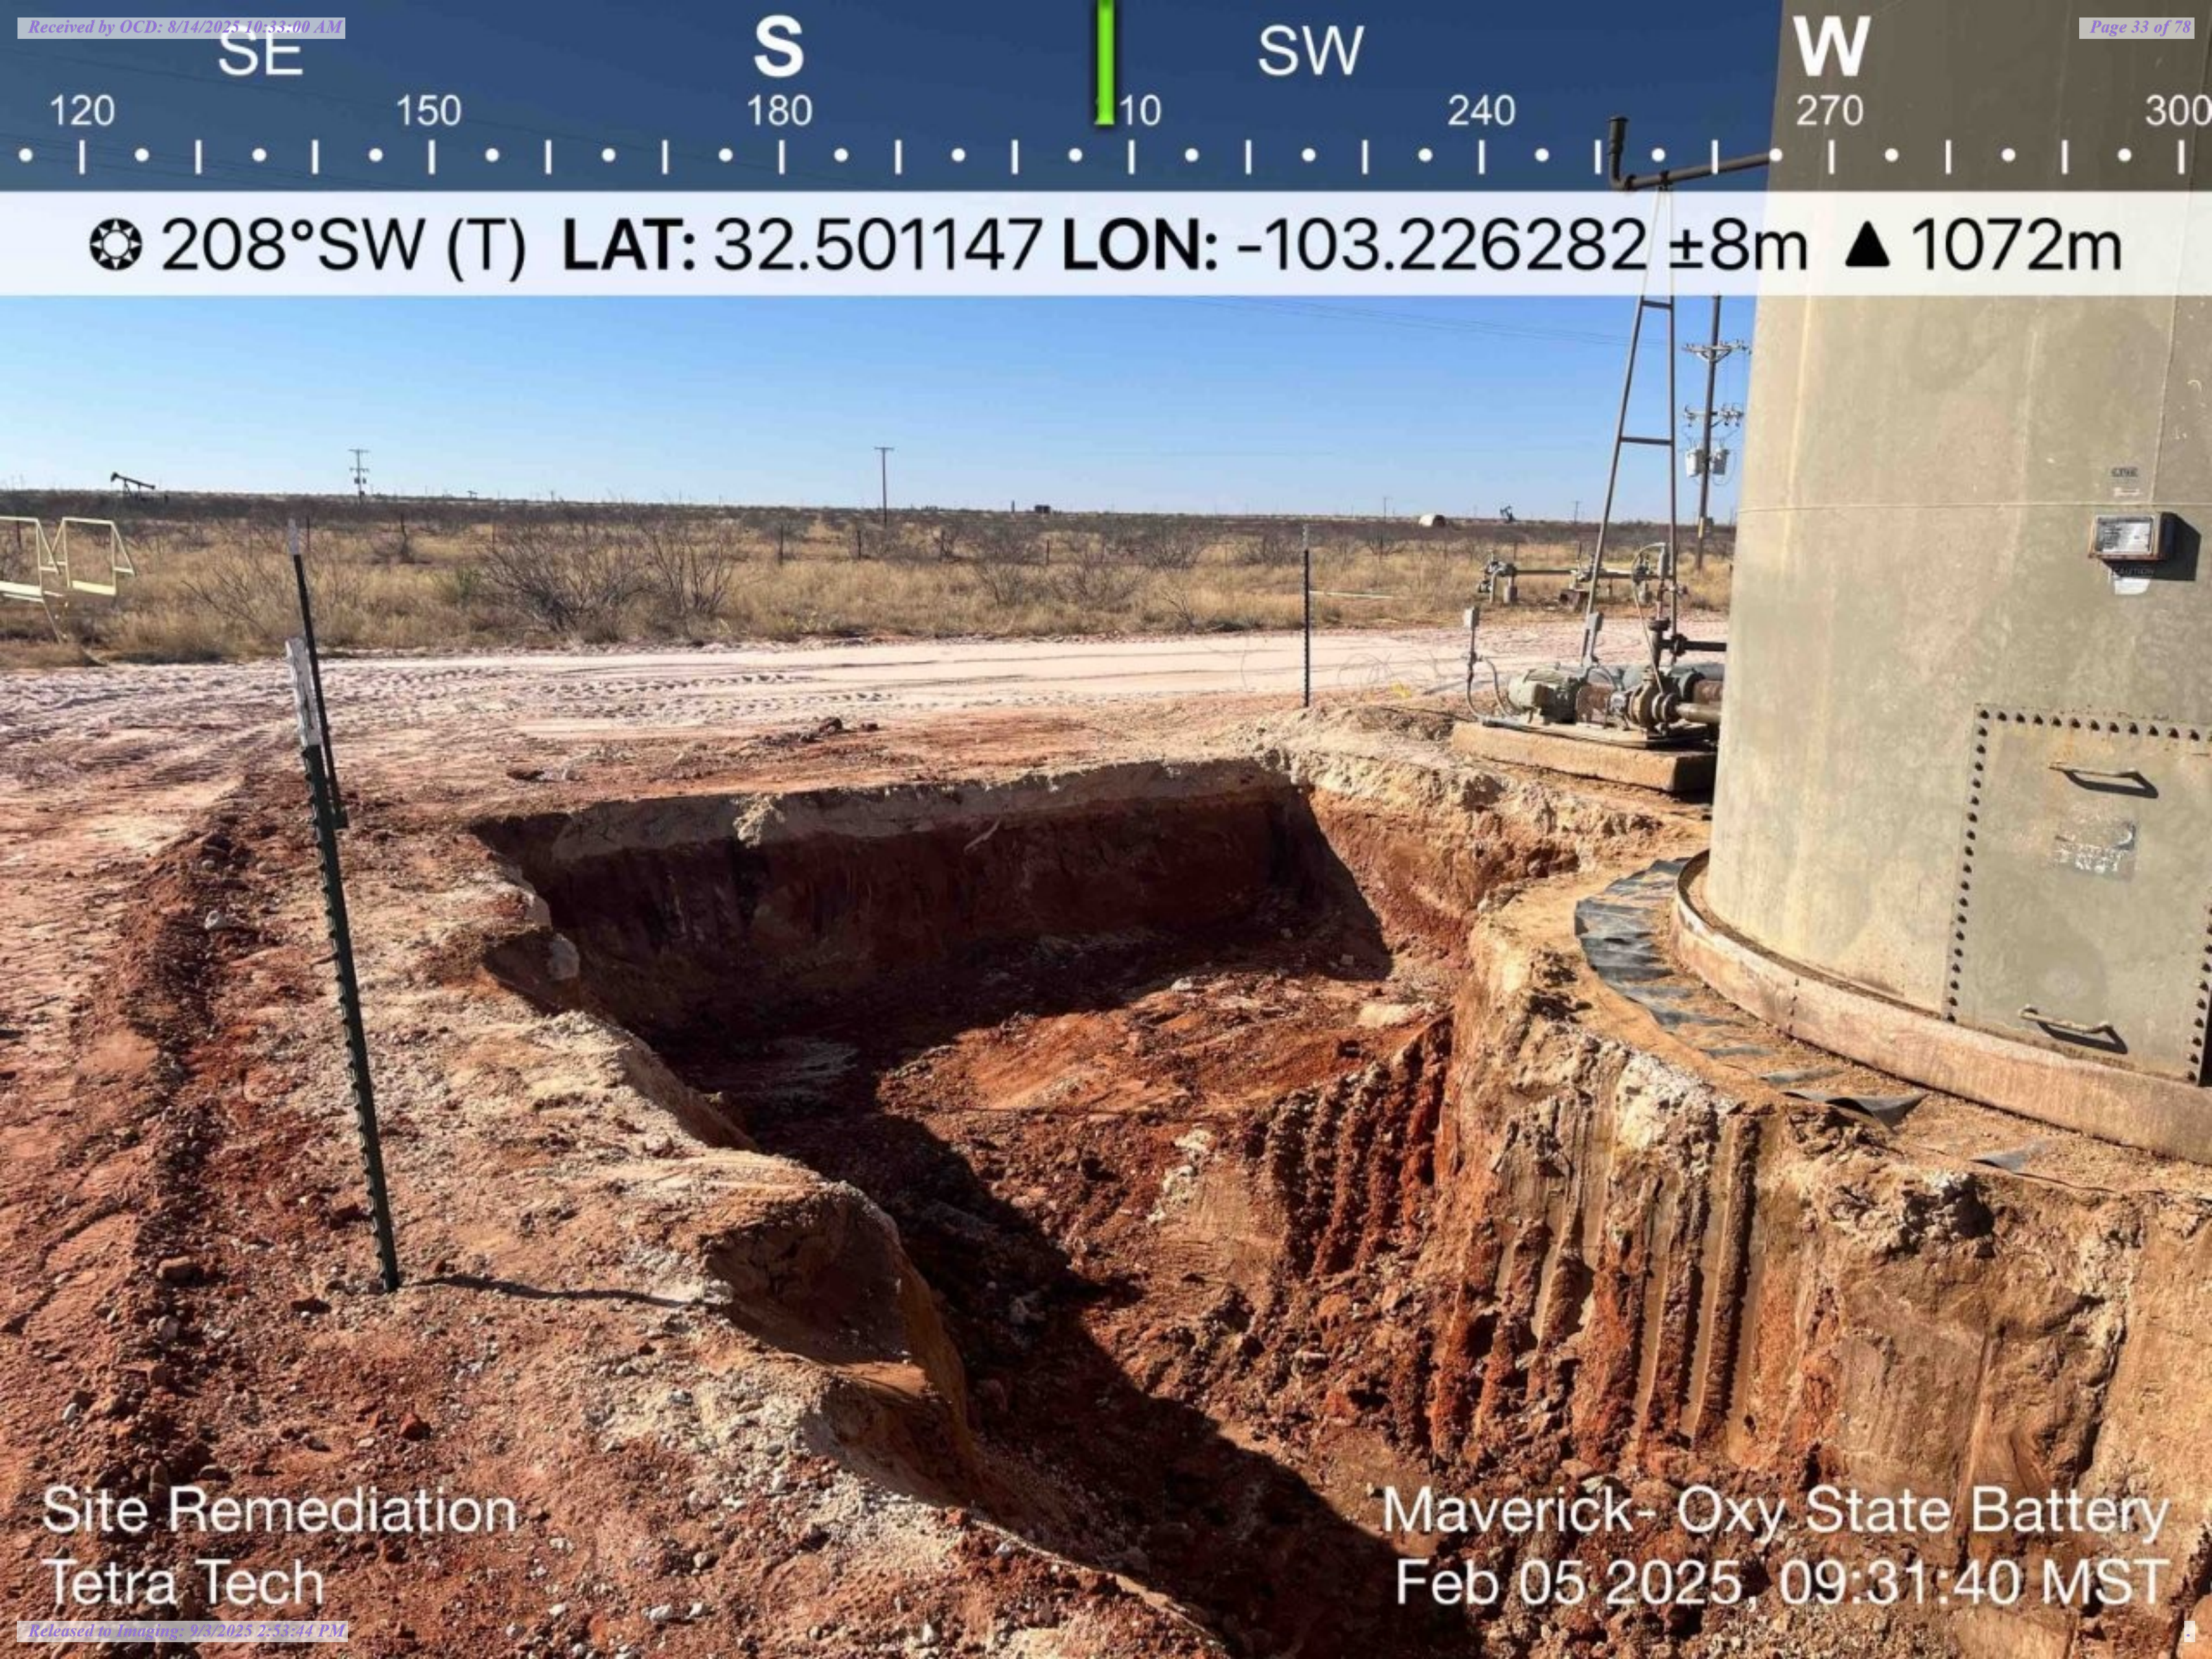
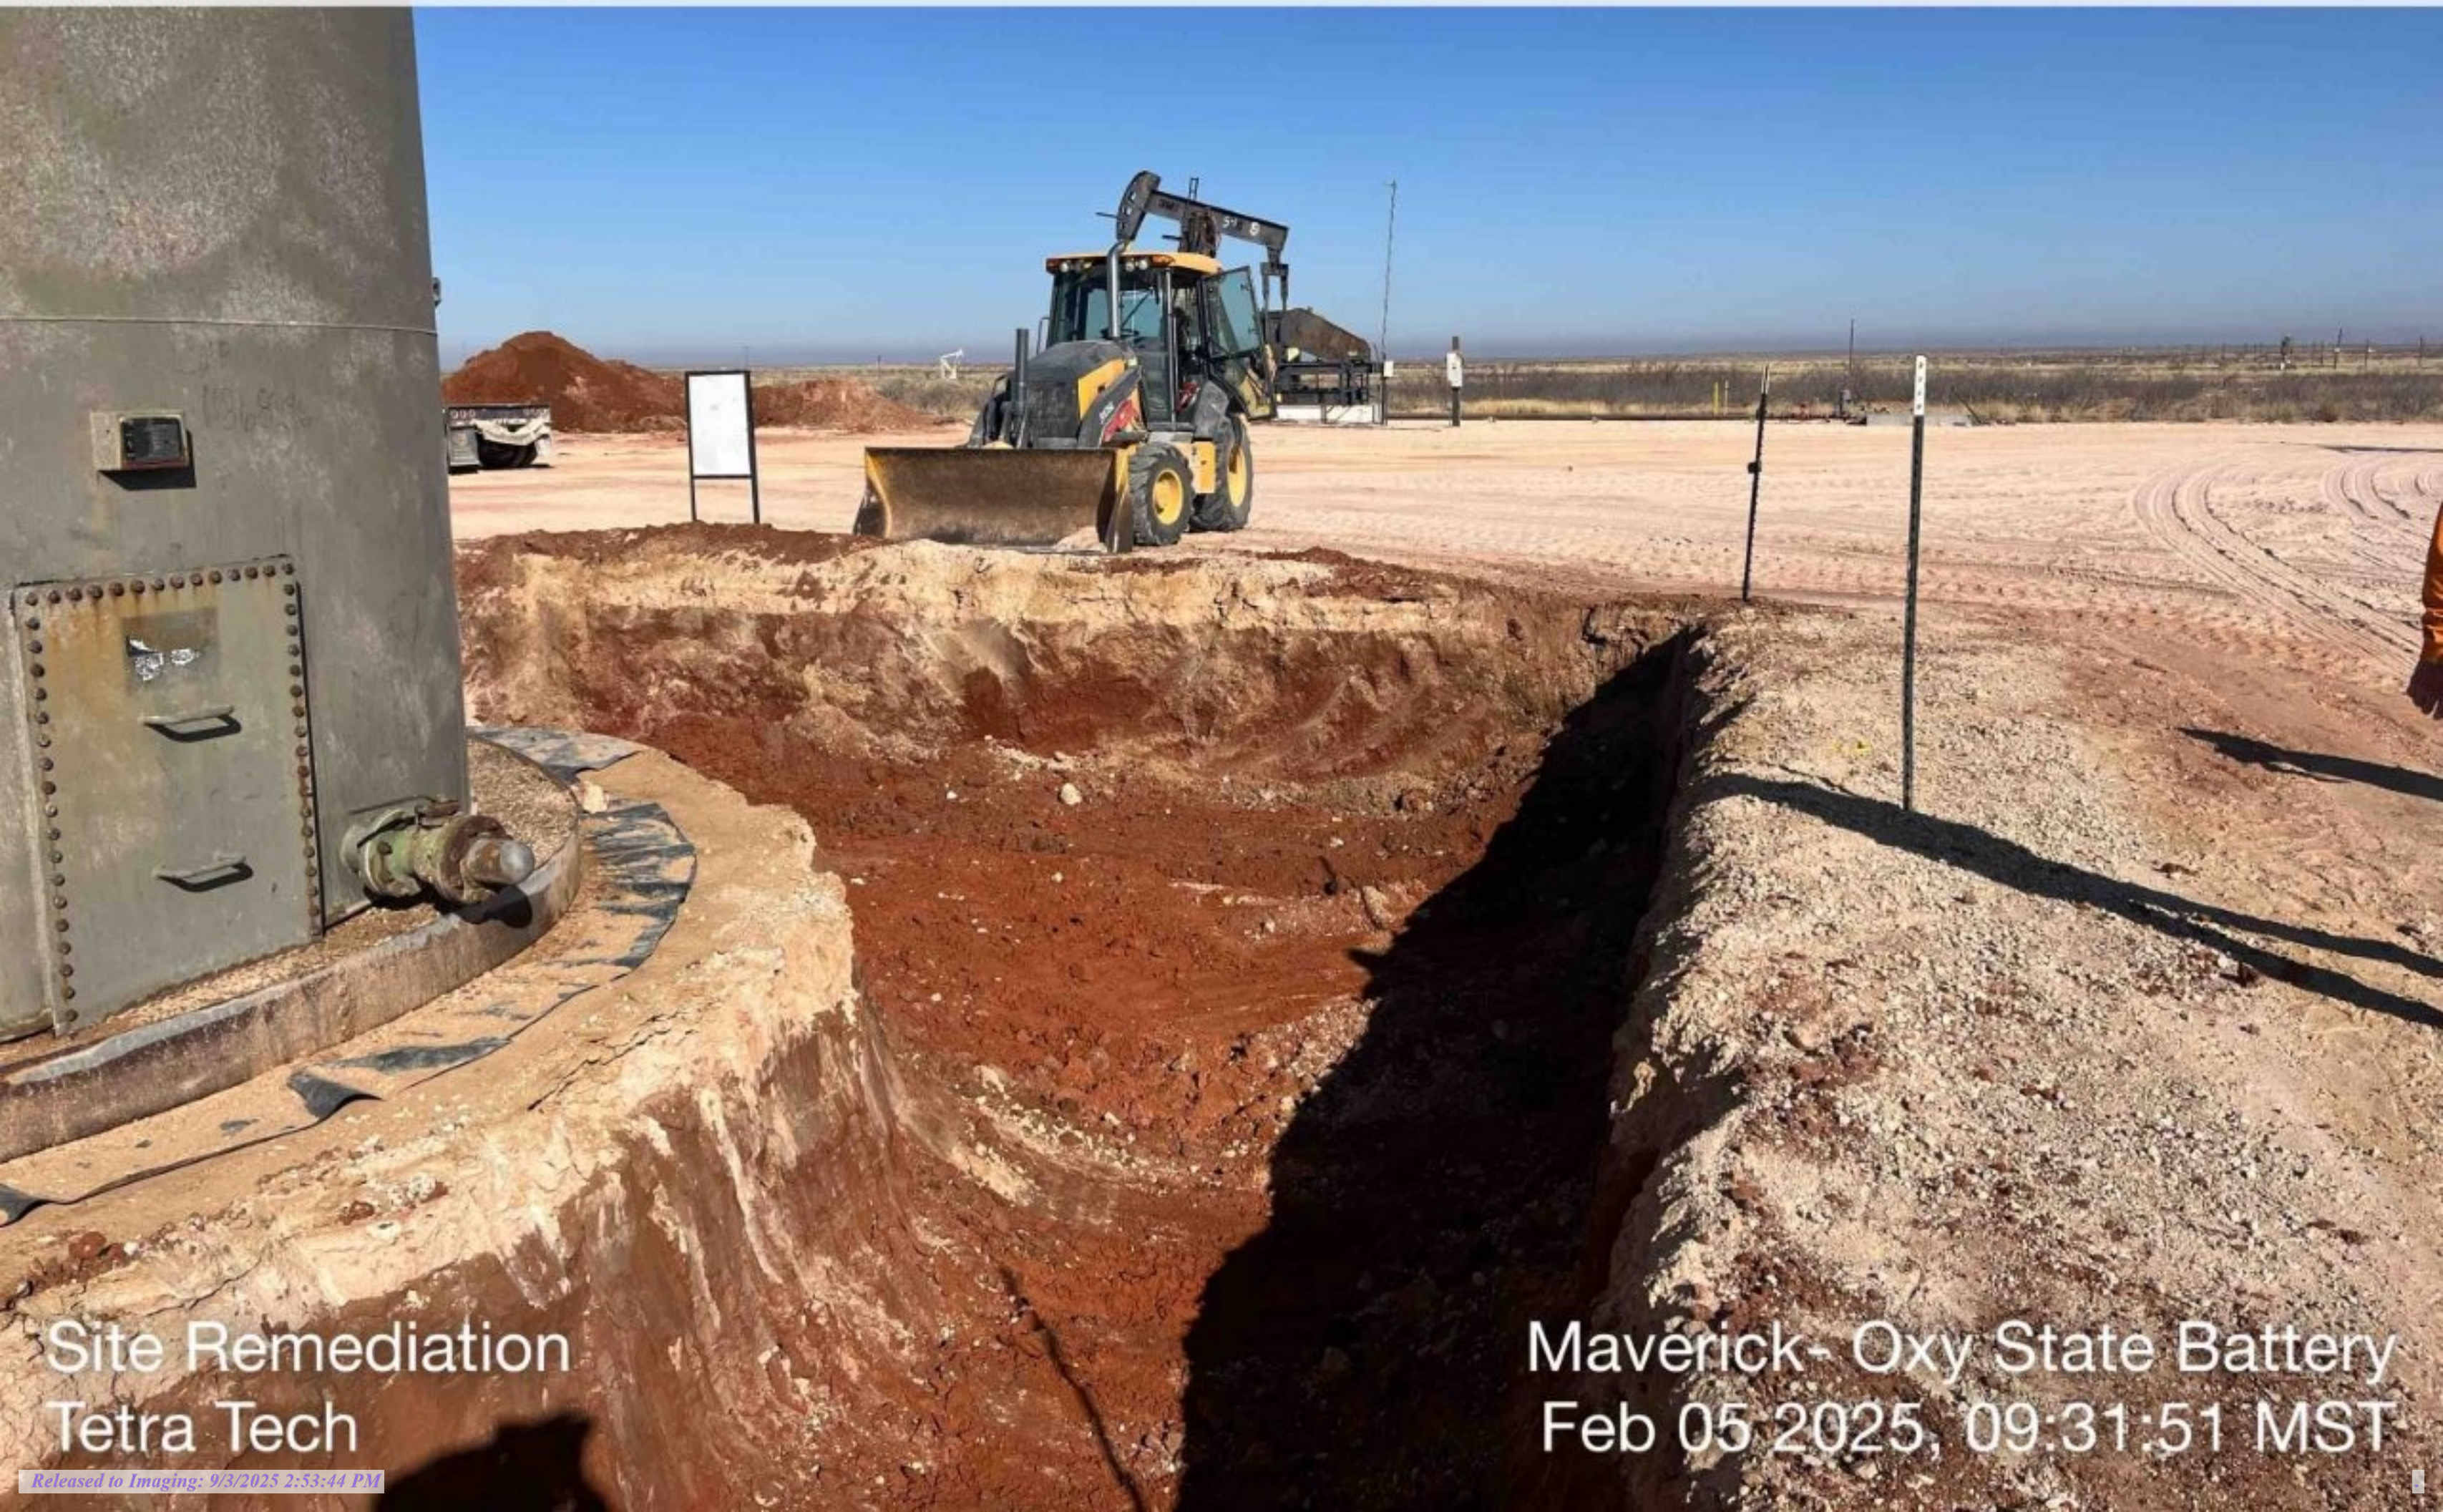
Site Remediation
Tetra Tech
