RE: **Release Investigation and Closure Report**
XTO Energy
JRU DI2 Battery OCD incident nAPP2428835246
Unit K, Section 25, Township 22 South, Range 30 East
32.362603°, -103.838139°
Eddy County, New Mexico
Terracon Project No. KH247052

Closure Documentation
JRU DI2 Battery | Eddy County, New Mexico
August 7, 2025 | Terracon Project No. KH247052

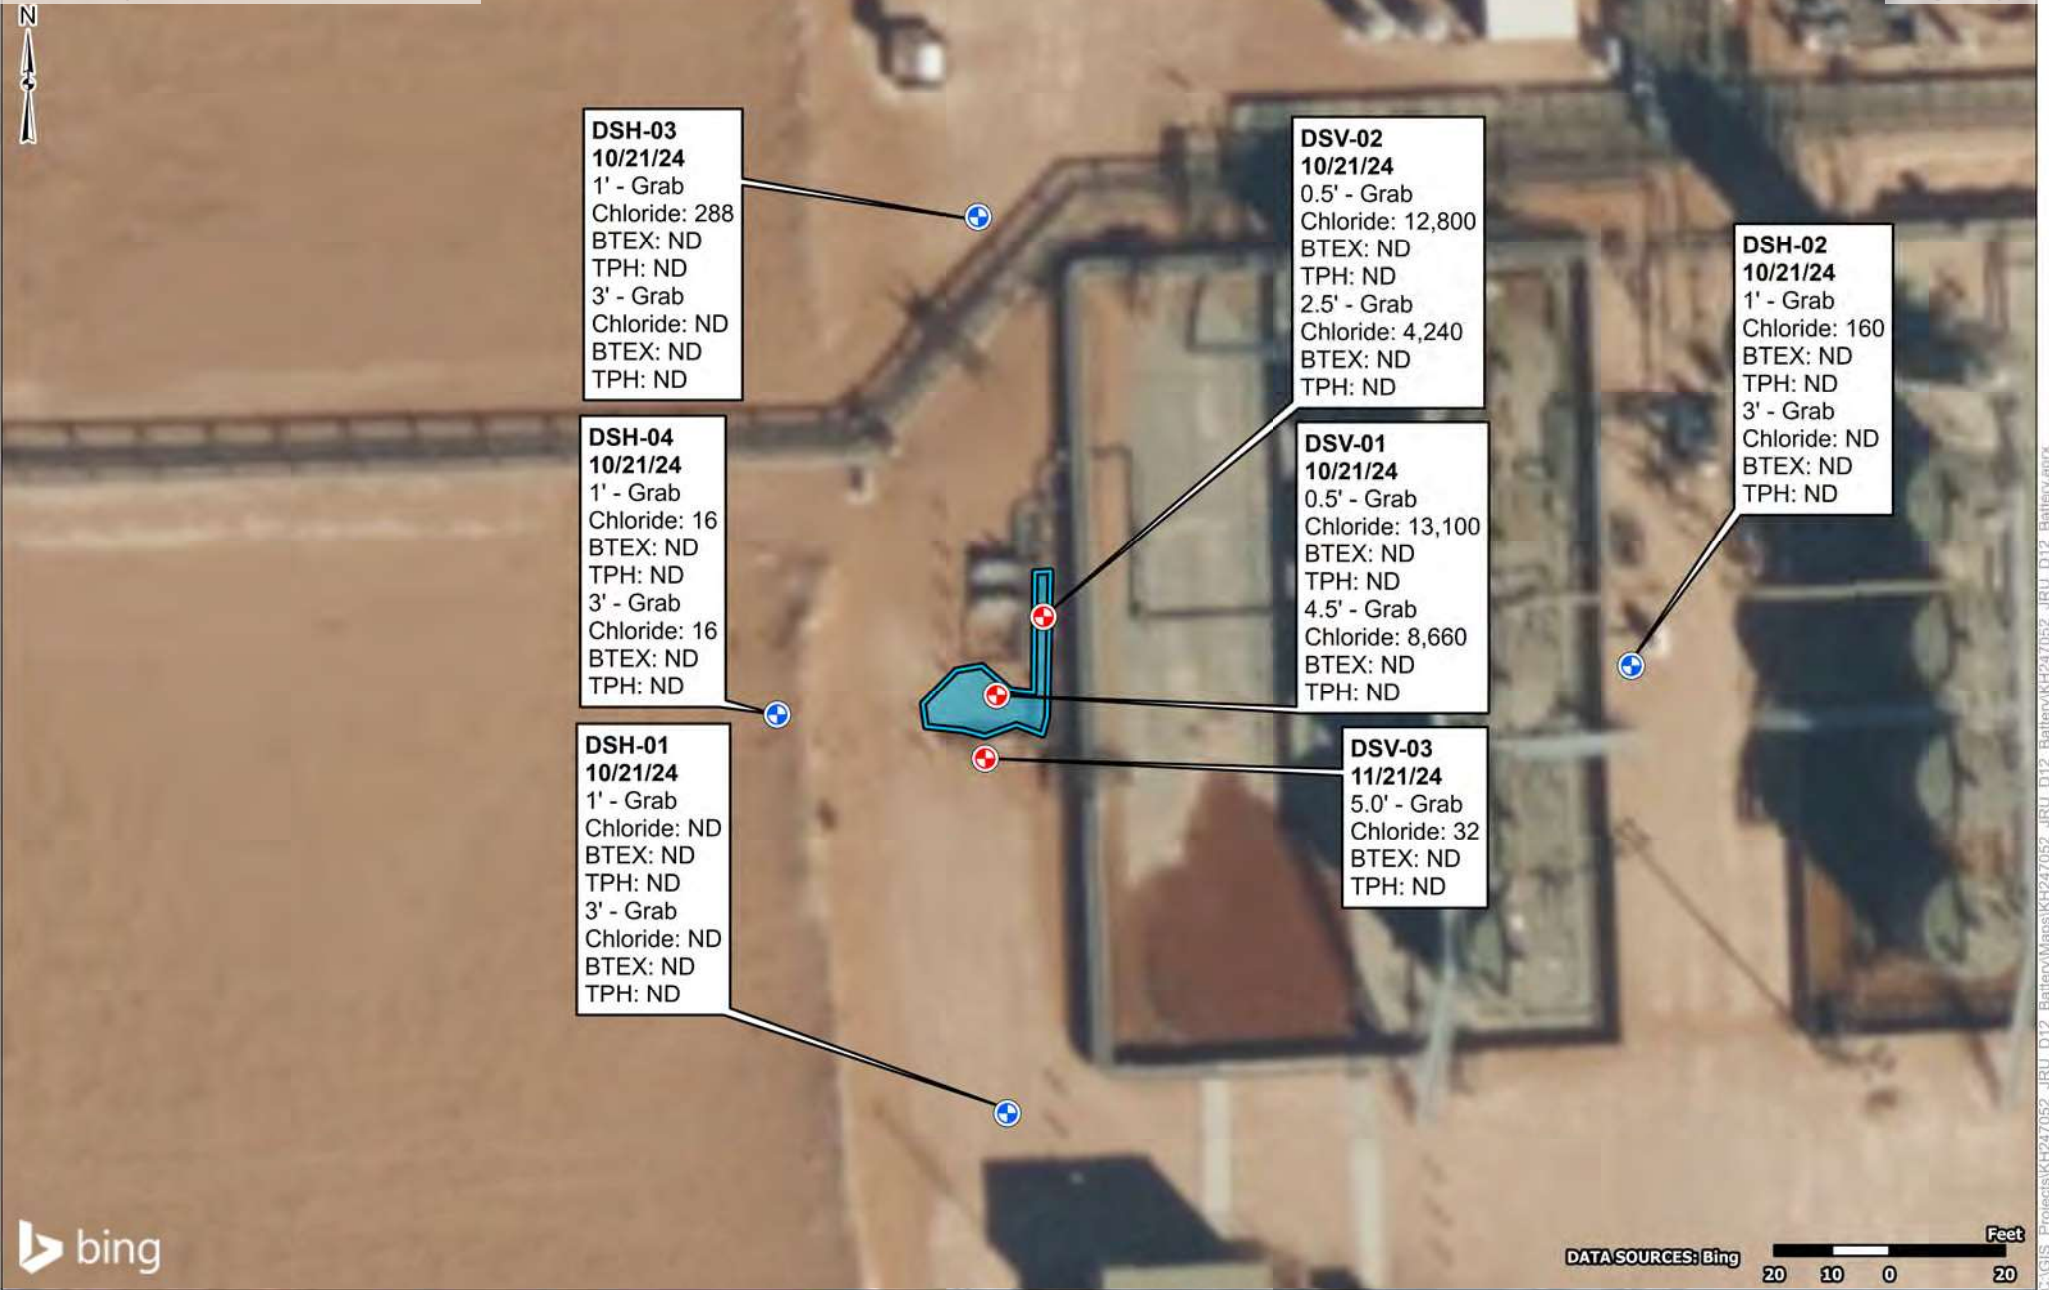
Remedial activities were conducted at the site from October 21, 2024, through November 21, 2024. An area of approximately 160 square feet was affected by the release. A total of 13 delineation samples from 7 locations were collected and submitted for analysis of BTEX, Chlorides, and TPH. Delineation sample results for BTEX and TPH from the laboratory were each reported as not detected above the laboratory sample detection limits. The sample results for Chloride were below the applicable NMOCD closure criteria referenced above of 20,000 mg/kg, with the highest result being 13,100 mg/kg from DSV-01 (0.5'). A Delineation Sample Map depicting the sample locations, analytical results, and the excavation extent are included in Appendix A, Exhibit 3. Delineation sample results are included in Appendix B, Table 1.

- Horizontal Delineation Sample
- Vertical Delineation Sample
- Inferred Release (166 Sq. Ft.)

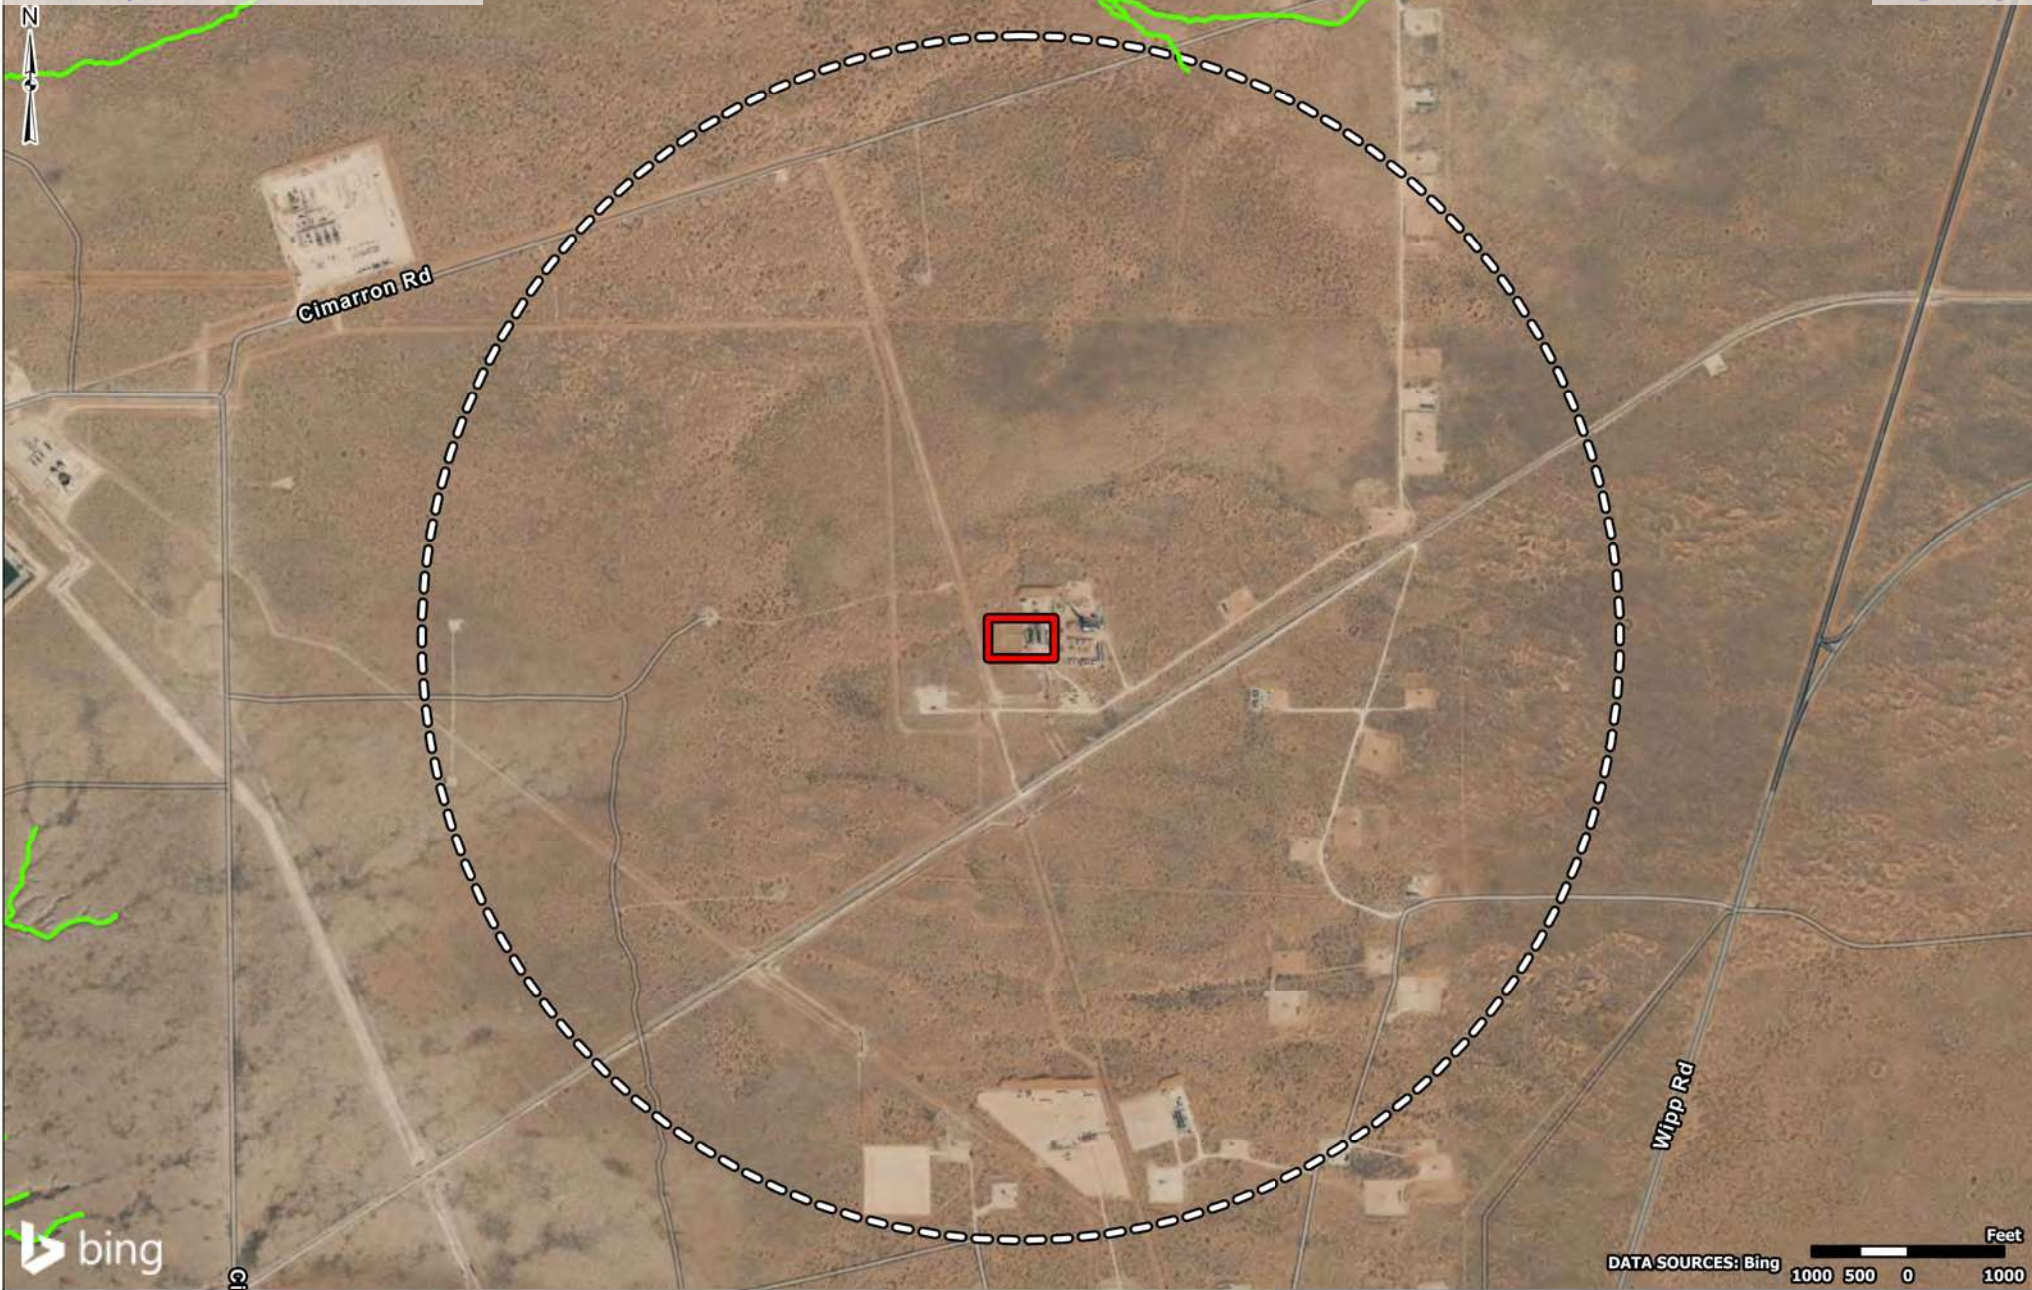
A review of the U.S. Fish and Wildlife Service National Wetlands Inventory website indicates that an ephemeral streambed is located approximately 1-mile northeast of the site. A Designated Wetland Area Map showing this feature is presented as Exhibit 5, Appendix A.

- Site Boundary
- 1 mi Radius
- Riverine

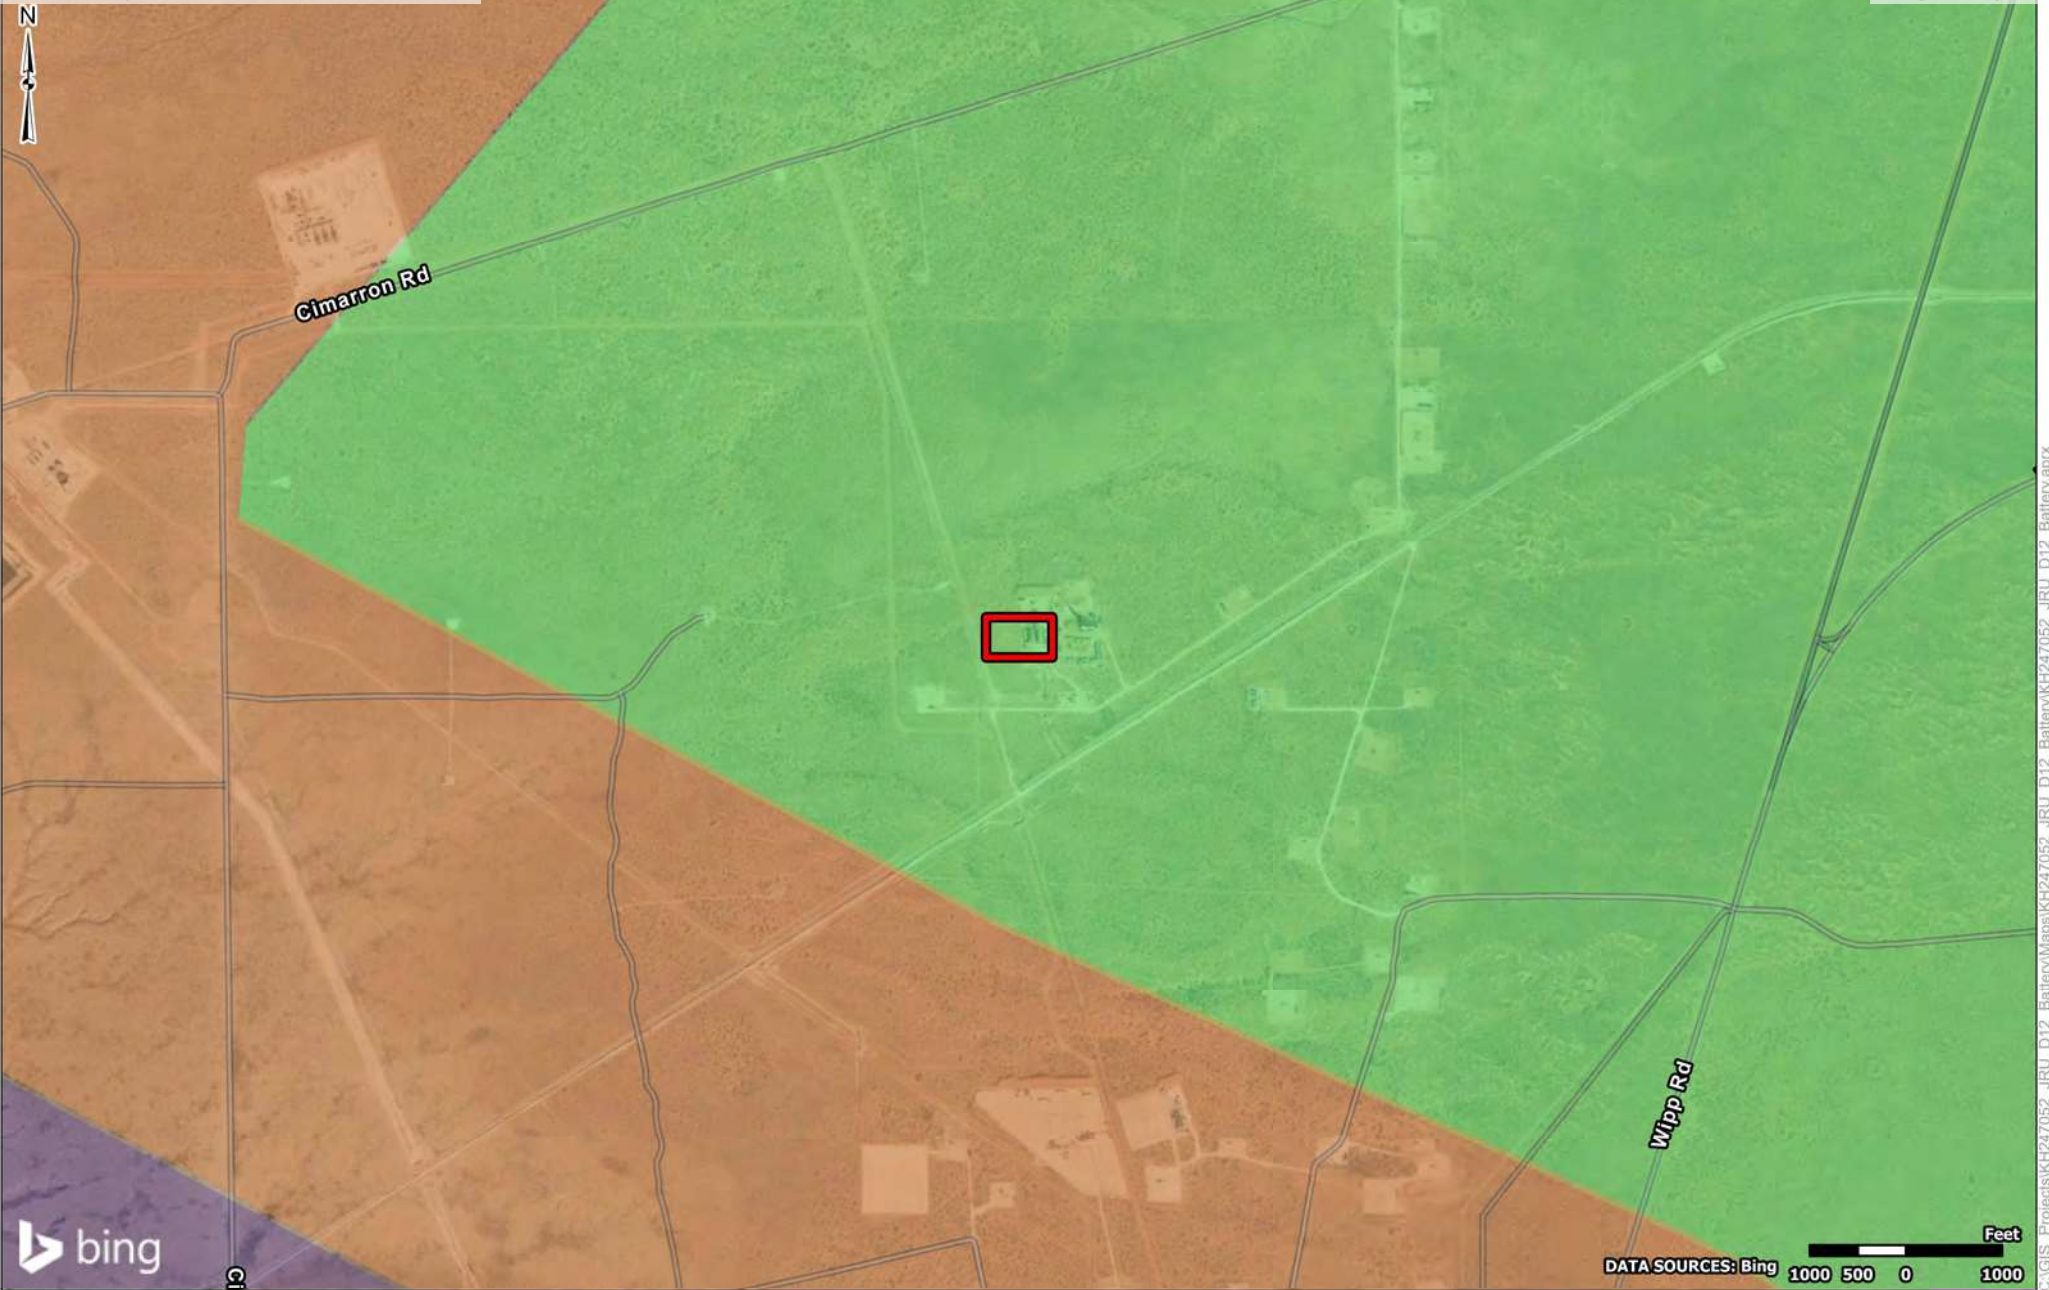
6

A review of geospatial data obtained from the BLM Carlsbad Field Office website indicated that the site is within an area of low risk for Karst formations. A copy of the Cave Karst Public UCP Map is presented as Exhibit 6, Appendix A.

- Site Boundary
- Karst Potential
 - Low
 - Medium

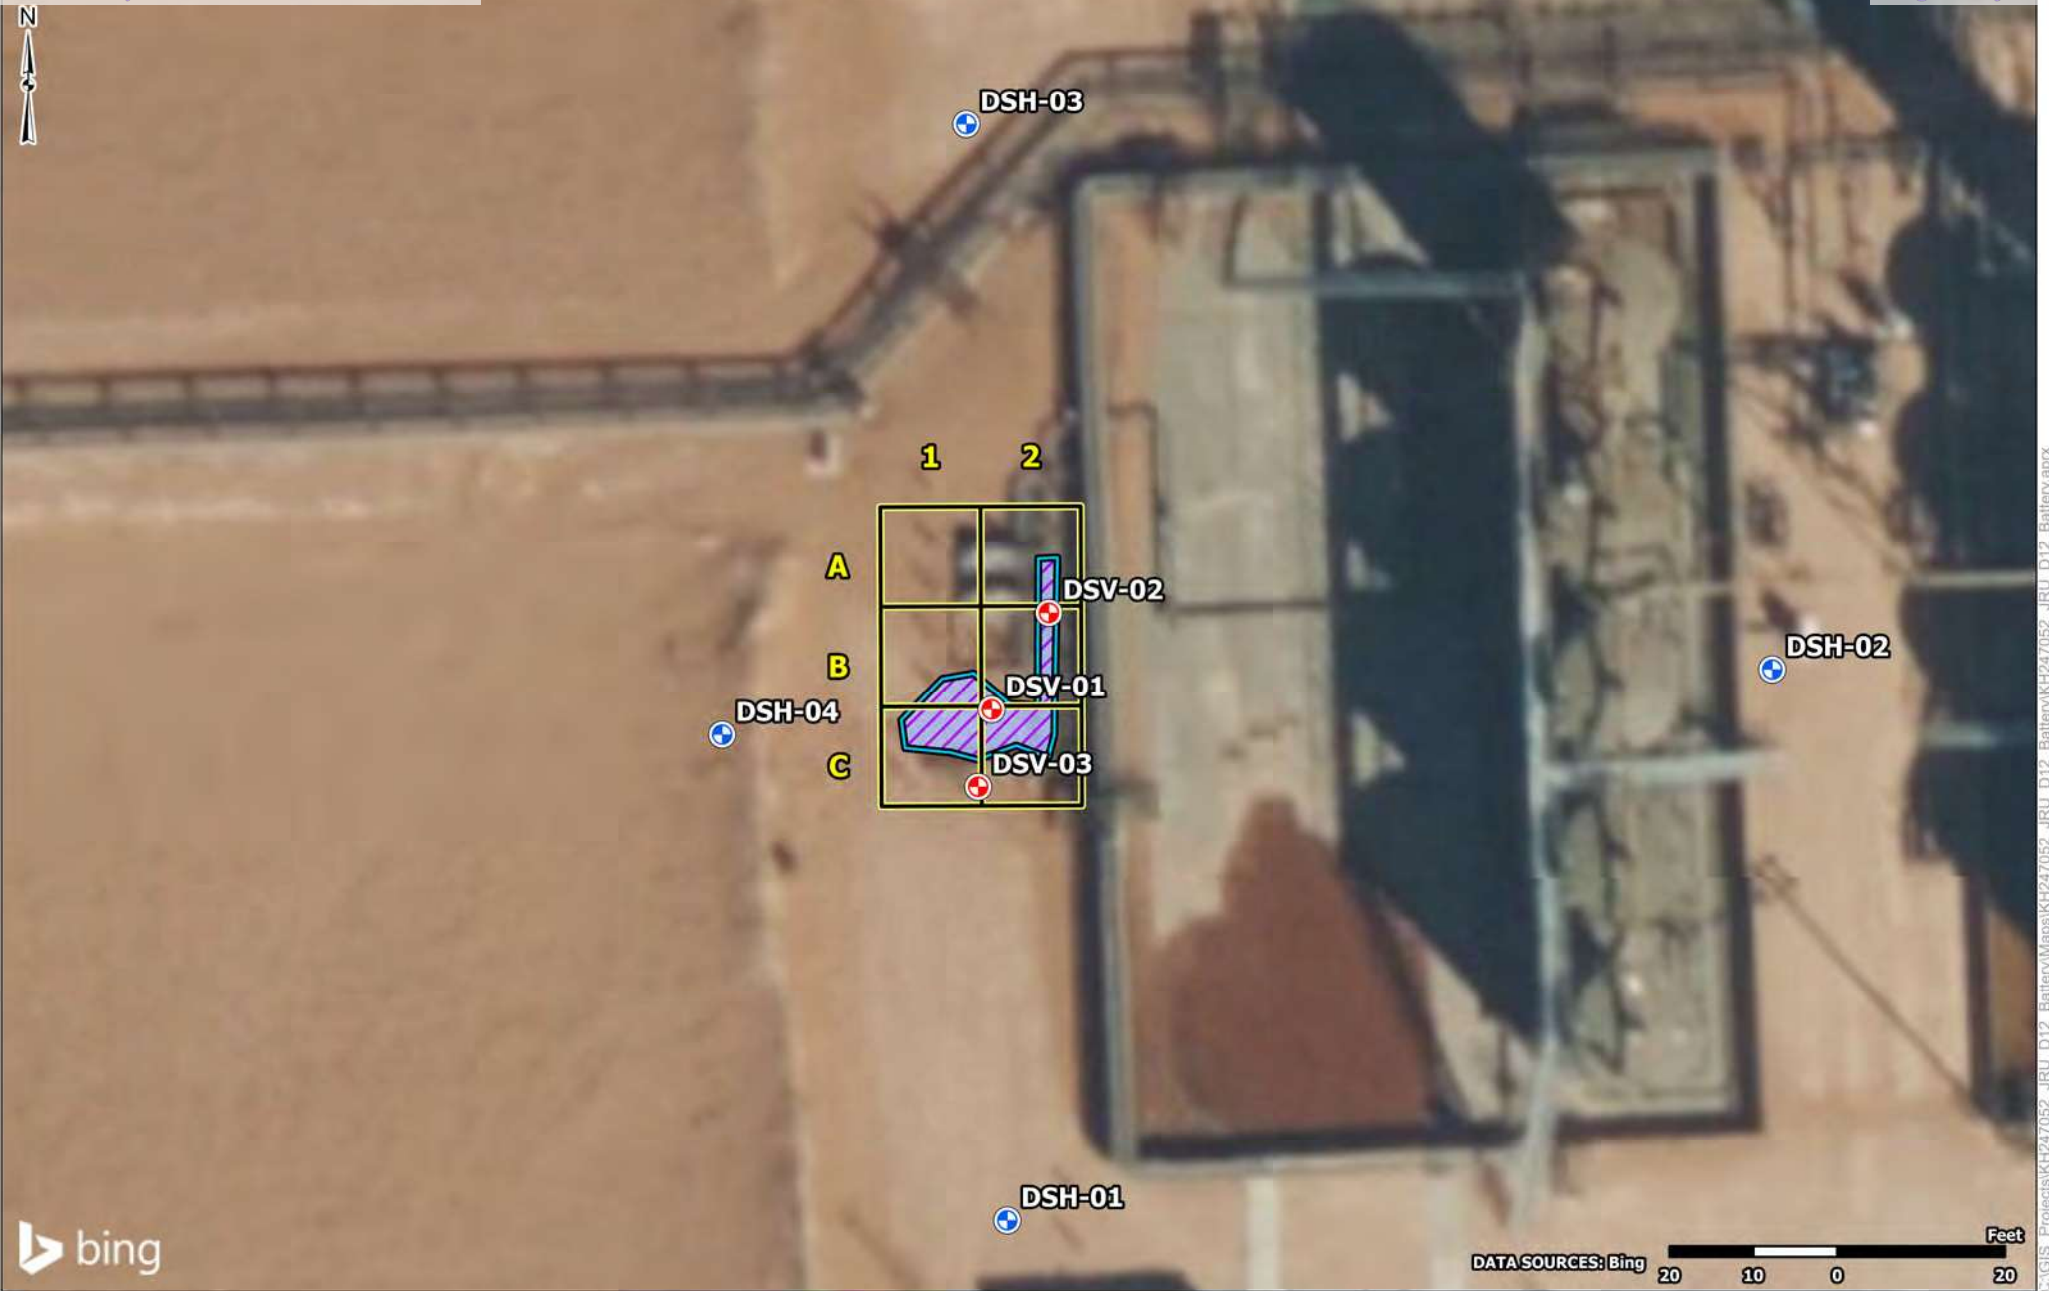
Areas exhibiting visual impact were excavated to a depth of between 0.0 feet to 0.5 feet bgs. A total of 5 five-point composite confirmation soil samples were collected on June 19, 2025, and submitted for analysis of BTEX, chloride, and TPH. All confirmation samples yielded results below the applicable NMOCD closure criteria. A total of approximately 3 cubic yards (cu. yds.) of surficial stained soils were excavated during remedial activities. Photographs of the project site are included in Appendix C. The analytical reports and Chain of Custody (COC) are included in Appendix D.

- 200 Sq Ft Grid
- 0.5' Excavation Area
- Inferred Release (166 Sq. Ft.)
- Horizontal Delineation Sample
- Vertical Delineation Sample

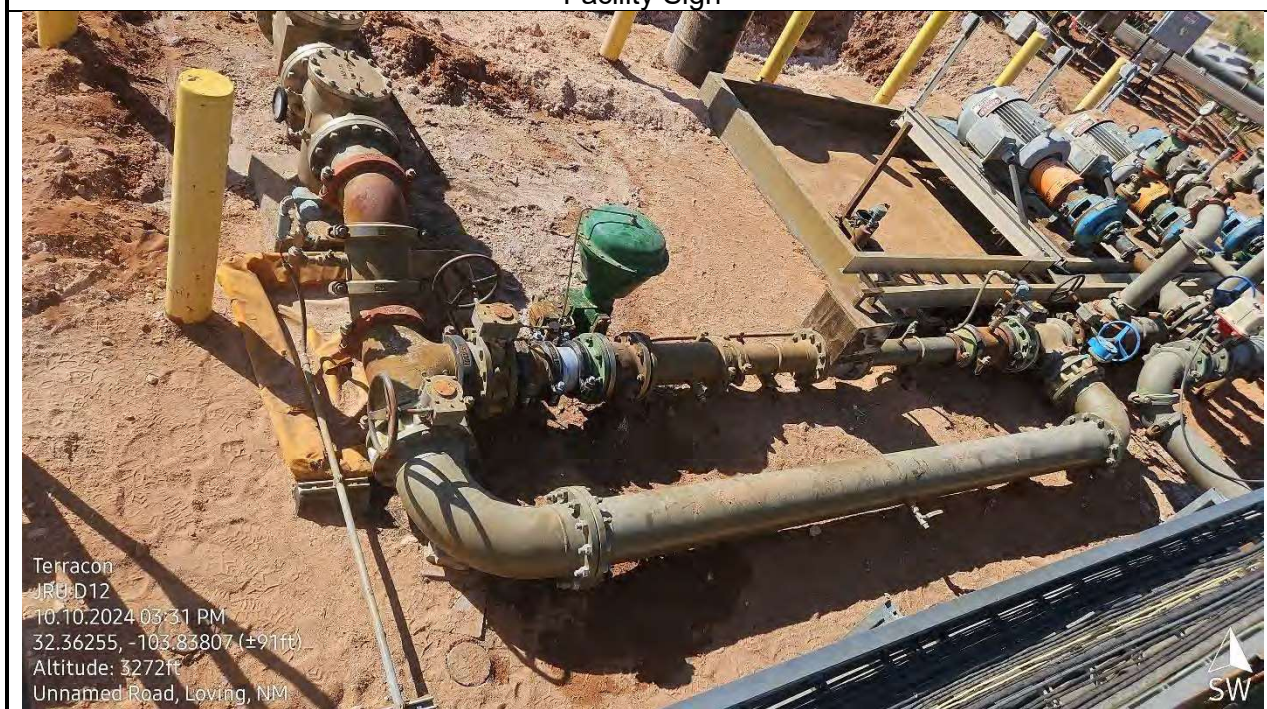
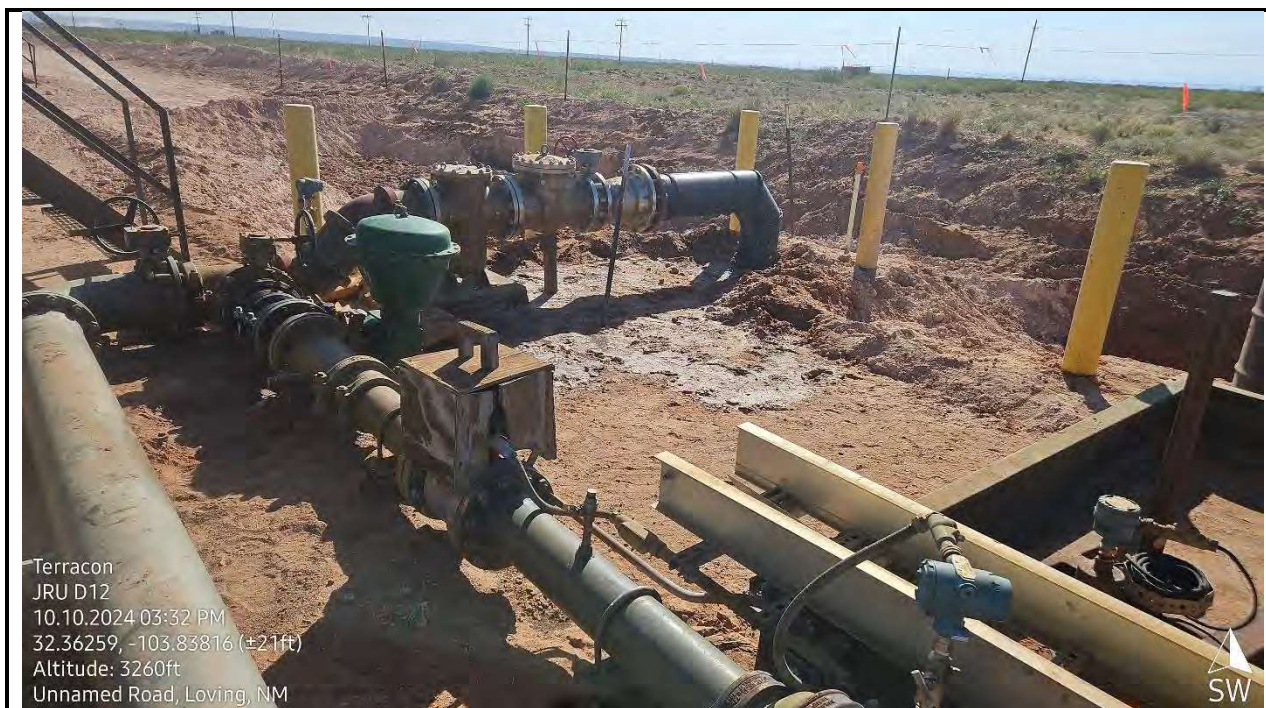
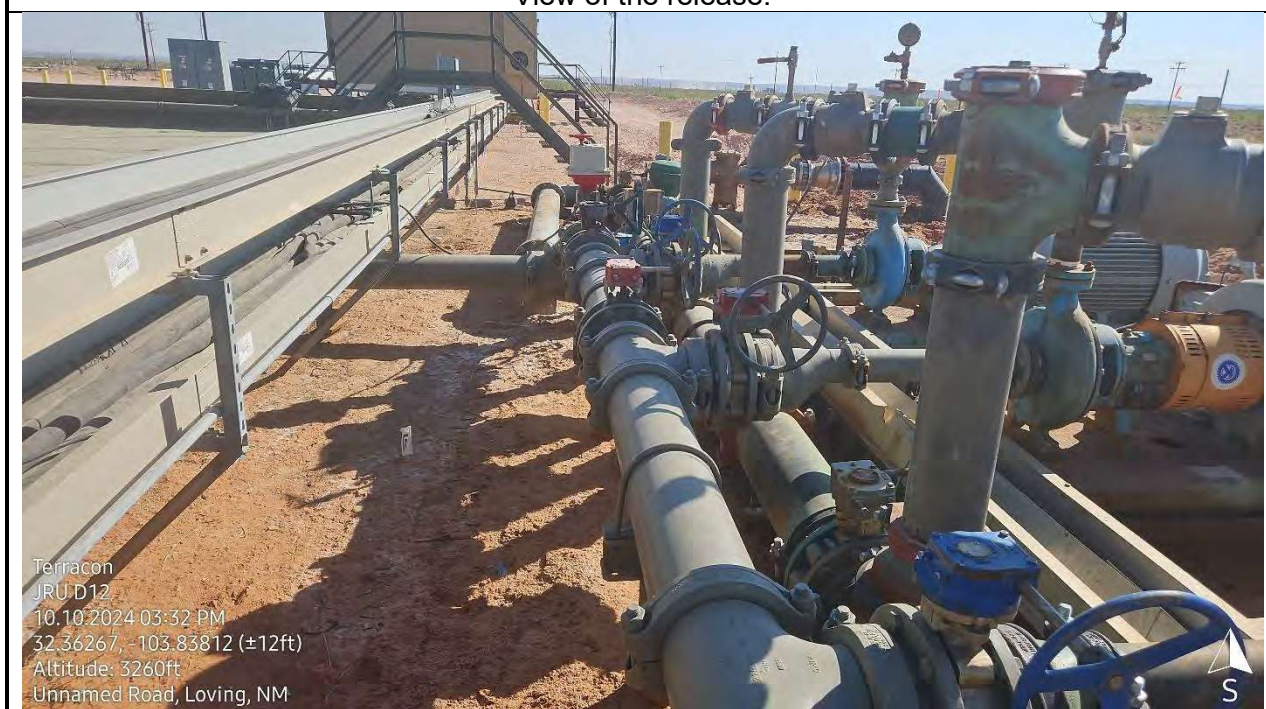
Released Product:	Produced Water		
Is the concentration of chloride in the produced water > 10,000 mg/L:	Yes		
Cause:	Corrosion		
Source:	Other (Specify)		
Release:	8	(bbls/Mcf)	
Recovered:	5	(bbls/Mcf)	
Additional Details:

View of the release.

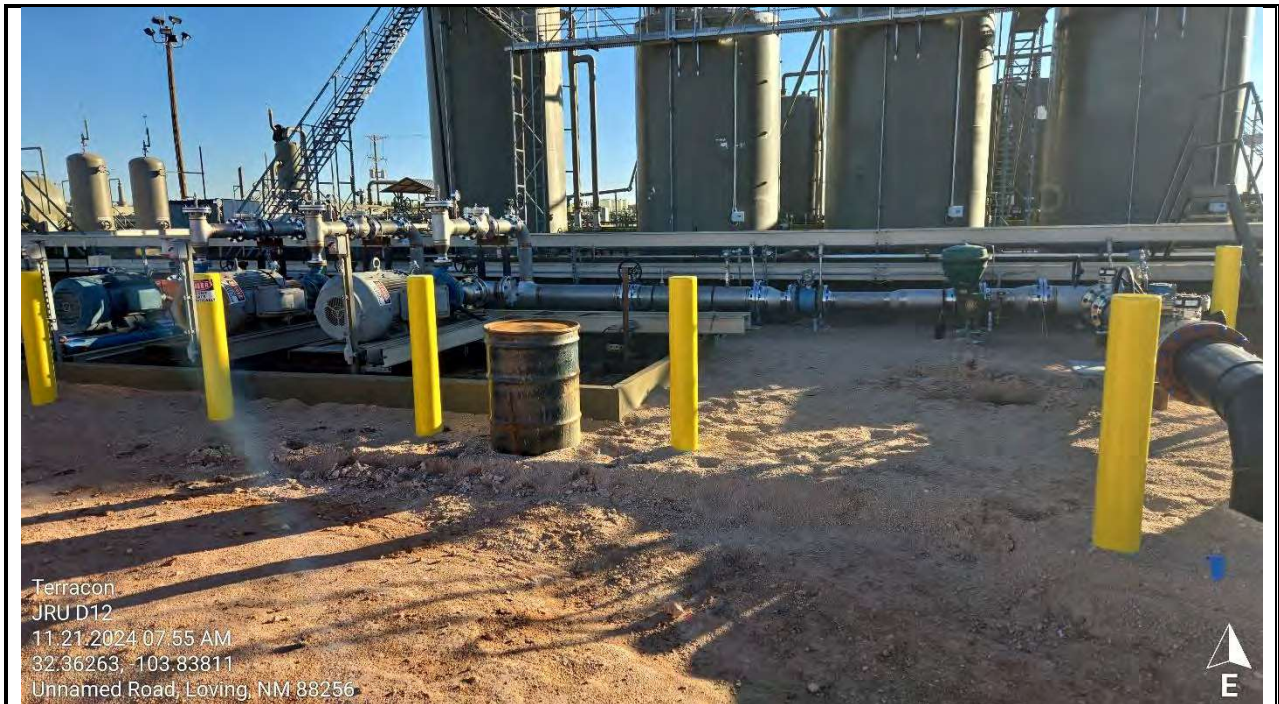
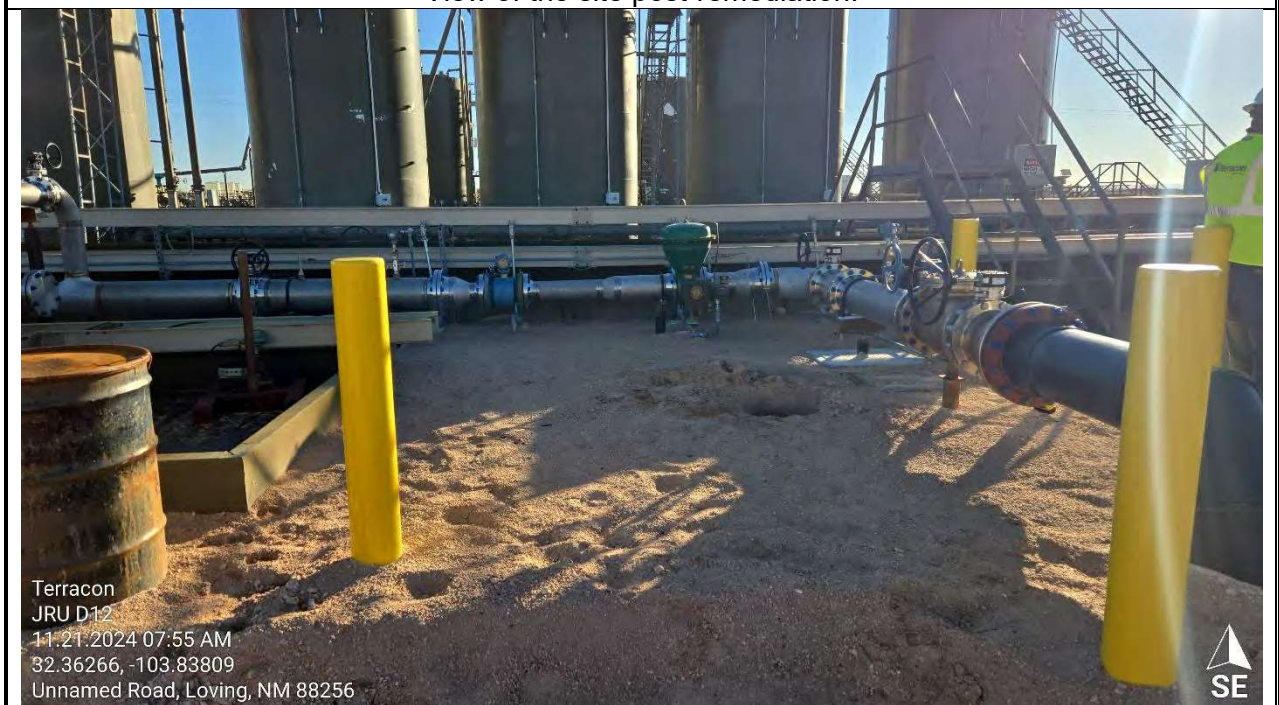
View of the site post-remediation.
