**Re: Closure Request  
Peach Booster Station  
Incident Number nAPP2504351069  
Lea County, New Mexico**

Matador Production Company  
Peach Booster Station  
Closure Request

**Photographic Log**  
Matador Production Company  
Peach Booster Station  
nAPP2504351069

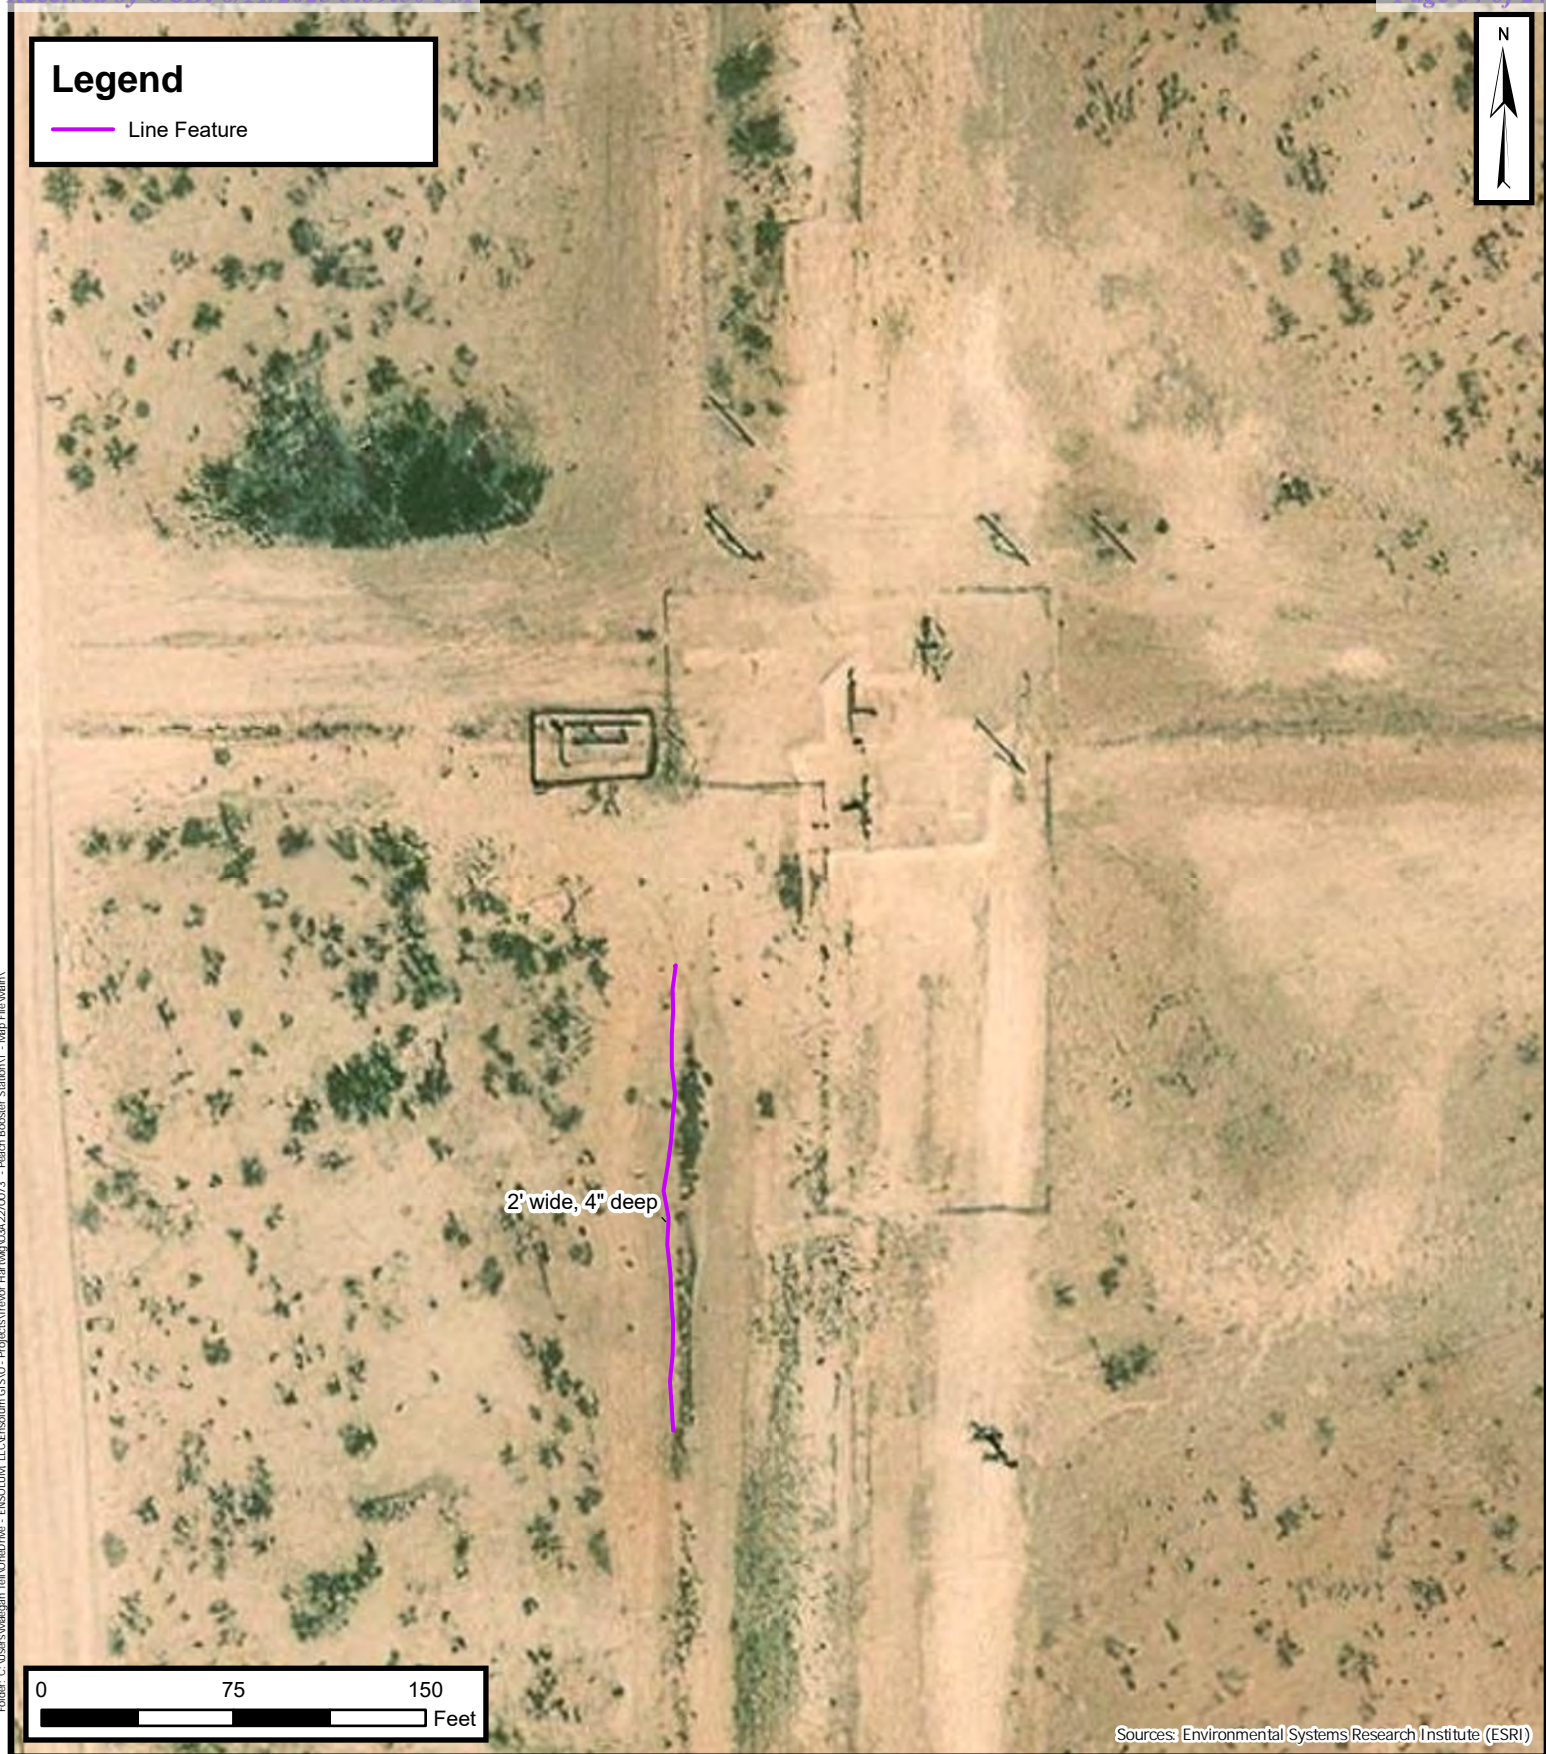
FIGURE  
6

On April 29, 2025, Ensolum performed the wetland and WOTUS delineation at the site using the methodology described in Section 3.0. The findings of the delineation are shown on **Figure 6** in **Appendix A**. GIS data was collected to determine the approximate size of each aquatic resource. Site photographs, included in **Appendix D**, provide an indication of the physical characteristics during the delineation. Description of the aquatic resource features observed on site are provided in the following sections:

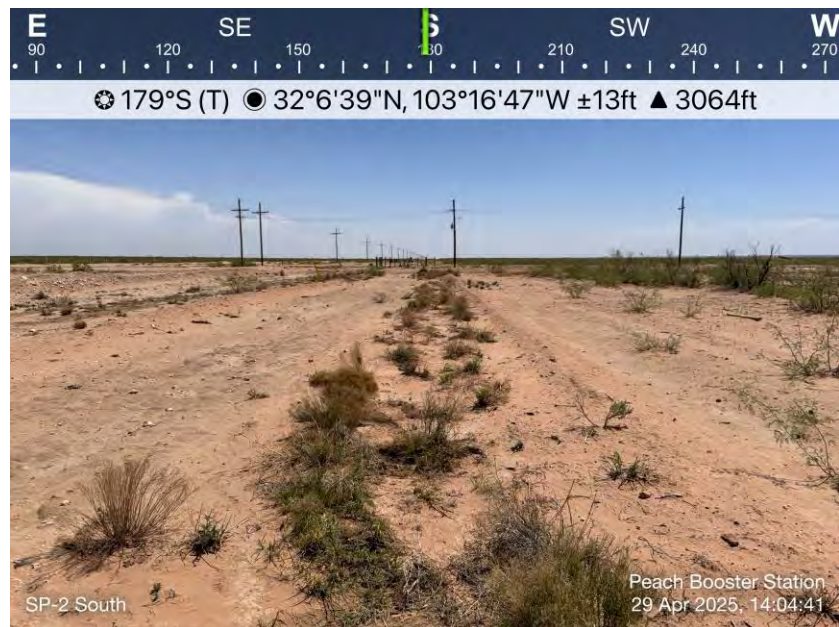
**Photograph No. 6**

**Photo Description:**  
Overview of SP-2 location  
within the survey area.

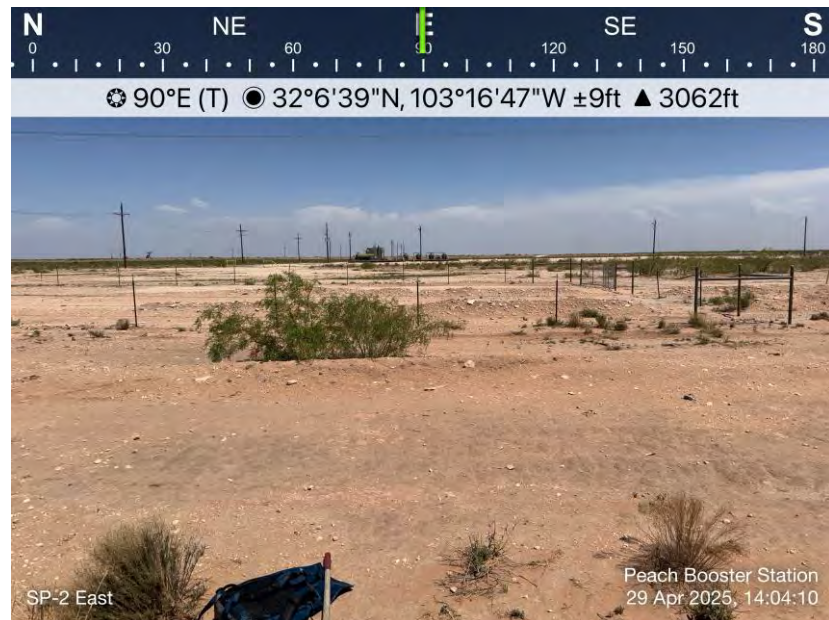
**Photograph No. 7**

**Photo Direction:**  
East

**Photo Description:**  
Overview of SP-2 location  
within the survey area.

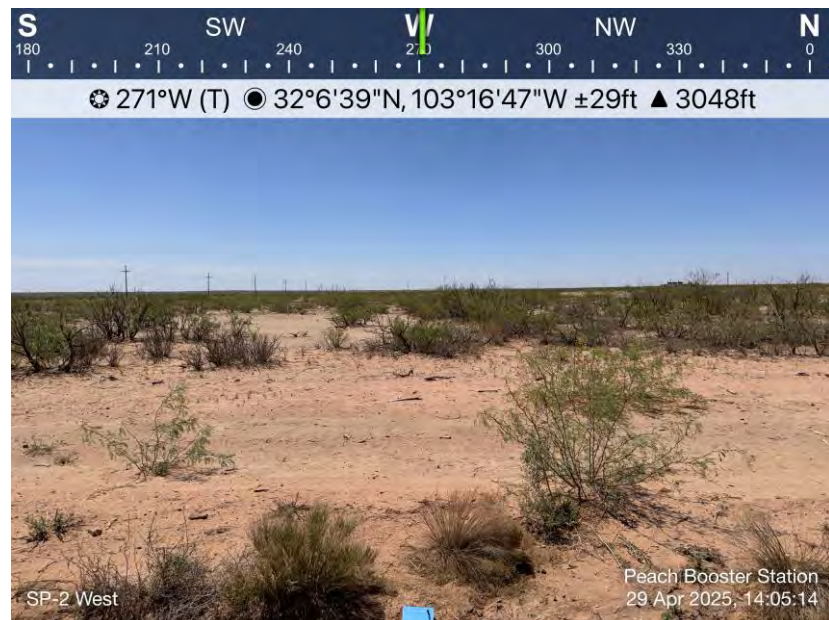
**Photograph No. 8**

**Photo Direction:**  
West

**Photo Description:**  
Overview of SP-2 location  
within the survey area.

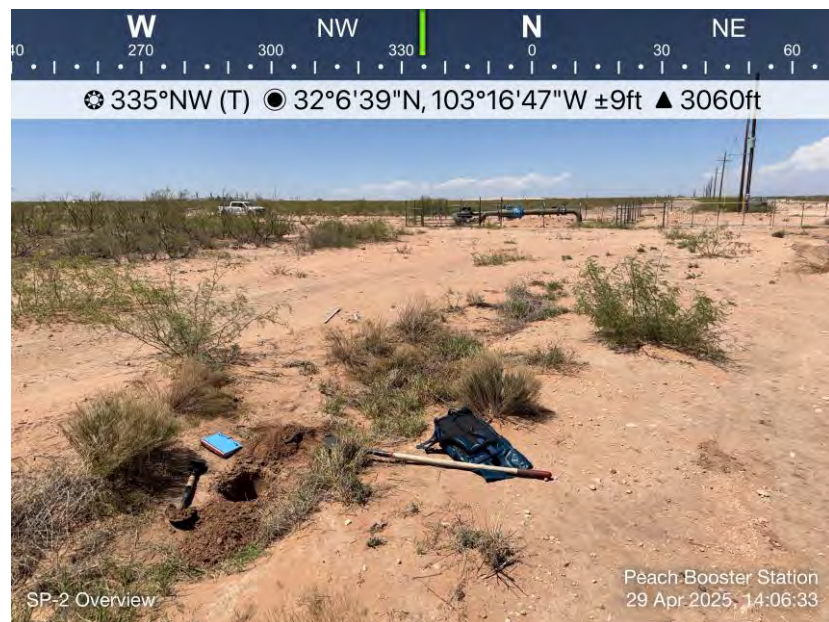
**Photograph No. 9**

**Photo Direction:**  
Northwest

**Photo Description:**  
Overview of SP-2 location  
within the survey area.

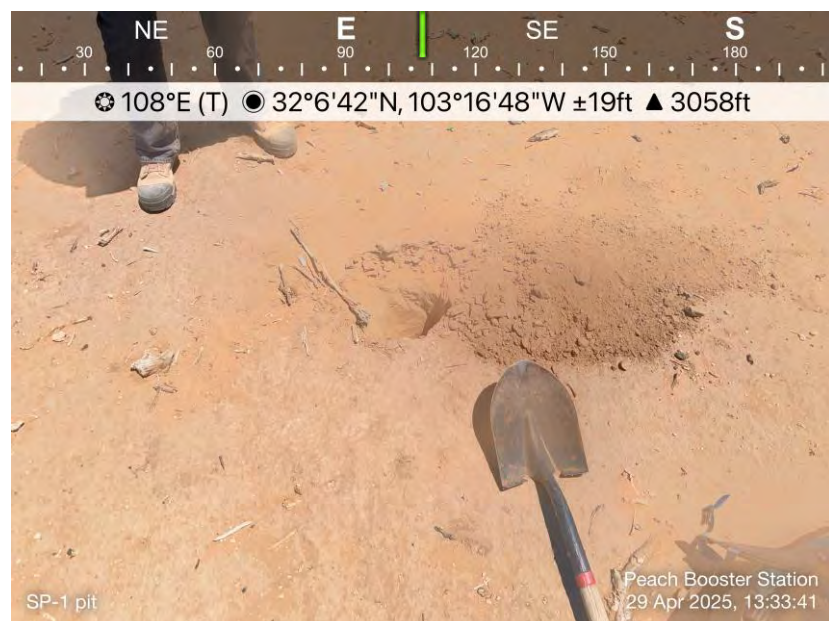
**Photograph No. 10**

**Photo Description:**  
View of soil profile for SP-1.

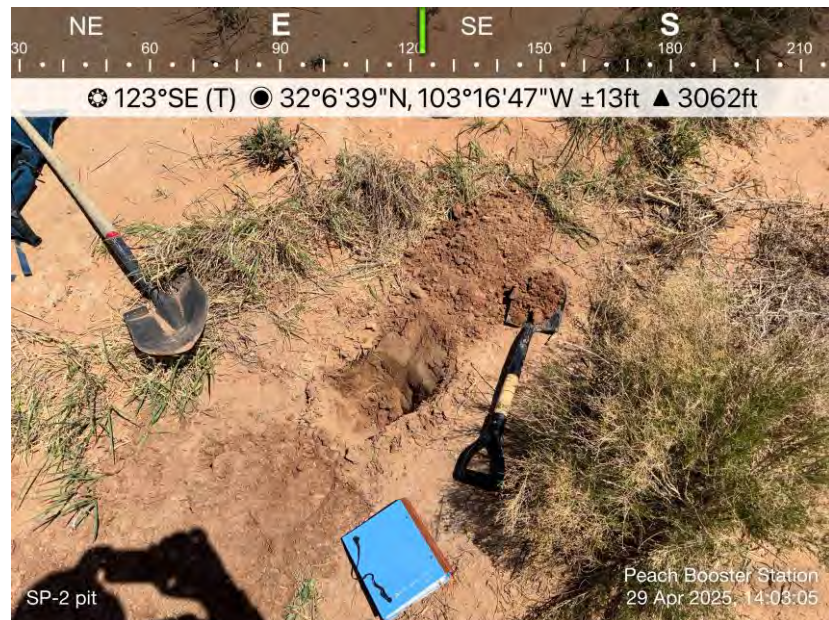
**Photograph No. 11**

**Photo Description:**  
View of soil profile SP-2.

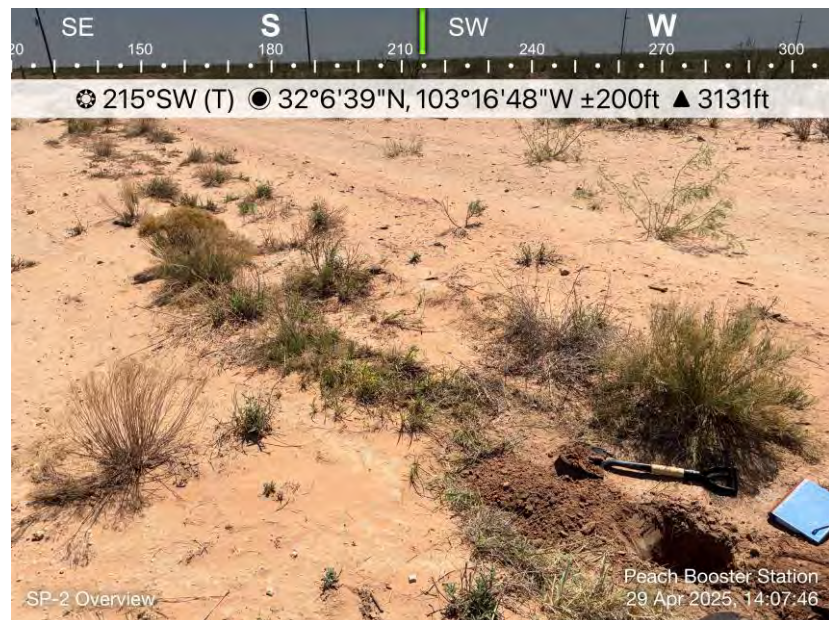
**Photograph No. 12**

**Photo Description:**  
View of small drainage feature found at SP-2.

Remarks:  
There was visible signs of soil cracks and there is evidence of a drainage pattern from precipitation events

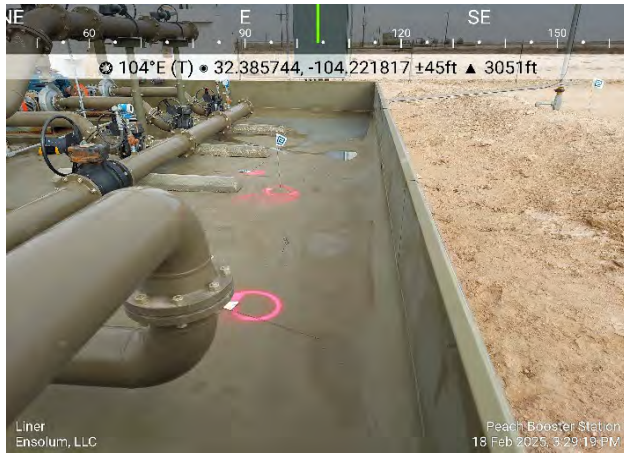
Photograph 1 Date: 2/18/2025  
Description: Liner Inspection (Surface Flaws)  
View: East

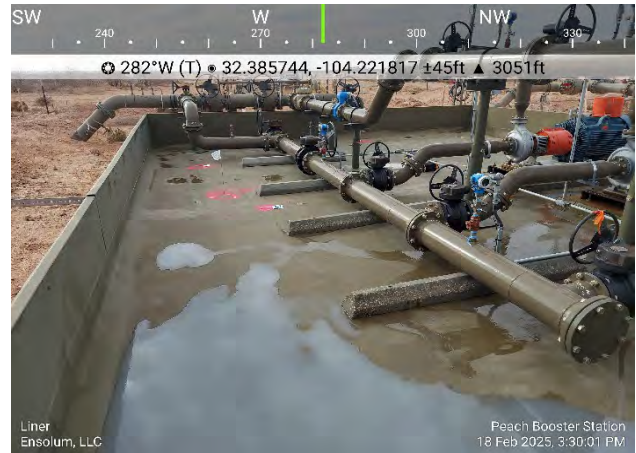
Photograph 2 Date: 2/18/2025  
Description: Liner Inspection (Surface Flaws)  
View: West

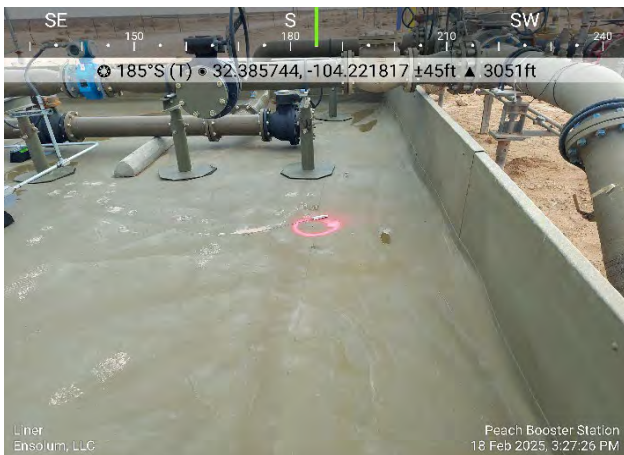
Photograph 3 Date: 2/18/2025  
Description: Liner Inspection (Surface Flaw)  
View: South

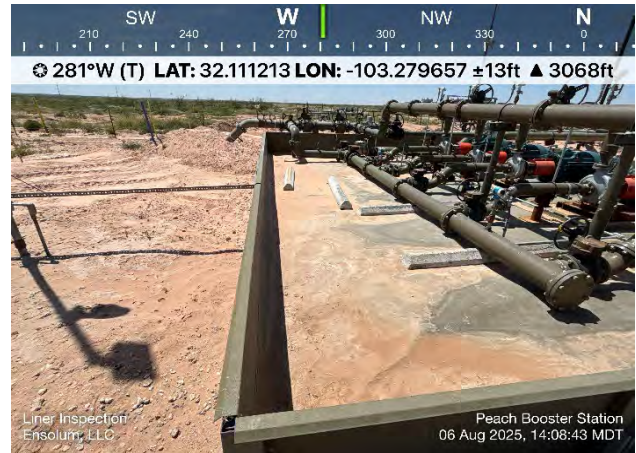
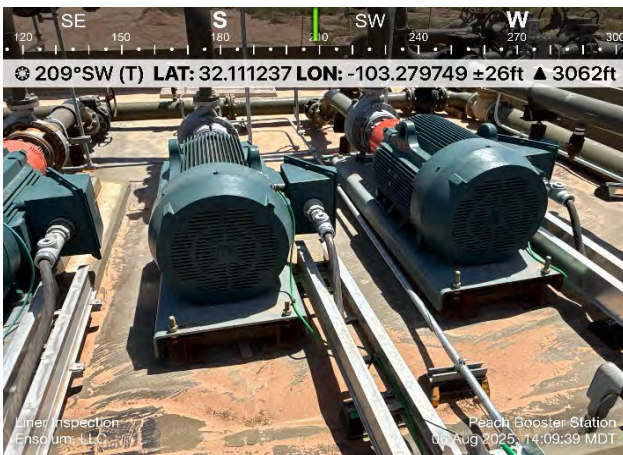
evident based on equipment located in the photographs taken they are of the correct Site and photographs 5 through 8 on the photographic log were re-taken from the same locations on August 6, 2025, with the correct coordinates to compare the original photos and corroborate the correct location, which are included in Appendix C.

Photograph 5 Date: 2/18/2025  
Description: Photo Retake (Correct GPS)  
View: East

Photograph 6 Date: 2/18/2025  
Description: Photo Retake (Correct GPS)  
View: West

Photograph 7 Date: 2/18/2025  
Description: Photo Retake (Correct GPS)  
View: South

Photograph 8 Date: 2/18/2025  
Description: Photo Retake (Correct GPS)  
View: East

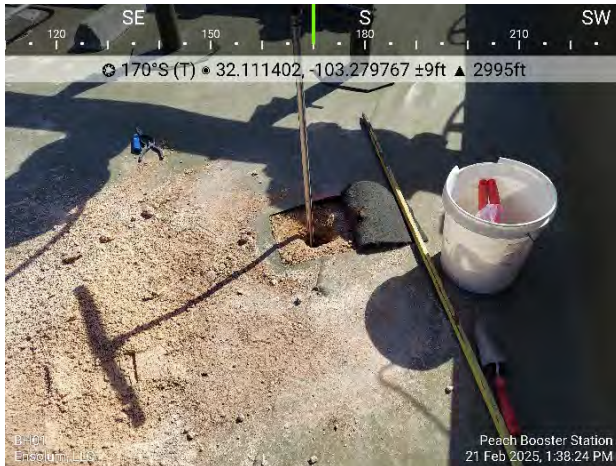
Photograph 13  
Description: BH01  
View: South

There was only one patch in the tank battery, right? Perhaps if you could send some additional photos of the seam? In photos 13 and 14 you can see the seam but not in 15.

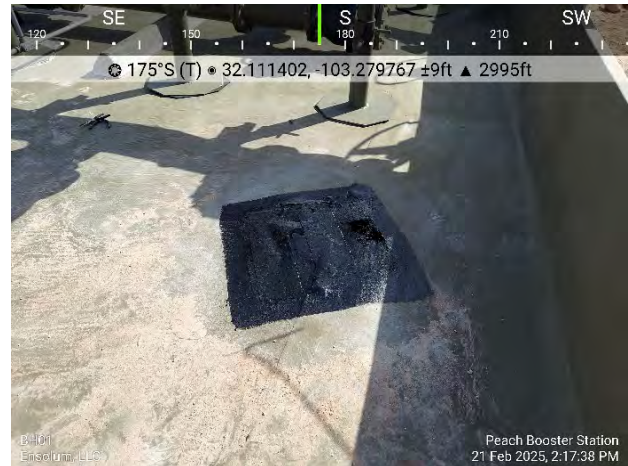
Photograph 14  
Description: BH01  
View: South

Replace Later

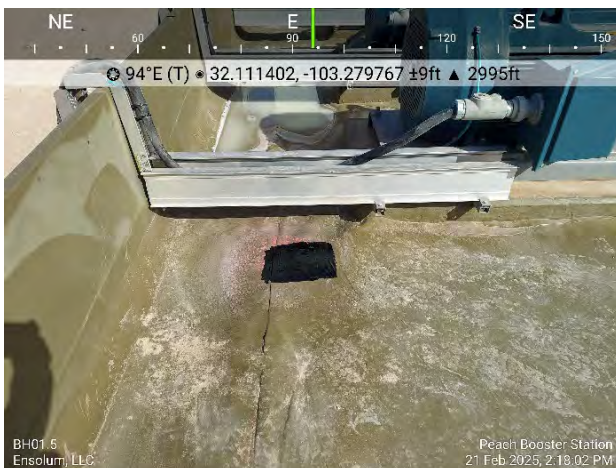
Photograph 15  
Description: BH01  
View: East

I am reviewing the submitted remediation closure report for the following release NAPP2504351069 PEACH BOOSTER STATION and noticed in Photograph 15, where BH01 was patched is a crack in the liner with a caption "Replace later." Do you know if this has been done or when this is going to be done? I look forward to hearing back from you on this.

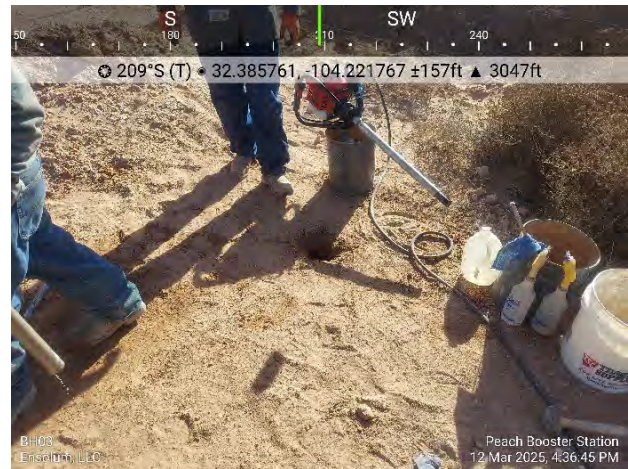
Photograph 18 Date: 3/12/2025  
Description: BH03  
View: Southwest

Replace Later

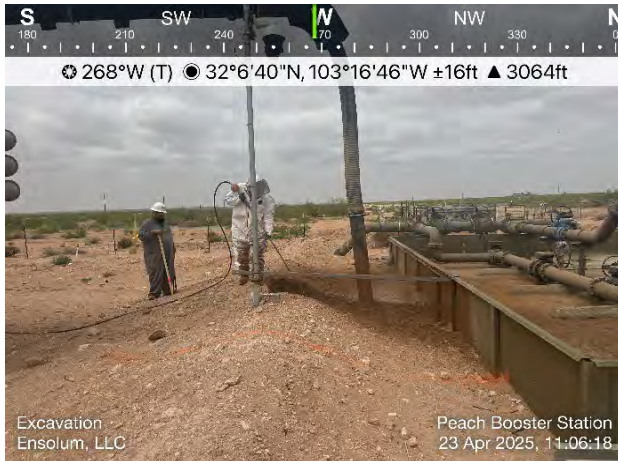
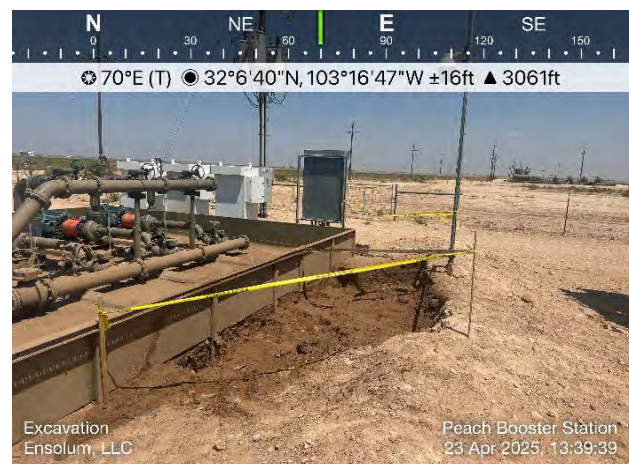
Photograph 21  
Description: Excavation  
View: West

Photograph 22  
Description: Excavation  
View: East

Photograph 23  
Description: Excavation  
View: West

Photograph 24  
Description: Excavation  
View: Northeast

Excavation of impacted and waste-containing soil has mitigated adverse conditions at this Site. Depth to groundwater is 82 feet bgs and no other sensitive receptors were identified near the release extent. Matador believes these remedial actions are protective of human health, the environment, and groundwater. As such, Matador respectfully requests closure for Incident Number nAPP2504351069.

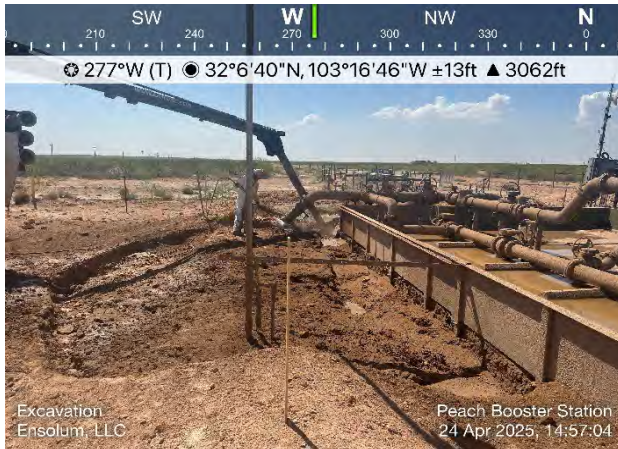
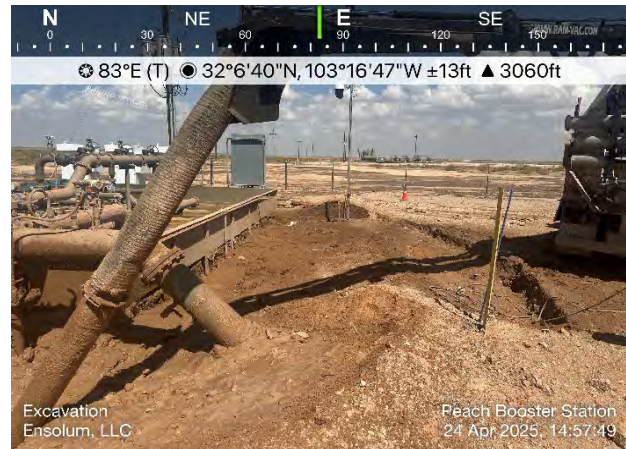
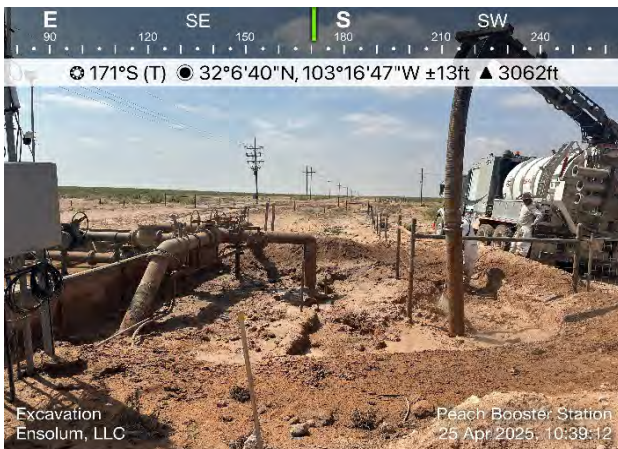
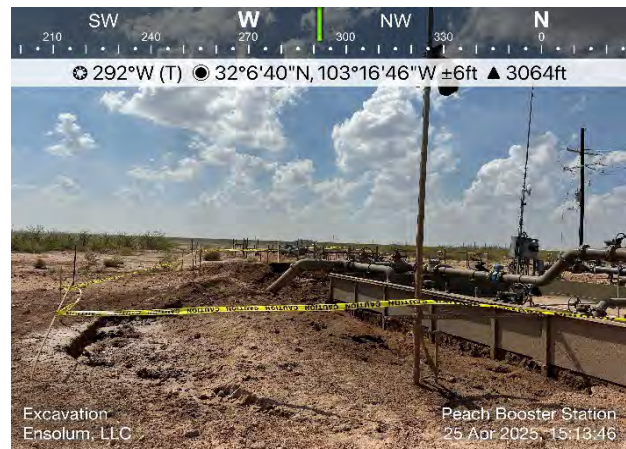
Photograph 25  
Description: Excavation  
View: West

Photograph 26  
Description: Excavation  
View: East

Photograph 27  
Description: Excavation  
View: South

Photograph 28  
Description: Excavation  
View: West
