NM-35 LINE LEAK

Remediation Summary & Closure Report

NMOCD Incident No. nAPP2413552773

Lea County, New Mexico

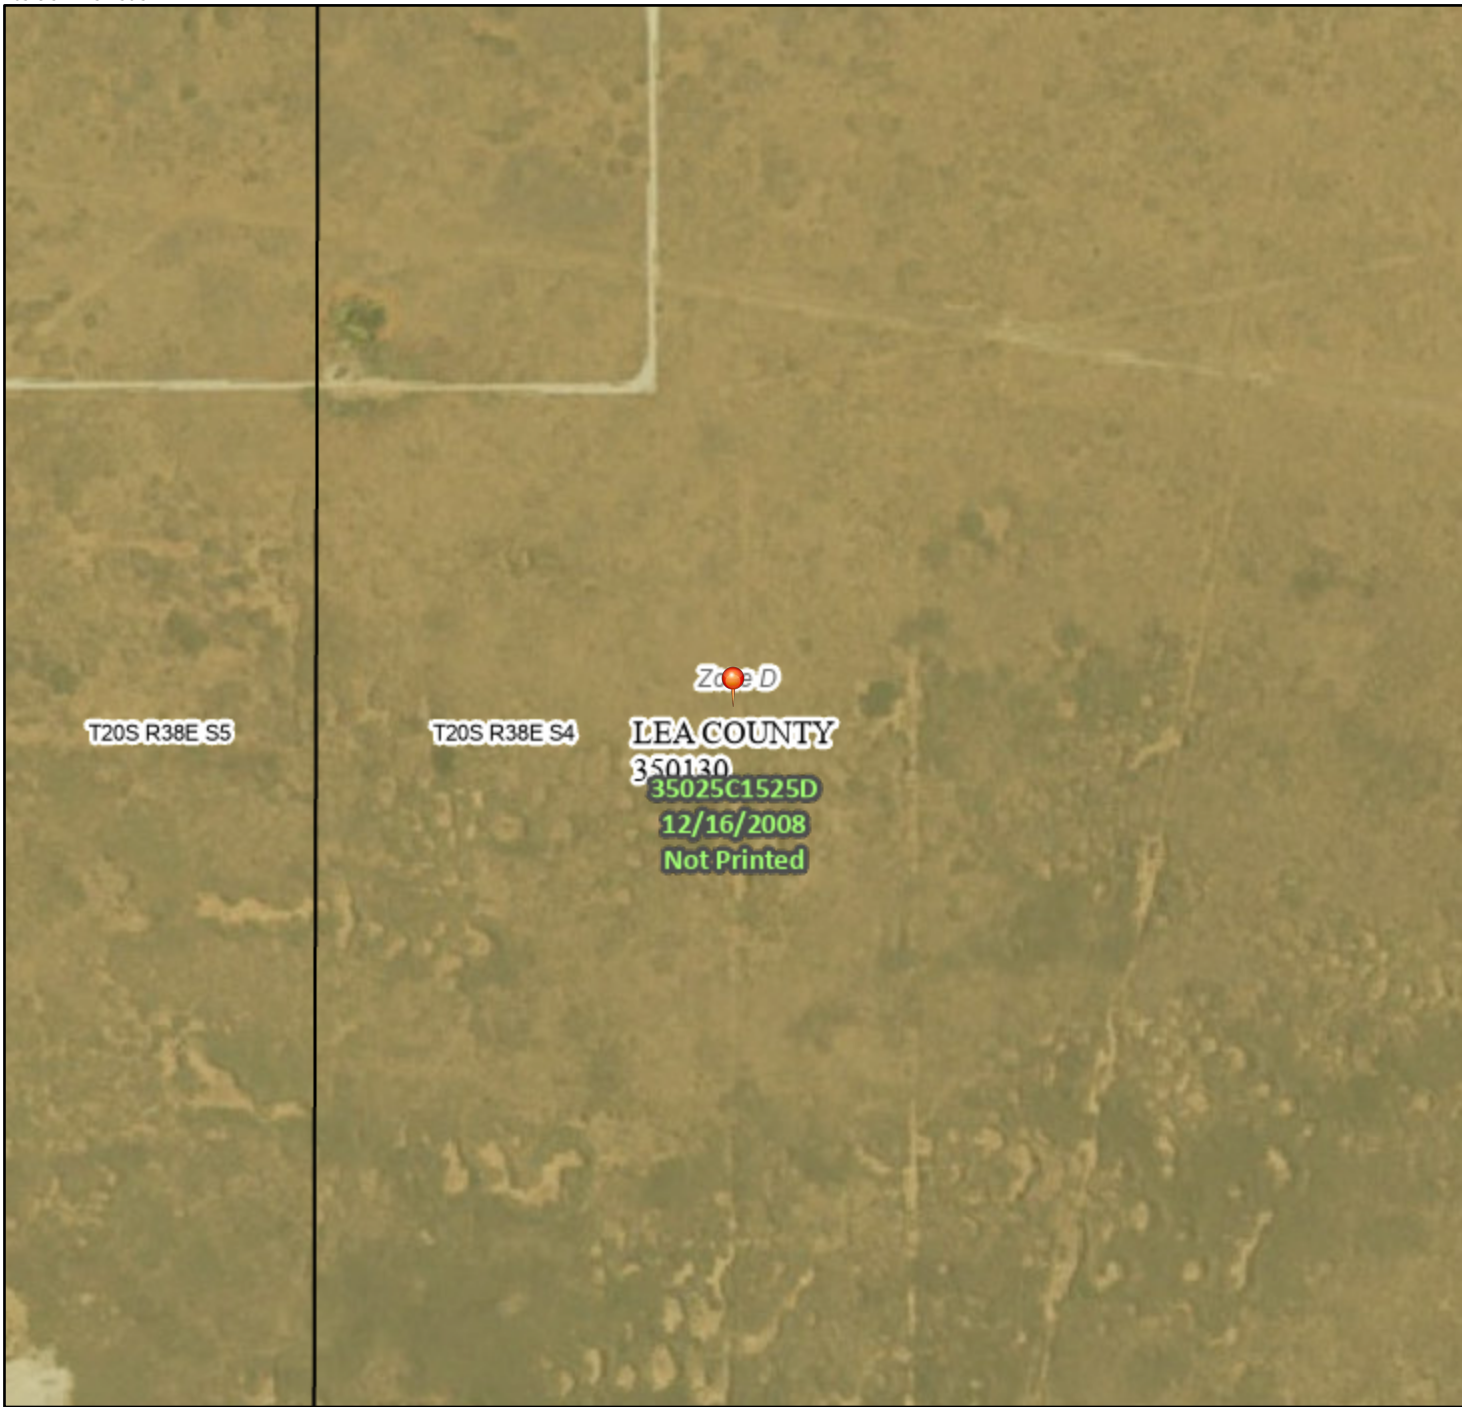
Figure 4

Review of flood map data published by the Federal Emergency Management Agency (FEMA) indicates the site is not located within a 100-year floodplain. A copy of the FEMA FIRMet Map can be found attached as Figure 4.

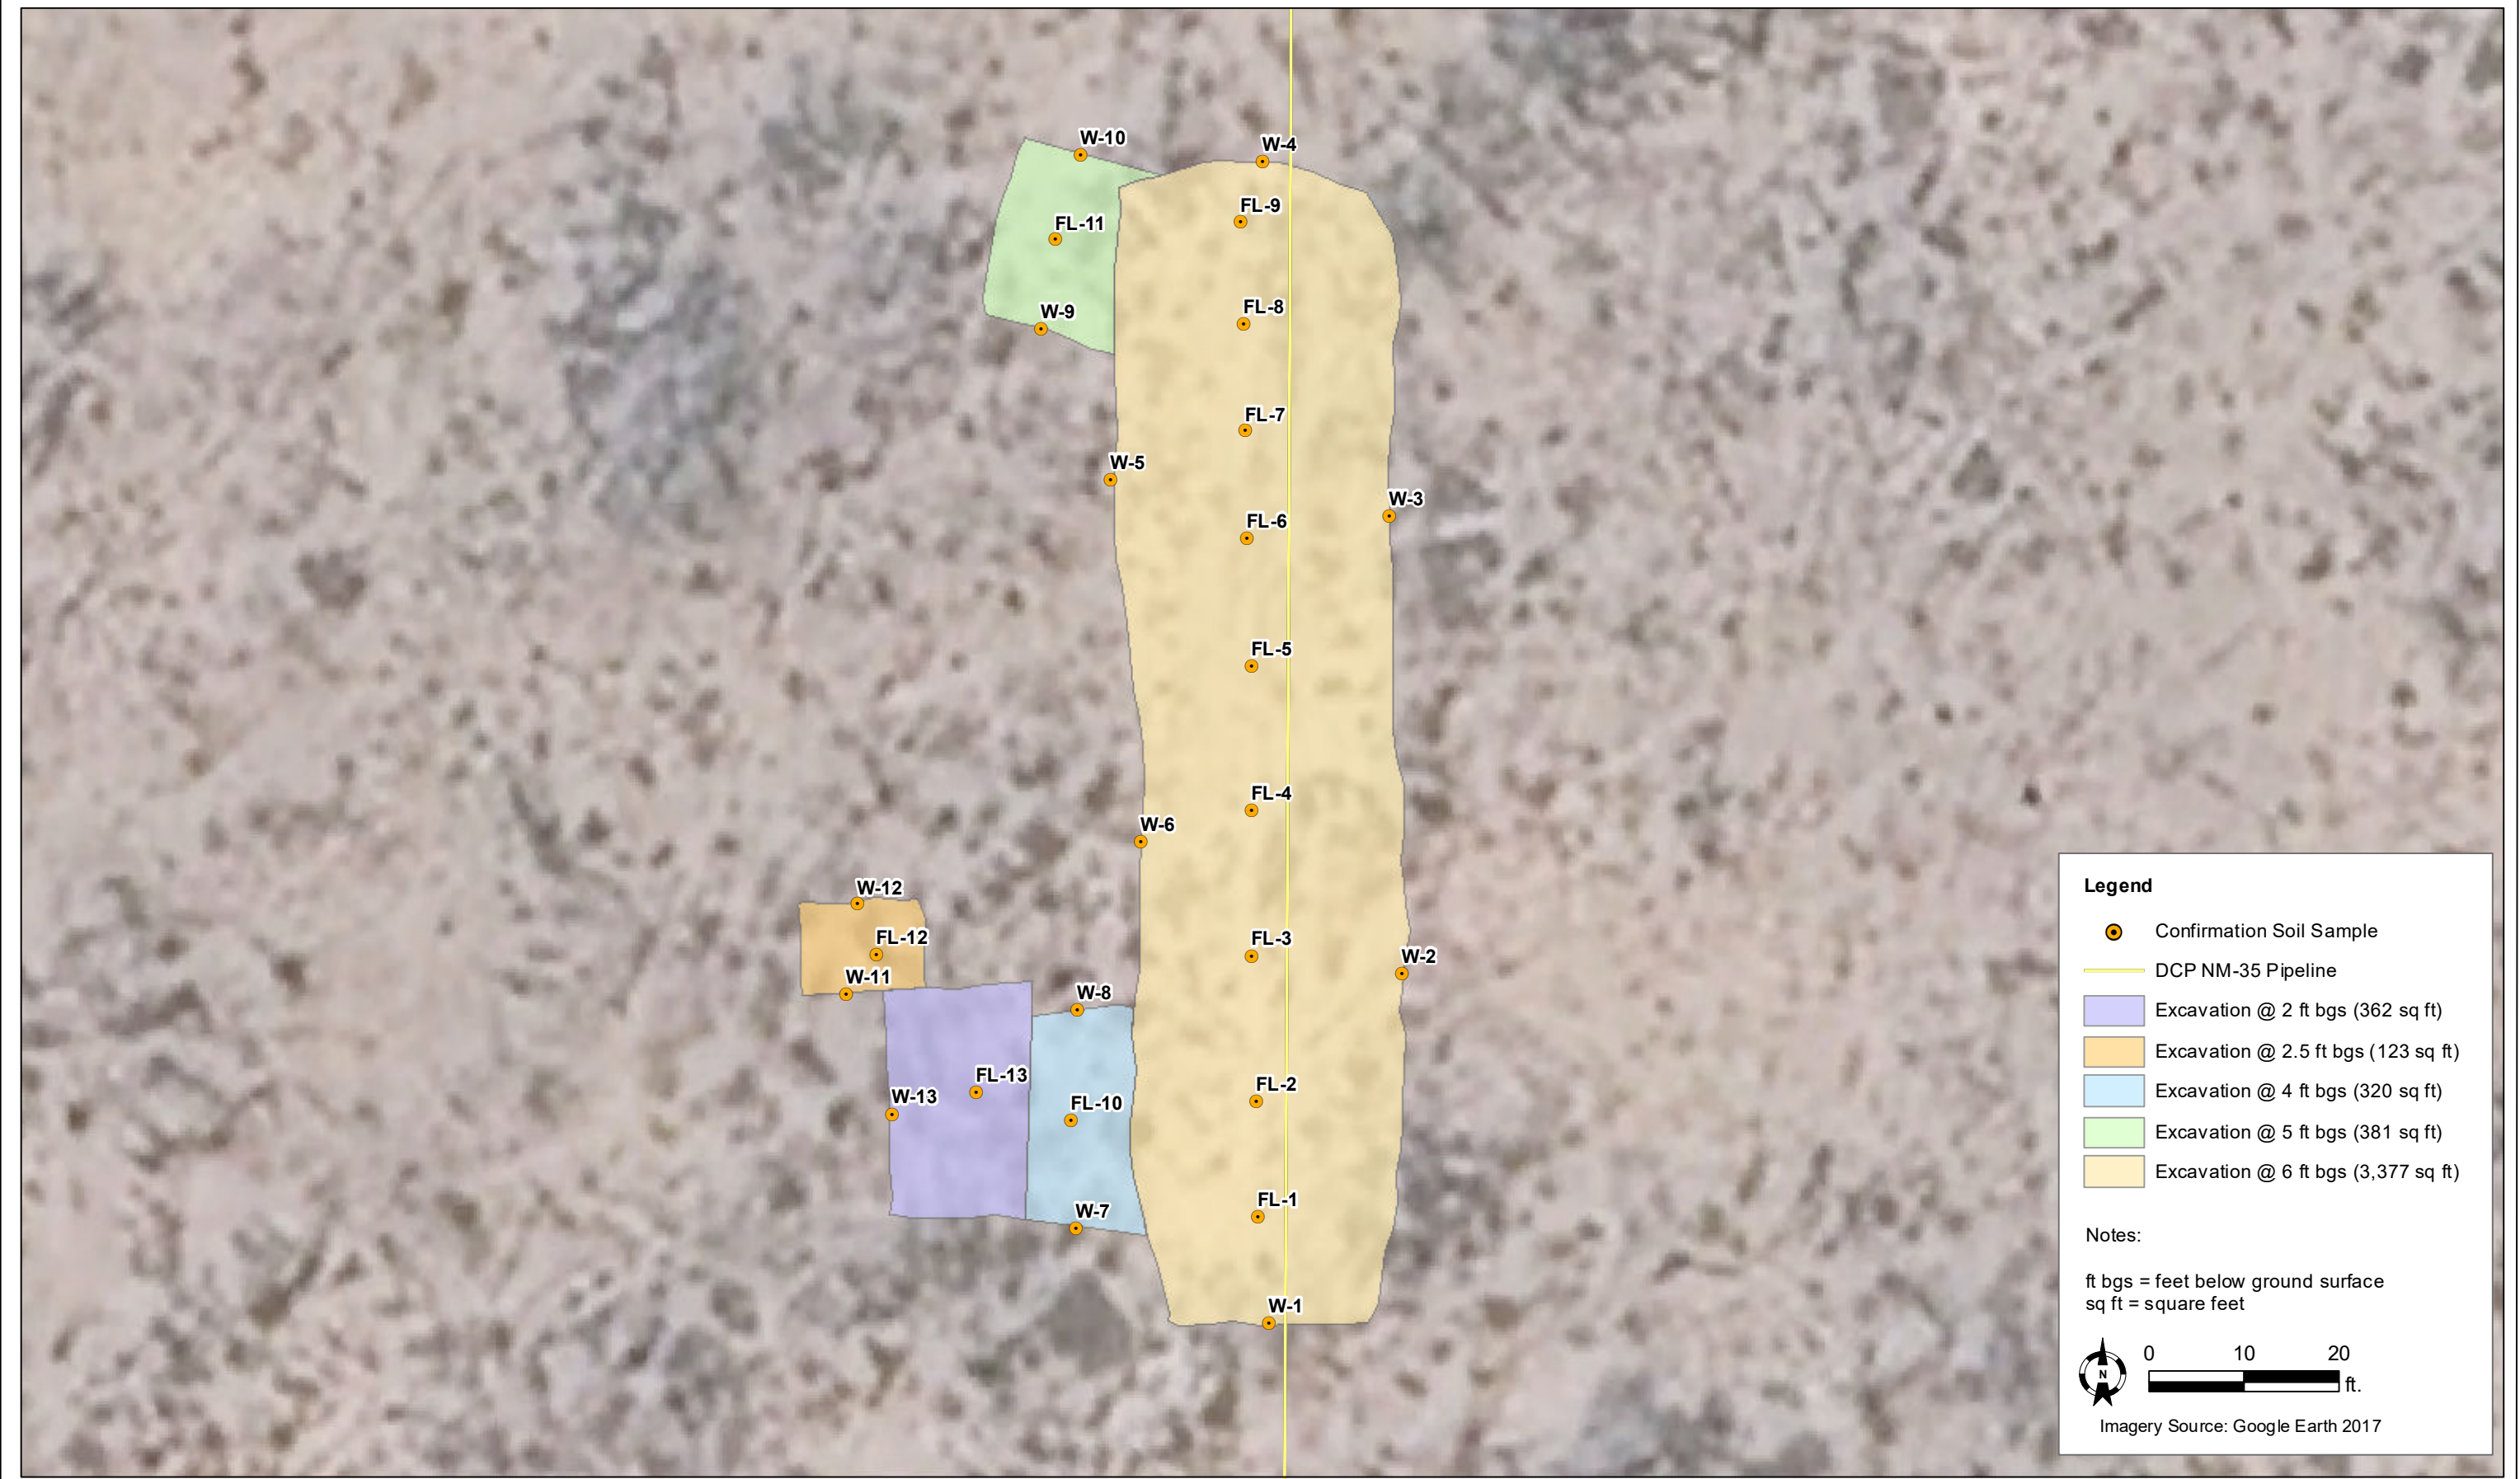
Tasman, Inc. 2620 W. Marland Blvd Hobbs, NM 88240	Phillips 66, LP NM 35 Line Leak - nAPP2413552773 UL "E", Sec. 4, T20S, R38E Lea County, New Mexico	Excavation Overview Map	Figure 5
DESIGNED BY: B. Martinez				
DRAWN BY: C. Flores

Tasman conducted initial assessment activities, identifying an approximately 3,377-square foot area that had been impacted by the release. Heavy equipment was used to remove approximately 324 cubic yards of impacted material from the release area. Based on laboratory analytical results from soil samples collected during confirmation sampling activities, impacted soil within the release area has been remediated below the applicable NMOCD Action Levels and in accordance with NMOCD standards. Additional project details are provided in the attached summary report.
