Incident Number: nAPP2431250006

## Release Assessment and Closure

Wolf AJA Federal Com #21H

Vertex File Number: 24E-04879

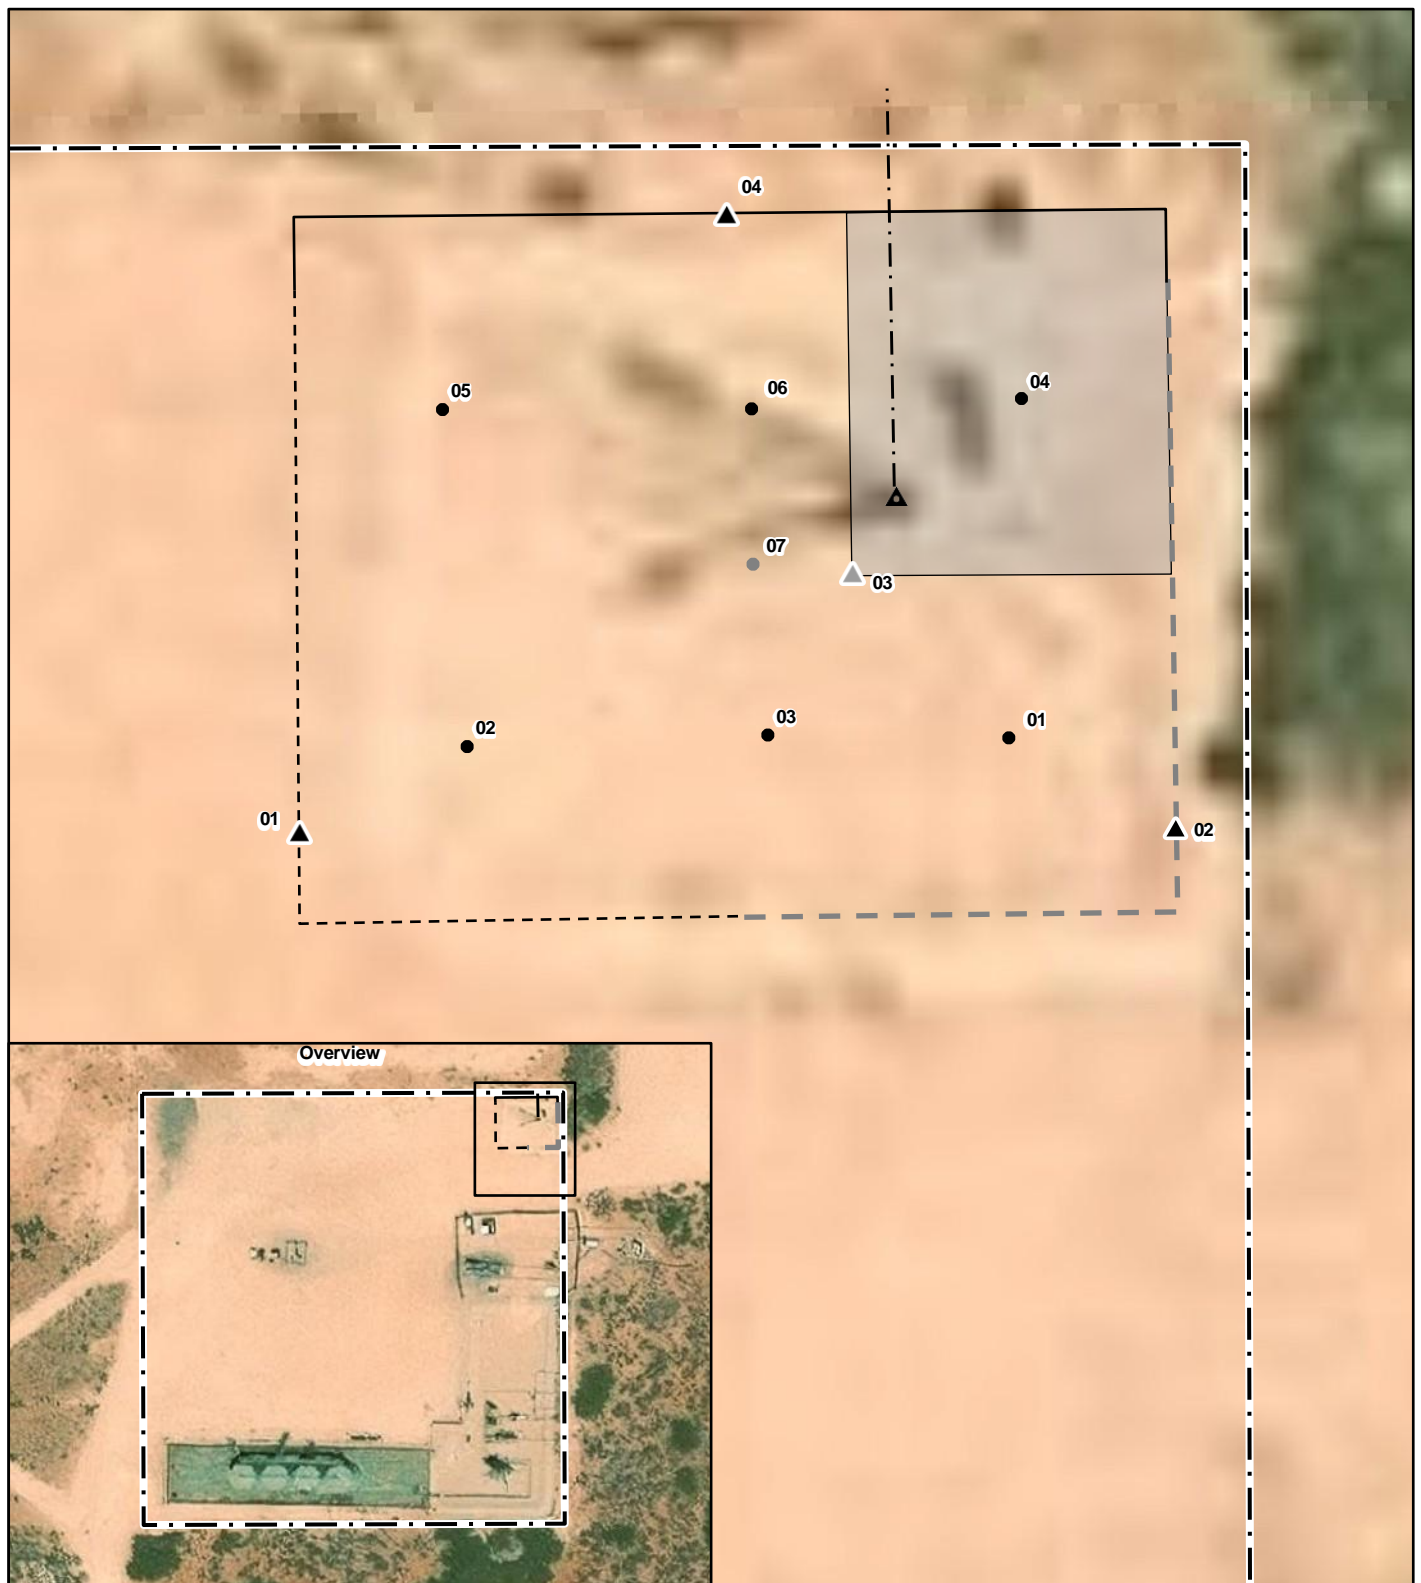
## **FIGURE**

0 2 4 8 ft  
NAD 1983 UTM Zone 13N  
Date: Dec 19/24  
Map Center:  
Lat: 32.432048°N,  
Long: 103.737498°W

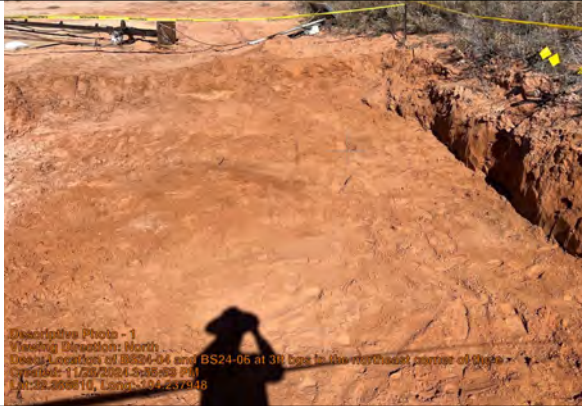
Viewing Direction: North

Location of BS24-04 and BS24-06 at 3ft bgs in the northeast corner of the excavation. WS24-01 was recollected at 0-3ft bgs.

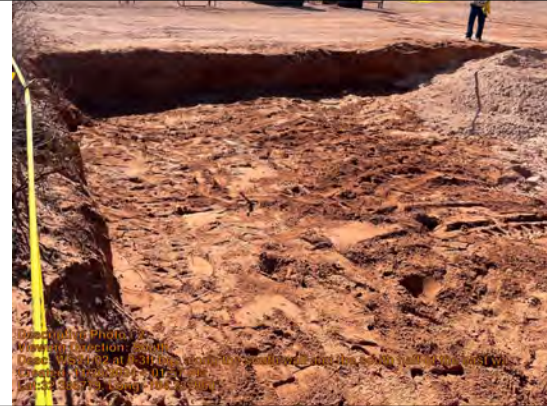
Viewing Direction: South

WS24-02 at 0-3ft bgs along the south wall and the south half of the east wall.

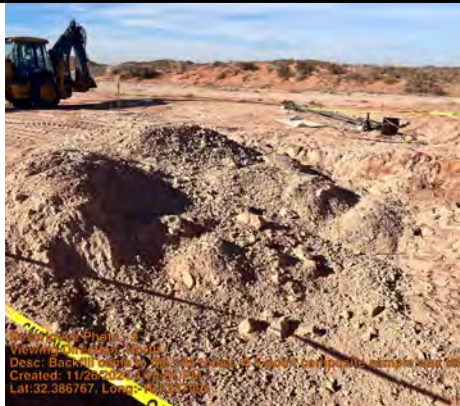
Viewing Direction: North

Backfill came to the site today. A 5-point composite sample was taken from the pile.

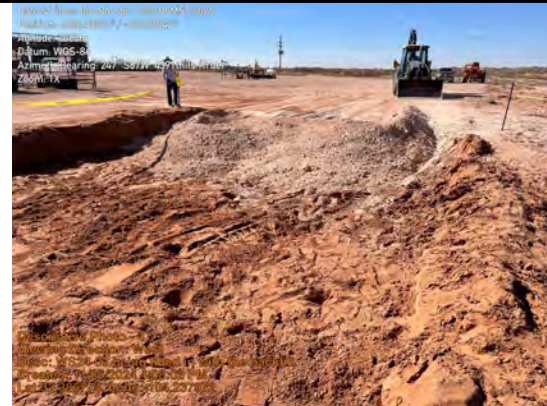
Viewing Direction: West

WS24-03 being filled in with the backfill.
