**Re: Site Assessment, Remediation, and Closure Request**  
**Bradley 8 Fee 3H**  
**API No. N/A**  
**GPS: Latitude 32.66839 Longitude -104.40284**  
**U/L "O," Sec. 08, T19S, R26E**  
**Eddy County, NM**  
**NMOCD Ref. No. nAPP2100543121**

Paragon Environmental LLC (Paragon) has been contracted by Spur Energy Partners (Spur) to perform a spill assessment and conduct remediation activities for the release site known as the Bradley 8 Fee 3H (Bradley). Details of the release are summarized below:

Bradley 8 Fee 3H  
API # 30-015-39812  
Eddy County, NM  
Site Map

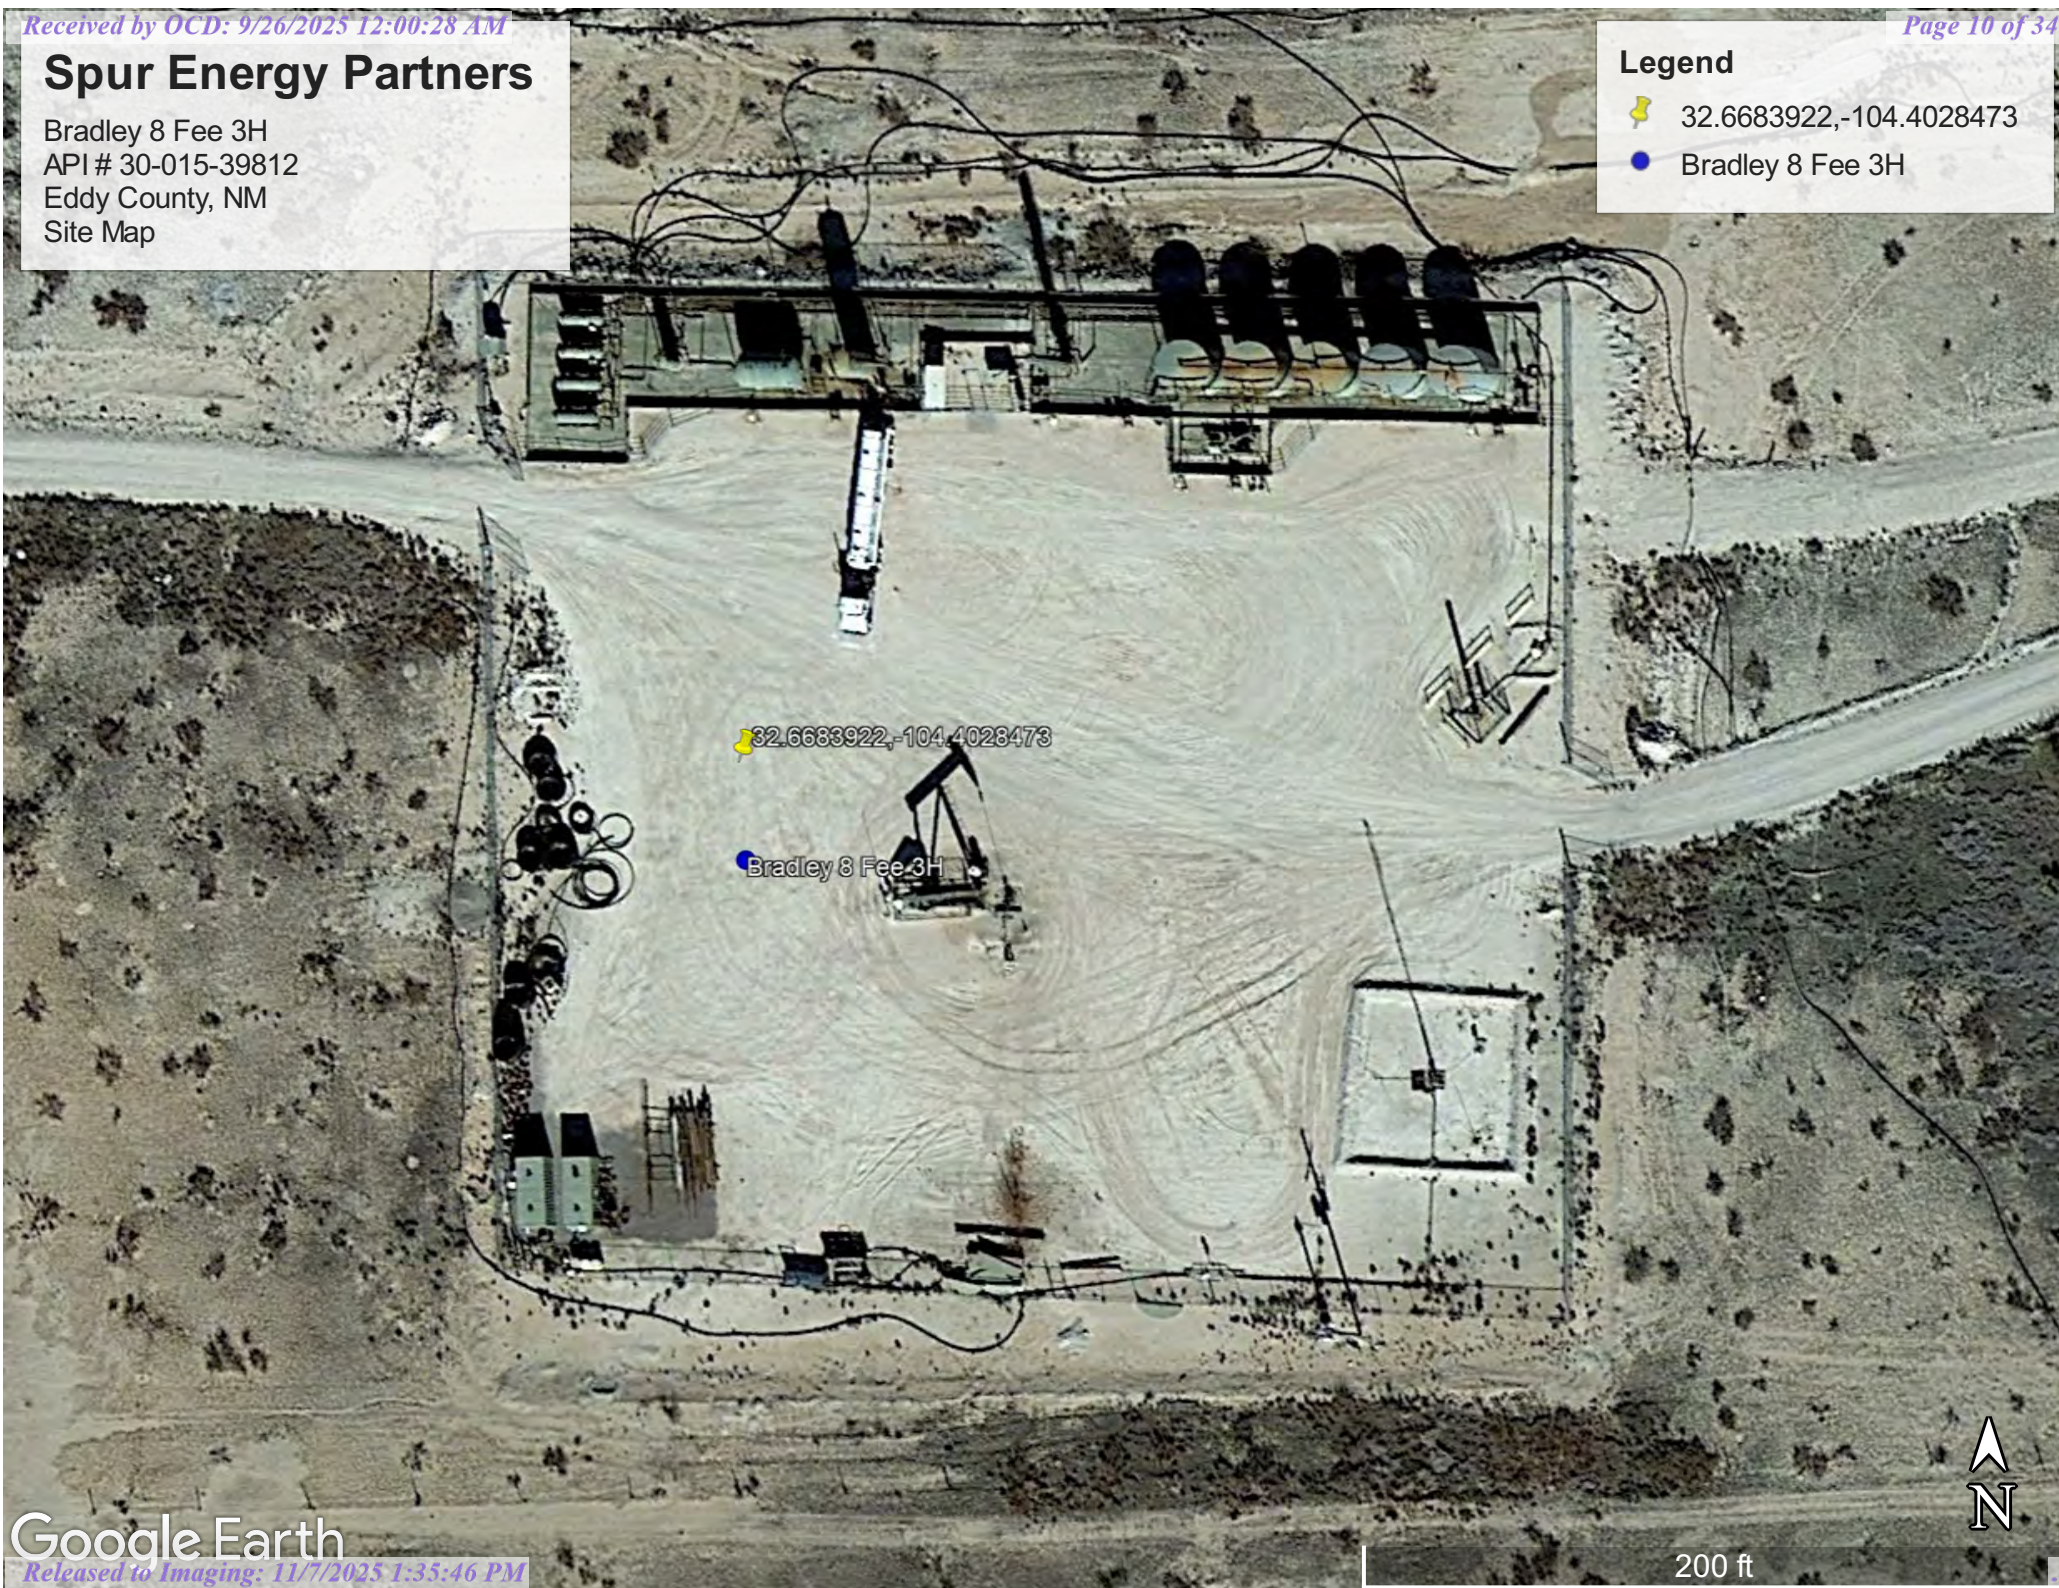
A Site Map is provided in Figure #1.

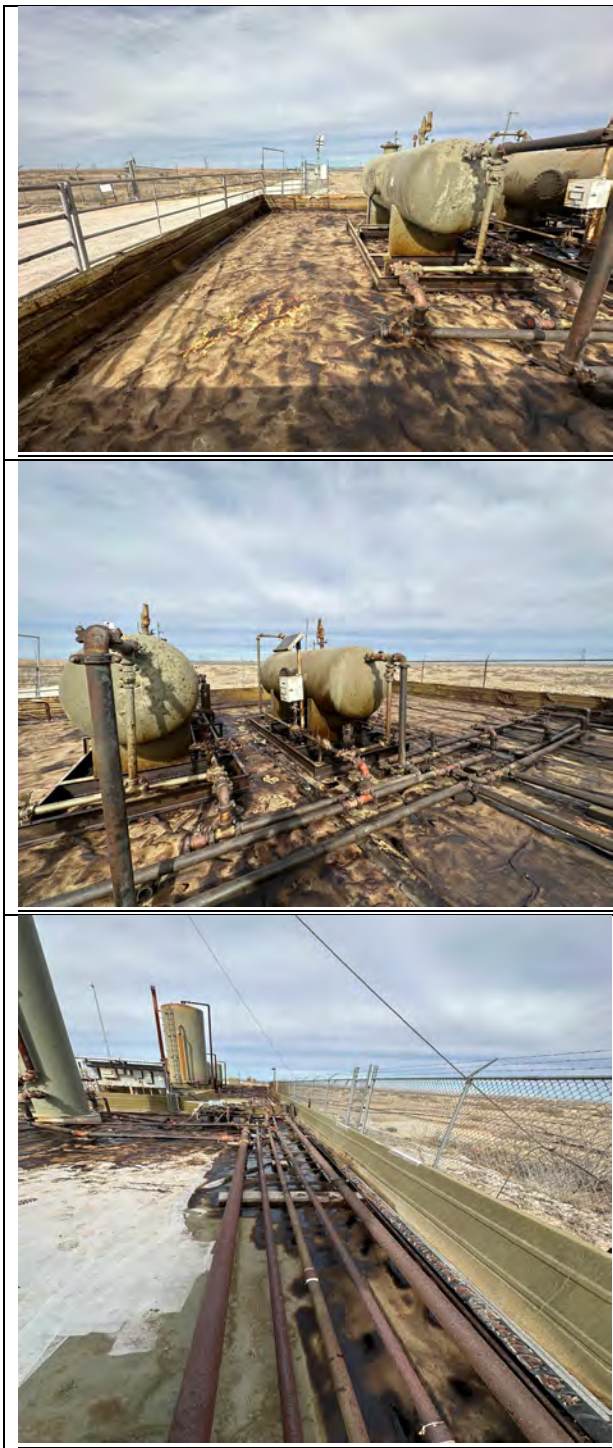
**Photographic Documentation  
Before**

| Release Details | | | |
|--|---|--|---|
| A pin hole developed in a 4" valve causing a release into the lined containment. | | | |

- On January 14<sup>th</sup> 2021, utilizing a power washer, a vacuum truck and a hand crew, Paragon was able to remove all the contamination from the containment. Upon finishing this we scheduled a liner inspection to close out the spill. We performed a liner inspection on July 28<sup>th</sup>, 2025, the results of this inspection concluded that the liner was in good condition and had the integrity to contain a spill.

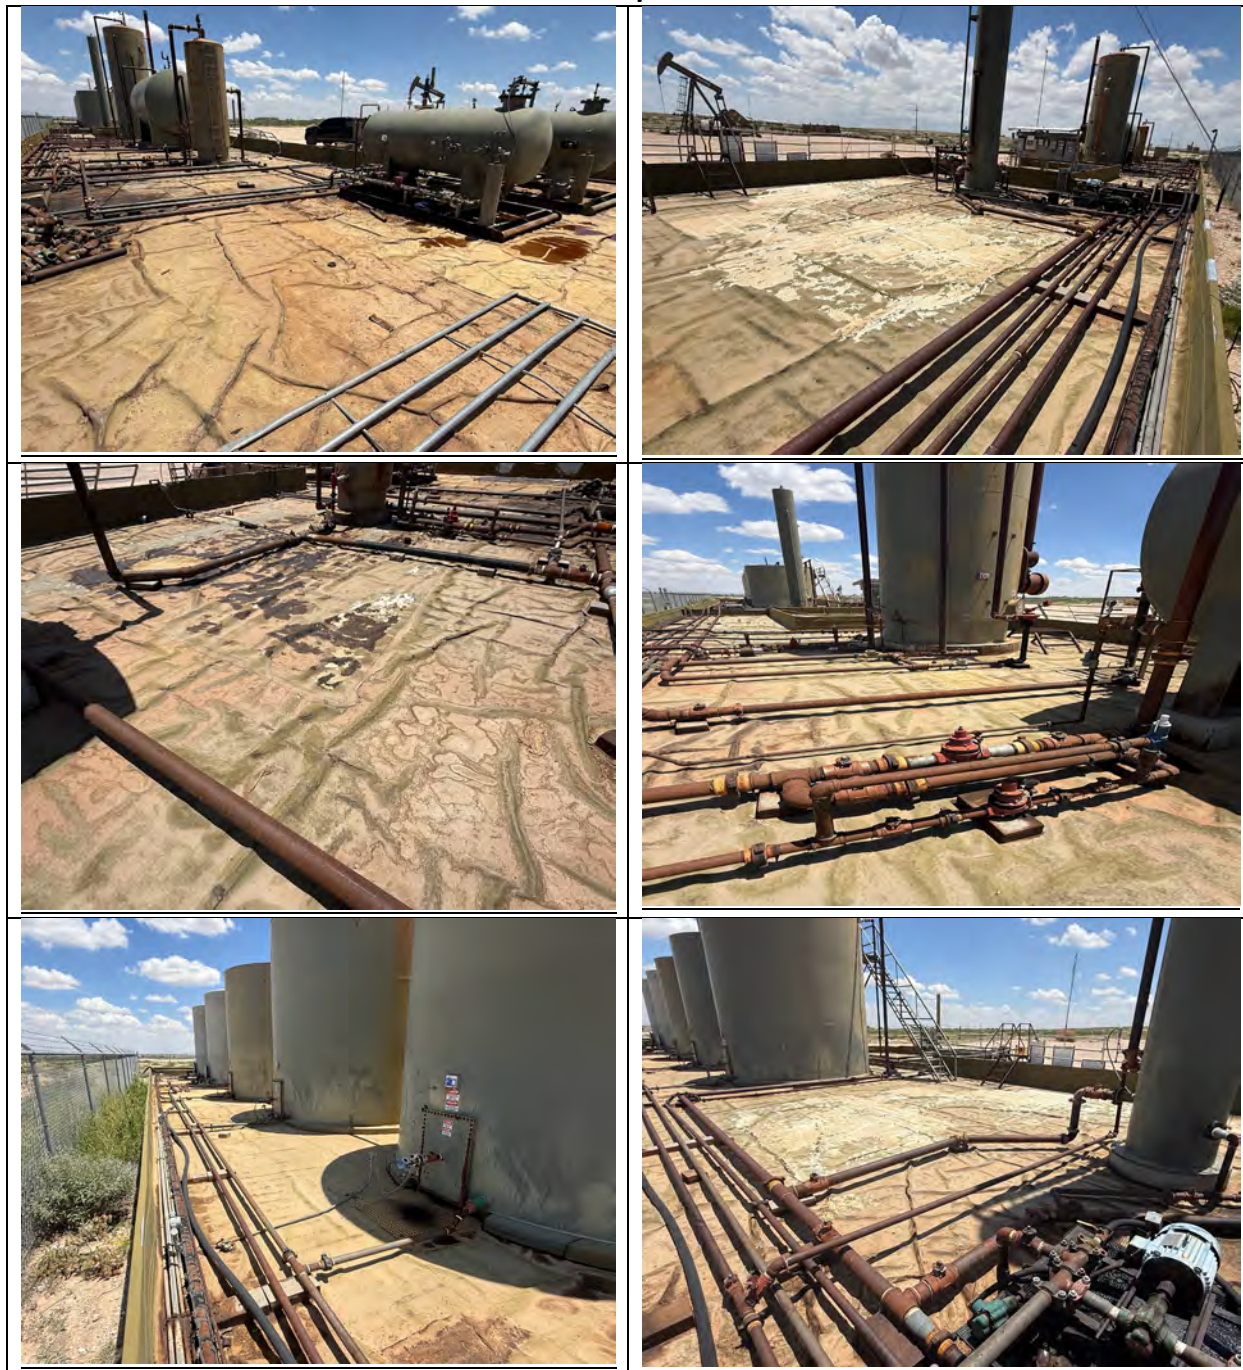
Photographic Documentation  
Liner Inspection

Comments: Liner is in good working condition. \_\_\_\_\_

Liner inspection attached in appendix D.
