MM LINE LEAK

Remediation Action Plan

NMOCD Incident No. nAPP2500224072
UL "J", Sec. 10, T17S, R28E
32.847164, -104.162730
Eddy County, New Mexico

August 20, 2025

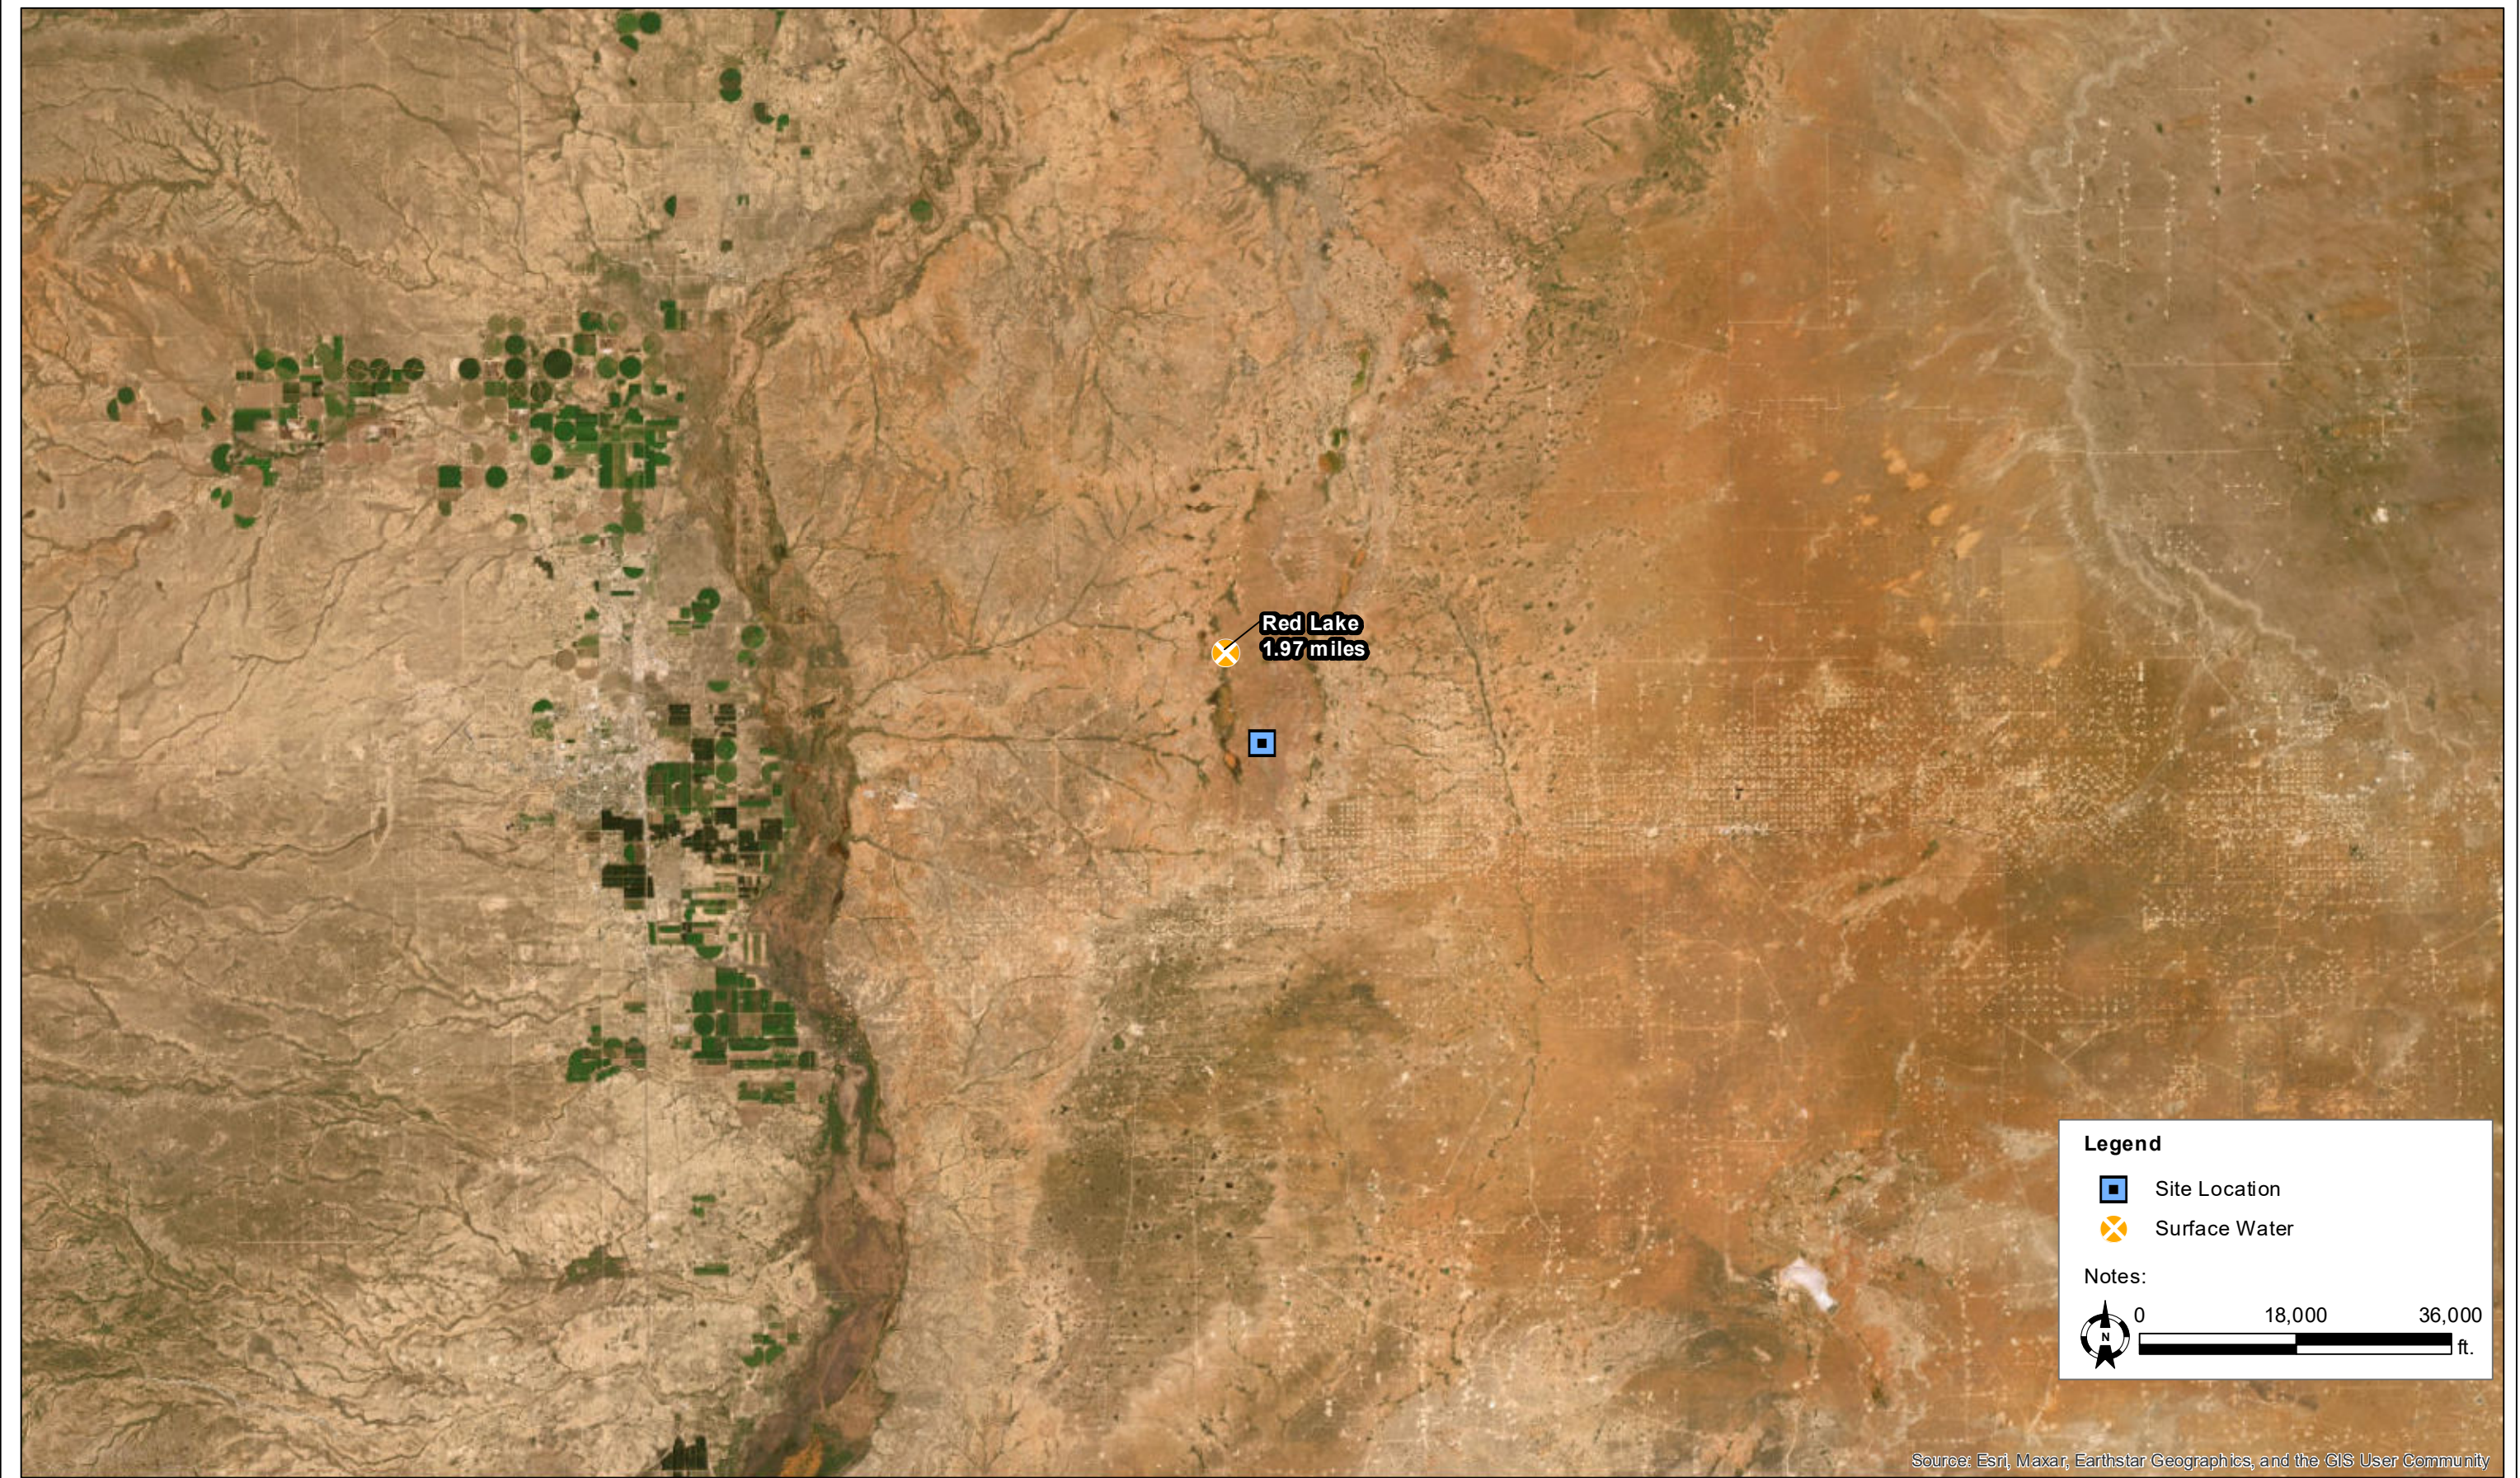
Figure
2

Areas of karst potential and subsurface mine locations are illustrated on Figure 2.

Karst Potential & Subsurface
Mine Map

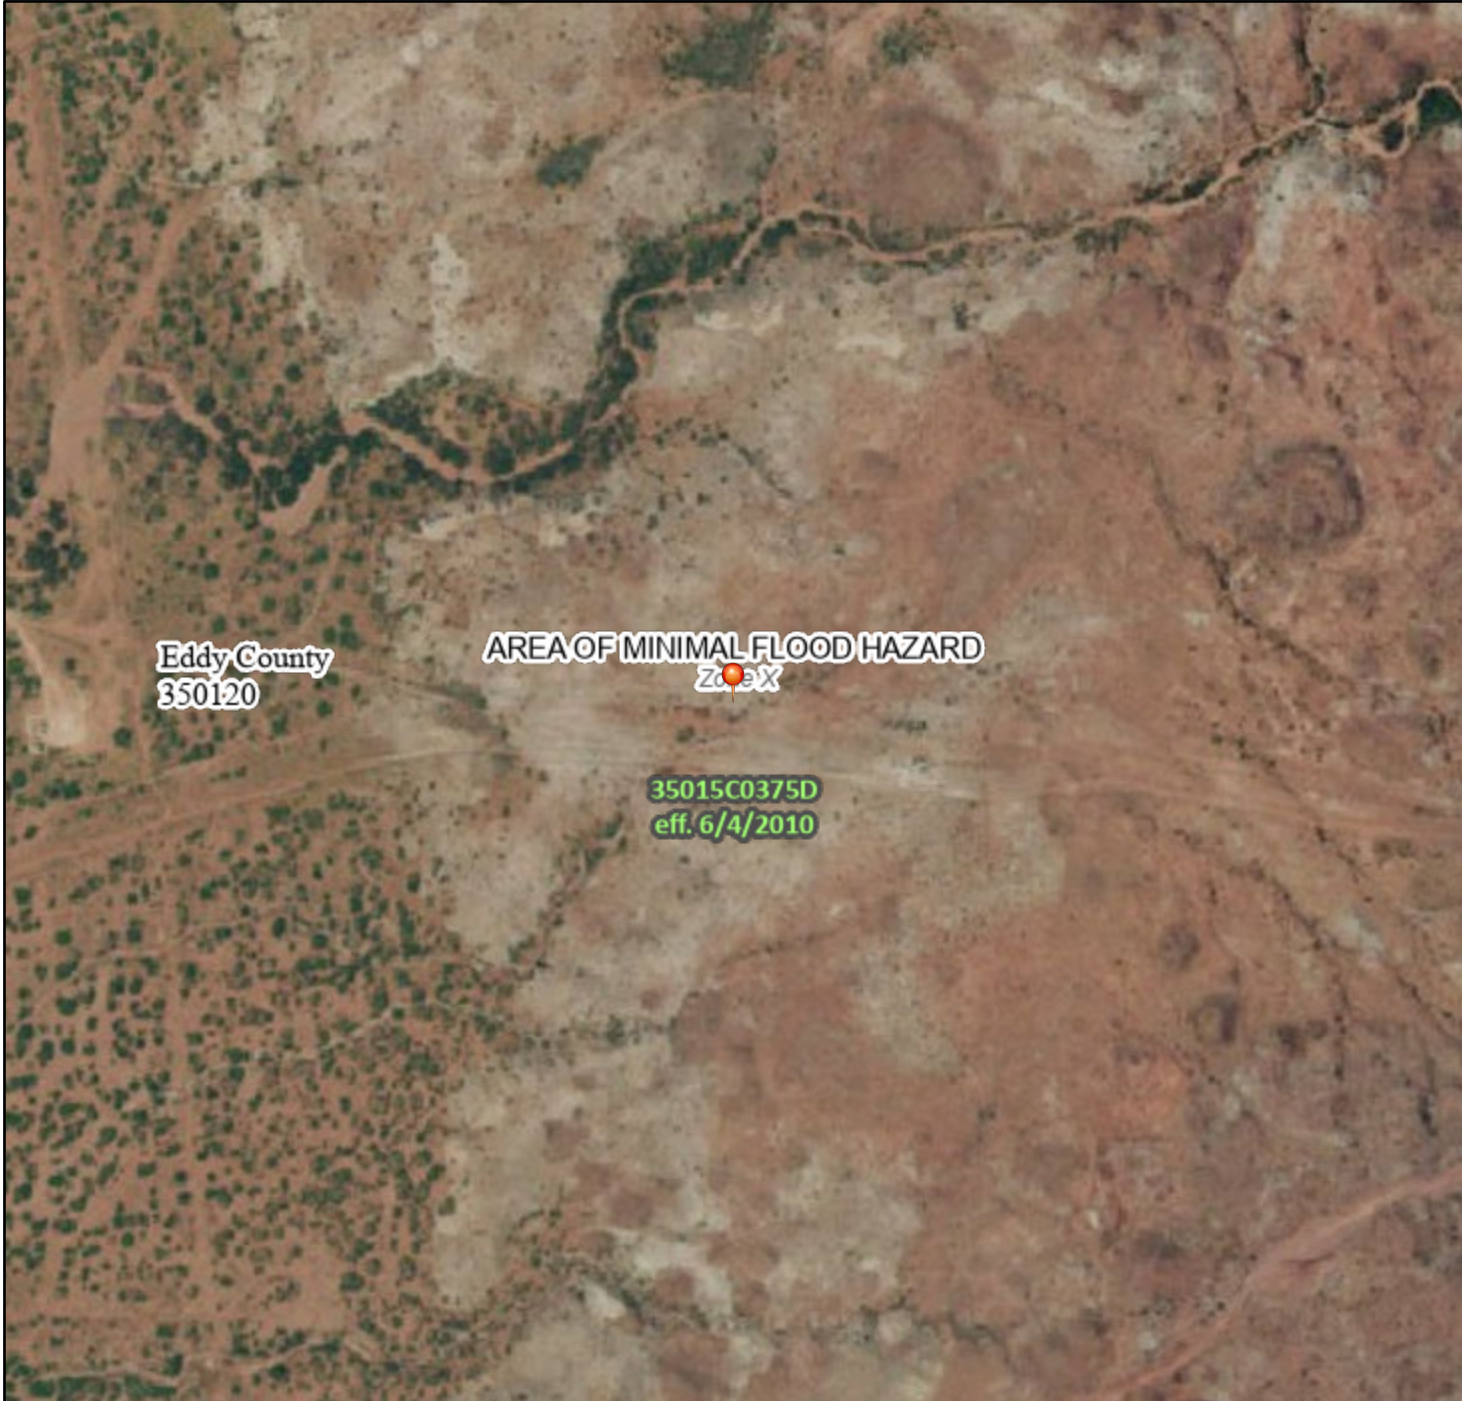
National Flood Hazard Layer FIRMette

Review of flood map data published by the Federal Emergency Management Agency (FEMA) indicates the site is not located within a 100-year floodplain. A copy of the FEMA FIRMete Map can be found attached as Figure 4.
