Site Assessment Summary, Variance Request & Proposed Remediation Plan

Mewbourne Oil Company

Layla 27 SWD #001

NMOCD Reference No. nAPP2428849677

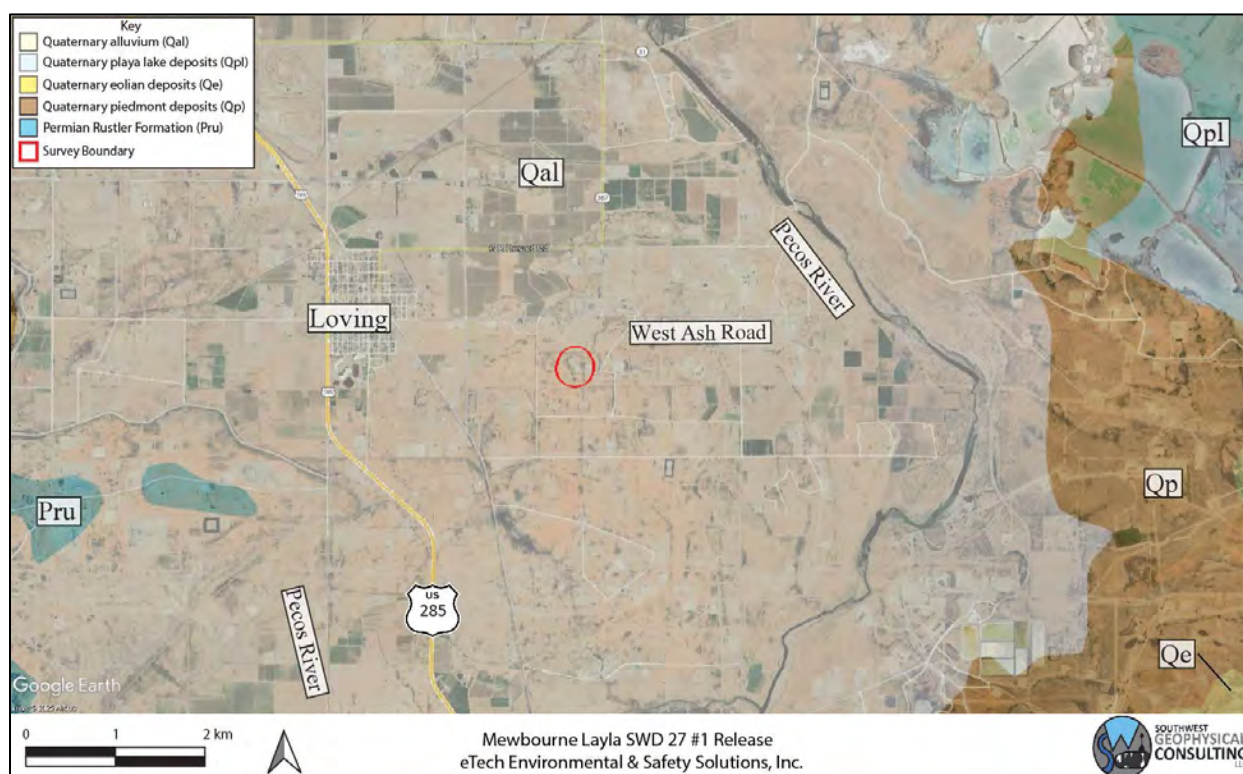
Figure 3: Geology overview. Geology map credit: The Digital Geologic Map of New Mexico in ARC/INFO Format. Background image credit: Google Earth. Image date: July 13, 2024. Image datum: WGS-84.

The site for the LS271 survey is located at an elevation of 926 meters (3,038 feet), \pm 3 meters (9.8 feet), and is located within a region underlain by the Permian Rustler Formation (Pru). The area is mantled by thin gypsiferous soils (gypsite), Quaternary alluvium (Qal), and piedmont gravels (Qp)^[11] up to 5 meters in depth (**Figure 3**).

The Rustler Formation is an evaporite facies composed mainly of thin siltstones and sandstones interbedded with claystones, dolomite, and gypsum, and contains both karst-forming strata (the Forty-niner and Tamarisk members) and two shallow aquifers (the Magenta and Culebra Dolomite members)^[12].

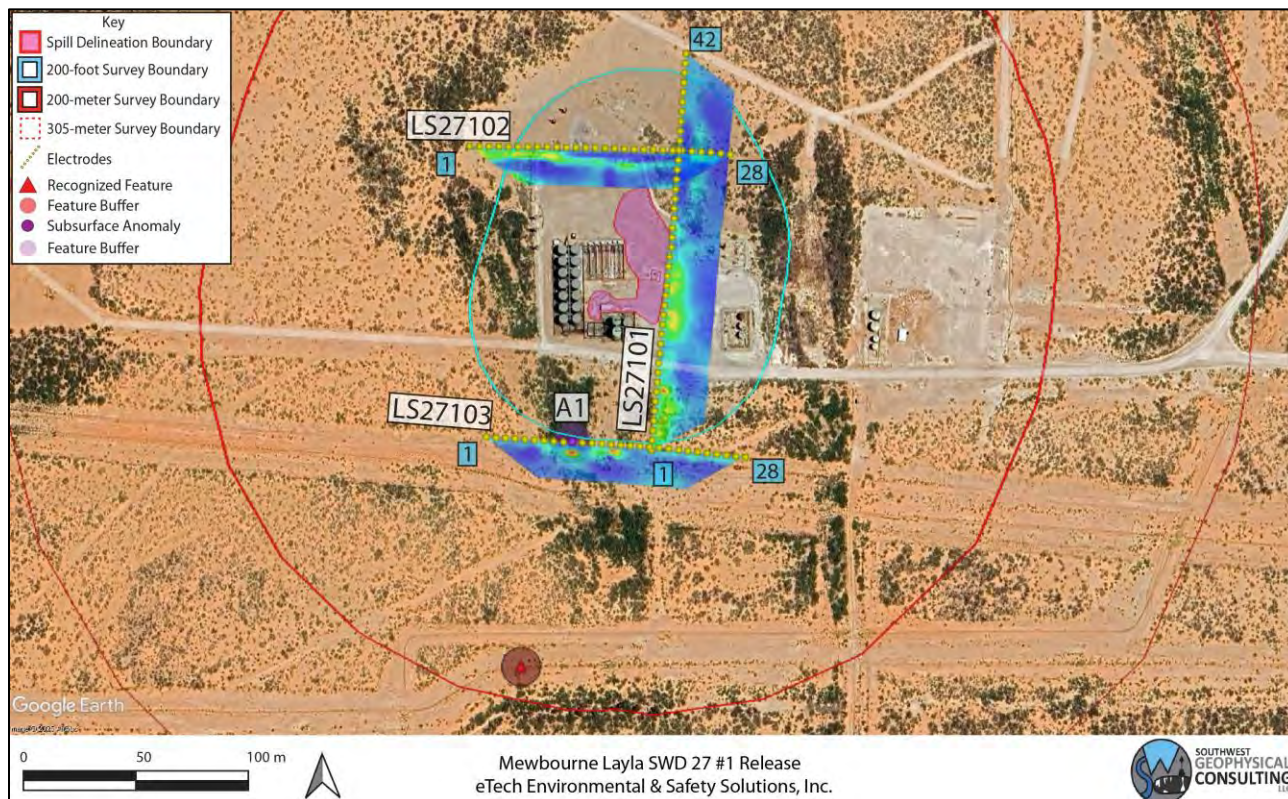
Figure 8: Data overlay. Colored trapezoids are 2D inverted resistivity lines. Background image credit: Google Earth. Image date: July 14, 2024.

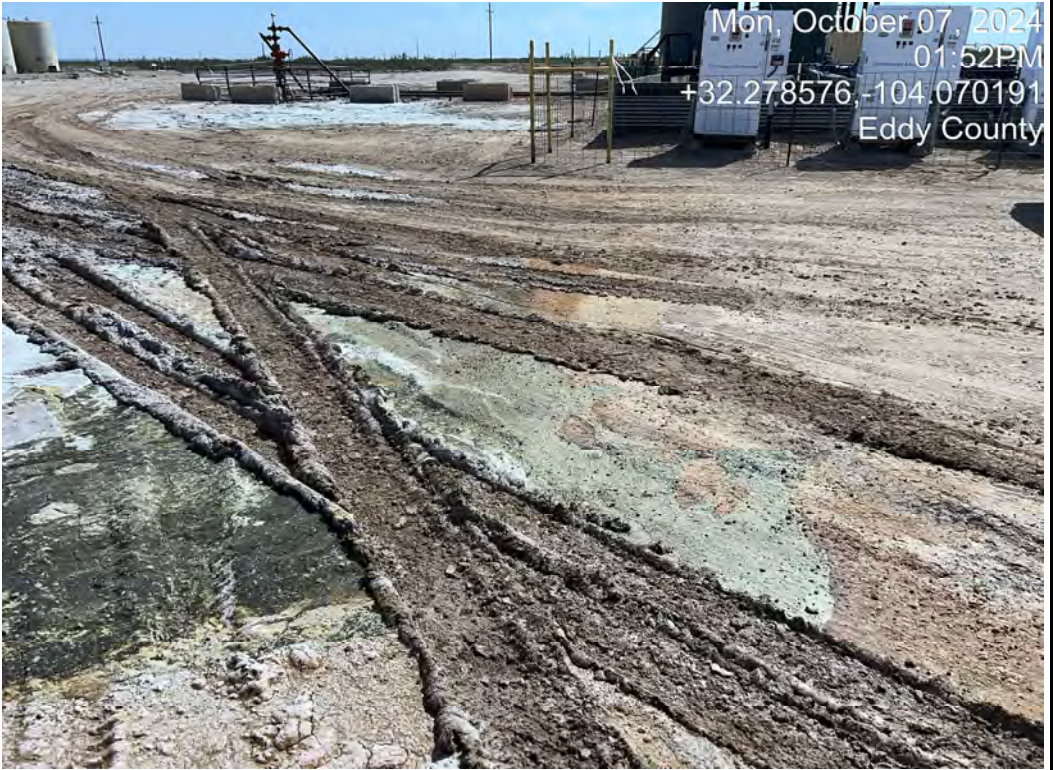
Photo Number: 2

<p>Mon, October 07, 2024 01:52PM +32.278576,-104.070191 Eddy County</p>
Photo Direction: South-Southeast	
Photo Description: View of the affected area.

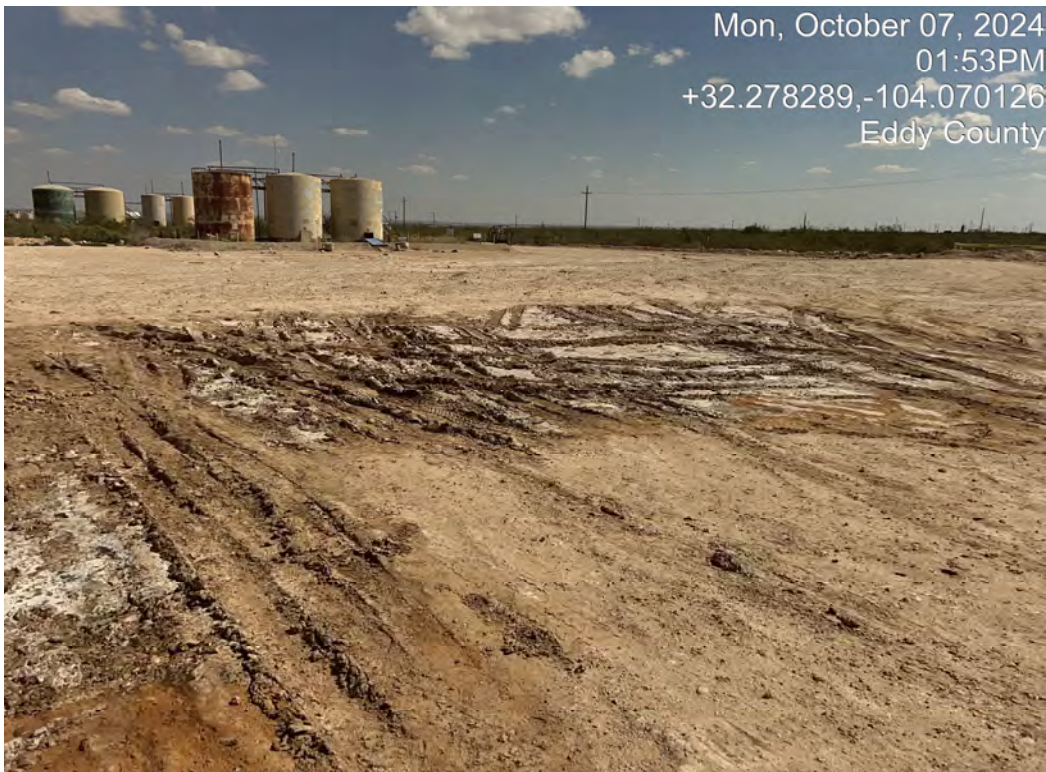
Photo Number: 4

Photo Direction: Southeast	
Photo Description: View of the affected area.

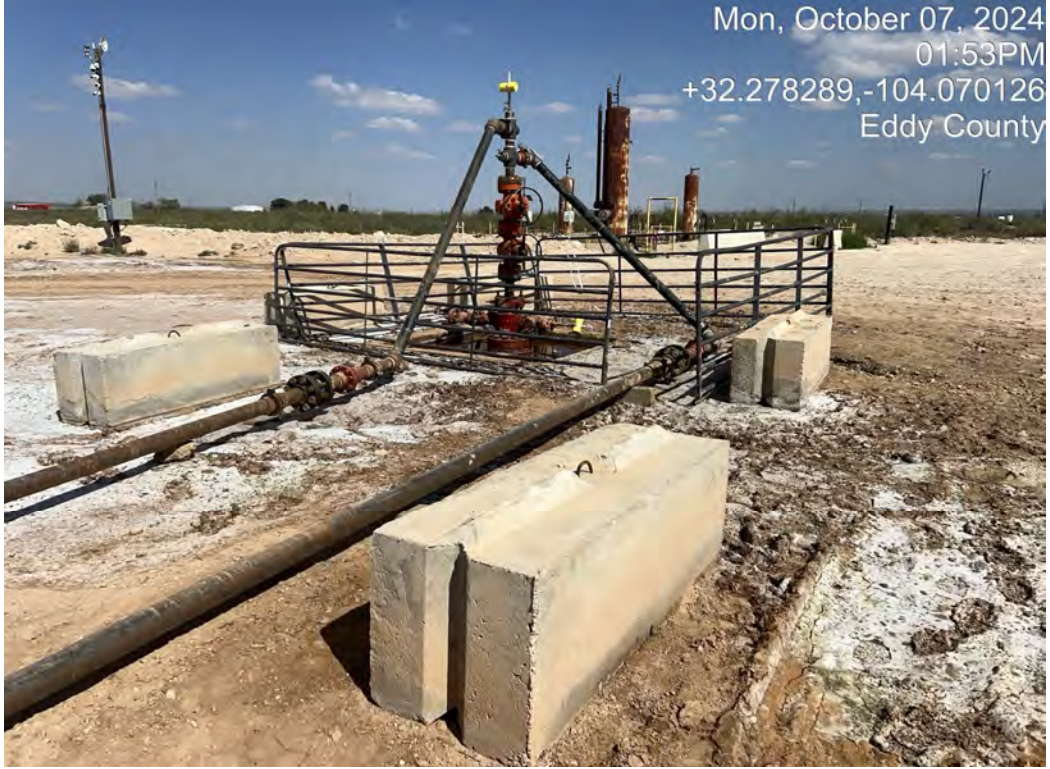
Photo Number: 5

<p>Mon, October 07, 2024 01:53PM +32.278289,-104.070126 Eddy County</p>
Photo Direction: East-Northeast	
Photo Description: View of the affected area.

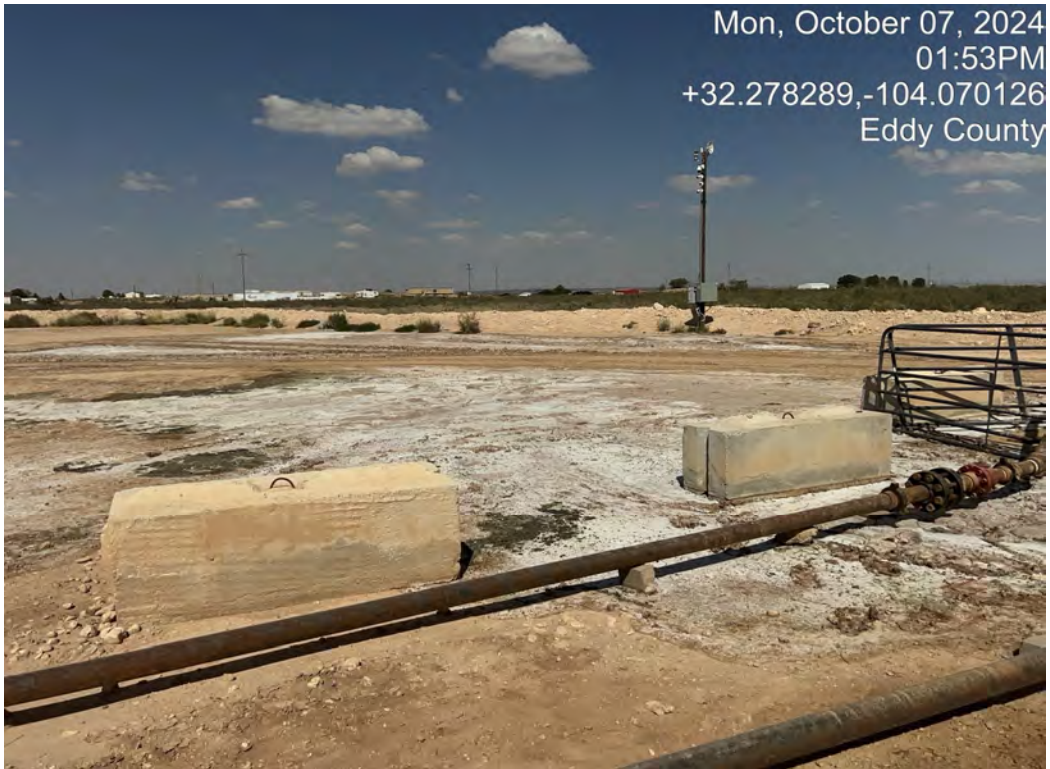
Photo Number: 6

<p>Mon, October 07, 2024 01:53PM +32.278289,-104.070126 Eddy County</p>
Photo Direction: Northeast	
Photo Description: View of the affected area.
