**Re: Closure Request
PLU 295
Incident Number nAPP2519950474
Eddy County, New Mexico**

Ensolum, LLC (Ensolum), on behalf of XTO Energy, Inc. (XTO), has prepared this *Closure Request* to document assessment, excavation, and soil sampling activities at the PLU 295 (Site). The purpose of the assessment and sampling activities was to assess for the presence or absence of impacts to soil following a release of produced water and crude oil on a lease road and into the pasture. Based on field observations, field screening activities, and soil sample laboratory analytical results, XTO is submitting this *Closure Request*, describing assessment, excavation, and soil sampling activities that have occurred and requesting no further action for Incident Number nAPP2519950474.

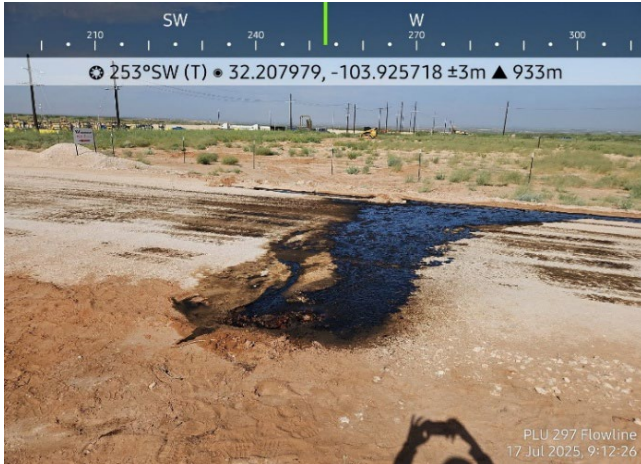
Photograph: 1 Date: 7/17/2025
Description: Initial release extent
View: Southwest

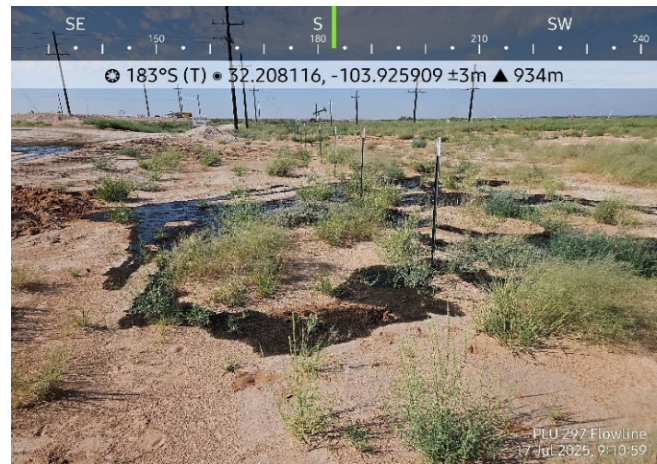
Photograph: 2 Date: 7/17/2025
Description: Initial release extent
View: South

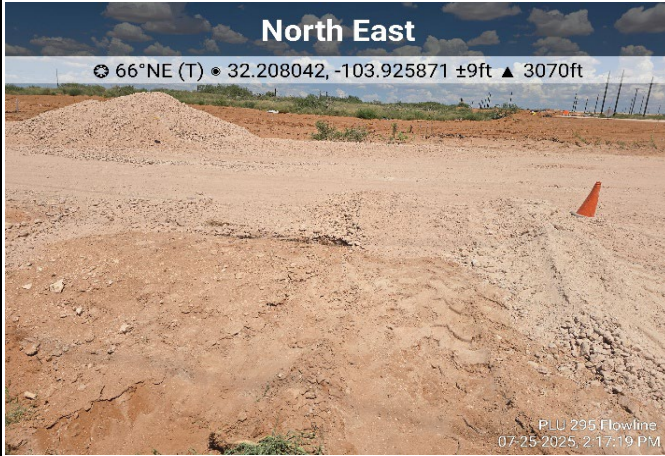
Photograph: 5 Date: 7/25/2025
 Description: Backfilled FS01 and FS02
 View: Northeast

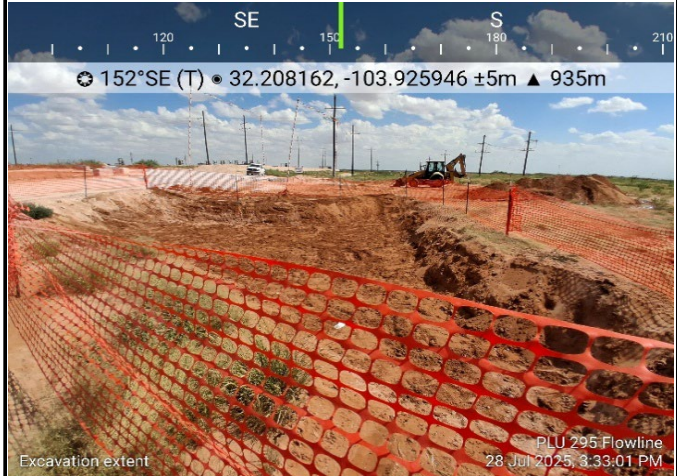
Photograph: 6 Date: 7/28/2025
 Description: Excavation extent; near FS03
 View: Southeast

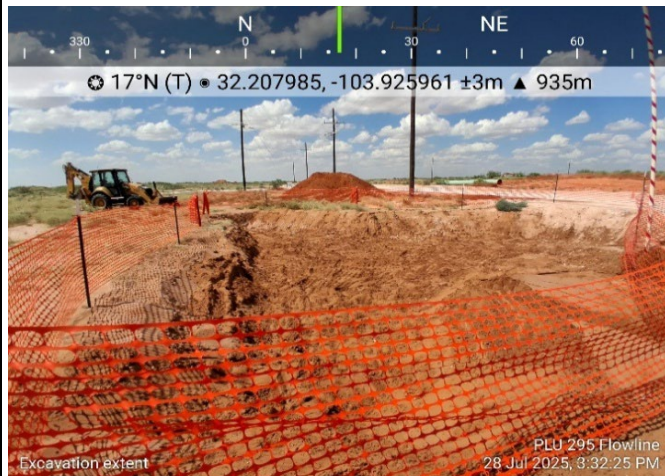
Photograph: 7 Date: 9/28/2025
 Description: Excavation extent; near FS10
 View: North

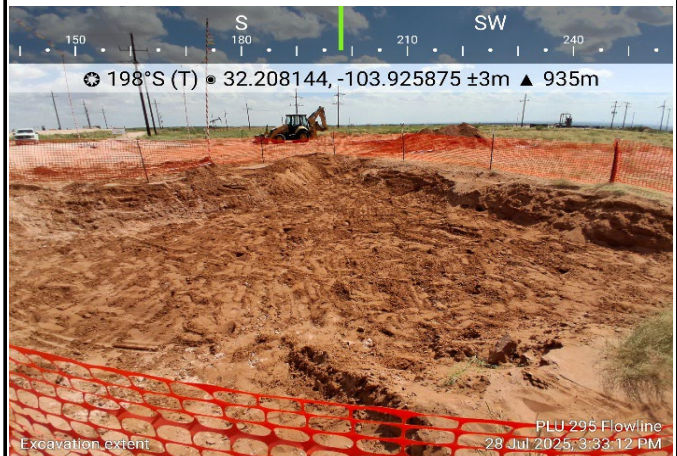
Photograph: 8 Date: 9/28/2025
 Description: Excavation extent; near FS07
 View: South

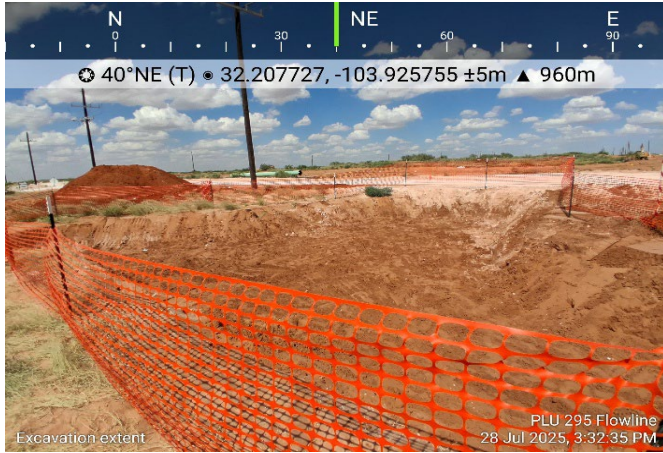
Photograph: 9 Date: 7/28/2025
Description: Excavation extent; near FS04
View: Northeast

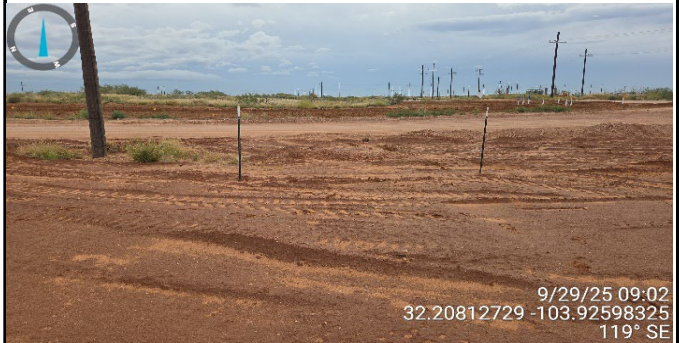
Photograph: 10 Date: 9/29/2025
Description: Backfilled excavation; near FS07
View: East

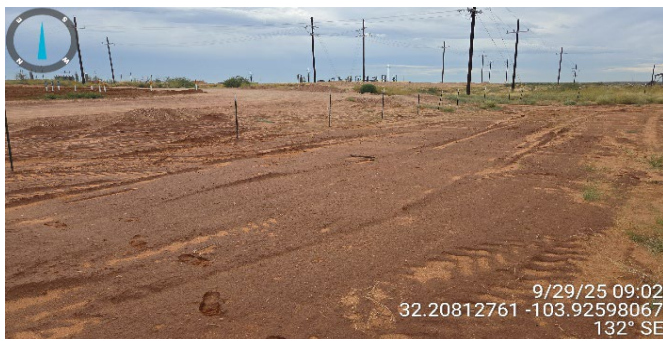
Photograph: 11 Date: 9/29/2025
Description: Backfilled excavation; near FS03
View: Southeast

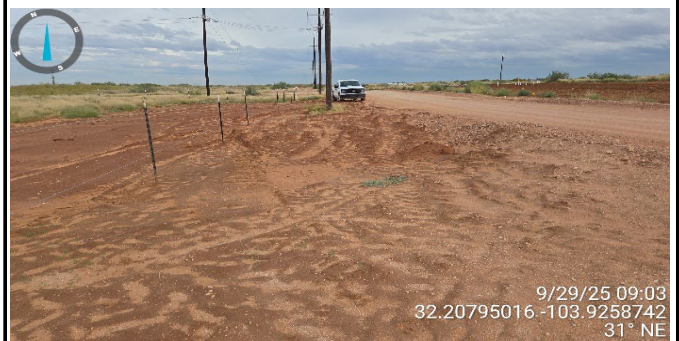
Photograph: 12 Date: 9/29/2025
Description: Backfilled excavation; near FS02
View: North
