March 12, 2019

Re: Closure Report for the EOG Resources, Lotus SWD #2, Unit G, Section 32, Township 22 South, Range 32 East, Lea County, New Mexico. 1RP-3721.

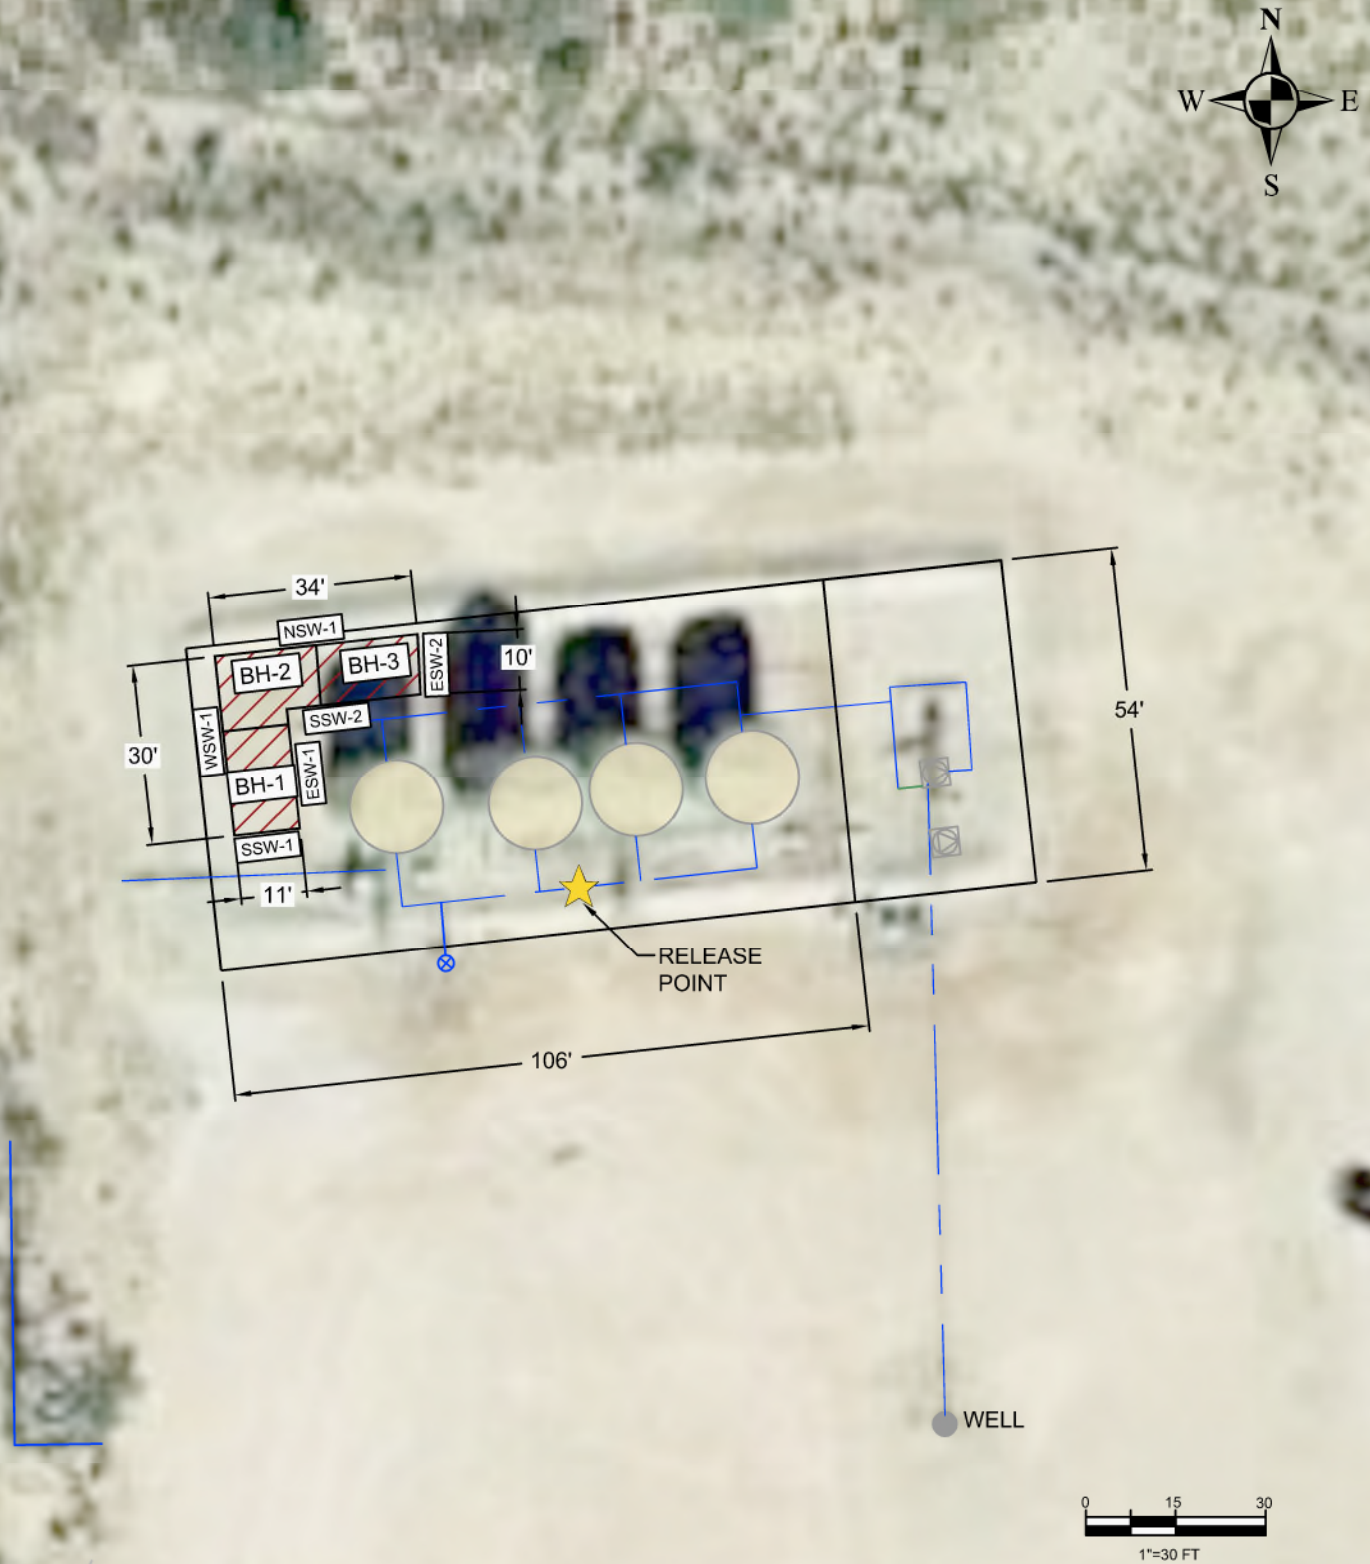
FIGURE 4

- 4.0' EXCAVATION AREA
- EQUIPMENT
- STEEL PIPE

EXCAVATION AREA &
DEPTH MAP
LEA COUNTY, NEW MEXICO

On November 28, 2018 to December 4, 2018, Tetra Tech personnel were onsite to oversee the remediation activities performed at the site. The area of auger hole (AH-2) was excavated to 4.0' below surface. Five-point composite confirmation samples were taken every 200 square feet to ensure proper removal of the impacted areas. A total of three bottom hole confirmation samples (Bottom Hole #1, Bottom Hole #2, and Bottom Hole #3) and six sidewall confirmation samples (North Sidewall #1, South Sidewall #1, South Sidewall #2, West Sidewall #1, East Sidewall #1, and East Sidewall #2) were collected. The samples were analyzed for TPH analysis by EPA method 8015 modified, BTEX by EPA Method 8021B and chloride by EPA method 300.0. Copies of laboratory analysis and chain-of-custody documentation are included in Appendix C.

Approximately 162 cubic yards of contaminated soil was transported offsite for proper disposal and the areas were backfilled with clean material to surface grade.

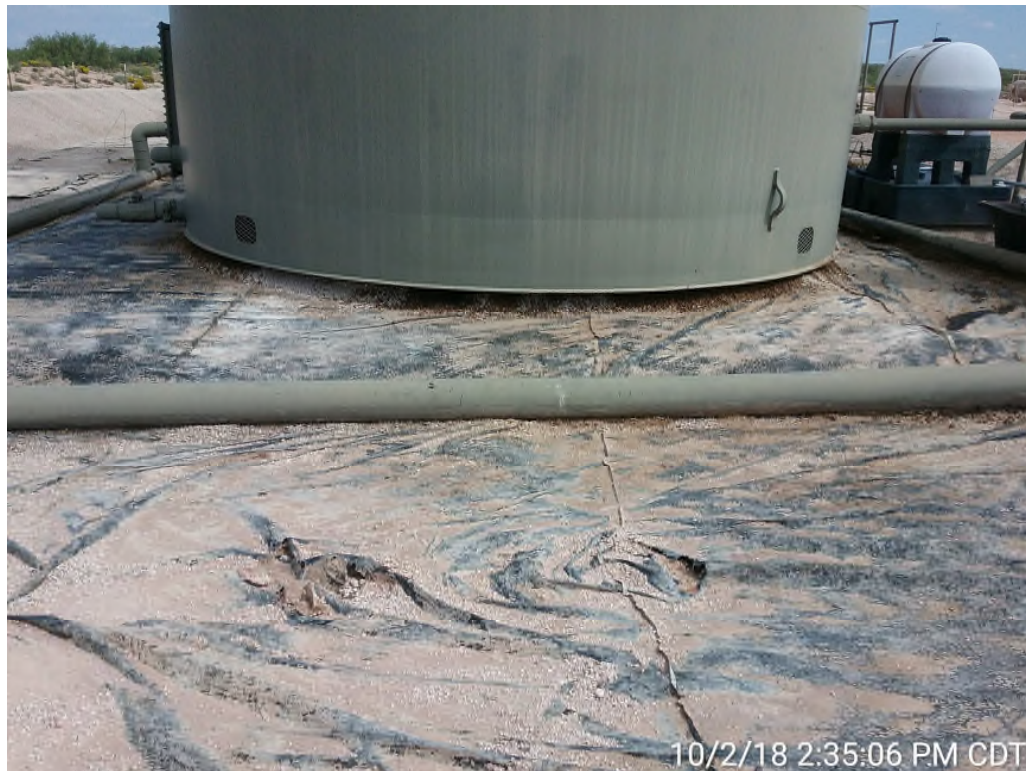
View East – Area of AH-1

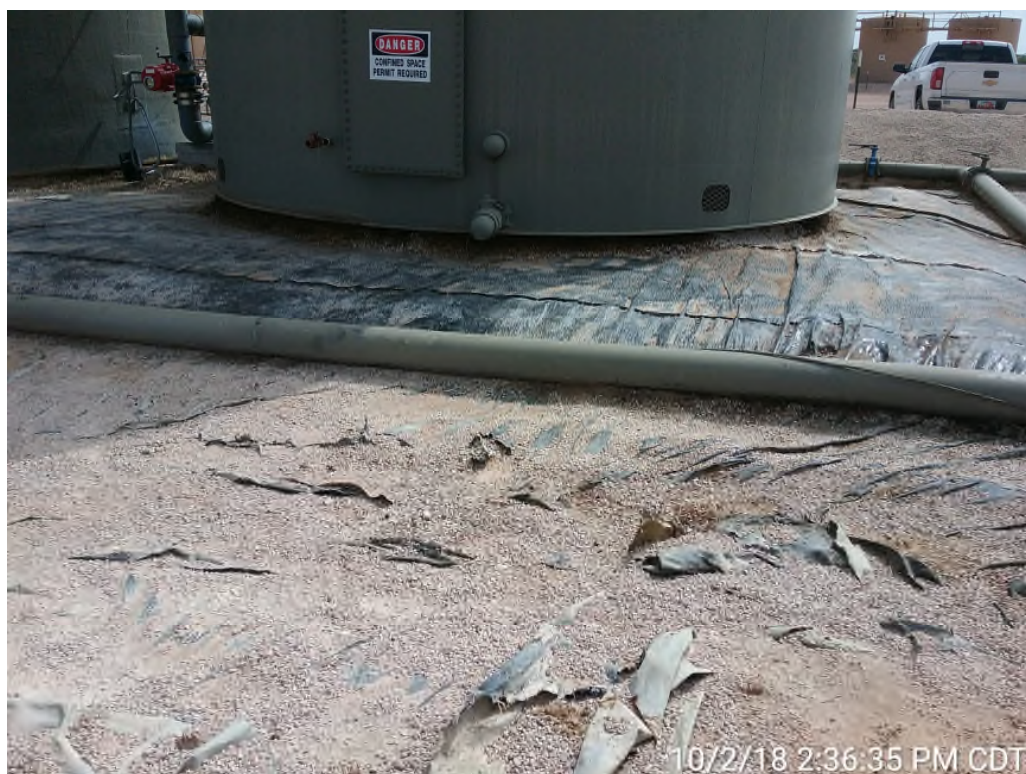
View South – Area of AH-2

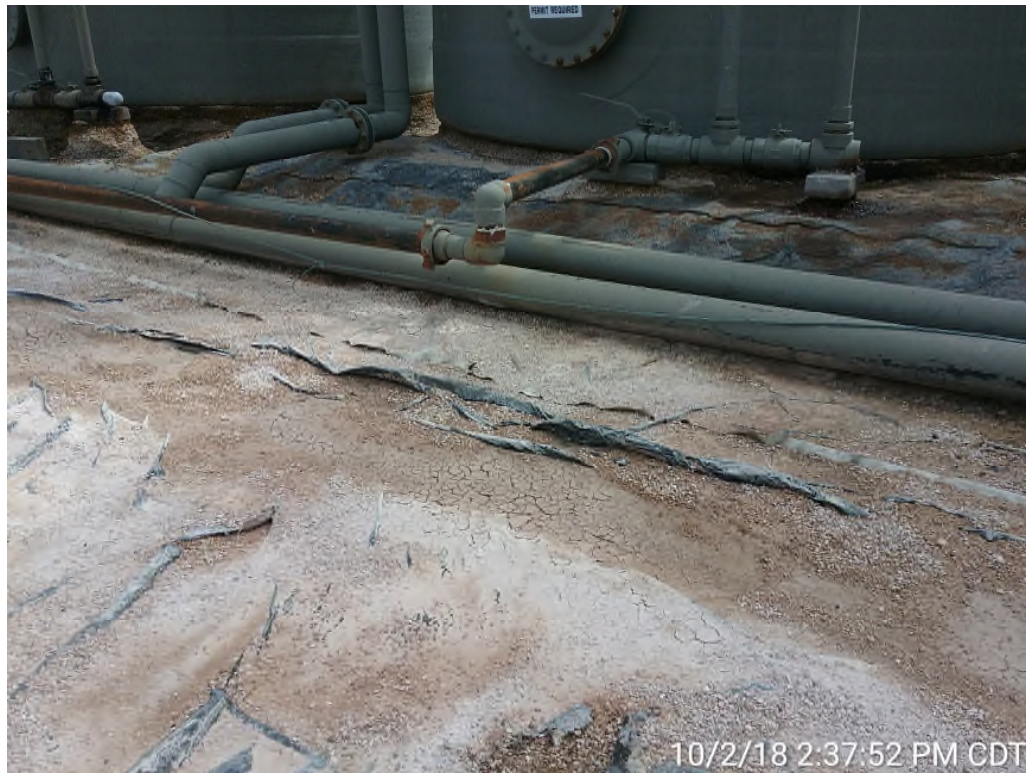
View Southeast – Area of AH-3

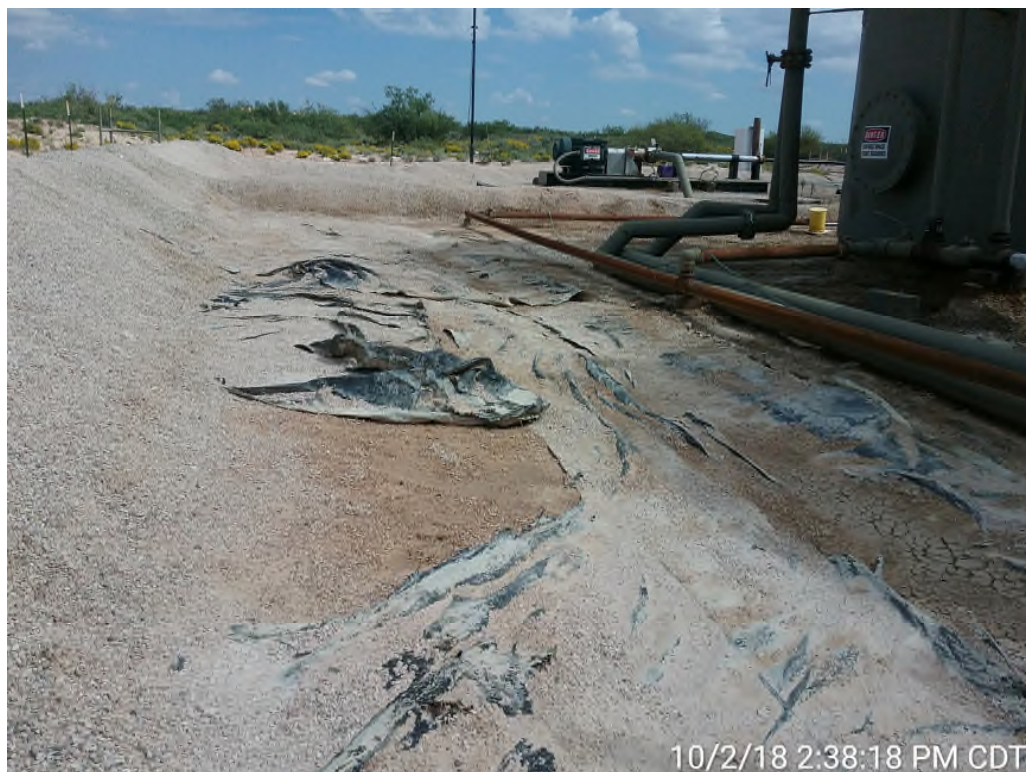
View East – Area of AH-4

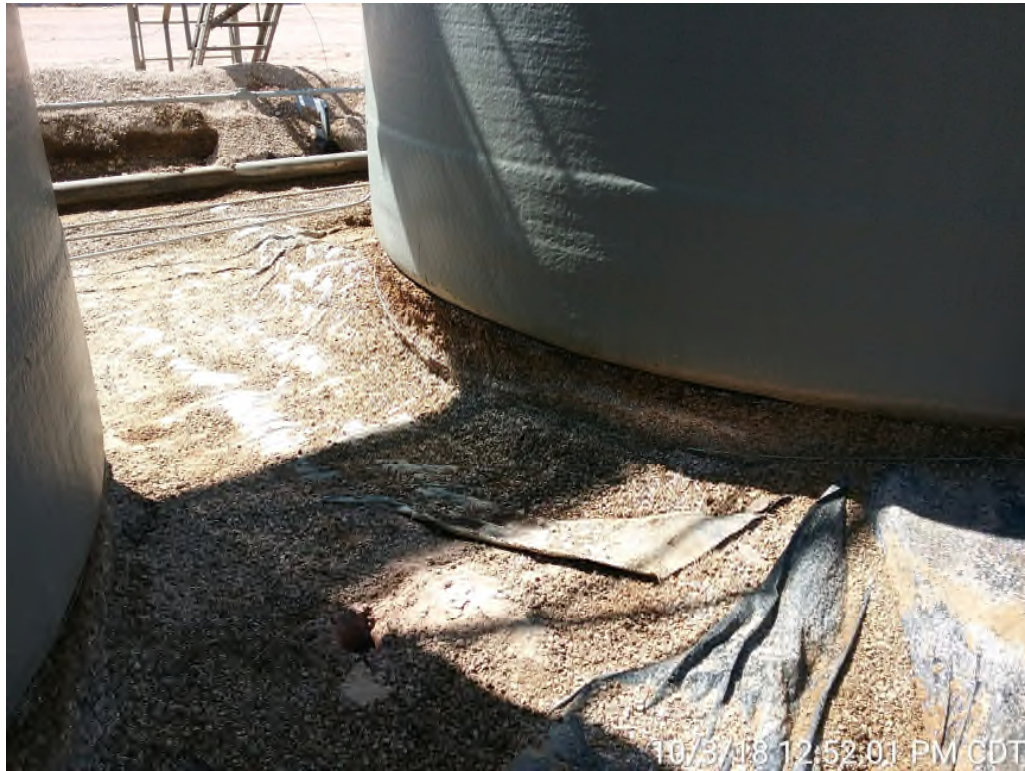
View Southwest – Area of AH-5

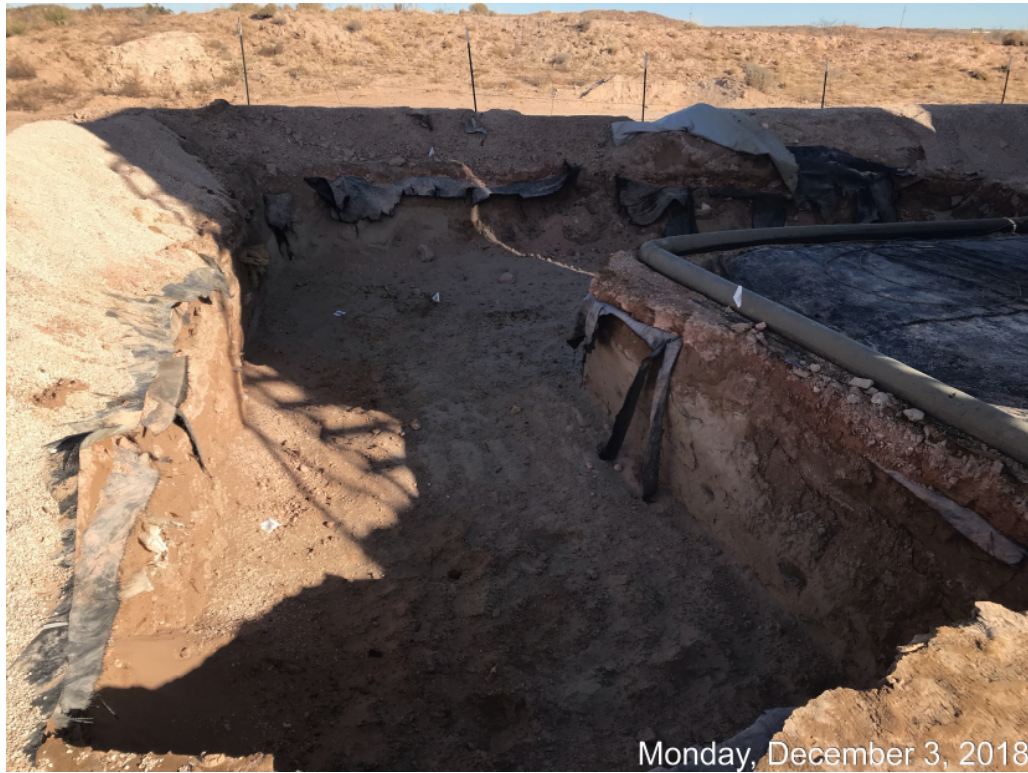
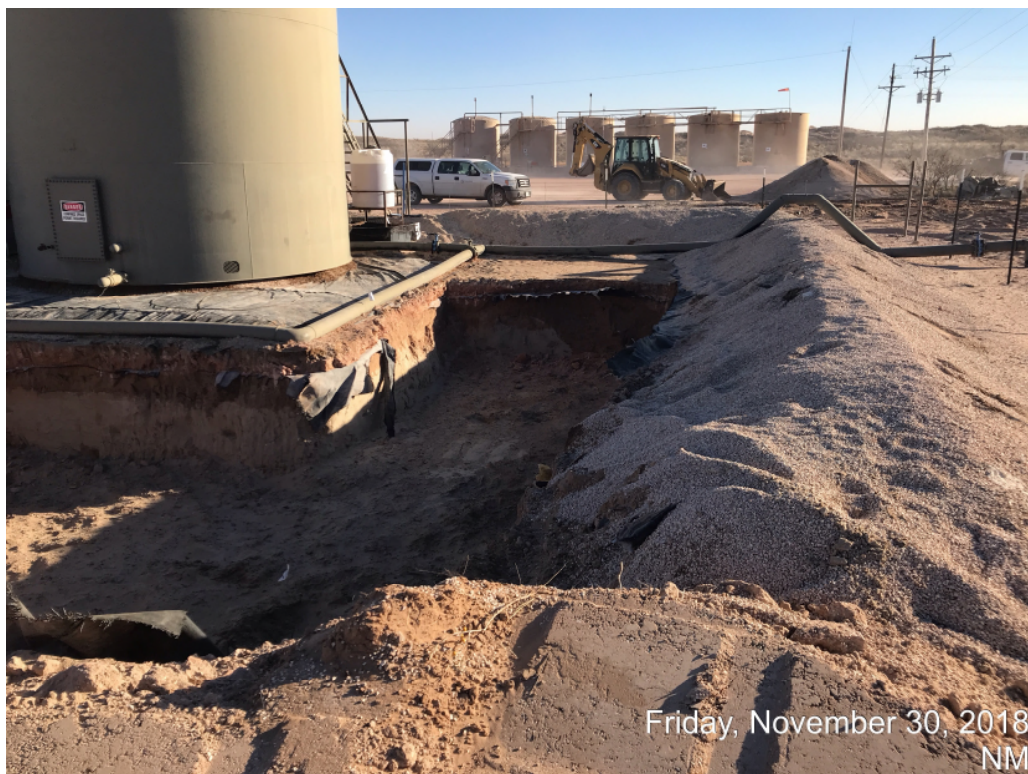
View North – Excavated Area of AH-2

View South – Excavated Area of AH-2

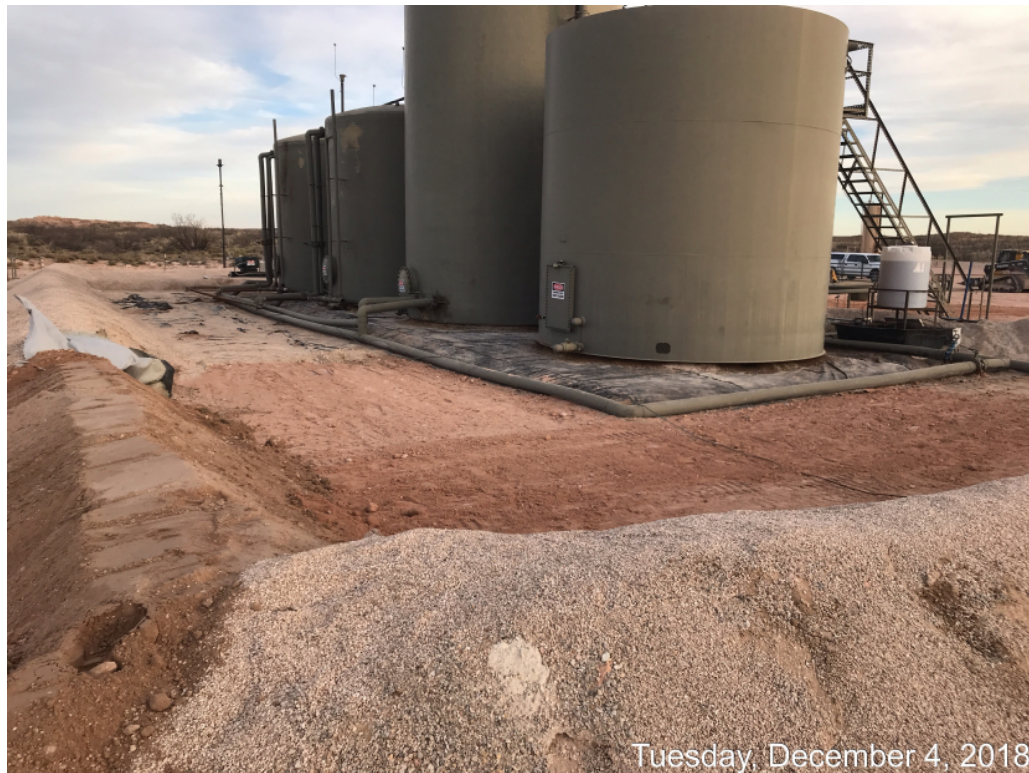
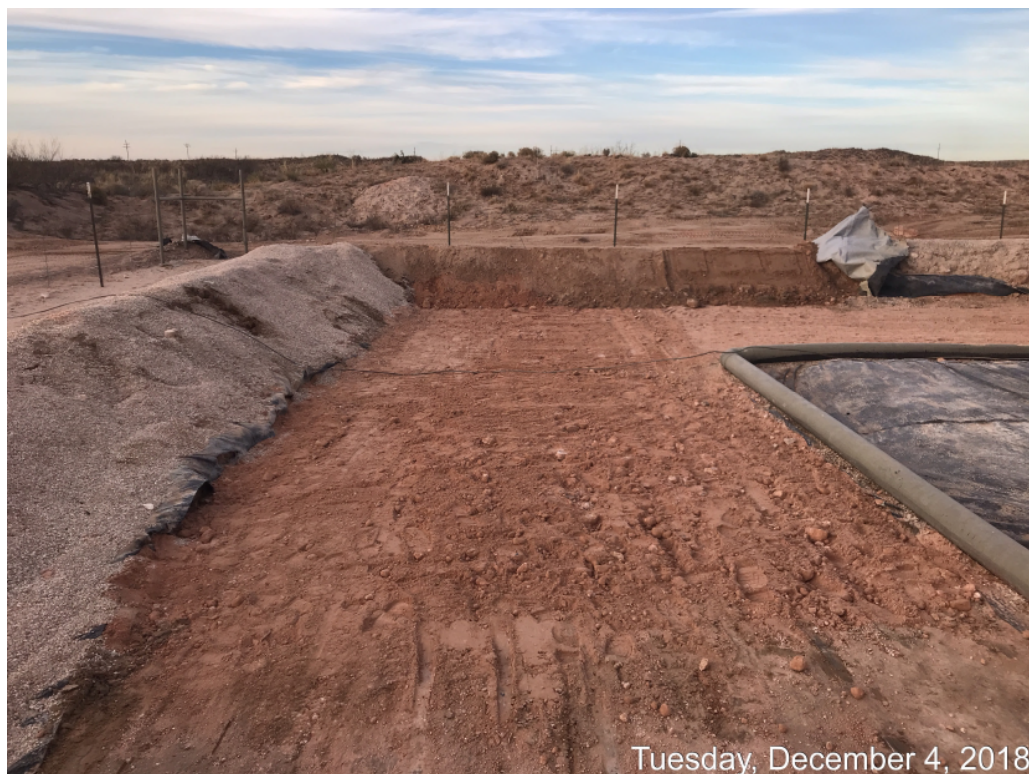
View Southeast – Backfilled Area of AH-2

View North – Backfilled Area of AH-2

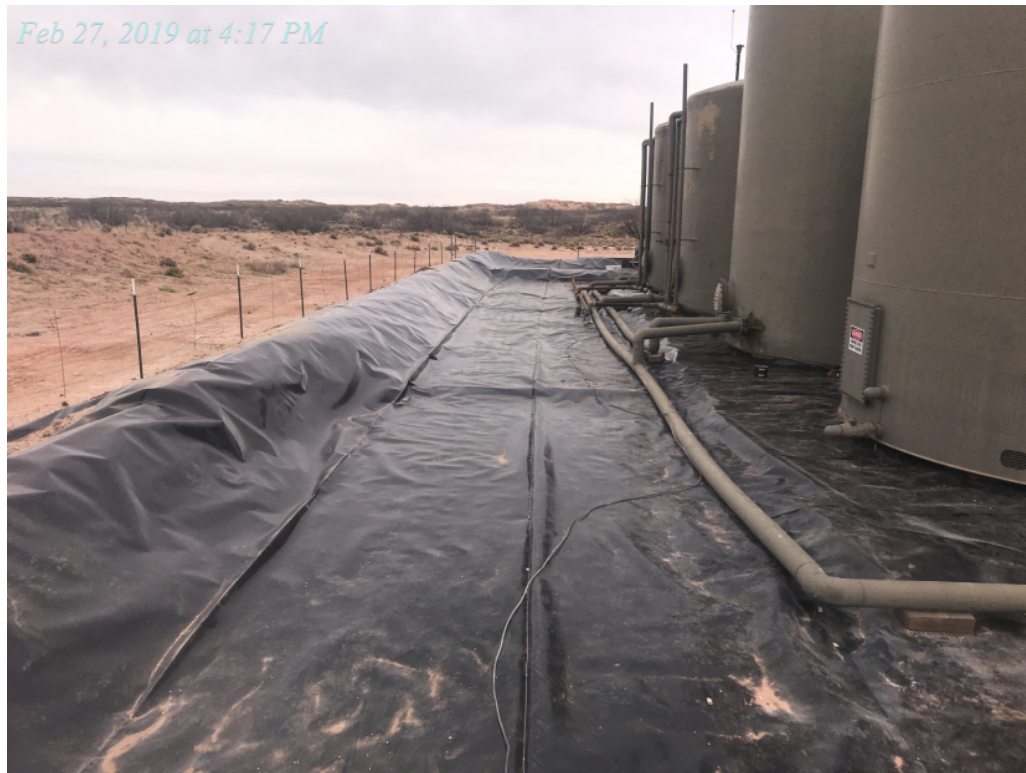
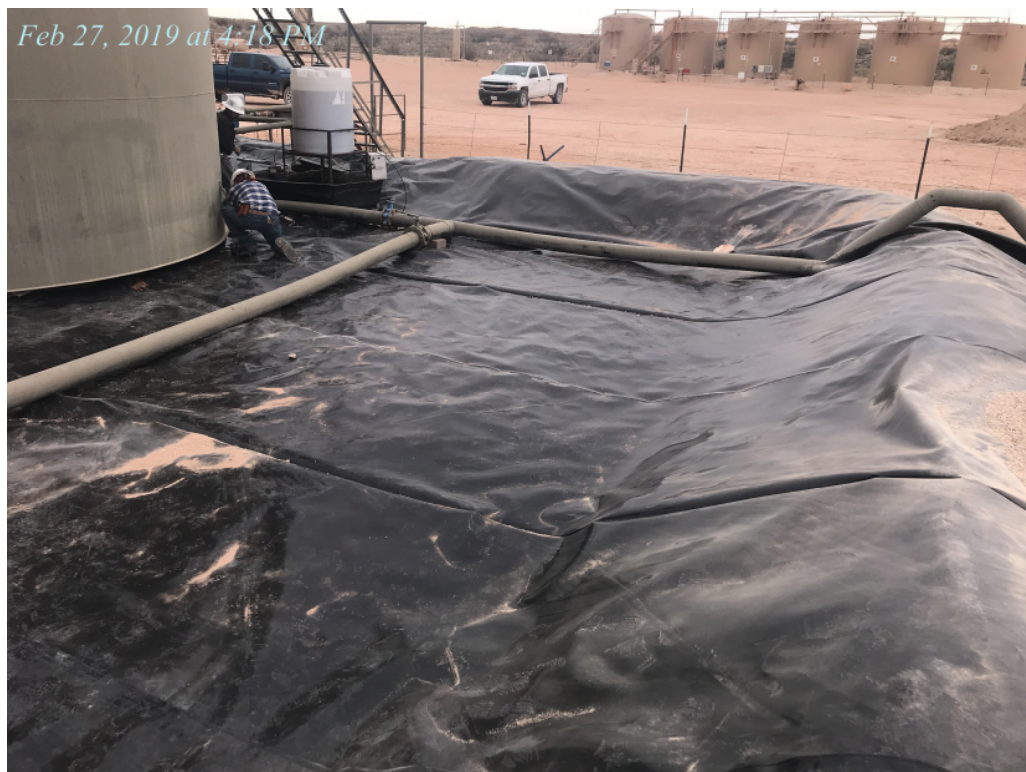
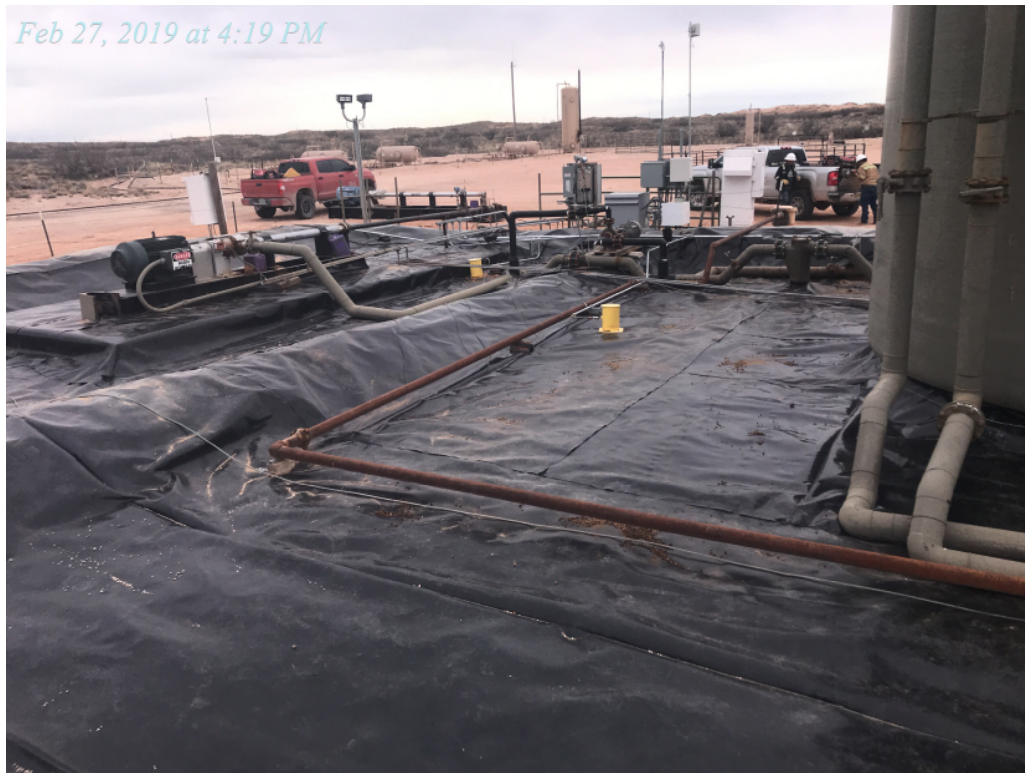
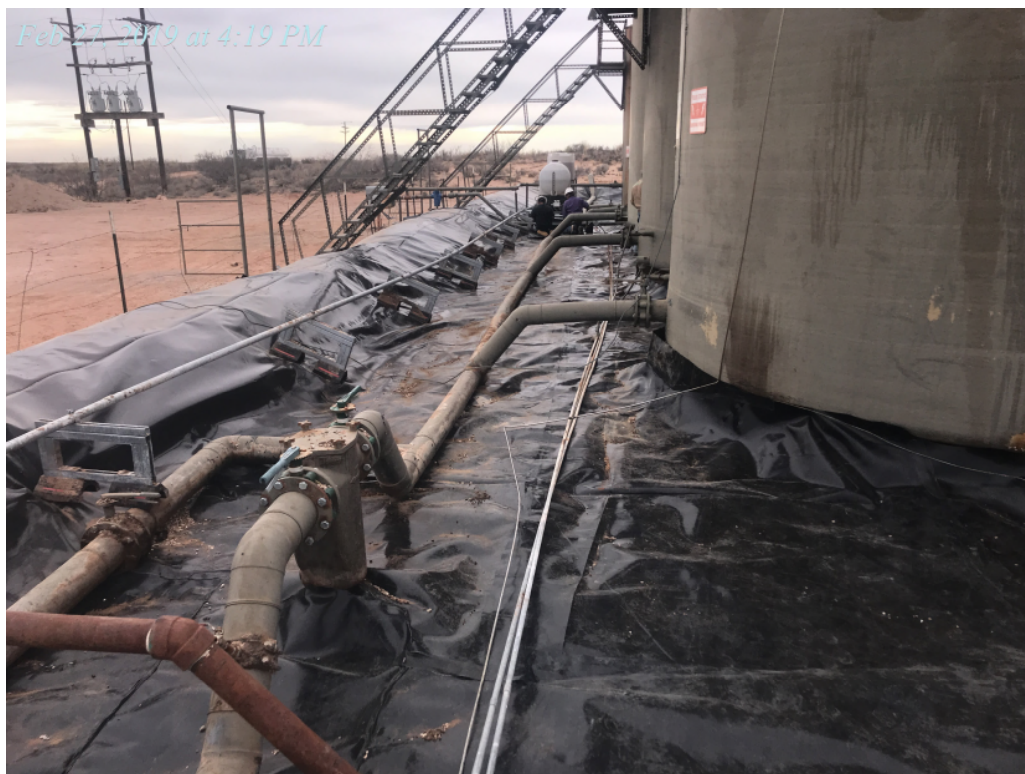
View East – Liner Installation

View South – Liner Installation

View Southeast – Liner Installation

View West – Liner Installation

The liner at the facility has been replaced and photo documentation is included.
