**Work Plan**  
**Convoy Booster Release**  
**Lea County, New Mexico**  
**Incident ID: NAPP2415666595**  
**Unit O Sec 28 T24S R33E**  
**32.183611°, -103.576709°**

**Produced Water Release**  
**Point of Release: Pump-Bearing Failure**  
**Release Date: 03/19/2024**  
**Volume Released: 150 barrels of Produced Water**  
**Volume Recovered: 130 barrels of Produced Water**

**Re: Work Plan  
Convoy Booster Release  
EOG Resources, Inc  
Incident ID: NAPP2415666595  
Site Location: Unit O, S28, T24S, R33E  
(Lat 32.183611°, Long -103.576709°)  
Lea County, New Mexico**

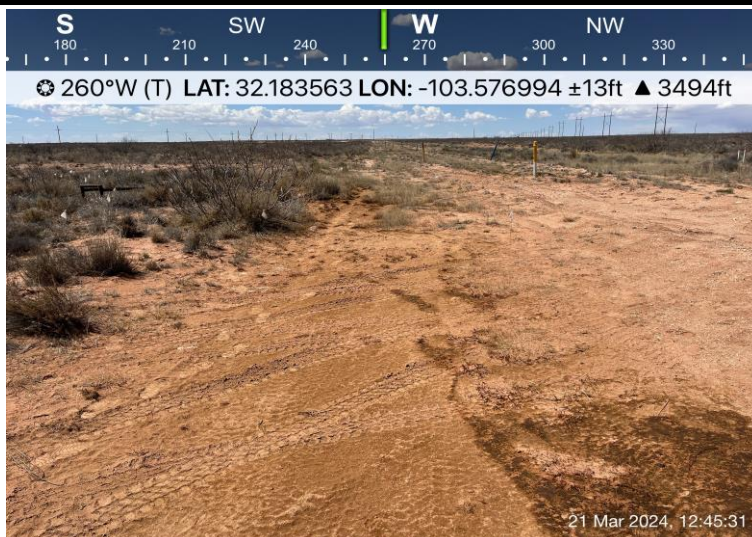
**Photograph No. 1****Facility:** Convoy Booster Release**County:** Lea County, New Mexico**Description:**

View West, area of S-1.

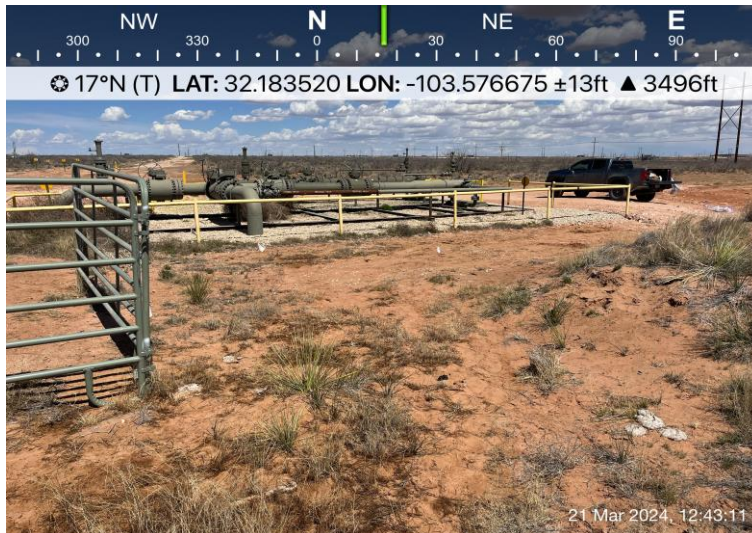
**Photograph No. 3****Facility:** Convoy Booster Release**County:** Lea County, New Mexico**Description:**

View Northeast, area of S-3.

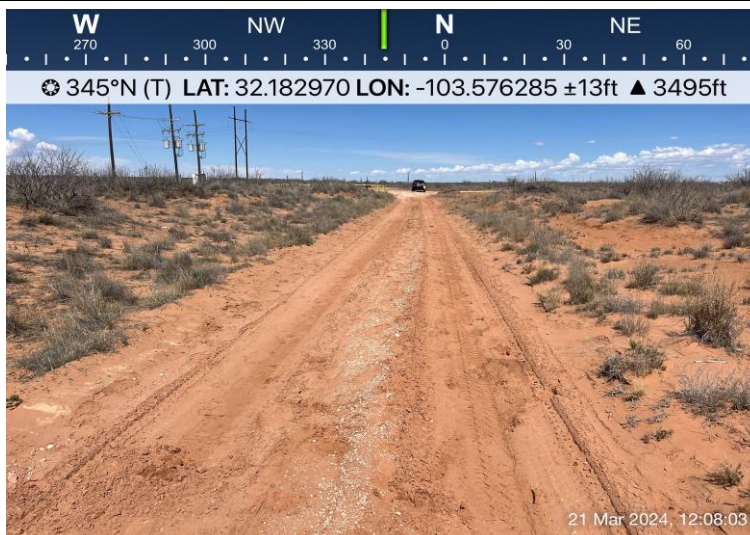
View North, area of S-4.

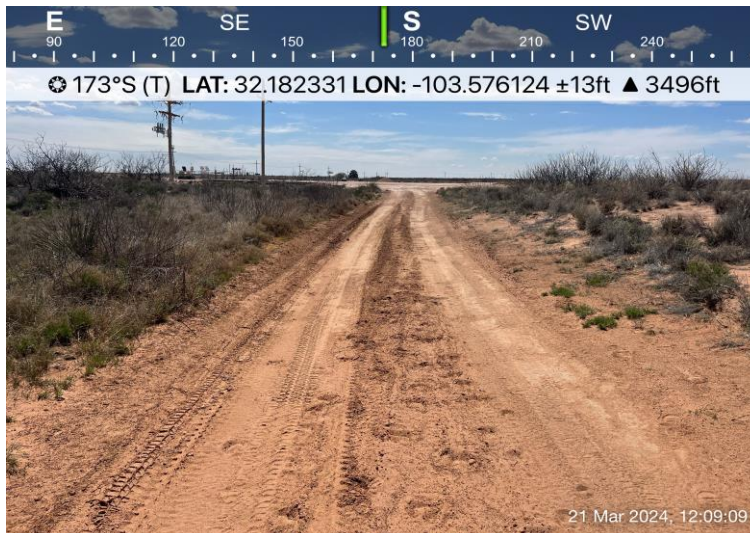
## Photograph No. 5

View South, area of S-5.
