# Deferral Request Report (Revised)

Marwari 28 CTB 1

NMOCD I.D. # nAPP2500723709

October 23, 2025 | Project No. AR257035

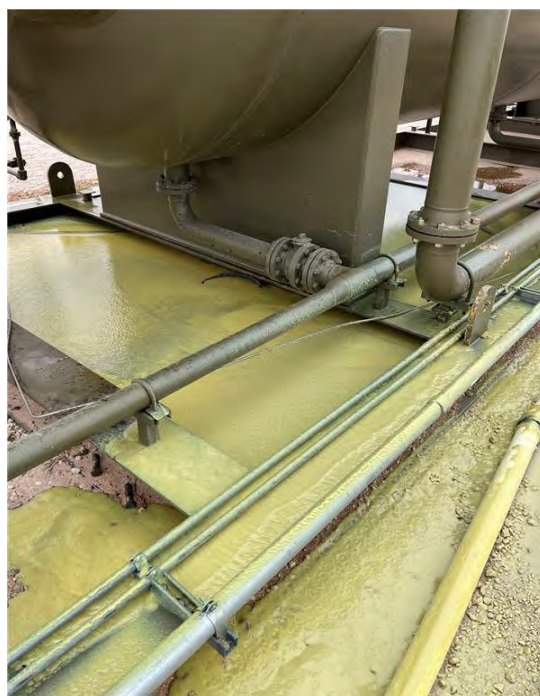
Photo 1

View of release area beneath East end of tank

Due to restricted access beneath the tank and the associated risk of compromising the structural integrity of the foundation, active remediation of the impacted soil is not feasible at this time. Therefore, Devon Energy respectfully requests a deferral of incident nAPP2500723709.

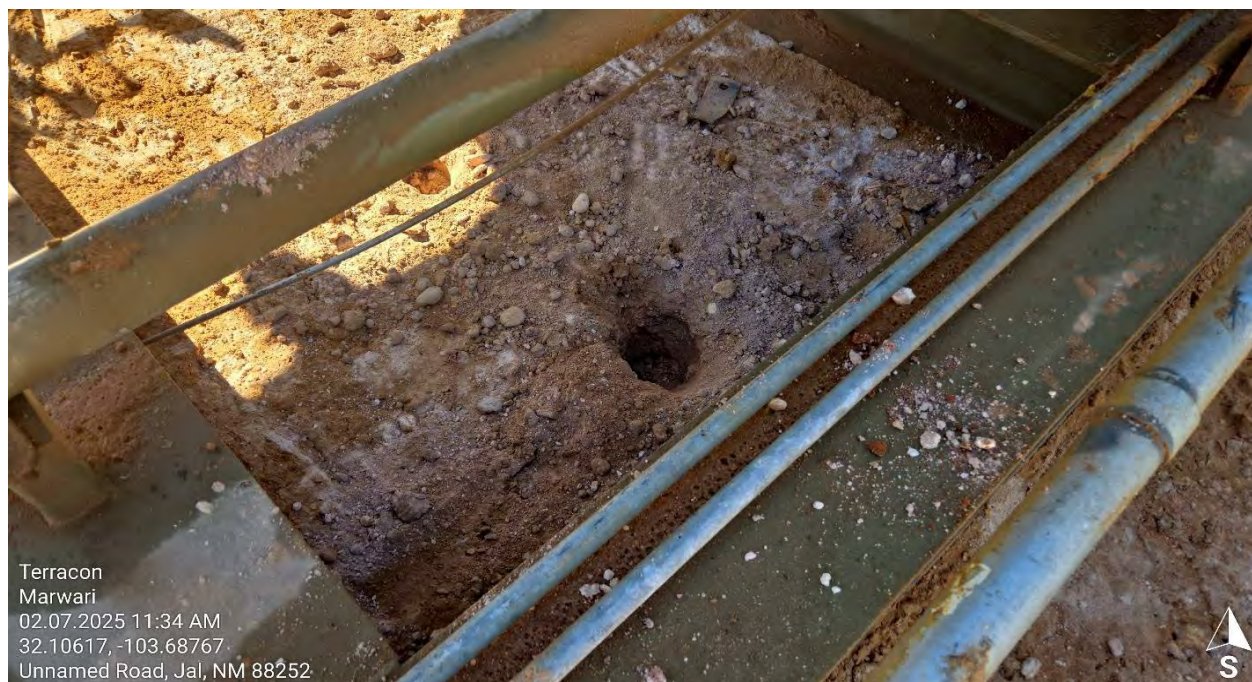
Photo 2

Due to limited accessibility to the release area within the skid beneath the horizontal tank, assessment of vertical extent of impact was conducted using a hand auger to advance two soil borings at an approximate 45-degree angle to a depth of 2.5 feet bgs to reach beneath the skid.

View of delineation sample location DSV-01 beneath East end of tank

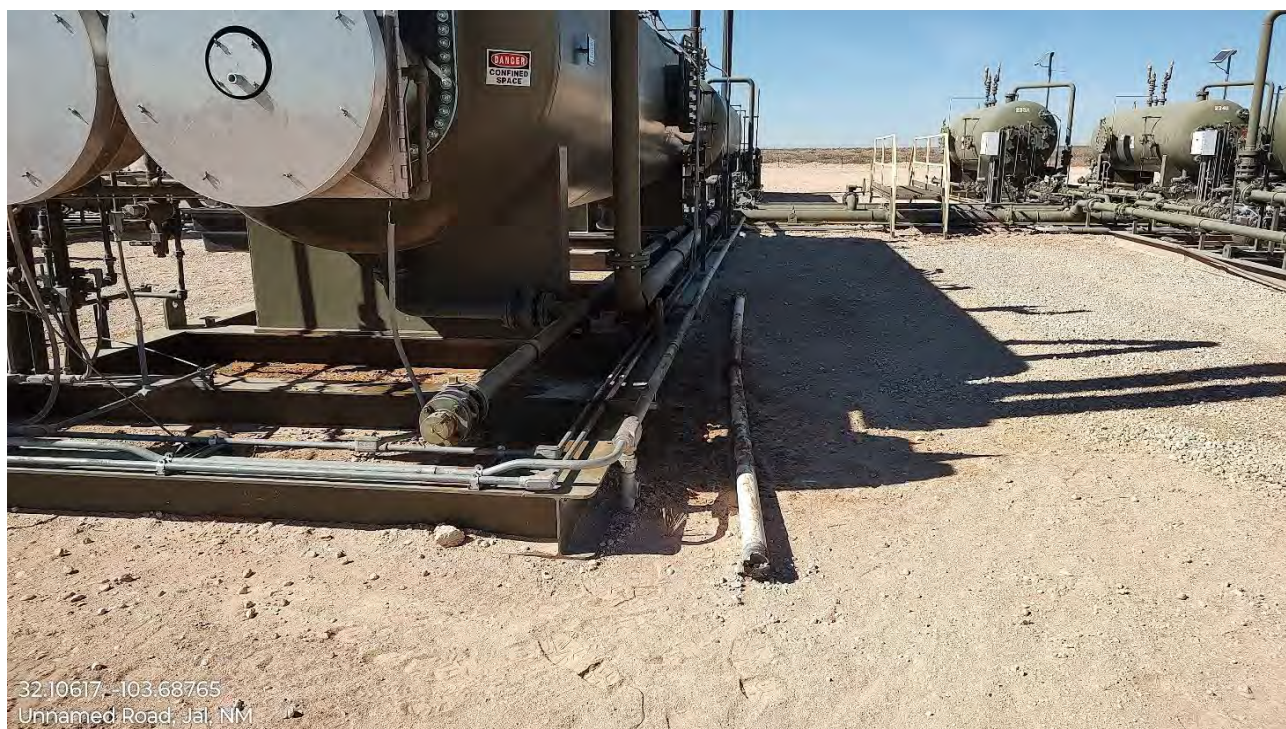
Photo 3

View of North side of tank looking West

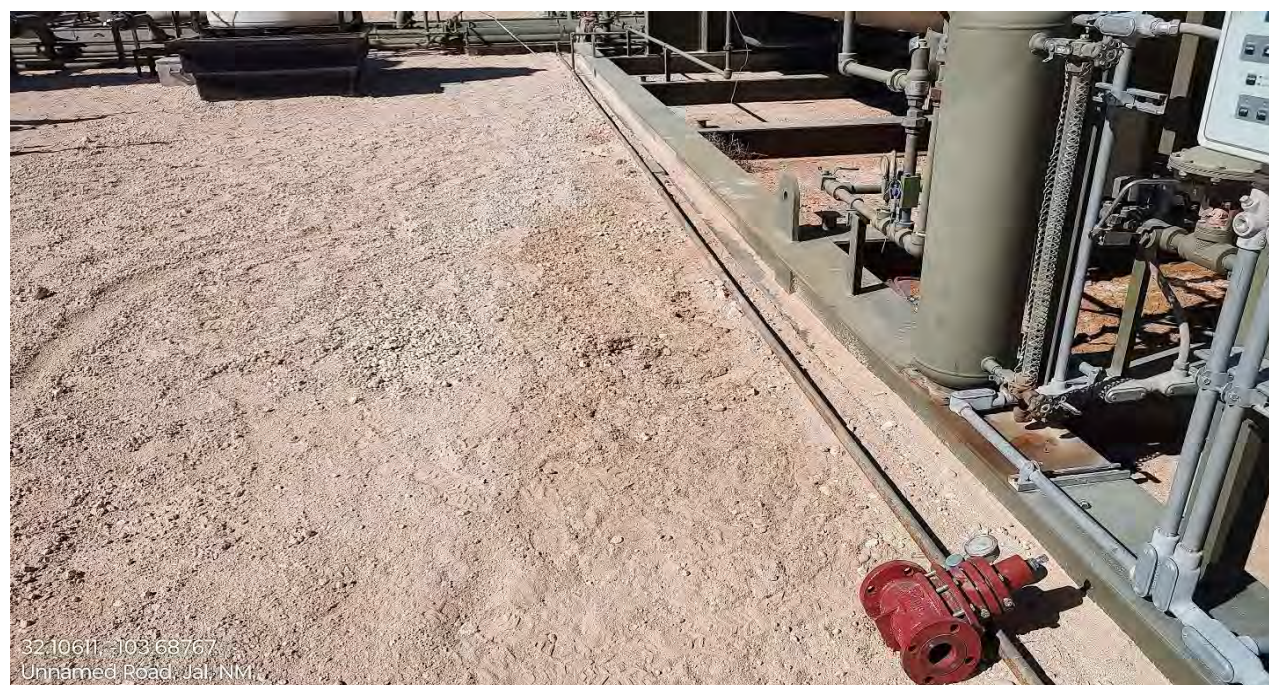
Photo 4

View of South side of tank looking West
