La Jara Water Gathering/ Spill ID nAPP2524128523

Simcoe Energy LLC
1199 Main Ave, Suite 101
Durango, CO 81301

Event Background:

La Jara Water Gathering Release

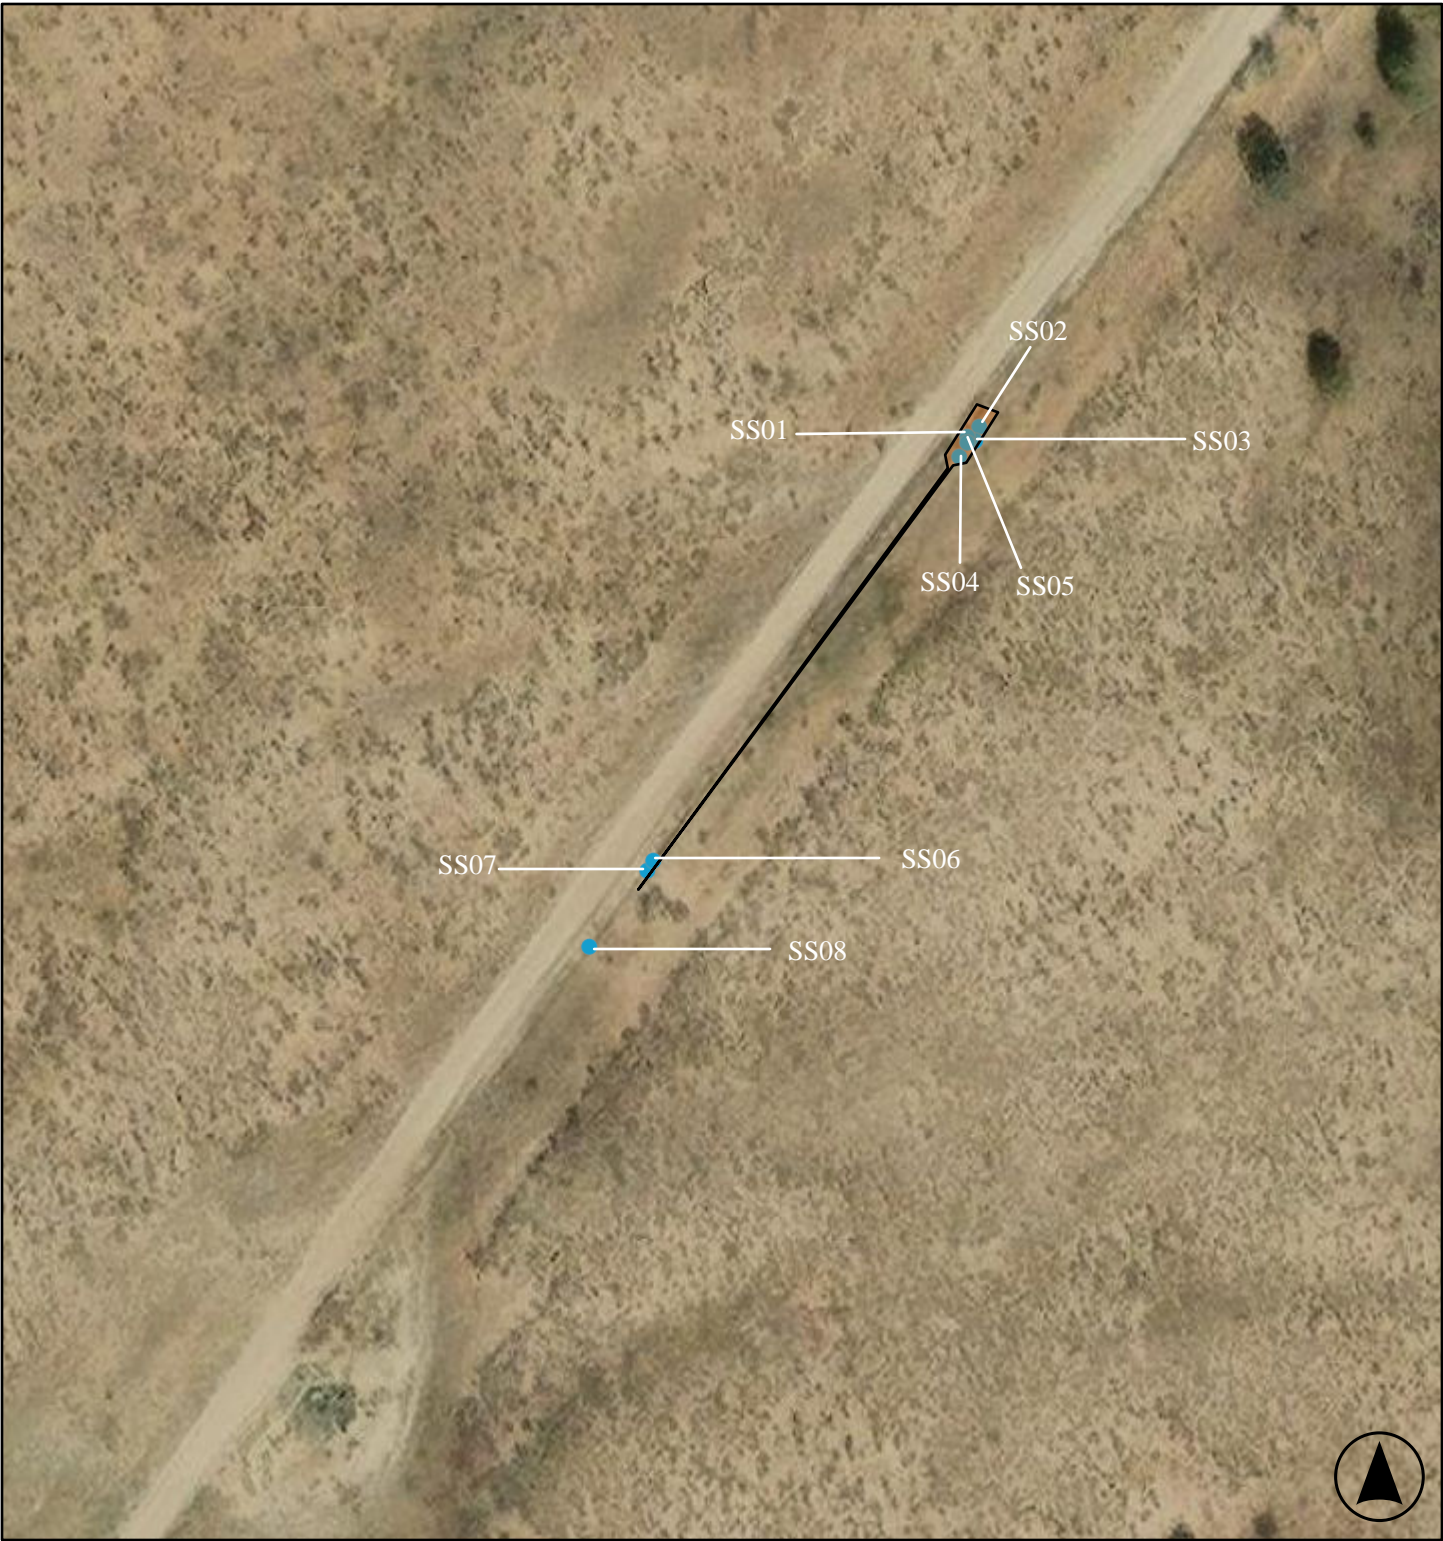
- Reportable Spill
- Sample

Distance to nearest surface water

1,830.67 ft

Distance to nearest well

4.24 mi

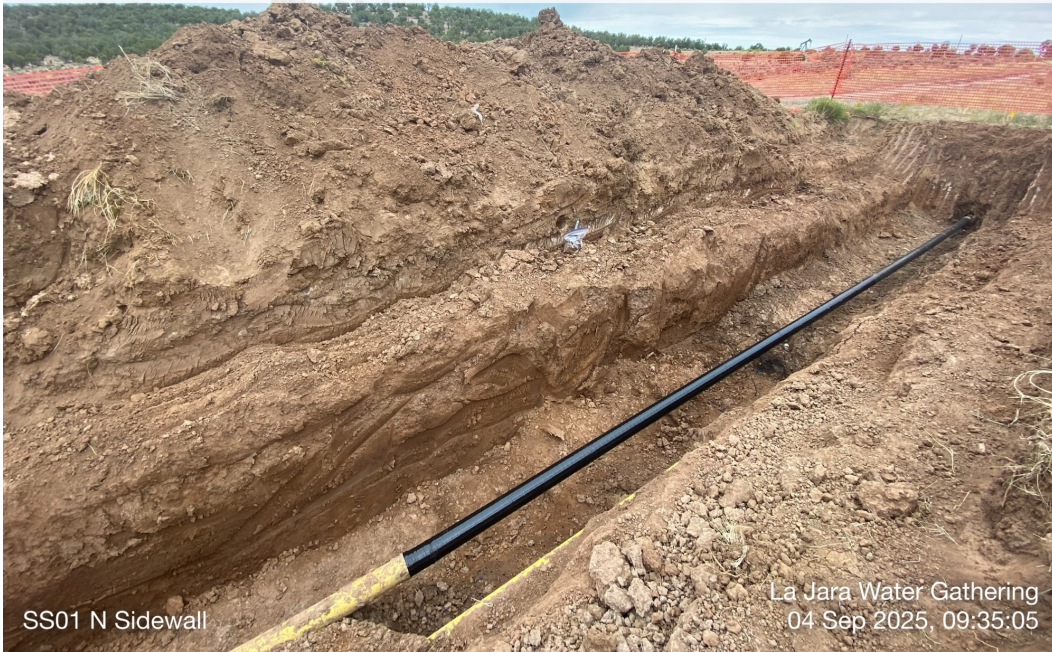
Blanco NM

On 8/25/2025 a water line leak was discovered along the right of way in the La Jara water gathering pipeline at approximately 36.8100205, -107.5112762. Produced water had daylighted to the surface and traveled south in the bar ditch of the road for 220'. SIMCOE LLC personnel were able to immediately isolate and contain the release.

1. SIMCOE removed 100 yards contaminated soil by excavation on 9/2/2025 and again on 9/12/2025. All contaminated soil was hauled to the Envirotech land farm #2 in New Mexico. After removal clean fill dirt was brought in to back fill the excavation.
2. The area was re-contoured to the preexisting grade.
3. Final reclamation will be conducted at the end of useful life of the pipeline as required by

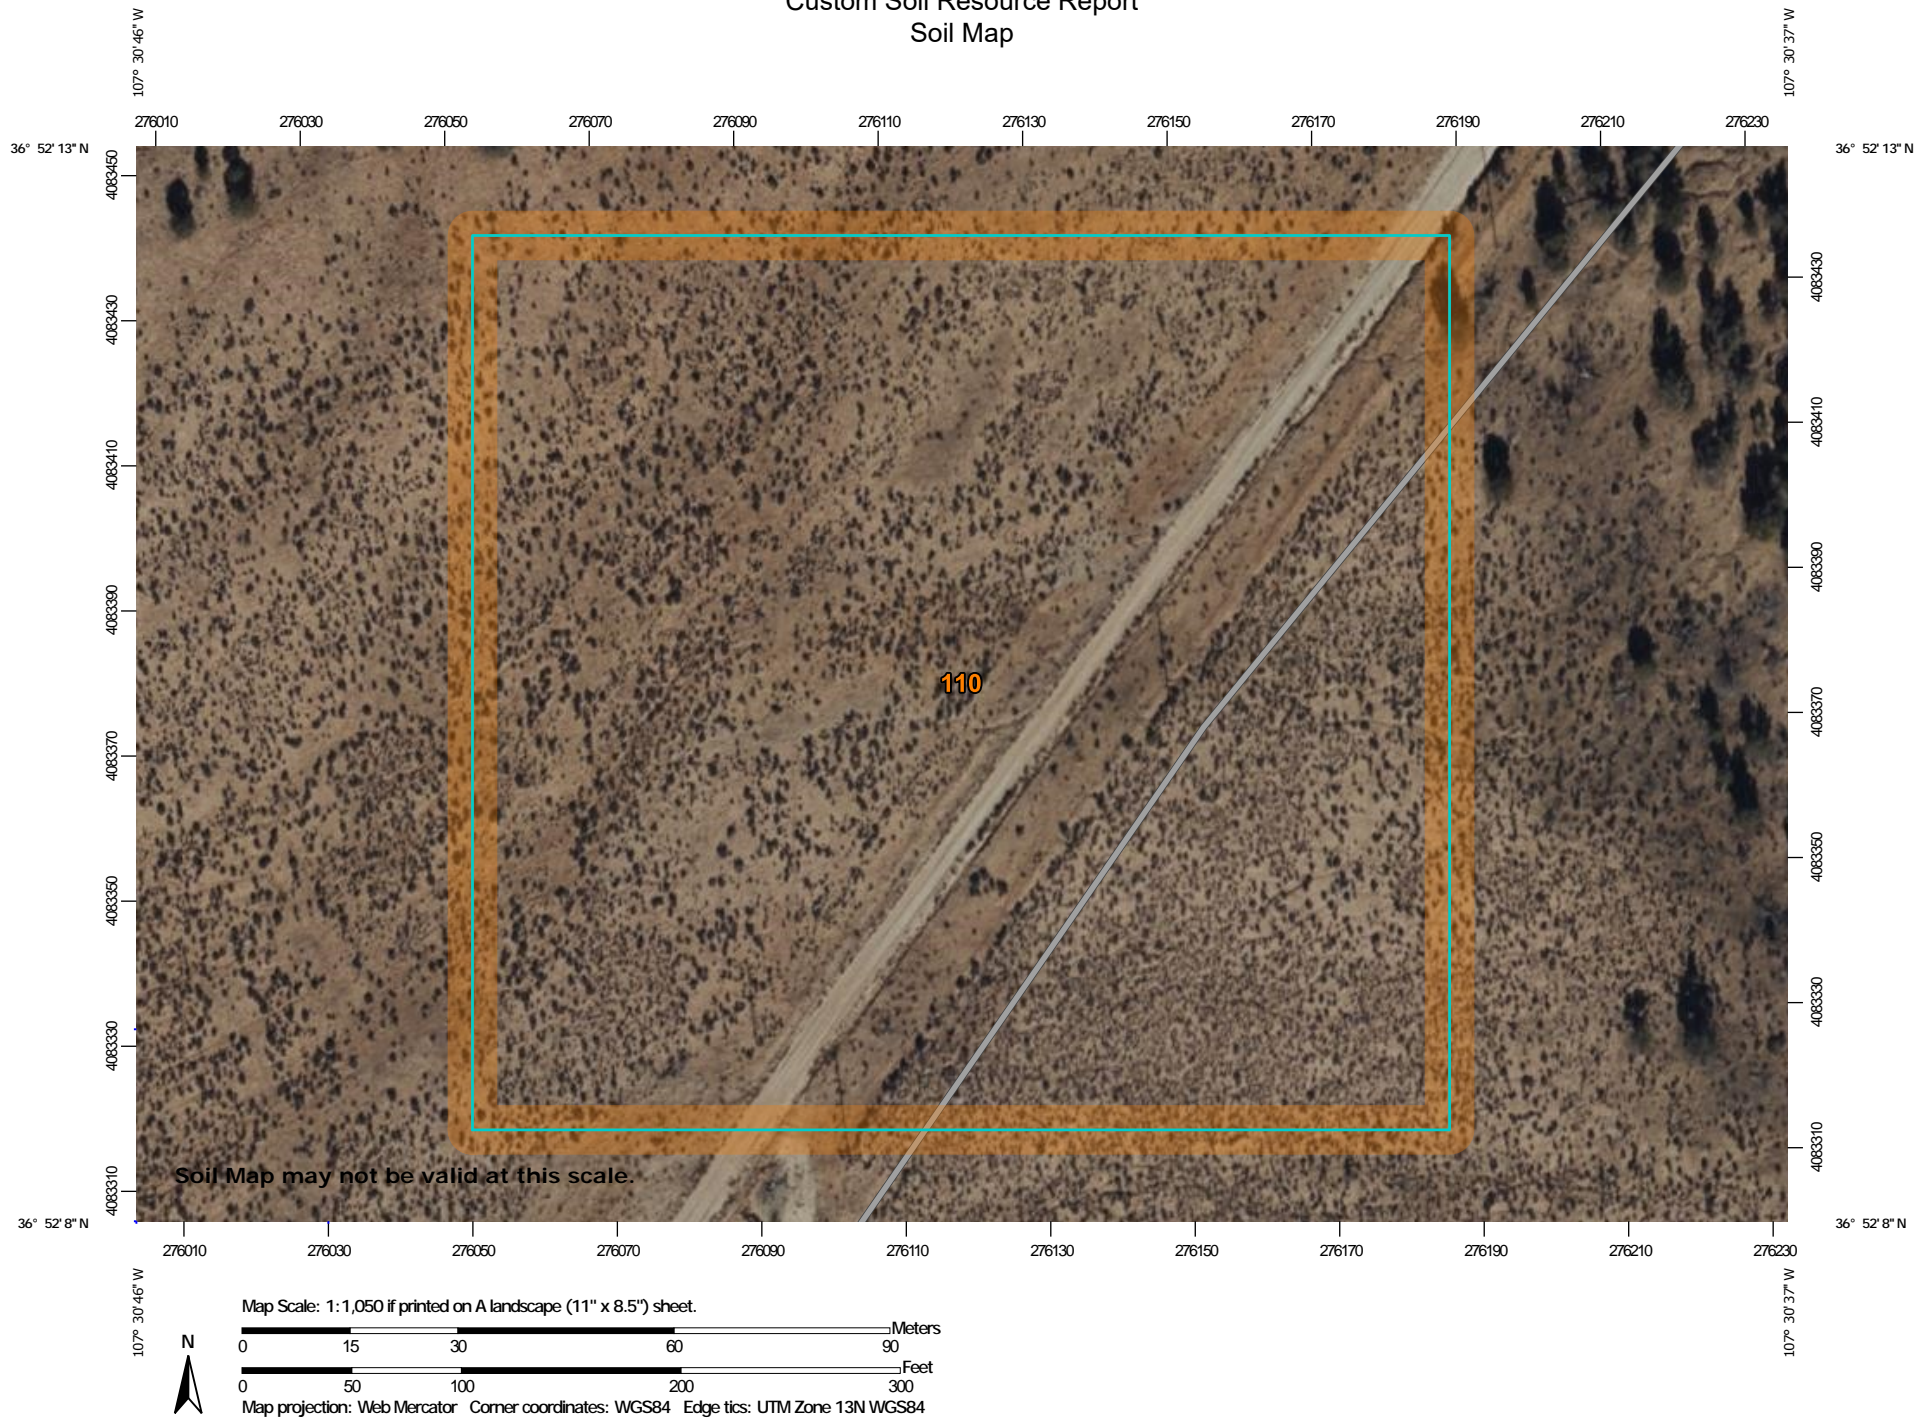
Custom Soil Resource Report
Soil Map

The soil map section includes the soil map for the defined area of interest, a list of soil map units on the map and extent of each map unit, and cartographic symbols displayed on the map. Also presented are various metadata about data used to produce the map, and a description of each soil map unit.

Map Unit Symbol	Map Unit Name	Acres in AOI	Percent of AOI
110	Vessilla-Menefee-Orlie complex, 1 to 30 percent slopes	4.1	100.0%
Totals for Area of Interest		4.1	100.0%
