# Remediation Summary & Soil Closure Request

## 3R Operating, LLC Shell State Tank Battery

Lea County, New Mexico  
Unit Letter "A", Section 18, Township 11 South, Range 33 East  
Latitude 33.369742° North, Longitude 103.647038° West  
NMOCD Reference No. nPRS0413152570

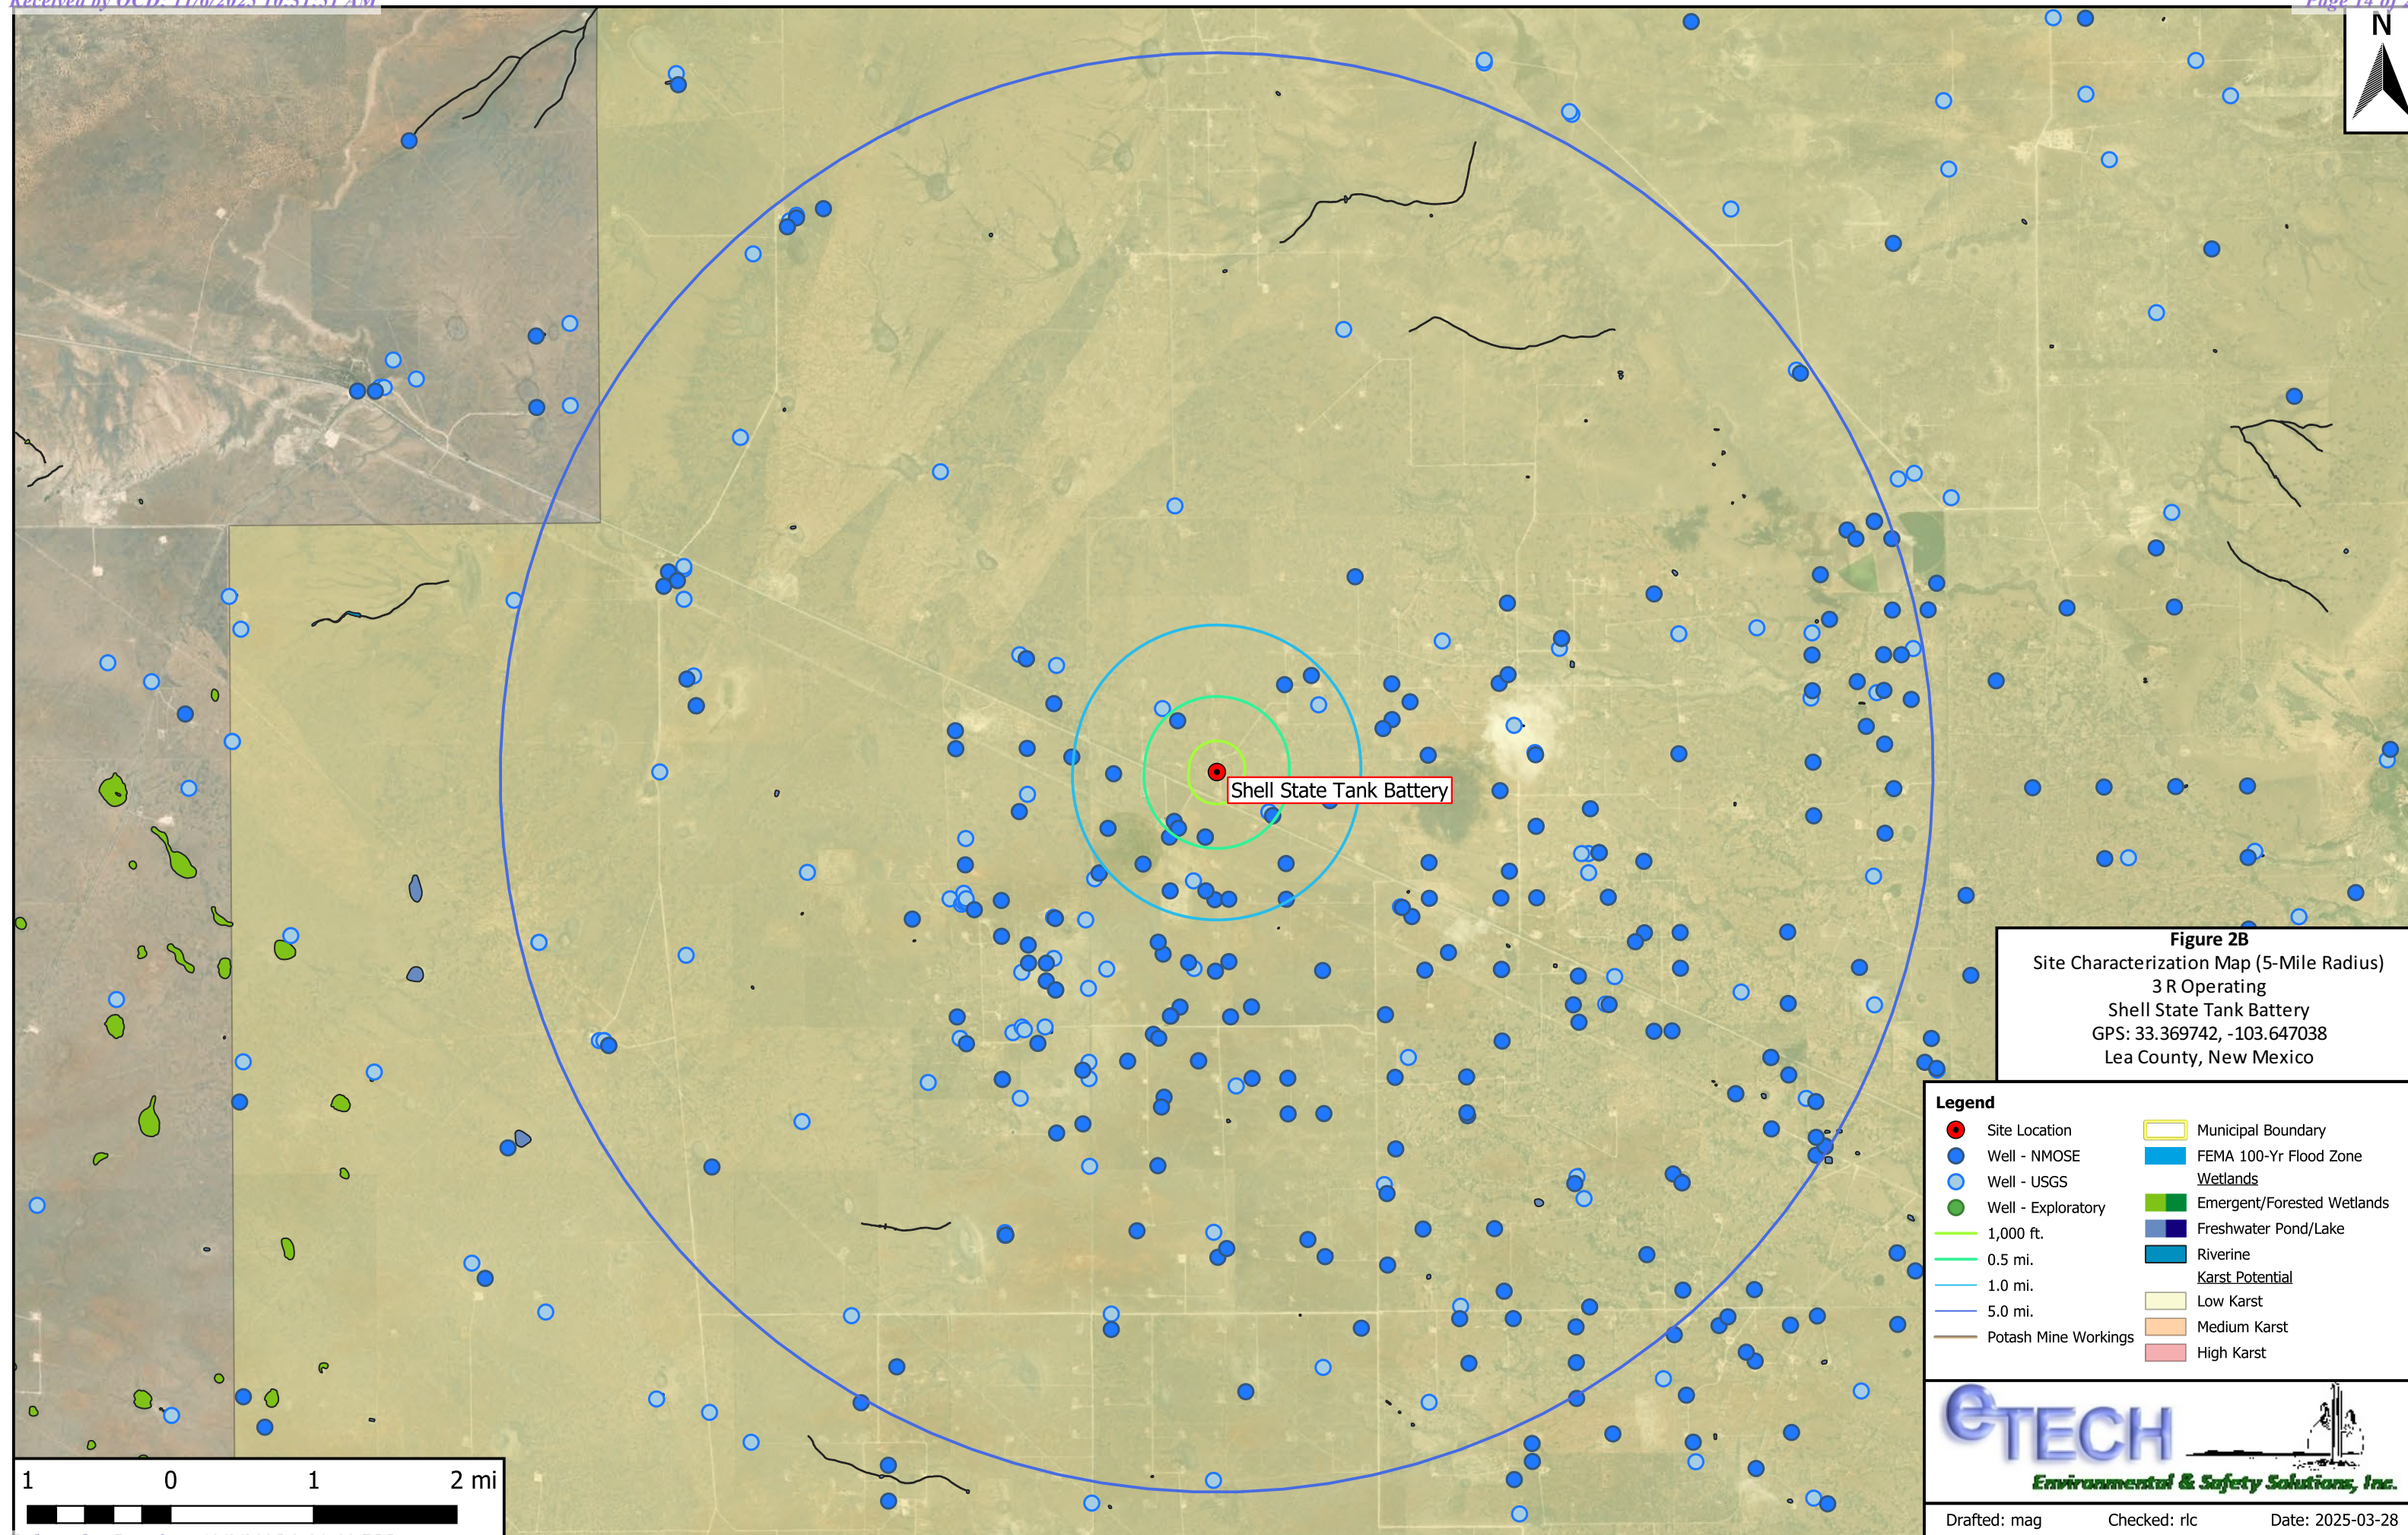
**Figure 2B**  
Site Characterization Map (5-Mile Radius)  
3 R Operating  
Shell State Tank Battery  
GPS: 33.369742, -103.647038  
Lea County, New Mexico

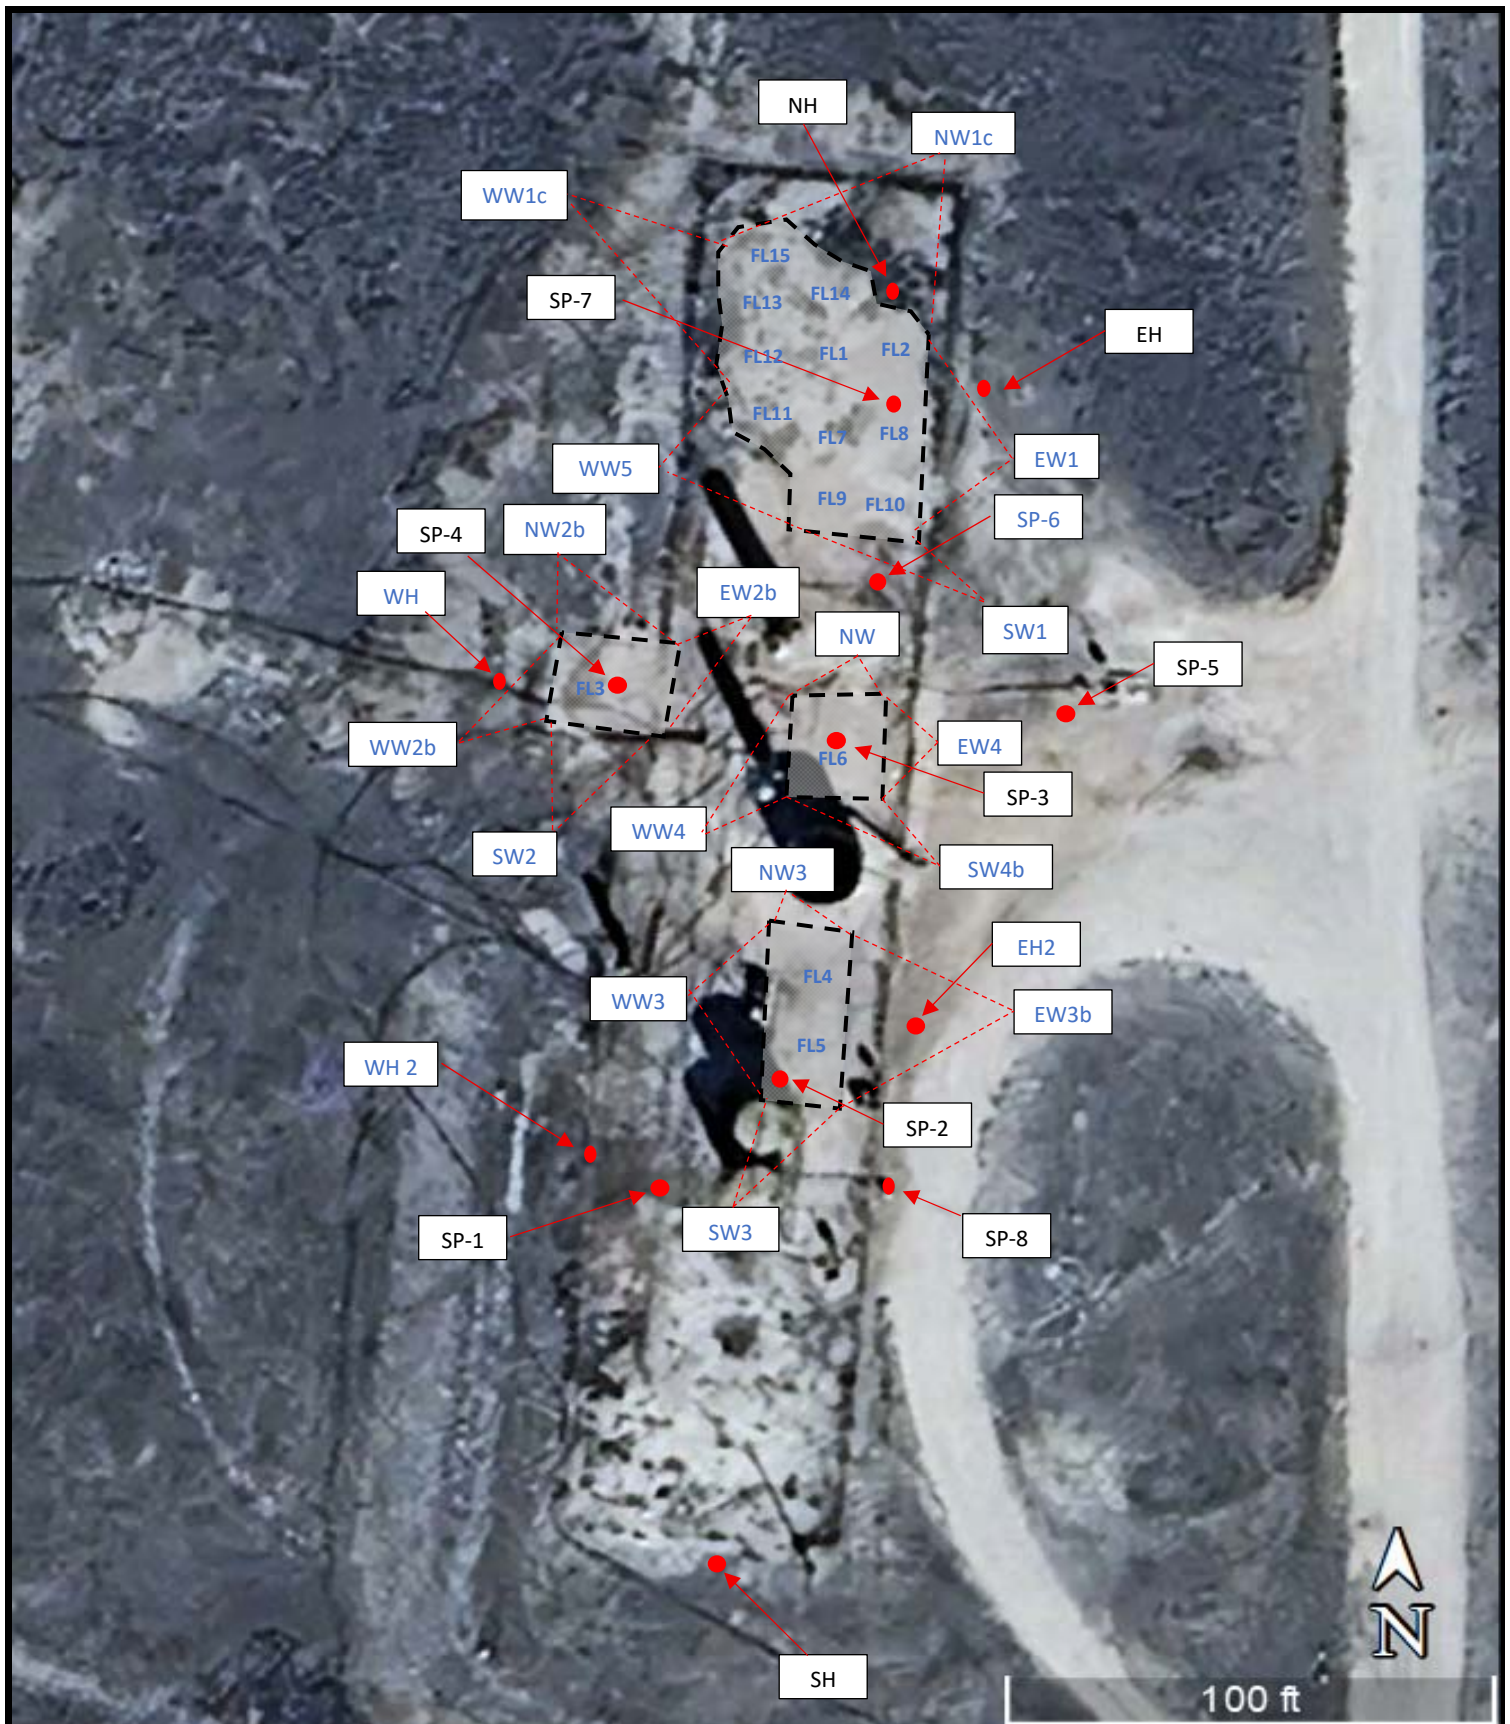
## **Figure 3**

### **Sample Location Map**

- Sample Point
- Excavated Area
- FL5 Confirmation Soil Sample

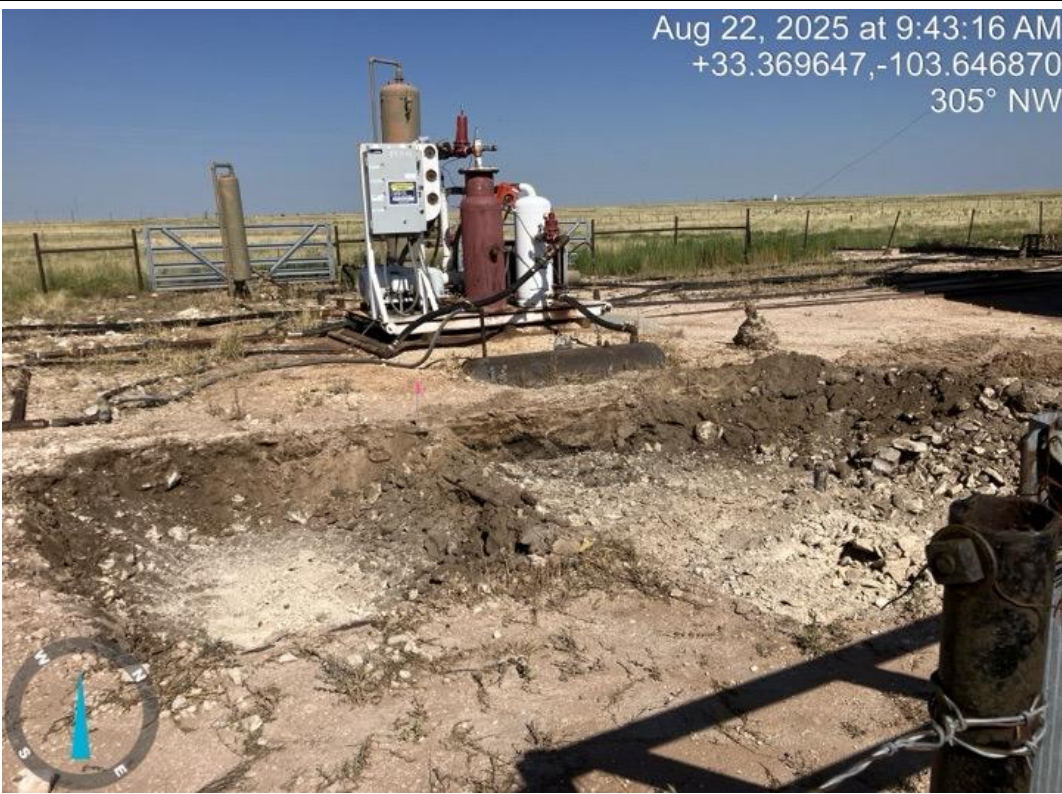
<b>Photo Number:</b> 3

<p>Aug 22, 2025 at 9:43:16 AM +33.369647,-103.646870 305° NW</p> <p>View of southern excavation.</p>
<b>Photo Direction:</b> Northwest	
<b>Photo Description:</b>

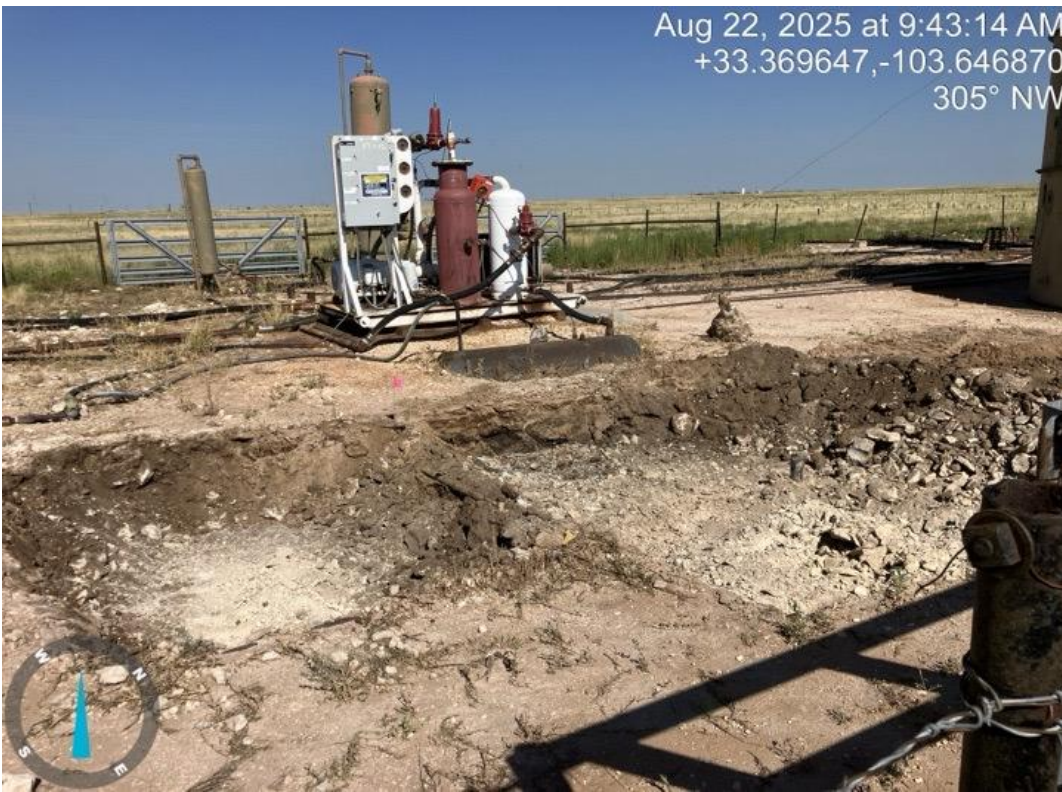
<b>Photo Number:</b> 4

<p>Aug 22, 2025 at 9:43:14 AM +33.369647,-103.646870 305° NW</p> <p>View of southern excavation.</p>
<b>Photo Direction:</b> Northwest	
<b>Photo Description:</b>

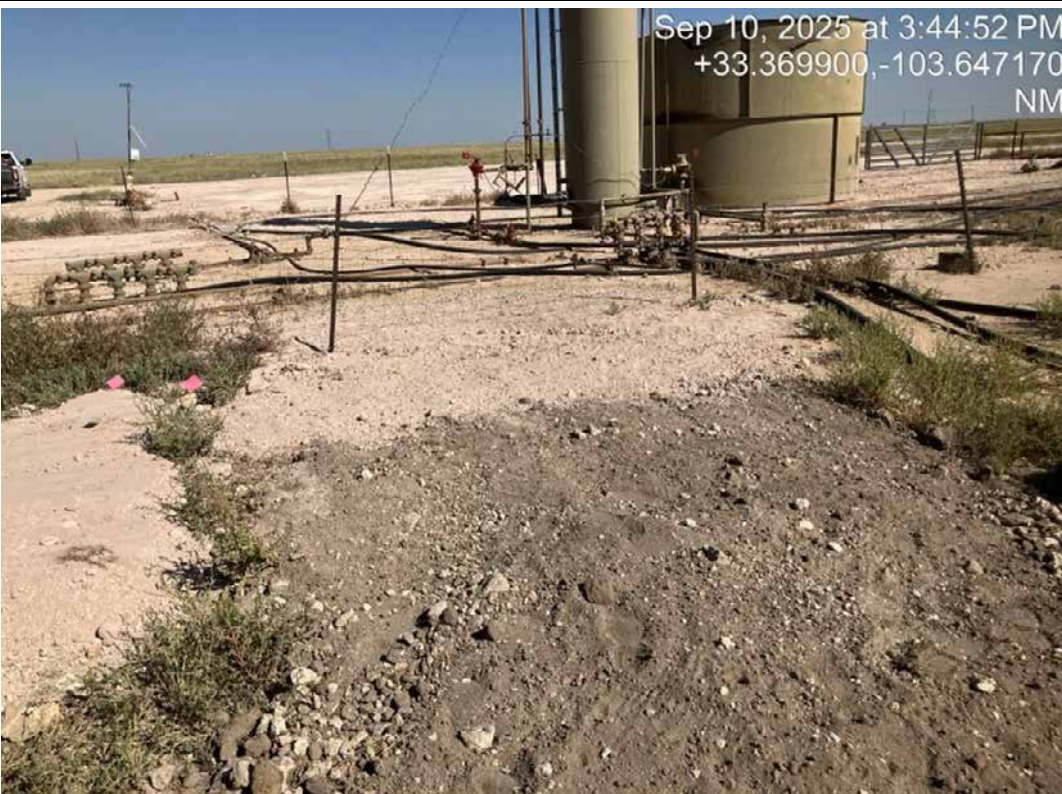
<b>Photo Number:</b> 9

<p>Sep 10, 2025 at 3:44:52 PM +33.369900,-103.647170 NM</p>
<b>Photo Direction:</b> East	
<b>Photo Description:</b>  View of western remediated area after backfill and regrading.

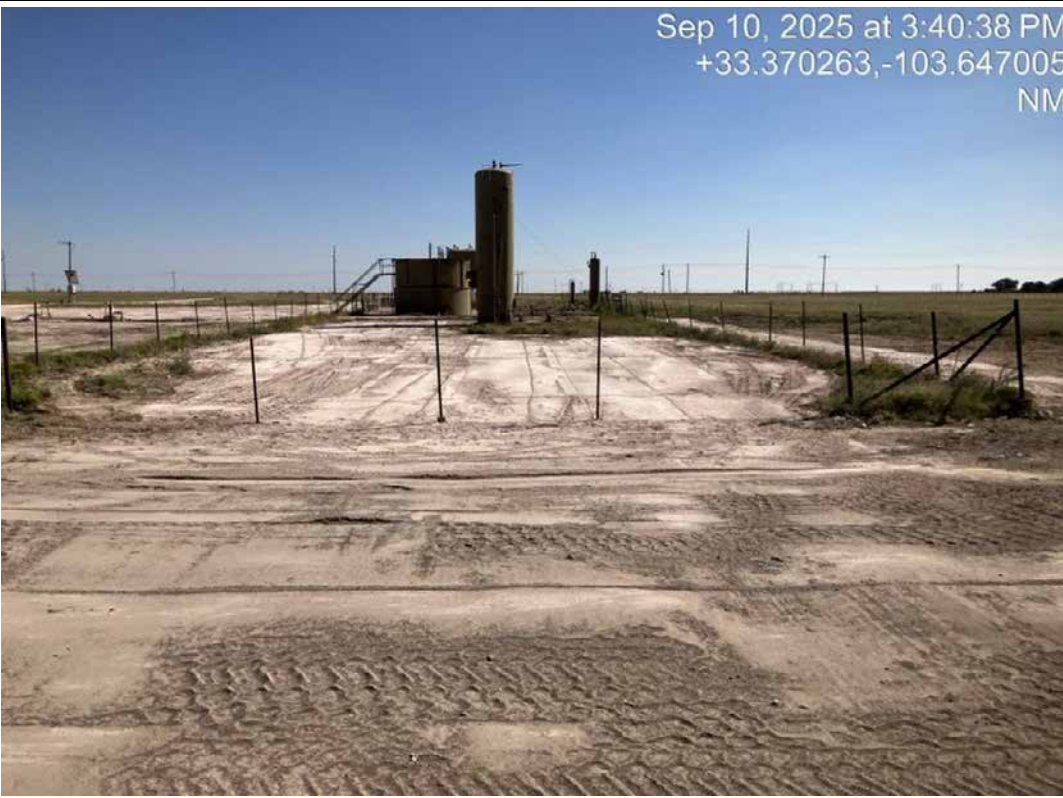
<b>Photo Number:</b> 11	<div>Sep 10, 2025 at 3:40:38 PM +33.370263,-103.647005 NM</div>

<b>Photo Direction:</b> South	
<b>Photo Description:</b>  View of northern remediated area backfill and regrading.

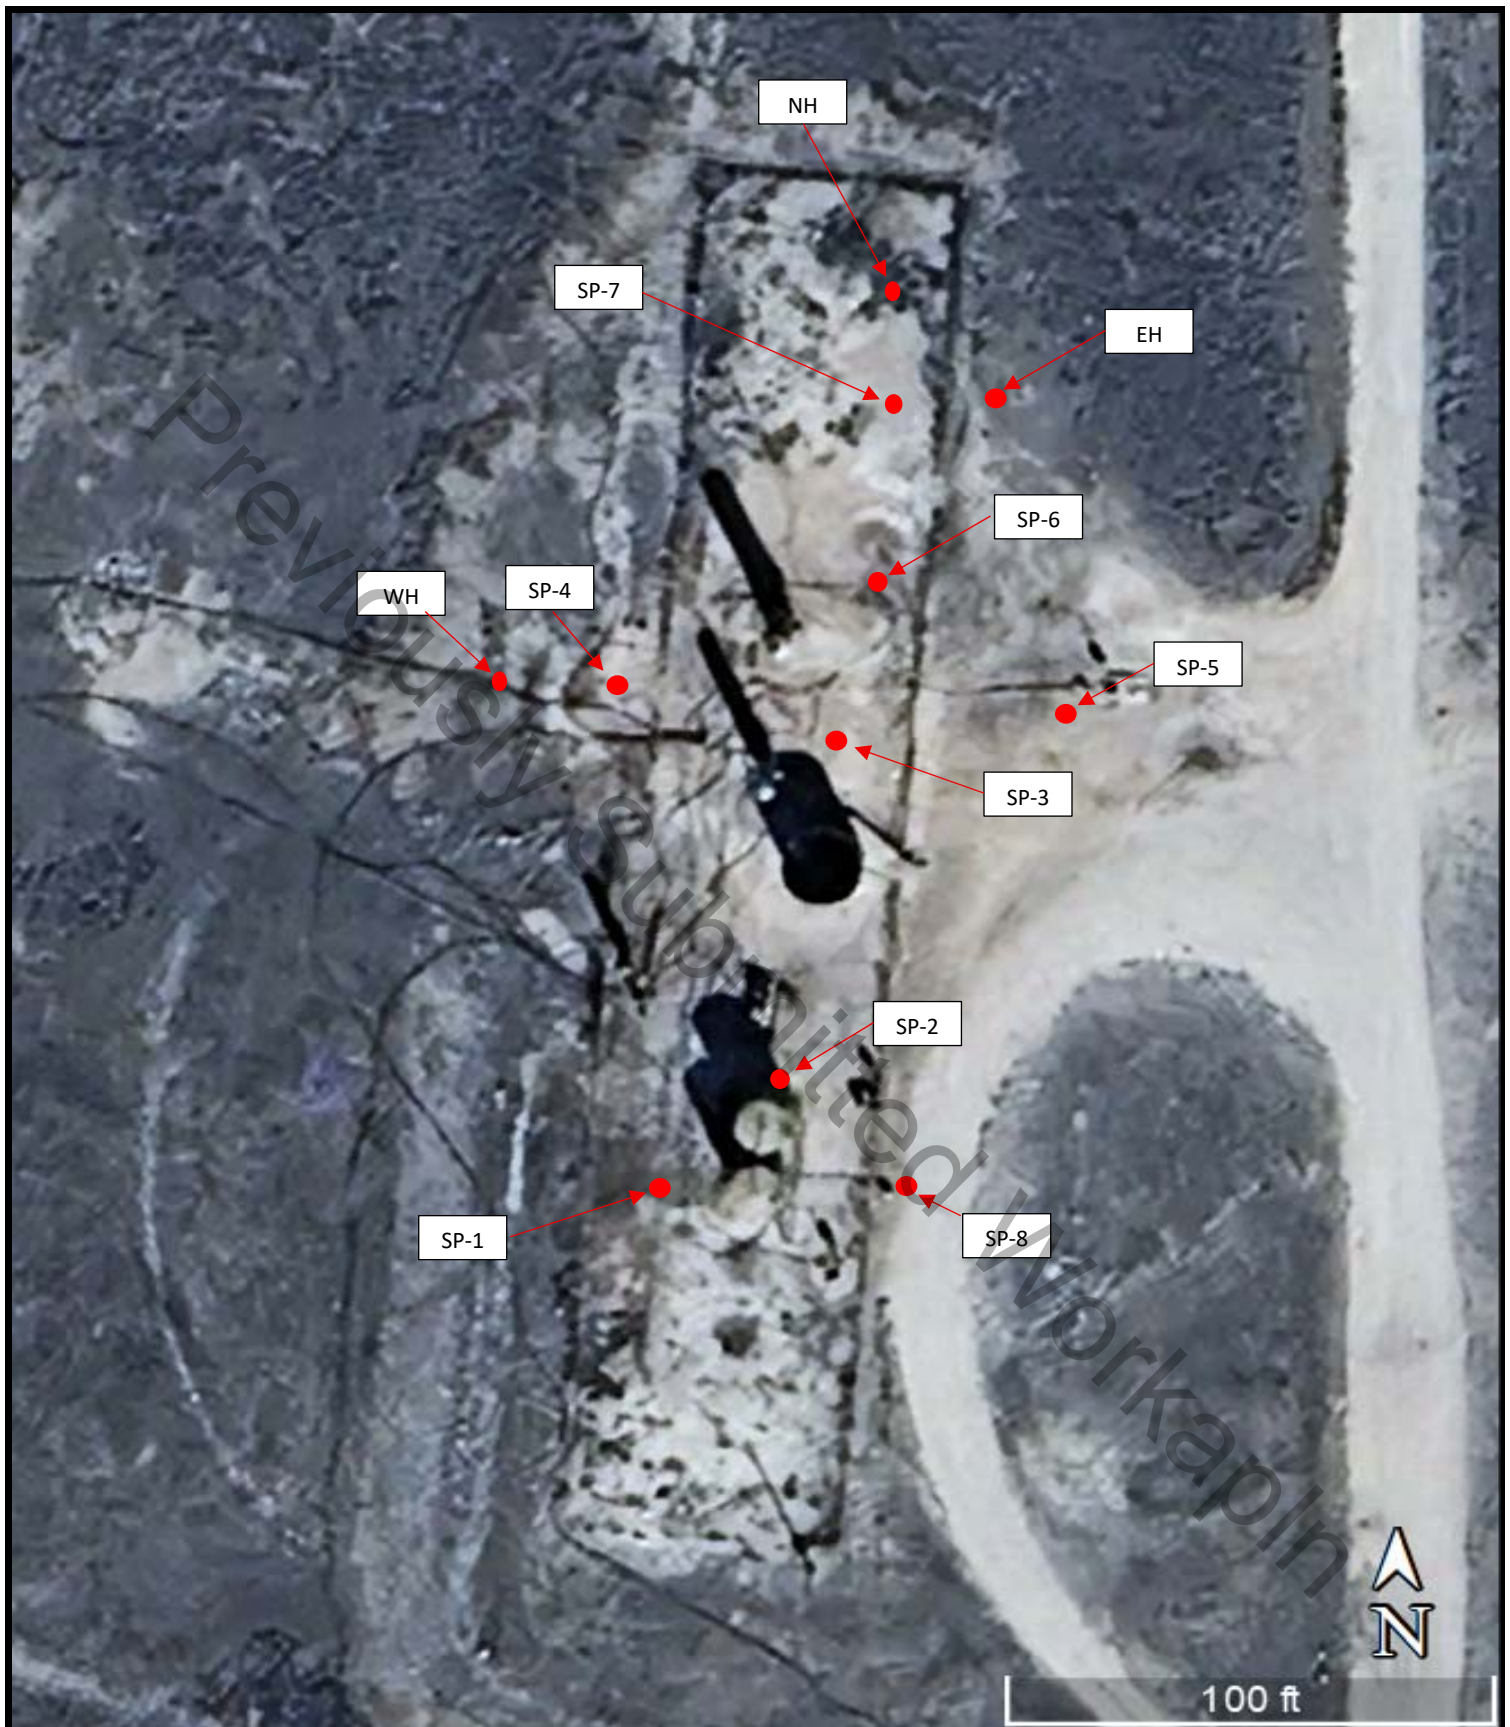
**Figure 3**  
**Site and Sample Location Map**

- Sample Point
- Affected Area
- Buried Pipeline
- Test Trench
- Excavated Area

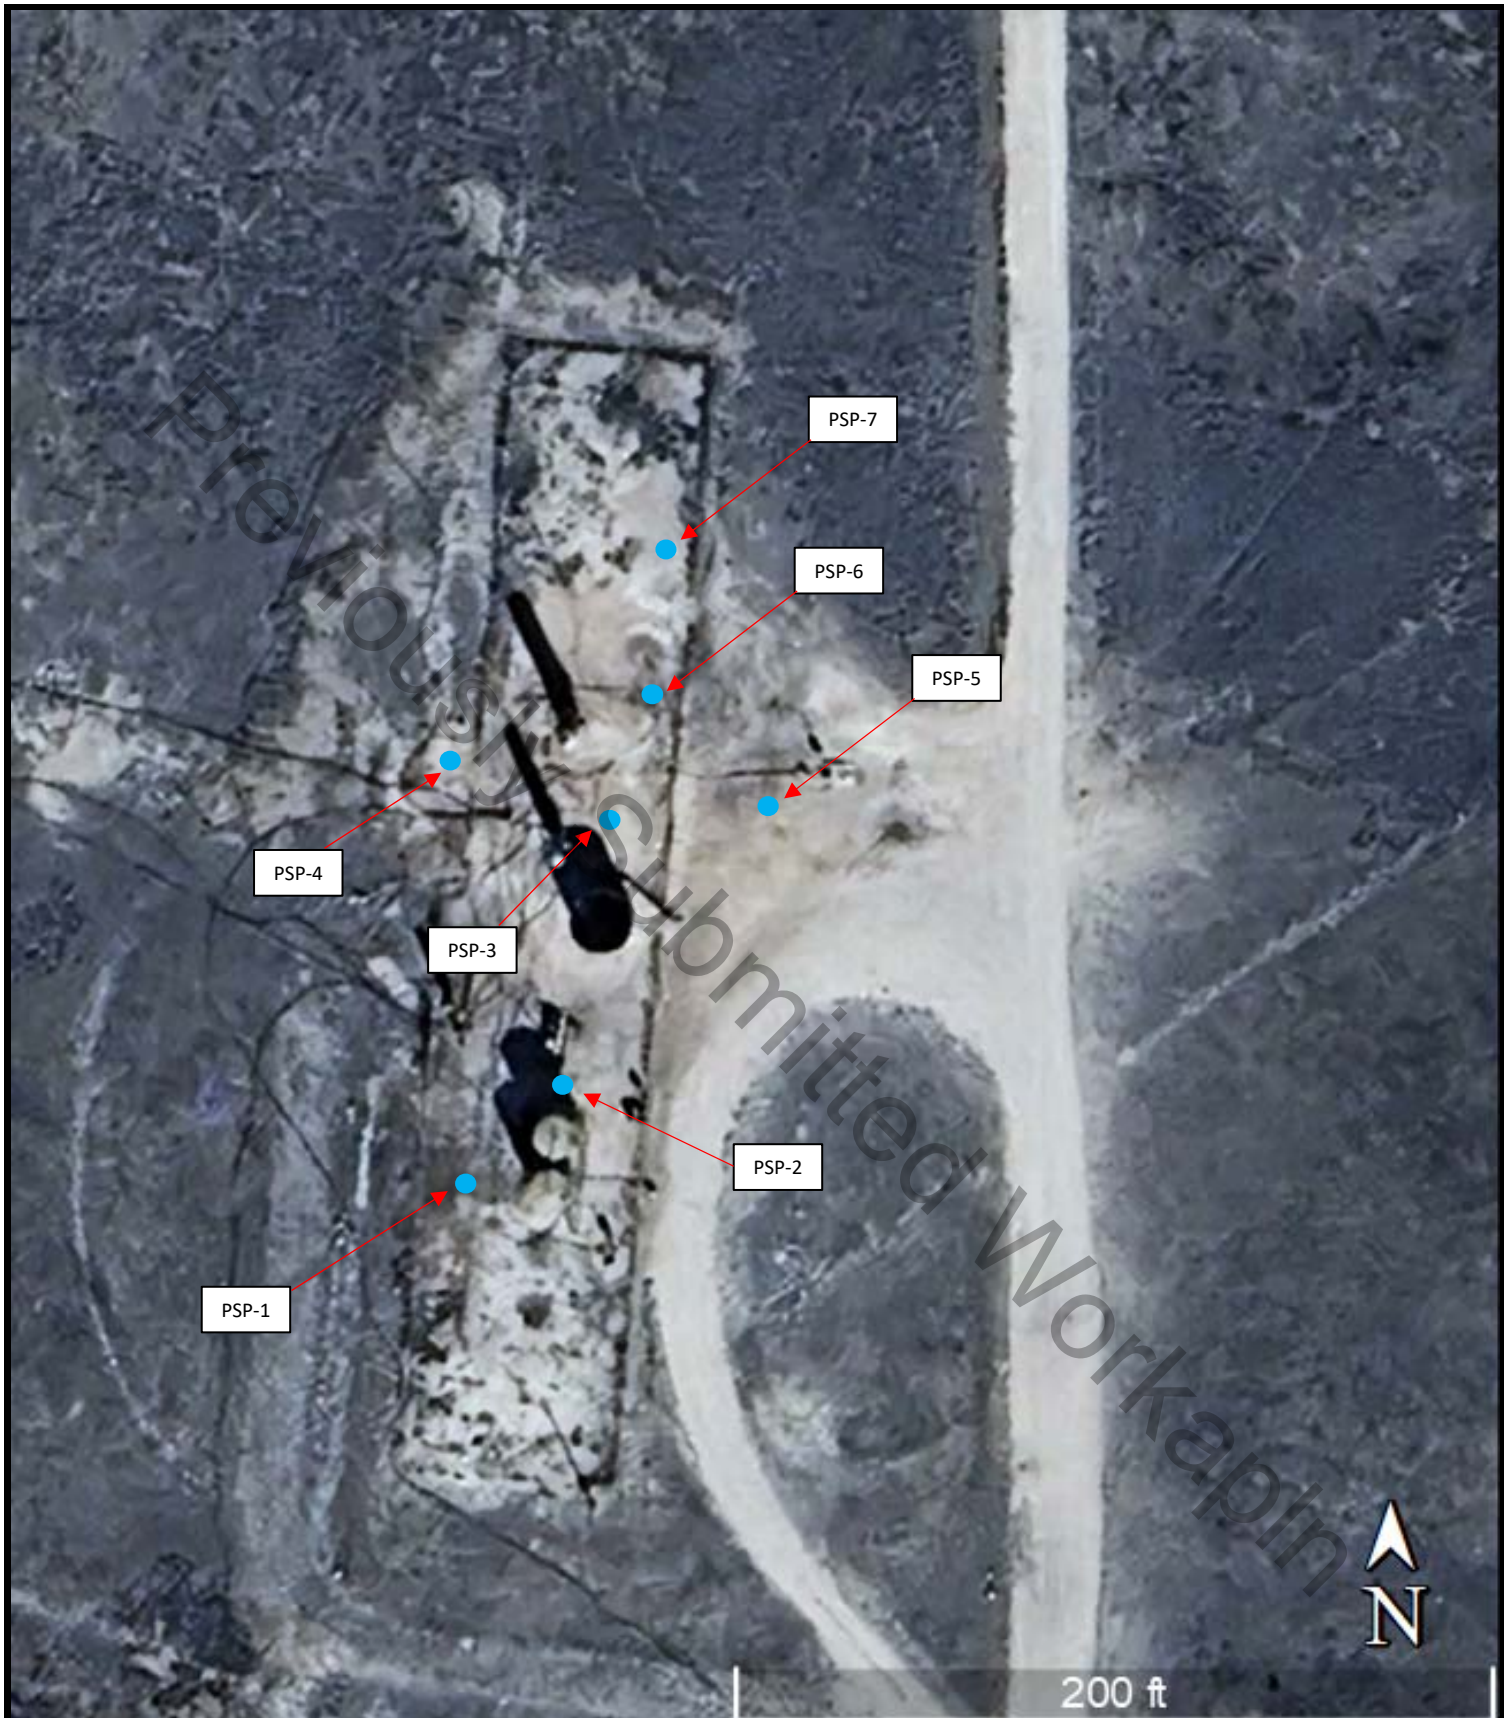
<b>Legend:</b>  ● Proposed Sample Point	<b>Attachment #3</b> Proposed Sample Location Map 3 R Operating Shell State Tank Battery GPS: 33.369742, -103.647038 Lea Co, NM
