**Re: Closure Request
PLU Battery 158
Incident Number NAPP2518847280
Eddy County, New Mexico**

Ensolum, LLC (Ensolum), on behalf of XTO Energy, Inc. (XTO), has prepared this *Closure Request* to document assessment, delineation, excavation, and soil sampling activities performed at the PLU Battery 158 (Site). The purpose of the remedial activities was to assess for the presence or absence of impacts to soil following a release of crude oil resulting from a flare fire. Based on confirmation soil sample laboratory analytical results, XTO is submitting this *Closure Request* for Incident Number NAPP2518847280.

XTO Energy, Inc.
Closure Request
PLU Battery 158

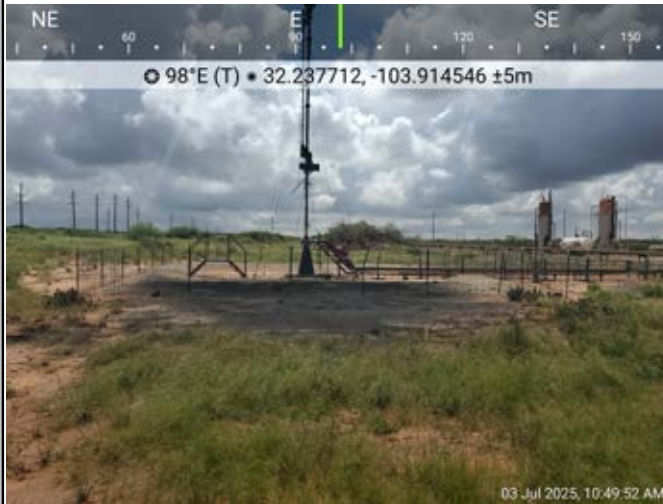
Photograph: 1
Description: Stained Area
View: East

On July 3, 2025, Ensolum personnel visited the Site to evaluate the release extent and soil staining from the fire based on information provided on the C-141 and visual observations. The release area was mapped utilizing a handheld Global Positioning System (GPS) unit and is depicted on Figure 2. Photographic documentation was collected during the assessment activities and is included in the Photographic Log in Appendix B.

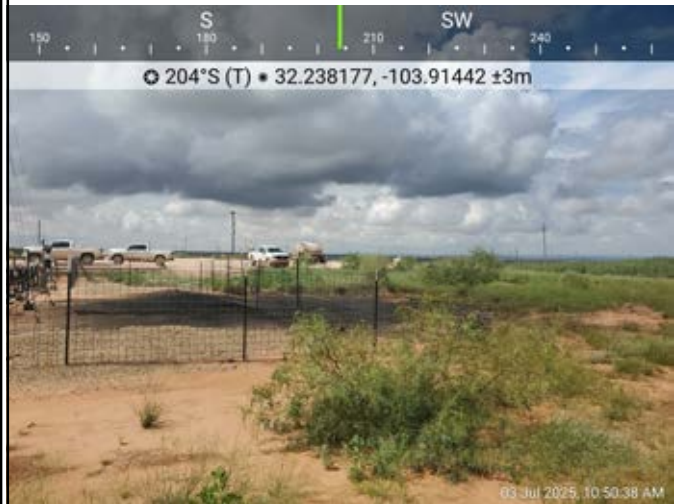
Photograph: 2
Description: Stained Area
View: Southwest

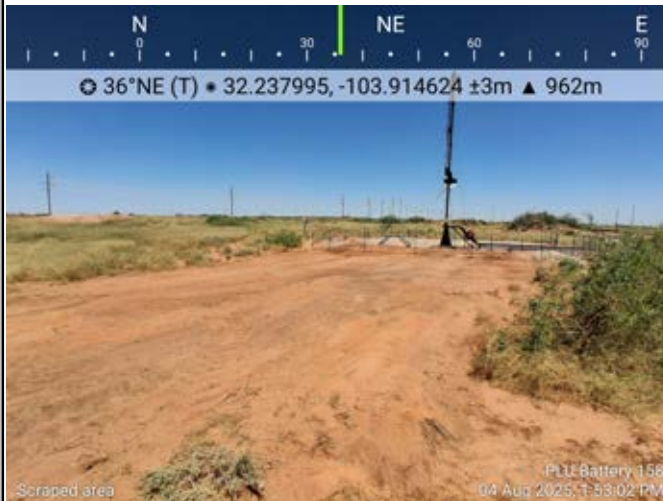
Photograph: 3
Description: Scraped Area near CS7, CS06, CS05,
CS04, CS03
View: Northeast

On August 4, 2025, Ensolum personnel returned to the Site to oversee surface scraping activities. The entirety of the surficial staining caused by the release was scraped to approximately 0.25 feet bgs utilizing heavy equipment. Following surface scraping activities, Ensolum personnel collected seven composite soil samples (CS01 through CS07) representing no more than 200 square feet from the scraped area. Composite soil samples CS01 and CS02 were collected from the pad surface at a depth of approximately 0.25 feet bgs, and samples CS03 through CS07 were collected from the pasture surface at a depth of approximately 0.25 feet bgs. The 5-point composite soil samples were collected by placing five equivalent aliquots of soil into a 1-gallon, resealable plastic bag and homogenizing the samples by thoroughly mixing. All soil samples were field screened for volatile organic compounds (VOCs) utilizing a calibrated photoionization detector (PID) and chloride Hach® chloride QuanTab® test

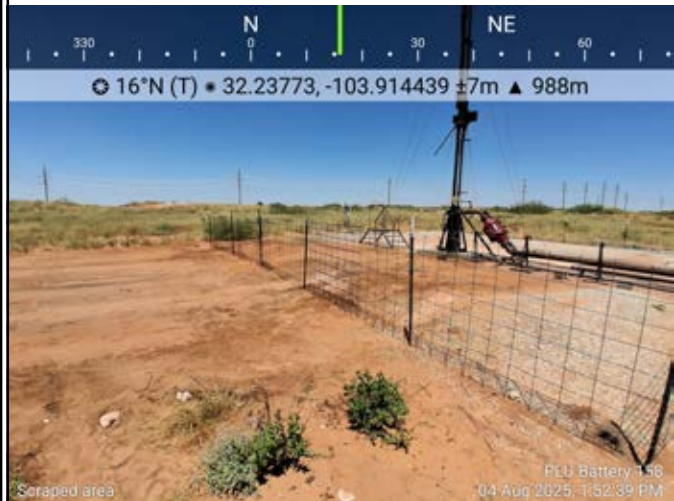
Photograph: 4
Description: Scraped area near CS01, CS02
View: North

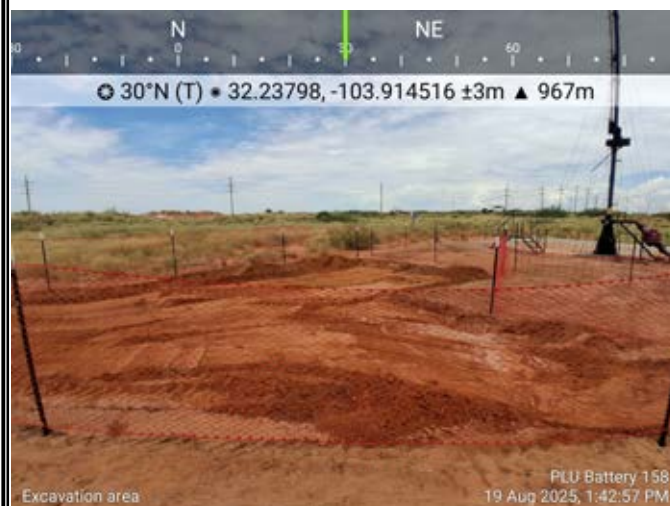
Description: Excavation activities near FS01,
FS02, FS03, FS04, SW01

View: Northeast

Impacted soil was excavated from the release extent as indicated by composite soil sample laboratory analytical results. Excavation activities were performed in the pasture utilizing a backhoe and transport vehicles. To direct excavation activities, soil was field screened as described above. The excavation was completed to a terminal depth of 1-foot bgs as shown on Figure 3. Photographic documentation of all delineation and excavation activities is included in Appendix B.

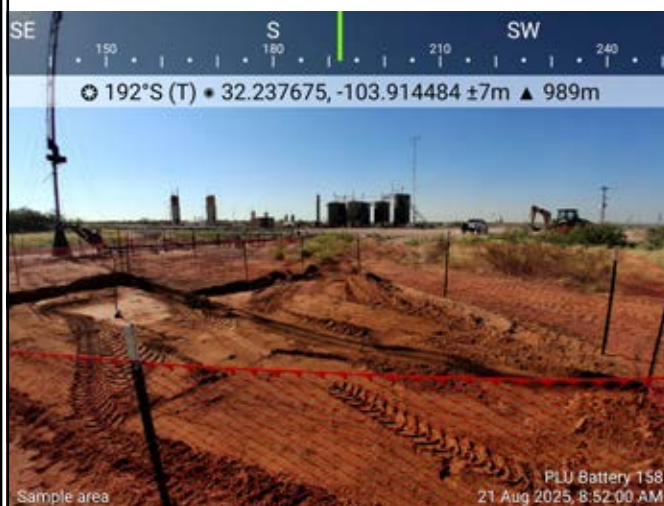
Description: Sampling activities near FS01,
FS02, FS03, FS04, SW01

View: South

Following the removal of impacted soil in the pasture, five composite soil samples (FS01 through FS04, and SW01) were collected representing no more than 200 square feet from the sidewalls and floor of the excavation. The composite samples were collected in the same manner as described above. Confirmation soil samples (FS01 through FS04) were collected from the floor of the excavation from a depth of 1-foot bgs. Confirmation soil sample SW01 was collected from the sidewalls of the excavation at a depth ranging from ground surface to 1-foot bgs. The soil samples were transported under strict chain-of-custody procedures to Cardinal Laboratories (Cardinal) in Hobbs, New Mexico, for analysis of the same COCs mentioned above, with the exception that chloride was analyzed following method SM4500.

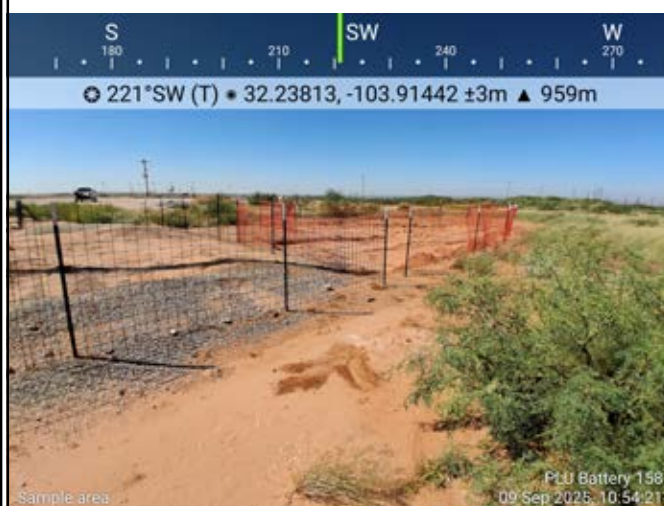
Description: Lateral delineation near SS01

Between August 19 and September 9, 2025, Ensolum personnel returned to the Site to oversee lateral delineation and excavation of impacted soil based on laboratory analytical results collected from the composite soil samples. Four discrete delineation soil samples (SS01 through SS04) were collected from outside the release extent at ground surface to assess the lateral extent of the release. The delineation soil samples were collected and handled in the same manner as described above and their locations are provided on Figure 2.
