Closure Report
Gramma Ridge Battery (09.08.2025)
Incident #: NAPP2525149049
Lea County, New Mexico
Unit D, Sec 14, T24S, R34E
32.222663°, -103.448462°

Produce Water Release
Point of Release: Equipment Failure
Release Date: 09.08.2025
Volume Released: 12 Barrels of Produced Water
Volume Recovered: 11 Barrels of Produced Water

Re: Closure Report
Gramma Ridge Battery (09.08.2025)
Incident ID: NAPP2525149049
Chevron U.S.A., Inc.
Site Location: Unit D, S14, T26S, R34E
32.222663, -103.448462
Lea County, New Mexico

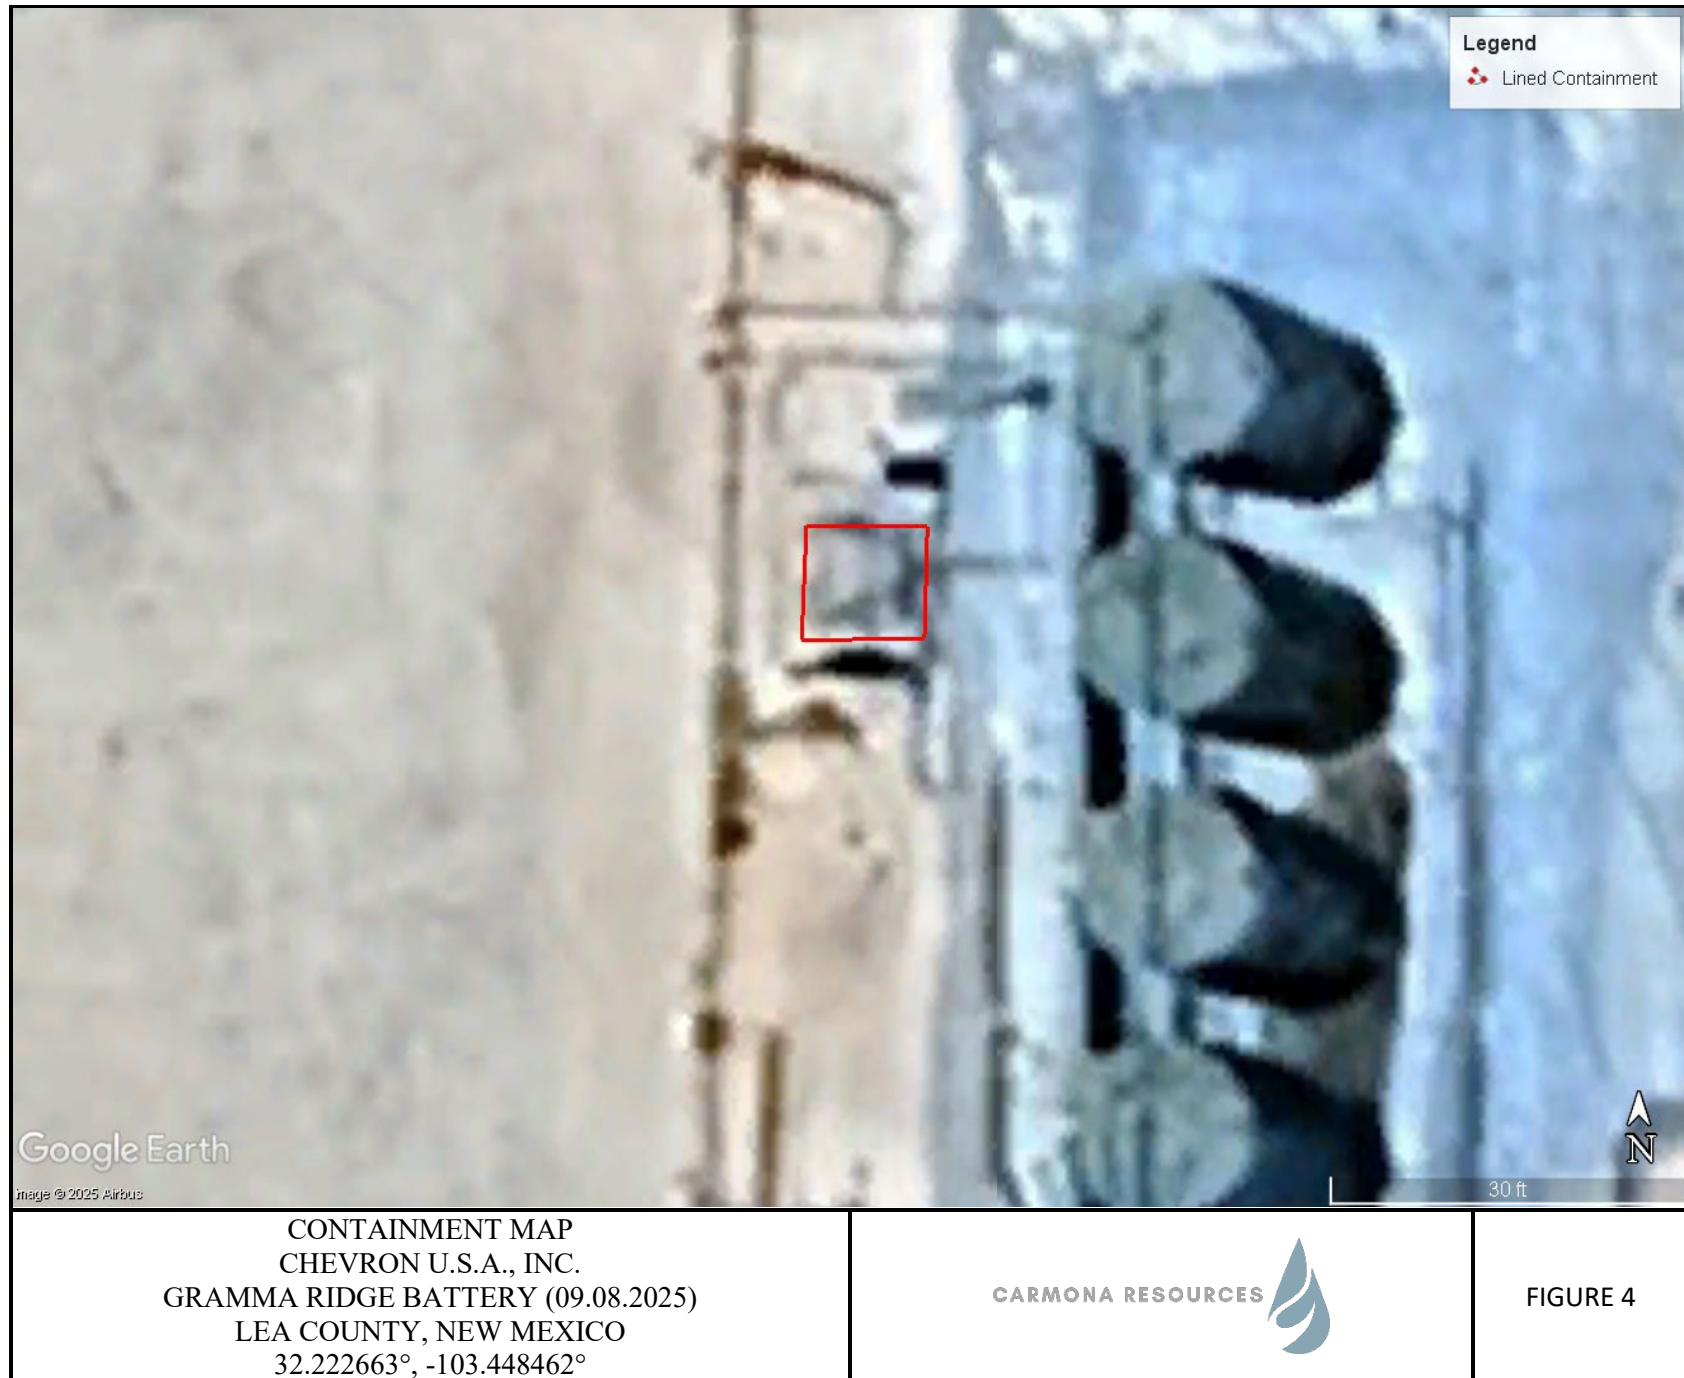
Prior to Carmona Resources conducting a Liner Inspection, Chevron contractors removed all fluid and washed the containment. The NMOCD division office was notified via NMOCD portal on September 15, 2025, per Subsection D of 19.15.29.12 NMAC. See Appendix C for the NMOCD correspondence prior to performing the liner inspection. On August 15, 2025, Carmona Resources, LLC conducted liner inspection activities to assess the tank batteries lined containment integrity and determined there were no integrity issues. During that time, it was confirmed that all unrecovered fluid from the initial release had been removed. Refer to the Photolog in Appendix A. Figure 4 shows the containment area outline.

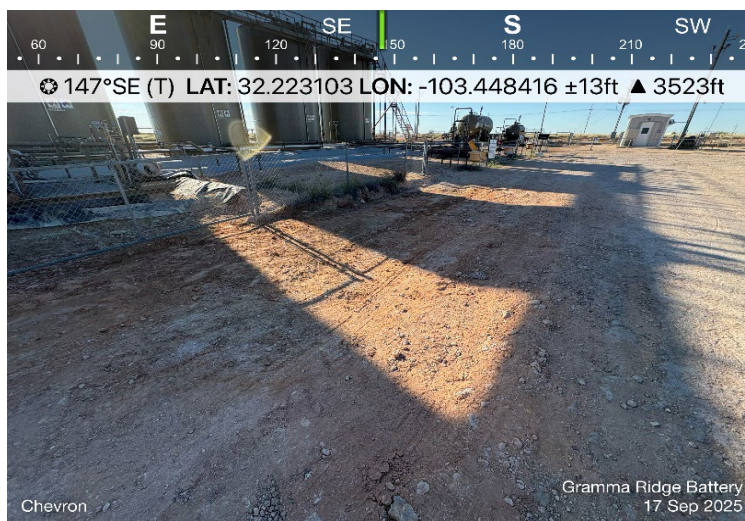
Photograph No. 2

View Southeast, Area of CS-1 and CS-2.

Prior to Carmona Resources arriving on location, a third-party contractor was onsite to conduct a surface scrape of the impacted area to remove all stained soil. On September 17, 2025, Carmona Resources personnel were onsite to collect confirmation floor and horizontal delineation samples, from the scraped area. Before collecting composite confirmation samples, the NMOCD division office was notified via NMOCD portal on September 15, 2025, per Subsection D of 19.15.29.12 NMAC. See Appendix C. The entire area was scraped to a depth of 0.5'. Due to the excavation area being less than 6 inches, horizontal delineation samples were collected in place of composite confirmation sidewall samples. A total of three (3) confirmation floor samples were collected (CS-1 through CS-3), and five (5) horizontal delineation samples (H-1 through H-5) were collected every 200 square feet to ensure the proper removal of the contaminated soils. For chemical analysis, the soil samples were collected and placed directly into laboratory-provided sample containers, stored on ice, and transported under the proper chain-of-custody protocol to Eurofins Laboratories in Midland, Texas. All collected samples were analyzed for TPH analysis by EPA method 8015 modified, BTEX by EPA Method 8021B, and Chloride by EPA method 300. Copies of laboratory analysis and chain-of-custody documentation are included in Appendix E. The excavation depth, confirmation floor sample locations, and horizontal delineation samples are shown in Figure 3.

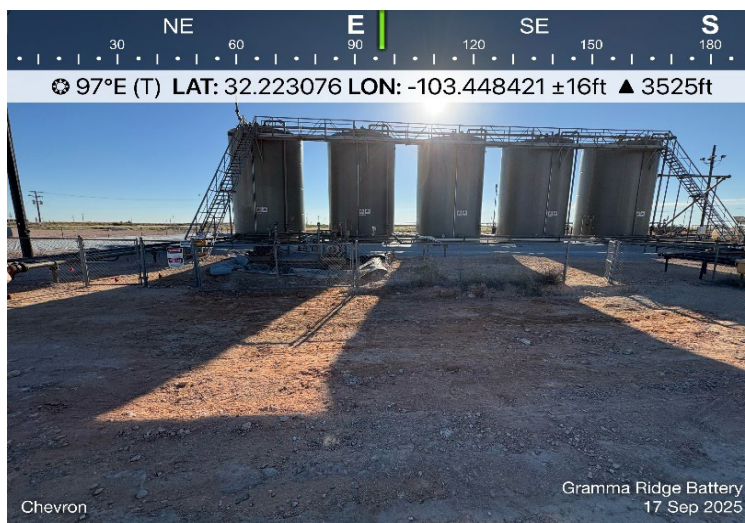
Photograph No. 3

View East, Area of CS-1 through CS-3.
