A-LINE LEAK

Remediation Action Plan

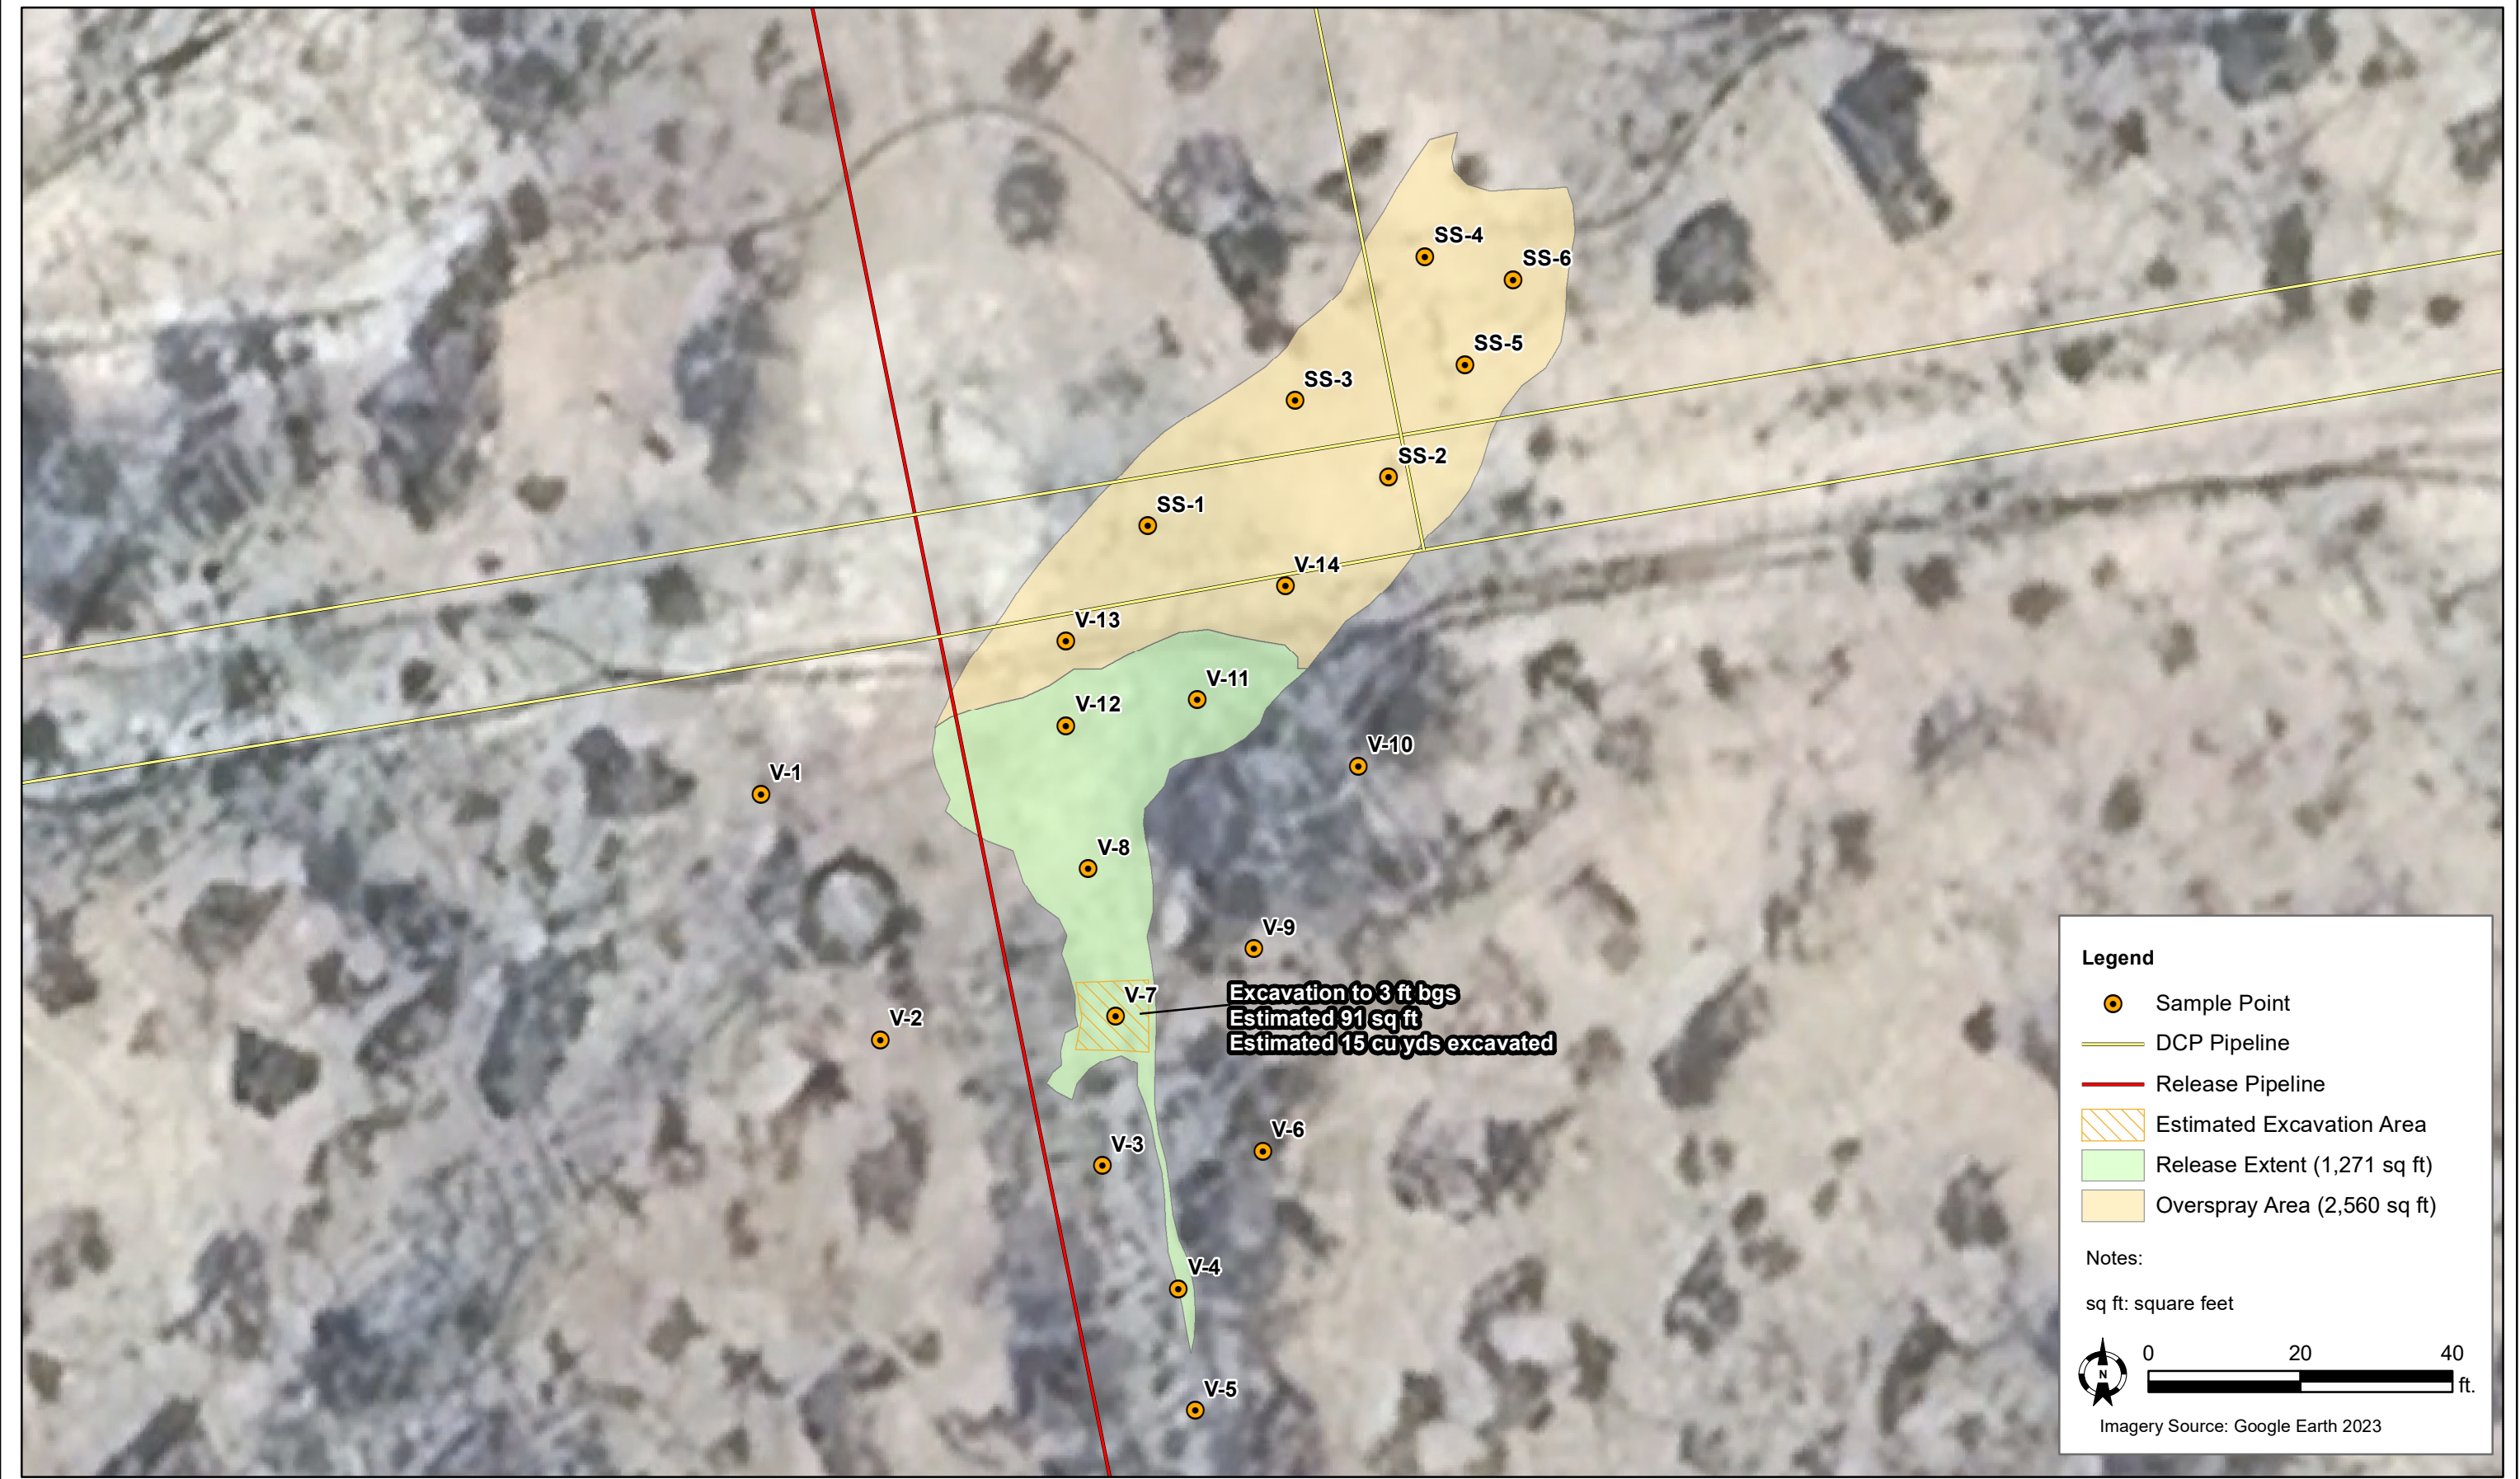
DATE:	October 2025
DESIGNED BY:	K. Stark
DRAWN BY:	K. Stark
