**Re: Liner Inspection Report
3R Operating, LLC
EagleClaw 5-8 Federal 1H-2H Production Facility Release
Unit Letter D, Section 5, Township 20 South, Range 35 East
Lea County, New Mexico
Incident ID# nAPP2526942638**

Liner Inspection Report
November 13, 2025

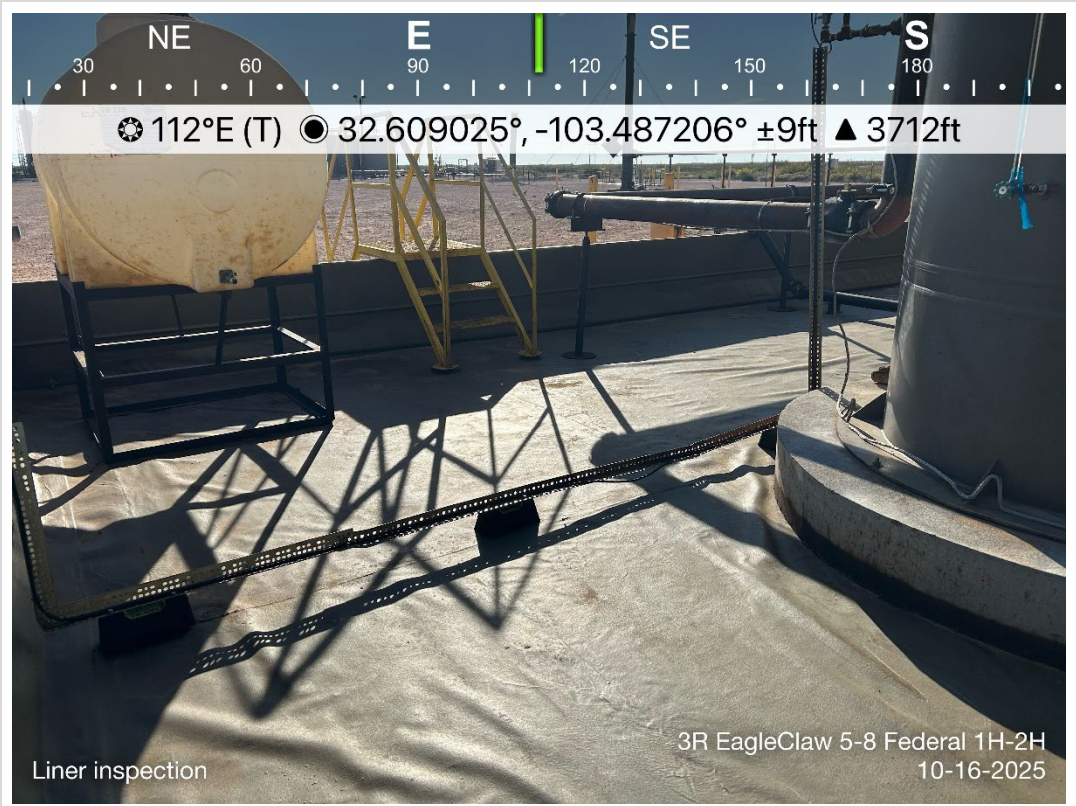
TETRA TECH, INC. PROJECT NO. 212C-AU-00695	DESCRIPTION	View east. Current lined containment conditions: no rips, holes, or tears observed.	3
	SITE NAME	EagleClaw 5-8 Federal 1H-2H Production Facility	10/16/2025

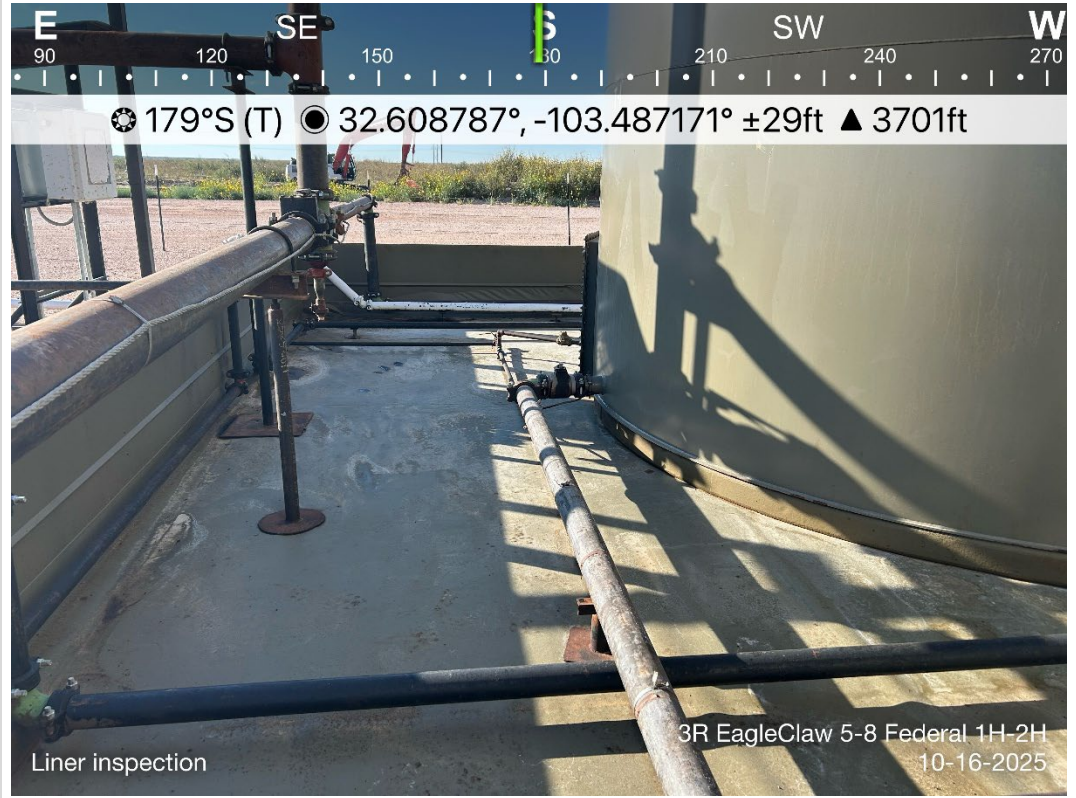
TETRA TECH, INC. PROJECT NO. 212C-AU-00695	DESCRIPTION	View south. Current lined containment conditions: no rips, holes, or tears observed.	4
	SITE NAME	EagleClaw 5-8 Federal 1H-2H Production Facility	10/16/2025

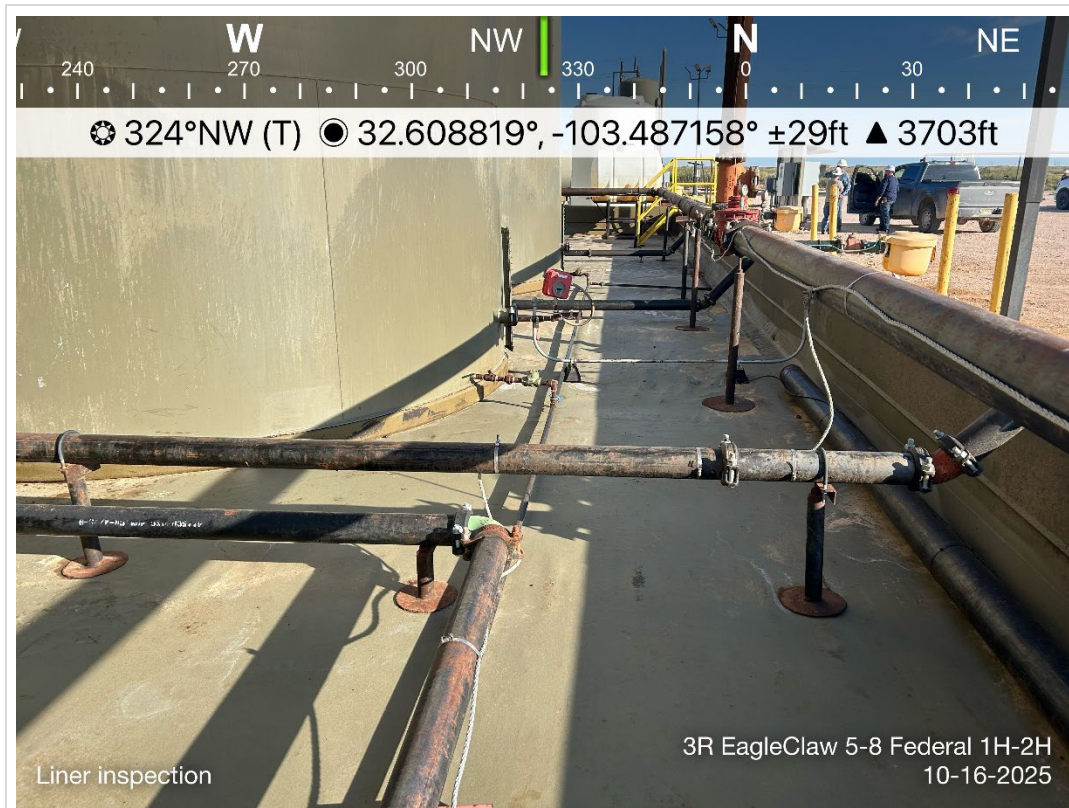
TETRA TECH, INC. PROJECT NO. 212C-AU-00695	DESCRIPTION	View northwest. Current lined containment conditions: no rips, holes, or tears observed.	5
	SITE NAME	EagleClaw 5-8 Federal 1H-2H Production Facility	10/16/2025

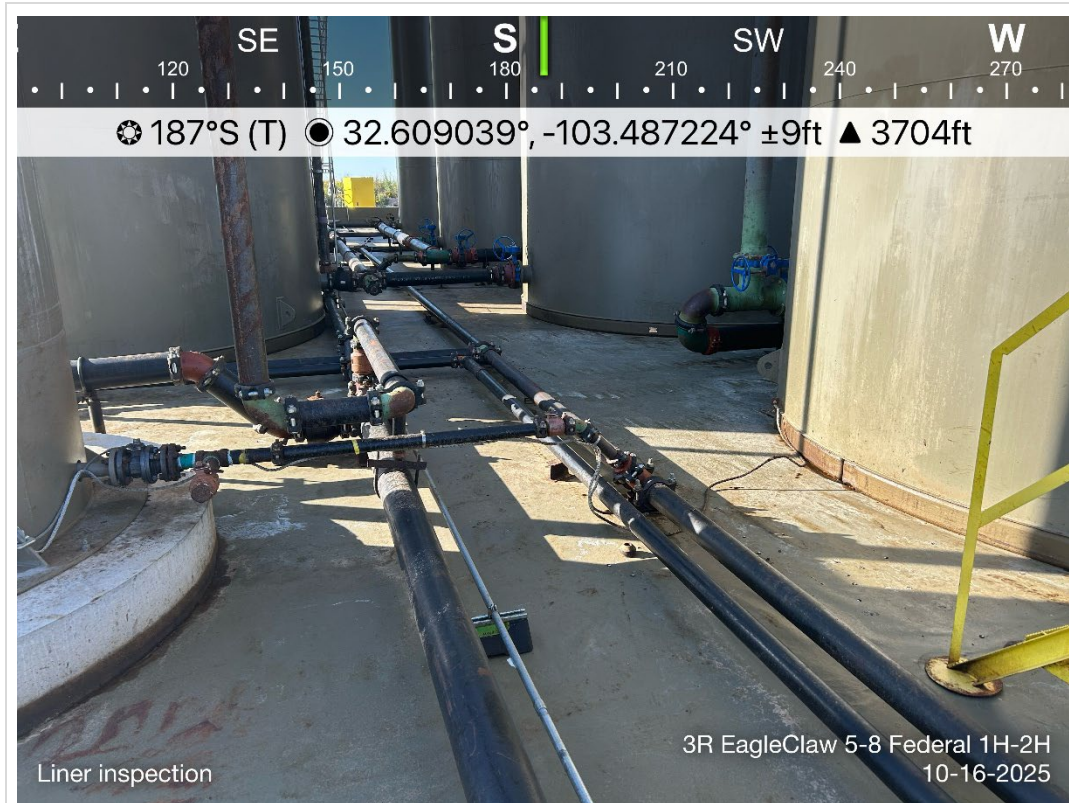
TETRA TECH, INC. PROJECT NO. 212C-AU-00695	DESCRIPTION	View south. Current lined containment conditions: no rips, holes, or tears observed.	6
	SITE NAME	EagleClaw 5-8 Federal 1H-2H Production Facility	10/16/2025

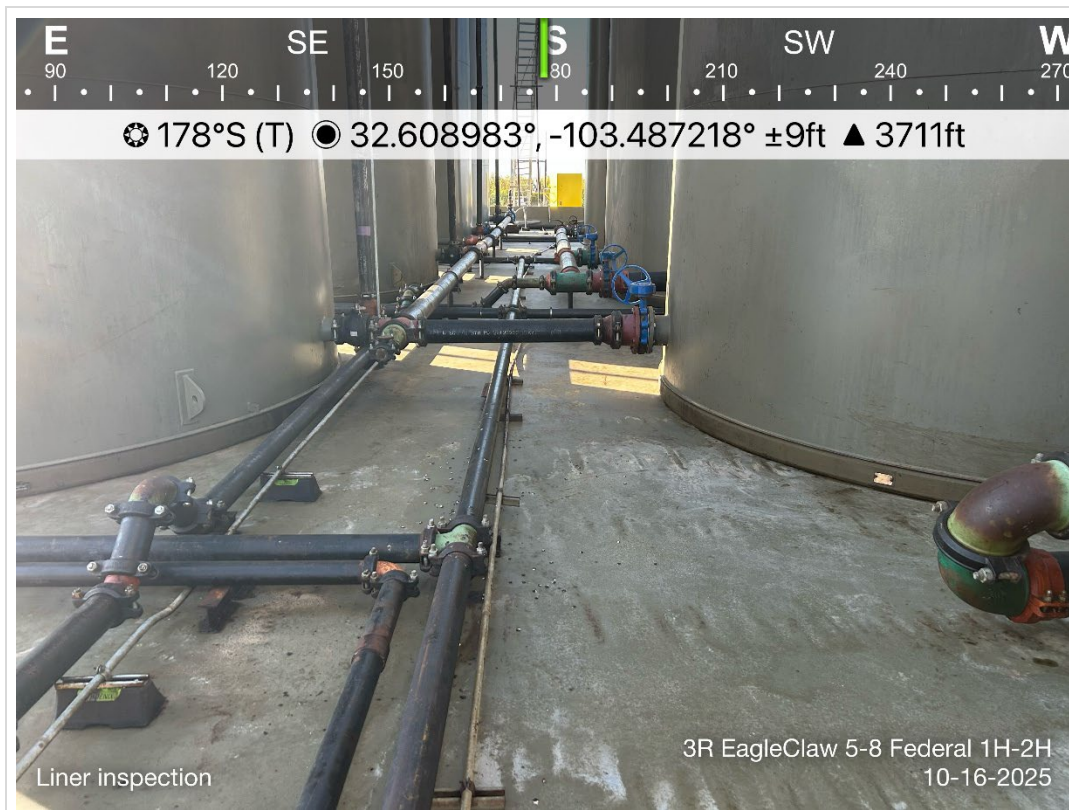
TETRA TECH, INC. PROJECT NO. 212C-AU-00695	DESCRIPTION	View south. Current lined containment conditions: no rips, holes, or tears observed.	7
	SITE NAME	EagleClaw 5-8 Federal 1H-2H Production Facility	10/16/2025

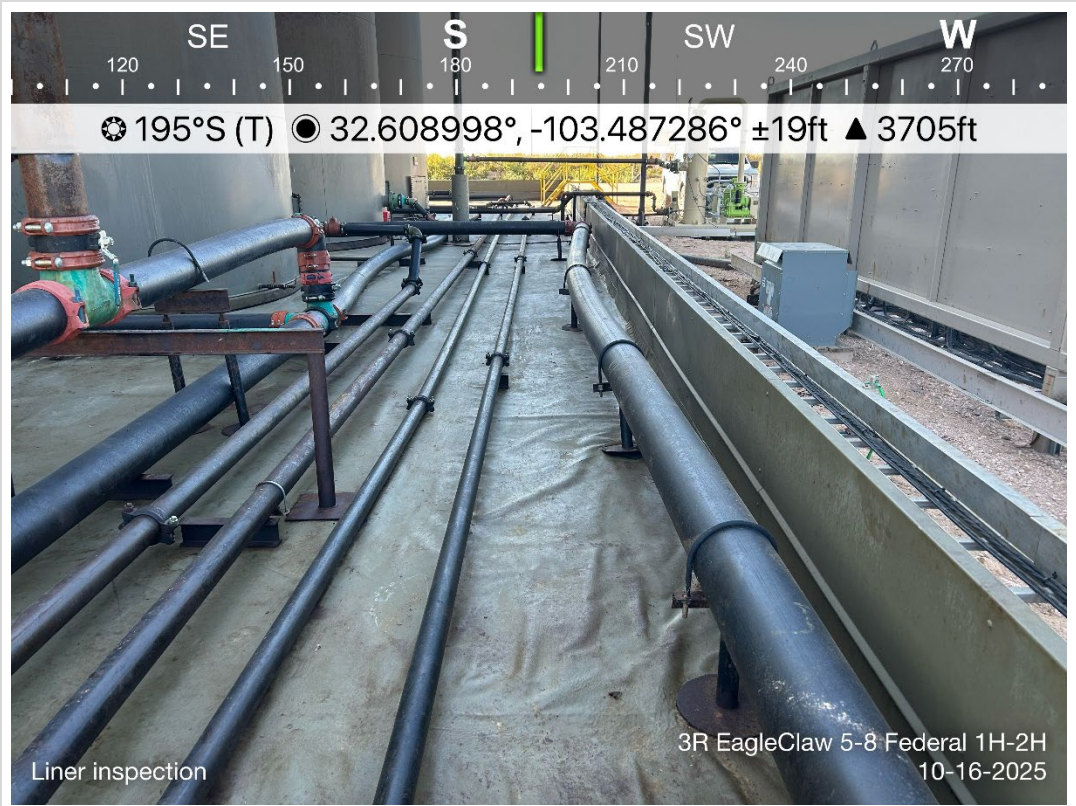
TETRA TECH, INC. PROJECT NO. 212C-AU-00695	DESCRIPTION	View south. Current lined containment conditions: no rips, holes, or tears observed.	9
	SITE NAME	EagleClaw 5-8 Federal 1H-2H Production Facility	10/16/2025

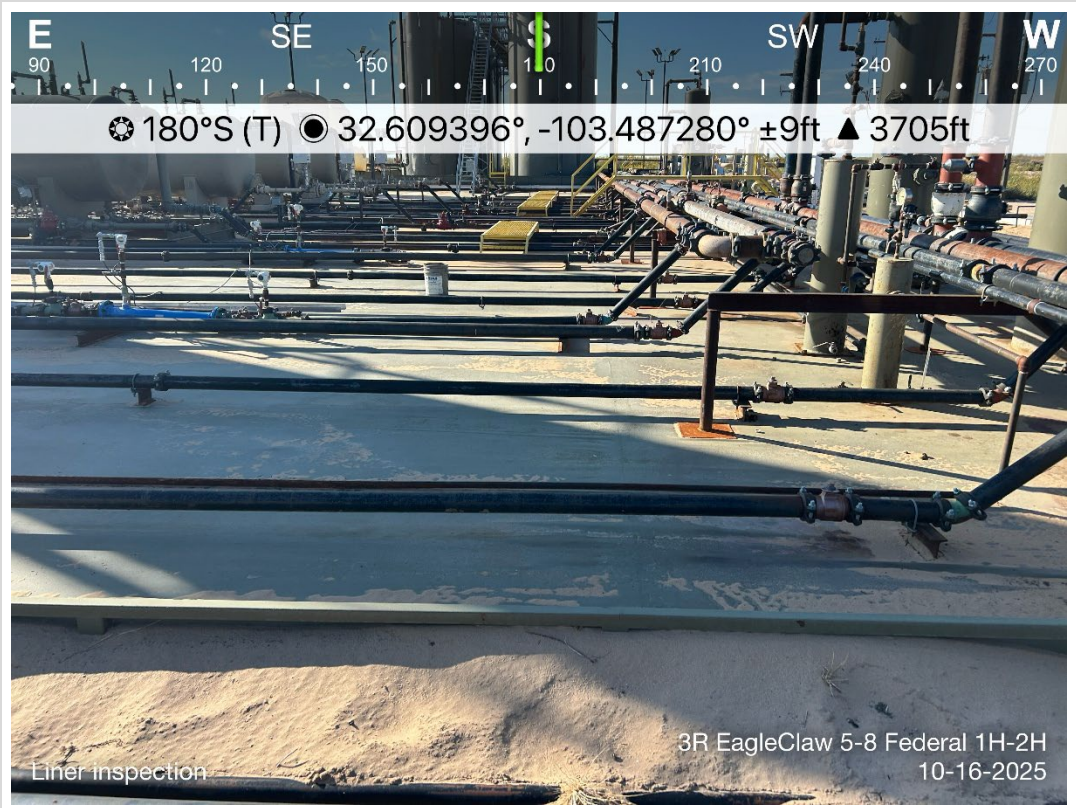
TETRA TECH, INC. PROJECT NO. 212C-AU-00695	DESCRIPTION	View south. Current lined containment conditions: no rips, holes, or tears observed.	11
	SITE NAME	EagleClaw 5-8 Federal 1H-2H Production Facility	10/16/2025
