## **Release Assessment and Closure**

**Mustang 8 CTB 3**

**Section 08, Township 25 South, Range 32 East**

**Vertex File Number: 25A-05243**

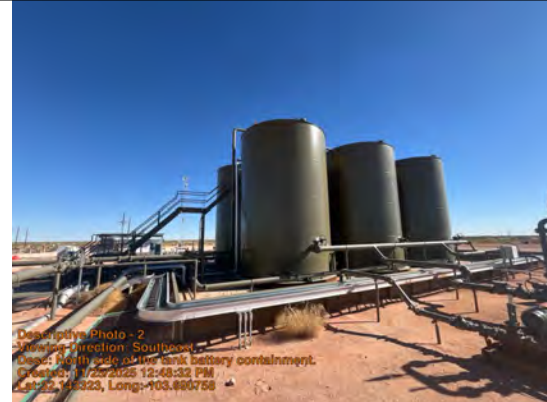
Viewing Direction: Southeast

North side of the tank battery containment.

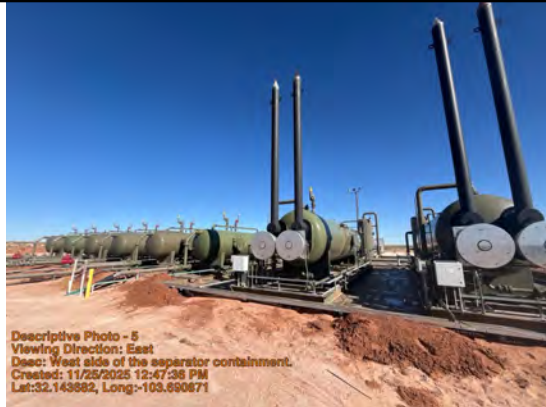
Viewing Direction: East

West side of the separator containment.

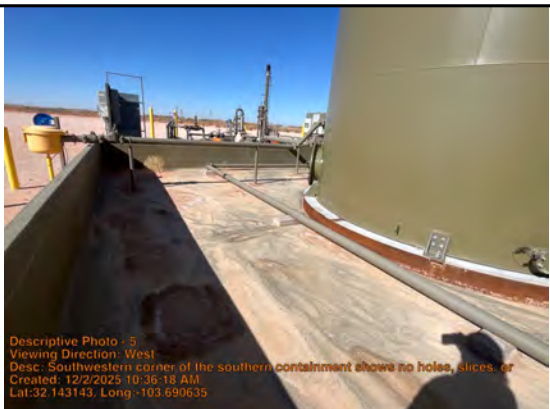
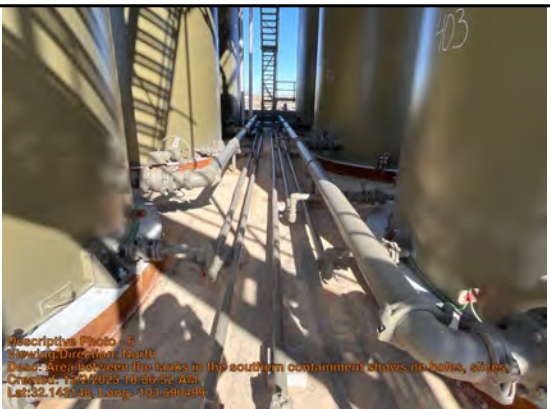
| <p>Southwestern corner of the southern containment shows no holes, slices, or other losses of integrity</p> | <p>Area between the tanks in the southern containment shows no holes, slices, or other losses of integrity</p> |

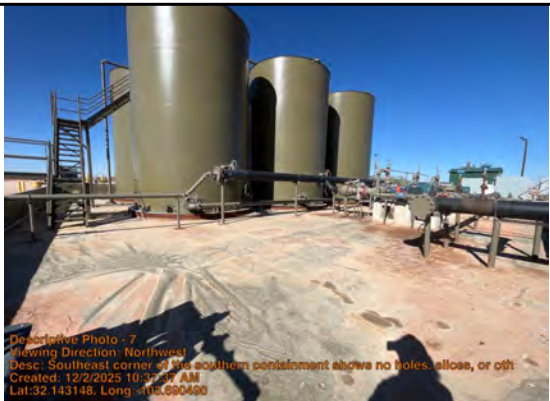
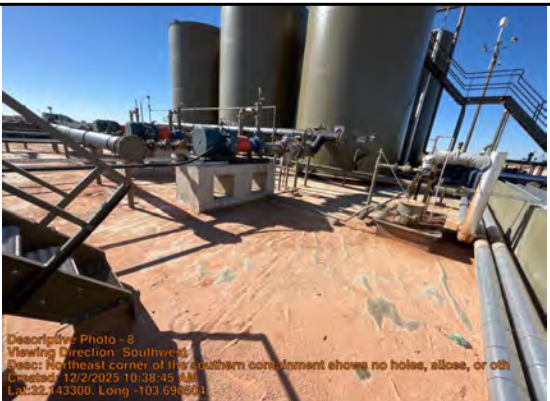
| <p>Southeast corner of the southern containment shows no holes, slices, or other losses of integrity</p> | <p>Northeast corner of the southern containment shows no holes, slices, or other losses of integrity</p> |

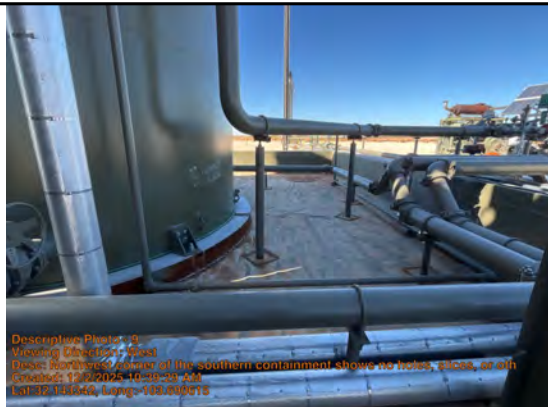
**Viewing Direction: West**

Northwest corner of the southern containment shows no holes, slices, or other losses of integrity

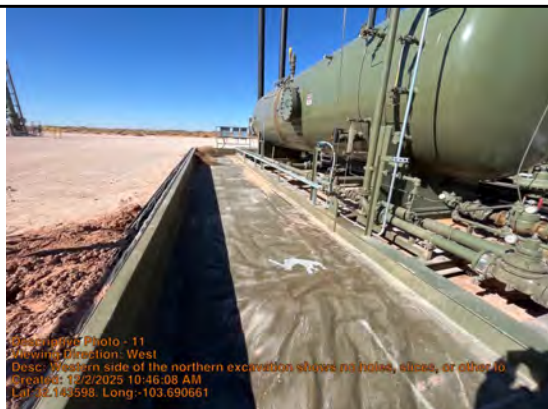
**Viewing Direction: West**

Western side of the northern containment shows no holes, slices, or other losses of integrity

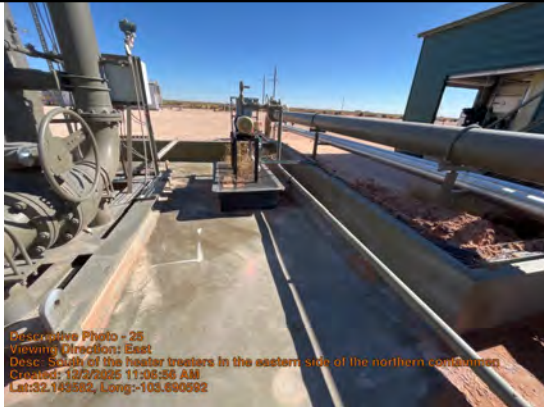
Viewing Direction: East

South of the heater treaters in the eastern side of the northern containment shows no holes, slices, or other losses of integrity
