**Re: Closure Request
Golden 8 Federal #001
Incident Numbers nKMW1035646177, nKMW1106629393, nJMW1333053660,
nAB1422637219, nAB1607837012, nAB1633656856, nAB1803638613, and
nAB1929041495
Eddy County, New Mexico**

XTO Energy, Inc.
Closure Request
Golden 8 Federal #001

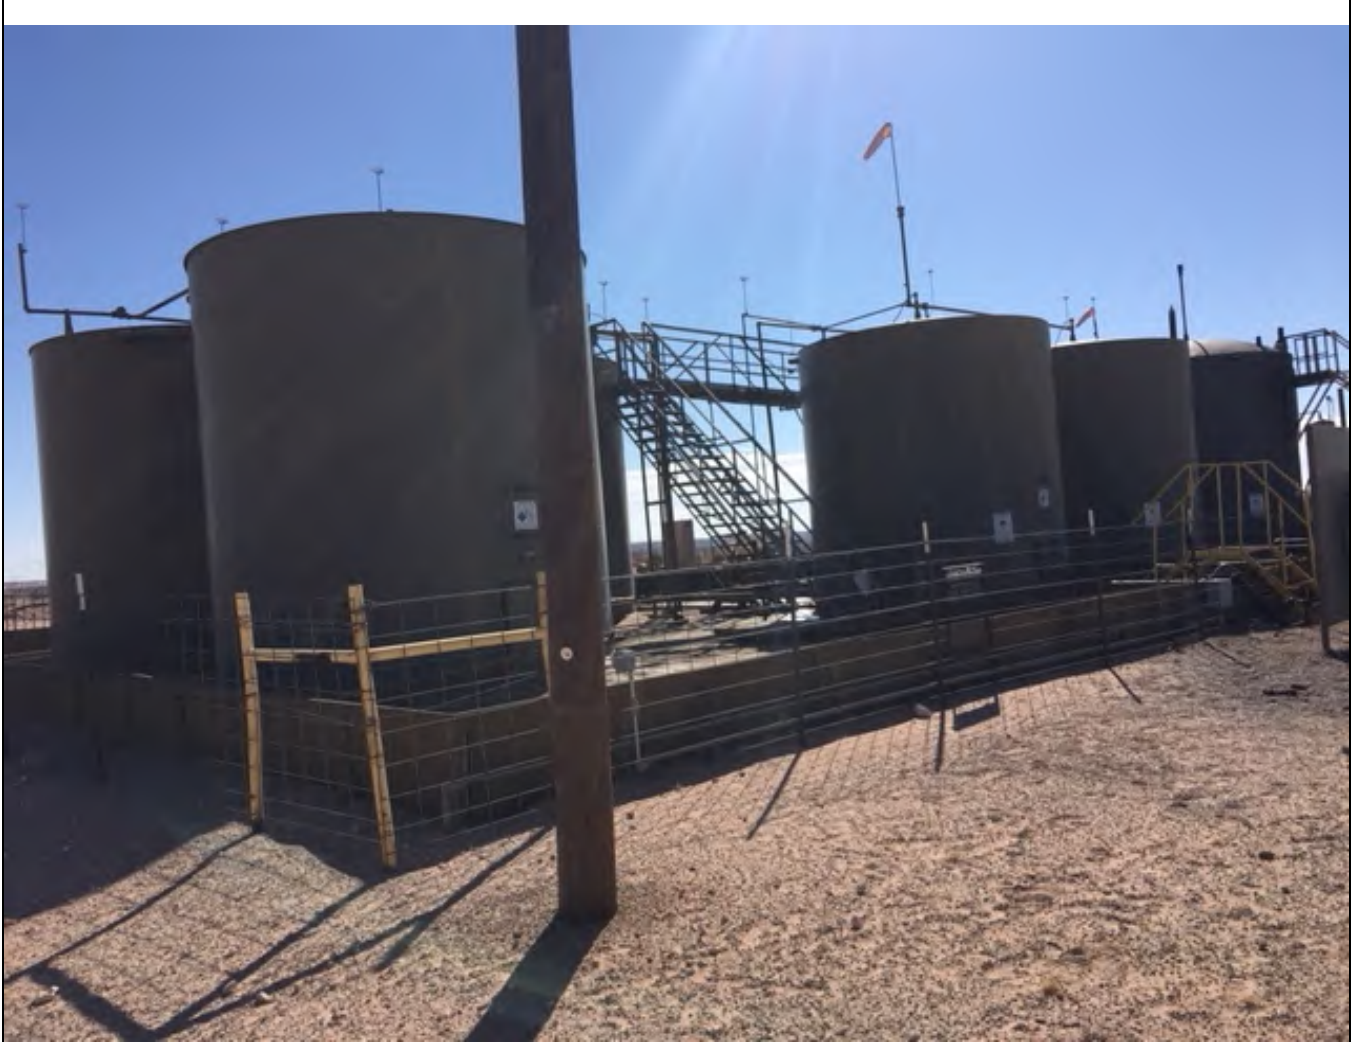
Western view of lined tank battery containment.

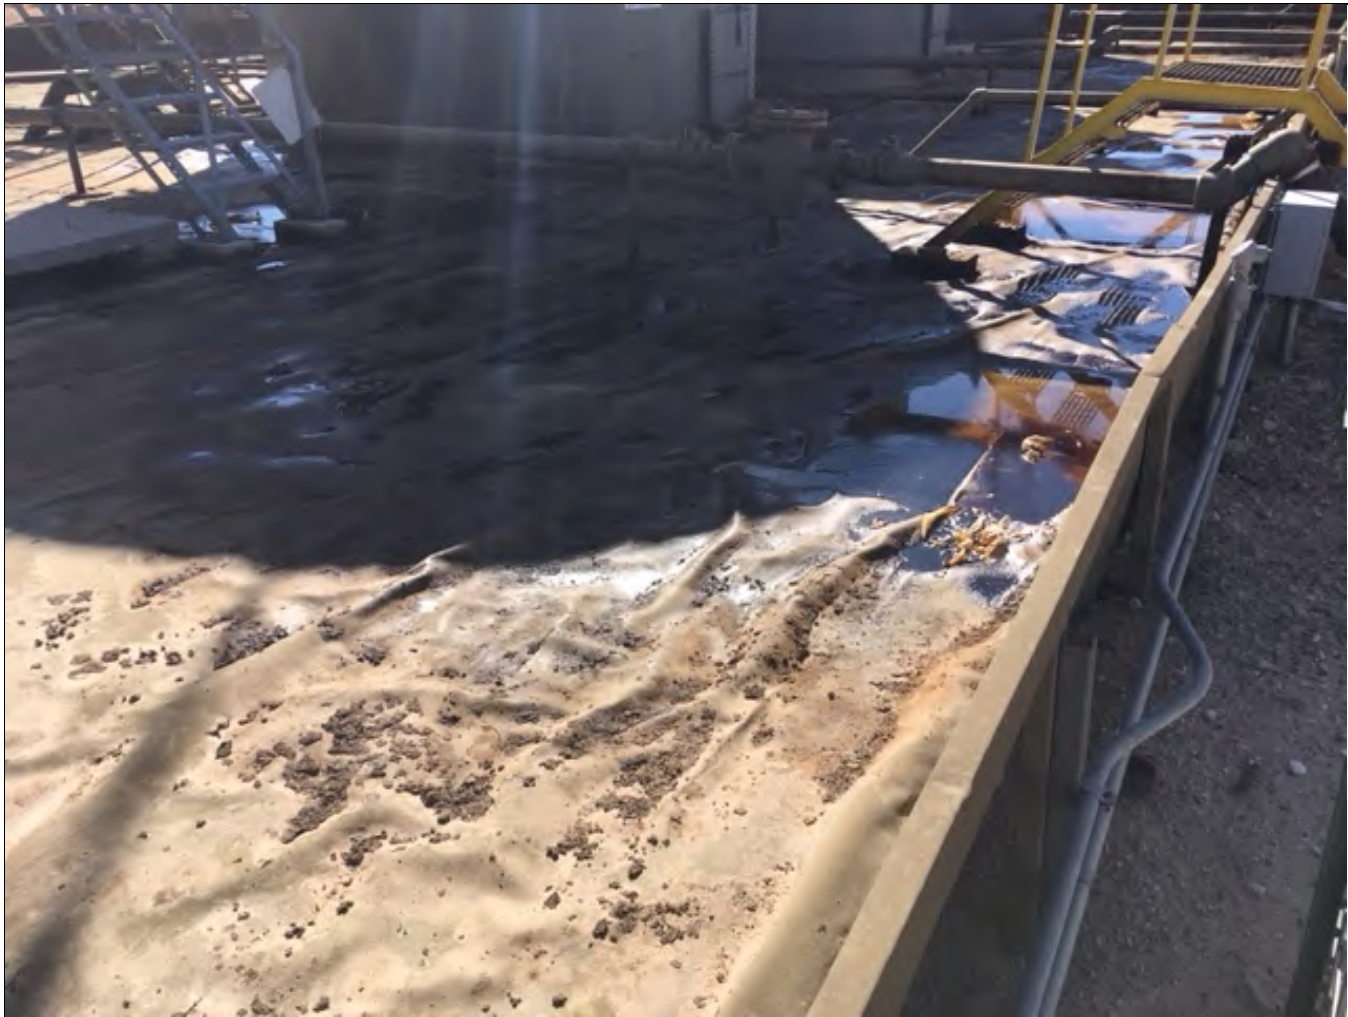
View of lined tank battery containment and liner hole during soil sampling activities.

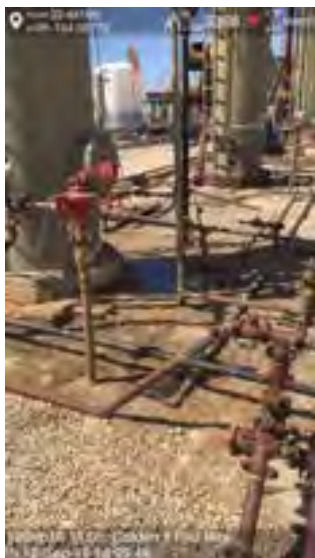
Photograph 1: Northwest view of release staining between equipment.

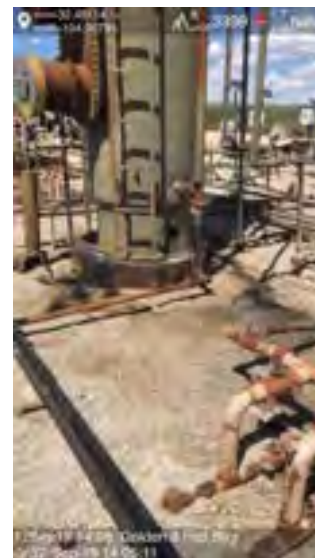
Photograph 2: Northern view of surficial staining within release extent.

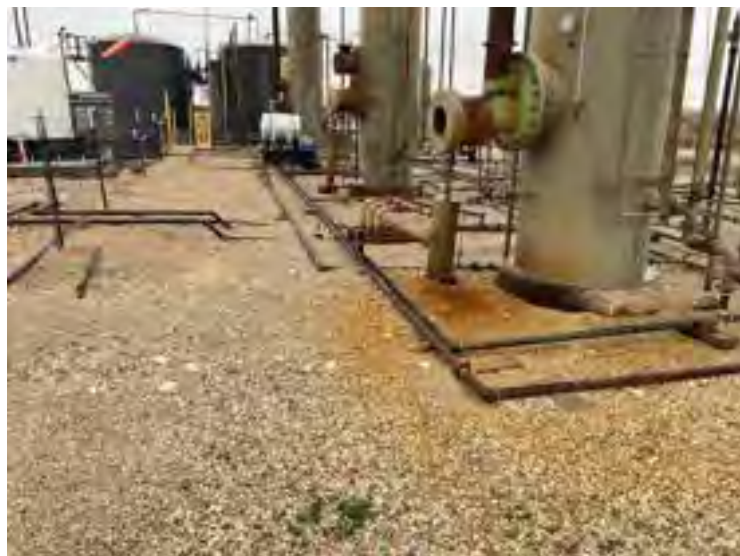
Photograph 3: Surficial staining between equipment.

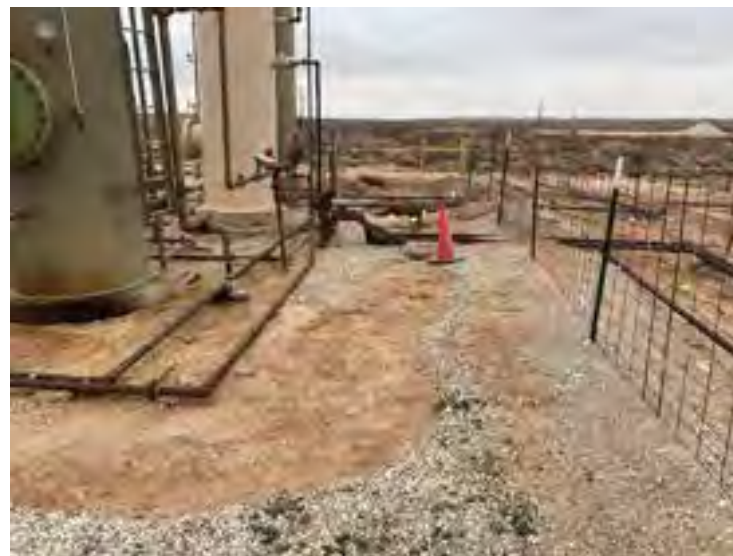
Photograph 4: View of equipment after hand shoveling activities.

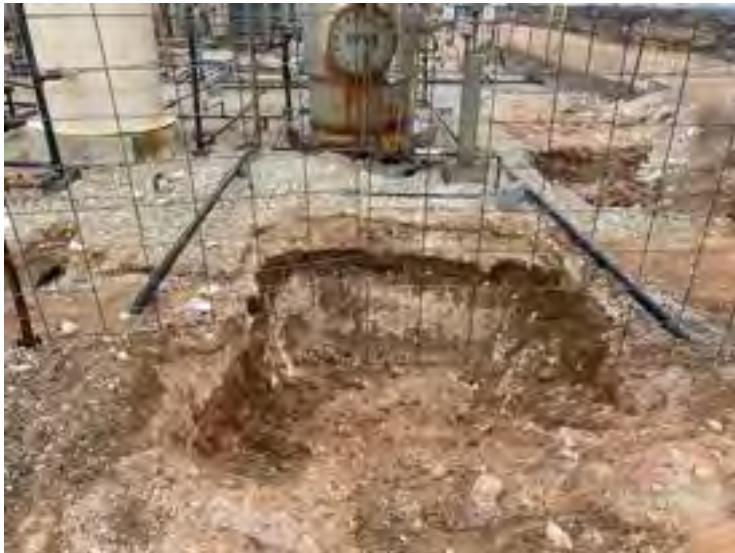
Photograph 7: View north of southern excavation activities.

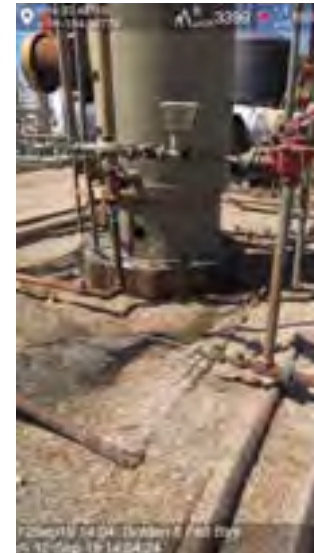
Photograph 8: Surficial staining before hand shoveling activities.

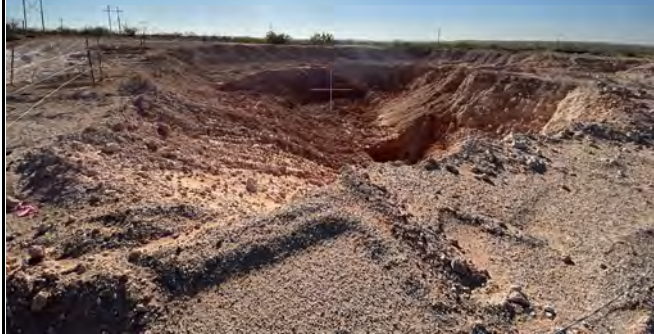
Photograph 1 Date :5/3/2024
Description: North portion of northern excavation
View: East

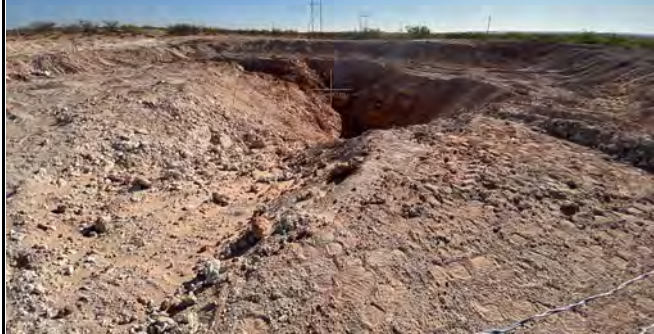
Photograph 2 Date :5/3/2024
Description: Northern excavation
View: Northeast

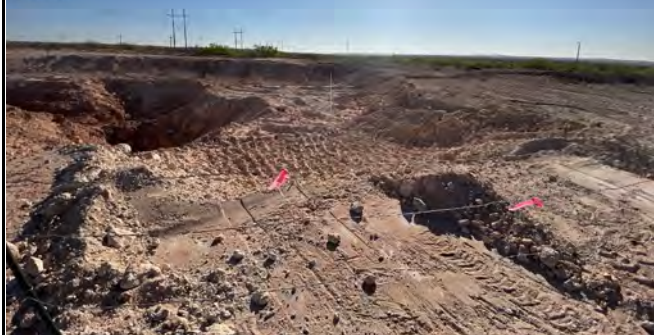
Photograph 3 Date :5/3/2024
Description: South portion of northern excavation
View: Northeast

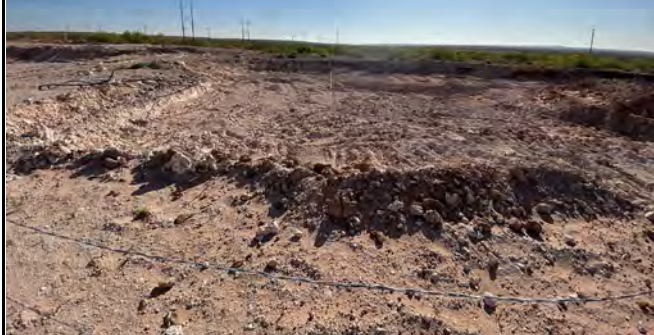
Photograph 4 Date :5/3/2024
Description: Southern excavation
View: Northeast

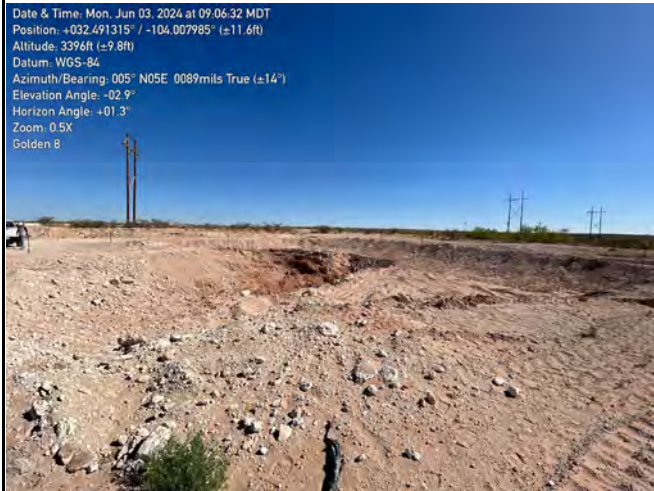
Photograph : 5 Date :6/3/2024
Description: Northern excavation
View: North

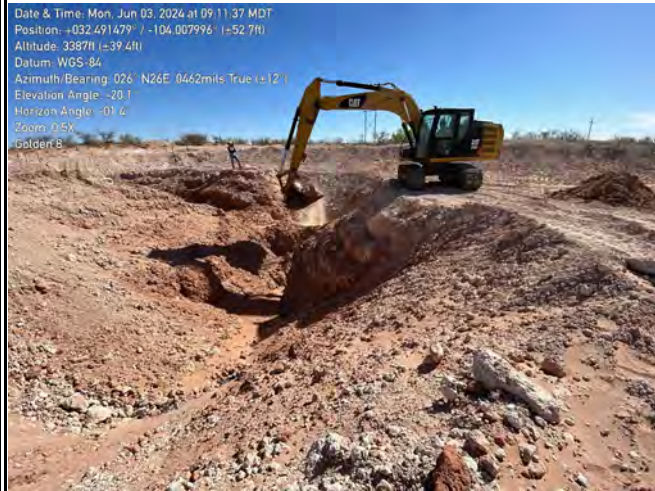
Photograph : 6 Date :6/3/2024
Description: Northern excavation
View: Northeast
