TT-1 LINE LEAK

Remediation Summary & Closure Report

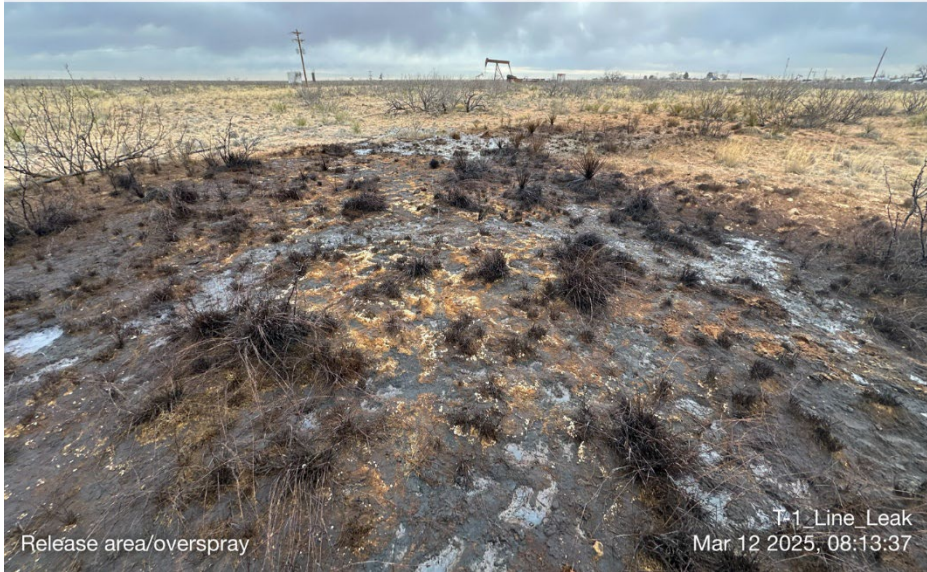
Release area/overspray

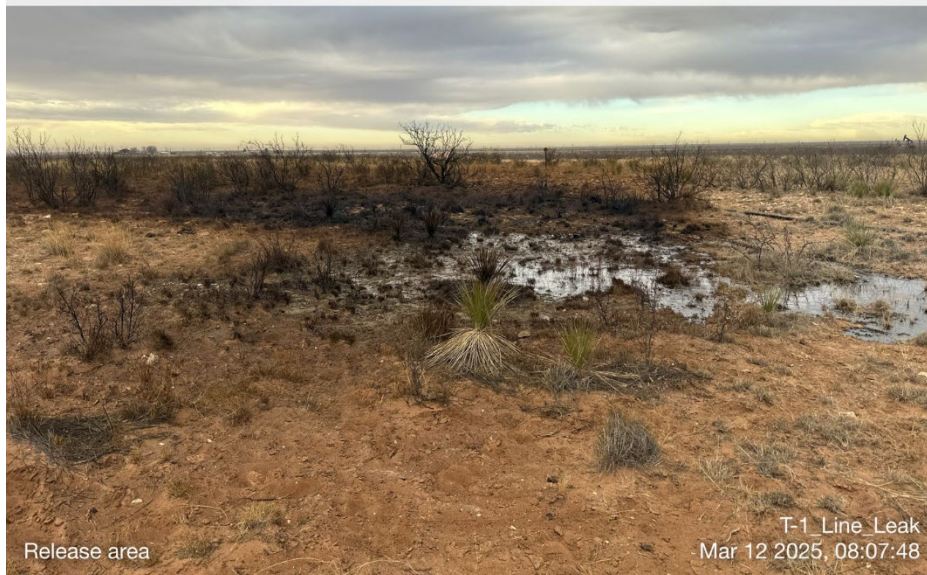
LAT: 32.381975 LON: -103.161487
