Remediation and Closure Report

Lost Tank Riser
Eddy County, New Mexico
(32.388341, -103.723071)

February 26, 2026

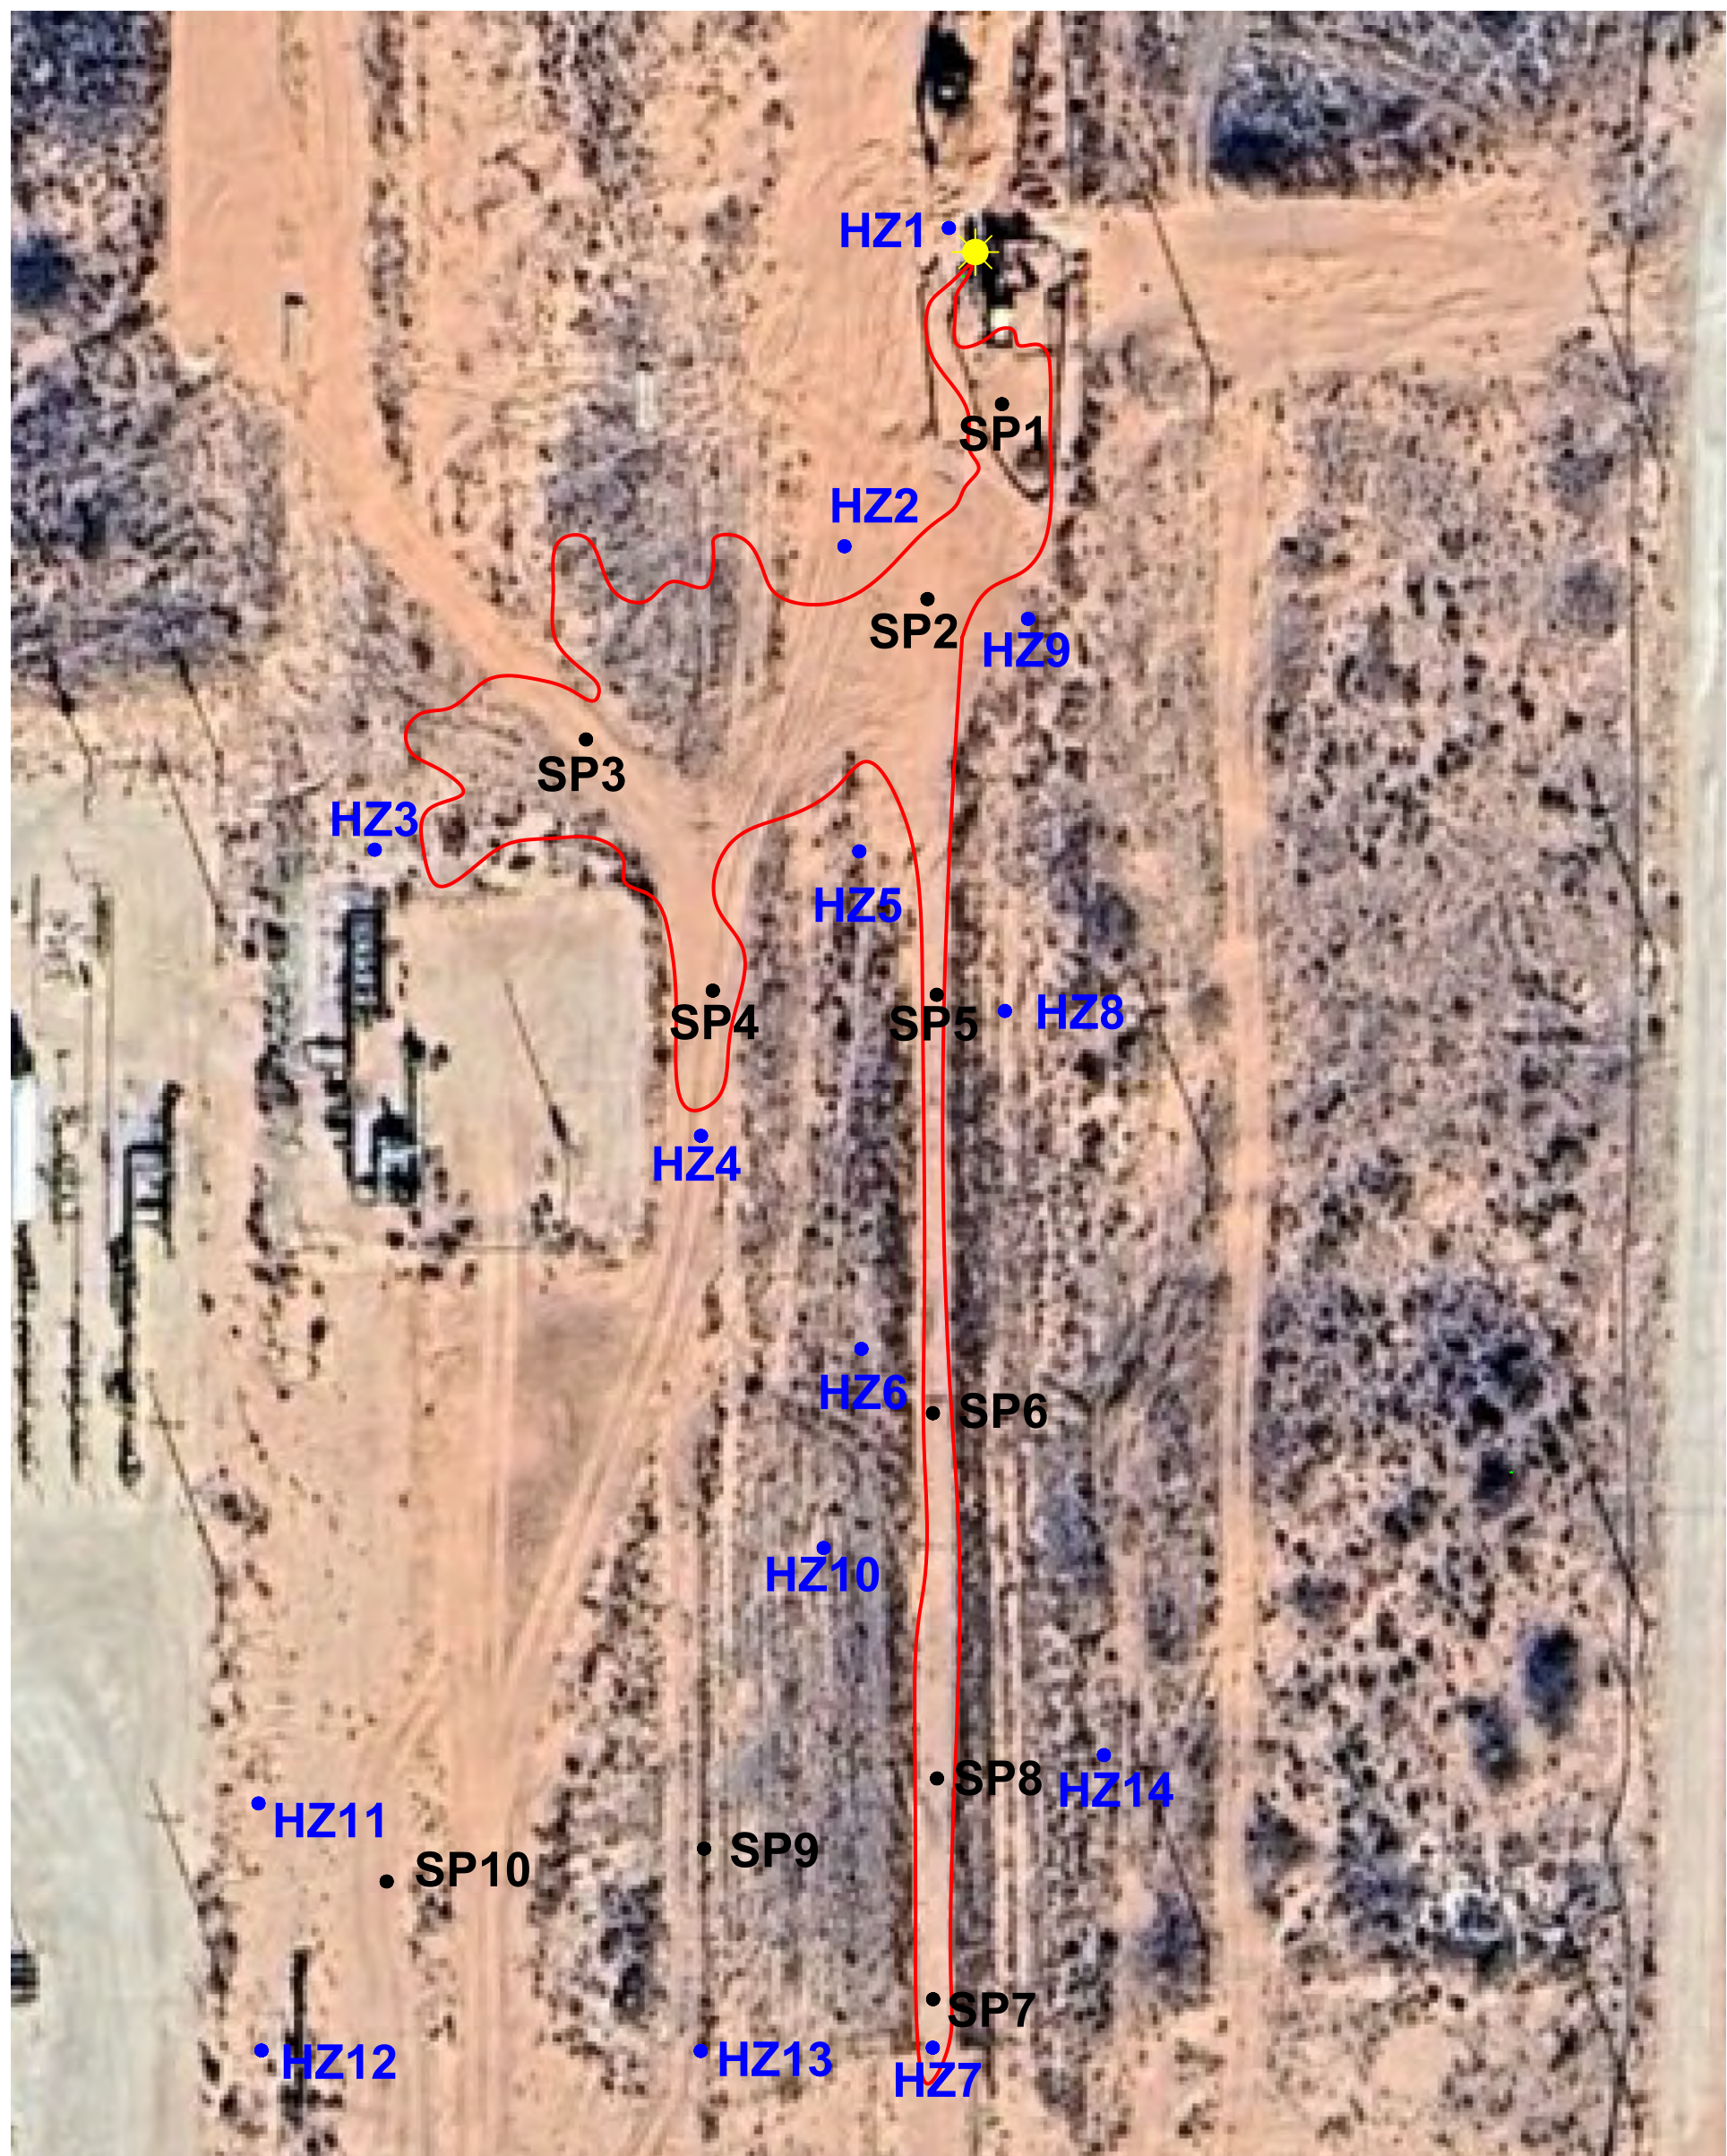
Title:			INITIAL INVESTIGATION DELINEATION MAP
32.388341, -103.723071			
Prepared for			RANCH AND OILFIELD CONSTRUCTION, LLC
Compiled by: GV	Date: GT	FIGURE	
Prepared by: GV	Scale: AS SHOWN	2	
Project Mgr: GT	Project: XX		
File: LOST TANK RISER CLOSURE.DWG

1. DELINEATION OF INCIDENT ID# nAPP2400362480 WAS CONDUCTED BY HUNGRY HORSE, LLC IN JANUARY 2024
2. DELINEATED AREA WAS EXCAVATED UNDER ROUX'S SUPERVISION. DELINEATION AREA WAS TO BE EXCAVATED 4-5 BELOW GROUND SURFACE (bgs).
3. HZ SAMPLES ARE SIDEWALL SOIL SAMPLES WHILE SP ARE SOIL SAMPLES TAKEN AT A REFERENCED BOTTOM

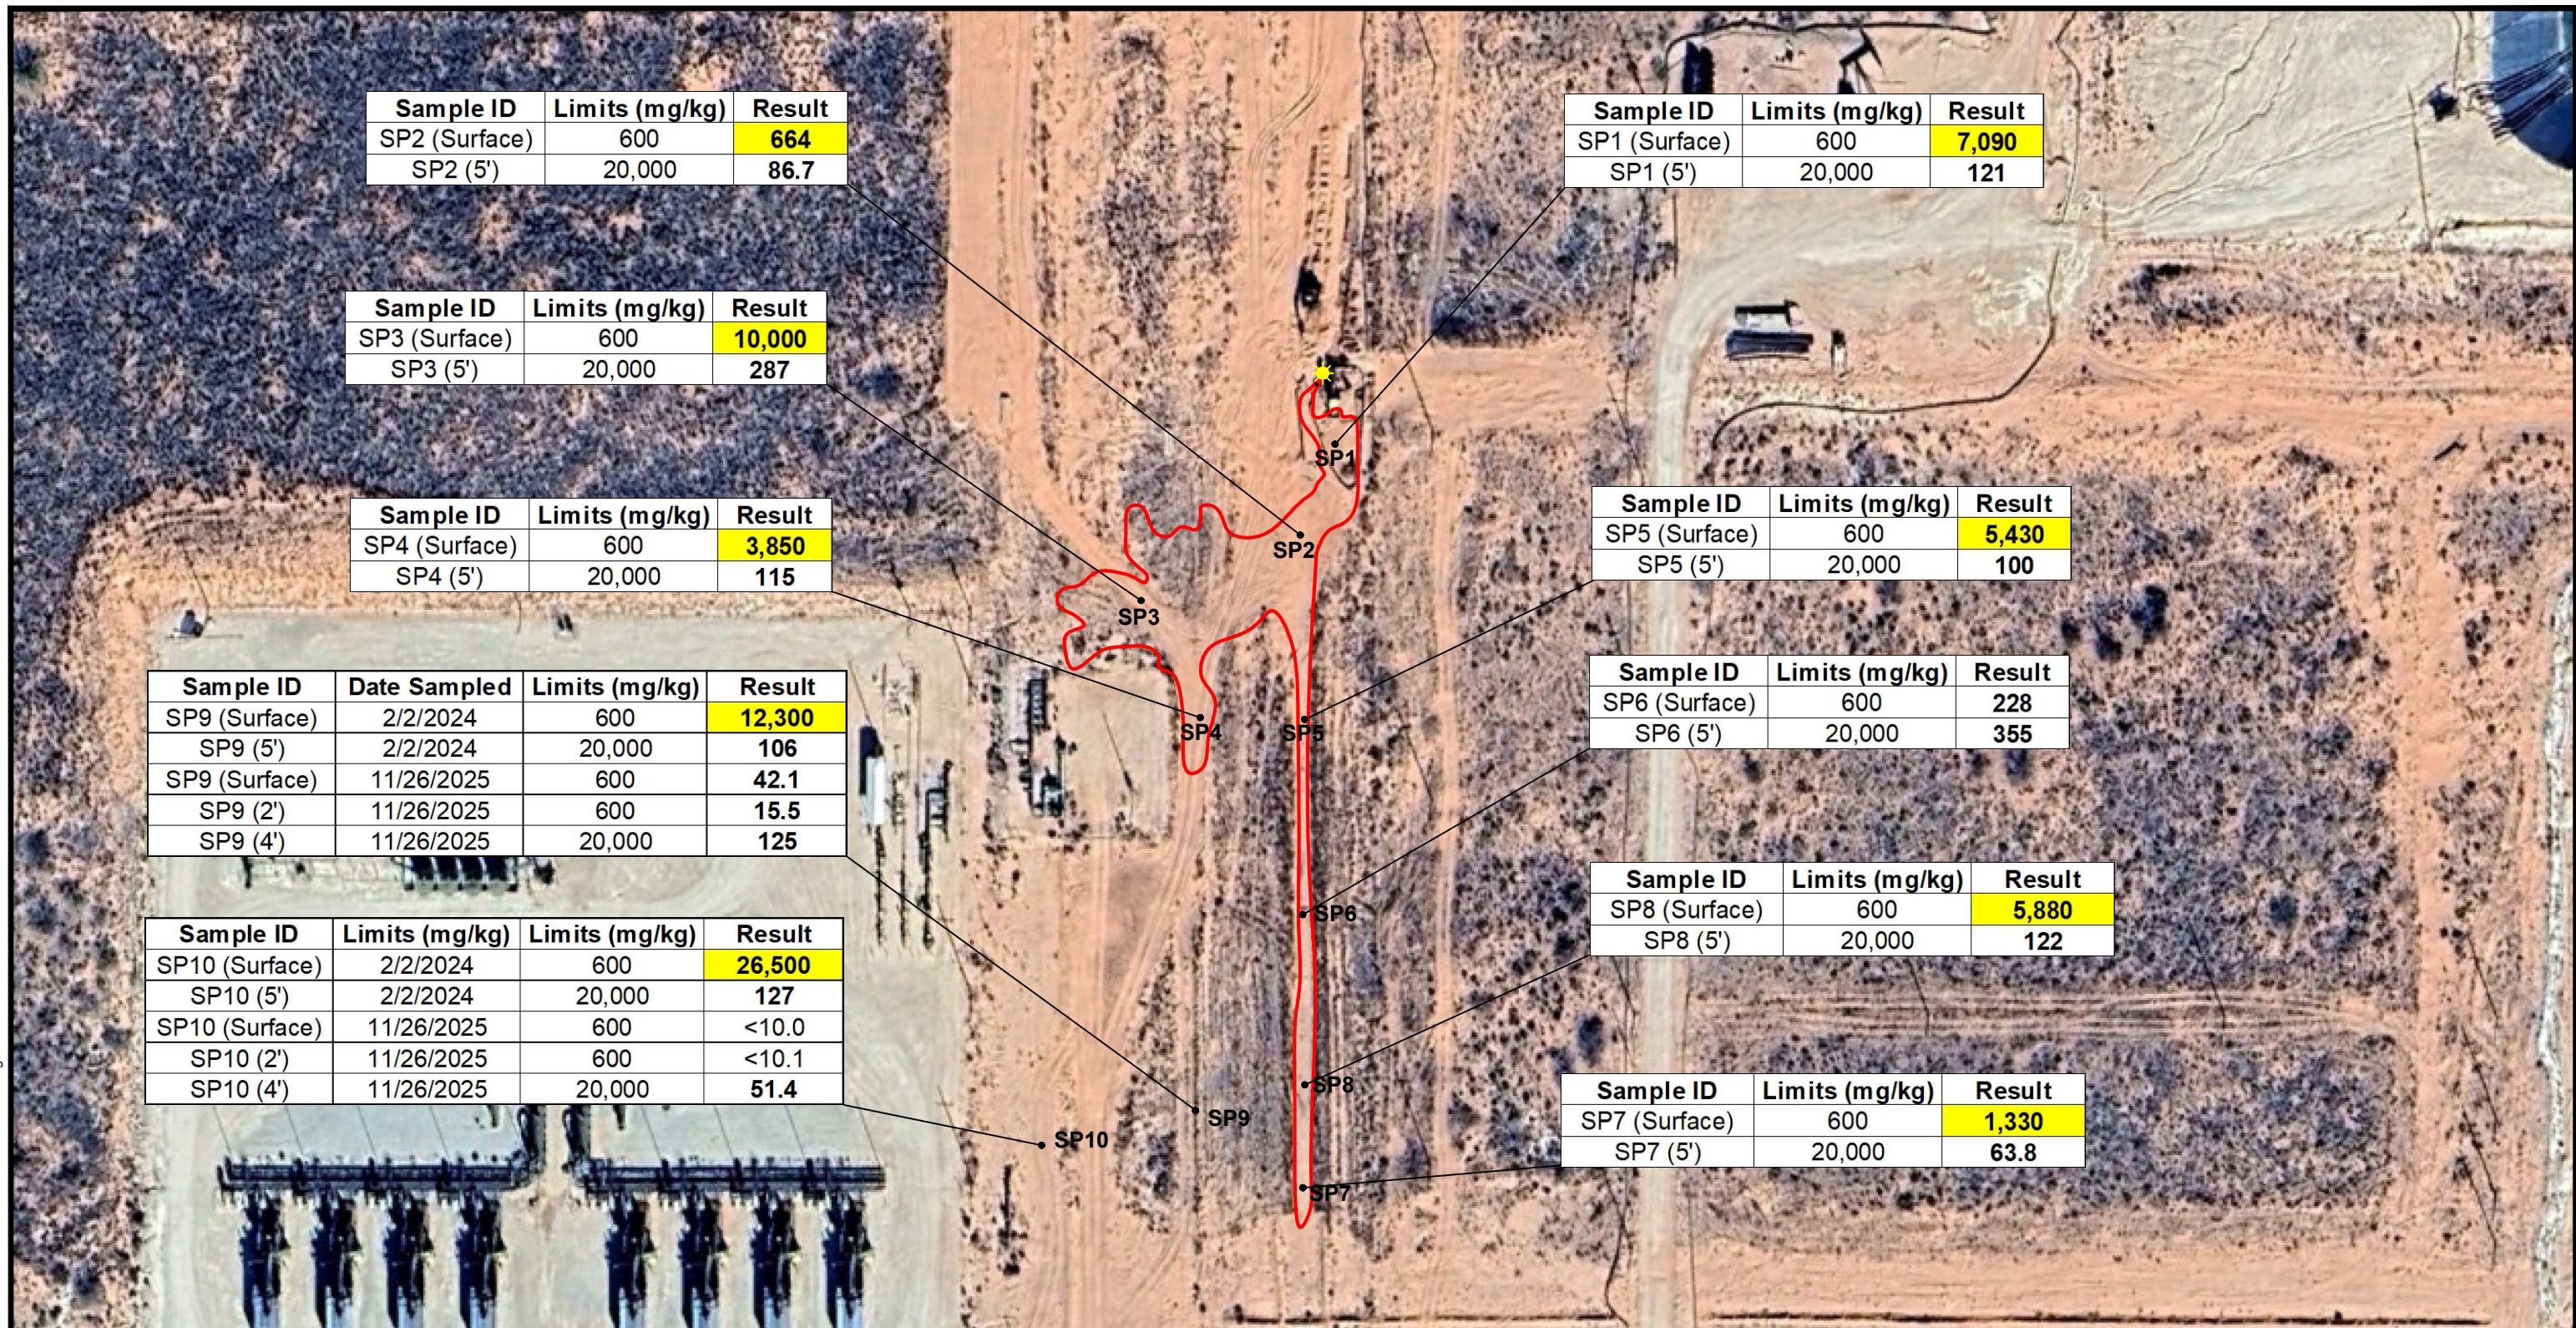
Title: **DELINEATION SAMPLE POINT (SP) CHLORIDE CONCENTRATION MAP**

Sample ID	Limits (mg/kg)	Result
SP2 (Surface)	600	664
SP2 (5')	20,000	86.7

Sample ID	Limits (mg/kg)	Result
SP1 (Surface)	600	7,090
SP1 (5')	20,000	121

1. SAMPLES WERE LOCATED AND COLLECTED ON FEBRUARY 2, 2024 BY HUNGRY HORSE, LLC.
2. YELLOW HIGHLIGHTING INDICATES SAMPLE RESULTS EXCEEDING THE CHLORIDE LIMIT 600 MILLIGRAMS PER KILOGRAMS (mg/kg)

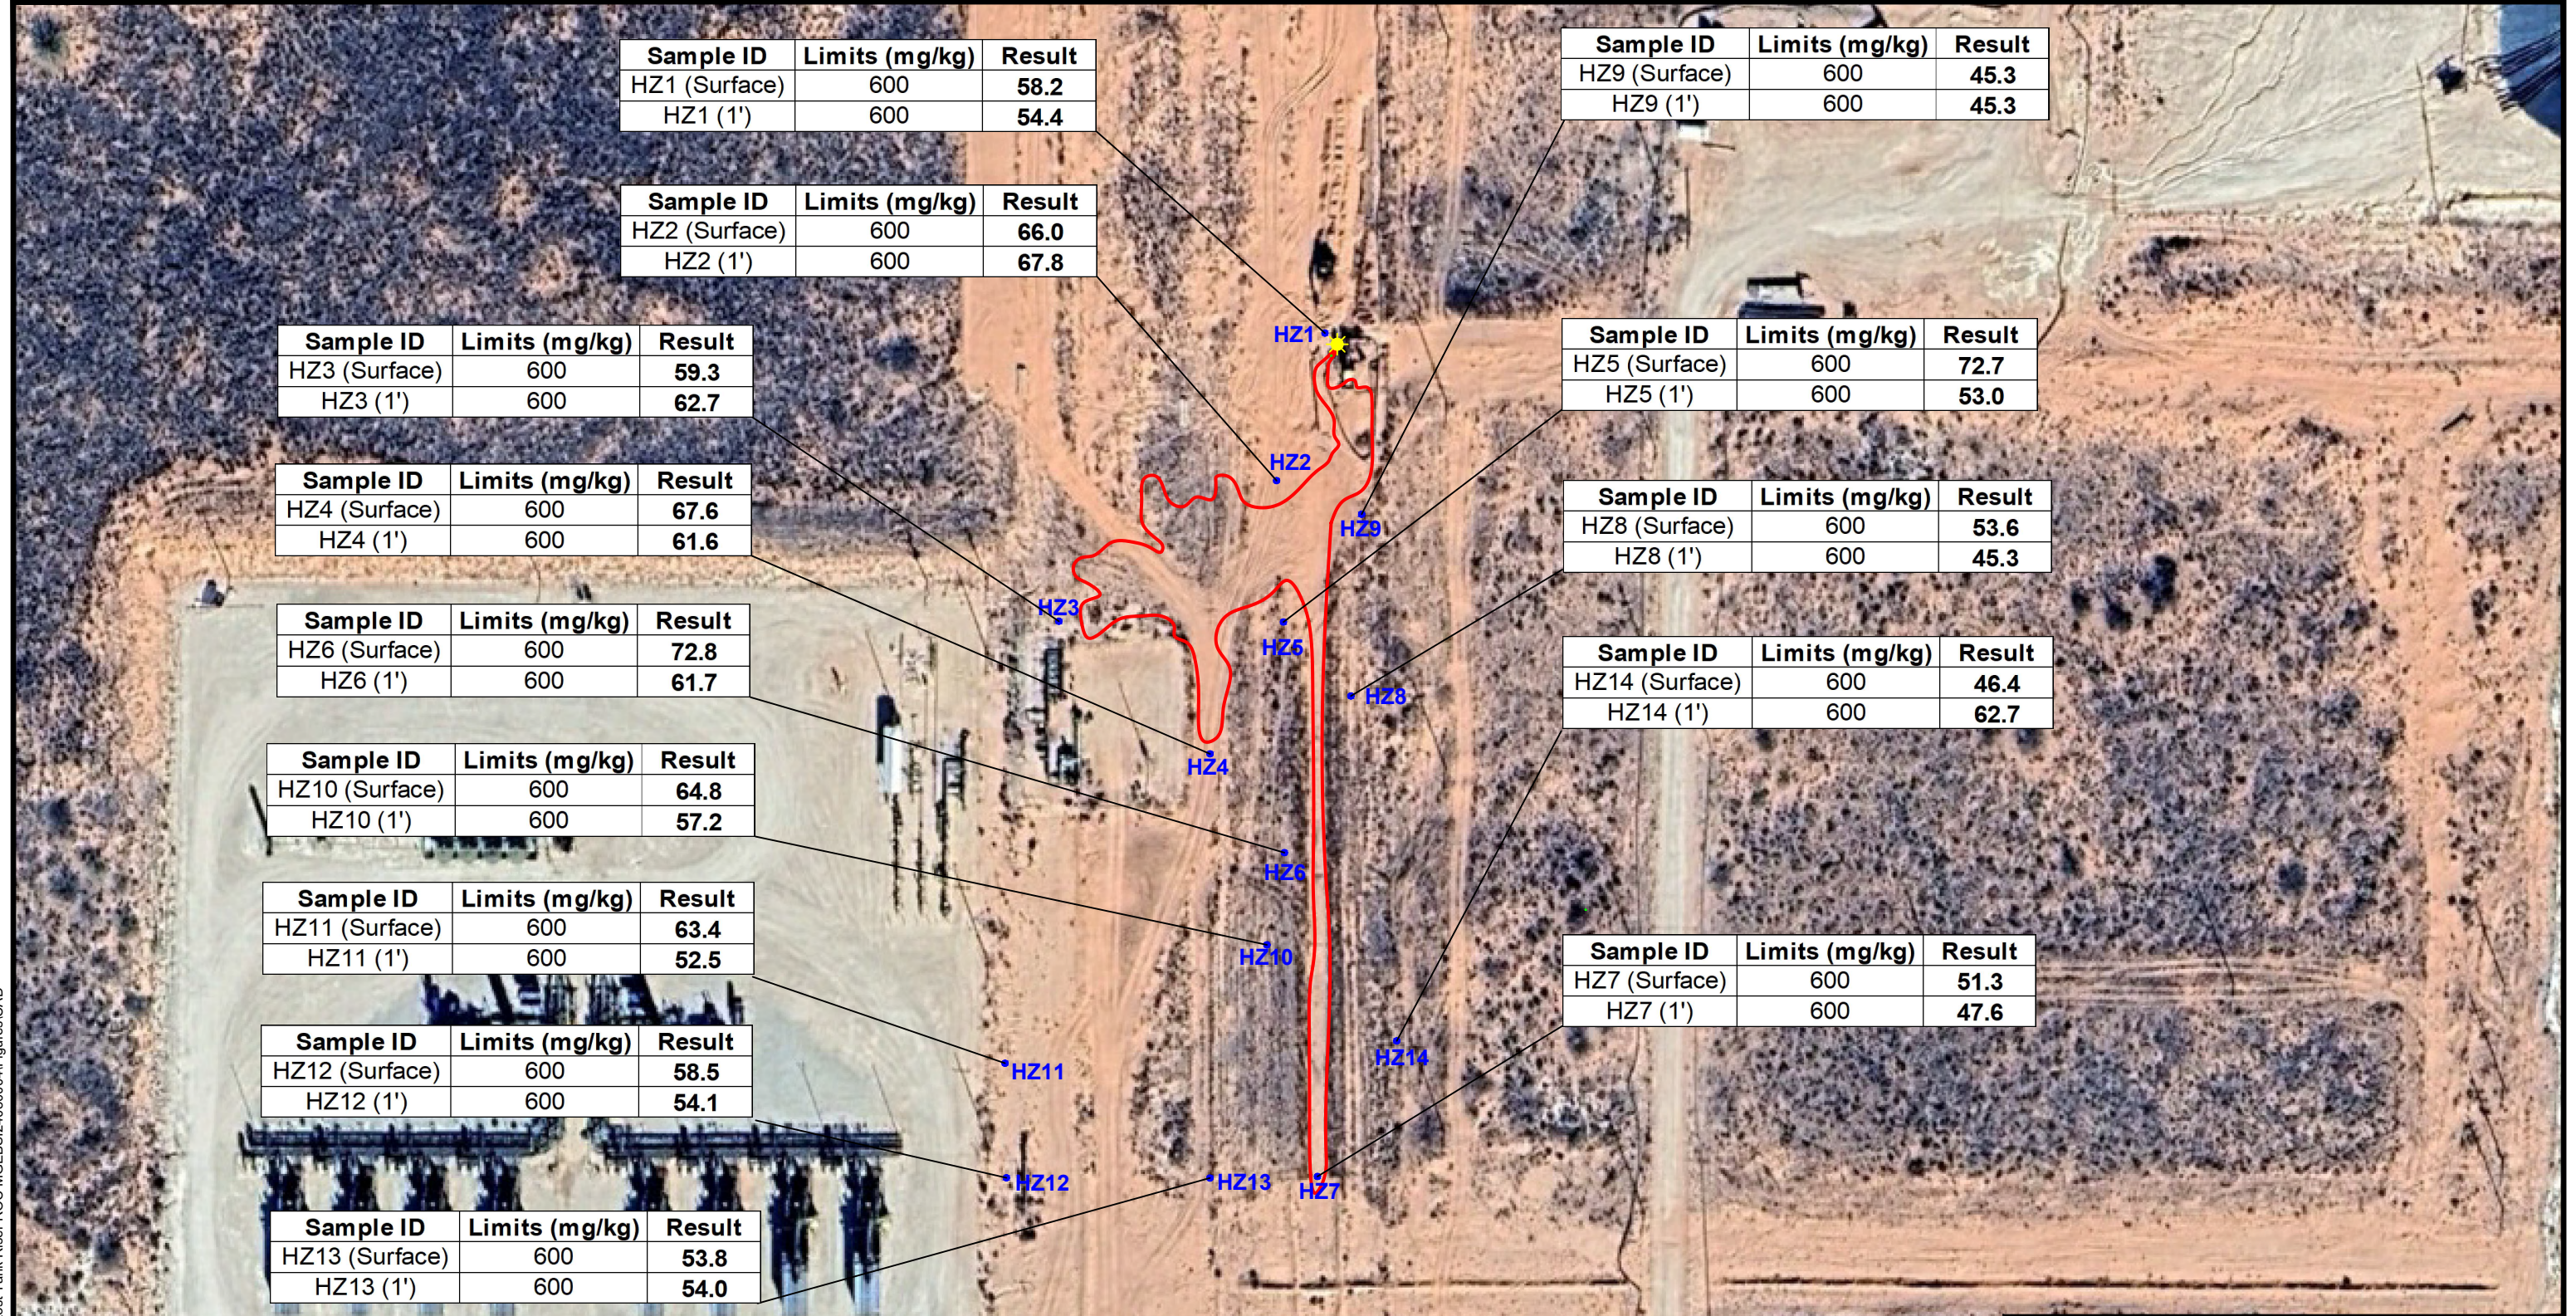
Title:
**HORIZONTAL SAMPLE POINT (HZ)
 CHLORIDE CONCENTRATION MAP**

- NOTES**
- SAMPLES WERE LOCATED COLLECTED ON FEBRUARY 2, 2024 BY HUNGRY HORSE, LLC.
 - YELLOW HIGHLIGHTING INDICATES SAMPLE RESULTS EXCEEDING THE CHLORIDE LIMIT 600 MILLIGRAMS PER KILOGRAMS (mg/kg).

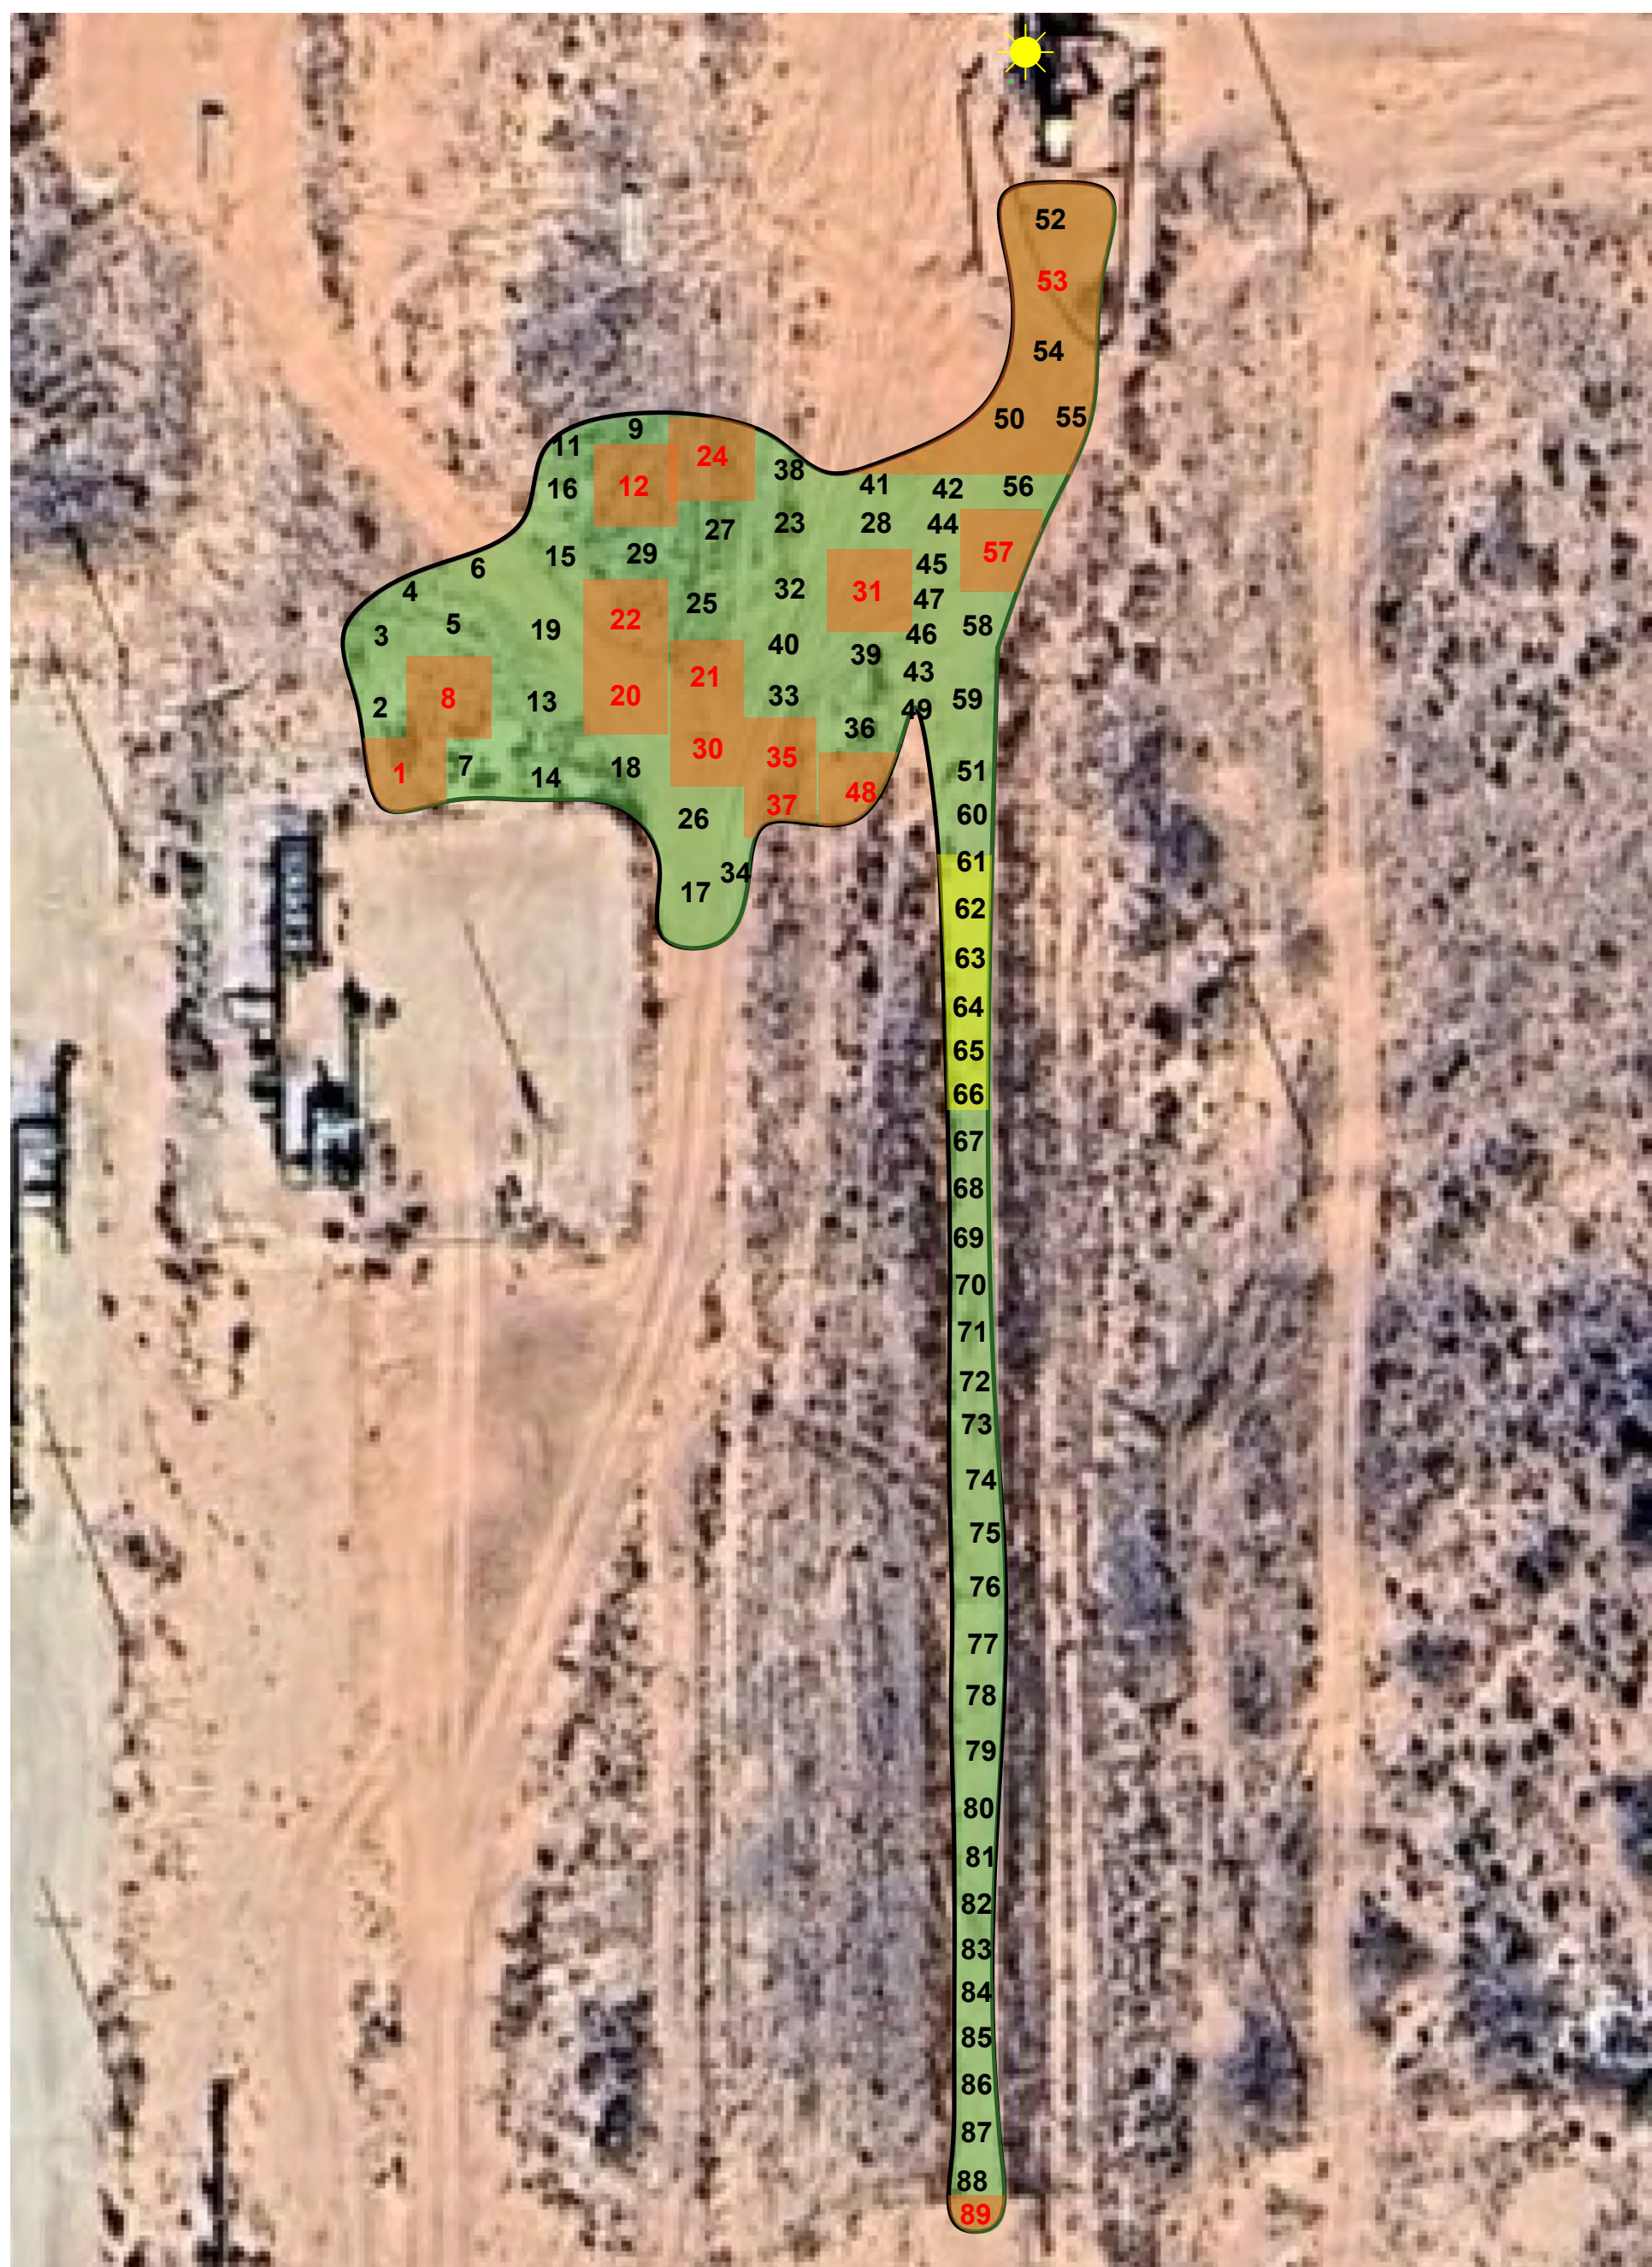
Title:			EXCAVATION AND CONFIRMATION SAMPLE MAP
32.388341, -103.723071			
Prepared for:			RANCH AND OILFIELD CONSTRUCTION, LLC
ROUX			
Compiled by: GV	Date: GT	FIGURE	
Prepared by: GV	Scale: AS SHOWN	5	
Project Mgr: GT	Project: 3360.0085P000		
File: LOST TANK RISER CLOSURE.DWG

1. RED HIGHLIGHTED NUMBERS INDICATE CONFIRMATION SAMPLES THAT EXCEED 600 MG/KG. THESE EXCEED THE NEW MEXICO OIL CONSERVATION DIVISION'S REQUIREMENTS FOR CHLORIDES IN SOIL.
2. CONFIRMATION SAMPLES WERE LABELED CS-1. SAMPLE NOMENCLATURE ON MAP IS USED FOR PRESERVATION OF SPACE WITHIN THE DRAWN EXCAVATED BOUNDARY

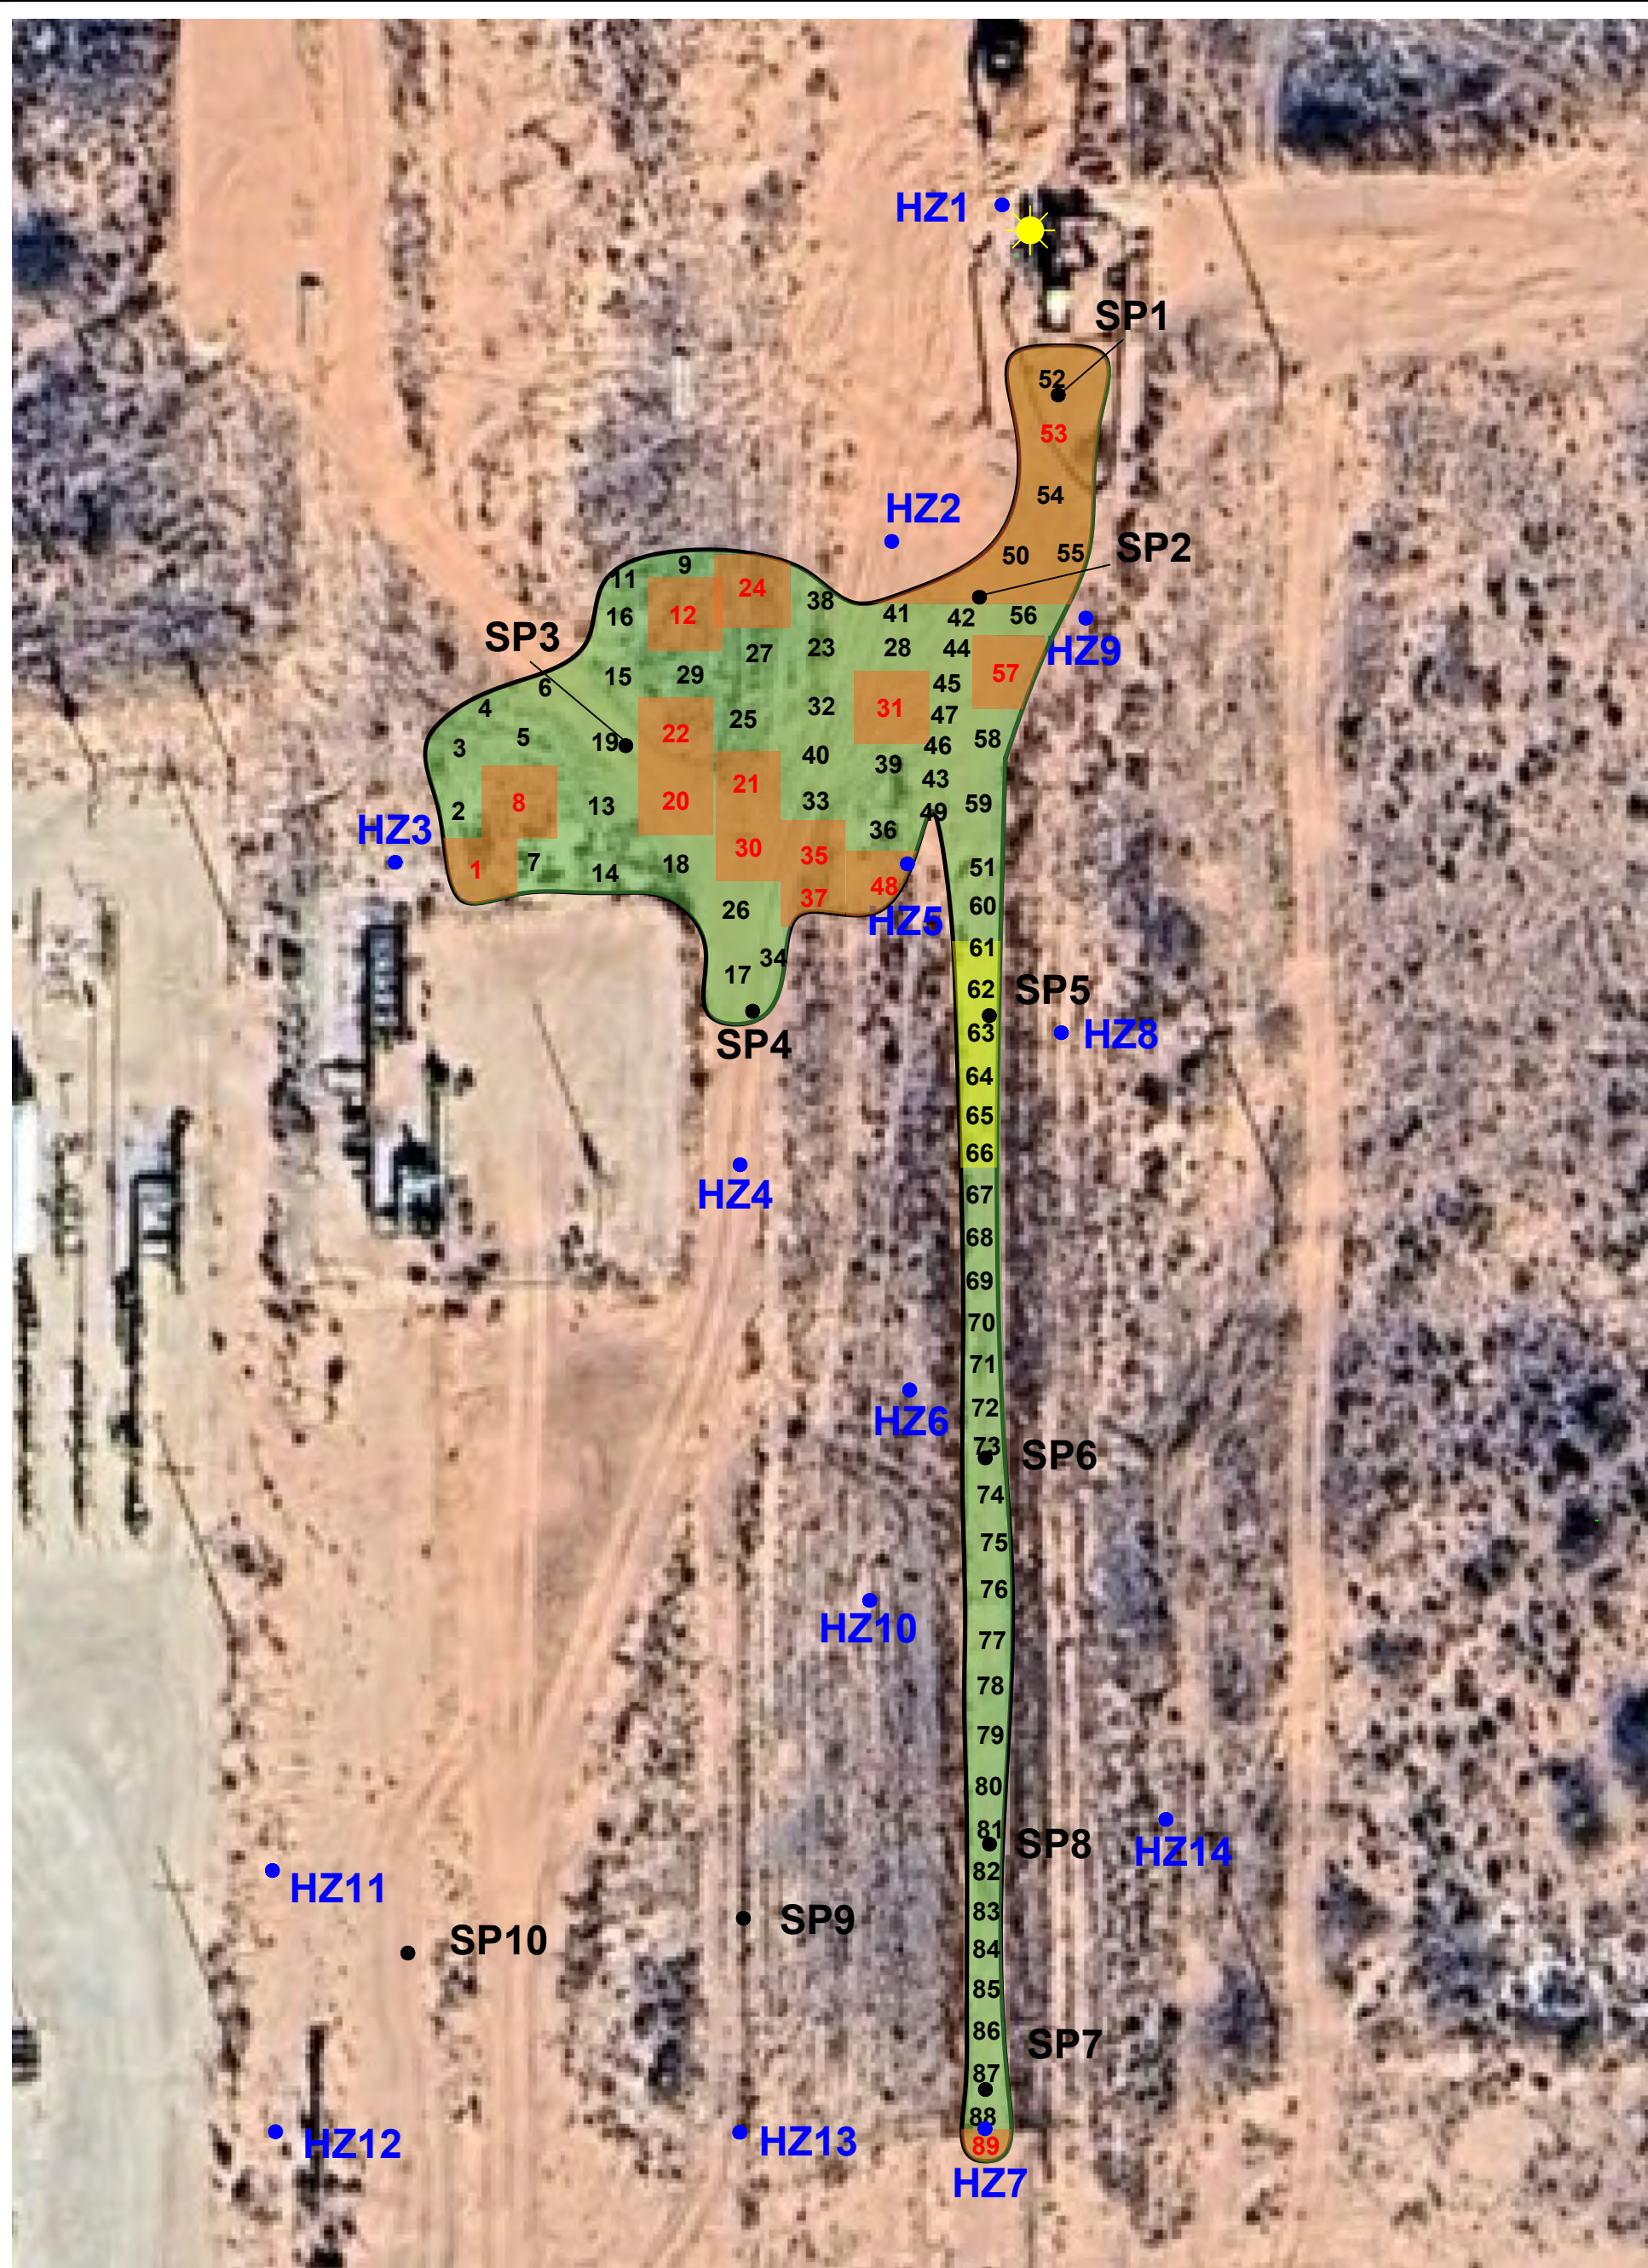
Title:		
CONFIRMATION AND DELINEATION SAMPLE LOCATION MAP		
32.388341, -103.723071		
Prepared for		
RANCH AND OILFIELD CONSTRUCTION, LLC		
Compiled by: GV	Date: 10/3/2025	FIGURE 6
Prepared by: GT	Scale: AS SHOWN	
Project Mgr: KB	Project: 3360.0085P000	
File: LOST TANK RISER CLOSURE.DWG

1. RED HIGHLIGHTED NUMBERS INDICATE CONFIRMATION SAMPLES THAT EXCEED 600 MG/KG.
2. CONFIRMATION SAMPLES WERE LABELED CS-1.
3. HZ AND SP SAMPLES ARE FROM INITIAL INVESTIGATION CONDUCTED BY HUNGRY HORSE, LLC.

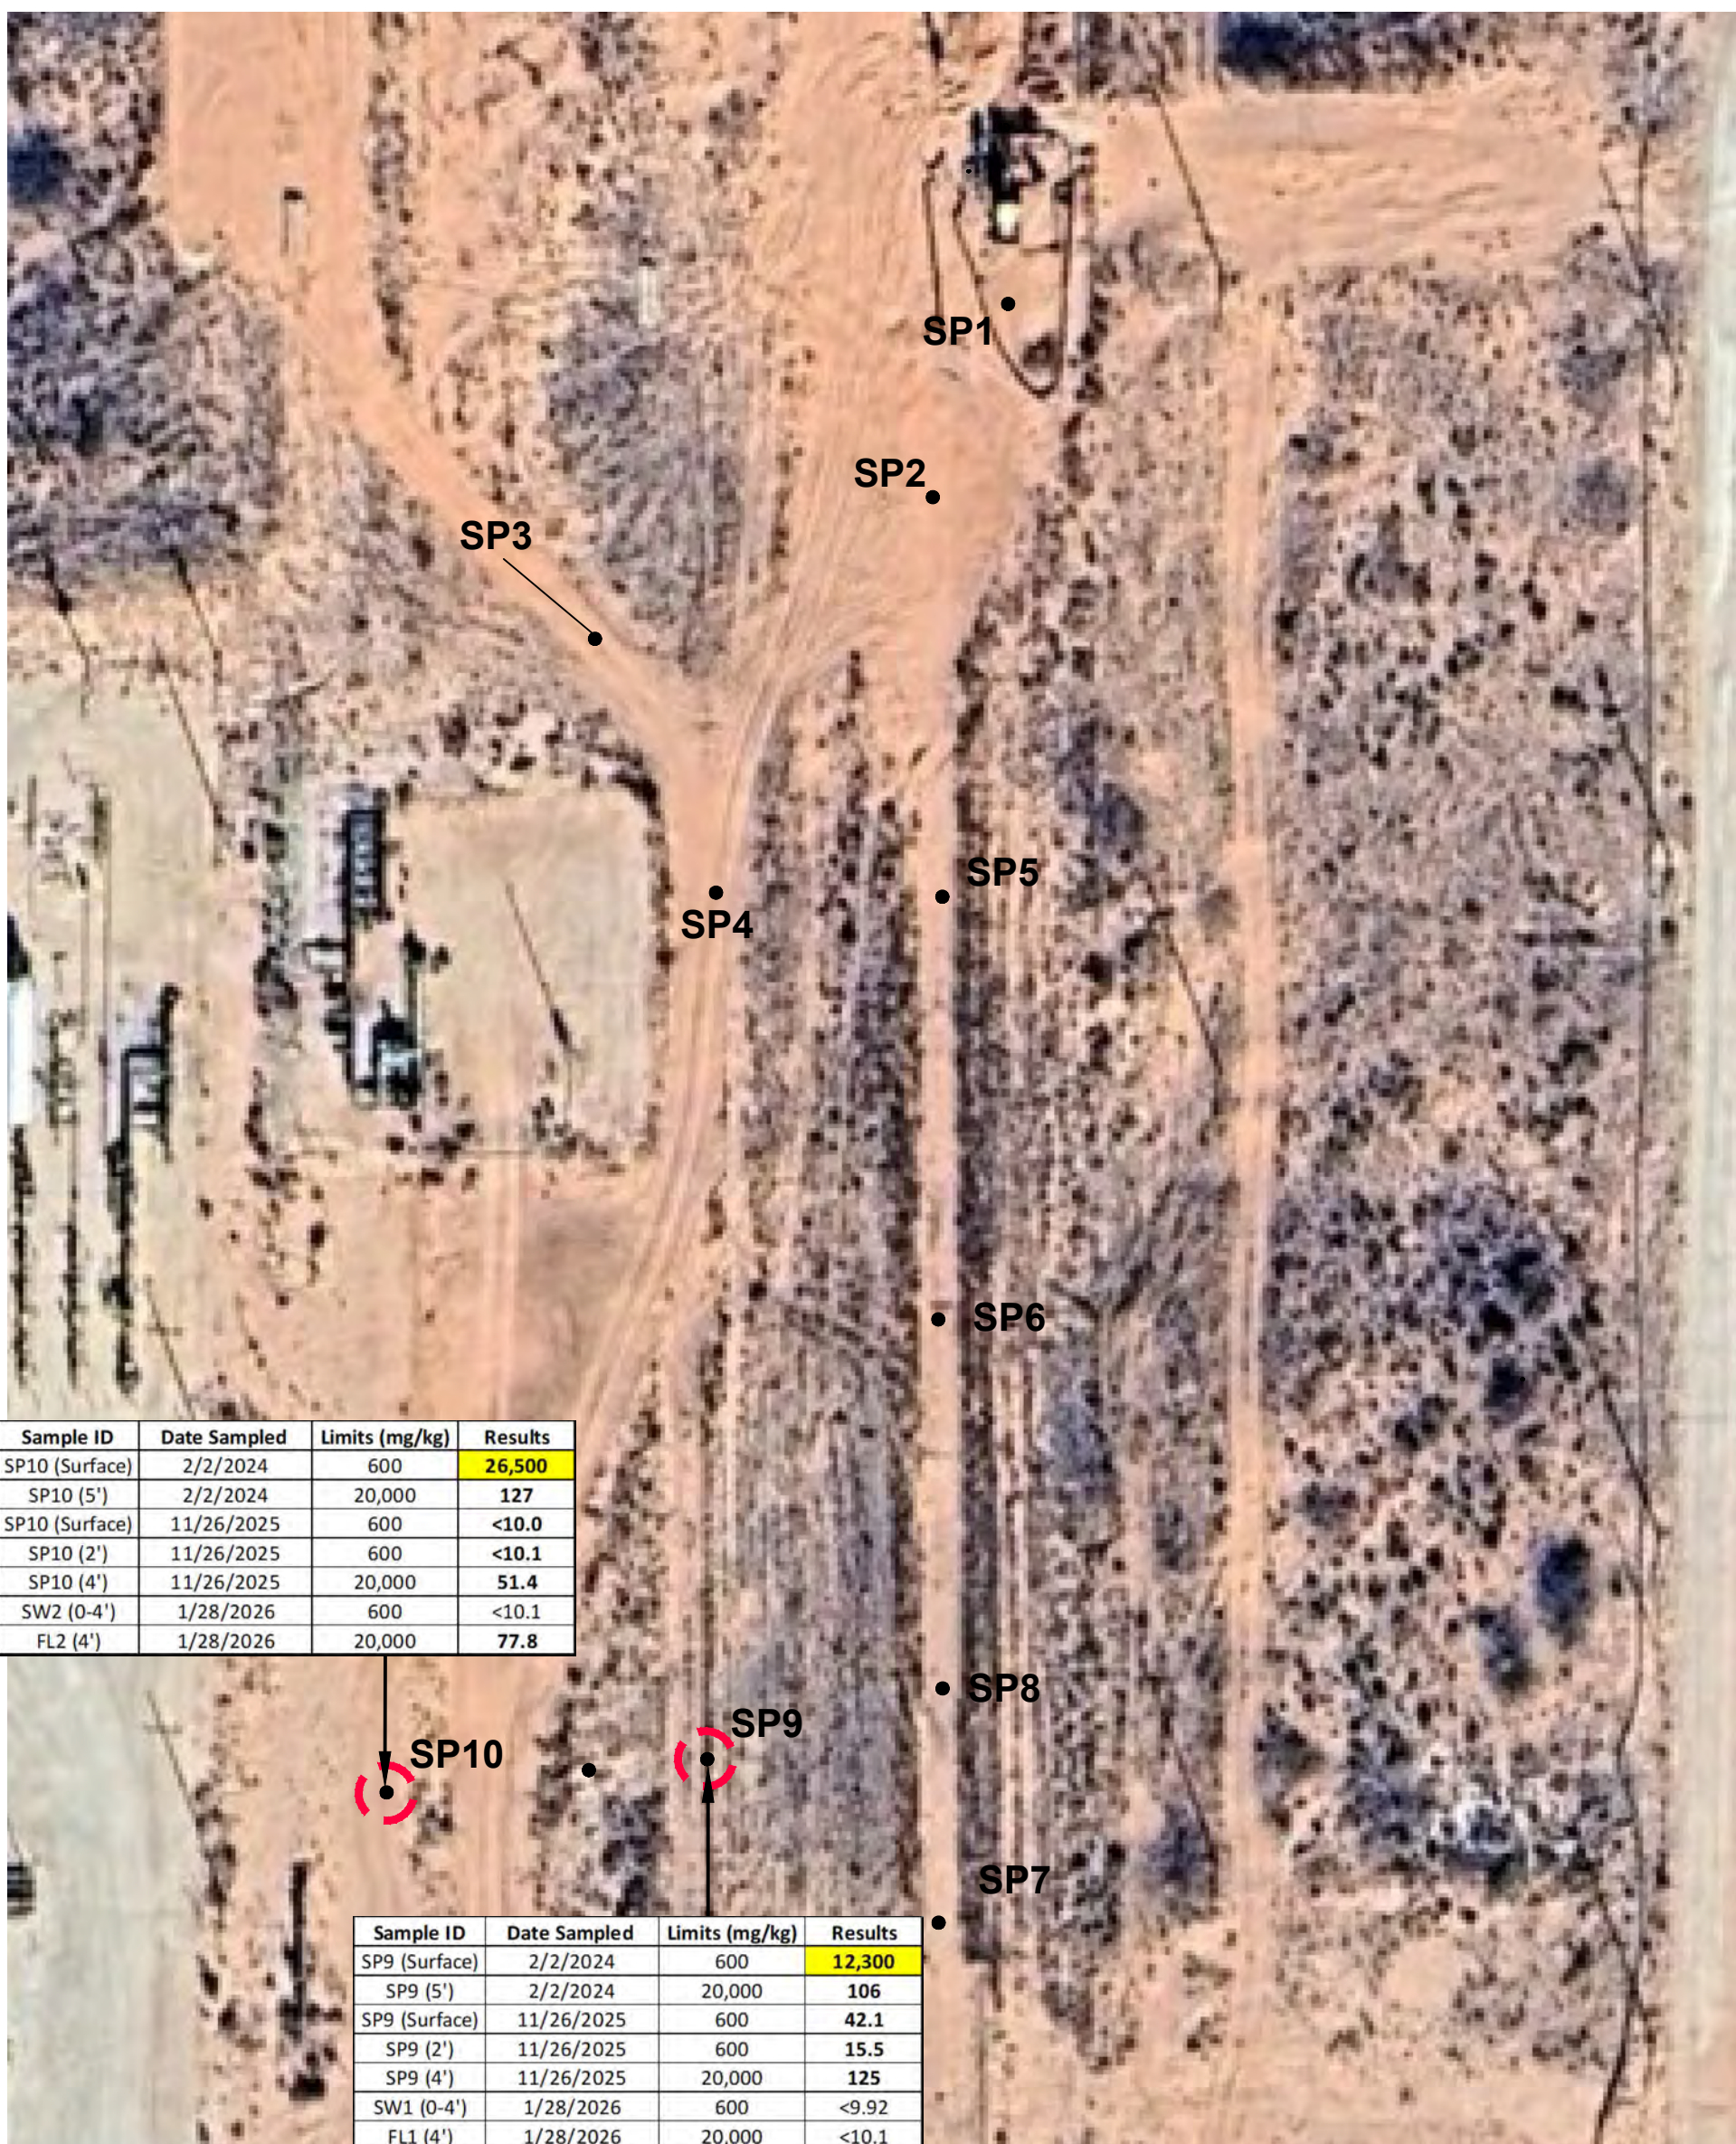
Title:			
SECONDARY RELEASE AREA			
32.388341, -103.723071			
Prepared for			
RANCH AND OILFIELD CONSTRUCTION, LLC			
ROUX	Compiled by: GV	Date: 02/19/2026	FIGURE 7
	Prepared by: GV/JSJG	Scale: AS SHOWN	
	Project Mgr: GT	Project: 3360.0085P000	
	File: SECONDARY RELEASE AREA FIGURE 7 02192026

1. DELINEATION OF INCIDENT ID# nAPP2400362480 WAS CONDUCTED BY HUNGRY HORSE, LLC IN JANUARY 2024.
2. DELINEATED AREA WAS EXCAVATED UNDER HUNGARY HORSE'S SUPERVISION. DELINEATION AREA WAS TO BE EXCAVATED 4-5 BELOW GROUND SURFACE (bgs).
3. YELLOW HIGHLIGHTING INDICATES SAMPLE RESULTS EXCEEDING THE CHLORIDE LIMIT 600 MILLIGRAMS PER KILOGRAMS (mg/kg).
