Remediation and Closure Report

Lost Tank Riser
Eddy County, New Mexico
(32.388341, -103.723071)

February 26, 2026

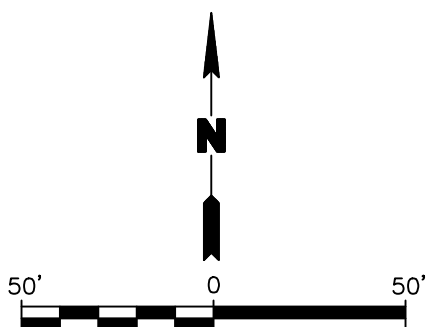
Title:			
SECONDARY RELEASE AREA			
32.388341, -103.723071			
Prepared for			
RANCH AND OILFIELD CONSTRUCTION, LLC			
ROUX	Compiled by: GV	Date: 02/19/2026	FIGURE 7
	Prepared by: GV/JSJG	Scale: AS SHOWN	
	Project Mgr: GT	Project: 3360.0085P000	
	File: SECONDARY RELEASE AREA FIGURE 7 02192026

Two soil samples (SP-9 and SP-10) were collected during the initial investigation conducted by Hungry Horse, LLC (Hungry Horse) outside of the identified impacted area (primary release) associated with the spill on January 3, 2024. Although unrelated to the January 2024 primary release, ROC, under the direction of Select, contracted Hungry Horse to collect additional soil samples at these two locations to determine if additional remediation was needed in the area. On November 26, 2025, Hungry Horse collected additional soil samples at SP-9 and SP-10, at the surface, 2-ft bgs, and four-ft bgs. Based on the analytical results, these soil results appeared not to warrant additional sampling or remediation activities as concentrations were below the applicable NMOCD standard of 600 mg/kg for chloride (**Table 2**). NMOCD requested additional confirmation samples to be collected per the five-point composite collection method in accordance with NMAC: 19.15.29. Excavation of the area was conducted under the supervision of Hungry Horse and confirmation samples were collected. These results indicated no exceedance of chloride, BTEX, or TPH (**Table 3 & Figure 7**) and the secondary release area does not warrant any further action.

NMOCD requested ROC to perform five-point composite confirmation sampling, in accordance with NMAC: 19.15.29, on the secondary release area near SP9 and SP10. Hungry Horse performed the confirmation sampling on January 28, 2026, where four additional soil confirmation samples (FL1, FL2, SW1, and SW2) were collected. Two floor samples (FL1 and FL2) and two side wall samples (SW1 and SW2) of the excavation were collected. Results are shown in **Table 3 & Figure 7**.

1. DELINEATION OF INCIDENT ID# nAPP2400362480 WAS CONDUCTED BY HUNGRY HORSE, LLC IN JANUARY 2024.
2. DELINEATED AREA WAS EXCAVATED UNDER HUNGARY HORSE'S SUPERVISION. DELINEATION AREA WAS TO BE EXCAVATED 4-5 BELOW GROUND SURFACE (bgs).
3. YELLOW HIGHLIGHTING INDICATES SAMPLE RESULTS EXCEEDING THE CHLORIDE LIMIT 600 MILLIGRAMS PER KILOGRAMS (mg/kg).

Post excavation soil samples were also collected from locations SP9 and SP10, and concentrations were below both surface and subsurface NMOCD chloride standards of 600 and 20,000 mg/kg, respectively. Therefore, additional excavation was not warranted. A detailed excavation sample confirmation map along with delineation samples map are shown in **Figure 6**. Additionally, chloride concentrations are shown in **Table 1** and **Table 2** and attached in **Appendix C**. NMOCD required additional confirmation sampling in accordance with NMAC: 19.15.29 in the areas of SP9 and SP10. Results indicated all samples were either below the chloride, BTEX, and TPH limits or non-detect (**Table 3 & Figure 7**). This confirmed the affected soil was removed and does not warrant any further action.

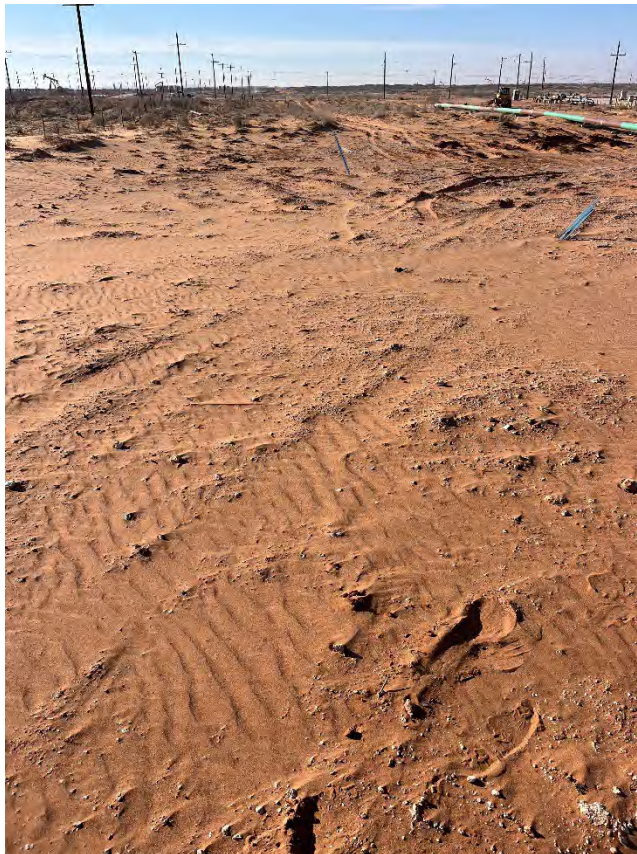
Photograph 1 (02/19/2025): Central northern portion of delineated impacted area prior to excavation; facing south

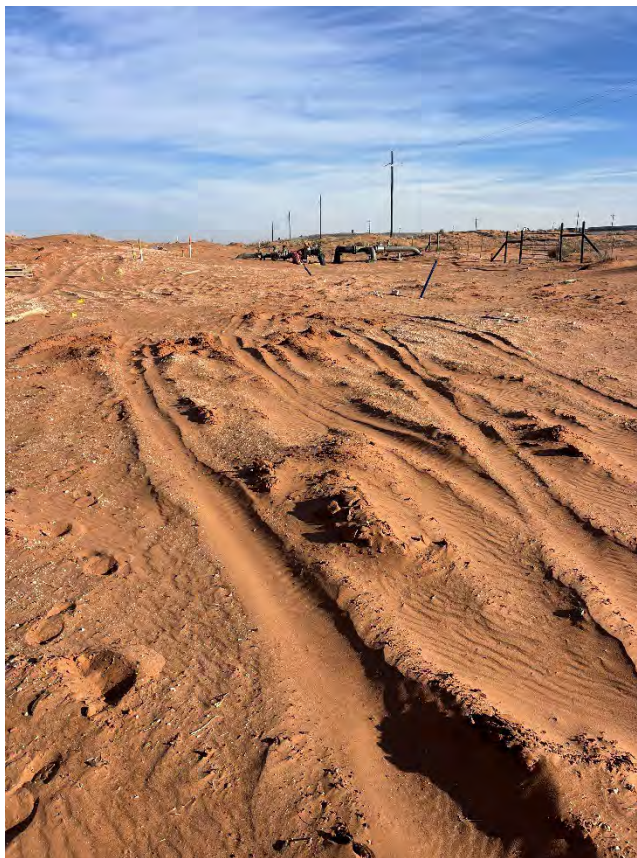
Photograph 2 (02/19/2025): Central northern section of the delineated area prior to excavation. Lay flat produced water pipelines shown; facing north.

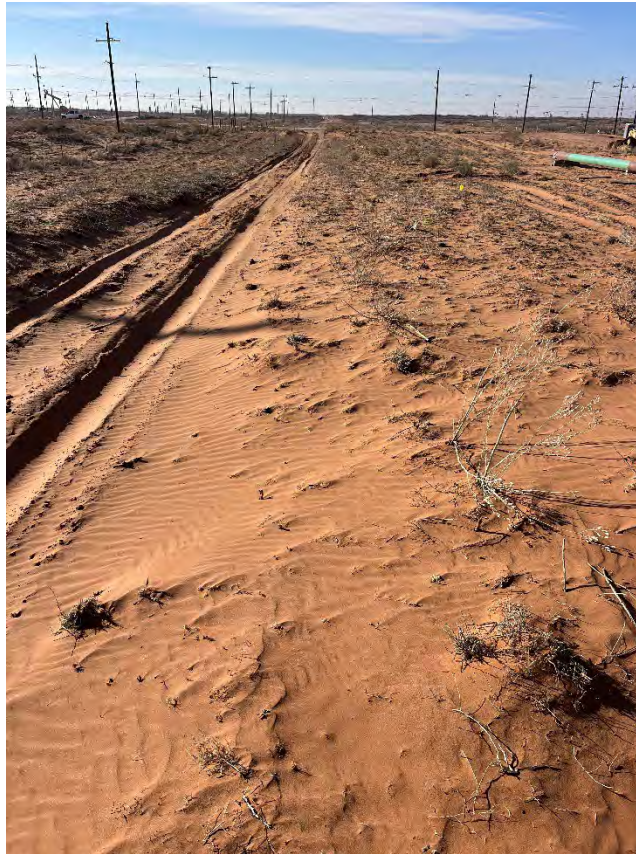
Photograph 3 (02/19/2025): Southern portion of delineated impacted area prior to excavation; facing south

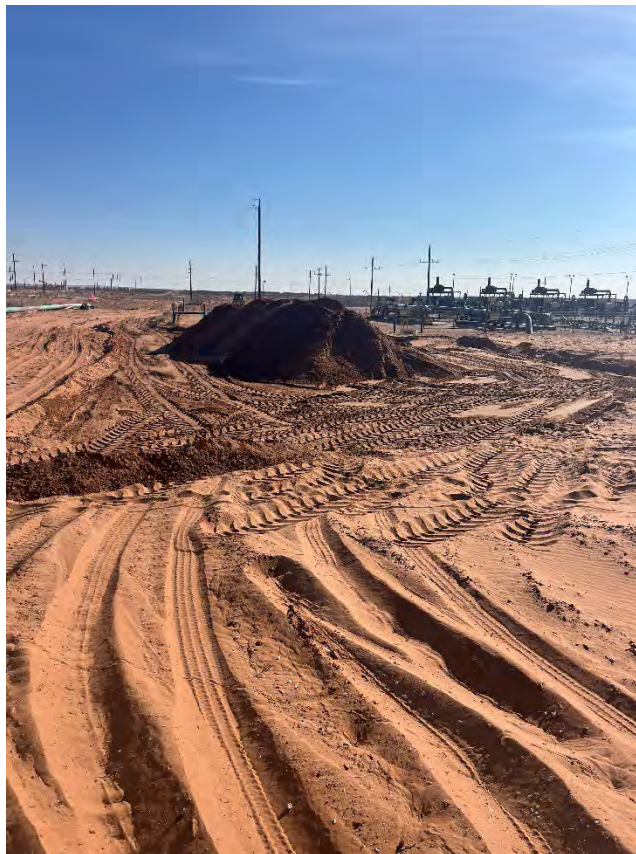
Photograph 4 (02/19/2025) : Central western section of the delineated area at 1' bgs with a soil pile; facing south.

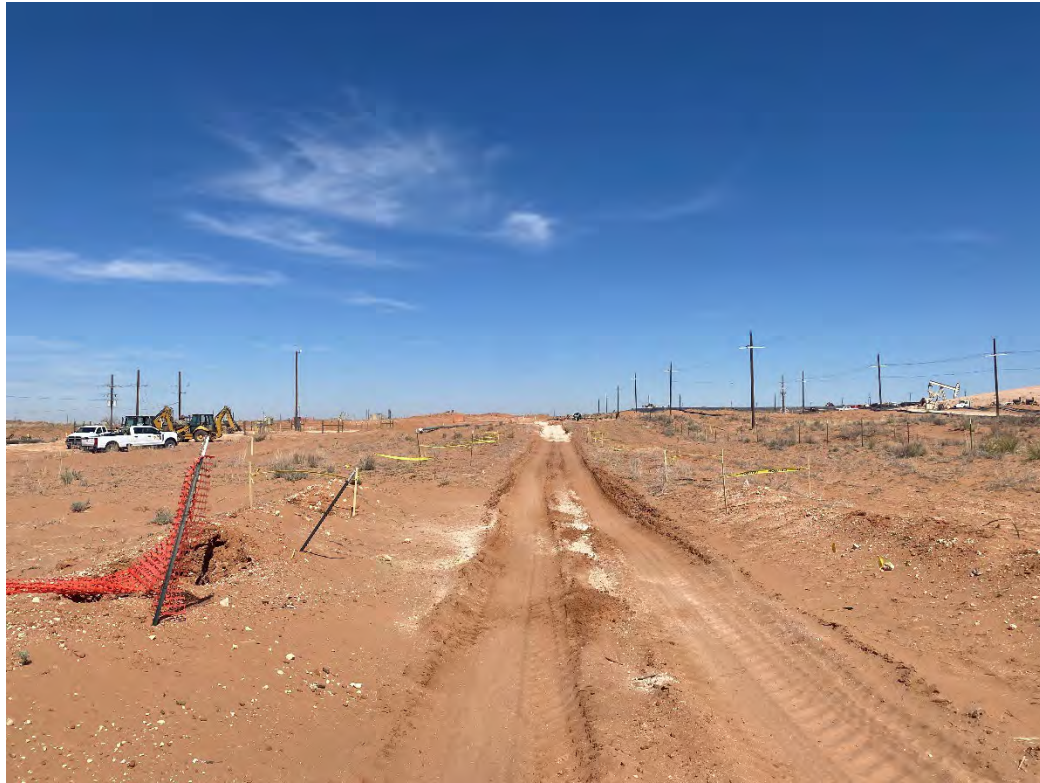
Photograph 5 (03/05/2025): Southern portion of impacted area at 1' bgs at CS-74; facing north.

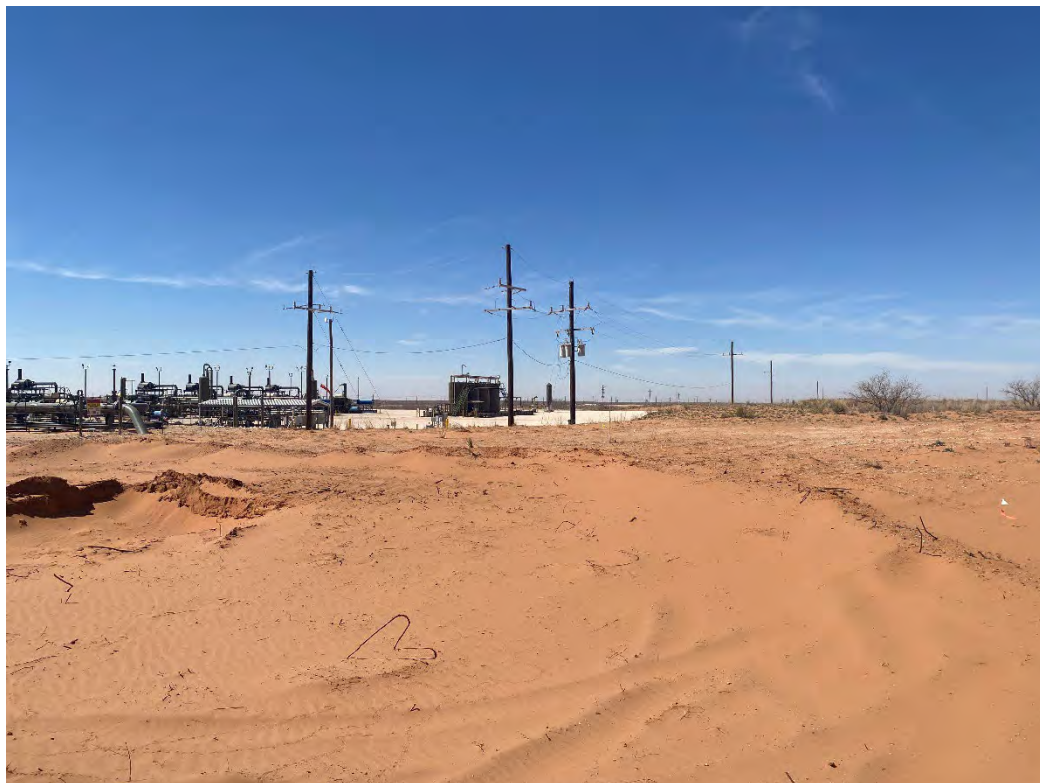
Photograph 6 (03/05/2025): Central western portion of excavation where CS-6 is located at 1' bgs. CS-8 sample location is shown to the left of the photograph at 4' bgs; facing south.

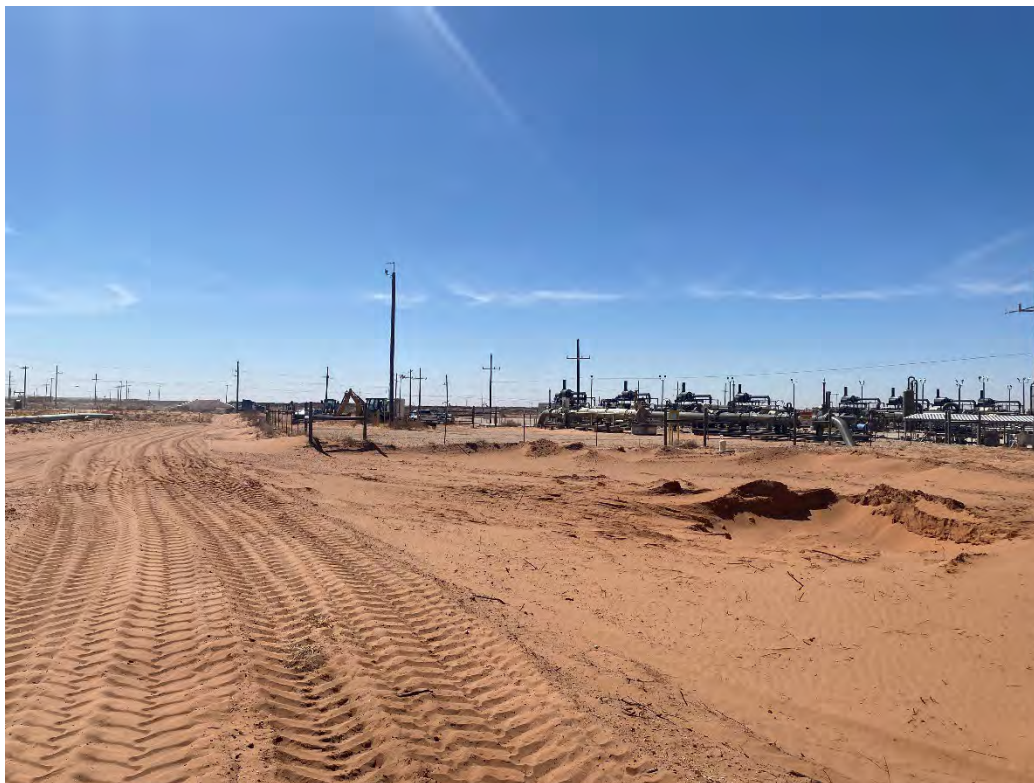
Photograph 7 (03/05/2025): Central western portion of excavation where CS-21 sample is located; facing southwest.

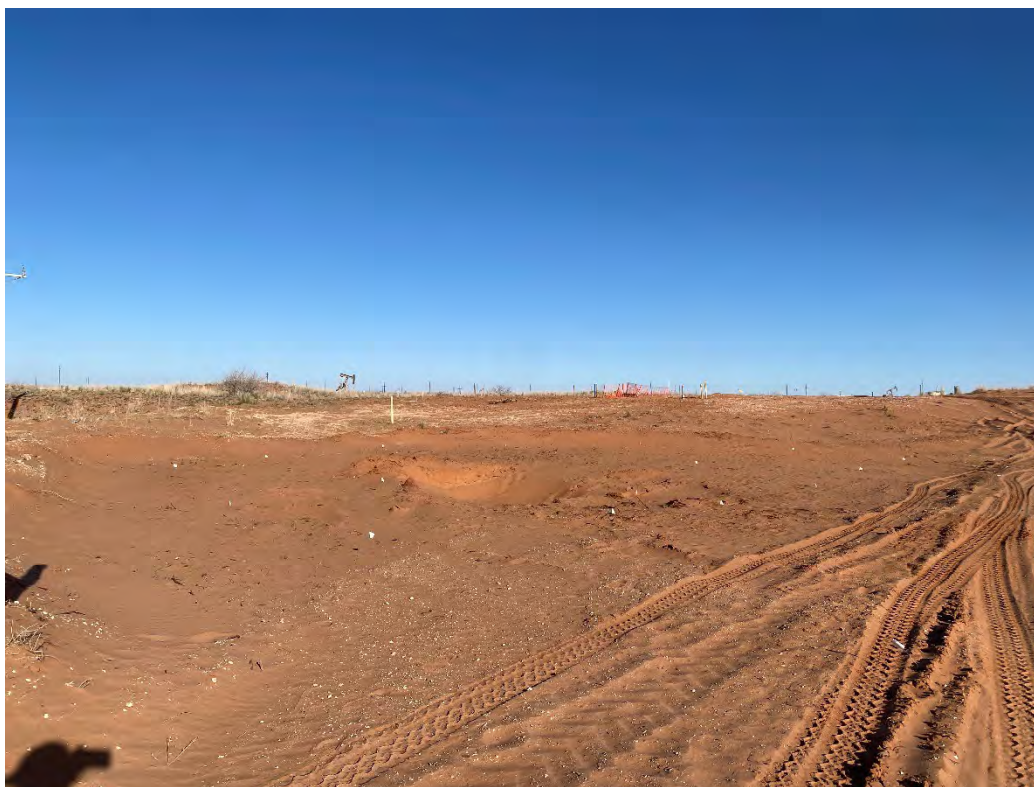
Photograph 8 (03/07/2025): Central western portion of excavation where CS-21 sample is located. Sample flags have been marked for confirmation sampling; facing northwest.

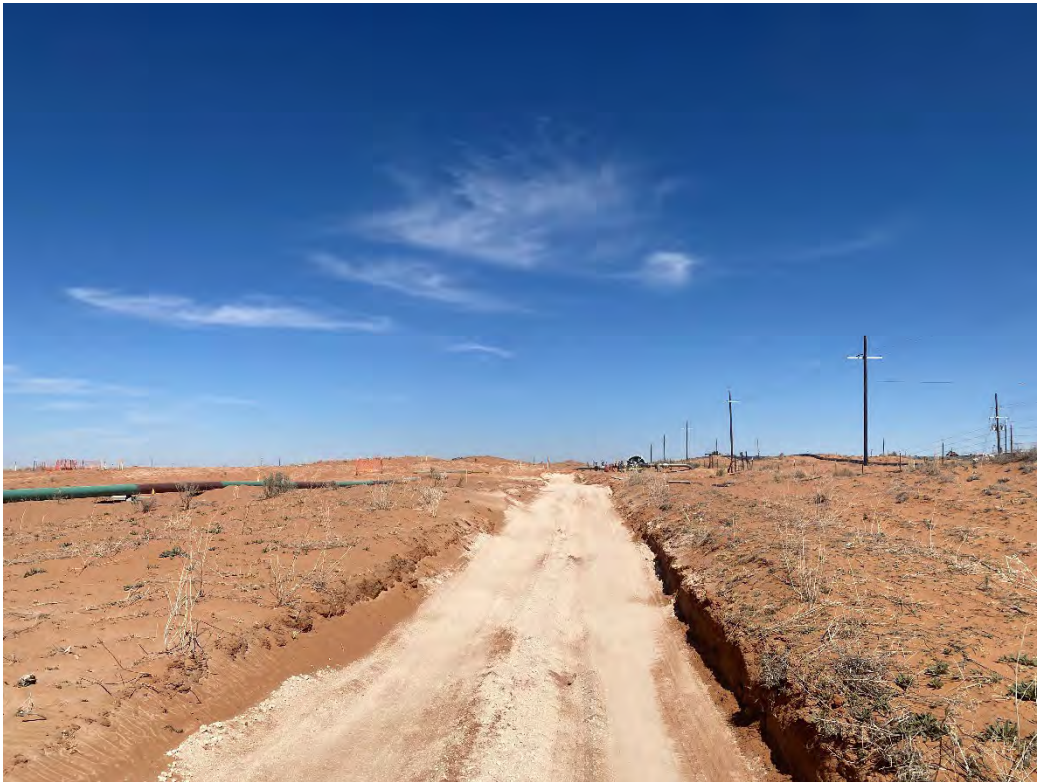
Photograph 9 (03/07/2025): Central southern portion of excavation where CS-61 through CS-66 samples are located at 2' bgs. Caliche road for hydro-excavation truck; facing north.

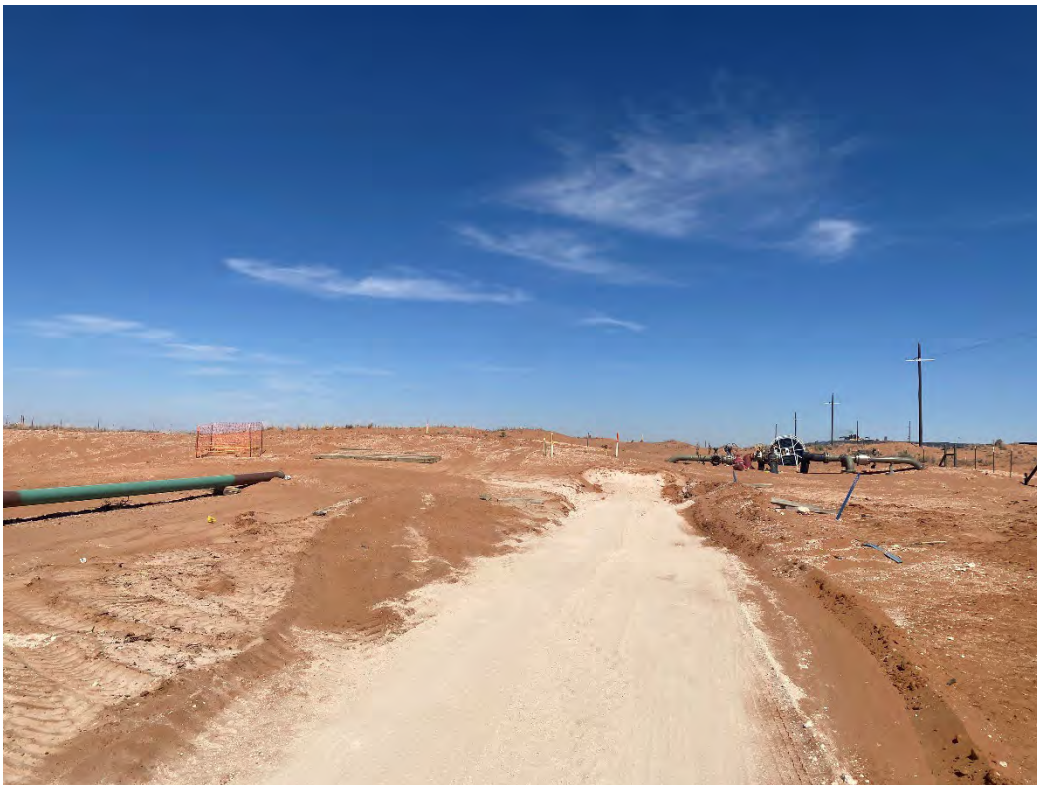
Photograph 10 (03/07/2025): Central northern portion of excavation where CS-51 is located at 1' bgs; facing north.

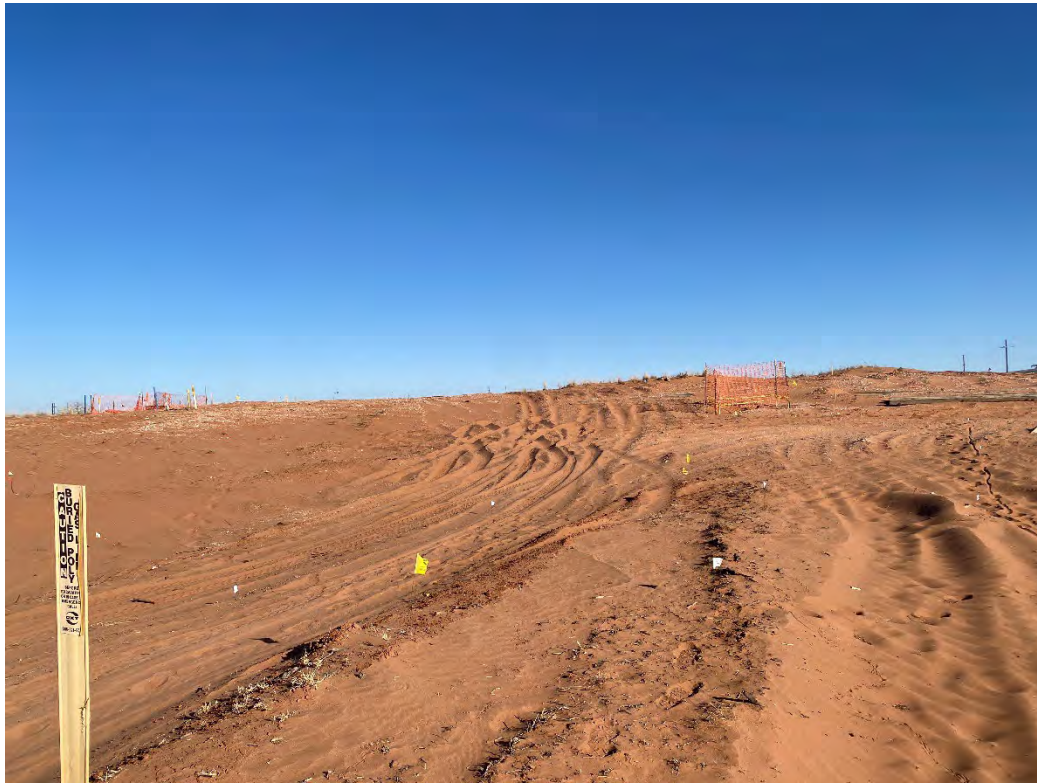
Photograph 11 (03/07/2025): Standing at sample location CS-32 while overlooking confirmation sample flags in the central northern portion of excavation at 1'bgs; facing north.

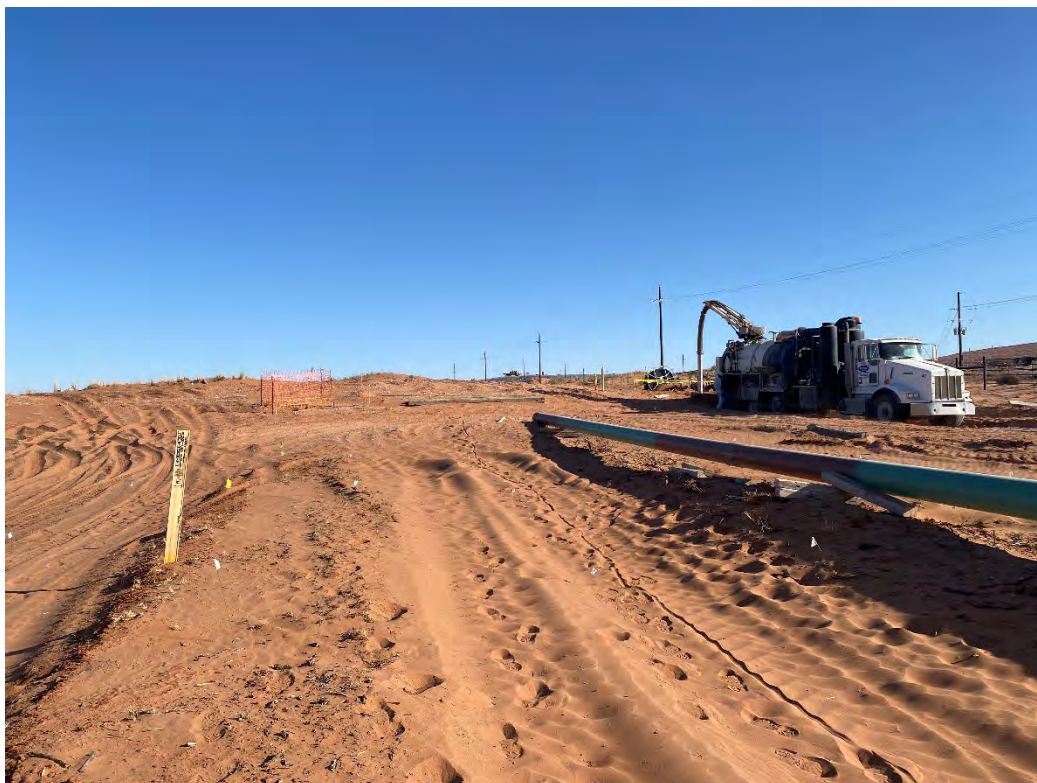
Photograph 12 (03/07/2025): Standing at sample location CS-32 while overlooking confirmation sample flags, aboveground pipeline, and hydro-excavation truck; facing northeast.

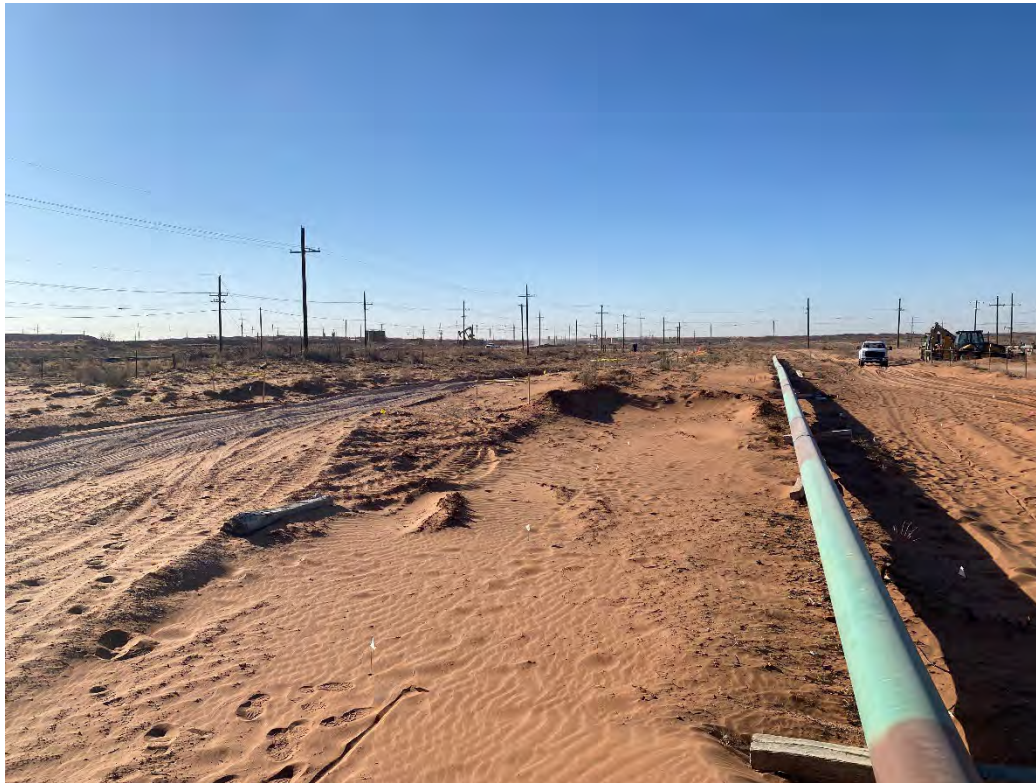
Photograph 13 (03/07/2025): Standing at sample location CS-31 overlooking central eastern portion of excavation; facing south.

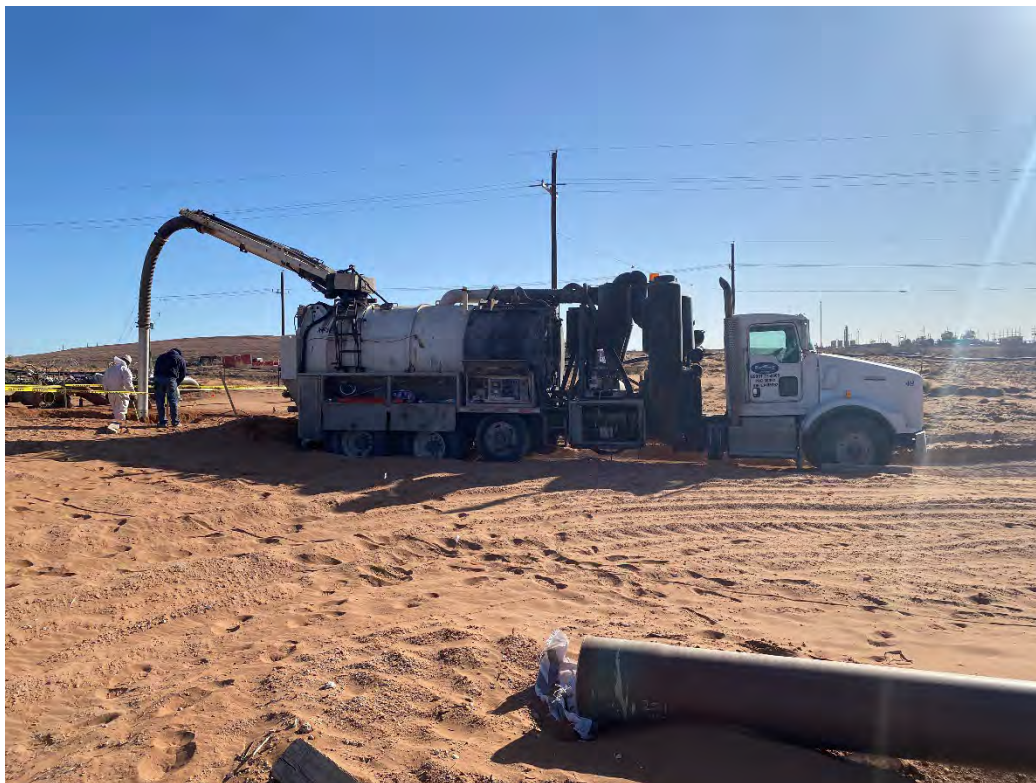
Photograph 14 (03/07/2025): Standing at sample location CS-31 overlooking hydro-excavation truck working on sample location CS-53; facing east.

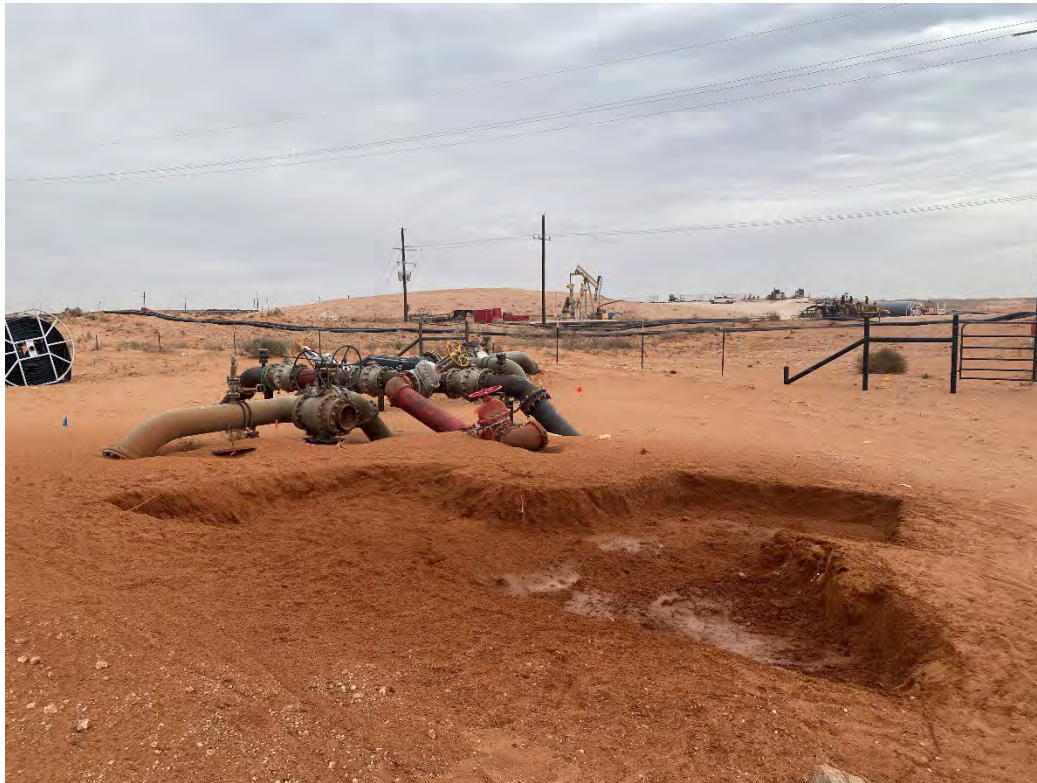
Photograph 15 (03/07/2025): Sample locations CS-52 through CS-54 at 1'bgs; facing northeast.

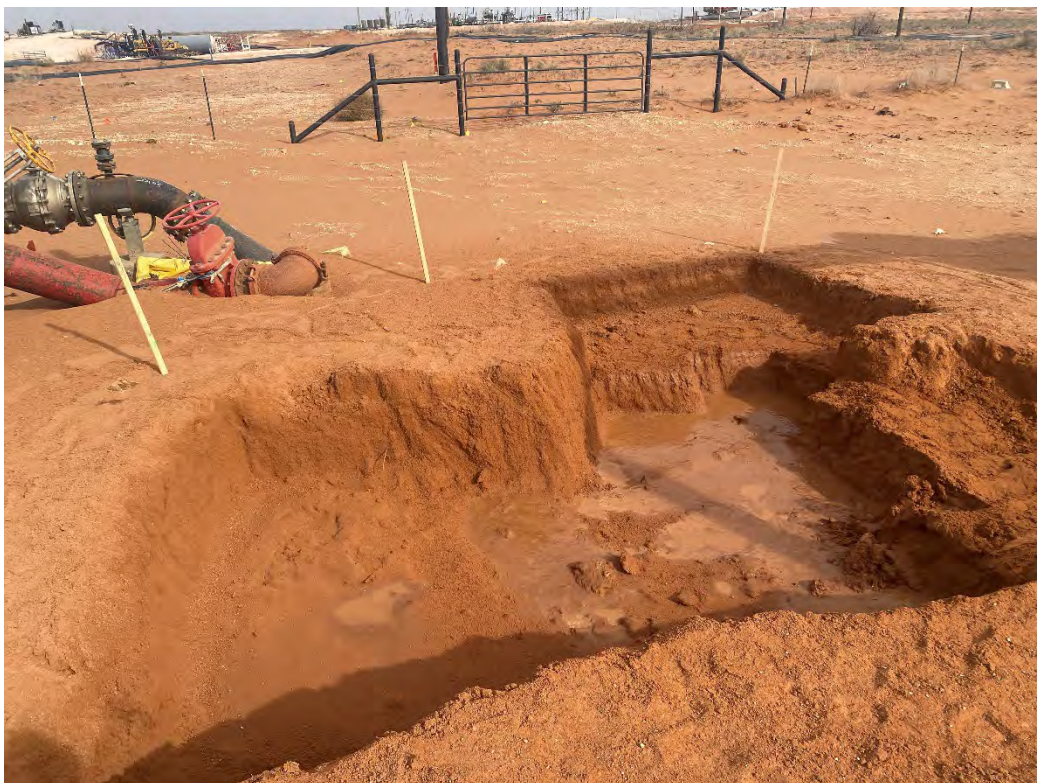
Photograph 16 (03/07/2025): Sample locations CS-52 through CS-54 at 2'bgs; facing northeast.

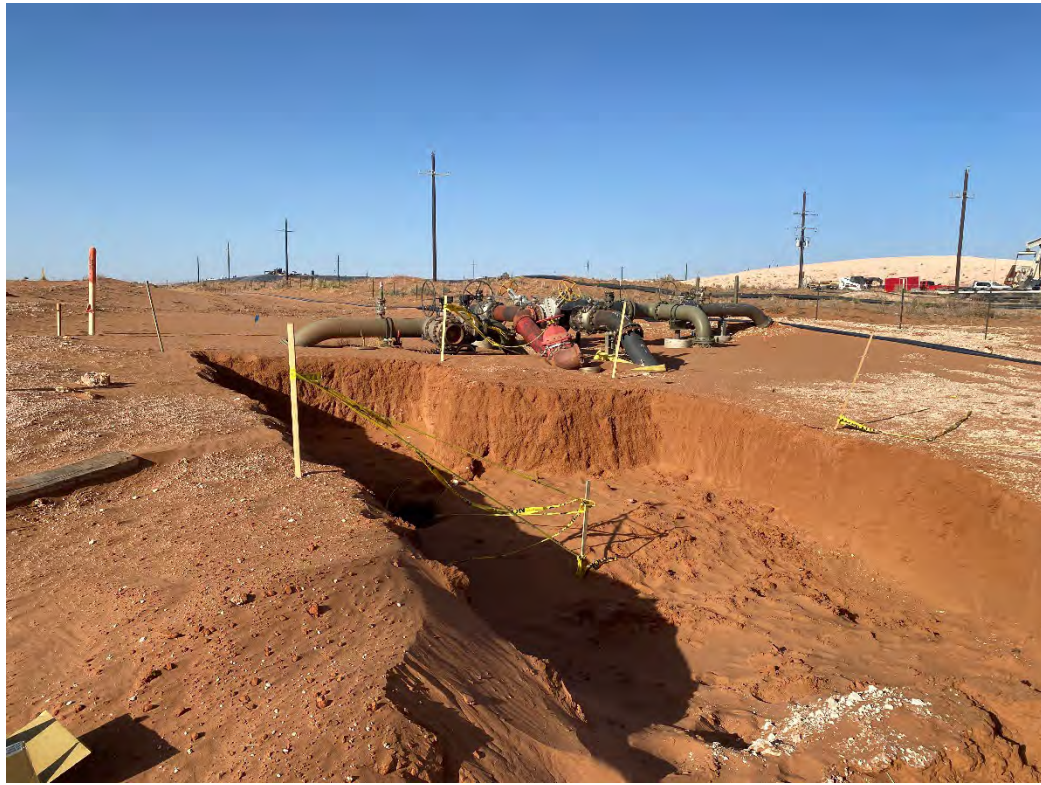
Photograph 17 (03/12/2025): Sample locations CS-50 and CS-52 through CS-54 at 4' bgs; facing northeast.

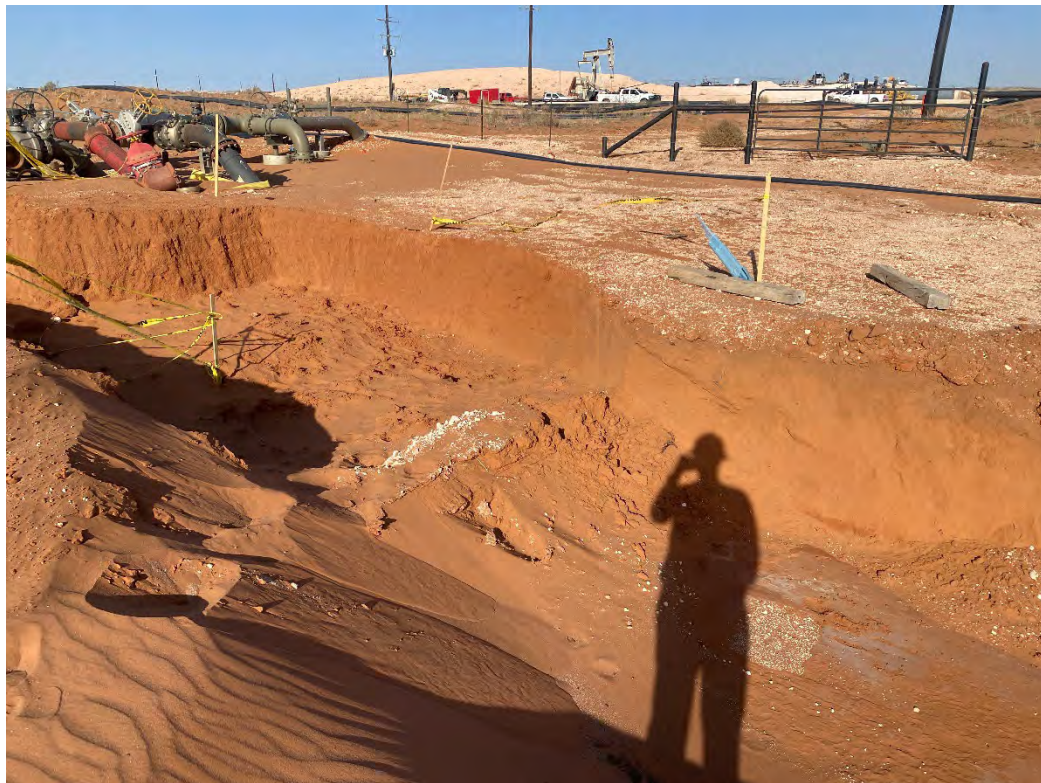
Photograph 18 (03/12/2025): Sample locations CS-50 and CS-52 through CS-54 at 4' bgs; facing northeast.

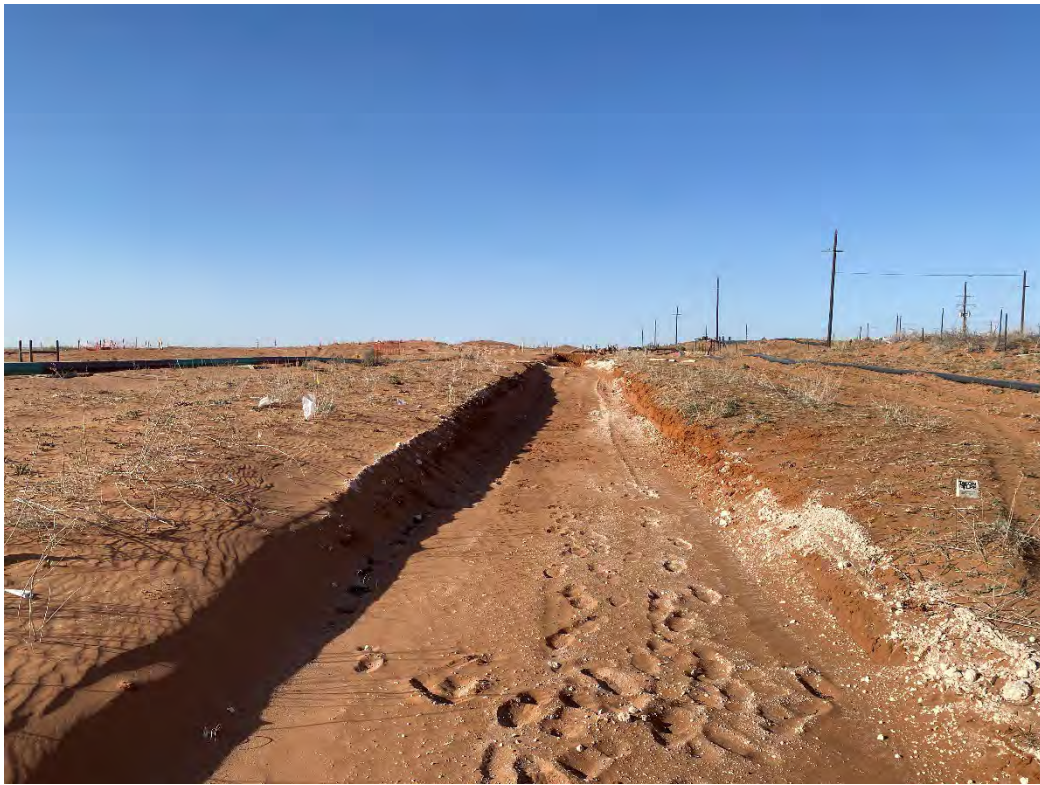
Photograph 19 (03/12/2025): Central southern portion of excavation where CS-61 through CS-66 samples are located at 2' bgs with no caliche road; facing north.

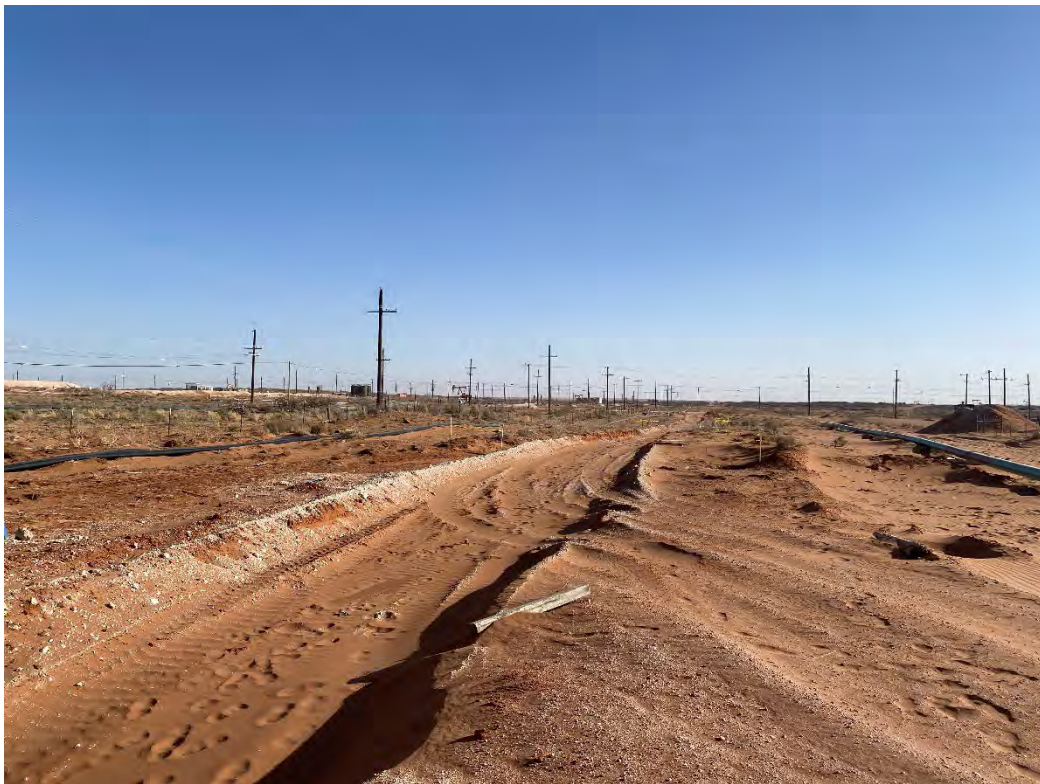
Photograph 20 (03/12/2025): Central southern portion of excavation where CS-61 through CS-66 samples are located at 2' bgs with no caliche road; facing south.

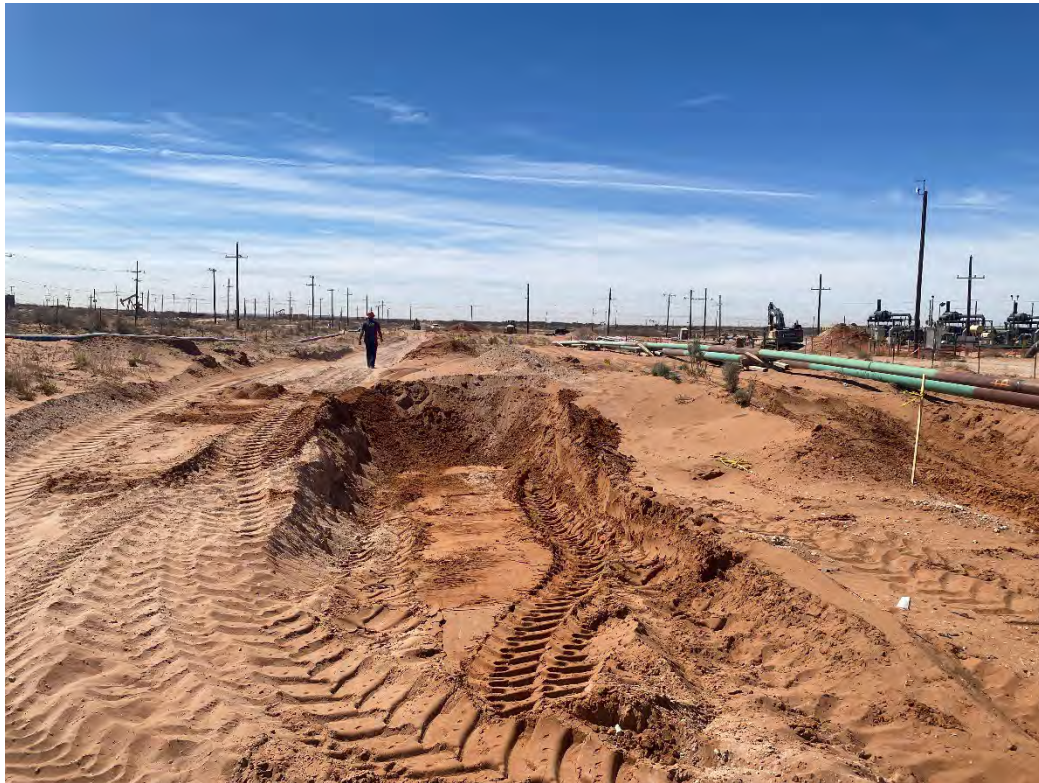
Photograph 21 (03/24/2025): Additional excavation at sample location CS-48 to 4' bgs; facing south.

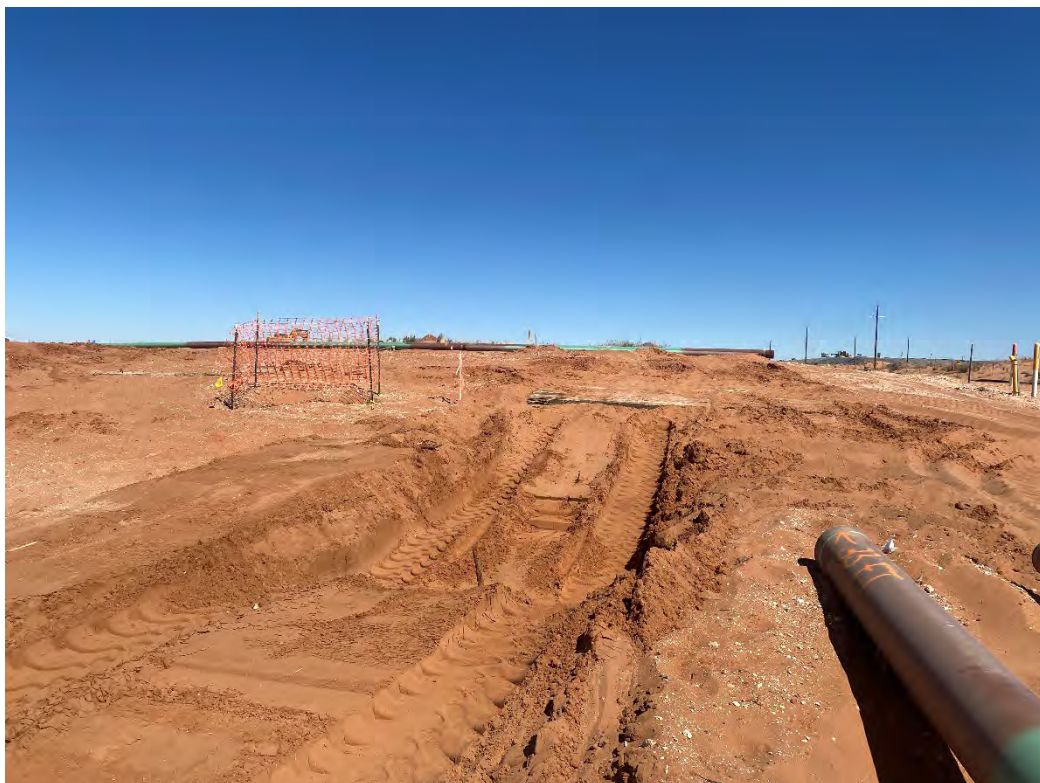
Photograph 21 (03/24/2025): Additional excavation at sample location CS-21 and CS-30 to 4' bgs; facing north.

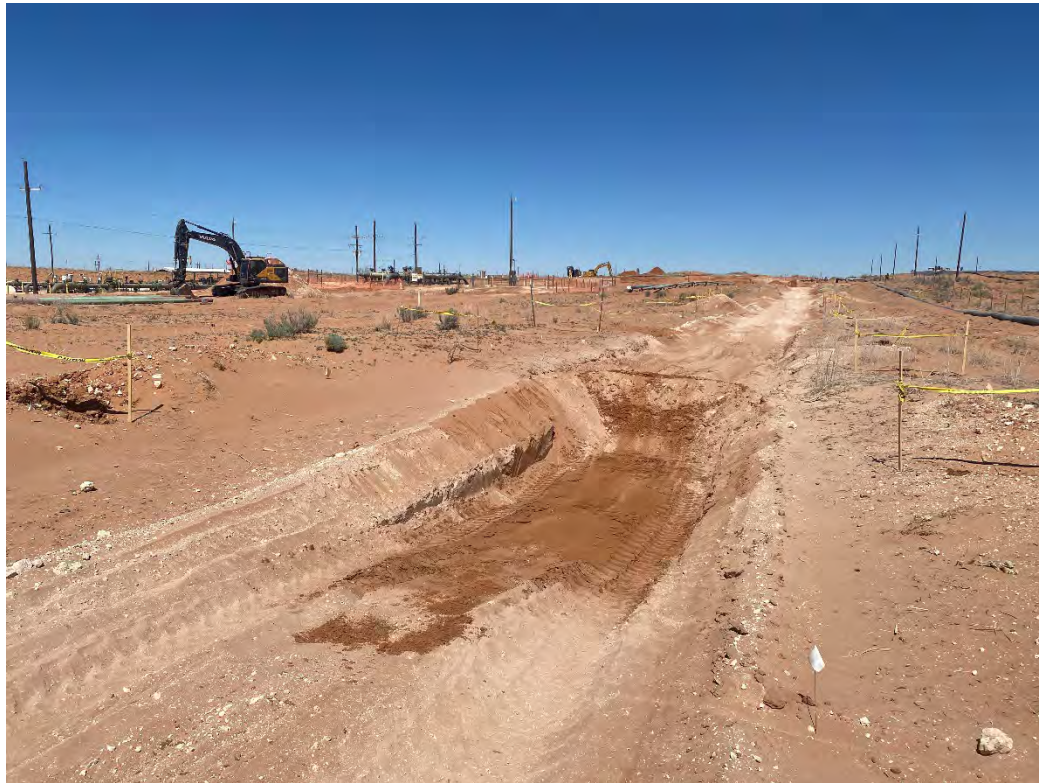
Photograph 23 (03/25/2025): Additional excavation at sample location CS-89 to 4' bgs; facing southeast.

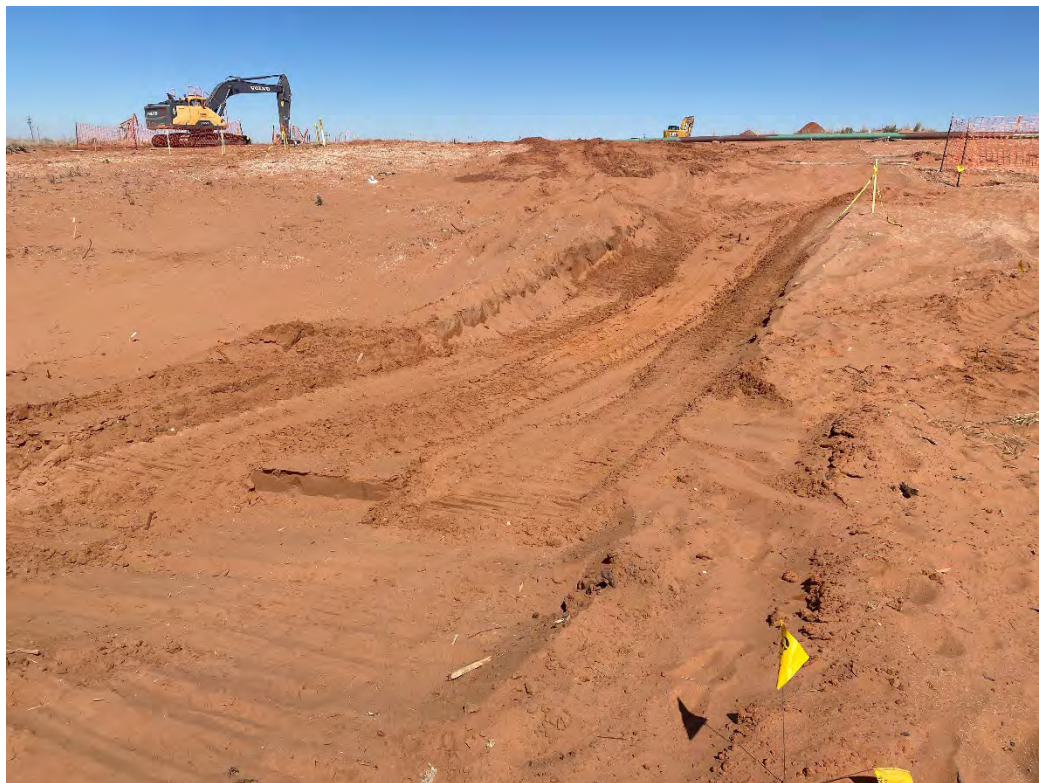
Photograph 24 (03/25/2025): Additional excavation at sample location CS-20 and CS-22 to 4' bgs; facing northwest.

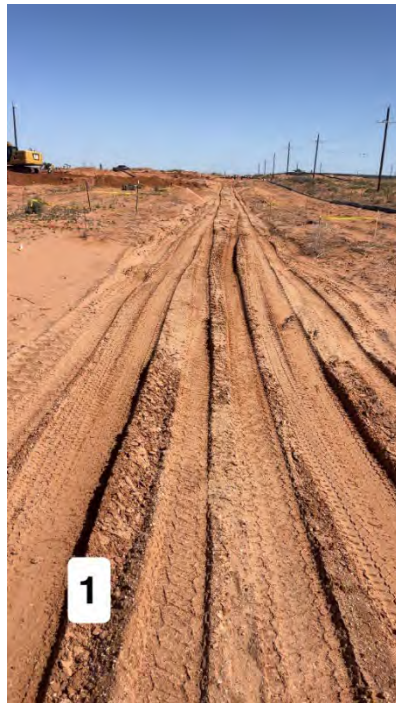
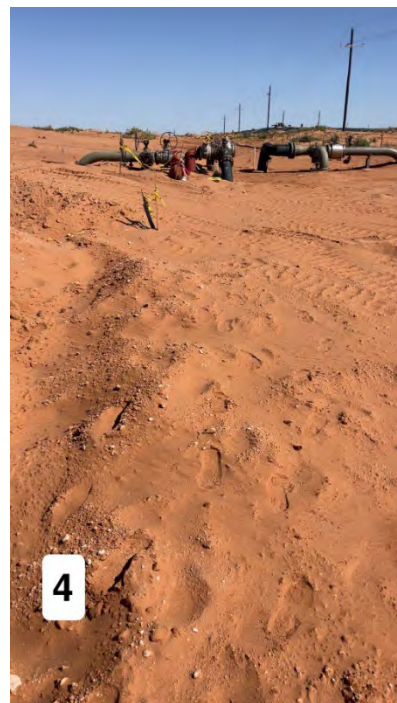
Photographs 25 & 26 (04/07/2025): Photograph 1 shows southern portion of excavation backfilled; facing north. Photograph 4 shows northeastern portion where lay flat pipeline is located backfilled; facing northeast.

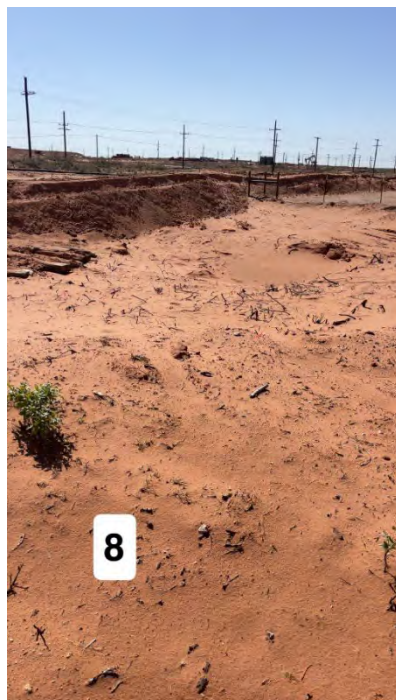
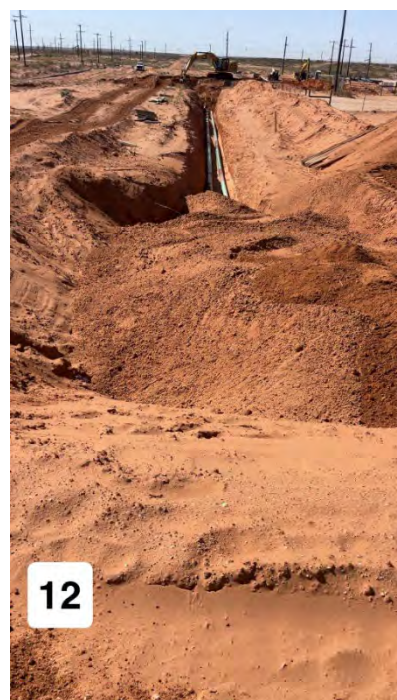
Photographs 27 & 28 (04/07/2025): Photograph 8 shows central western portion of excavation backfilled; however, Gama Construction, LLC (Gama) is working on subsurface pipelines adjacent to the area; facing southeast. Photograph 12 shows Gama's excavation area in sample locations CS-24, 27, 25, 21, 30, 26, and 17; facing south.

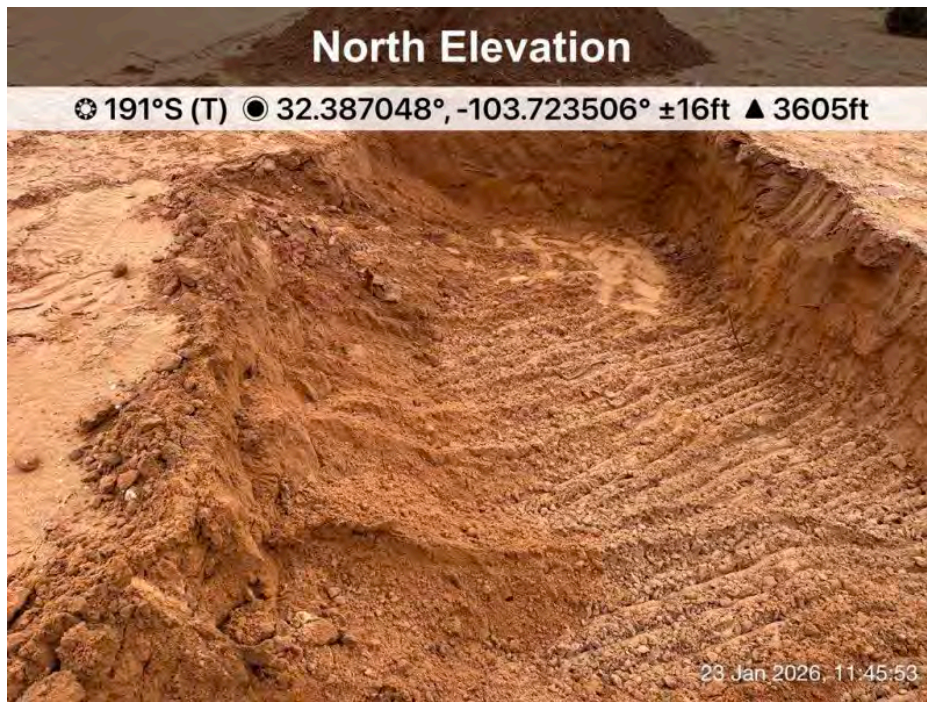
Photographs 29 (01/23/2026): Photograph of the secondary release area, viewing north.

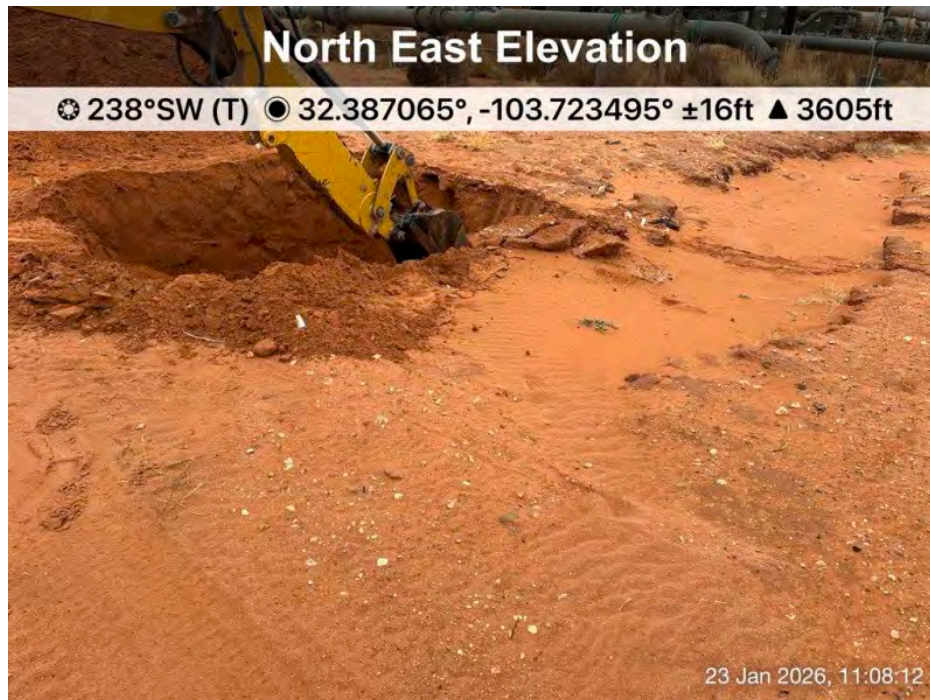
Photographs 30 (01/23/2026): Photograph of the secondary release area, viewing northeast.
