Remediation and Closure Report

Lost Tank Riser
Eddy County, New Mexico
(32.388341, -103.723071)

February 26, 2026

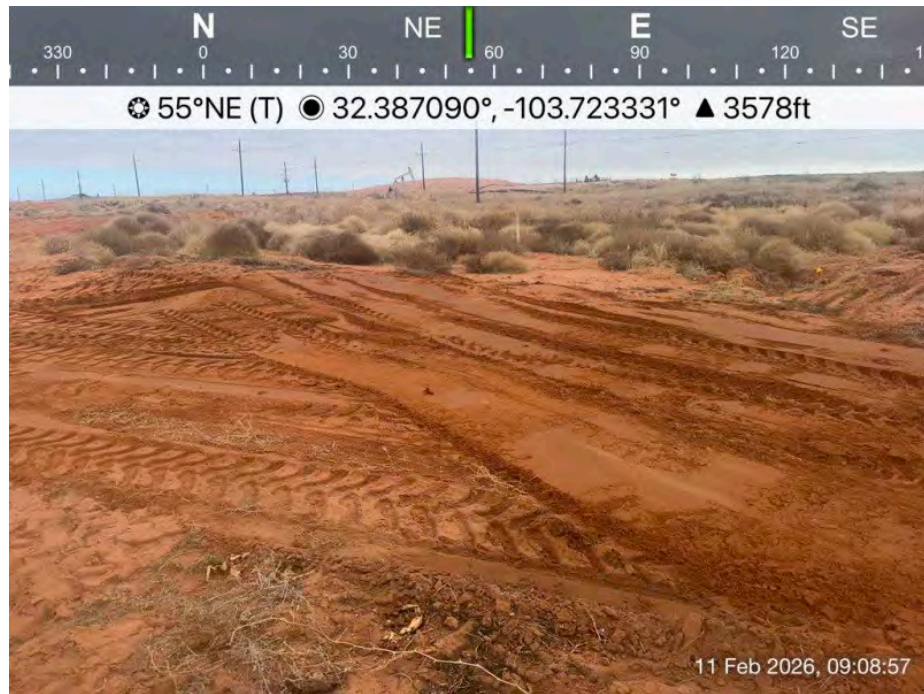
Photographs 31 (02/11/2026): Photograph of the secondary release area backfilled, viewing northeast.

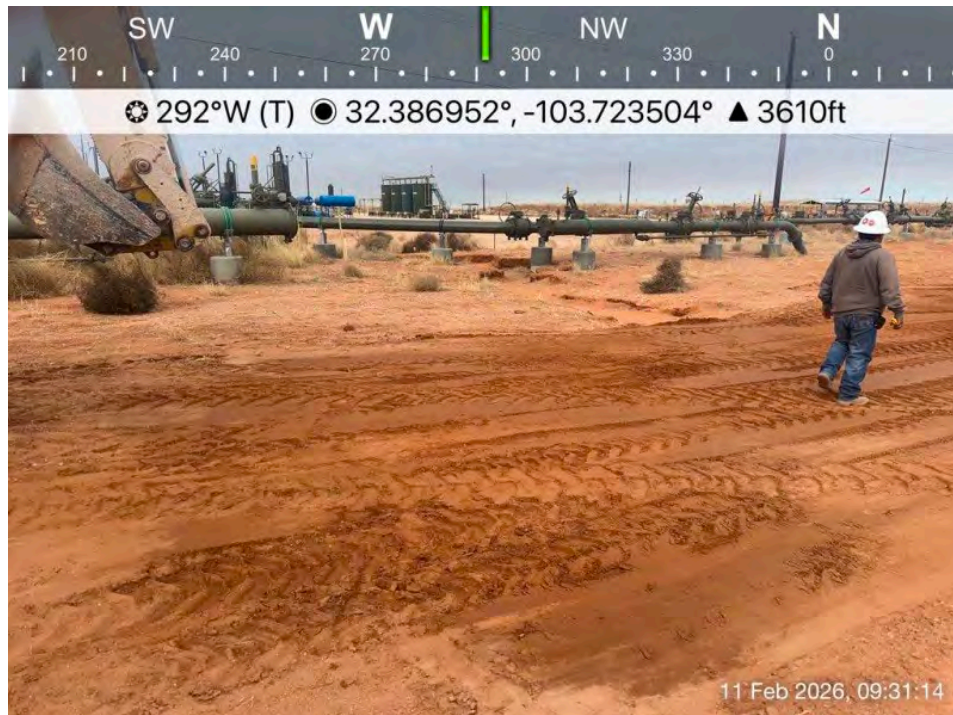
Photographs 32 (02/11/2026): Photograph of the secondary release area backfilled, viewing west.
