## **Environmental Site Remediation Work Plan**

### **Green Clean Line Leak**

Incident ID: nAPP2602229583

April 2026

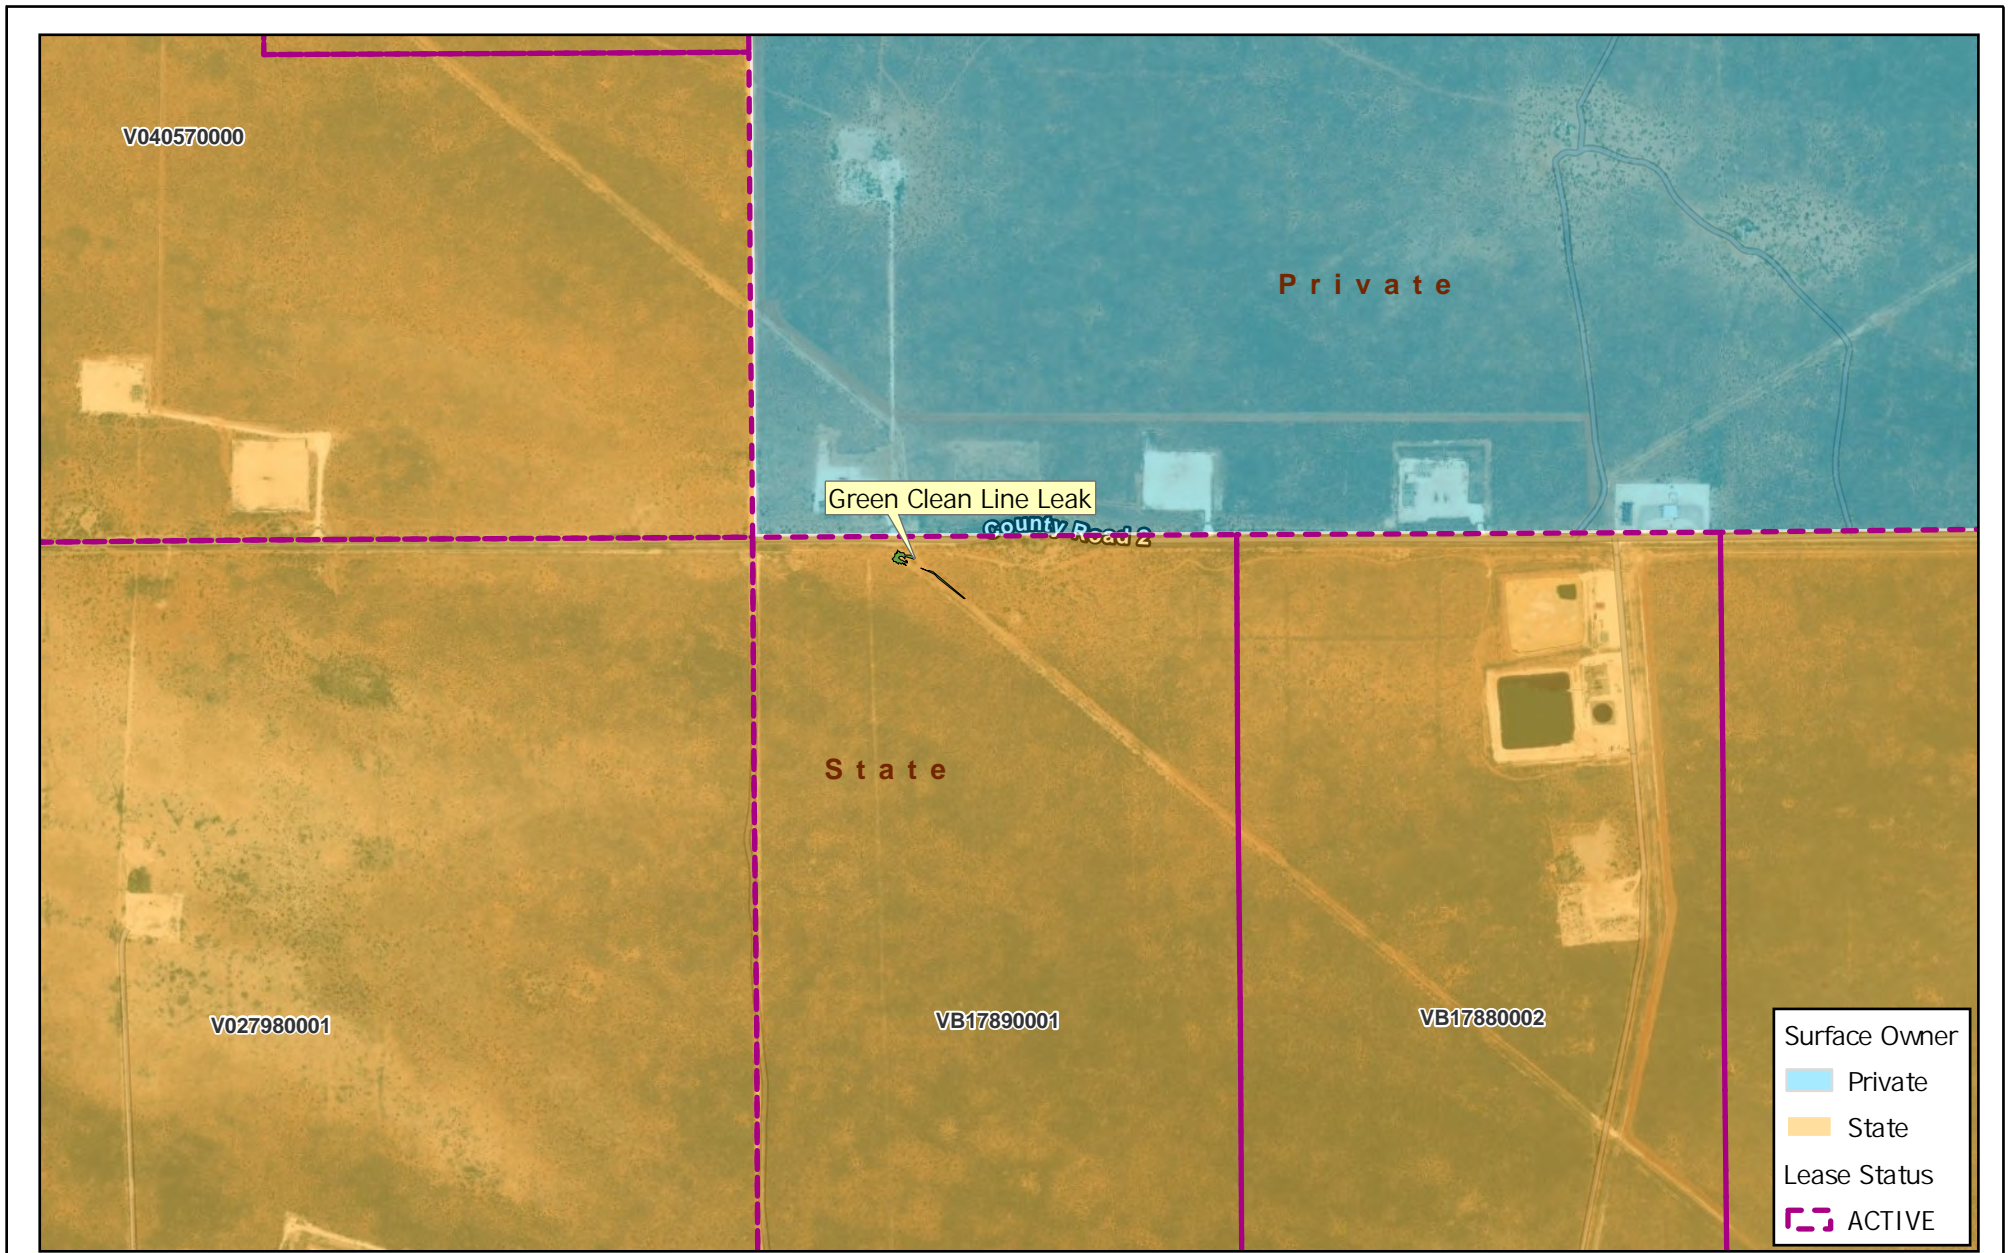
Figure 1. Lease Boundary

The site is located approximately 21.1 miles west of Jal on New Mexico State Trust Lands. Figure 1 shows the site relative to lease boundaries.

<p>Map Center: Lat/Long: 32.2668°N, 103.547172°W</p> <p>Date: Mar 31/26</p> <p>NAD 1983 StatePlane New Mexico East FIPS 3001 Feet</p>		<p>Lease Boundary Green Clean Line Leak</p>	<p>FIGURE: 1</p>	<p>Terra Oilfield Services</p>
--	---	--	---	----------------------	--

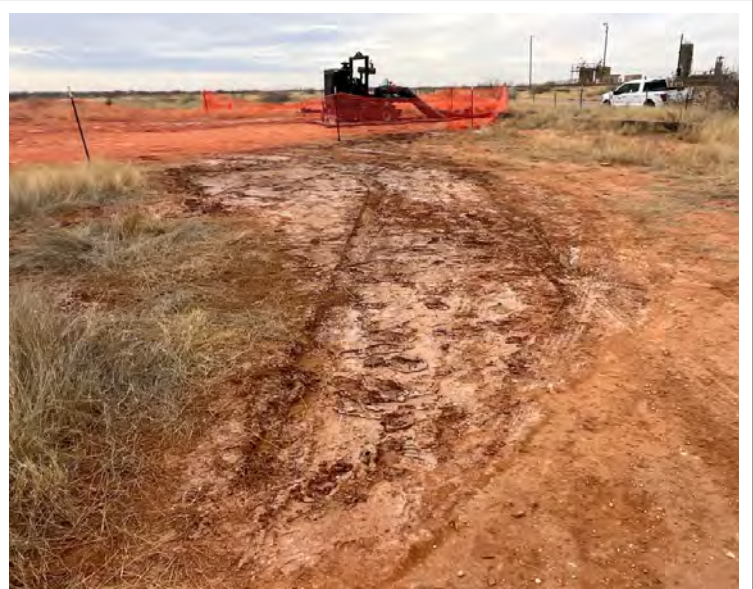
Date: 1/22/2026
Time: 12:50
Notes: Eastern extent of the release
Latitude: 32.26806666666666
Longitude: -103.54881944444445
Direction: SE

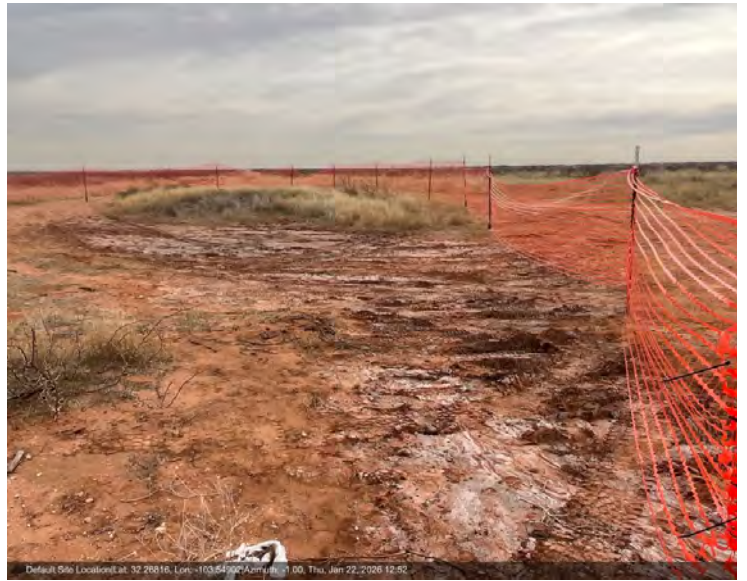
Date: 1/22/2026  
 Time: 12:52  
 Notes: Eastern extent of the release  
 Latitude: 32.26815833333333  
 Longitude: -103.54901944444444  
 Direction: SE

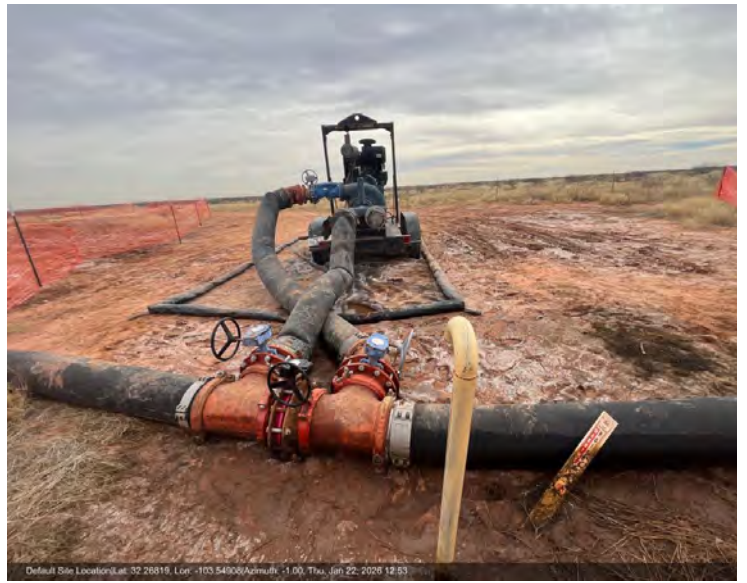
Date: 1/22/2026  
 Time: 12:53  
 Notes: Presumed release point  
 Latitude: 32.268188888888886  
 Longitude: -103.54908055555555  
 Direction: S

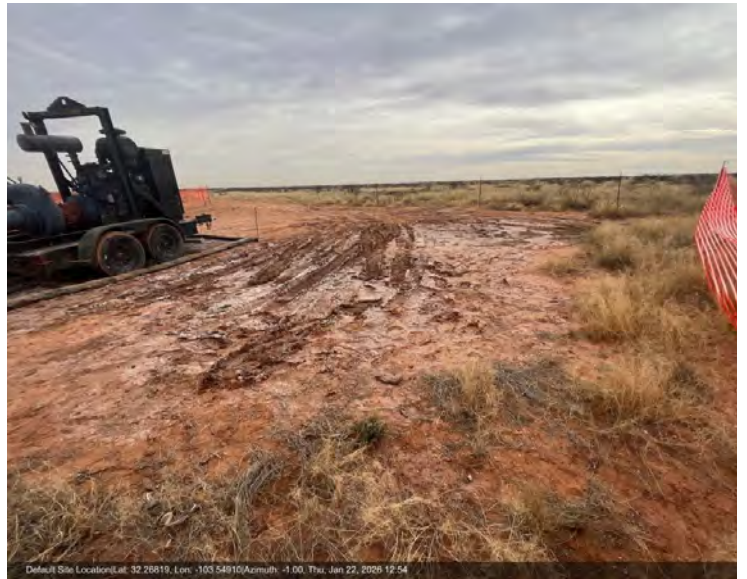
Date: 1/22/2026  
Time: 12:54  
Notes: Western side of the release  
Latitude: 32.26818888888886  
Longitude: -103.54910277777778  
Direction: N

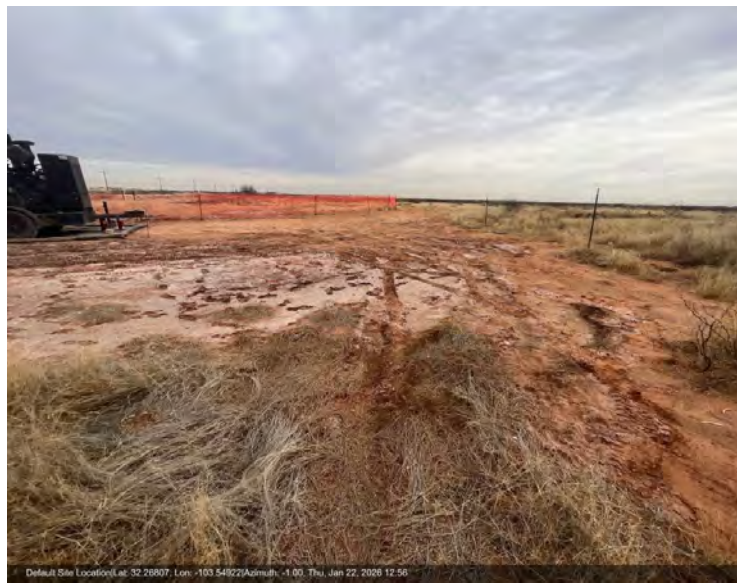
Date: 1/22/2026  
Time: 12:56  
Notes: Northwest part of release area  
Latitude: 32.26806666666666  
Longitude: -103.54922499999999  
Direction: S

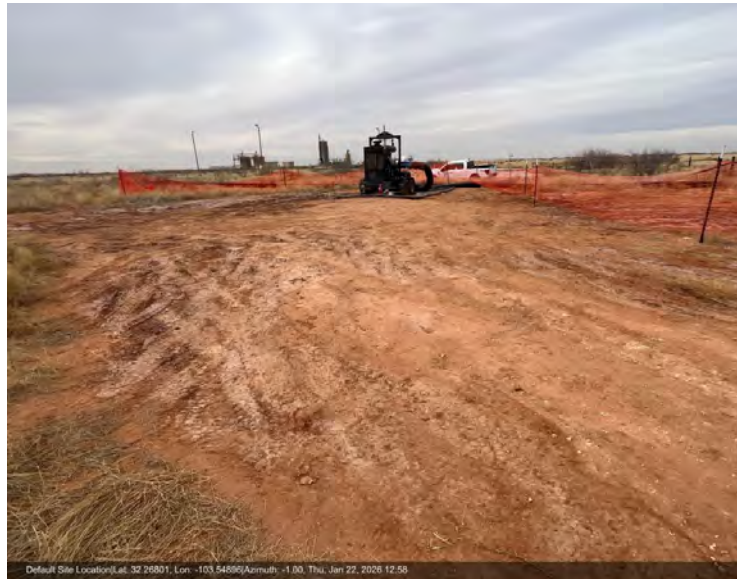
Date: 1/22/2026  
 Time: 12:58  
 Notes: Northern extent of the release are appears to be less saturated  
 Latitude: 32.26800555555554  
 Longitude: -103.54896388888889  
 Direction: N

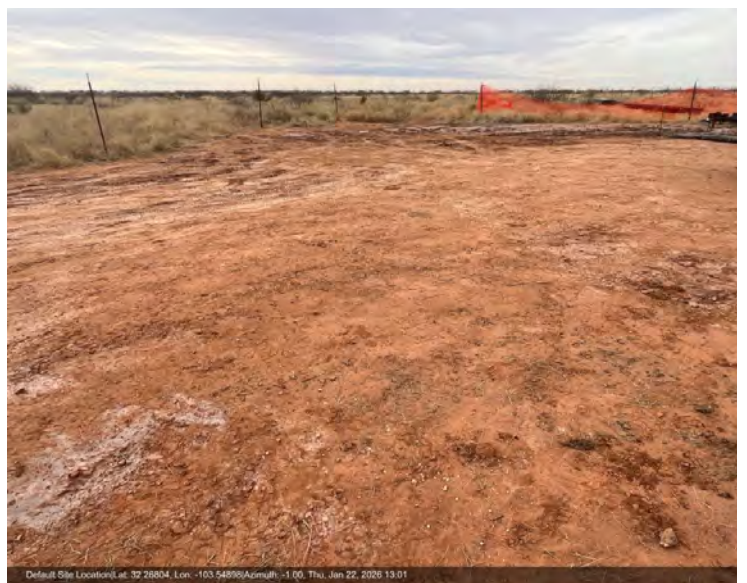
Date: 1/22/2026  
 Time: 13:01  
 Notes: Central area of the release does not appear to have staining. It is notably at a slightly higher elevation  
 Latitude: 32.268036111111111  
 Longitude: -103.54898055555556  
 Direction: E

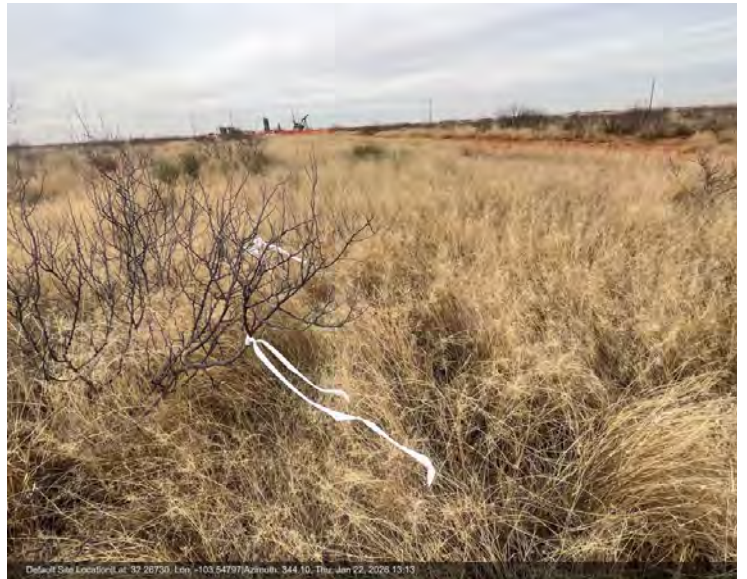
Date: 1/22/2026  
Time: 13:13  
Notes: Southwest 811 point  
Latitude: 32.26730277777778  
Longitude: -103.54796666666667  
Direction: N

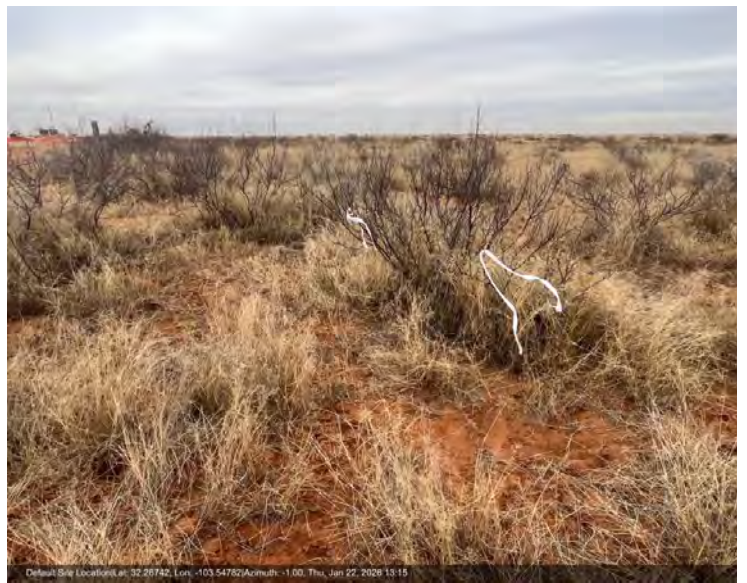
Date: 1/22/2026  
Time: 13:15  
Notes: Southeast 811 point  
Latitude: 32.267424999999996  
Longitude: -103.54782222222222  
Direction: E

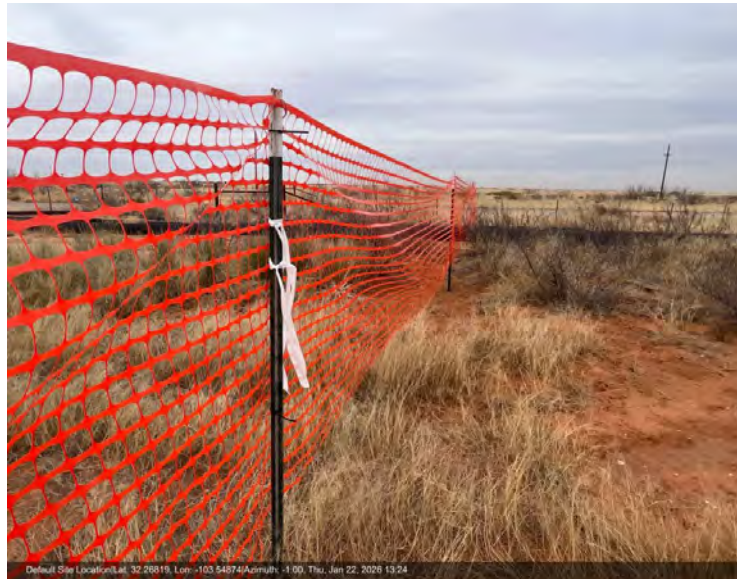
Date: 1/22/2026  
Time: 13:24  
Notes: Central 811 point  
Latitude: 32.268188888888886  
Longitude: -103.54873611111111  
Direction: W

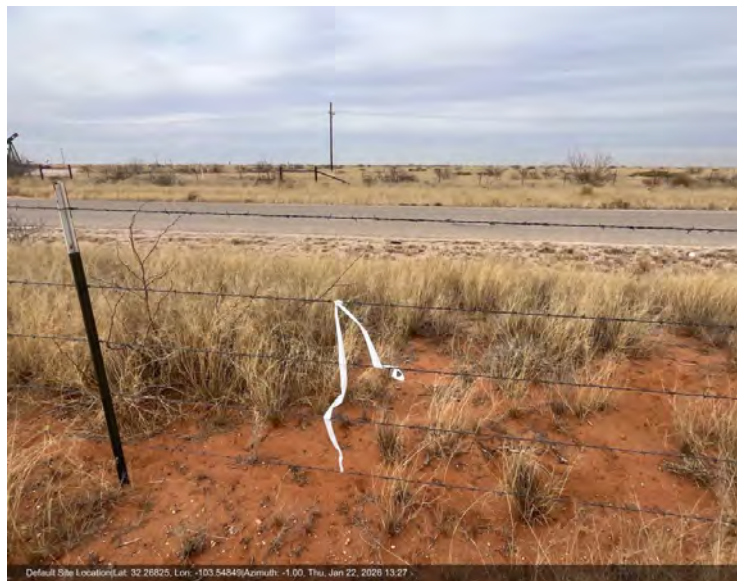
Date: 1/22/2026  
Time: 13:27  
Notes: Eastern 811 point  
Latitude: 32.26825  
Longitude: -103.54849166666666  
Direction: NE

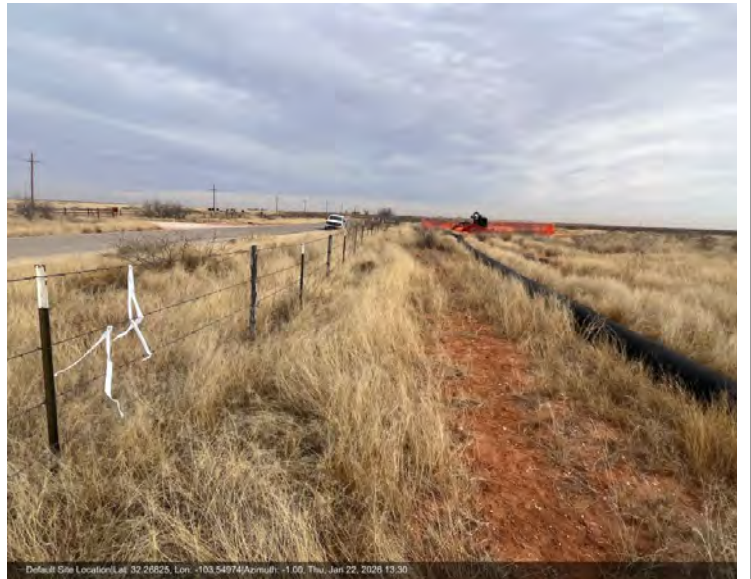
Date: 1/22/2026  
Time: 13:30  
Notes: Northern 811 point  
Latitude: 32.26825  
Longitude: -103.54973611111112  
Direction: NW

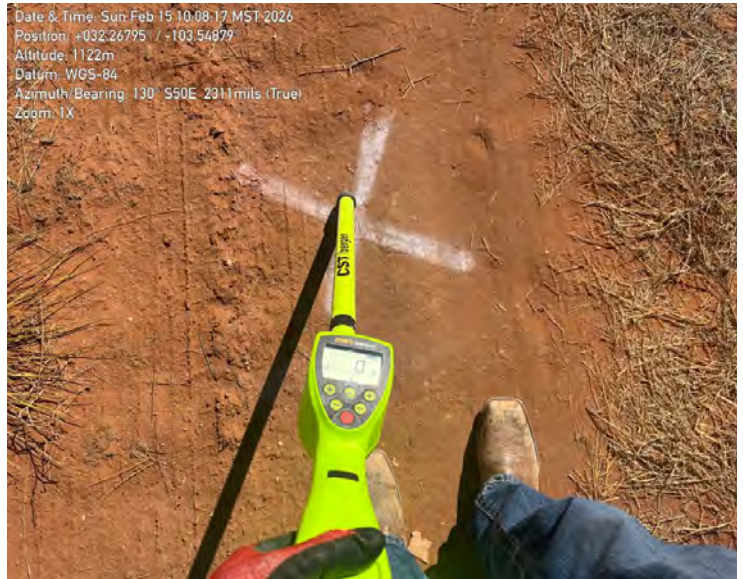
Date: 2/15/2026  
 Time: 19:05  
 Notes: Magnetic line locator was used in areas of planned ground disturbance.  
 Latitude: 32.26794722222222  
 Longitude: -103.54878611111111  
 Direction: E

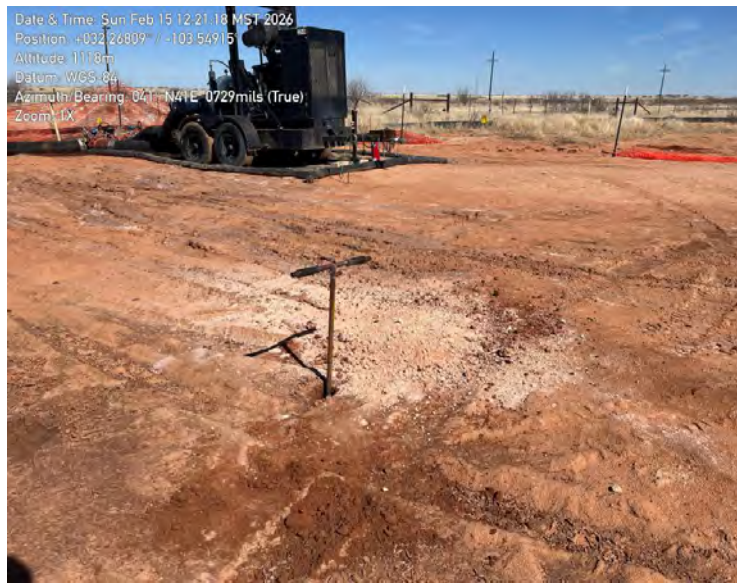
Date: 2/15/2026  
 Time: 19:05  
 Notes: BH26-02 at 8ft bgs. Sample point hit refusal 8.5ft bgs.  
 Latitude: 32.26809444444444  
 Longitude: -103.54915  
 Direction: E

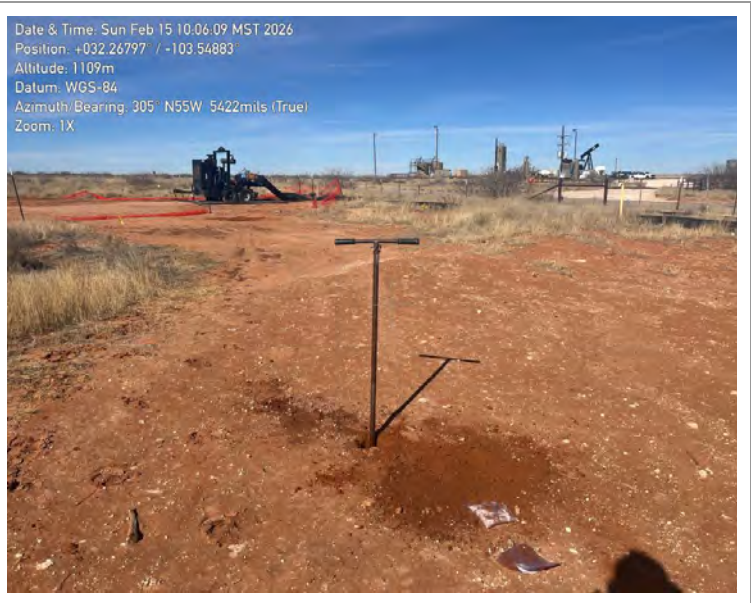
Date: 2/15/2026  
 Time: 19:05  
 Notes: BH26-04 at 2ft bgs.  
 Latitude: 32.26797222222222  
 Longitude: -103.54883333333333  
 Direction: E

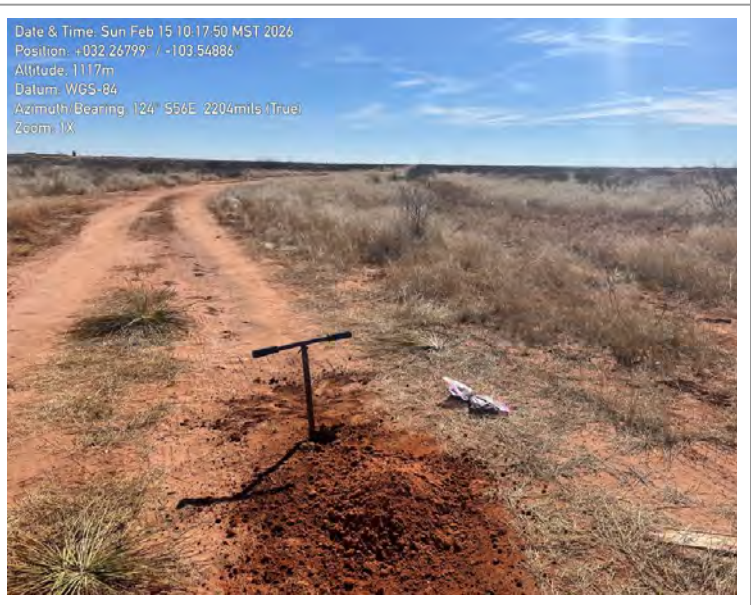
Date: 2/15/2026  
 Time: 19:05  
 Notes: BH26-05 at 4ft bgs.  
 Latitude: 32.267986111111114  
 Longitude: -103.54886111111111  
 Direction: E

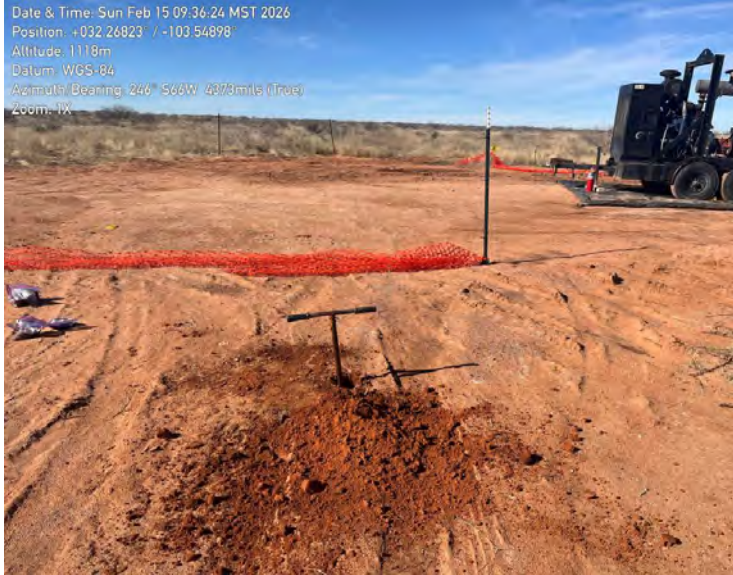
<p>Date: 2/15/2026  Time: 19:05  Notes: BH26-03 at 4ft bgs.  Latitude: 32.268225  Longitude: -103.54898055555556  Direction: E</p>

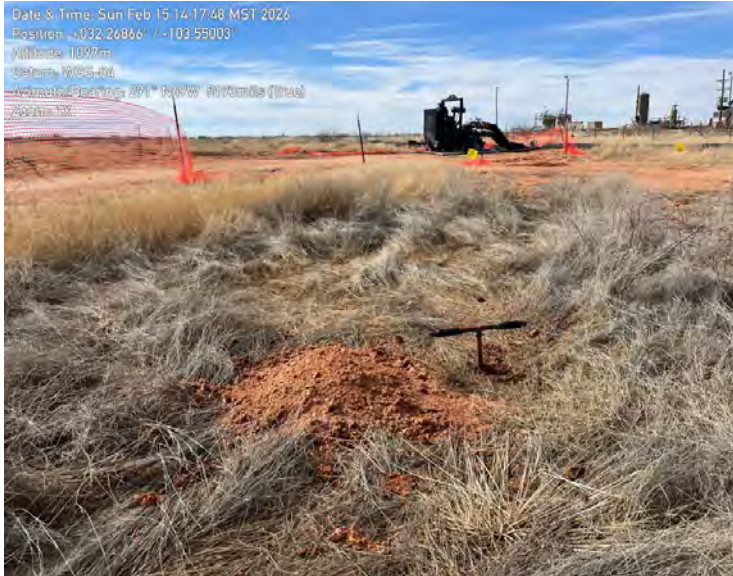
<p>Date &amp; Time: Sun Feb 15 09:36:24 MST 2026  Position: +032.26823 / -103.54898  Altitude: 1118m  Datum: WGS-84  Azimuth/Bearing: 246° S60W 4279miles (True)  Zoom: 1X</p>
<p>Date: 2/15/2026  Time: 19:05  Notes: BH26-06 at 9ft bgs.  Latitude: 32.268658333333335  Longitude: -103.55002777777777  Direction: E</p>

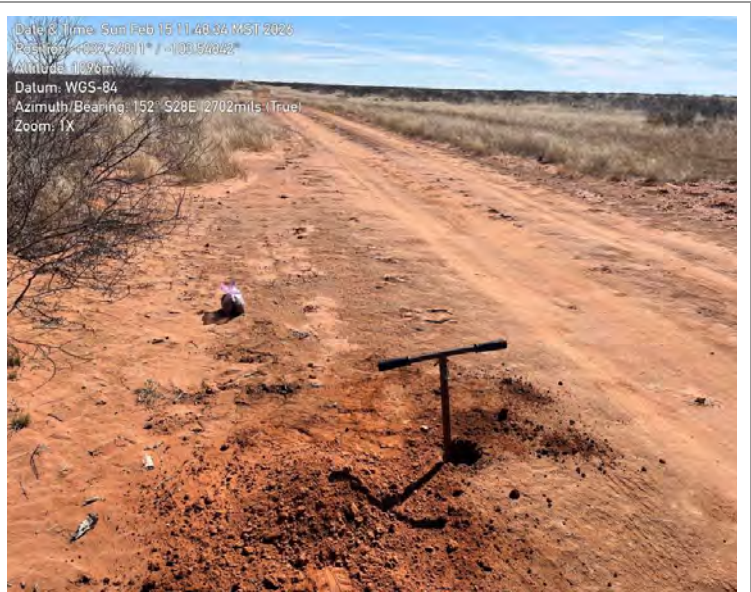
Date: 2/15/2026  
 Time: 19:05  
 Notes: BH26-07 at 2ft bgs.  
 Latitude: 32.26810555555556  
 Longitude: -103.54842222222221  
 Direction: E

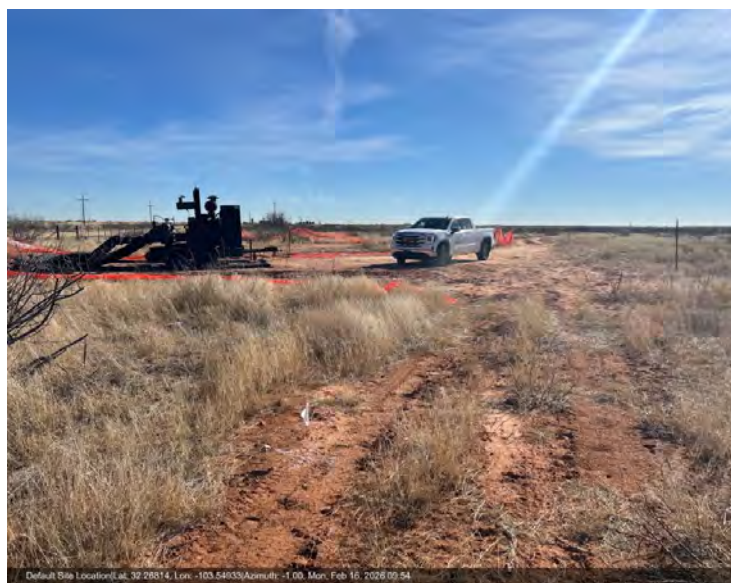
Date: 2/16/2026
Time: 09:20
Notes: BH26-01 marked with white flagging, edge of the release going west
Latitude: 32.26813611111111
Longitude: -103.54933055555556
Direction: N

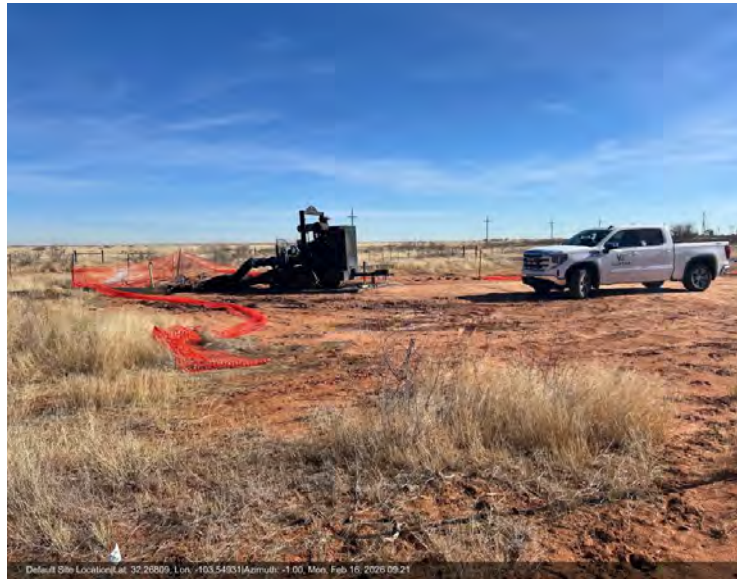
Date: 2/16/2026  
Time: 09:21  
Notes: View of the release  
Latitude: 32.26808888888889  
Longitude: -103.54930833333333  
Direction: E

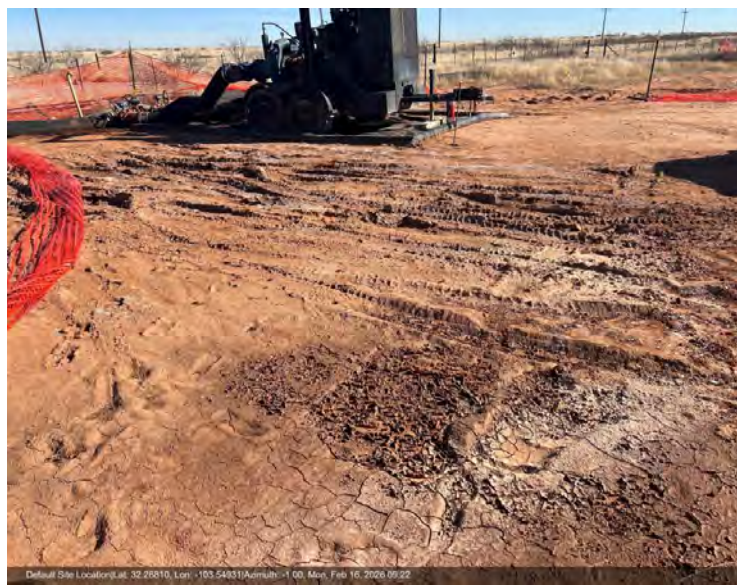
Date: 2/16/2026  
Time: 09:22  
Notes: Salt present at the surface of the release  
Latitude: 32.268097222222224  
Longitude: -103.54930833333333  
Direction: SE

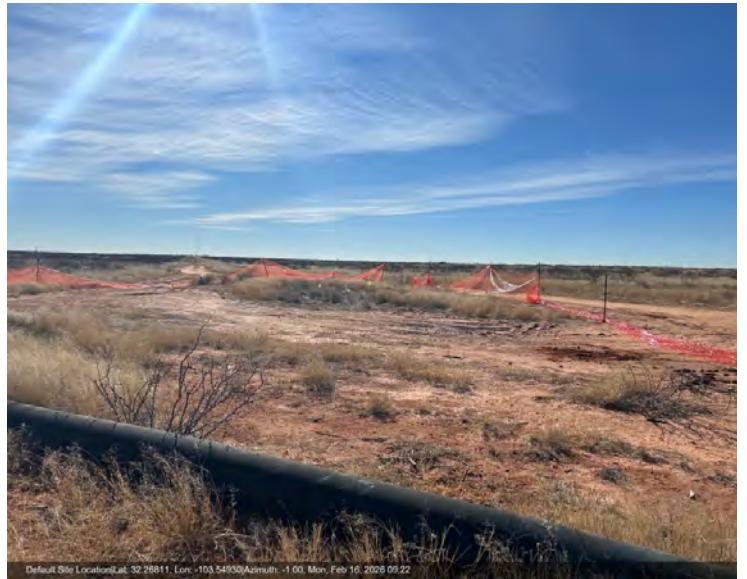
Date: 2/16/2026  
 Time: 09:22  
 Notes: Viewing the release towards BH26-03  
 Latitude: 32.26810555555556  
 Longitude: -103.54930277777778  
 Direction: E

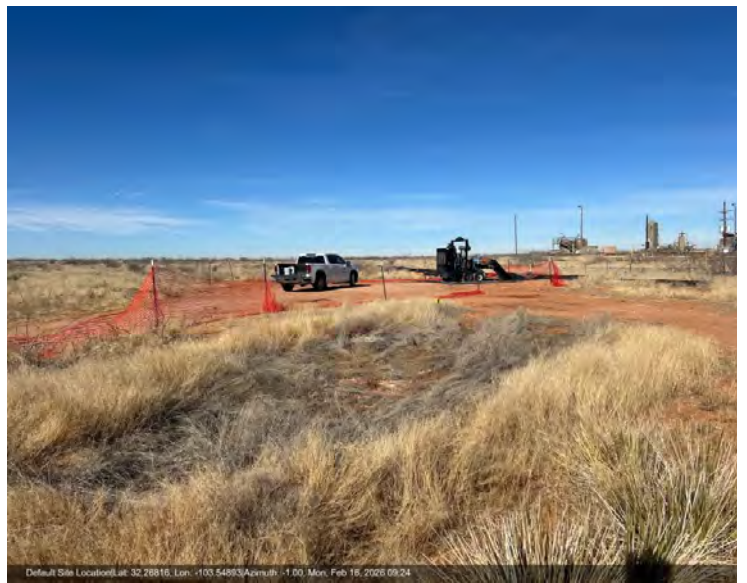
Date: 2/16/2026  
 Time: 09:24  
 Notes: View of the release where point of source is at  
 Latitude: 32.26815833333333  
 Longitude: -103.54892777777778  
 Direction: E

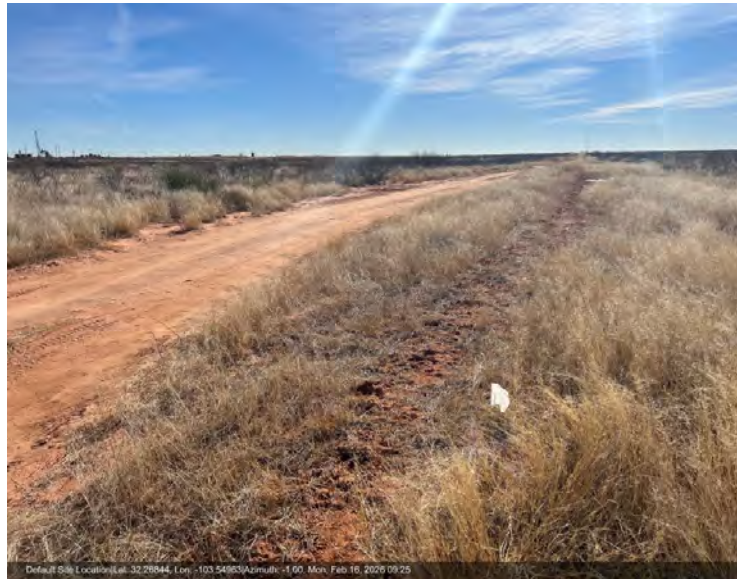
Date: 2/16/2026  
 Time: 09:25  
 Notes: BH26-08 marked with white flagging looking  
 downslope of the release  
 Latitude: 32.26843611111111  
 Longitude: -103.54963055555555  
 Direction: E

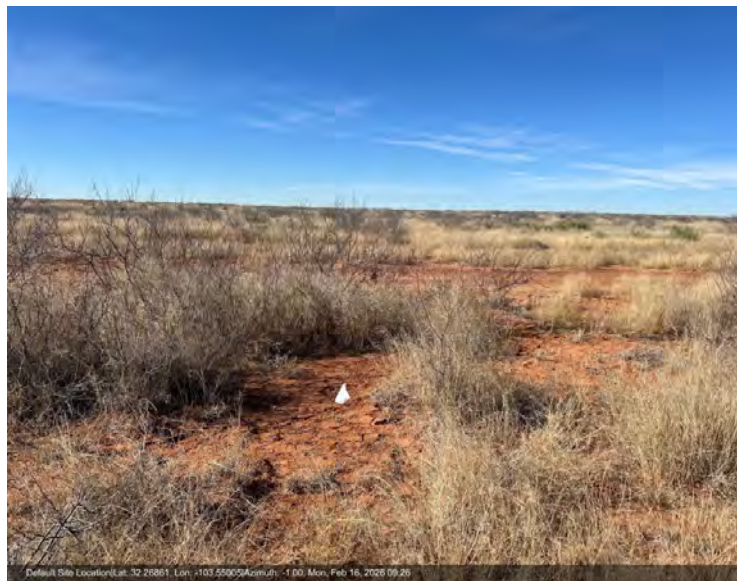
Date: 2/16/2026  
 Time: 09:26  
 Notes: BH26-09 marked with white flagging  
 Latitude: 32.26861111111111  
 Longitude: -103.55004722222222  
 Direction: E

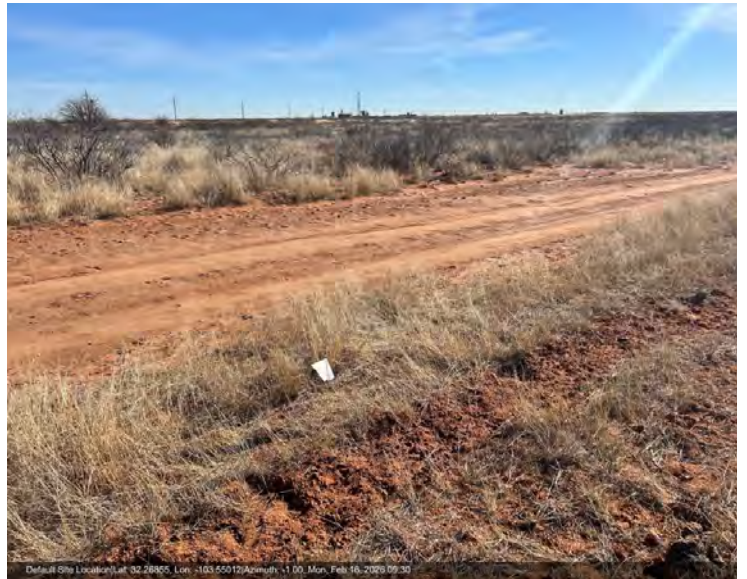
Date: 2/16/2026  
 Time: 09:30  
 Notes: BH26-10 marked with white flagging  
 Latitude: 32.26855277777778  
 Longitude: -103.55011666666667  
 Direction: E

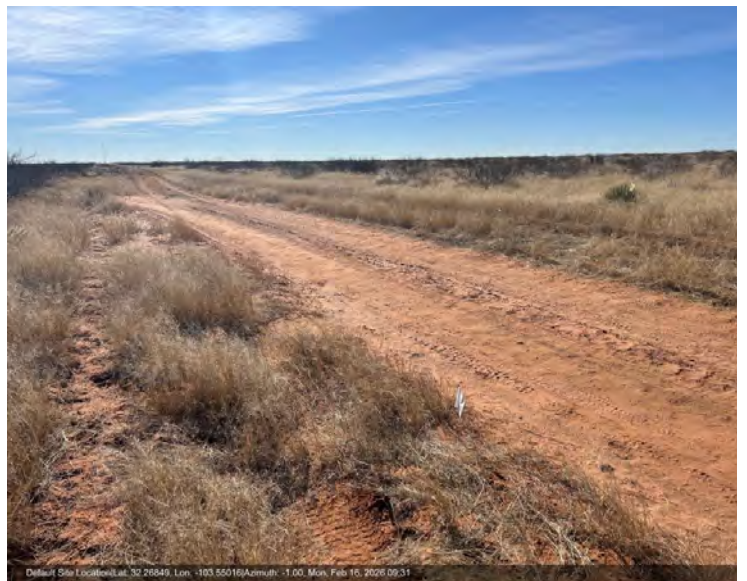
Date: 2/16/2026  
 Time: 09:31  
 Notes: BH26-11 marked with white flagging  
 Latitude: 32.26849444444444  
 Longitude: -103.55016388888889  
 Direction: NE

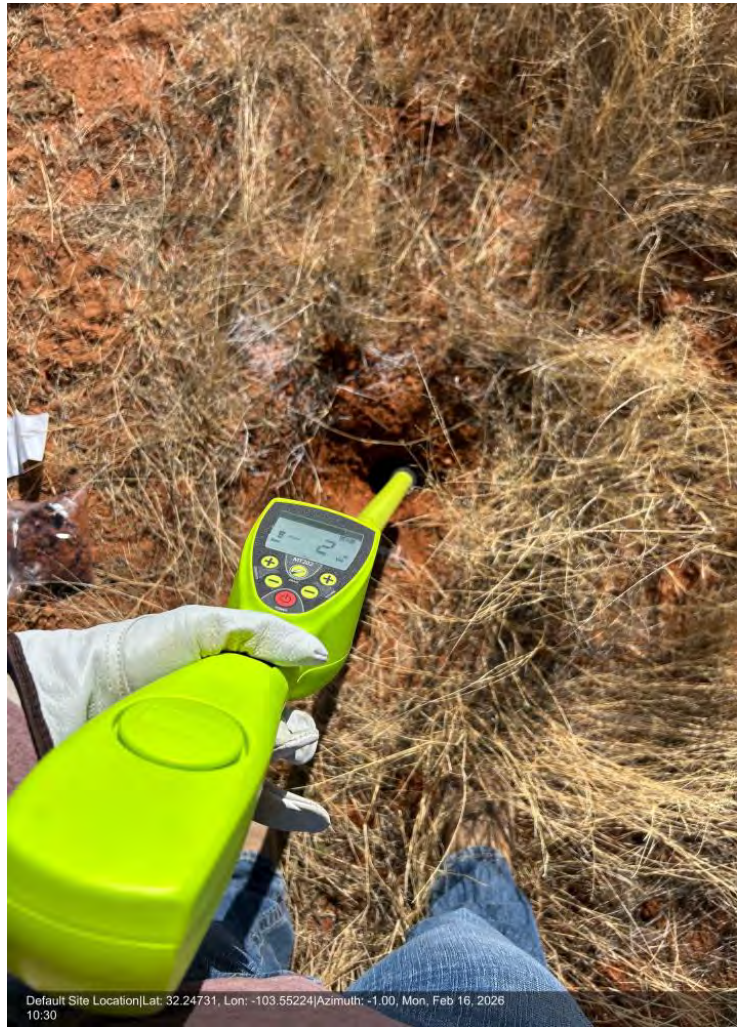
Date: 2/16/2026  
 Time: 10:30  
 Notes: Line locating where boreholes will be acquired  
 Latitude: 32.24730555555556  
 Longitude: -103.55223888888888  
 Direction: N

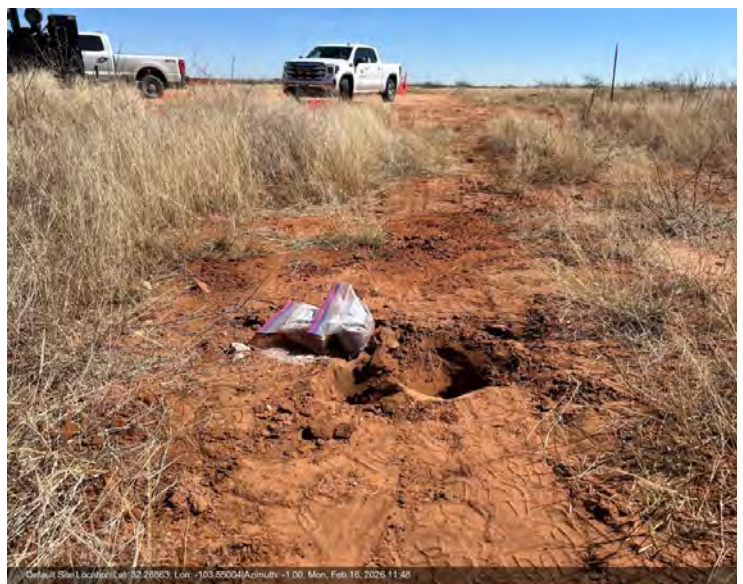
Date: 2/16/2026  
 Time: 11:48  
 Notes: BH26-01 collected at 0' and 2'  
 Latitude: 32.26862777777778  
 Longitude: -103.55004166666666  
 Direction: W

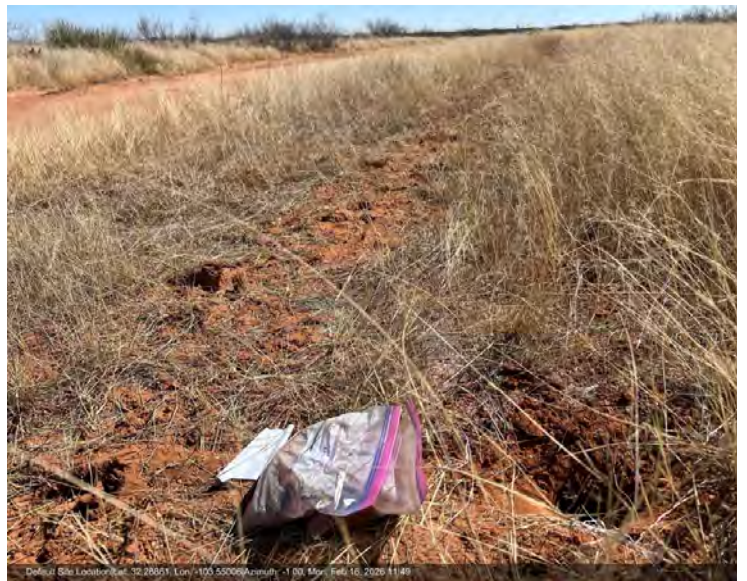
Date: 2/16/2026  
Time: 11:49  
Notes: BH26-08 collected at 0' and 2'  
Latitude: 32.26861111111111  
Longitude: -103.55006388888889  
Direction: NW

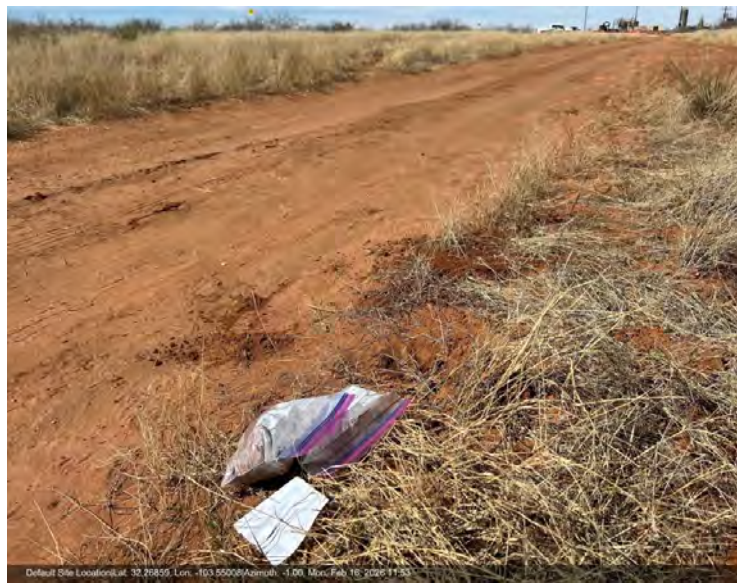
Date: 2/16/2026  
Time: 11:53  
Notes: BH26-11 collected at 0' and 2'  
Latitude: 32.26858611111111  
Longitude: -103.55008055555555  
Direction: NW

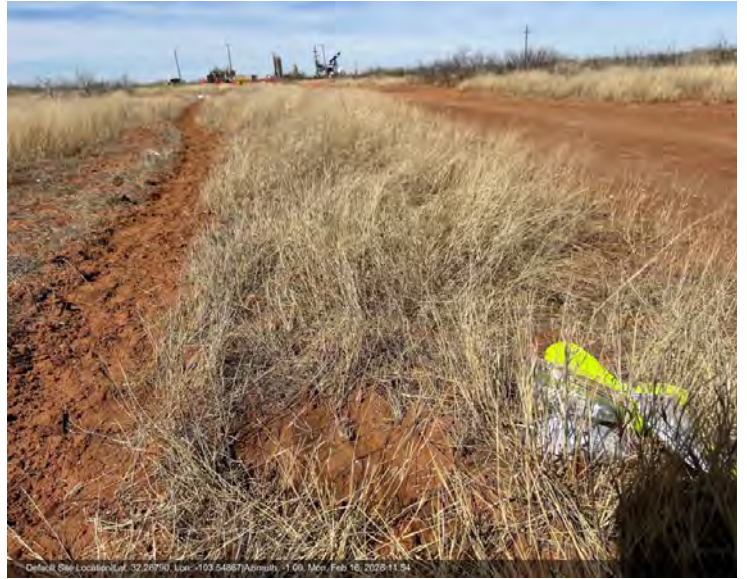
Date: 2/16/2026  
Time: 11:54  
Notes: BH26-10 collected at 0' and 2'  
Latitude: 32.26789722222224  
Longitude: -103.54866944444444  
Direction: W

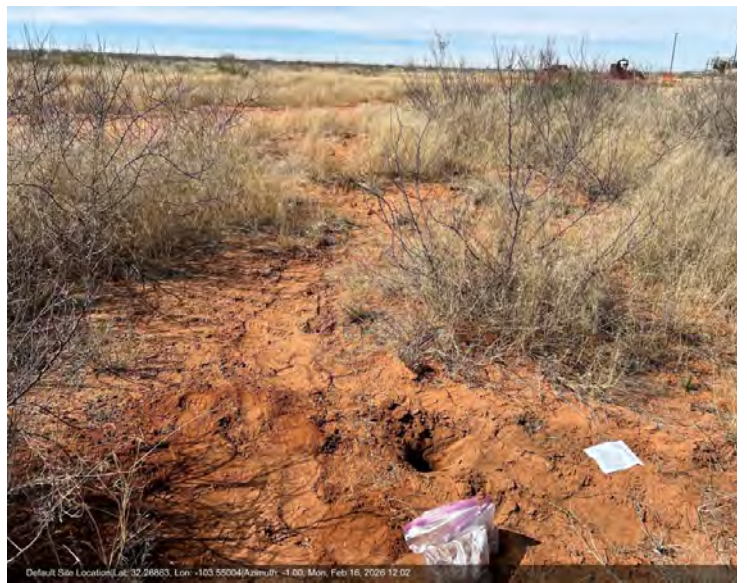
Date: 2/16/2026  
Time: 12:02  
Notes: BH26-09 collected at 0' and 2'  
Latitude: 32.26862777777778  
Longitude: -103.55004166666666  
Direction: SE

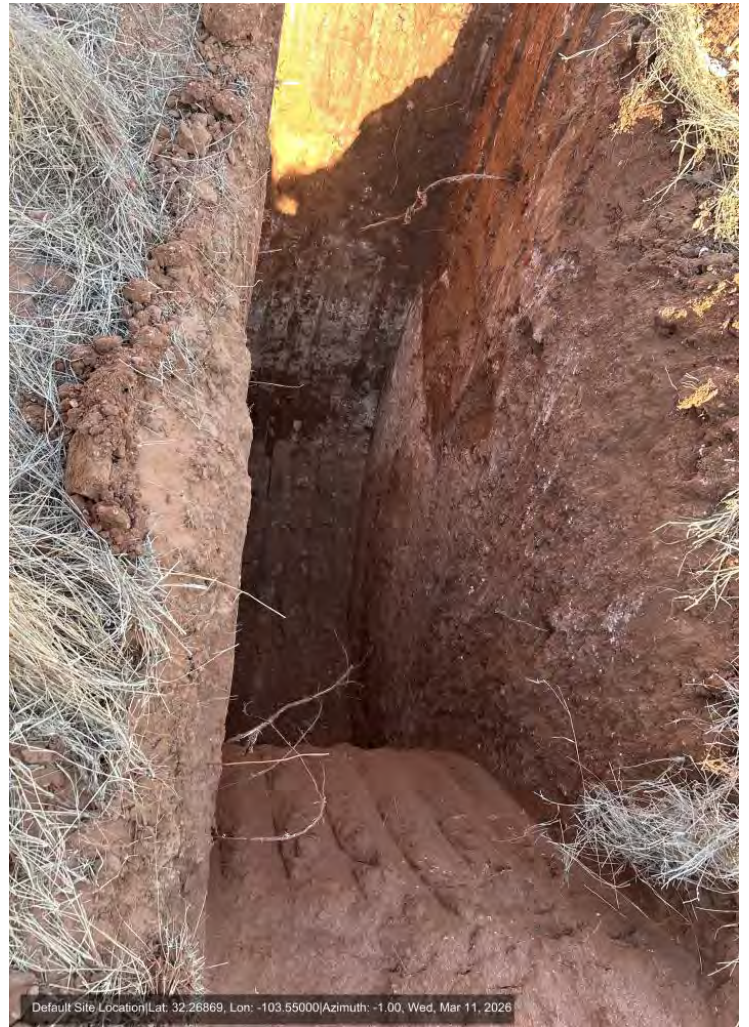
Date: 3/11/2026  
Time: 09:39  
Notes: TP26-01 Excavated to 12ft, sample was collected.  
Latitude: 32.26869444444444  
Longitude: -103.55000277777778  
Direction: SE

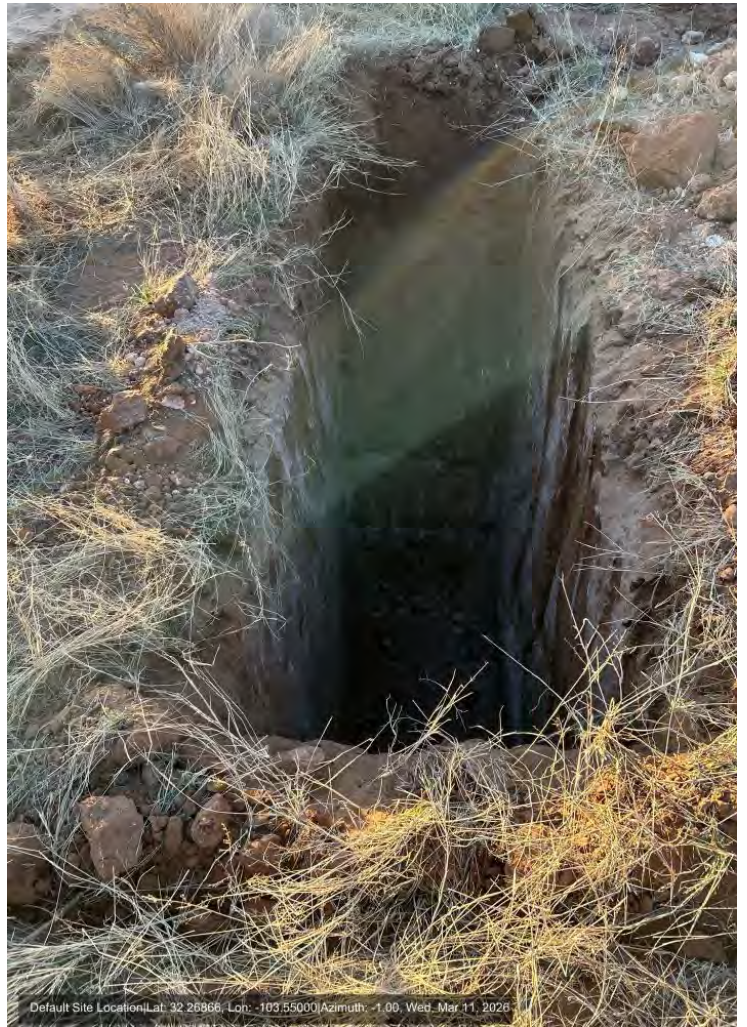
Date: 3/11/2026  
 Time: 07:30  
 Notes: Initial TP26-01 sample point to 10 ft.  
 Latitude: 32.26866388888889  
 Longitude: -103.55000277777778  
 Direction: N

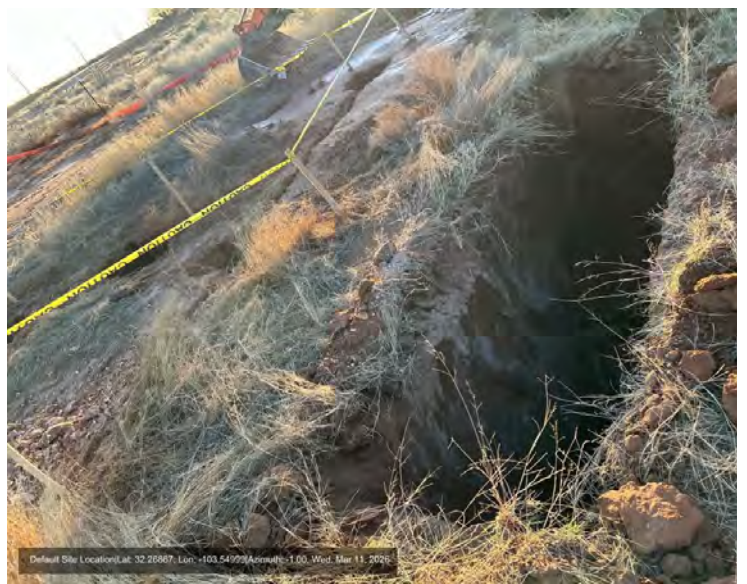
Date: 3/11/2026  
 Time: 07:30  
 Notes: Initial TP26-01 sample point to 10 ft. An 8 ft sample was also collected here. This area was discovered to be clean.  
 Latitude: 32.26867222222222  
 Longitude: -103.54999444444444  
 Direction: N

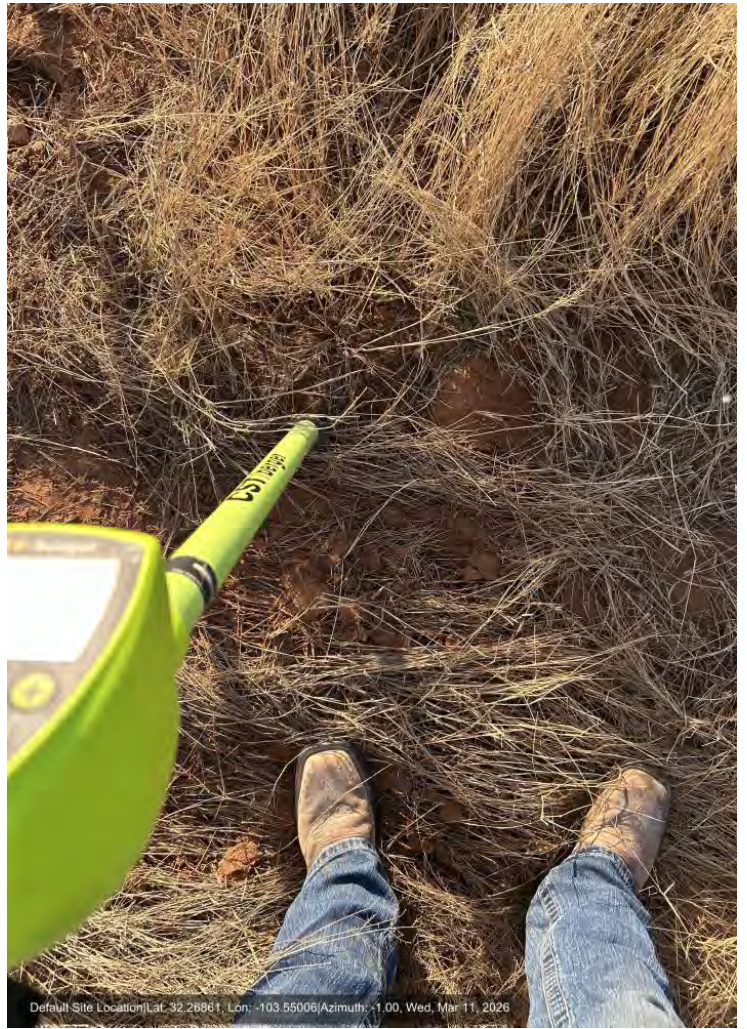
Date: 3/11/2026  
Time: 08:07  
Notes: Prior to moving closer to original BH26-06 (moved slightly outside of it due to buried pipeline safety procedures) performed a line sweep.  
Latitude: 32.26860833333333  
Longitude: -103.55005555555556  
Direction: E

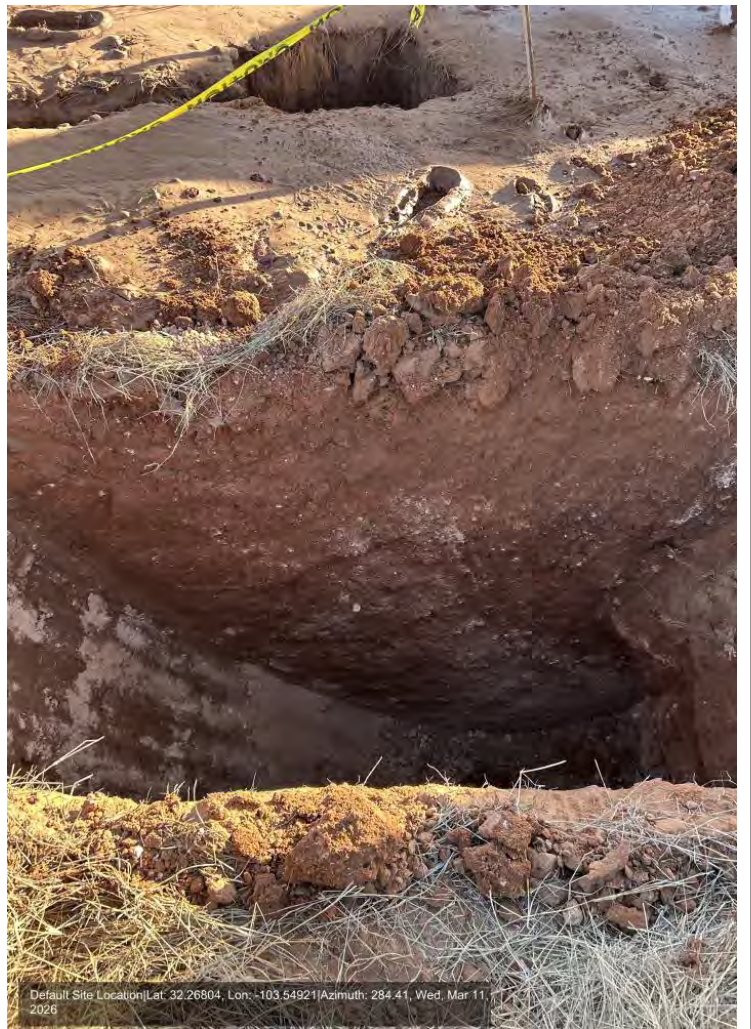
Date: 3/11/2026  
Time: 08:30  
Notes: TP26-01 location south of original starting location. Excavated to 8ft, sample was collected and found to correlate with BH26-06.  
Latitude: 32.26804444444444  
Longitude: -103.54921111111111  
Direction: SE
