## **Environmental Site Remediation Work Plan**

### **Green Clean Line Leak**

Incident ID: nAPP2602229583

April 2026

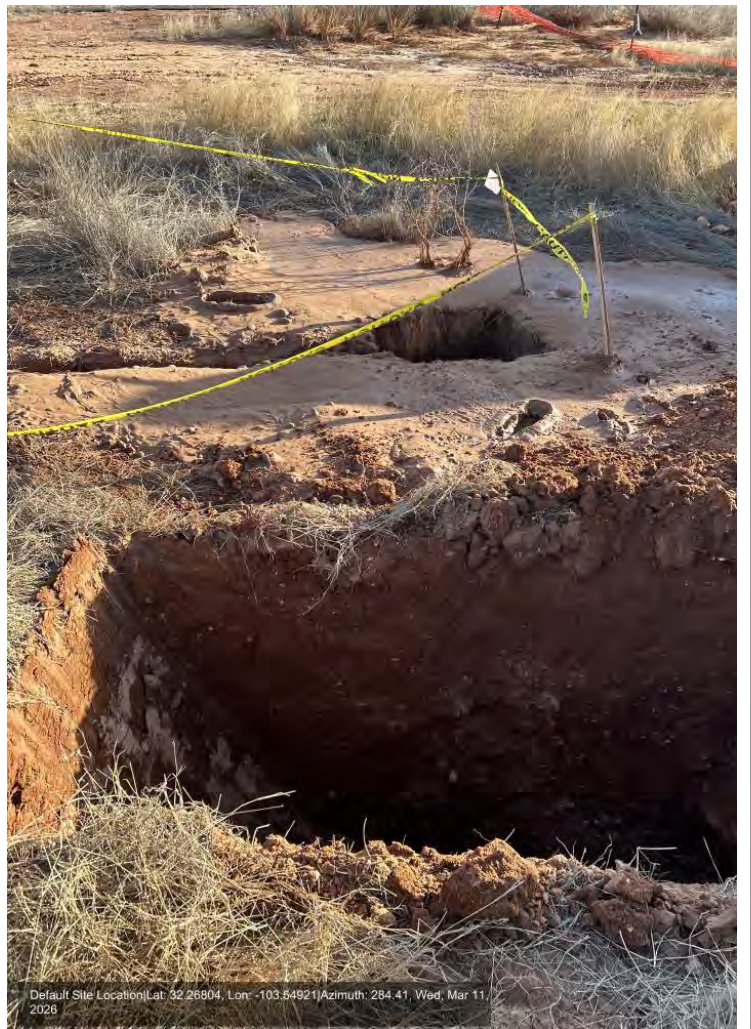
Date: 3/11/2026  
Time: 08:30  
Notes: Excavated to 8ft, sample was collected and found to correlate with BH26-06.  
Latitude: 32.26804444444444  
Longitude: -103.54921111111111  
Direction: SE

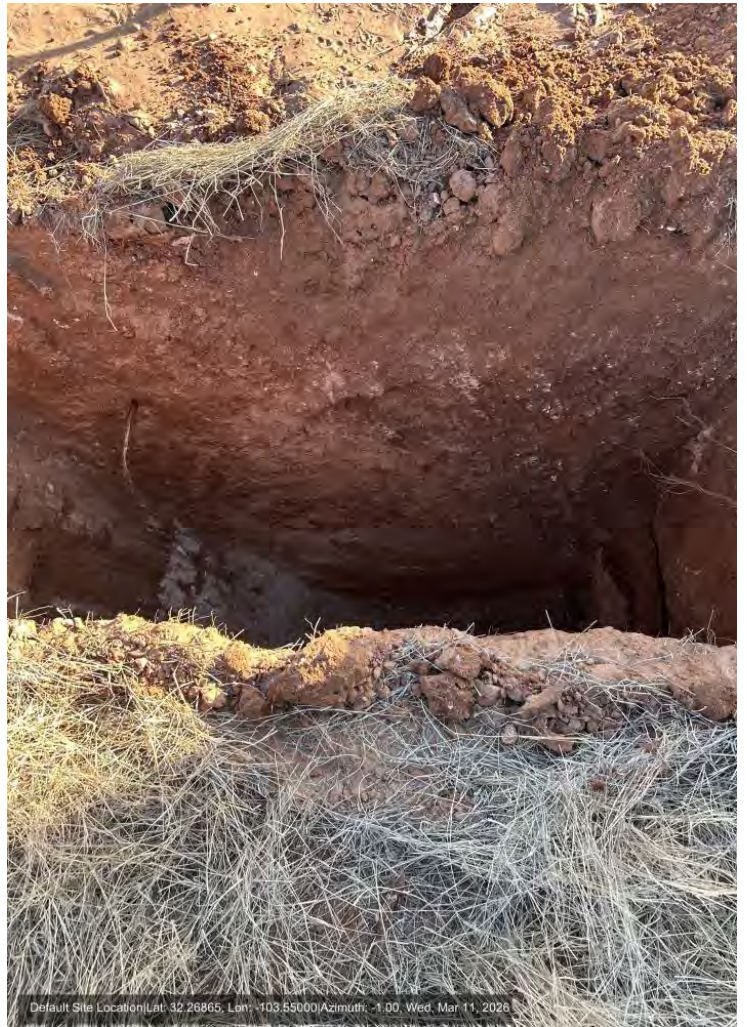
Date: 3/11/2026  
Time: 08:38  
Notes: TP26-01 Excavated to 10ft, sample was collected. 8 ft sample was collected from this location.  
Latitude: 32.268652777777774  
Longitude: -103.55000277777778  
Direction: NE

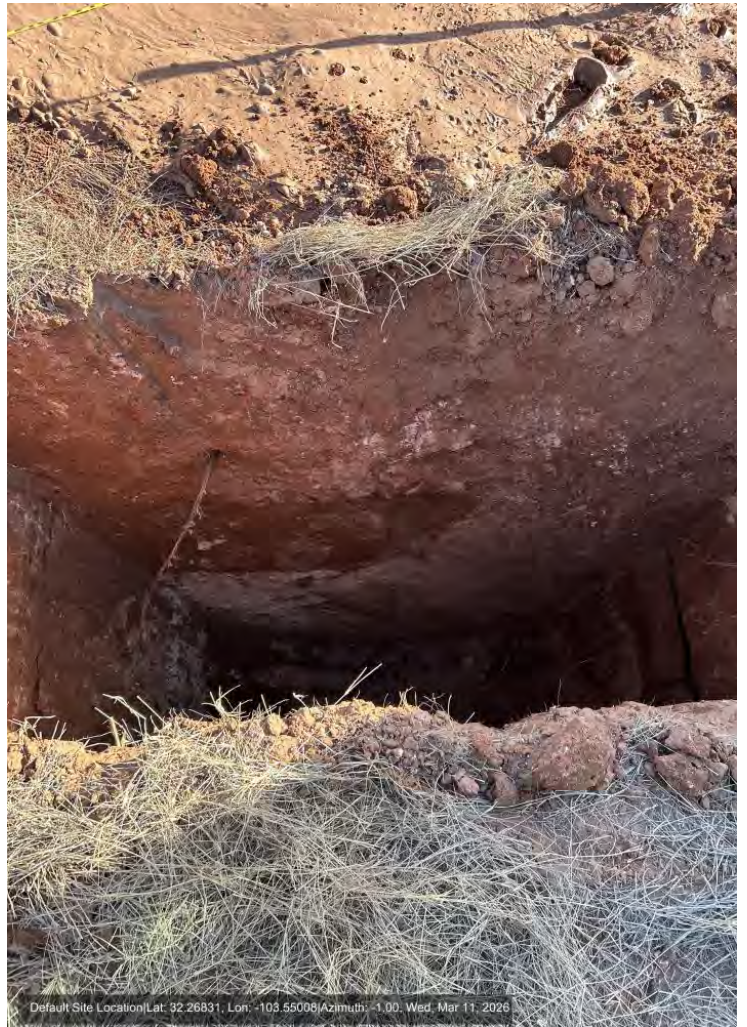
Date: 3/11/2026  
Time: 09:14  
Notes: TP26-01 Excavated to 11ft, sample was collected.  
Latitude: 32.26831388888889  
Longitude: -103.55008055555555  
Direction: SW

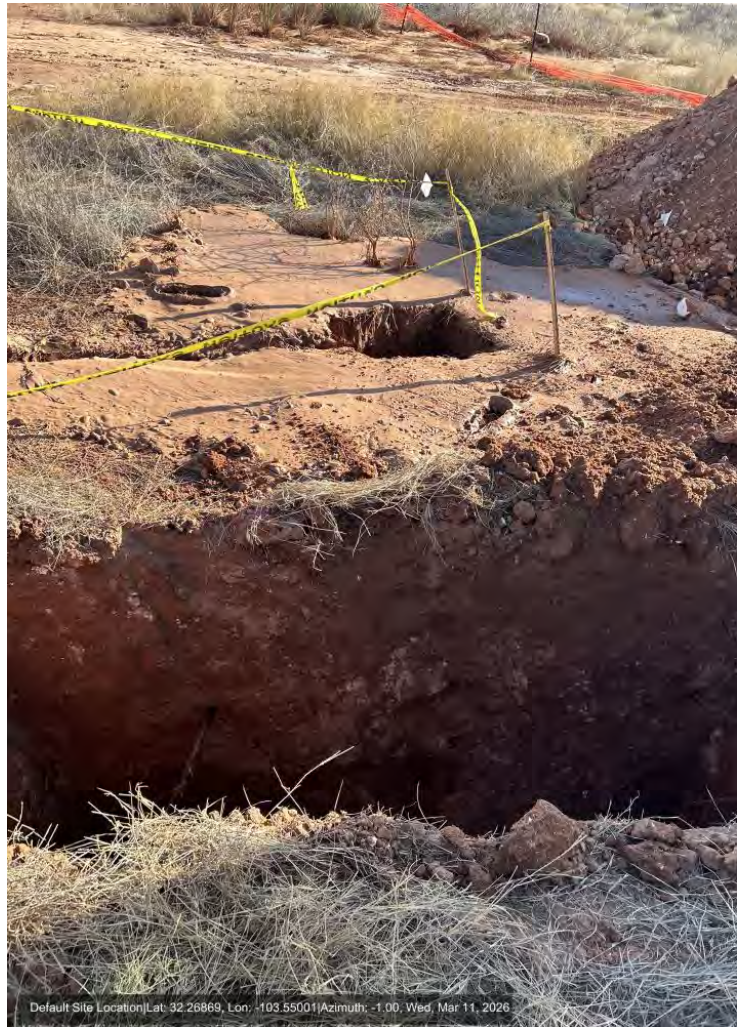
Date: 3/11/2026  
 Time: 09:14  
 Notes: TP26-01 Excavated to 11ft, sample was collected.  
 Latitude: 32.26868888888889  
 Longitude: -103.55001111111111  
 Direction: SW

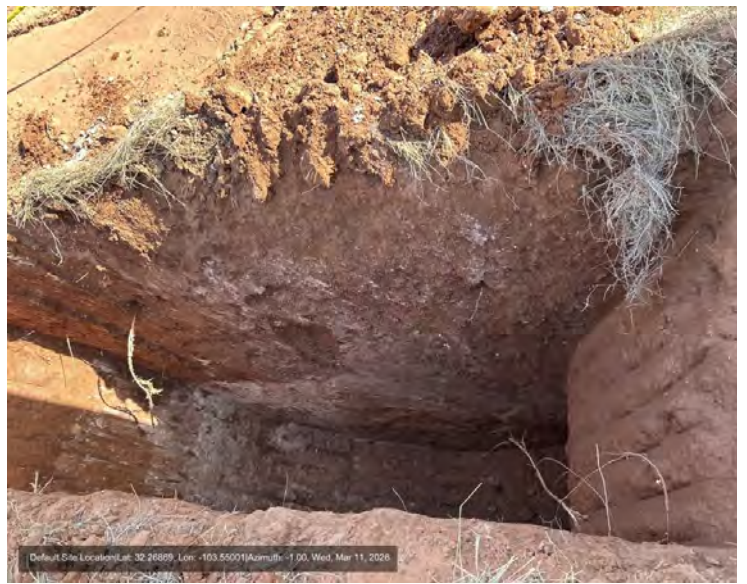
Date: 3/11/2026  
 Time: 10:12  
 Notes: TP26-01 Excavated to 12.25ft, sample was collected.  
 Latitude: 32.26868888888889  
 Longitude: -103.55001111111111  
 Direction: N

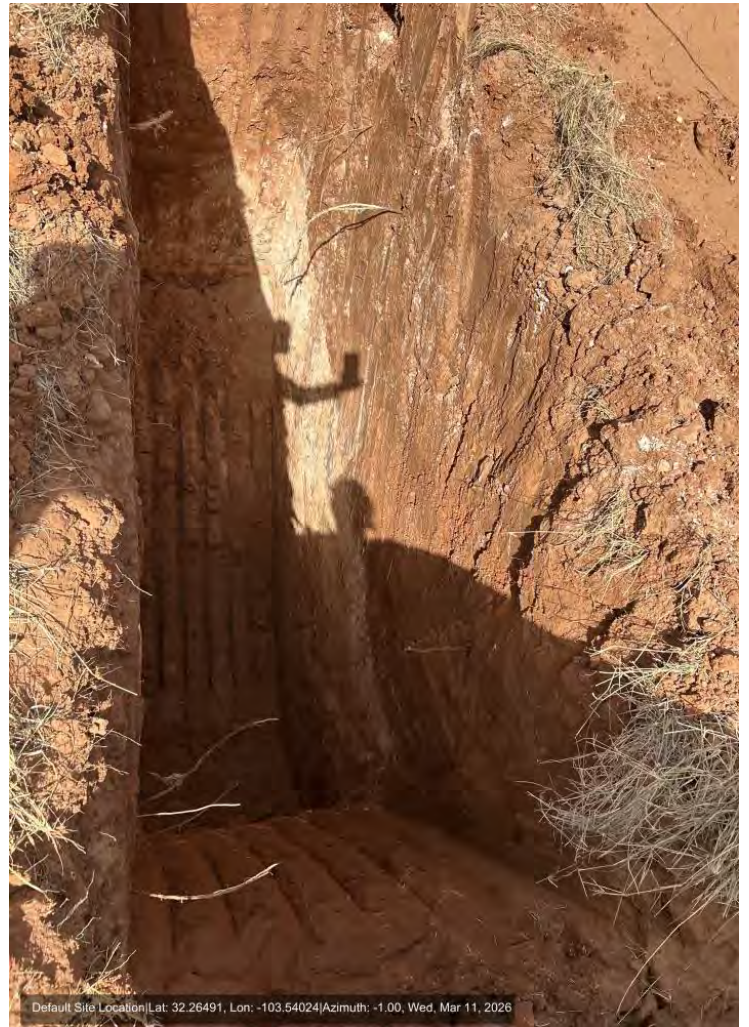
Date: 3/11/2026  
Time: 12:02  
Notes: TP26-01 Excavated to 12.8ft, sample was collected.  
Latitude: 32.26491388888889  
Longitude: -103.54023611111111  
Direction: S

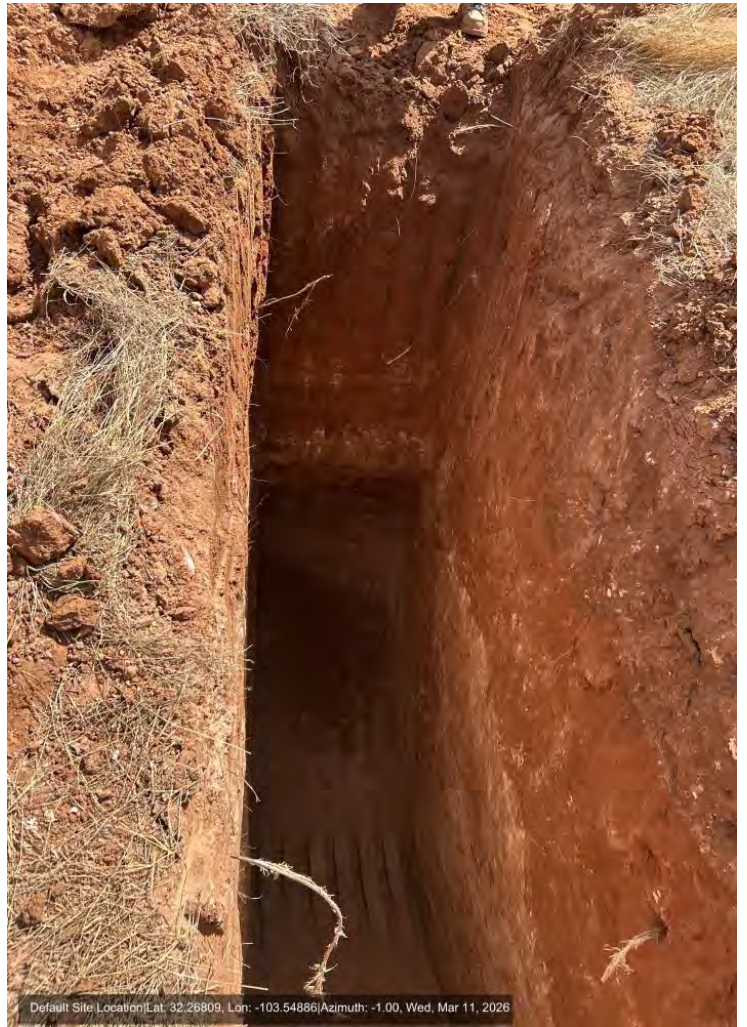
Date: 3/11/2026  
 Time: 13:04  
 Notes: TP26-01 Excavated to 13ft, sample was collected. Transition between red sand and dense rocky sandy material begins.  
 Latitude: 32.26808888888889  
 Longitude: -103.54885833333333  
 Direction: S

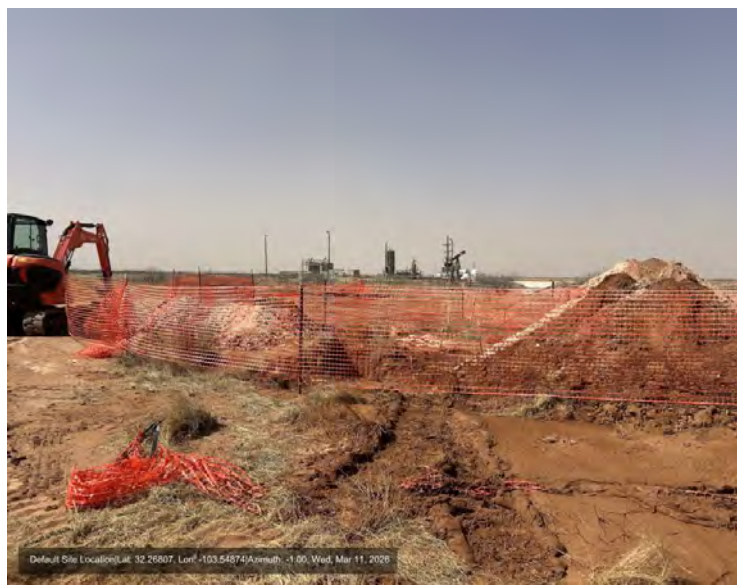
Date: 3/11/2026  
 Time: 14:07  
 Notes: TP26-01 excavation area secured per Devon safety approval with fencing.  
 Latitude: 32.26806944444444  
 Longitude: -103.54873611111111  
 Direction: S

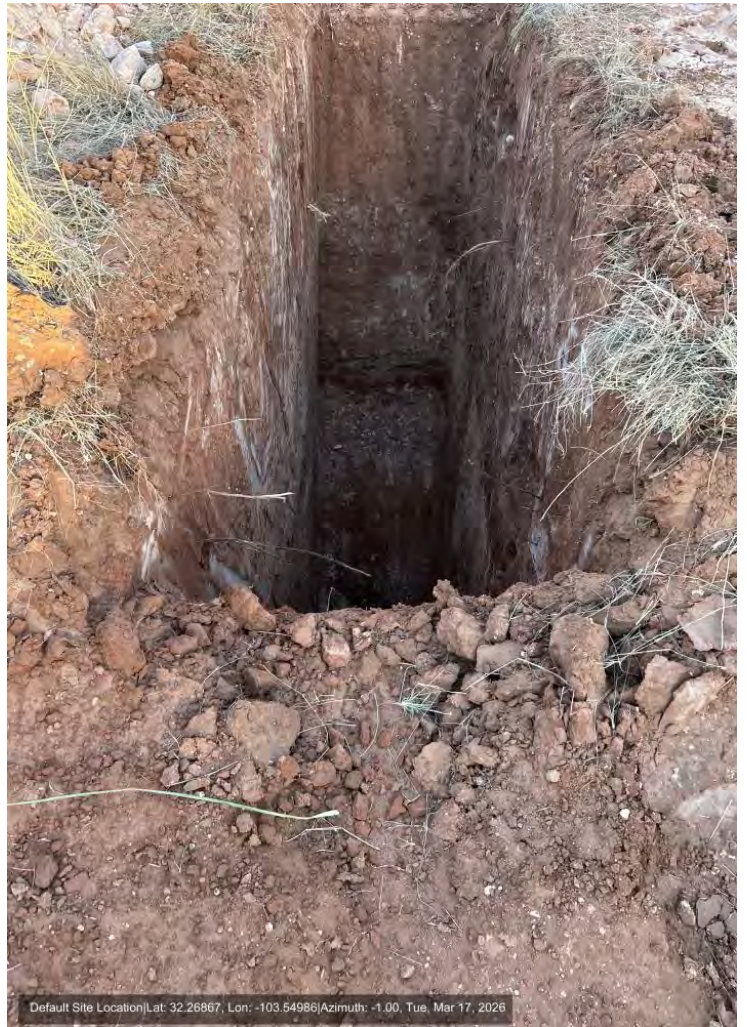
Date: 3/17/2026  
Time: 07:25  
Notes: TP26-01 at 13 ft, collected discrete sample.  
Latitude: 32.26867222222222  
Longitude: -103.5498638888889  
Direction: SW

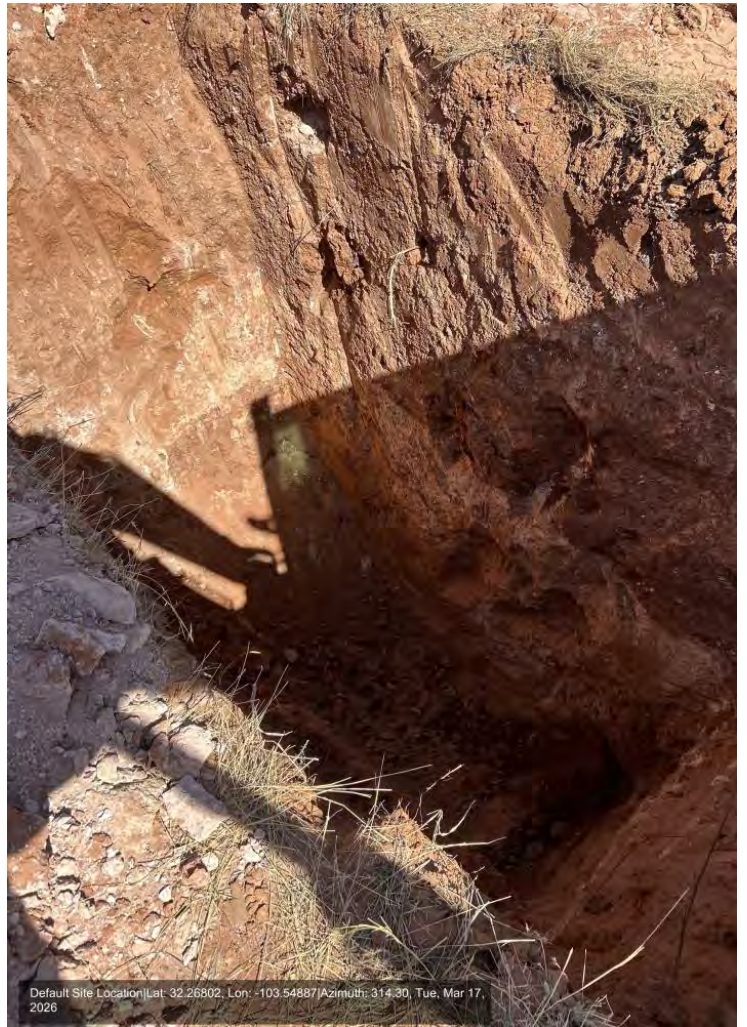
Date: 3/17/2026  
Time: 11:28  
Notes: TP26-01 at 13.6 ft, collected discrete sample.  
Latitude: 32.26801944444444  
Longitude: -103.54887222222222  
Direction: NW

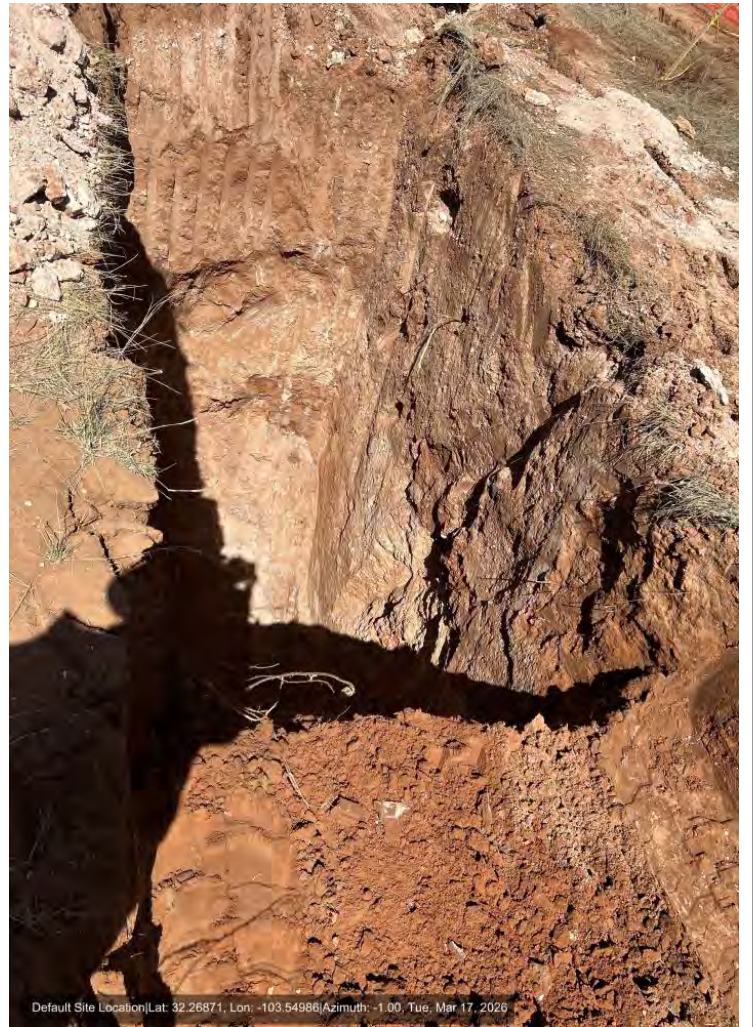
Date: 3/17/2026  
Time: 11:49  
Notes: TP26-01 at 14 ft, collected discrete sample.  
Latitude: 32.26871111111111  
Longitude: -103.54985833333333  
Direction: SW

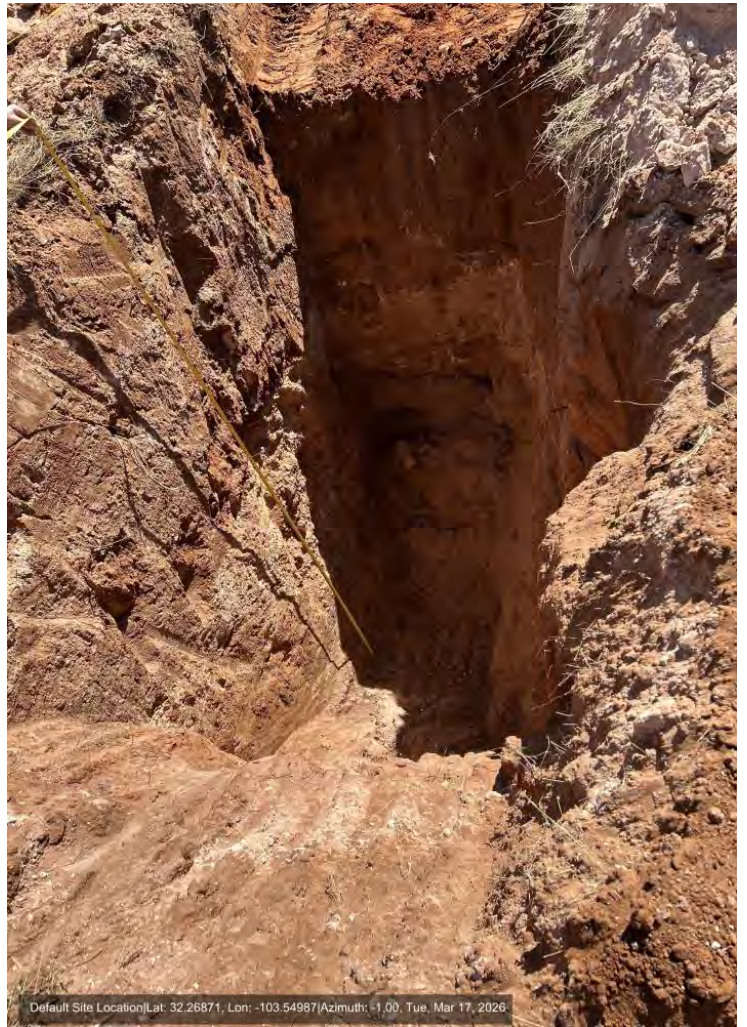
Date: 3/17/2026  
Time: 11:58  
Notes: TP26-01 at 14 ft, with measuring tape.  
Latitude: 32.26871111111111  
Longitude: -103.54987222222222  
Direction: S

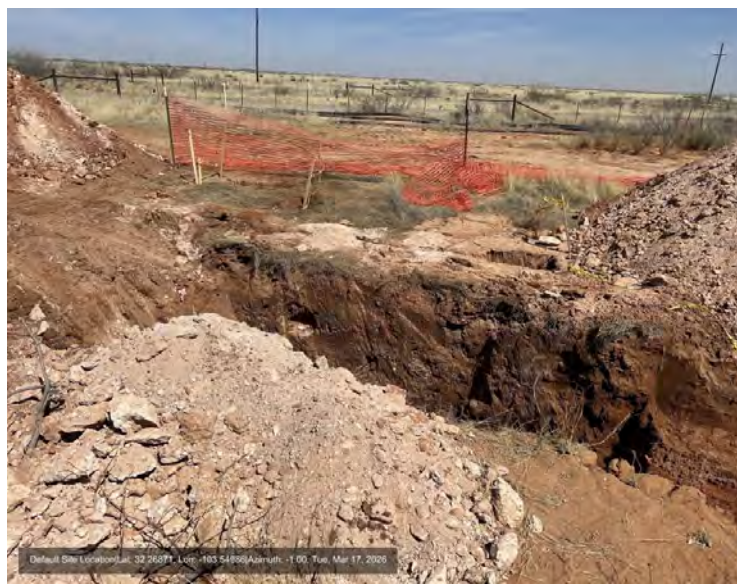
Date: 3/17/2026  
Time: 11:58  
Notes: TP26-01 at 14 ft location.  
Latitude: 32.26871111111111  
Longitude: -103.54985833333333  
Direction: S

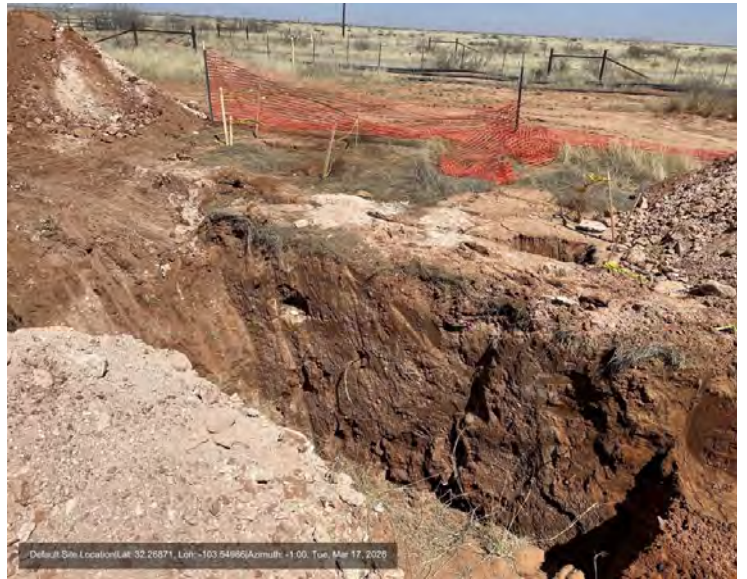
Date: 3/17/2026  
Time: 11:58  
Notes: TP26-01 at 14 ft, location.  
Latitude: 32.26871111111111  
Longitude: -103.54985833333333  
Direction: S

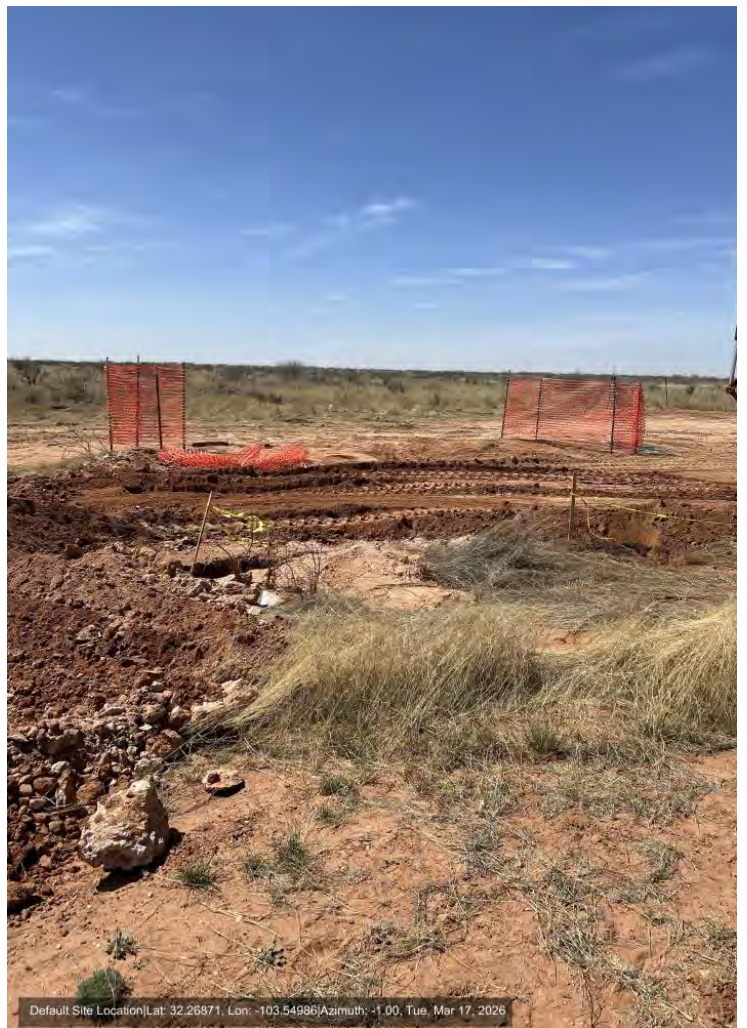
Date: 3/17/2026  
Time: 12:40  
Notes: Area backfilled  
Latitude: 32.26871111111111  
Longitude: -103.54985833333333  
Direction: S

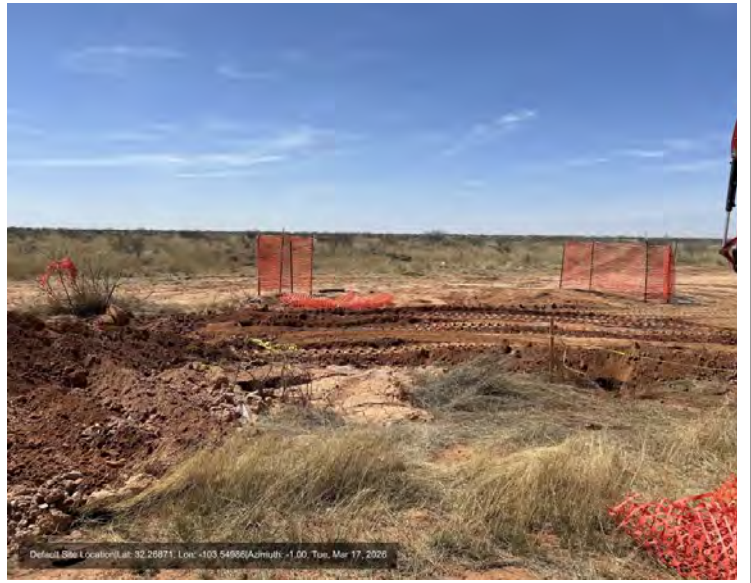
Date: 3/17/2026  
Time: 12:40  
Notes: Area backfilled  
Latitude: 32.26871111111111  
Longitude: -103.54985833333333  
Direction: S

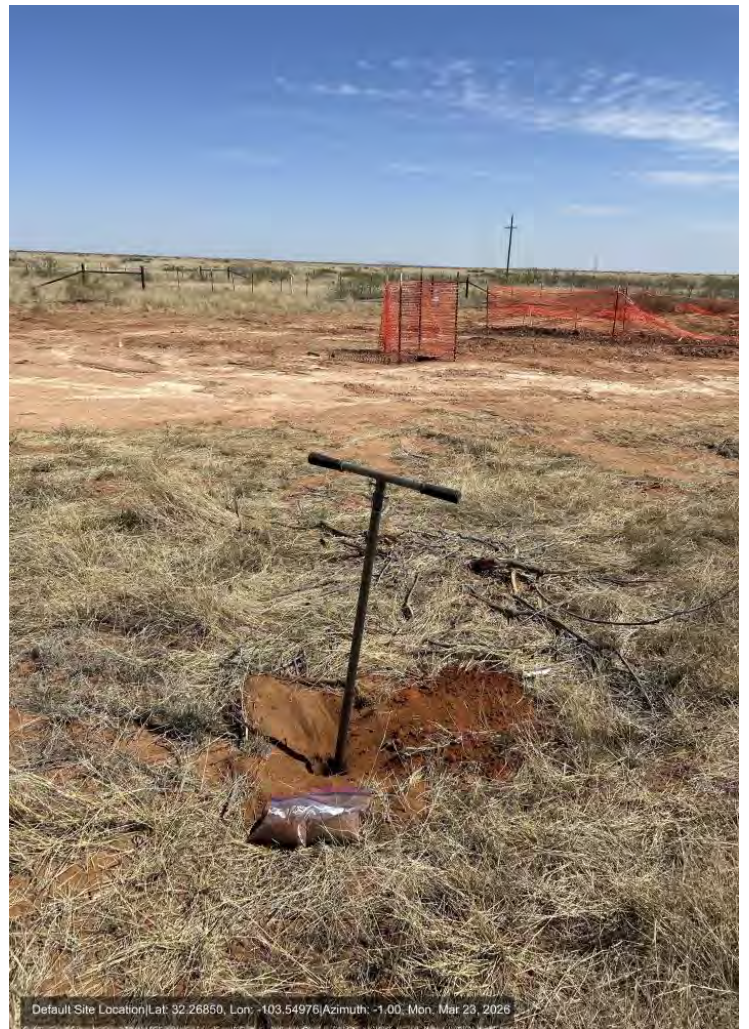
Date: 3/23/2026  
 Time: 10:58  
 Notes: View from south looking slight northeast. BH26-12 with hand auger in borehole at 2 ft. Samples BH26-12 0ft and 2ft.  
 Latitude: 32.26849722222222  
 Longitude: -103.54975833333333  
 Direction: W

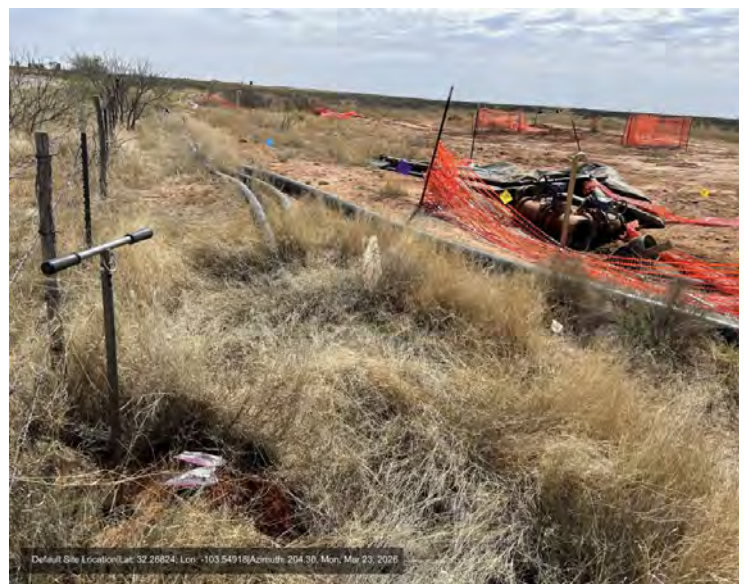
Date: 3/23/2026  
 Time: 11:15  
 Notes: View from west looking eastsoutheast. BH26-13 with hand auger in borehole at 2 ft. Samples BH26-13 0ft and 2ft  
 Latitude: 32.26823888888889  
 Longitude: -103.54917777777777  
 Direction: SW

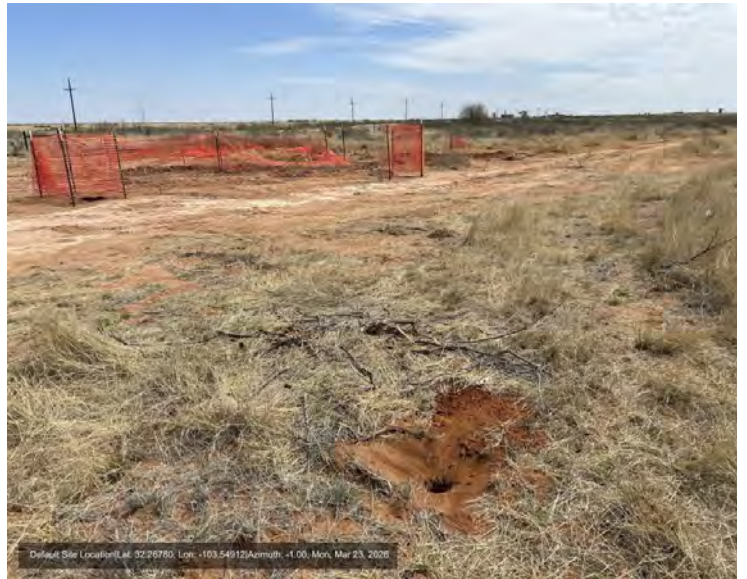
Date: 3/23/2026  
 Time: 12:06  
 Notes: View from south looking eastnortheast. Sample point BH26-12.  
 Latitude: 32.267802777777774  
 Longitude: -103.549119444444444  
 Direction: W

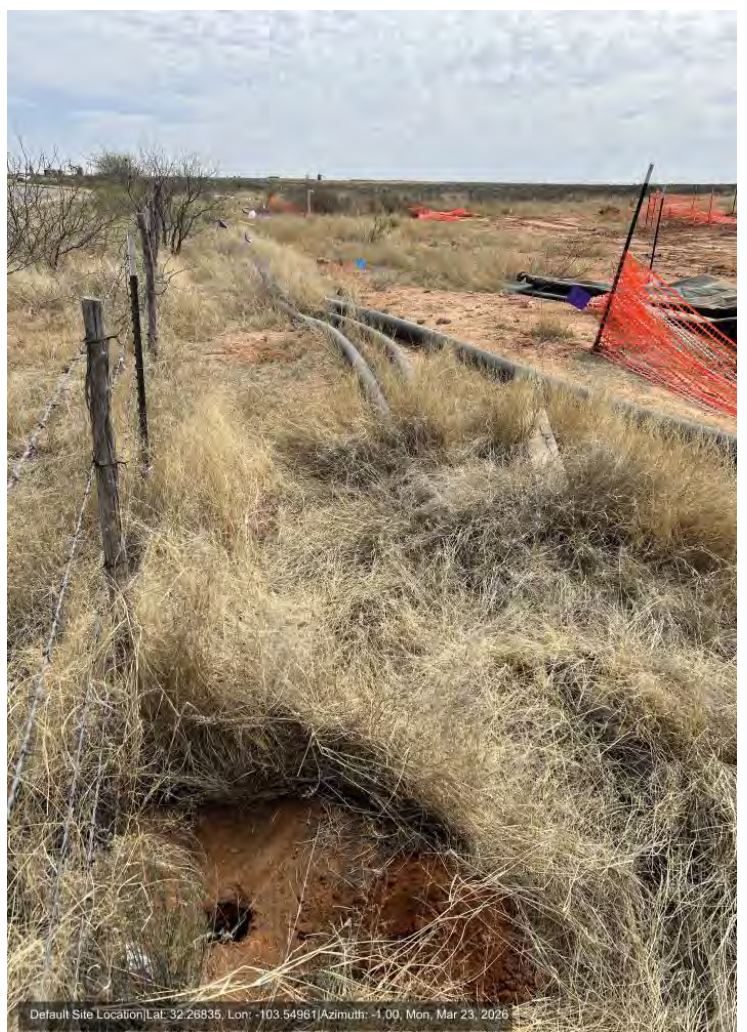
Date: 3/23/2026  
 Time: 12:06  
 Notes: View from west looking east. BH26-13. Sample point BH26-13.  
 Latitude: 32.268352777777778  
 Longitude: -103.549605555555556  
 Direction: W
