**Closure Report
Yukon Gold 31 CTB 2 (04.05.2026)
Incident ID: NAPP2609623591
Unit H, Sec 31, T23S, R30E
Eddy County, New Mexico
32.262993°, -103.913058°**

**Produced Water Release
Point of Release: Valve Developed Pinhole Leak
Release Date: 04.05.2026
Volume Released: 39 Barrels of Produced Water
Volume Recovered: 27 Barrels of Produced Water**

**Re: Closure Report
Yukon Gold 31 CTB 2 (04.05.2026)
Devon Energy Production Company
Incident ID: nAPP2609623591
Site Location: Unit H, S31, T23S, R30E
(Lat 32.262993°, Long -103.913058°)
Eddy County, New Mexico**

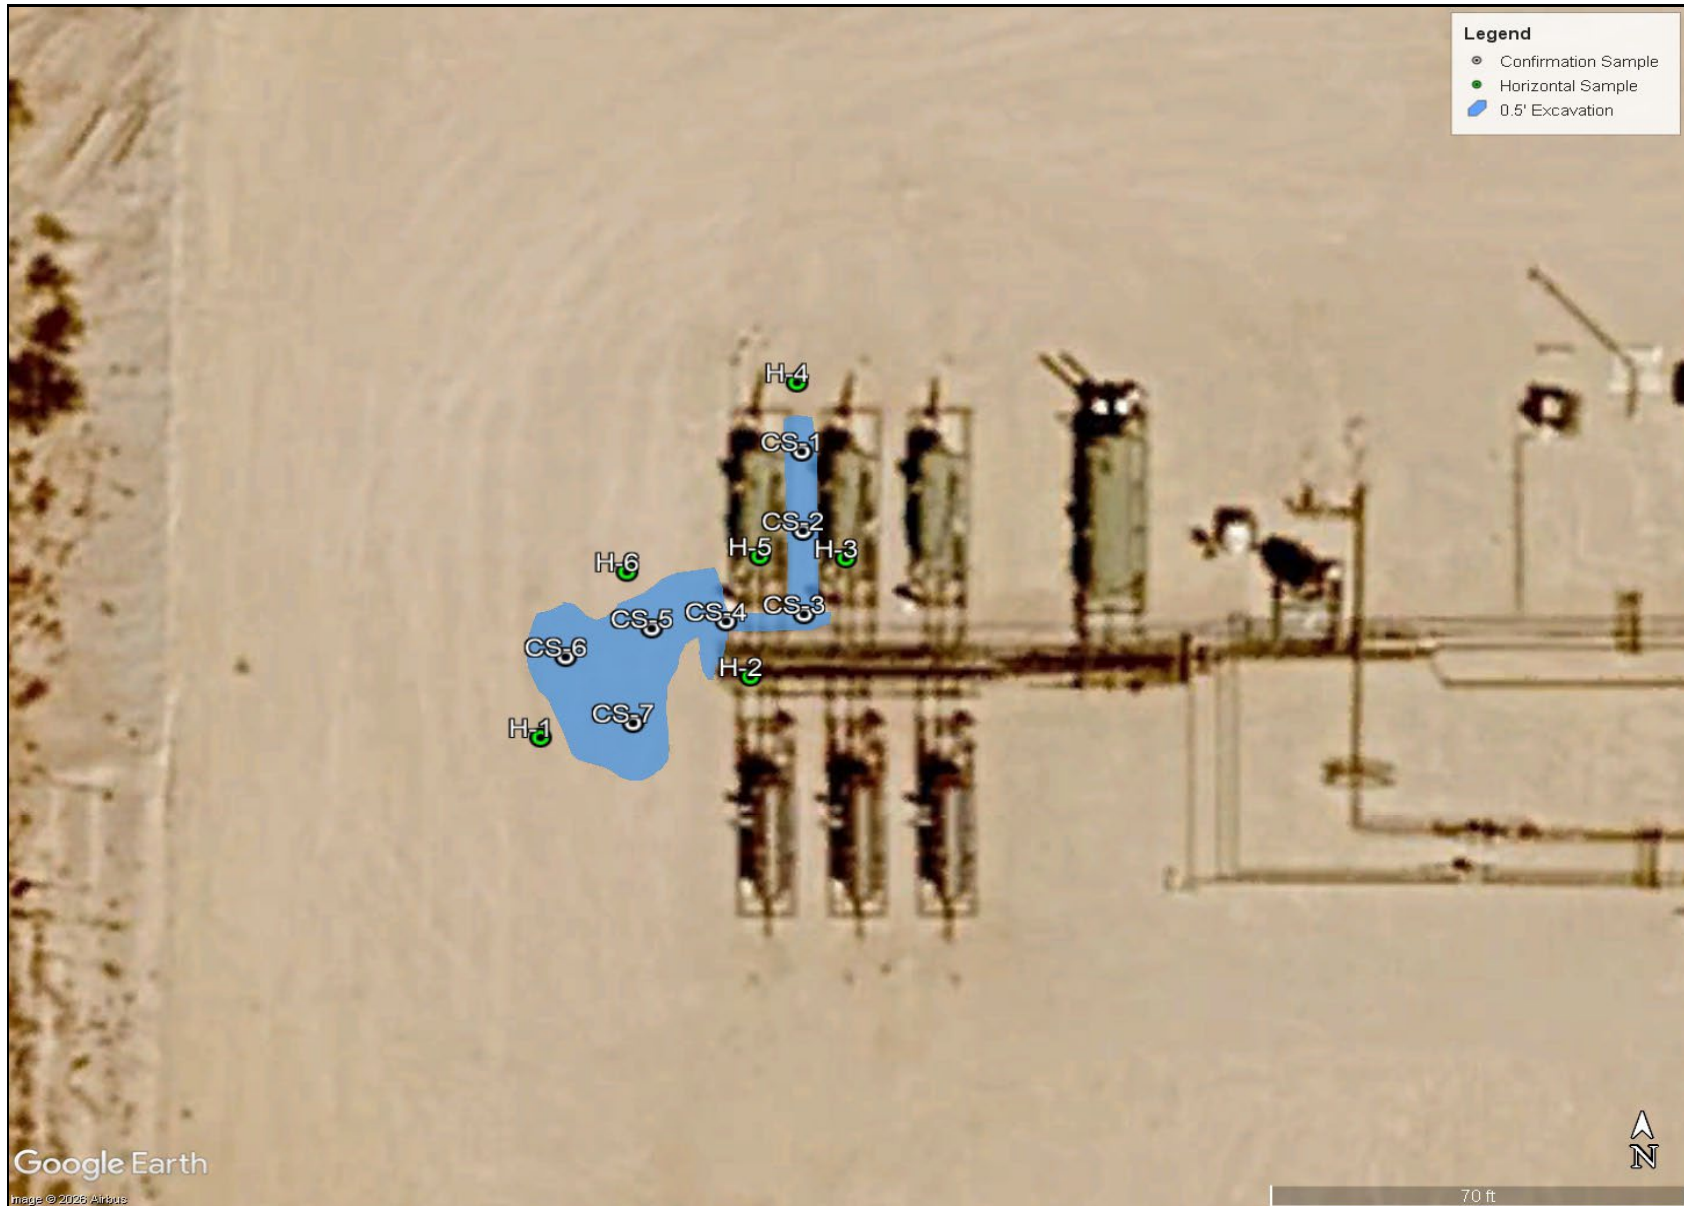
FIGURE 3

Based on the initial C-141 obtained from the New Mexico Oil Conservation Division (NMOCD), the release was discovered on April 5, 2026, due to a valve developing a pinhole leak, allowing fluids to reach the surface of the pad. It resulted in the release of thirty-nine (39) barrels of produced water, with twenty-seven (27) barrels of produced water recovered. The spill boundaries are shown in Figure 3. The initial C-141 form is attached in Appendix C.

EXCAVATION DEPTH MAP
DEVON ENERGY PRODUCTION COMPANY
YUKON GOLD 31 CTB 2 (04.05.2026)
EDDY COUNTY, NEW MEXICO
32.262993°, -103.913058°

Once the remediation activities were completed, the excavated areas were backfilled with clean material to surface grade. Approximately 1,104 square feet of contamination was remediated, resulting in approximately 21 cubic yards of material excavated and transported offsite for proper disposal. The backfill material was sourced from Northern Delaware Basin Landfill and was collected for laboratory analysis on April 17, 2026, before being utilized. Laboratory data can be found in Table 1.

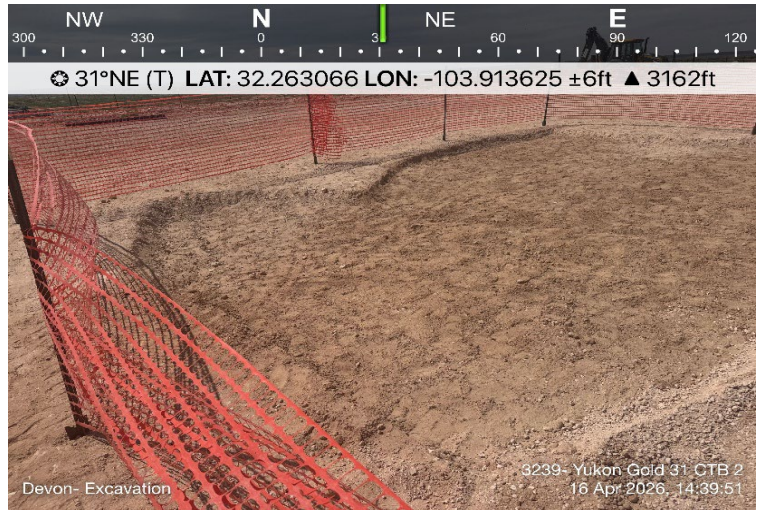
Description:
View Northeast, area of CS-4 through CS-7.

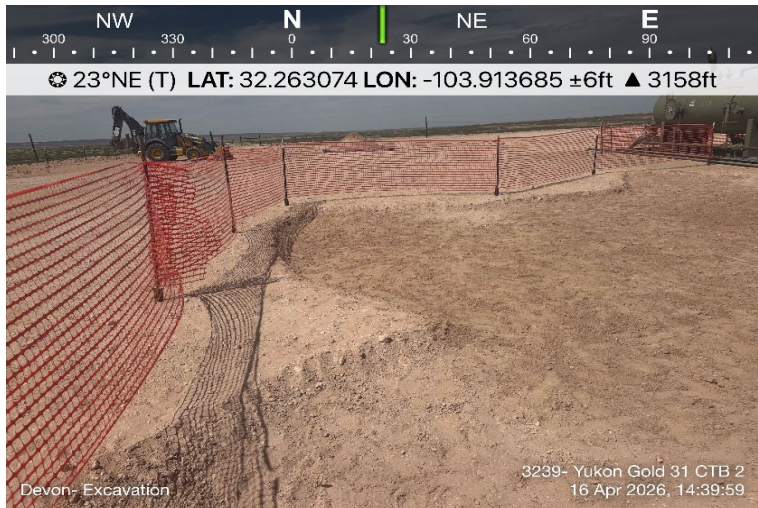
Photograph No. 2

Description:
View Northeast, area of CS-4 through CS-7.

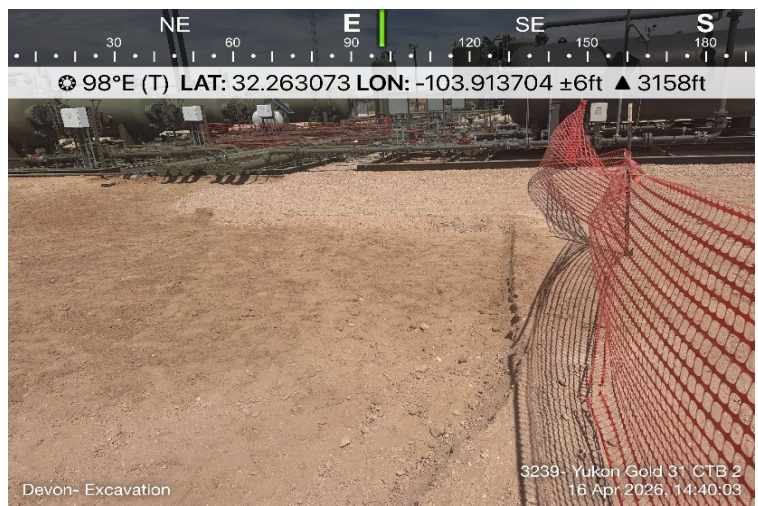
Photograph No. 3

Description:
View East, area of CS-4 through CS-7.

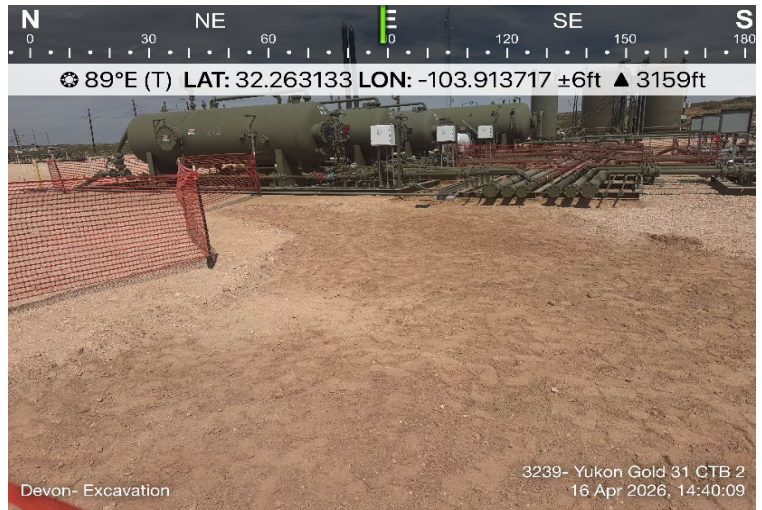
View East, area of CS-4 through CS-7.

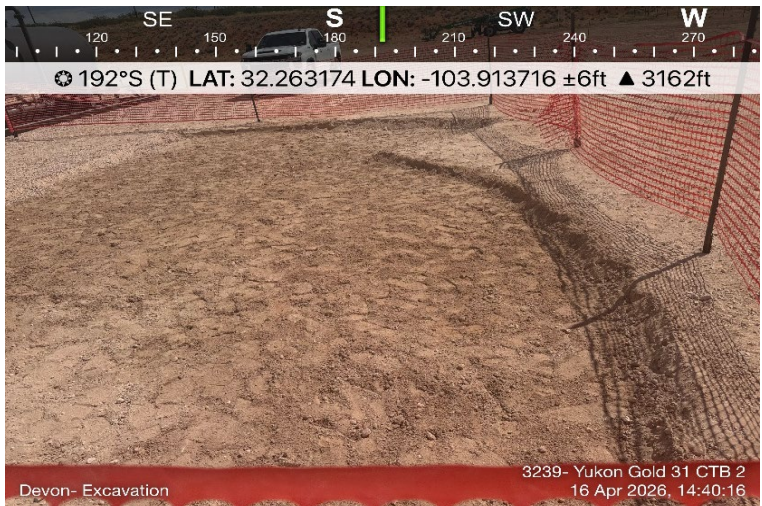
Photograph No. 5

View South, area of CS-4 through CS-7.

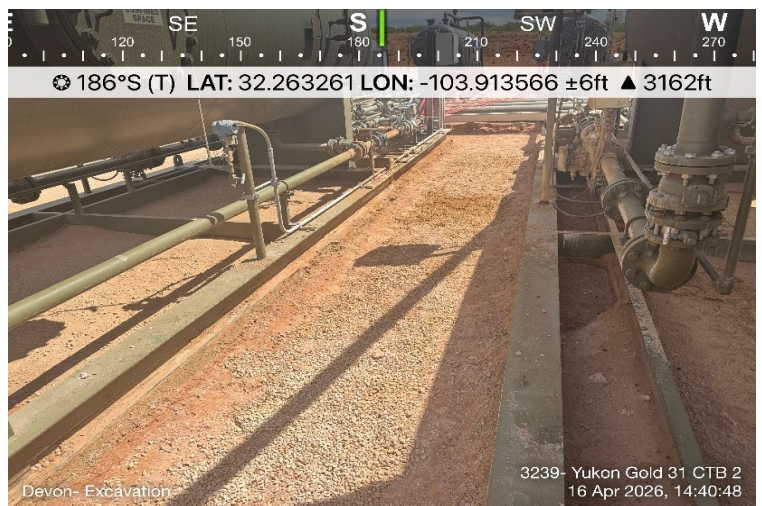
Photograph No. 6

View South, area of CS-1 through CS-3.

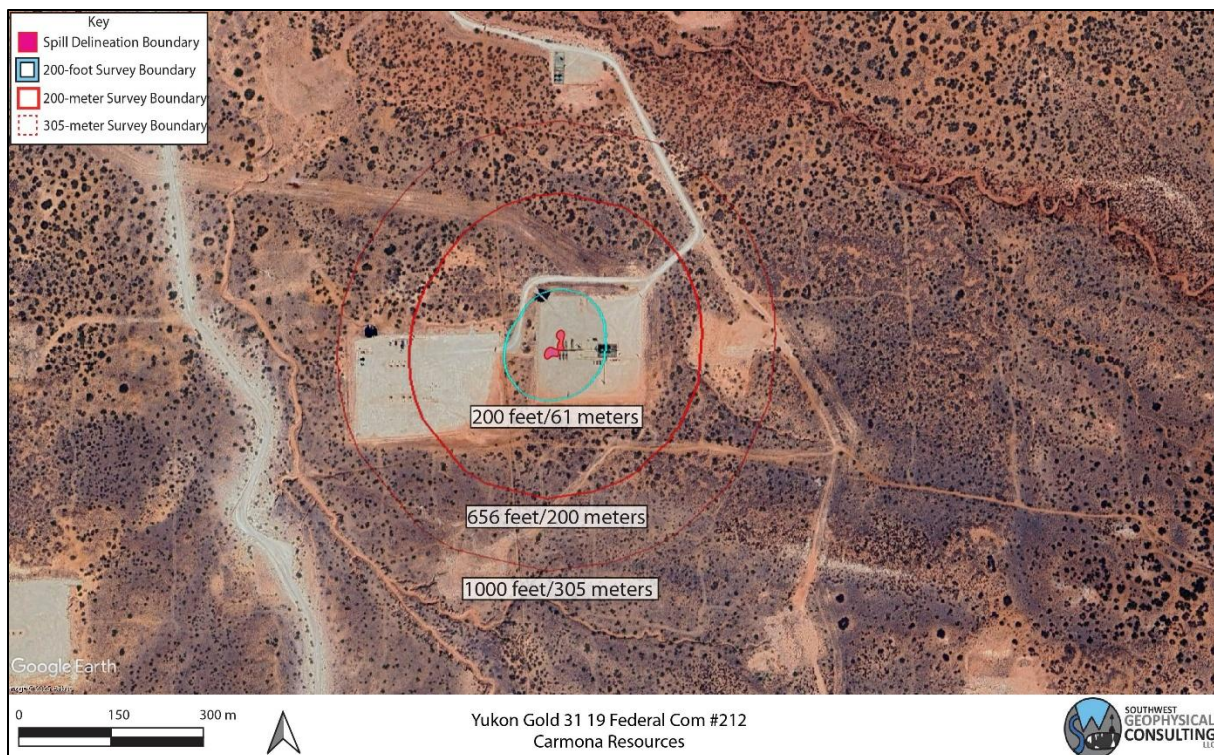
Figure 4: Surface survey overview. Background image credit: Google Earth. Image date: August 21, 2024. Datum: WGS-84.

Aerial karst surveys are conducted at low elevation within 200 meters of the spill delineation boundary^[4] (**Figure 4**) following a preplanned raster pattern flightpath designed for the purpose of generating at least 75% imagery overlap. The collected high-resolution, georeferenced imagery is stitched together to develop orthomosaic imagery which is further developed into a digital elevation model (DEM); the DEM is then processed into a local relief model (LRM) (**Figure 6**). This LRM is color coded to enhance differences in elevation of as little as five centimeters. The orthoimagery, DEM, and LRM are uploaded to a server where they are analyzed by an experienced karst geologist. Finally, the data is reviewed by a senior karst geologist for quality assurance and downloaded into a table for inclusion in a written report^[16].

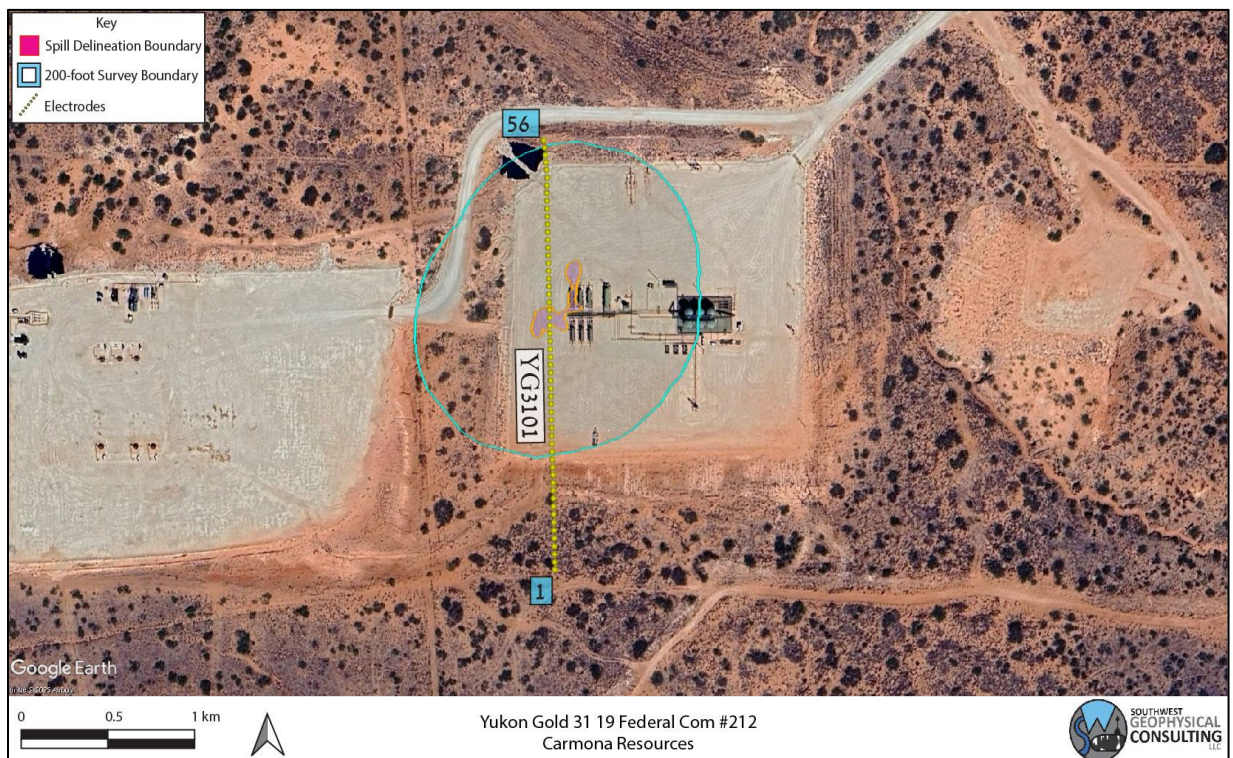
For this survey, an Advanced Geosciences Inc. (AGI) SuperSting™ Wifi R8 with a multi-electrode switchbox, a 56-electrode array of 40-centimeter-long electrodes, and a tablet controller were used to image the subsurface. This survey consisted of one resistivity line in a dipole-dipole strong-gradient configuration laid out south to north. The single line consisted of 56 electrodes at 4-meter spacing, resulting in a 220-meter-long array (**Figure 5, Table 1**). A preconfigured command file was used to run the data collection (DDSG56). This electrode configuration provided a depth of investigation of 44 meters (144 feet) and a resolution of 2.0 to 2.5 meters (6.6 to 8.2 feet) within the first 5 to 8 meters (16 to 26 feet) from the surface. A Leica GS18 GPS was used to record electrode locations and elevations.

Figure 5: Geophysical survey overview. One survey line was conducted with 56 electrodes each at 4-meter spacing (yellow dots denoted with blue numbers). Background image credit: Google Earth. Image date: August 21, 2024. Image datum: WGS-84.

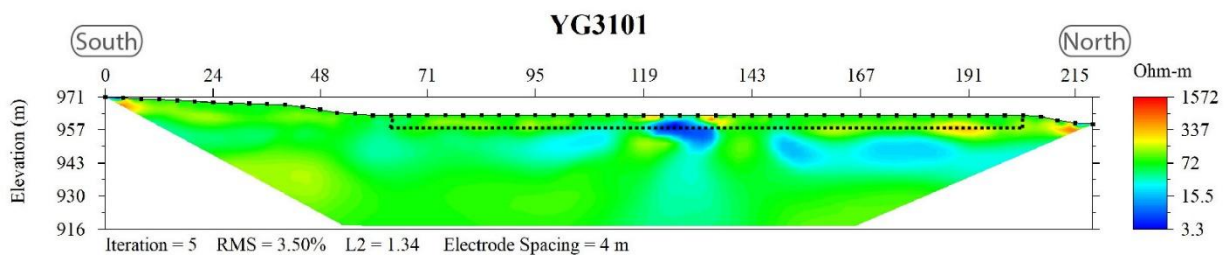
The results of this study indicate a moderately well-layered geologic system with resistivities between 3.3 and 1,572 Ohm-m (**Figure 7**). Please keep in mind when viewing the 2D inverted resistivity sections that color maps can be widely different for each view. Always check the color map located on the right side of the image when viewing the 2D images to ensure you understand the range of resistivities presented. Distances along the top and depths along the left side are in meters. The color map along the right side is in Ohm-m. Due to the nature of the survey, shallower zones have higher resolution between electrodes than deeper zones; therefore, small features at depth will not be visible.

Figure 7: 2D inverted resistivity sections. Reds and oranges indicate higher resistivity values. Yellows and greens are medium-resistivity values. Blues are low-resistivity values. Please note that the color scale is relative. The dashed black line indicates the location of the well pad.

No anomalies consistent with air-filled subsurface voids are found within the YG31 survey area. However, small solutionally enlarged voids or fractures at or near the resolution limit of the survey (1.5 – 2.0 meters) may be present. Slightly higher-than-average resistivity areas less than 10 meters beneath the surface are interpreted as dry caliche or gypsite soils. Due to their low resistivity values when compared with significant subsurface voids, these features should not be a concern during remediation efforts. Areas of moderate resistivity (yellows, and greens) near the surface are interpreted as dry gypsite soils and gypsum bedrock of the Rustler Formation^[17] (**Figure 7** and **Figure 8**).

The low-resistivity area between 3.3 – 15 Ohm-m is interpreted to represent fluid from the brine release. Other low resistivity areas between 15 and 50 may represent surface-to-subsurface hydrologic pathways, or a layer of either clays and halite lenses or moist or saturated layers within the Rustler Formation. (**Figure 7**).

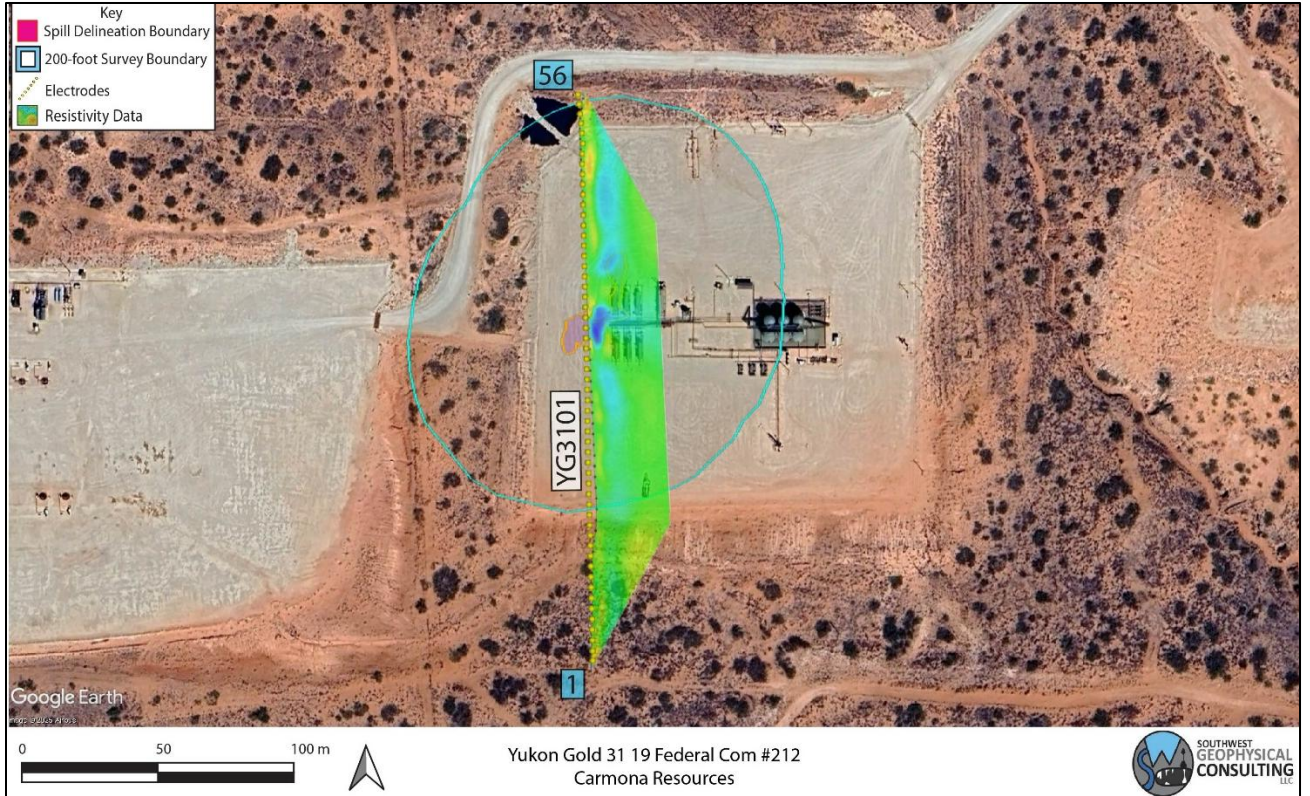
Figure 8: Data overlay. Colored trapezoid is the 2D inverted resistivity line. Background image credit: Google Earth. Image date: March 20, 2023.
