RE: **Spud Muffin 31 CTB 1 - Closure Request Report**
Incident Number: nAPP2524019423
GPS: 32.25575506°, -104.0262478°
Eddy County, New Mexico
ESRR Project No. 7141

Spud Muffin 31 CTB 1 - Closure Request Report
Incident Number: nAPP2524019423
GPS: 32.25575506°, -104.0262478°

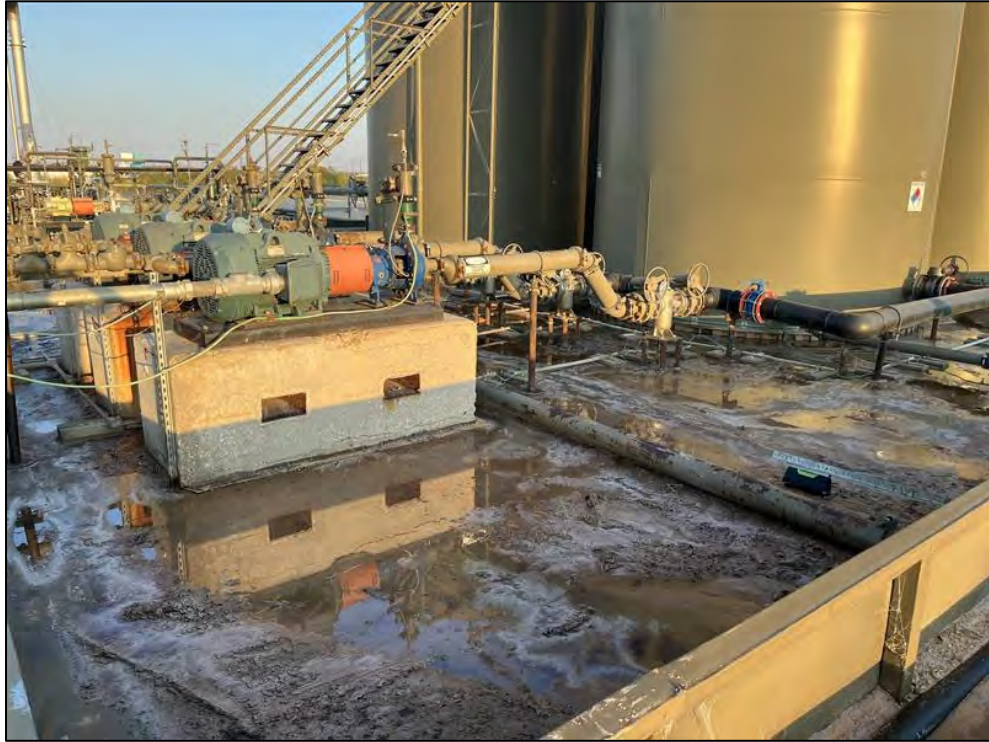
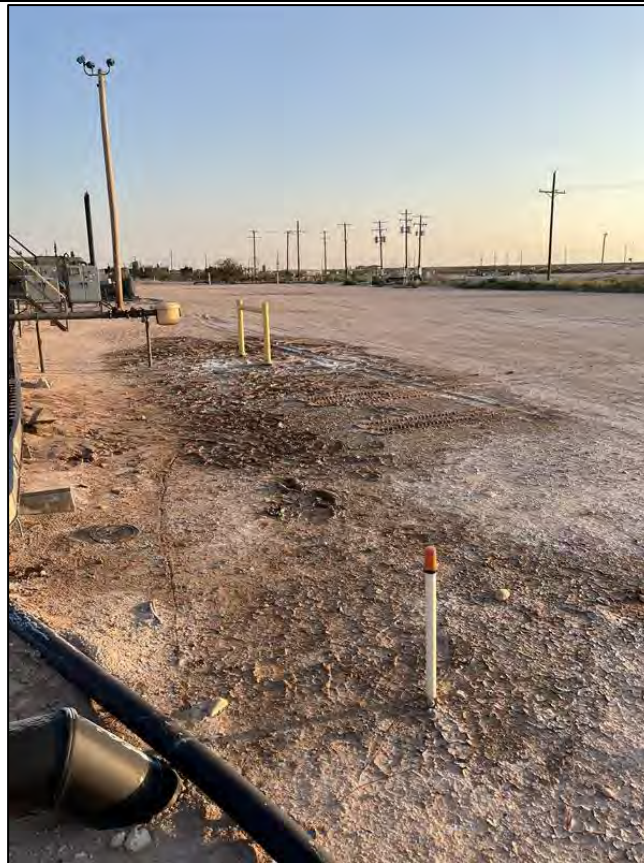
On August 25, 2025, a transfer pump developed a pinhole leak, causing the release of approximately 5 barrels (bbls) of produced water within a lined secondary containment (LSC), and onto the Devon operated production pad due to windblown overspray. A vacuum truck was immediately dispatched to the Site and recovered 4 bbls of fluids. ESRR conducted initial site assessment activities and mapped the observed release footprint on August 29, 2025, hereafter referred to as the Area of Concern (AOC) (**Figure 2**). Devon gave notice to the New Mexico Oil Conservation Division (NMOCD) on August 28, 2025, by Notification of Release (NOR) and was subsequently assigned Incident Number nAPP2524019423. A Corrective Action Form C-141 (Form C-141) was submitted on August 29, 2025 and approved by the NMOCD on September 2, 2025.

PHOTO 1: Southeastern view during initial site assessment. 8/25/2025

PHOTO 2: Southwestern view during initial site assessment. 8/25/2025

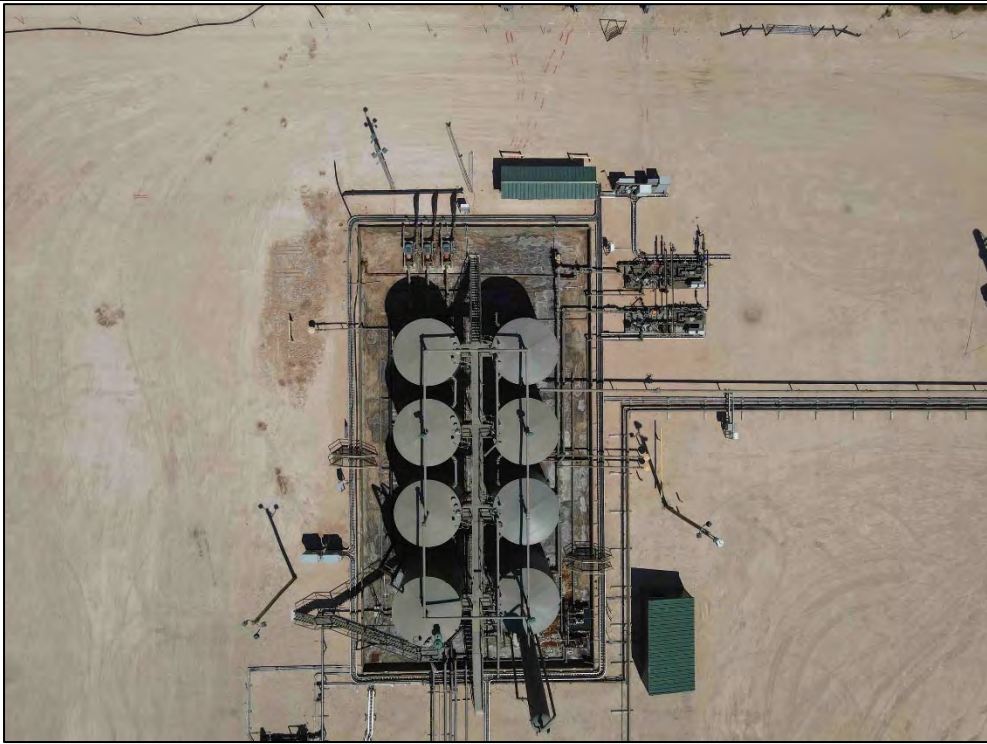
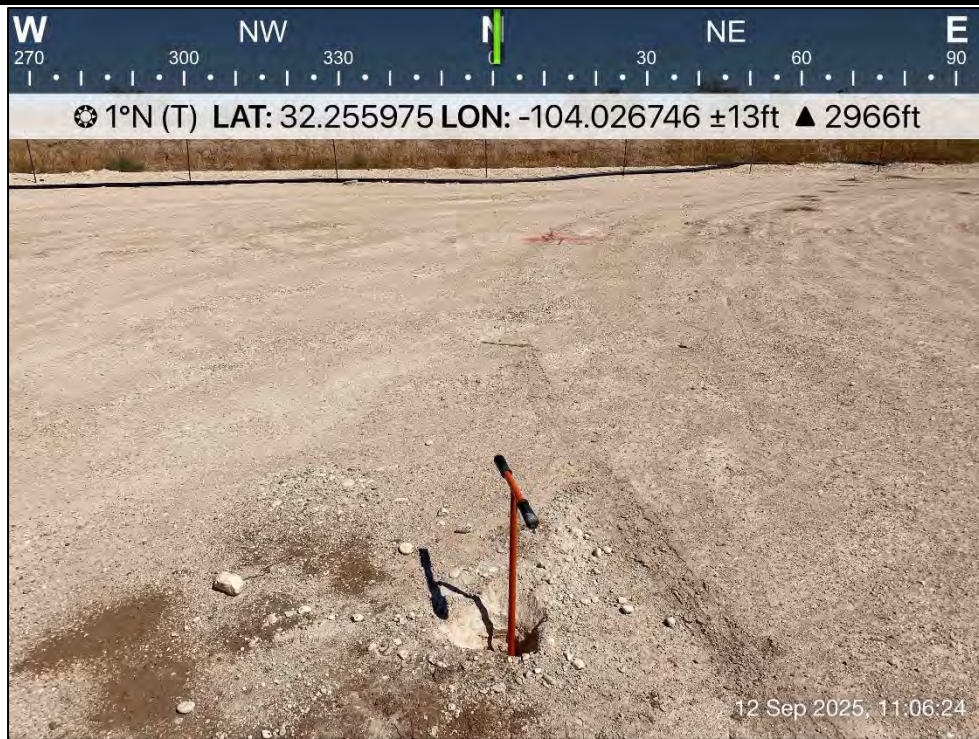
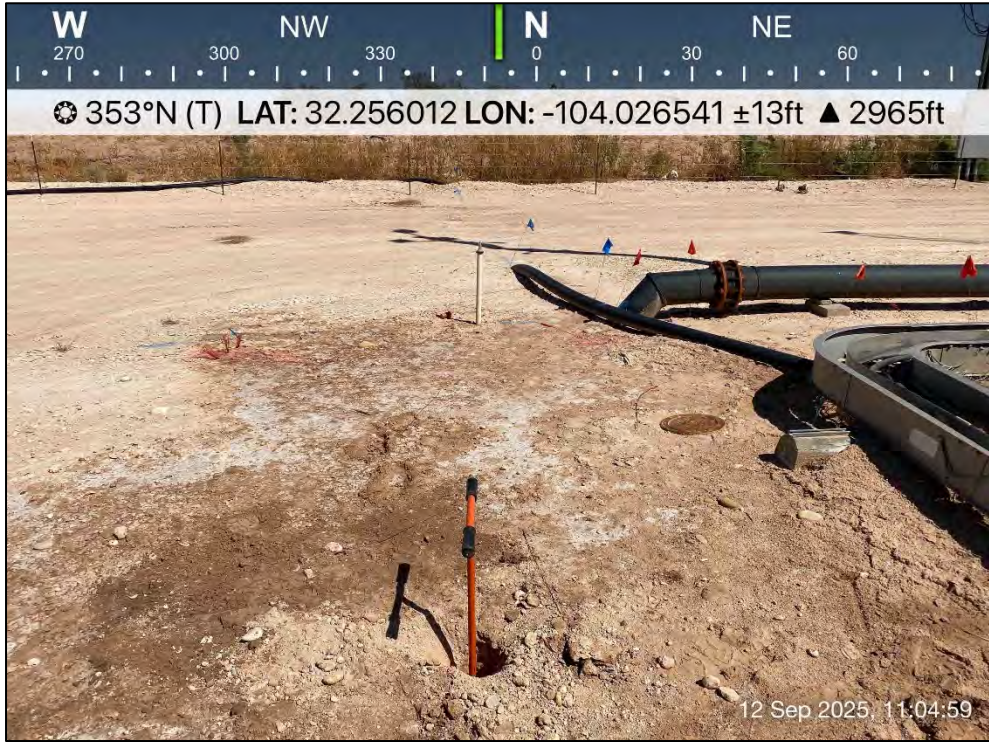
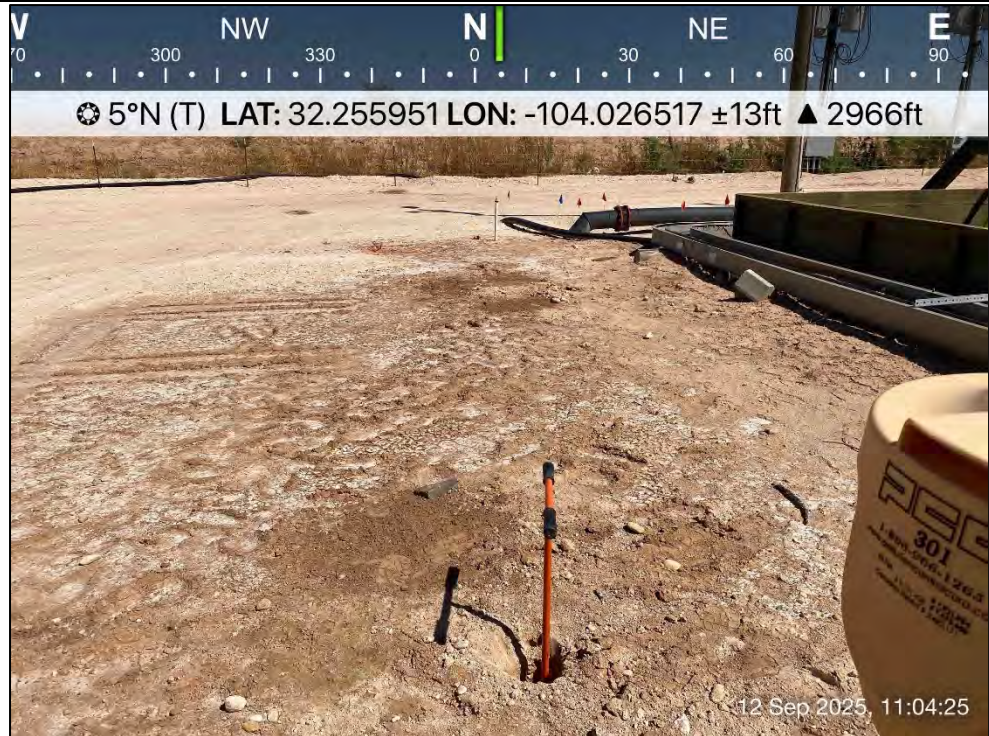
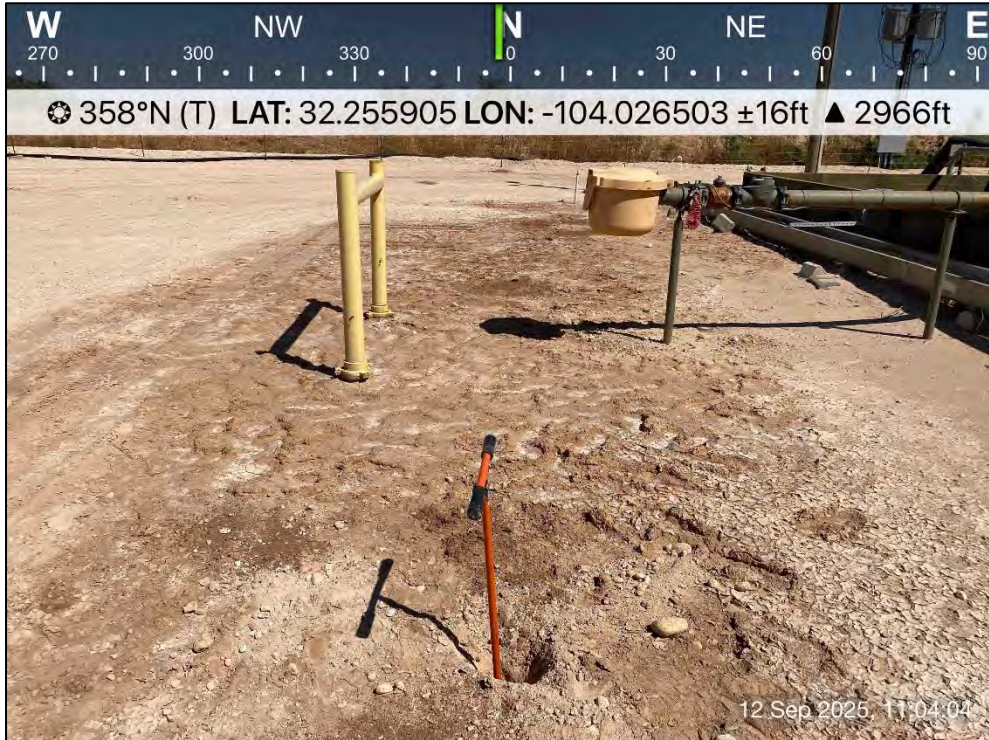
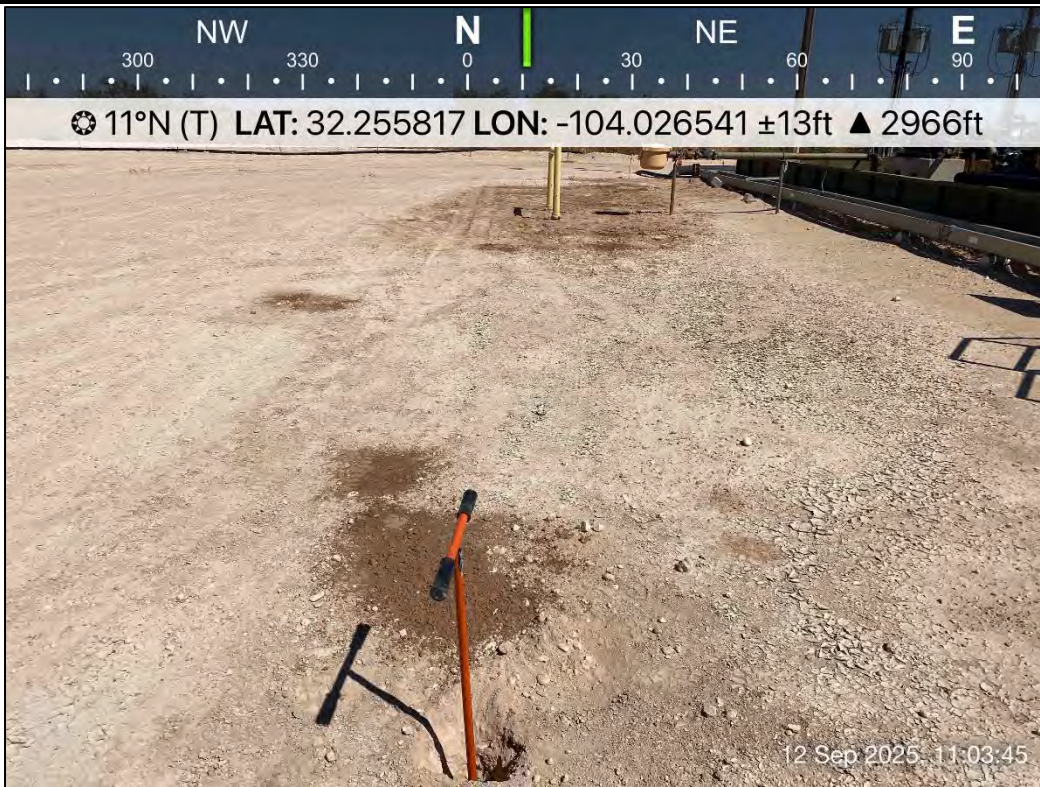
On September 12, 2025, ESRR conducted delineation activities to assess the presence or absence of soil impacts associated with the AOC. Six delineation boreholes (HA-1 through HA-6) were advanced via hand auger within and surrounding the AOC. Delineation activities were driven by field screening soil for chloride utilizing QuanTab[®] test strips. A minimum of three soil samples were collected from each delineation borehole, representing the highest observed field screening concentrations and the greatest depth. Delineation soil samples were placed directly into lab-provided pre-cleaned jars, packed with minimal void space, labeled, and placed on ice. The delineation soil samples were transported under strict

PHOTO 3: Northern aerial view during delineation activities. 9/12/2025

PHOTO 4: Northern view during delineation activities. 9/12/2025

PHOTO 5: Northern view during delineation activities. 9/12/2025

PHOTO 6: Northern view during delineation activities. 9/12/2025

PHOTO 7: Northern view during delineation activities. 9/12/2025

PHOTO 8: Northeastern view during delineation activities. 9/12/2025

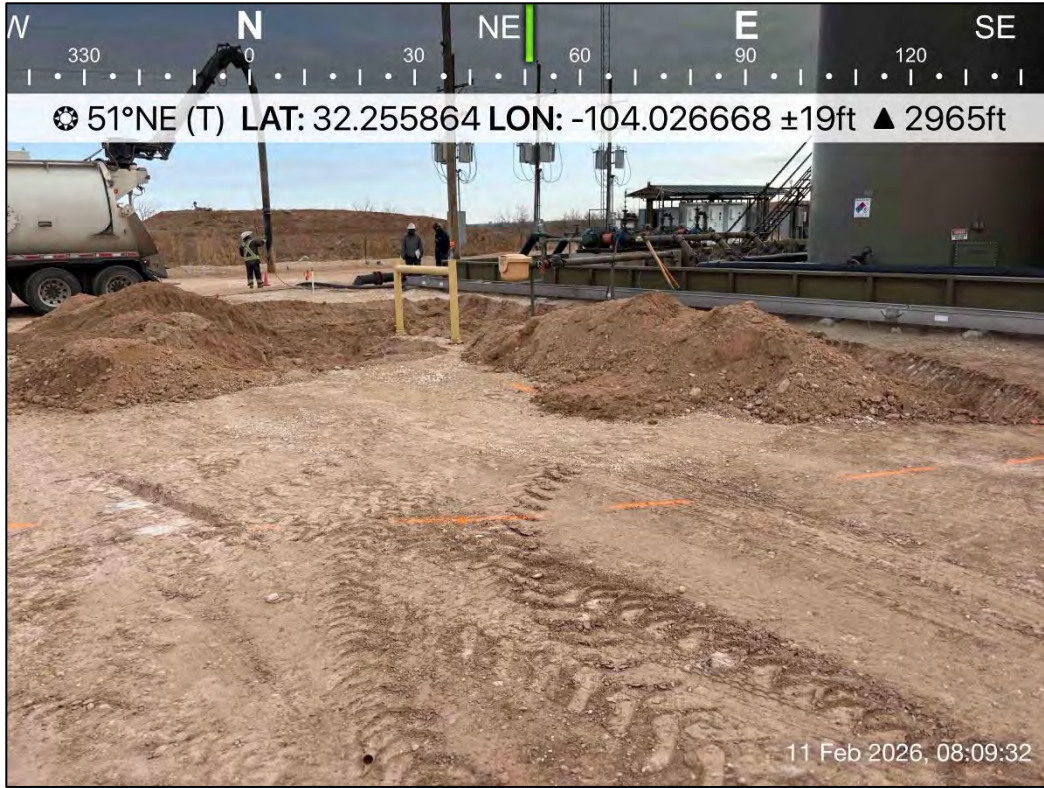
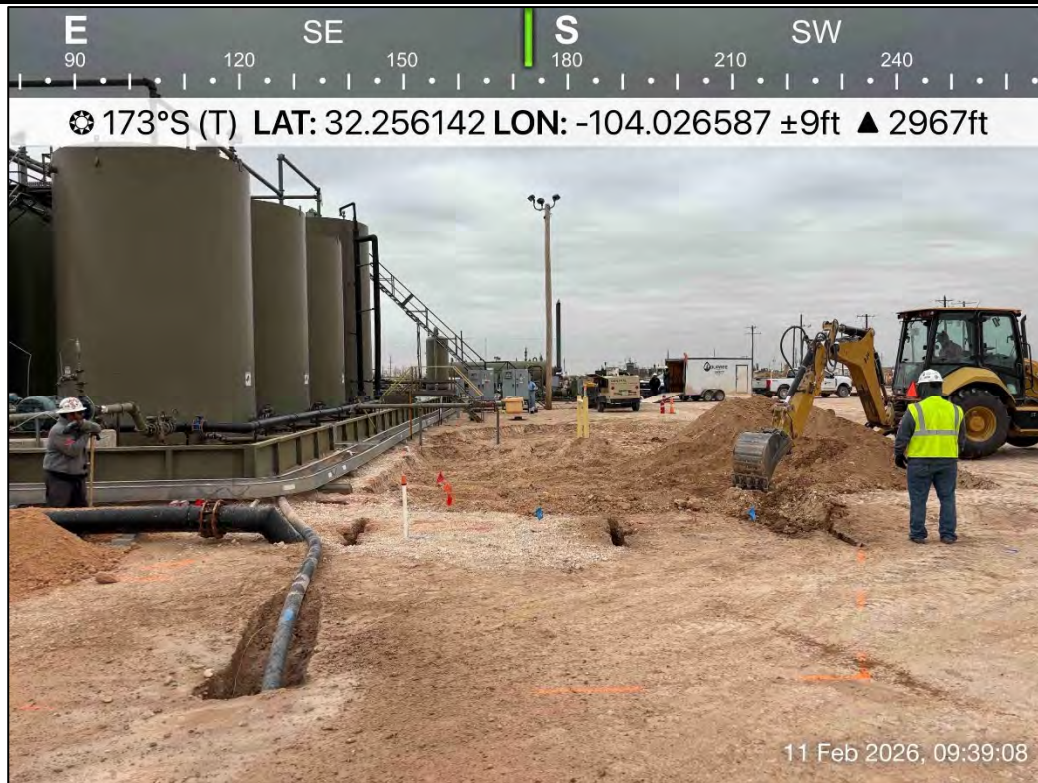
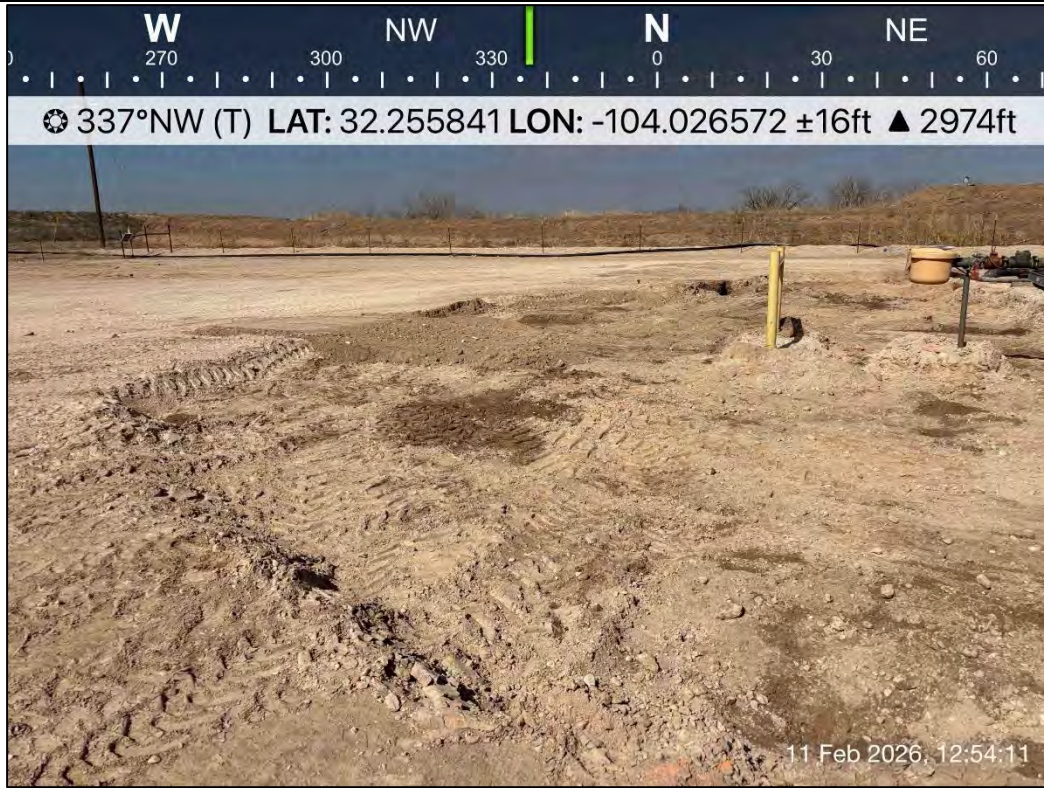
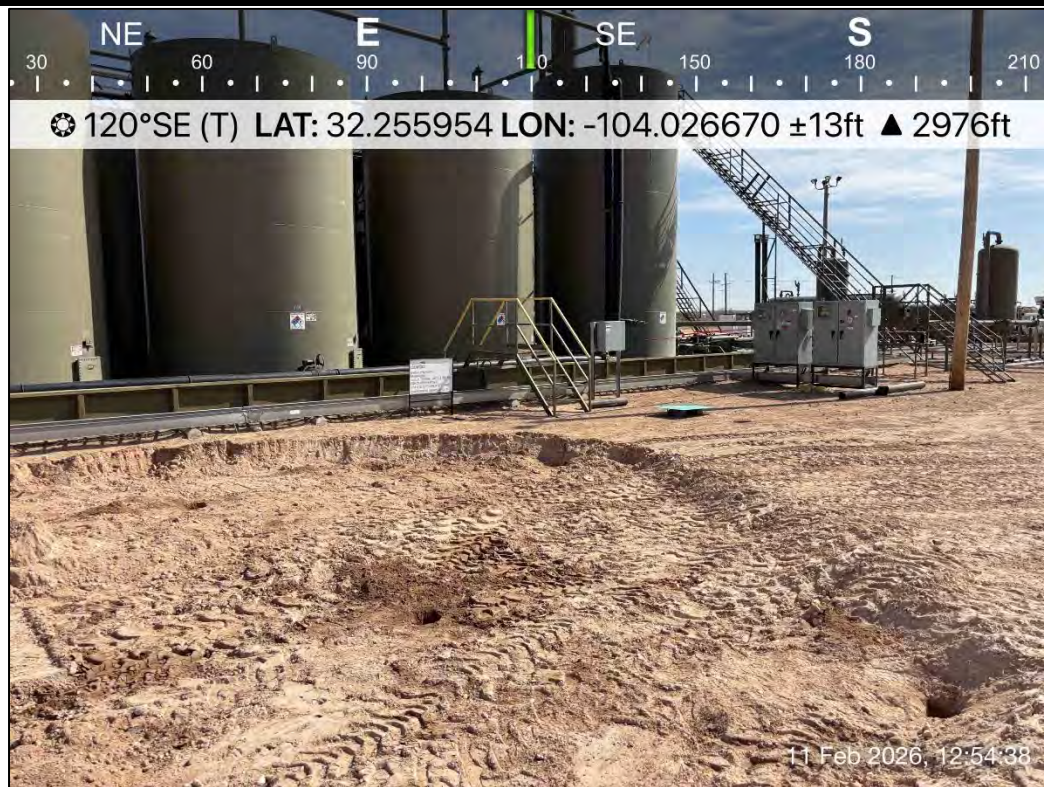
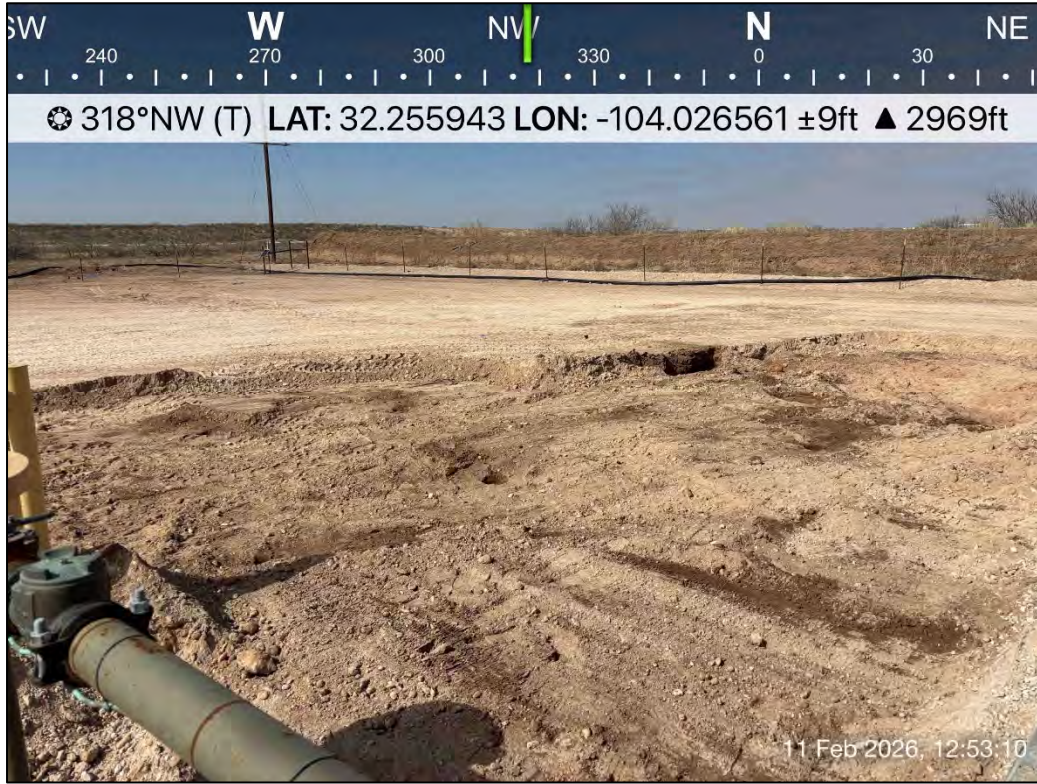
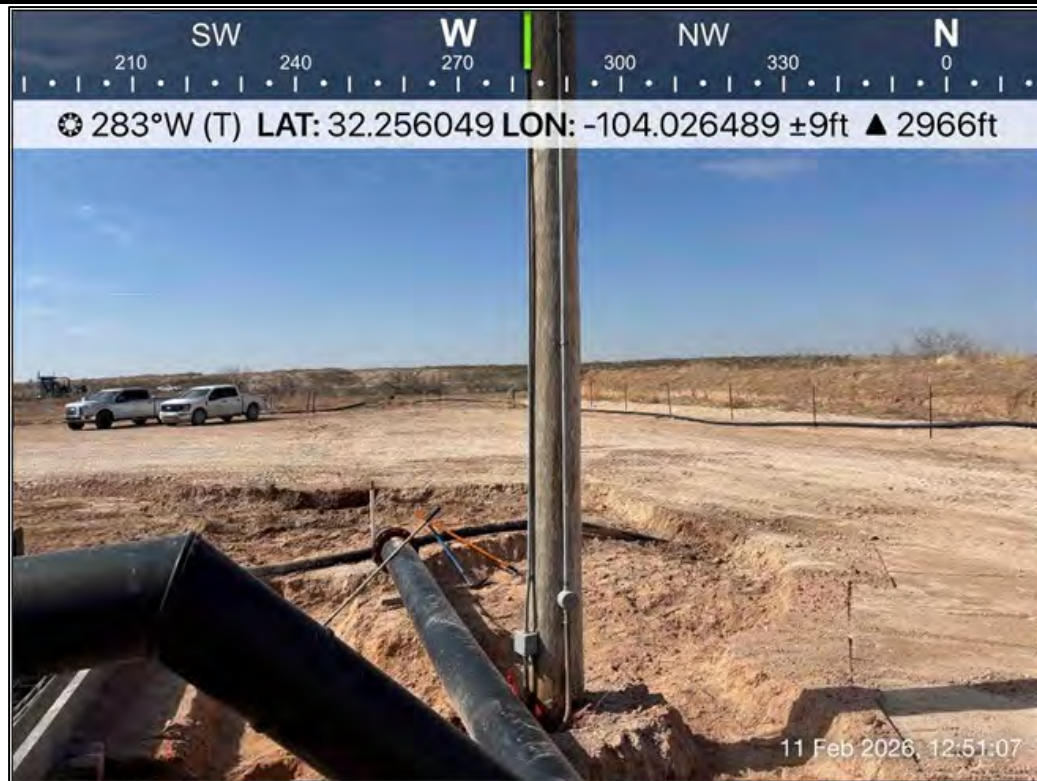
PHOTO 9: Northeastern view during excavation activities. 2/11/2026

PHOTO 10: Southern view during excavation activities. 2/11/2026

PHOTO 11: Northwestern view of excavation extent. 2/11/2026

PHOTO 12: Southeastern view of excavation extent. 2/11/2026

PHOTO 13: Northwestern view of excavation extent. 2/11/2026

PHOTO 14: Northeastern view of excavation extent. 2/11/2026

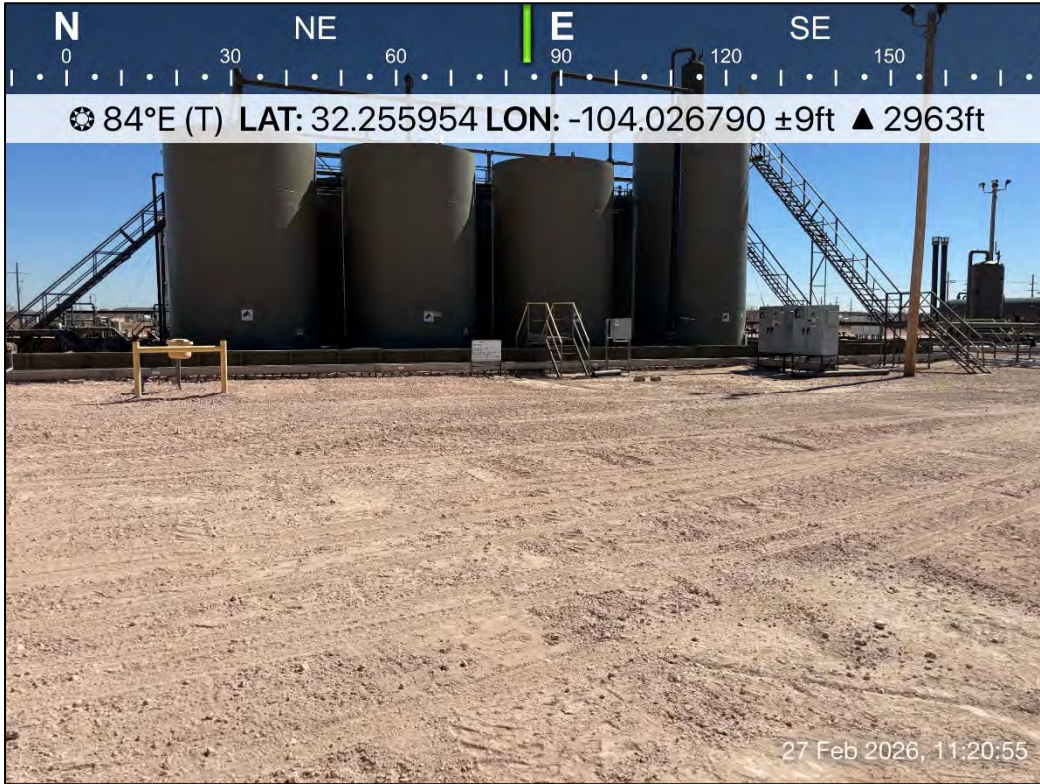
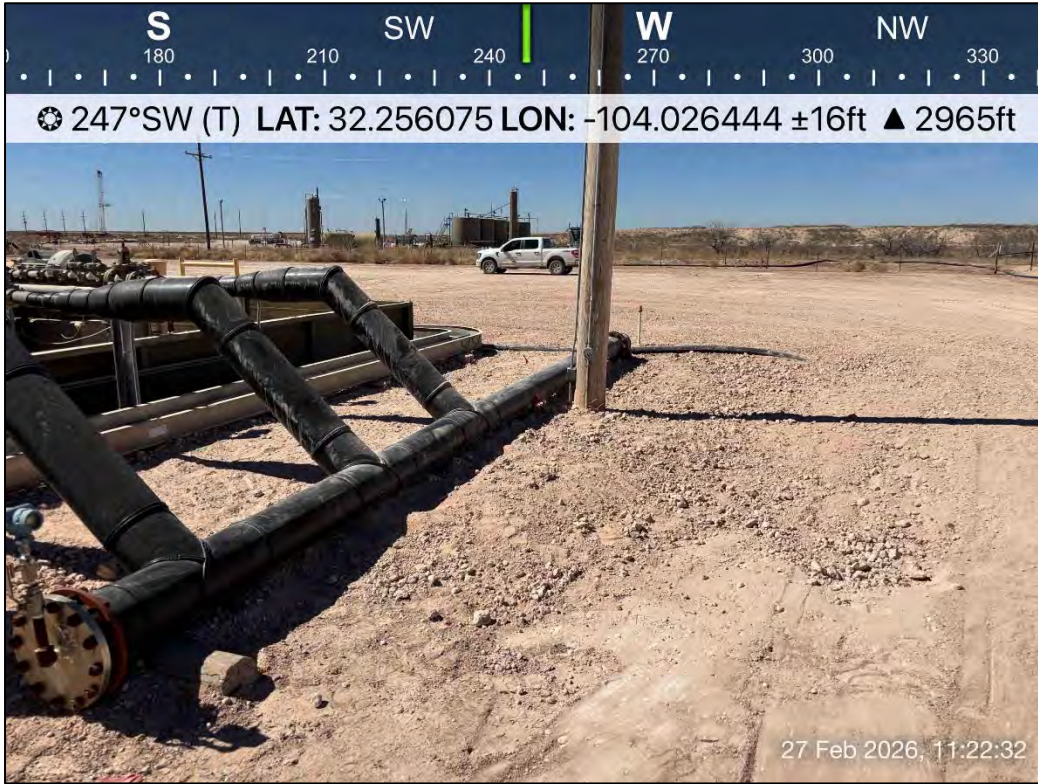
PHOTO 15: Western view following restoration activities. 2/27/2026

PHOTO 16: Northeastern view following restoration activities. 2/27/2026

PHOTO 17: Southwestern view following restoration activities. 2/27/2026
