RE: **Spud Muffin 31 CTB 1 - Closure Request Report**
Incident Number: nAPP2524019423
GPS: 32.25575506°, -104.0262478°
Eddy County, New Mexico
ESRR Project No. 7141

Spud Muffin 31 CTB 1 - Closure Request Report
Incident Number: nAPP2524019423
GPS: 32.25575506°, -104.0262478°

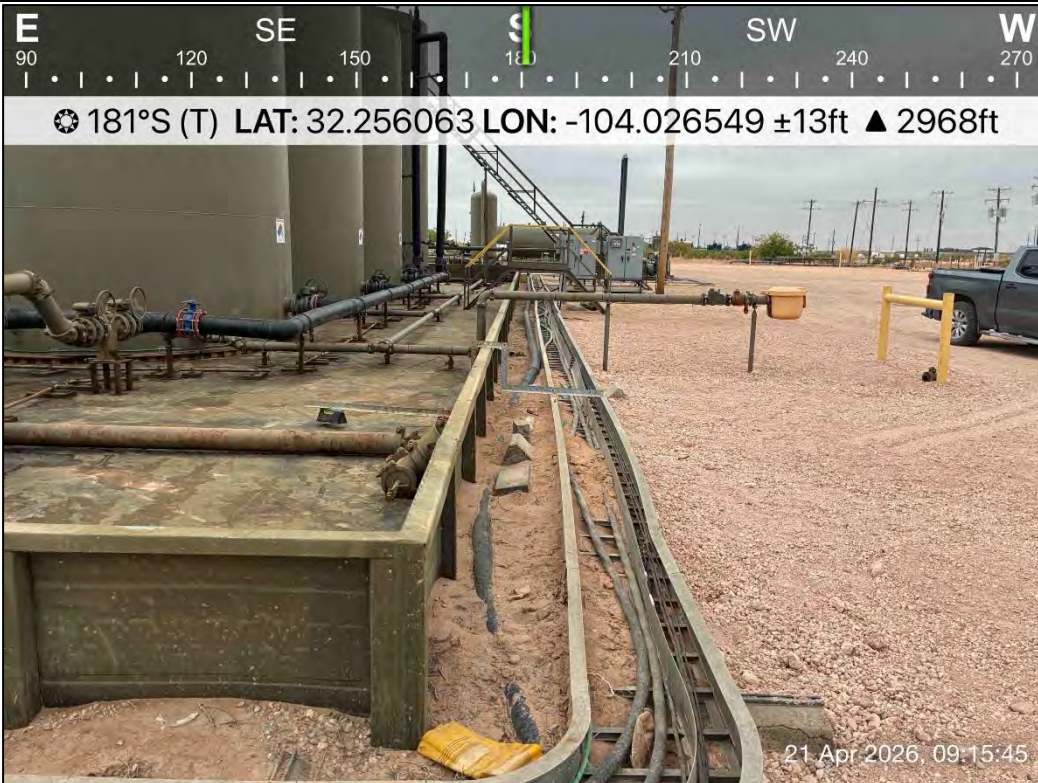
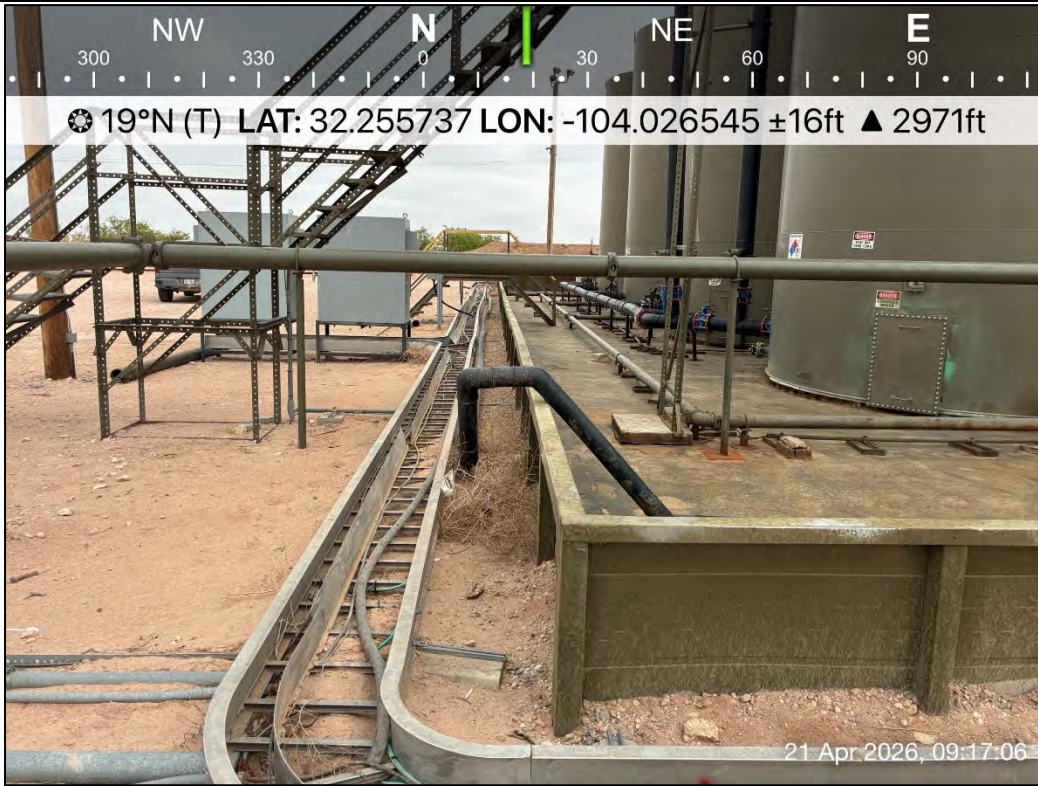
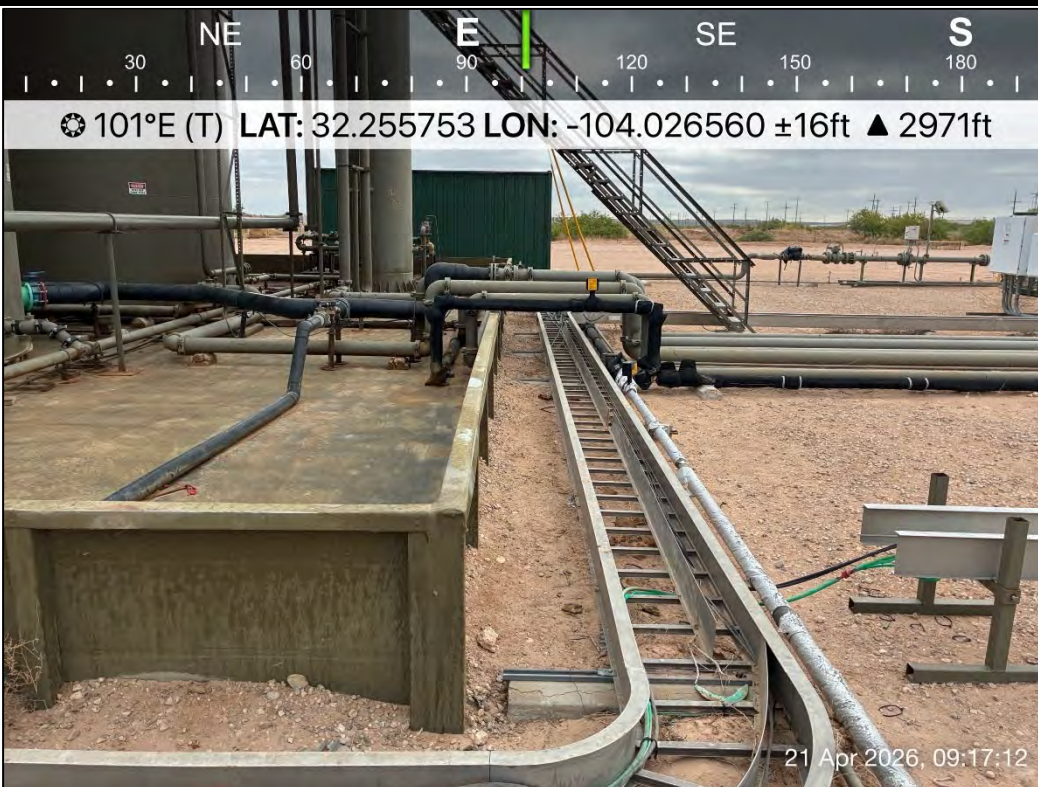
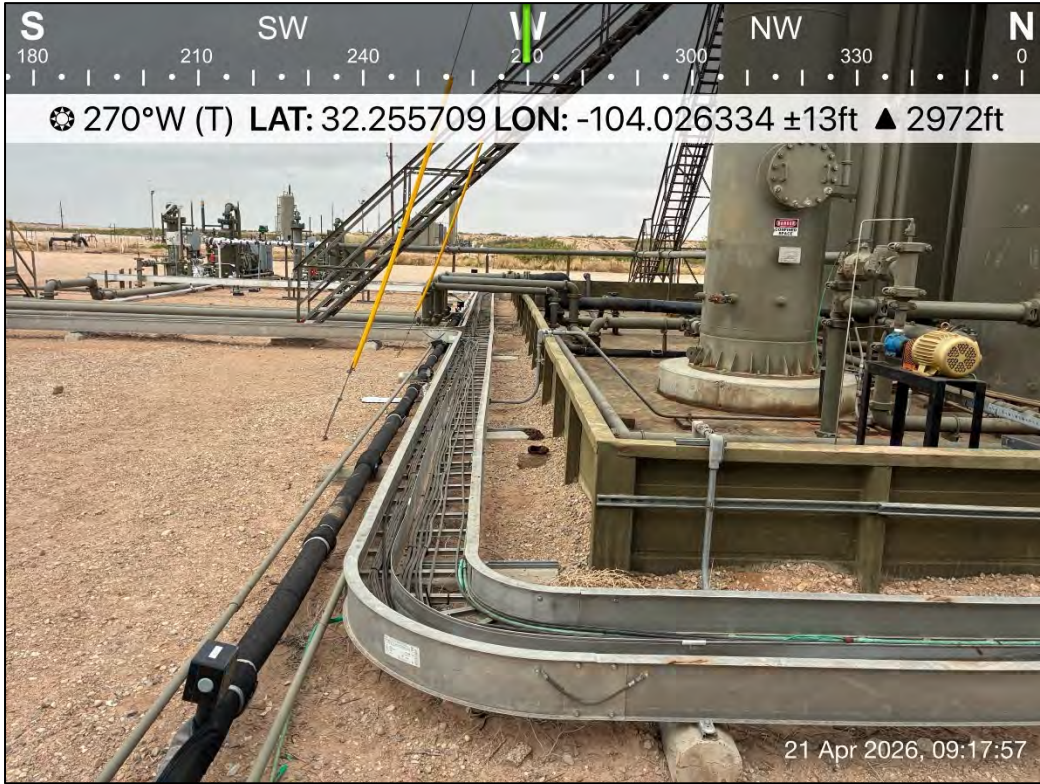
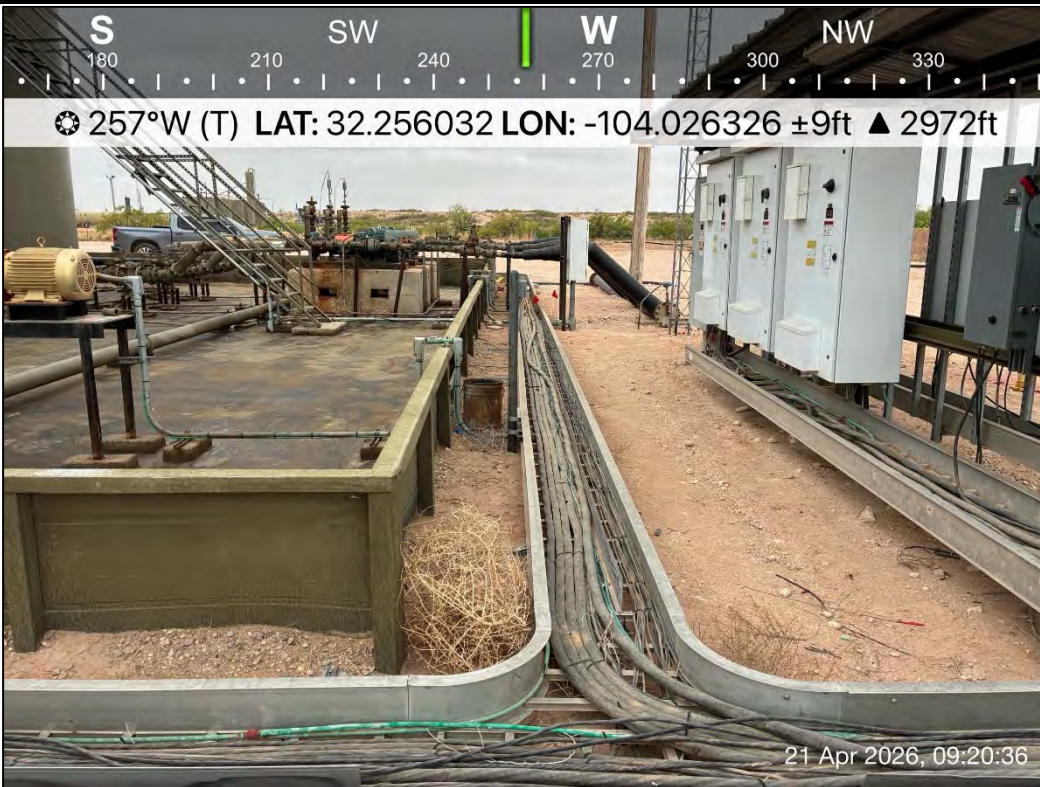
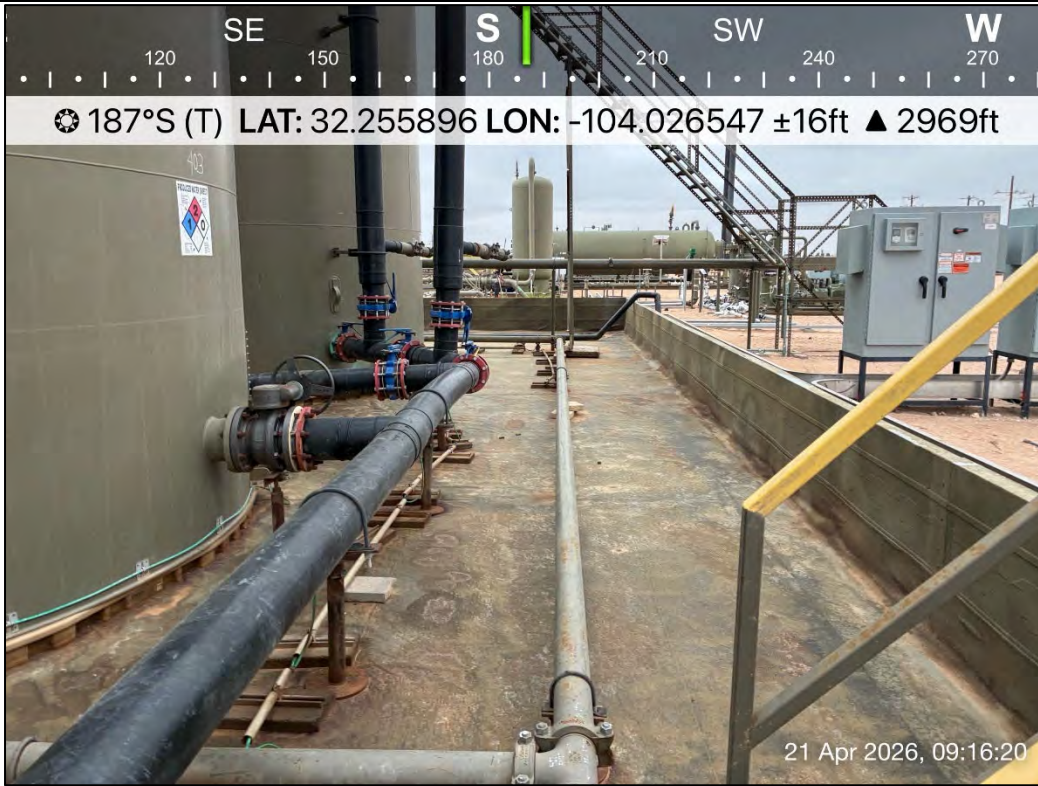
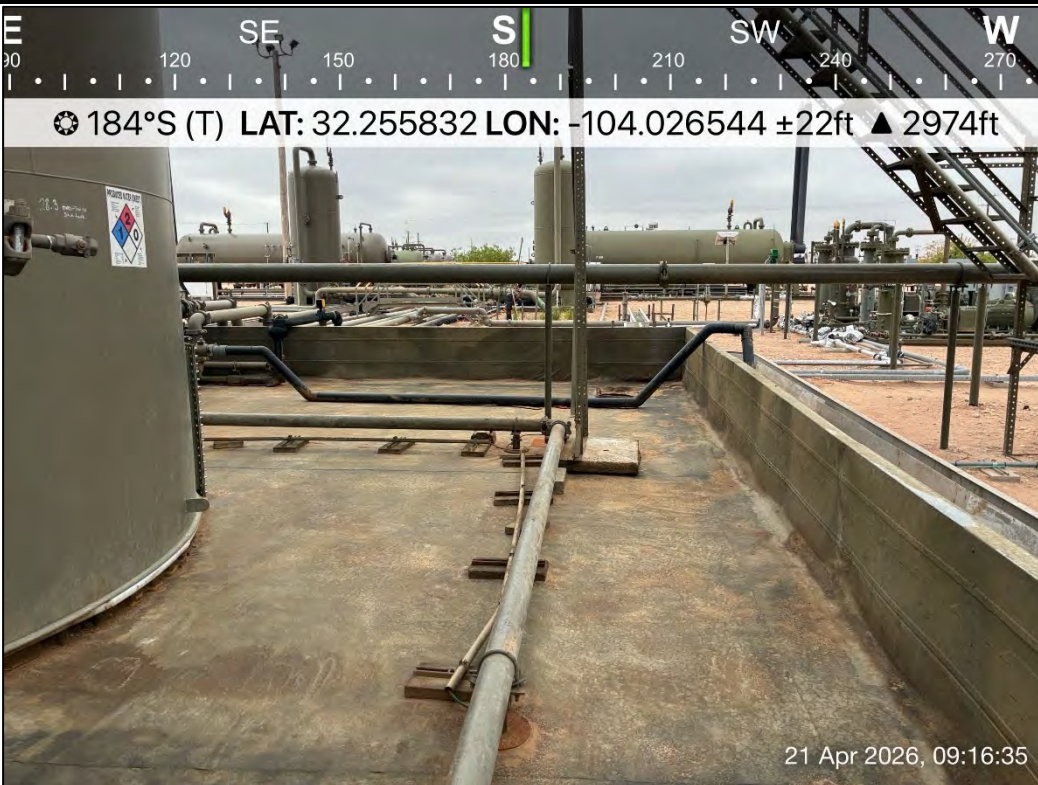
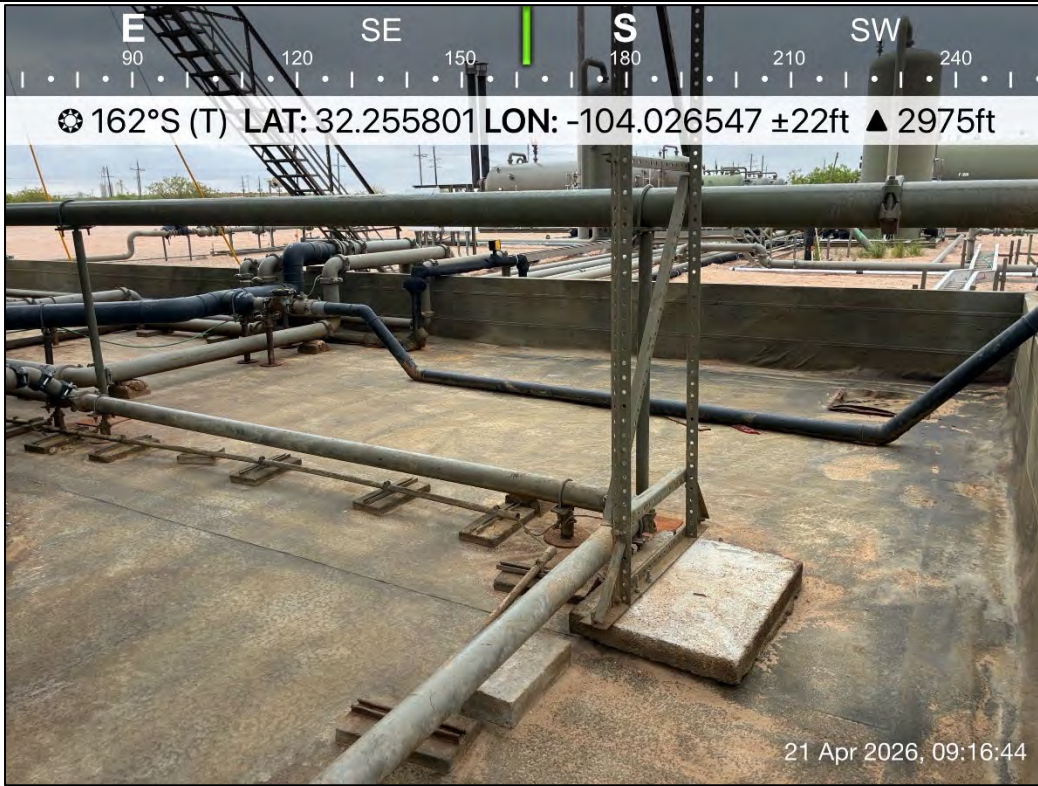
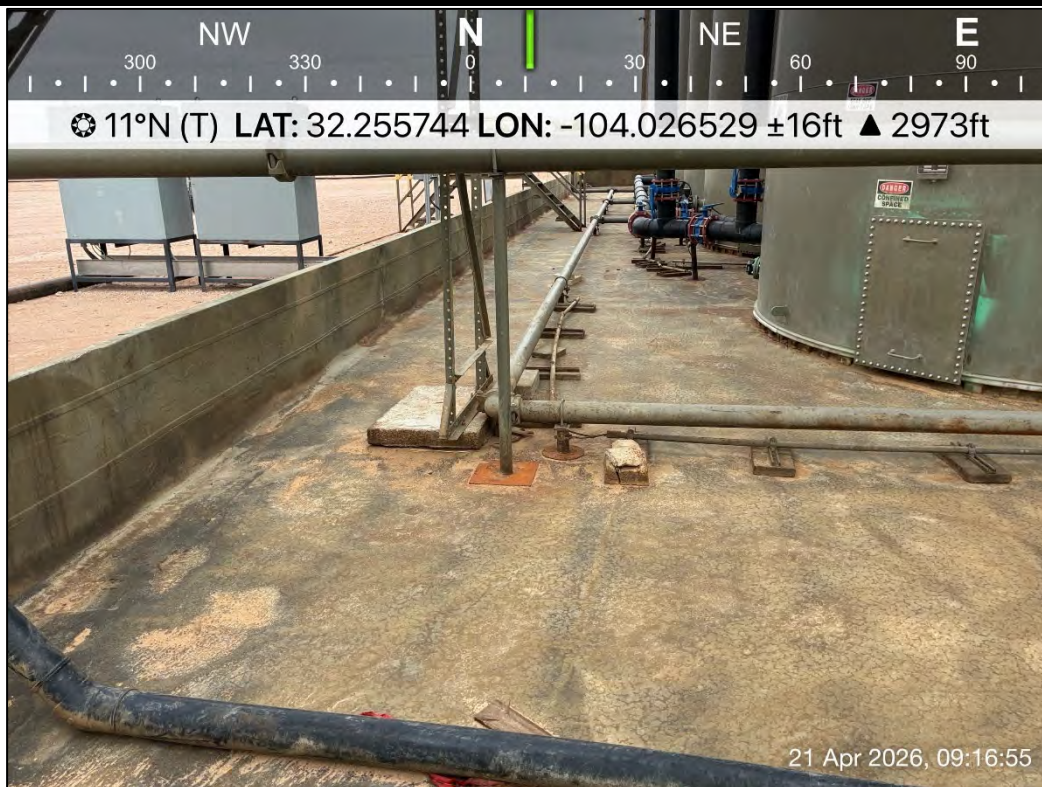
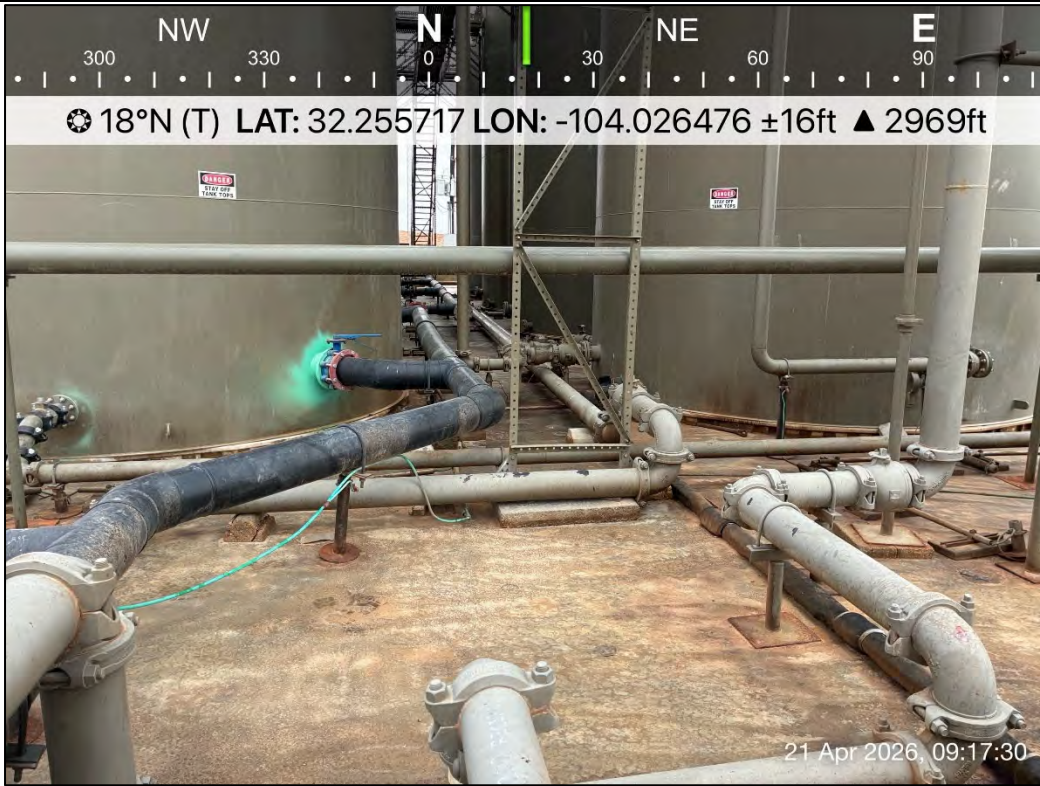
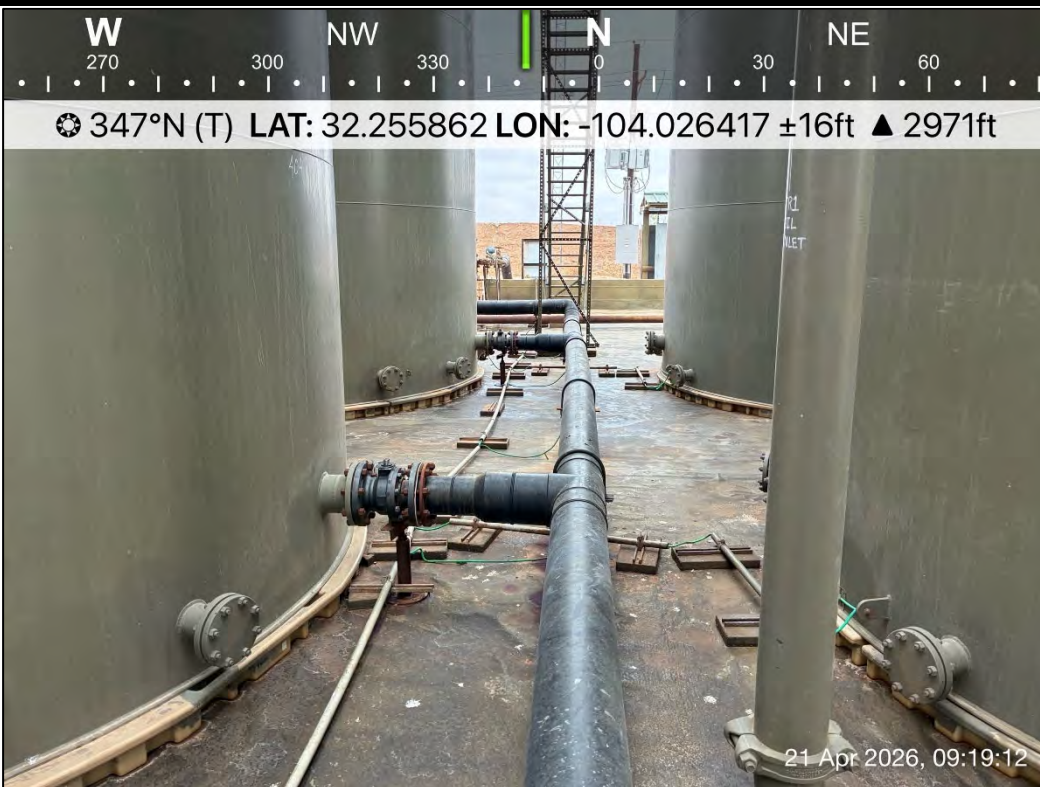
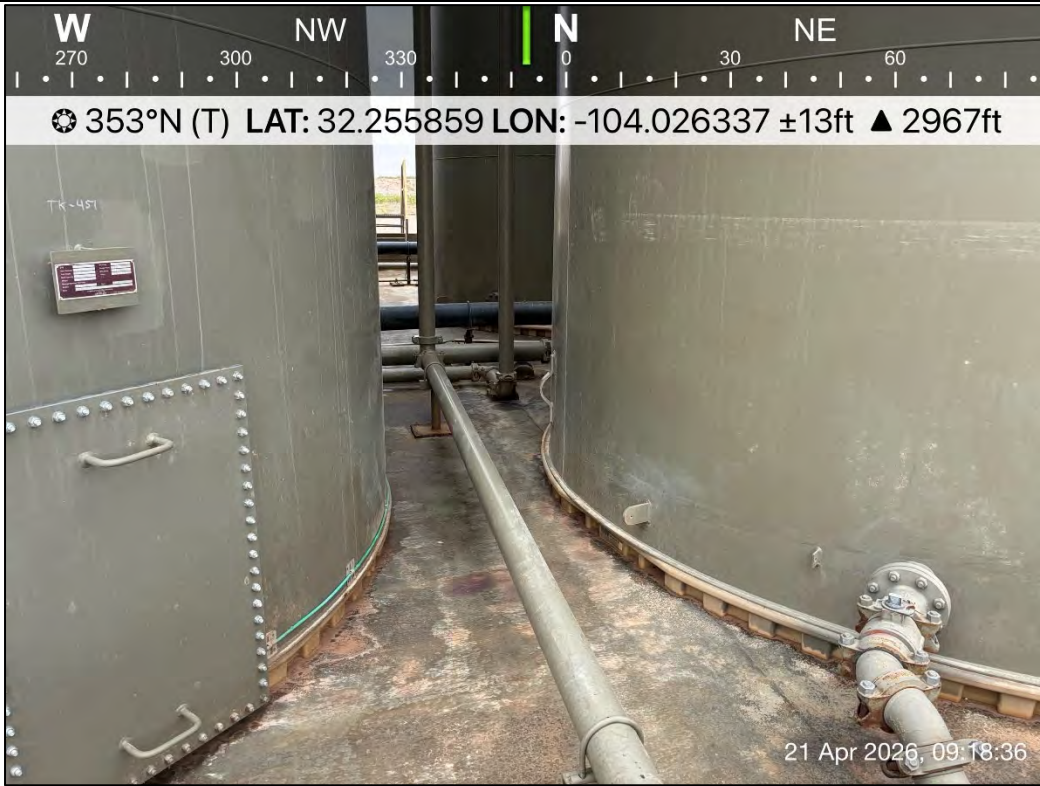
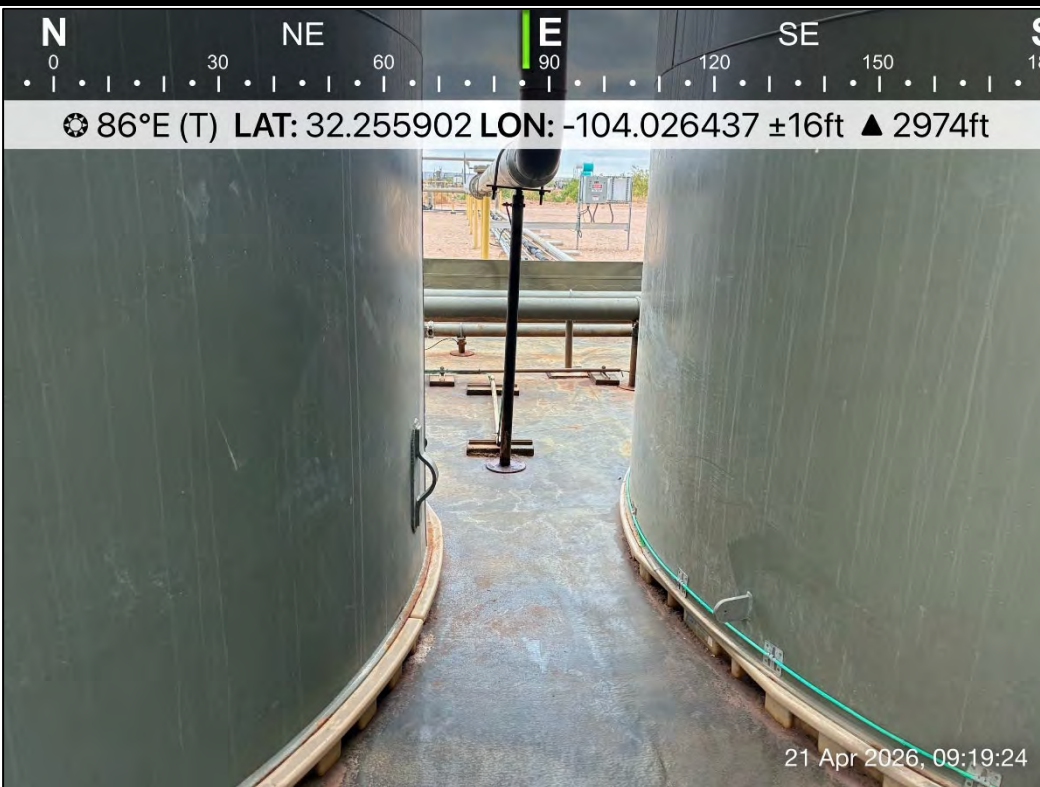
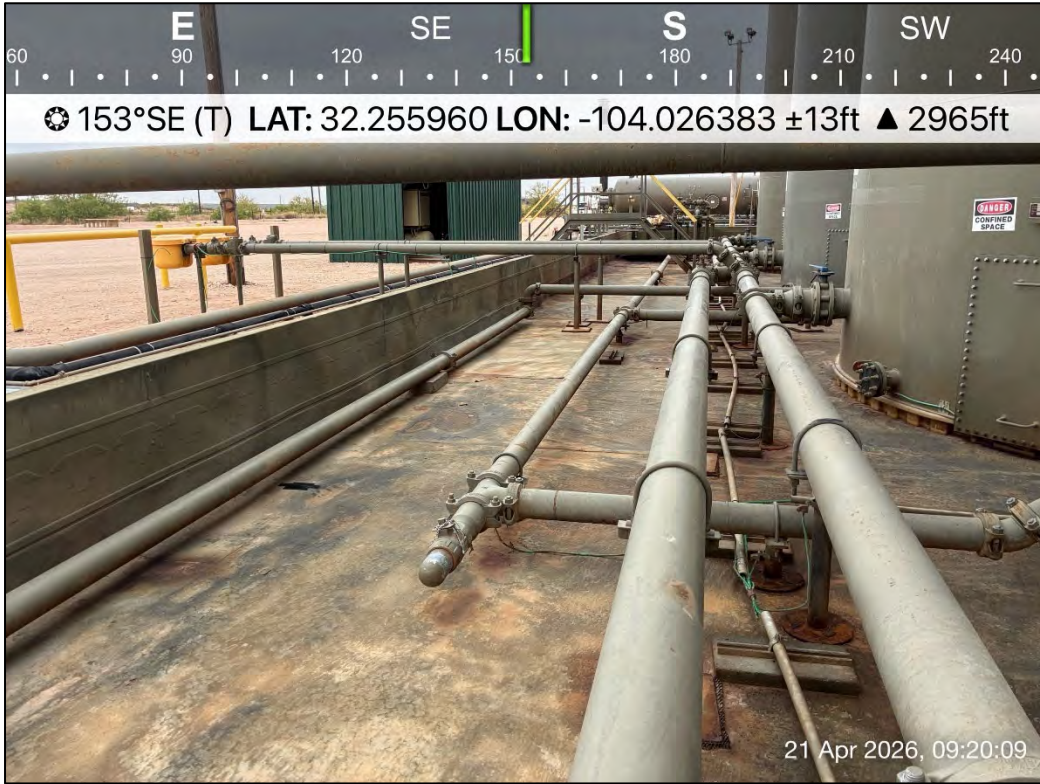
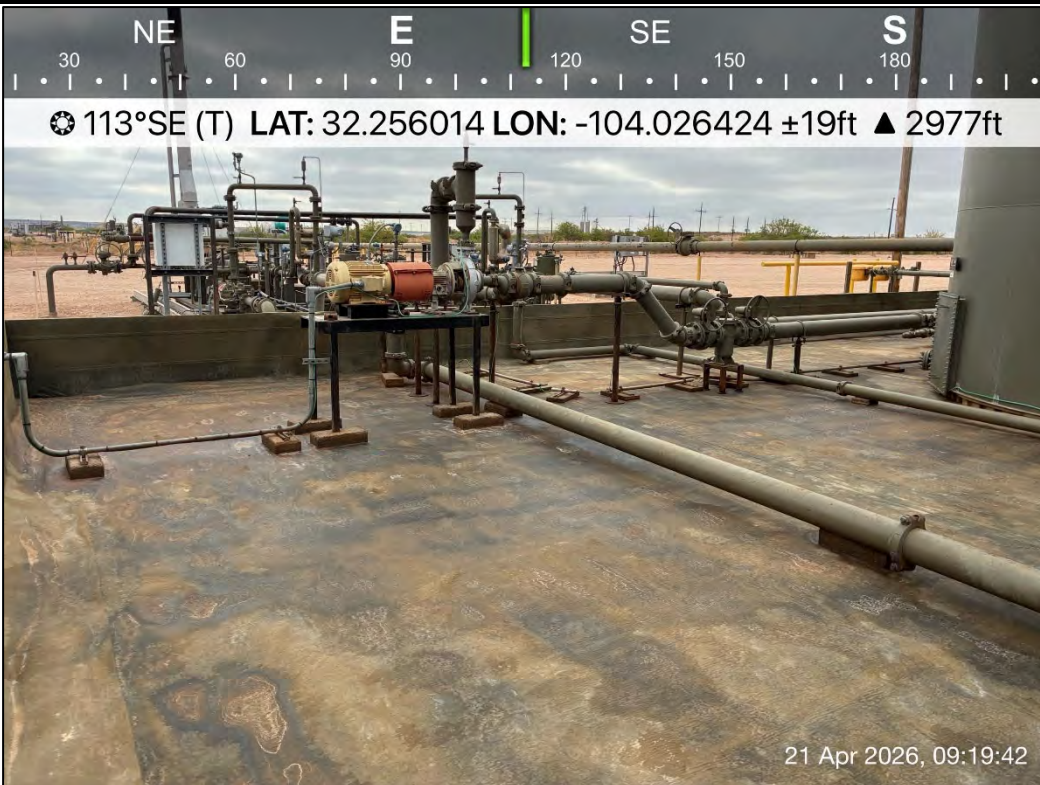
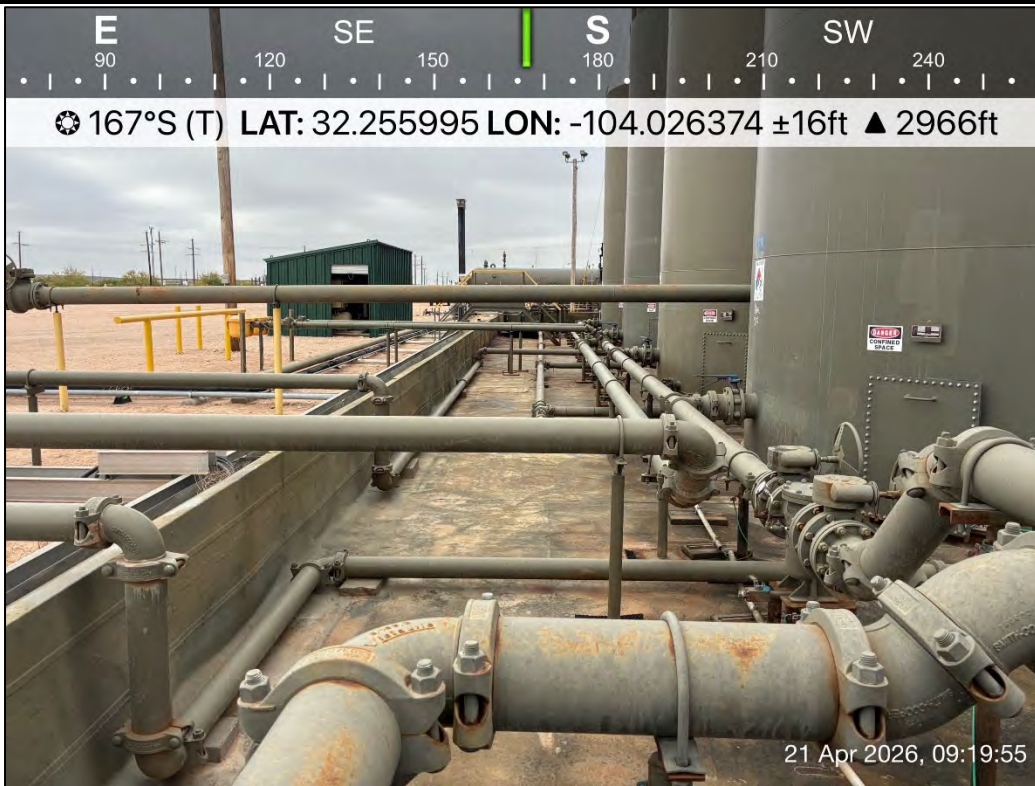
On April 21, 2026, ESRR conducted a thorough visual inspection of the LSC and found no tears, cracks, cuts, breaks, or other signs of damage within the LSC confirming no evidence of a breach of the LSC. As a result, impacts to the production pad were confirmed to have occurred due to windblown overspray of fluids from the LSC. **Photographic Documentation** of liner inspection activities is attached.

PHOTO 18: Southern view outside of containment during liner inspection activities. 4/21/2026

PHOTO 19: Northeastern view outside of containment during liner inspection activities. 4/21/2026

PHOTO 20: Southeastern view outside of containment during liner inspection activities. 4/21/2026

PHOTO 21: Western view outside of containment during liner inspection activities. 4/21/2026

PHOTO 22: Southwestern view outside of containment during liner inspection activities. 4/21/2026

PHOTO 23: Southern view during liner inspection activities. 4/21/2026

PHOTO 24: Southern view during liner inspection activities. 4/21/2026

PHOTO 25: Southeastern view during liner inspection activities. 4/21/2026

PHOTO 26: Northeastern view during liner inspection activities. 4/21/2026

PHOTO 27: Northeastern view during liner inspection activities. 4/21/2026

PHOTO 28: Northwestern view during liner inspection activities. 4/21/2026

PHOTO 29: Northern view during liner inspection activities. 4/21/2026

PHOTO 30: Eastern view during liner inspection activities. 4/21/2026

PHOTO 31: Southeastern view during liner inspection activities. 4/21/2026

PHOTO 32: Southeastern view during liner inspection activities. 4/21/2026

PHOTO 33: Southeastern view during liner inspection activities. 4/21/2026
