Characterization Schematic
 Corral Canyon 20-32 FED State Com 306H

Client Name: ExxonMobil Production Company
 Site Name: Corral Canyon 20-32 FED State Com 306H
 NMOCD Tracking #: nAPP2601529351
 Project #: 26A-00691
 Lab Reports: H261454 and H261875

Table 3. Initial Characterization Laboratory Results

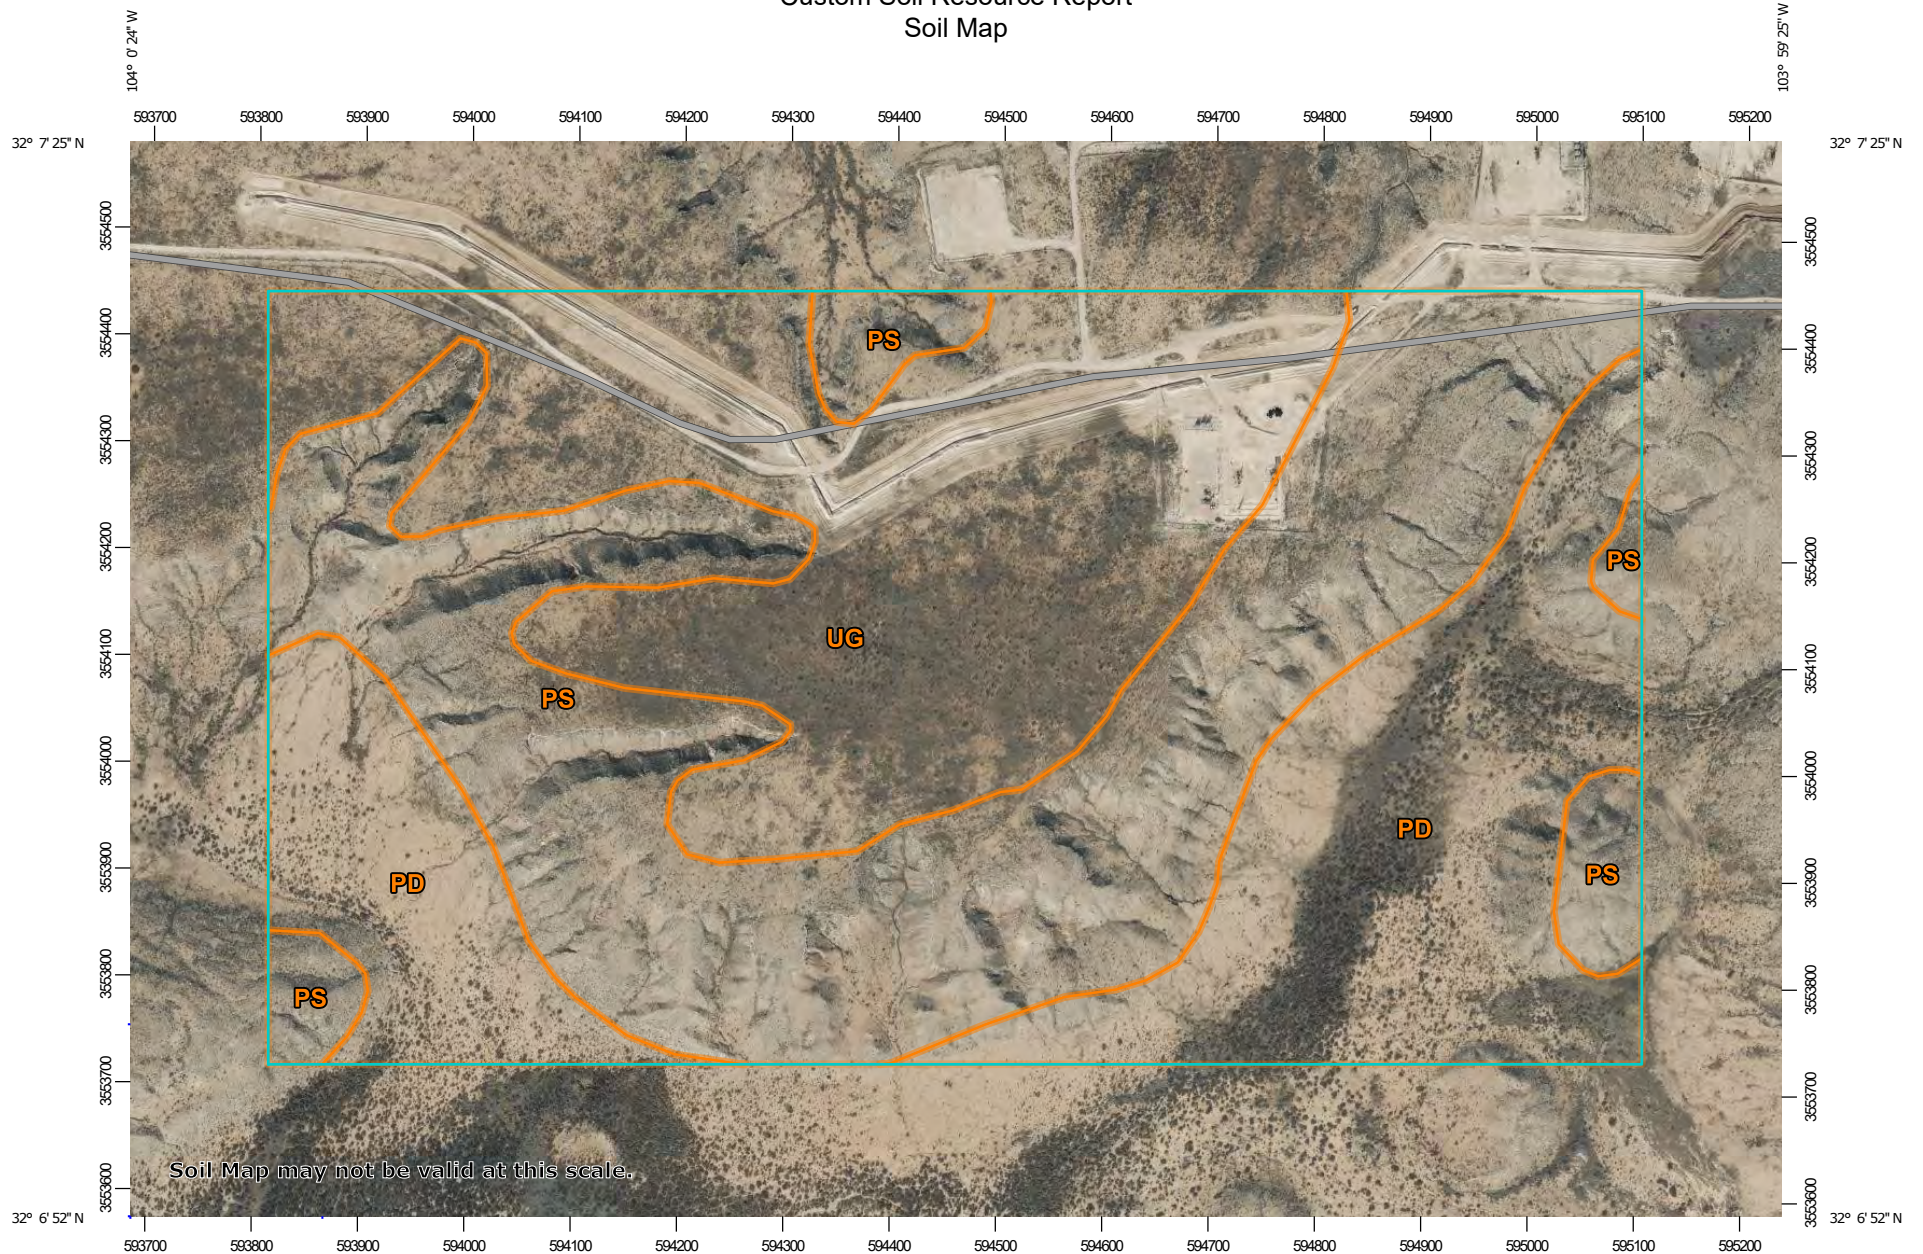
Plate 1. Soil Classification

Custom Soil Resource Report Soil Map

National map unit symbol: 1w55
Landscape: Uplands
Elevation: 3,000 to 5,000 feet
Mean annual precipitation: 10 to 15 inches
Mean annual air temperature: 60 to 64 degrees F
Frost-free period: 190 to 220 days
Farmland classification: Not prime farmland

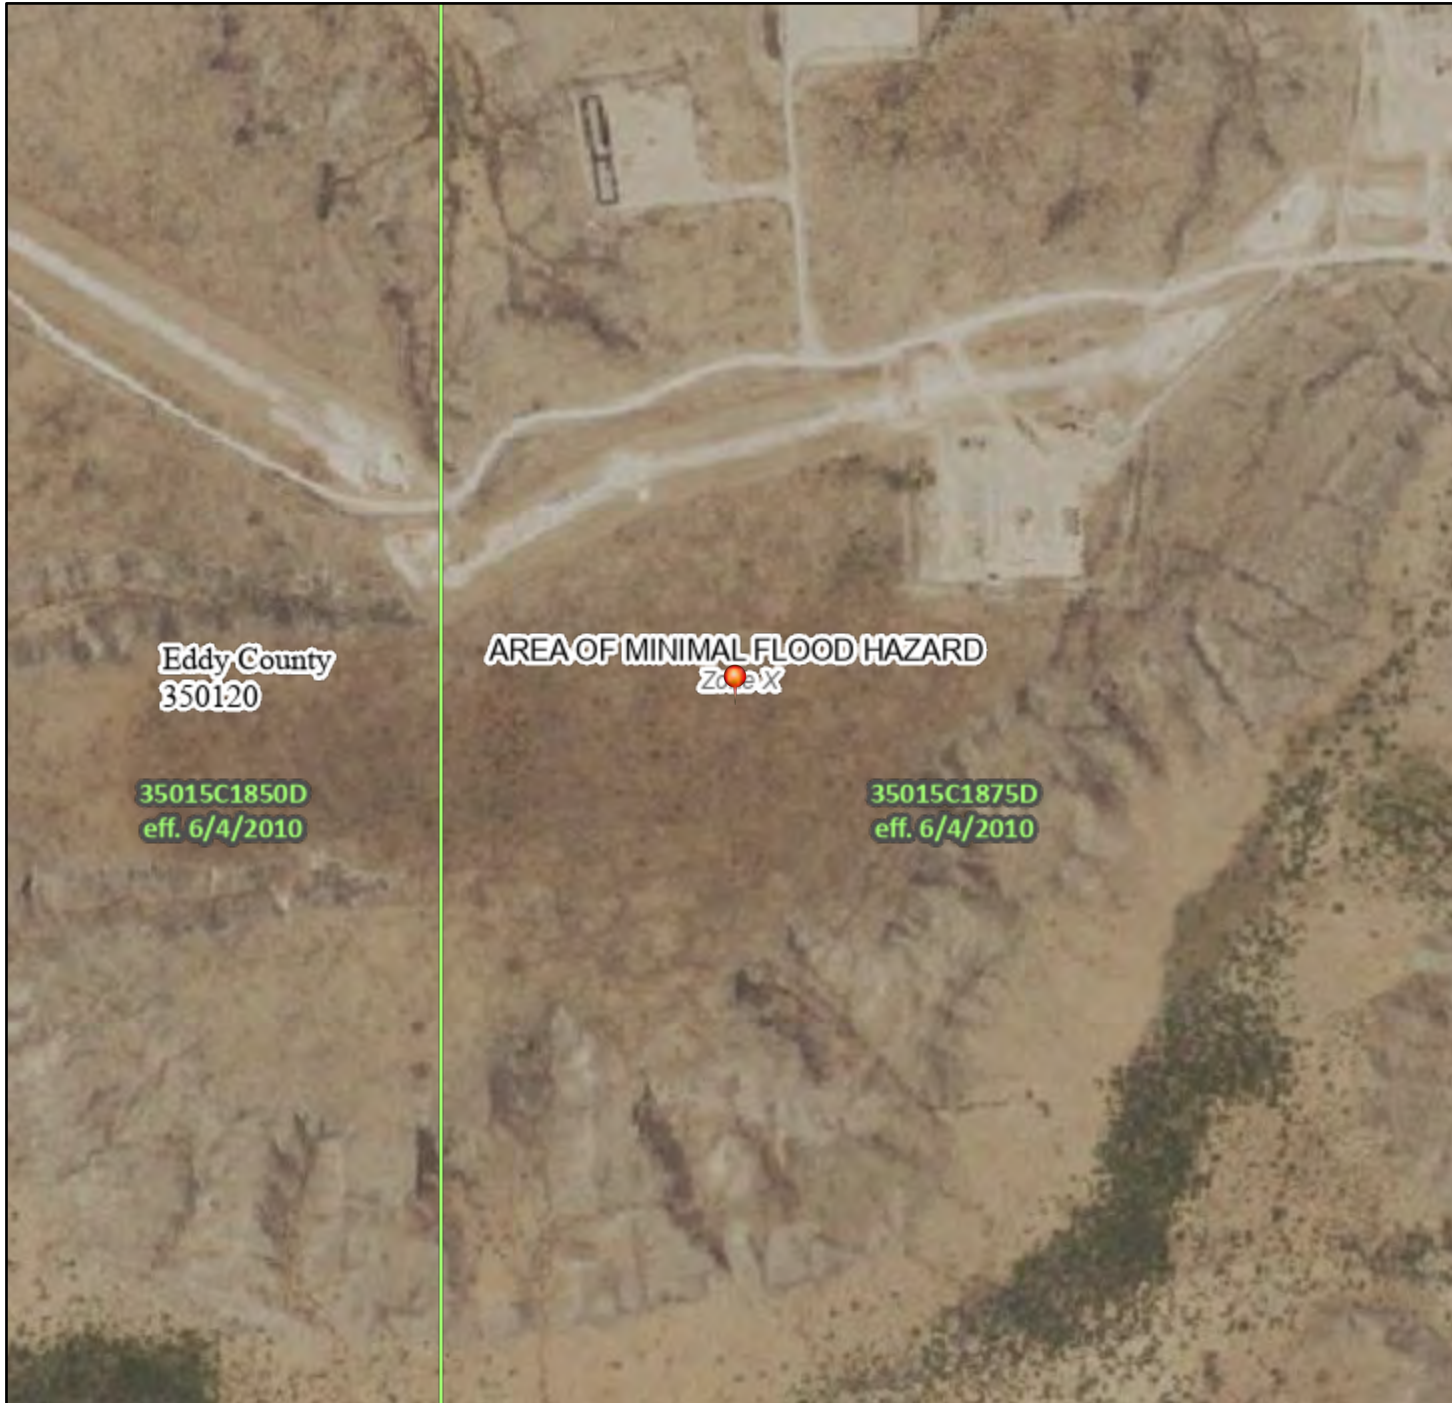
Plate 8. Flood Hazard

National Flood Hazard Layer FIRMMette

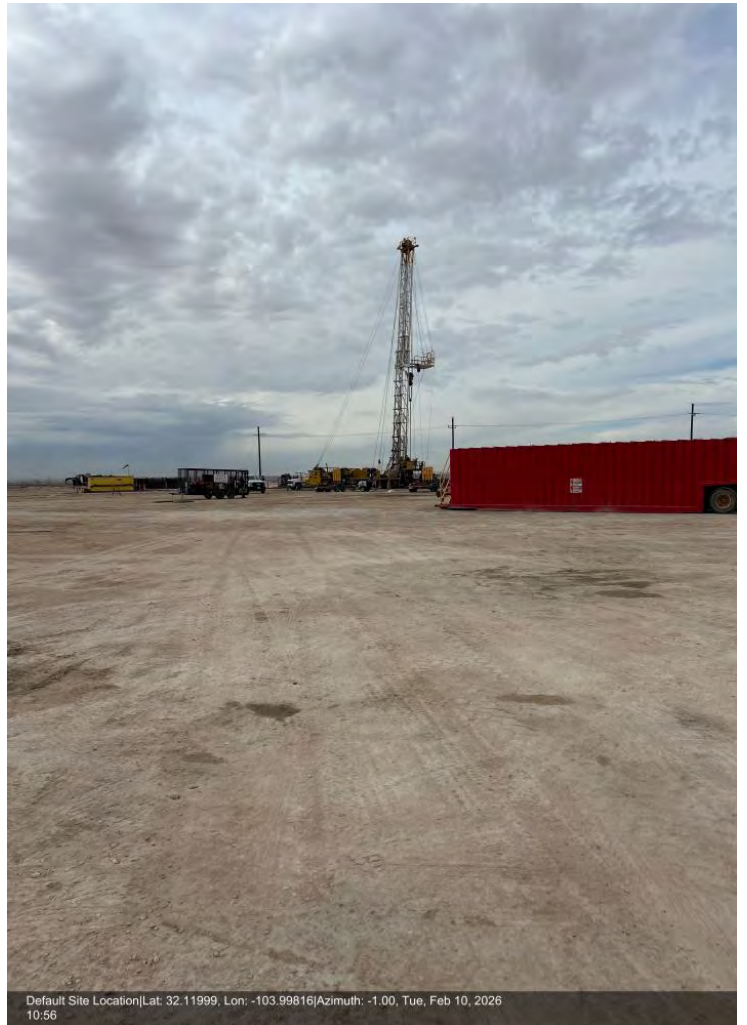
Date: 2/10/2026
 Time: 10:56
 Notes: Frac operations in progress
 Latitude: 32.11998888888889
 Longitude: -103.99816111111112
 Direction: E

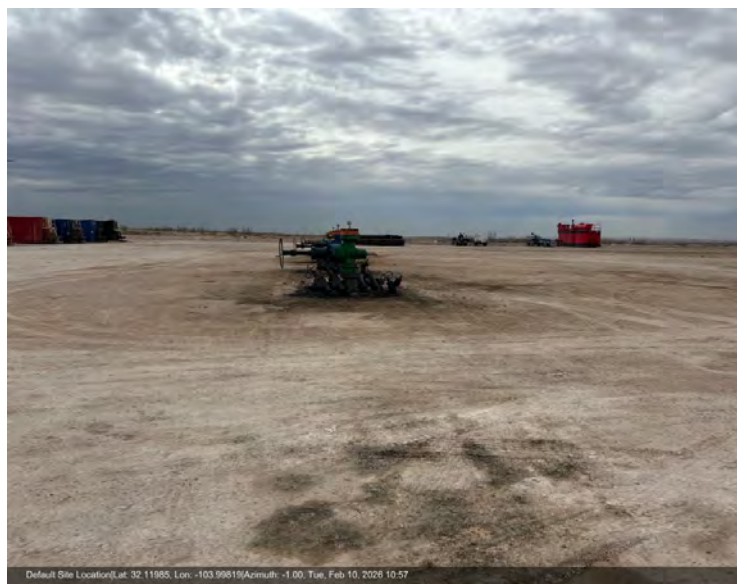
Date: 2/10/2026
 Time: 10:56
 Notes: Release area mapped
 Latitude: 32.11985
 Longitude: -103.99819166666667
 Direction: NE

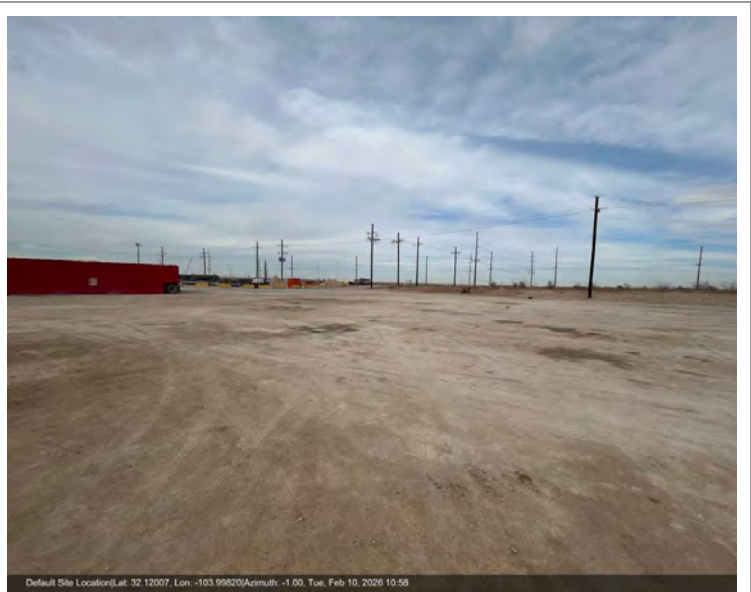
Date: 2/10/2026
 Time: 10:58
 Notes: Large portions of the pad are contaminated from the Frac and coil tubing operations
 Latitude: 32.120066666666666
 Longitude: -103.9982
 Direction: N

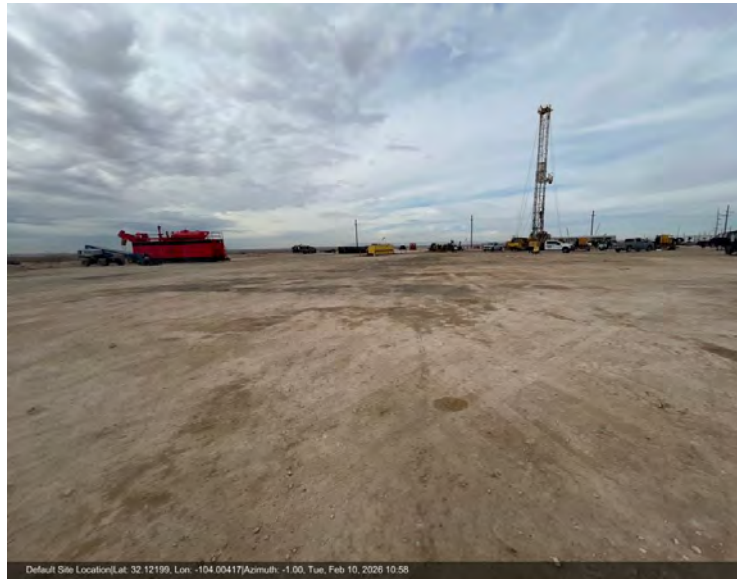
Date: 2/10/2026
 Time: 10:58
 Notes: Large portions of the pad are contaminated from the Frac and coil tubing operations
 Latitude: 32.12199444444445
 Longitude: -104.00417222222222
 Direction: N

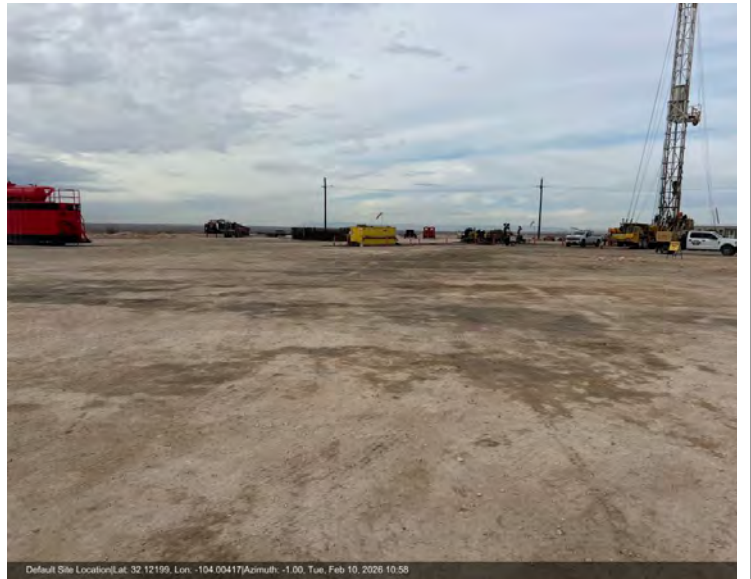
Date: 2/10/2026
Time: 10:58
Notes: Large portions of the pad are contaminated from the Frac and coil tubing operations
Latitude: 32.12199444444445
Longitude: -104.00417222222222
Direction: N

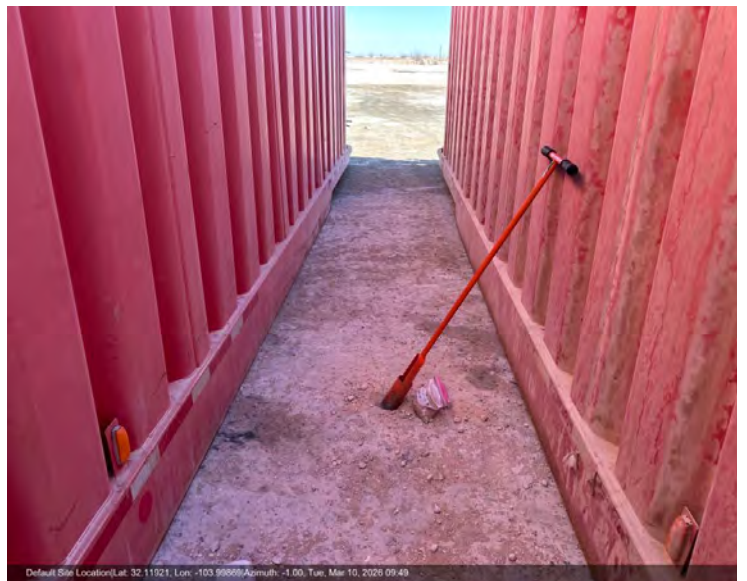
Date: 3/10/2026
 Time: 09:49
 Notes: BH26-02 @ 0'
 Latitude: 32.119205555555555
 Longitude: -103.998694444444444
 Direction: S

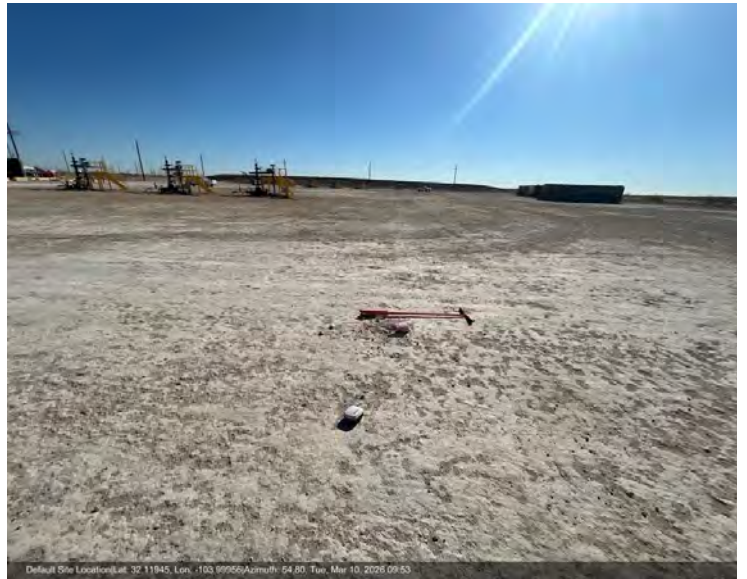
Date: 3/10/2026
 Time: 09:53
 Notes: BH26-03 @ 0'
 Latitude: 32.11945
 Longitude: -103.99956388888889
 Direction: W

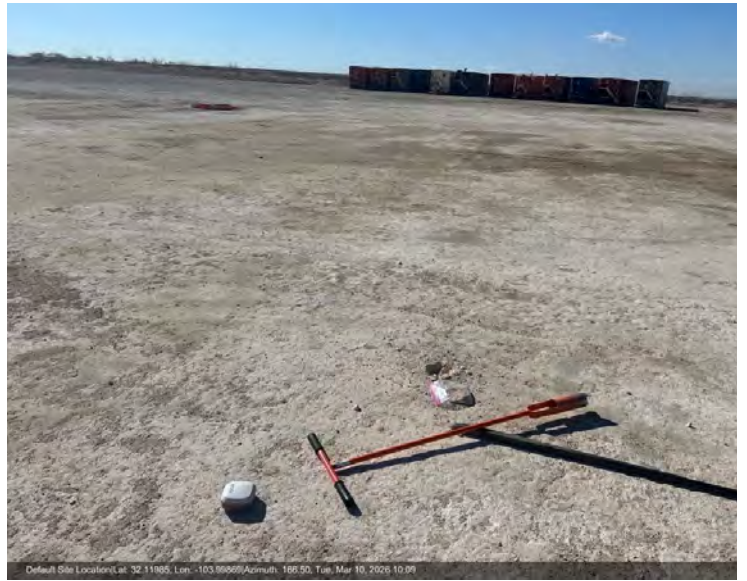
Date: 3/10/2026
 Time: 10:09
 Notes: BH26-05 @ 0'
 Latitude: 32.11985
 Longitude: -103.99868888888889
 Direction: NE

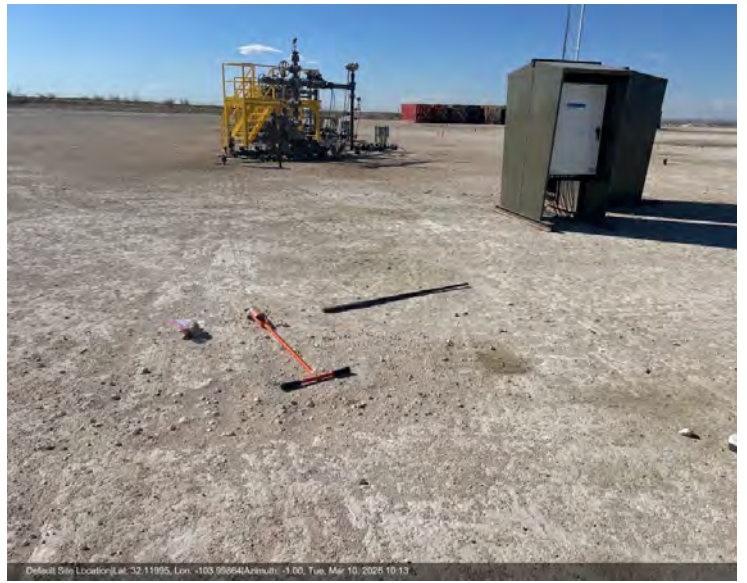
Date: 3/10/2026
 Time: 10:13
 Notes: BH26-06 @ 0'
 Latitude: 32.119952777777776
 Longitude: -103.99863611111111
 Direction: S

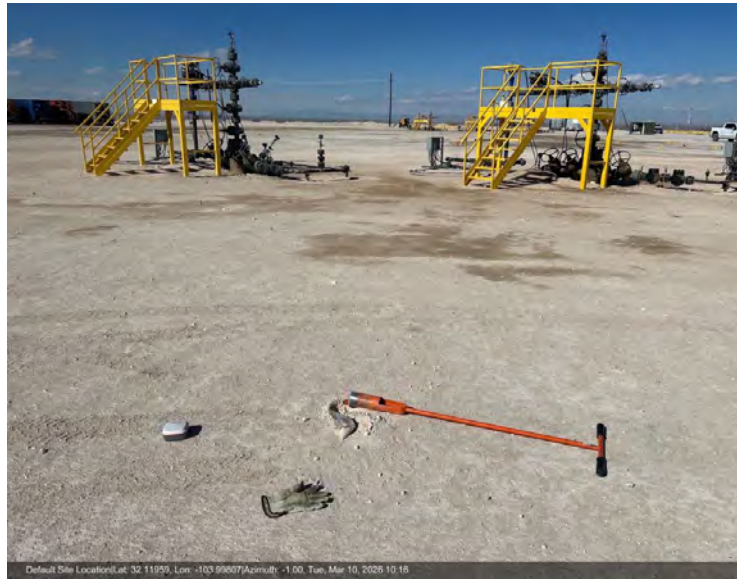
Date: 3/10/2026
 Time: 10:16
 Notes: BH26-07 @ 0'
 Latitude: 32.119591666666665
 Longitude: -103.99806944444444
 Direction: S

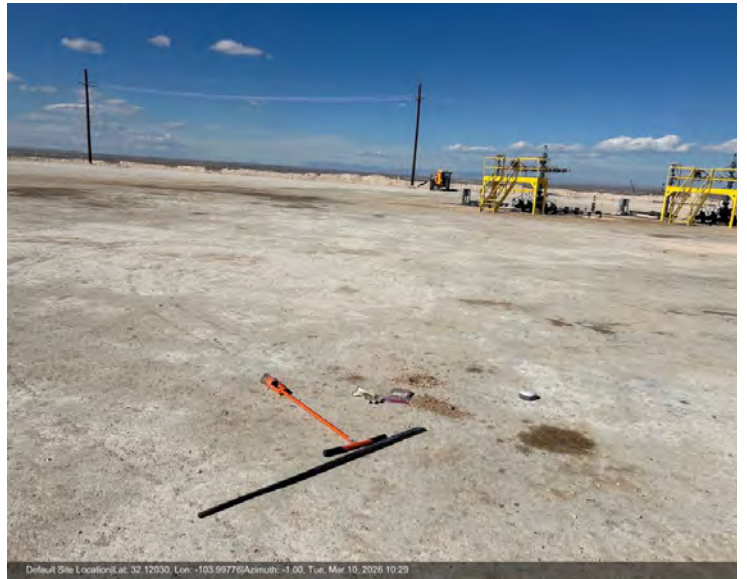
Date: 3/10/2026
 Time: 10:29
 Notes: BH26-09 @ 0'
 Latitude: 32.12029722222222
 Longitude: -103.99775555555556
 Direction: E

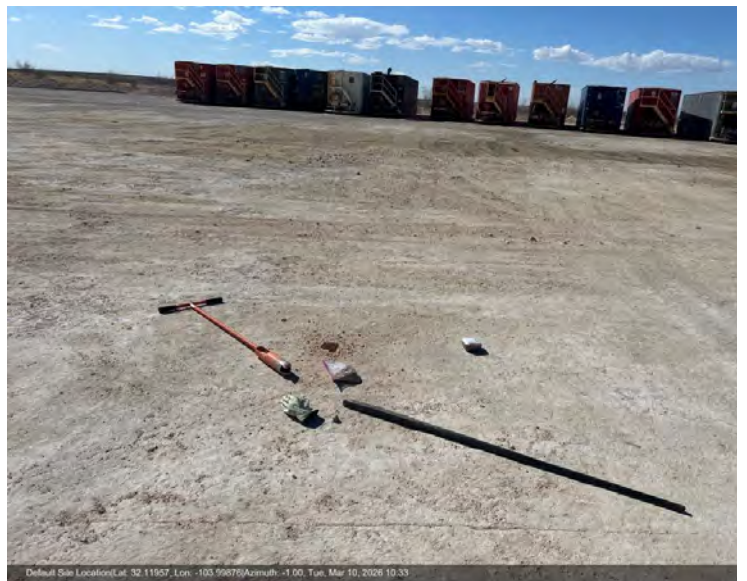
Date: 3/10/2026
 Time: 10:33
 Notes: BH26-10 @ 0'
 Latitude: 32.119566666666664
 Longitude: -103.99875555555556
 Direction: N

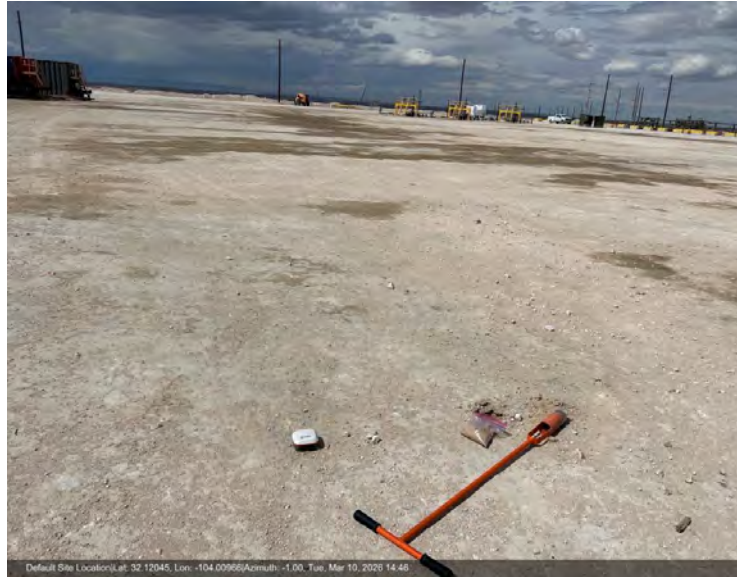
Date: 3/10/2026
 Time: 12:29
 Notes: BH26-01 @ 0'
 Stepped out approximately 20'
 Latitude: 32.12045277777778
 Longitude: -104.00965833333333
 Direction: NE

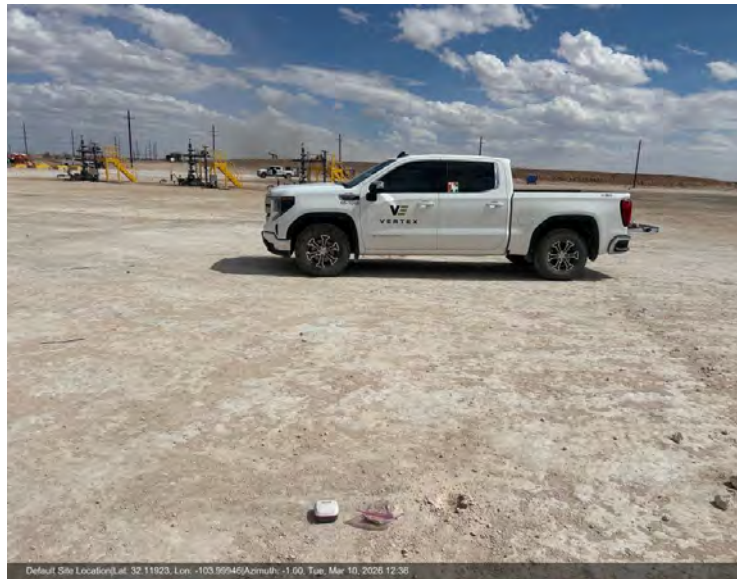
Date: 3/10/2026
 Time: 12:36
 Notes: BH26-03 @ 0'
 Stepped out approximately 20'
 Latitude: 32.119233333333334
 Longitude: -103.99945833333334
 Direction: S

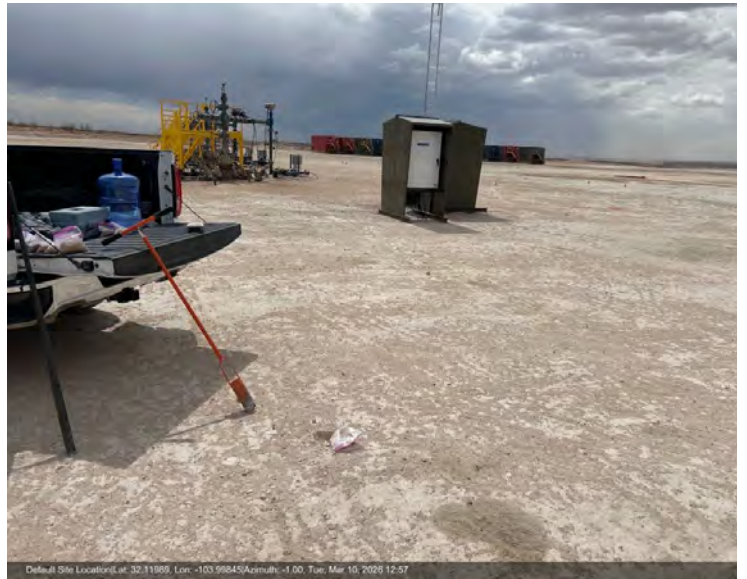
Date: 3/10/2026
 Time: 12:57
 Notes: BH26-06 @ 0'
 Stepped out approximately 20'
 Latitude: 32.11989166666667
 Longitude: -103.99845277777779
 Direction: NE

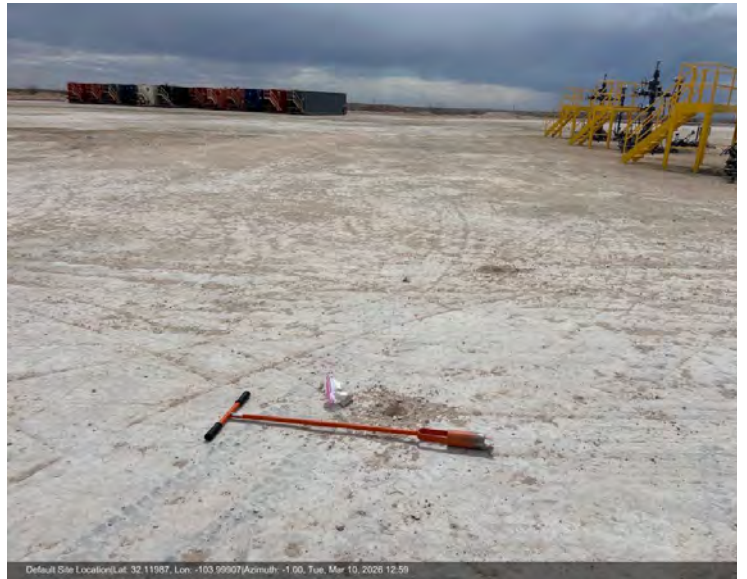
Date: 3/10/2026
 Time: 12:59
 Notes: BH26-04 @ 0'
 Stepped out approximately 20'
 Latitude: 32.11986944444445
 Longitude: -103.99906944444444
 Direction: N

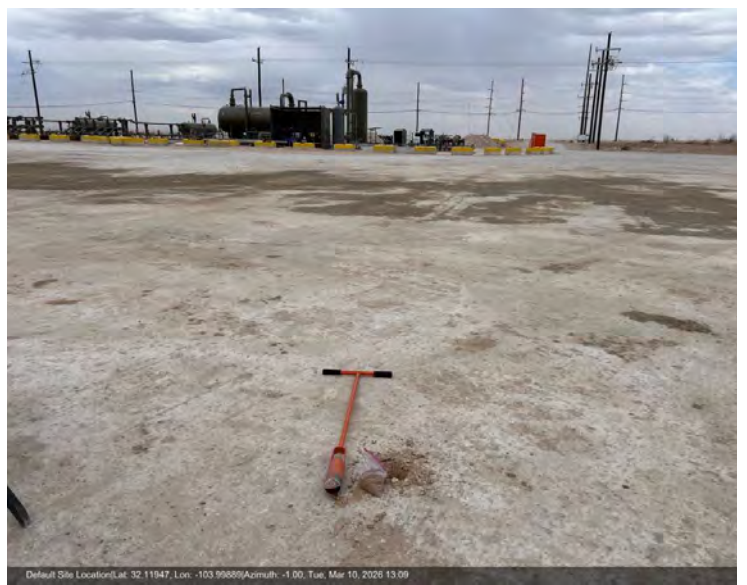
Date: 3/10/2026
 Time: 13:09
 Notes: BH26-08 @ 0'
 Stepped out approximately 20'
 Latitude: 32.11946944444445
 Longitude: -103.99889444444445
 Direction: E

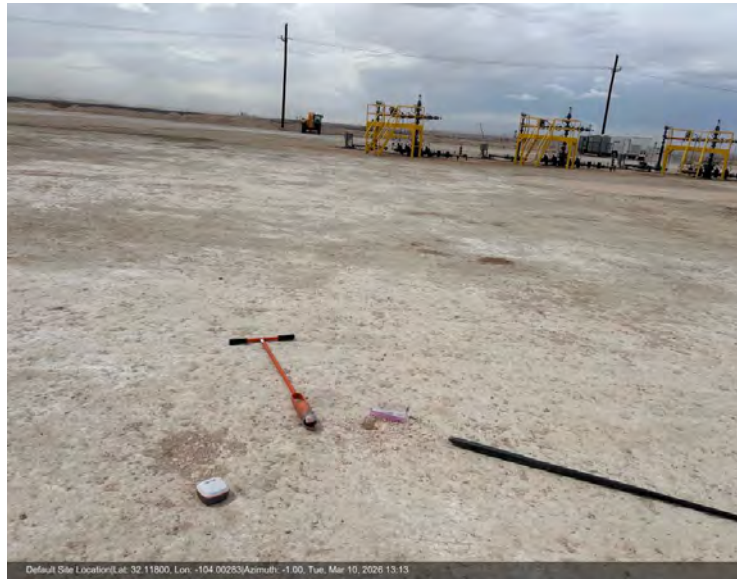
Date: 3/10/2026
 Time: 13:13
 Notes: BH26-09 @ 0'
 Stepped out approximately 20'
 Latitude: 32.118002777777775
 Longitude: -104.00283055555556
 Direction: E

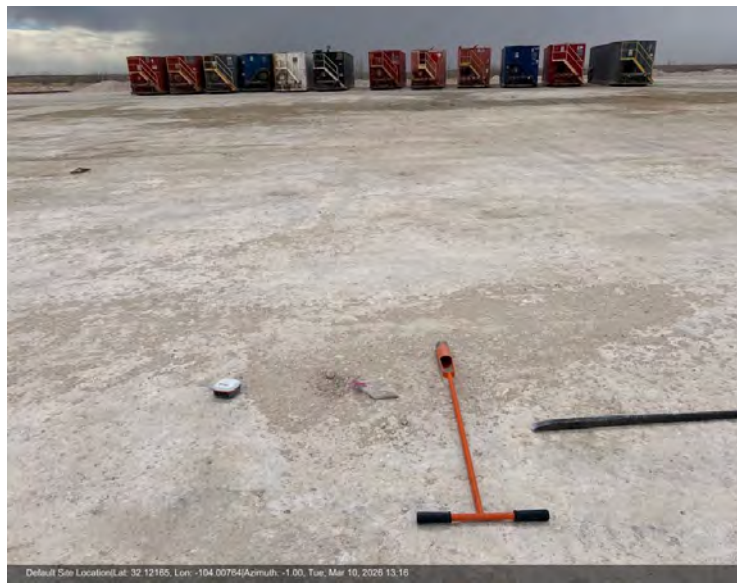
Date: 3/10/2026
 Time: 13:16
 Notes: BH26-10 @ 0'
 Stepped out approximately 20'
 Latitude: 32.12165
 Longitude: -104.007636111111111
 Direction: S

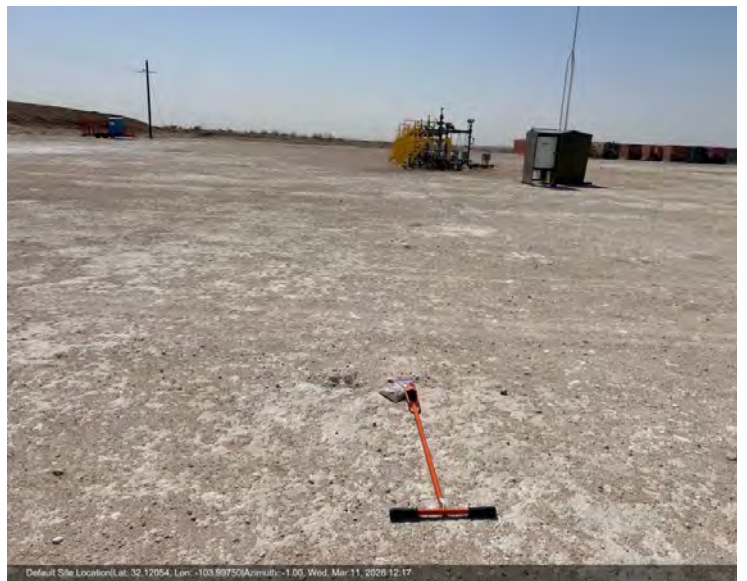
Date: 3/11/2026
 Time: 12:17
 Notes: BH26-06 @ 0 stepped out another 20'
 Latitude: 32.120536111111115
 Longitude: -103.99749722222222
 Direction: NW

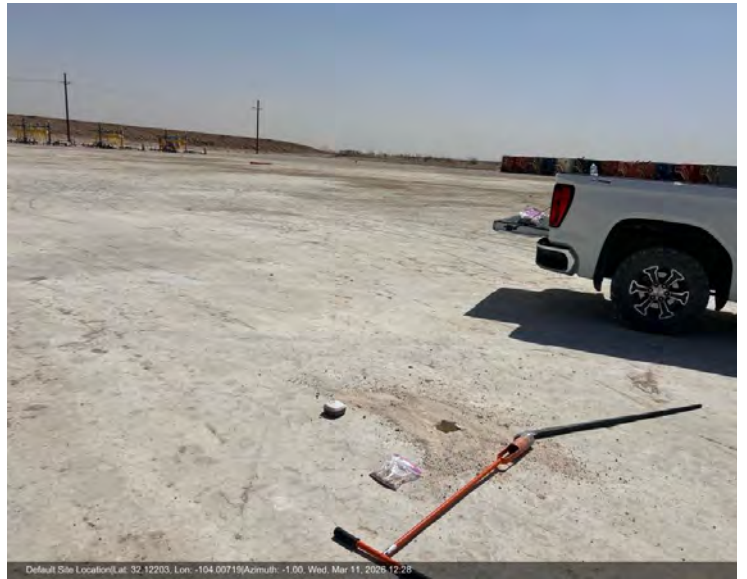
Date: 3/11/2026
 Time: 12:28
 Notes: BH26-04 @ 1' Refusal
 Latitude: 32.12202777777778
 Longitude: -104.00719444444445
 Direction: SW

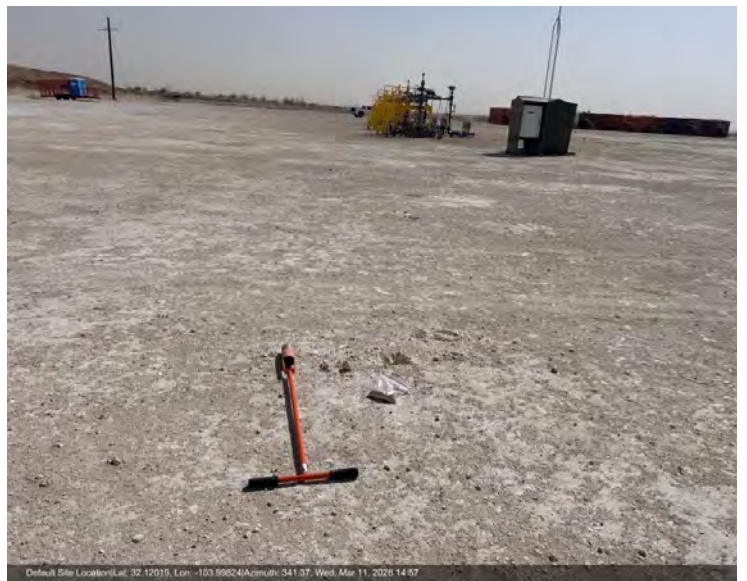
Date: 3/11/2026
Time: 14:57
Notes: BH26-06 @ 1' Refusal
Latitude: 32.12018611111111
Longitude: -103.99824444444445
Direction: E

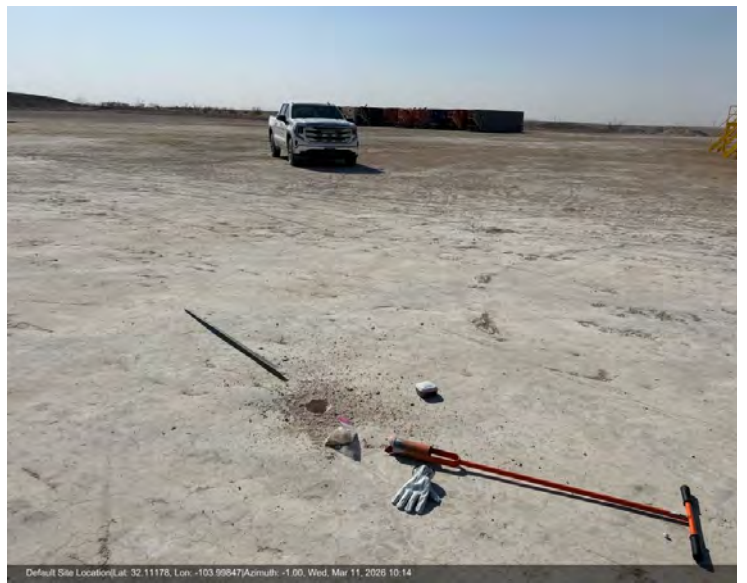
Date: 3/11/2026
 Time: 10:14
 Notes: BH26-04 @ 0 stepped out another 20'
 Latitude: 32.111783333333335
 Longitude: -103.99847222222222
 Direction: NE

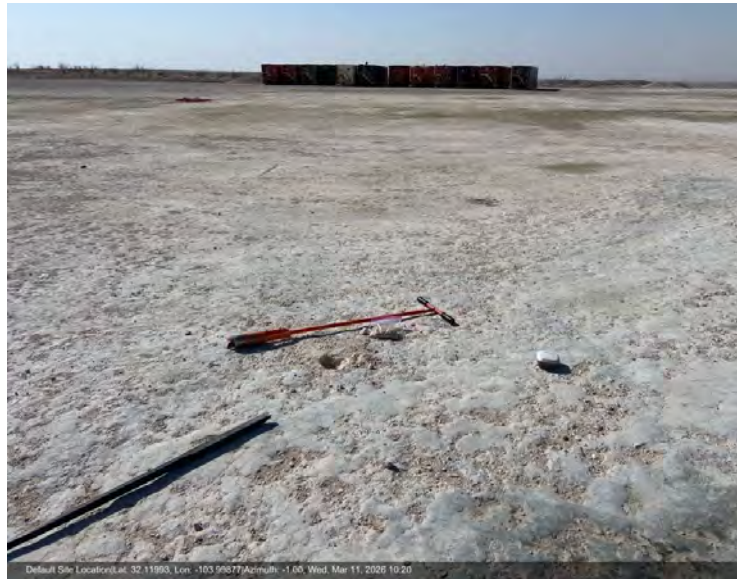
Date: 3/11/2026
 Time: 10:20
 Notes: BH26-05 @ 0 stepped out another 20'
 Latitude: 32.11993055555555
 Longitude: -103.99877222222223
 Direction: SE

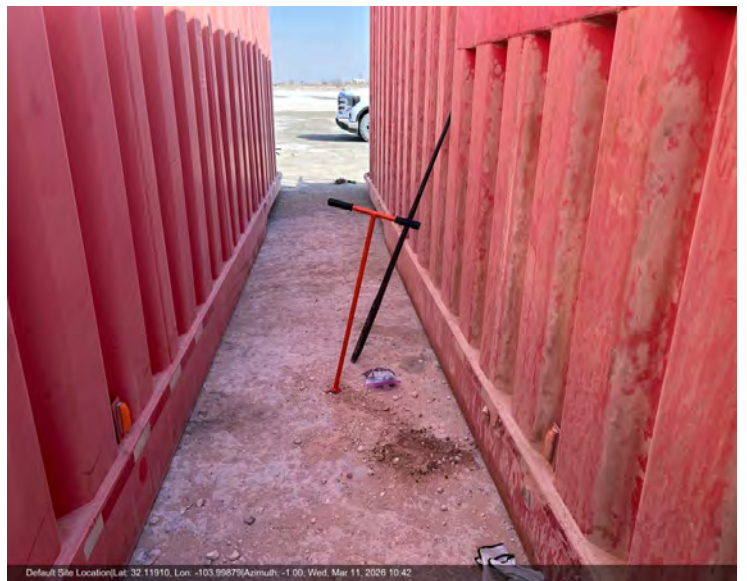
Date: 3/11/2026
 Time: 10:42
 Notes: BH26-02 @ 1' refusal
 Latitude: 32.1191
 Longitude: -103.99878611111112
 Direction: W

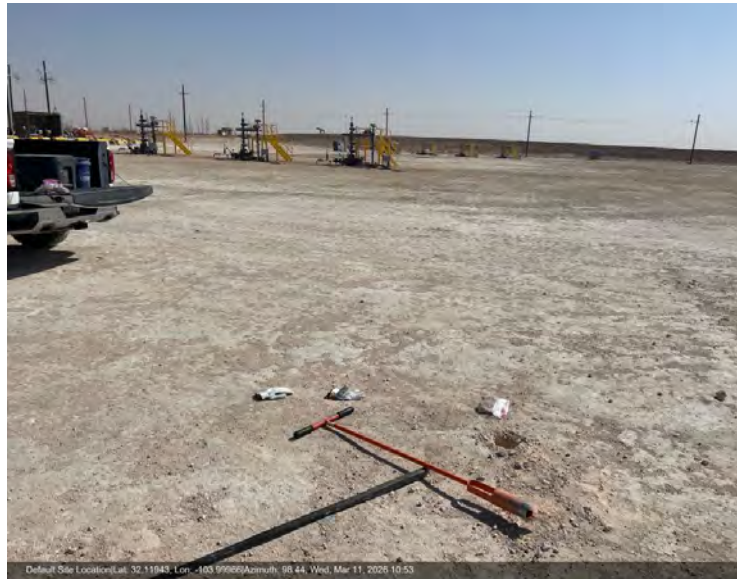
Date: 3/11/2026
 Time: 10:53
 Notes: BH26-03 @ 1' refusal
 Latitude: 32.11942777777778
 Longitude: -103.99965555555556
 Direction: W

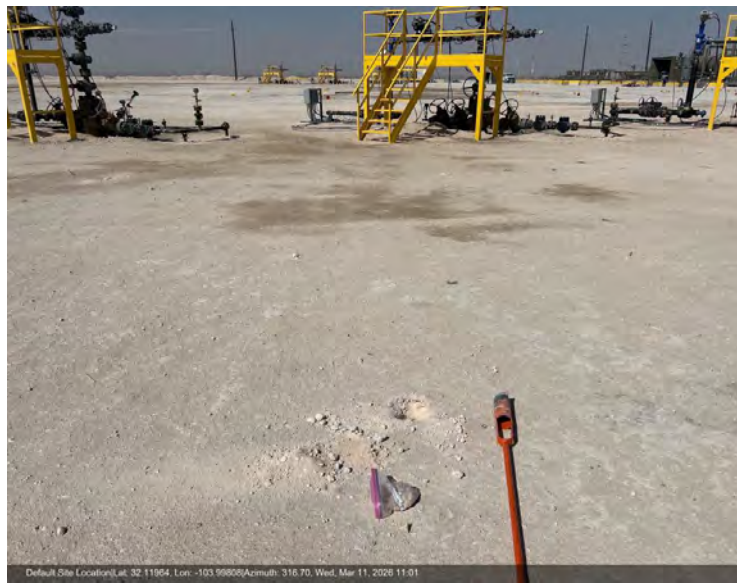
Date: 3/11/2026
 Time: 11:01
 Notes: BH26-07 @ 1' refusal
 Latitude: 32.119644444444445
 Longitude: -103.99807777777778
 Direction: NW

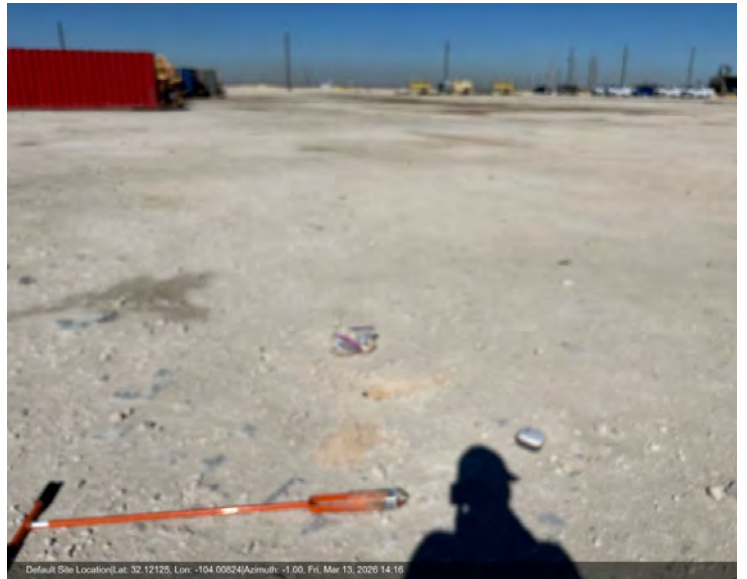
Date: 3/13/2026
 Time: 10:17
 Notes: BH26-01 @ 0'
 BH26-01 @ 1' Refusal
 stepped out again
 Latitude: 32.12125277777778
 Longitude: -104.00823888888888
 Direction: NE

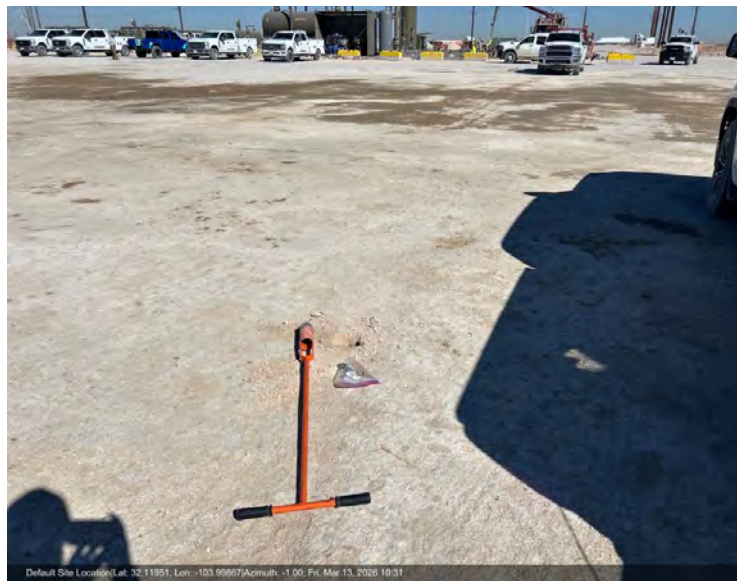
Date: 3/13/2026
 Time: 10:31
 Notes: BH26-08 @ 0.5' Refusal
 Latitude: 32.119511111111111
 Longitude: -103.99867222222223
 Direction: W

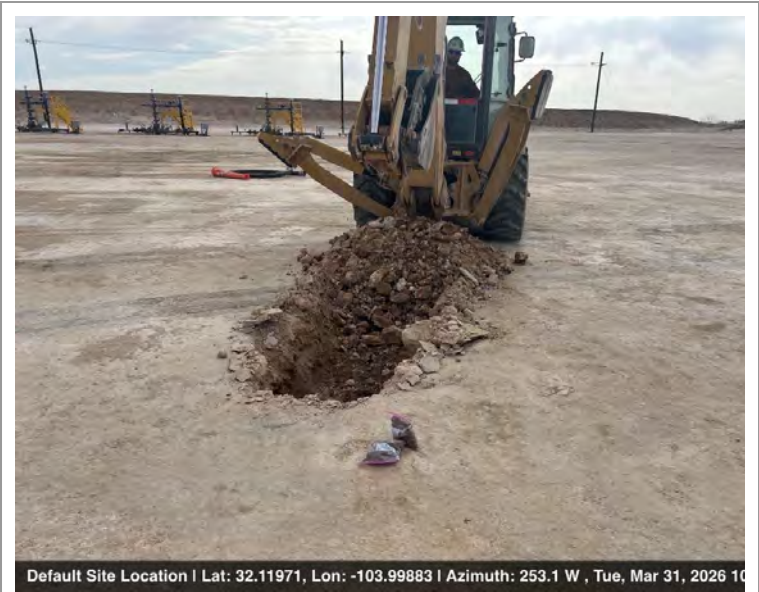
Date: 3/31/2026
 Time: 10:03
 Notes: BH26-08 @ 1'
 BH26-08 @ 2' Refusal
 Bedrock at 2'
 Latitude: 32.11971388888889
 Longitude: -103.99883333333334
 Direction: W

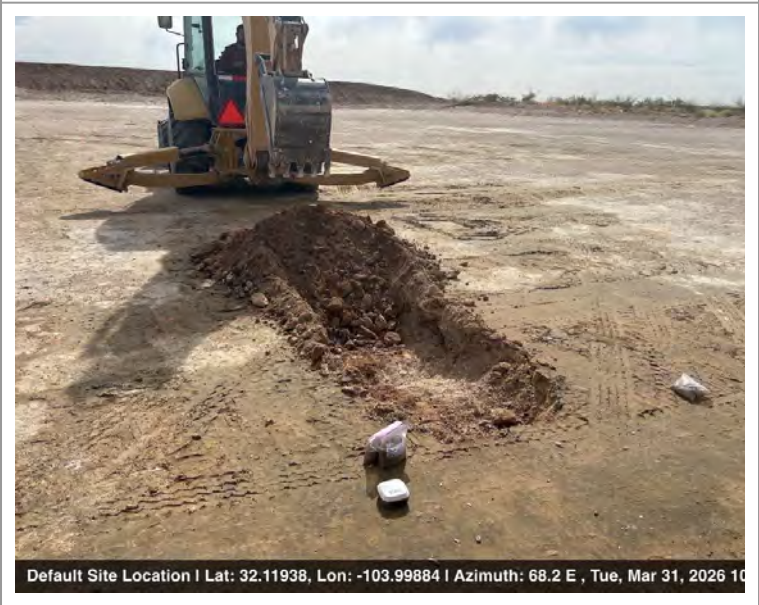
Date: 3/31/2026
 Time: 10:18
 Notes: BH26-11 @ 0'
 BH26-11 @ 1'
 BH26-11 @ 1.5 Refusal
 Bedrock at 1.5'
 Latitude: 32.11938055555556
 Longitude: -103.99883888888888
 Direction: E

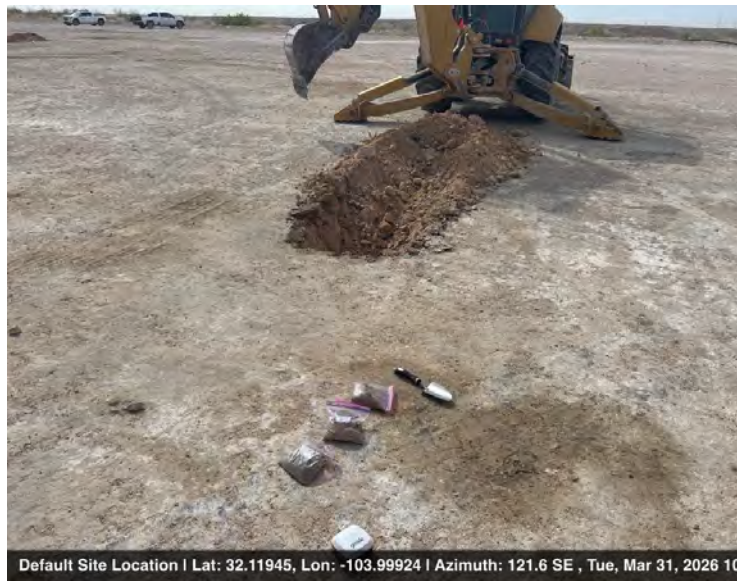
Date: 3/31/2026
 Time: 10:19
 Notes: BH26-13 @ 0
 BH26-13 @ 1'
 BH26-13 @ 2'
 Latitude: 32.11945
 Longitude: -103.99924444444444
 Direction: SE

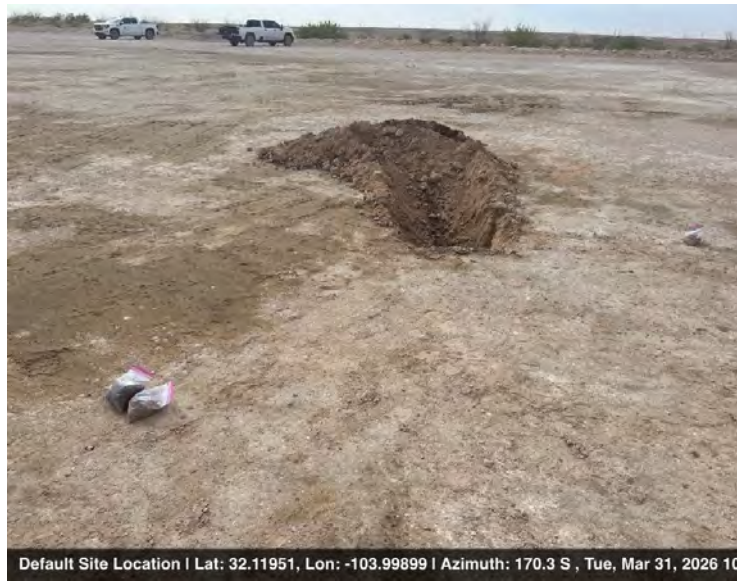
Date: 3/31/2026
 Time: 10:23
 Notes: BH26-12 @ 0'
 BH26-12 @ 1'
 BH26-12 @ 2'
 Latitude: 32.119505555555556
 Longitude: -103.99899444444445
 Direction: S

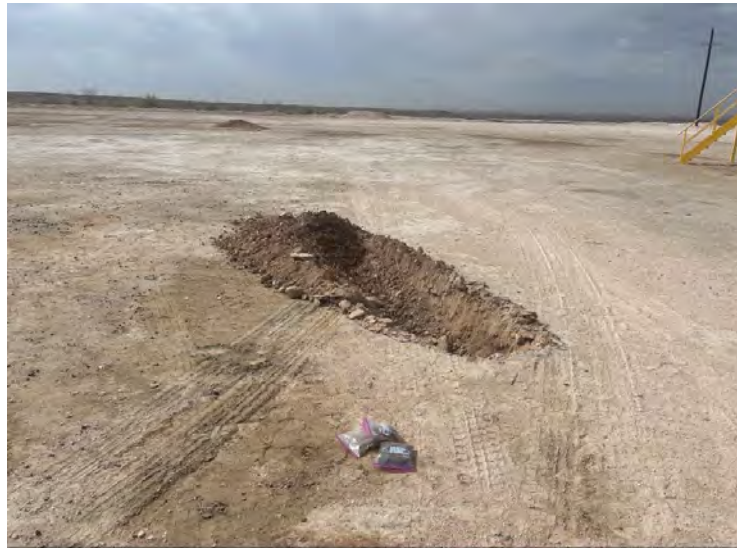
Date: 3/31/2026
 Time: 10:28
 Notes: BH26-14 @ 0'
 BH26-14 @ 1'
 BH26-14 @ 2'
 Latitude: 32.119686111111115
 Longitude: -103.99896111111111
 Direction: N

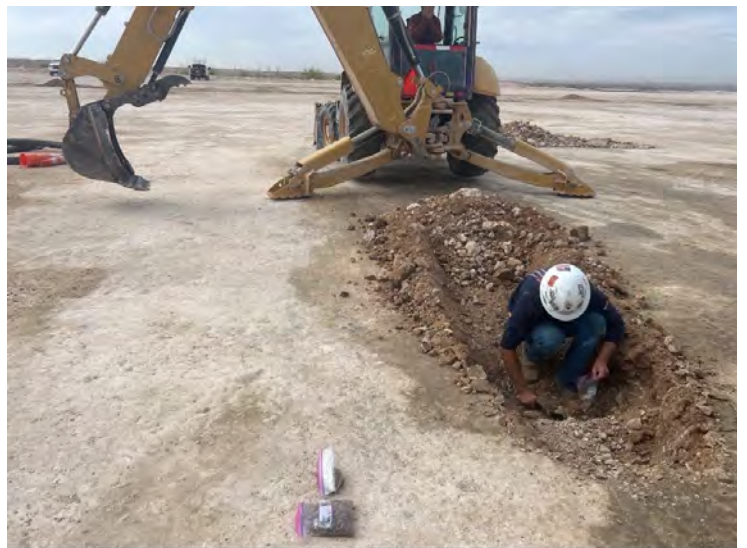
Date: 3/31/2026
 Time: 10:32
 Notes: BH26-15 @ 0'
 BH26-15 @ 1'
 BH26-15 @ 1.5' Refusal
 Bedrock at 1.5'
 Latitude: 32.119705555555555
 Longitude: -103.999
 Direction: E

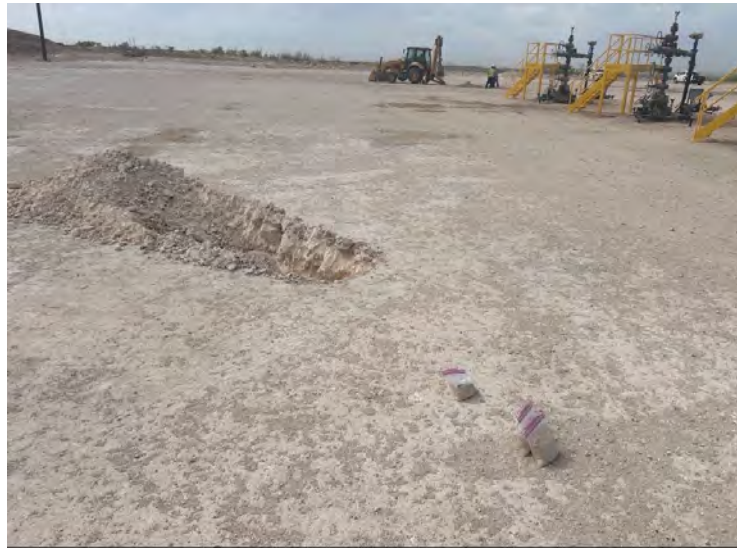
Date: 3/31/2026
 Time: 10:40
 Notes: BH26-16 @ 0
 BH26-16 @ 1'
 BH26-16 @ 2'
 Latitude: 32.119797222222225
 Longitude: -103.99814722222223
 Direction: E

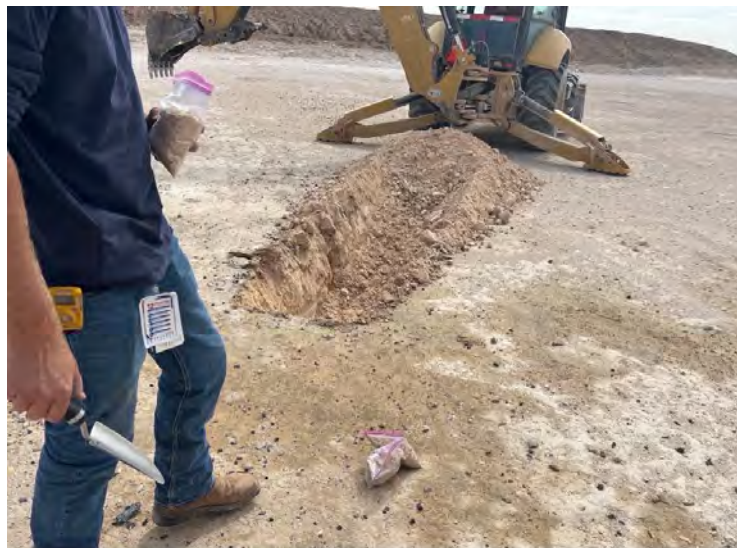
Date: 3/31/2026
 Time: 10:42
 Notes: BH26-17 @ 0'
 BH26-17 @ 1'
 BH26-17 @ 2'
 Latitude: 32.120044444444446
 Longitude: -103.99803055555556
 Direction: SE

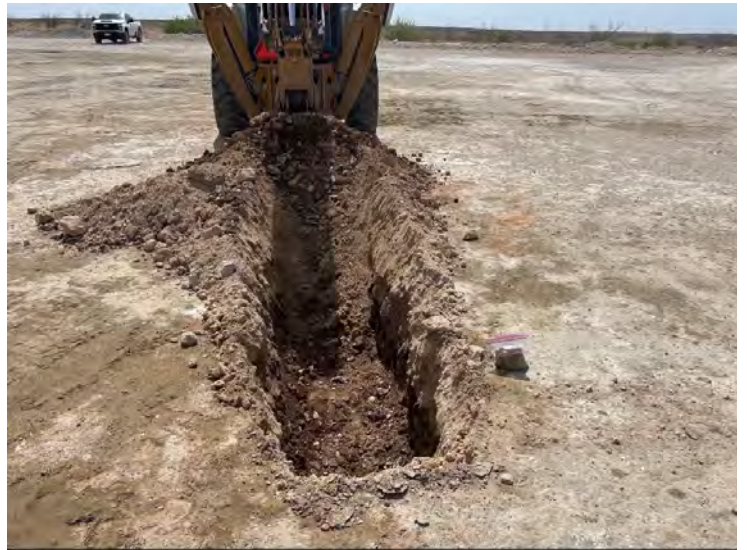
Date: 3/31/2026
 Time: 12:11
 Notes: BH26-12 @ 3' Refusal
 Latitude: 32.11937222222225
 Longitude: -103.99906111111112
 Direction: NW
